Expertise

Protocol number: 41065478  
Order No. / Reference: 25050547  
Inspection date: 14 Aug 2025

Manufacturer: Ford

Model: Focus 1.0 EcoBoost Start-Stopp-System TITANIUM

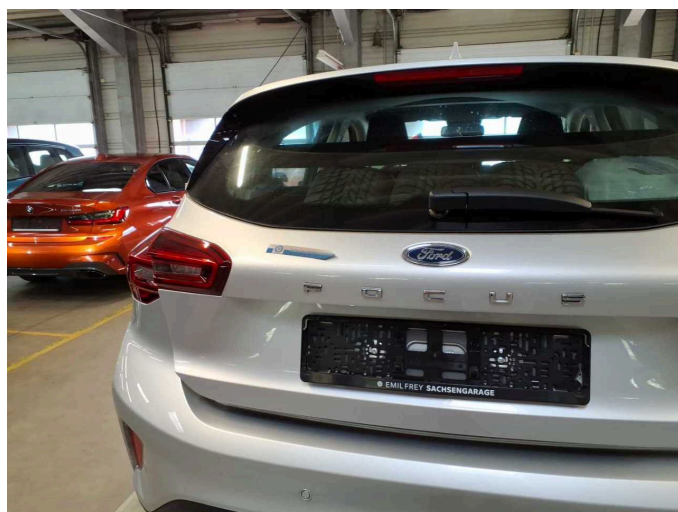
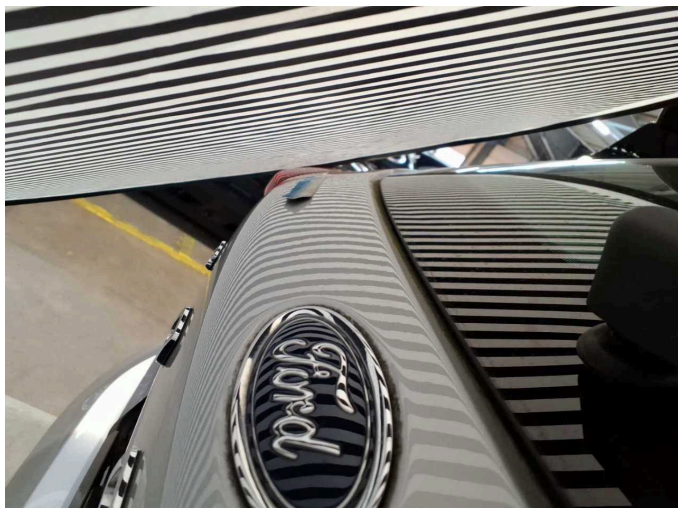
No.	Component group	Description
1	Misc.	Main inspection - No evidence - No deduction
2	Boot lid / rear door	Boot lid - dent(s) - Smooth repair work

Damage 2: Boot lid / rear door: Boot lid - dent(s) - Smooth repair work

**Damage 2:** Boot lid / rear door: Boot lid - dent(s) - Smooth repair work

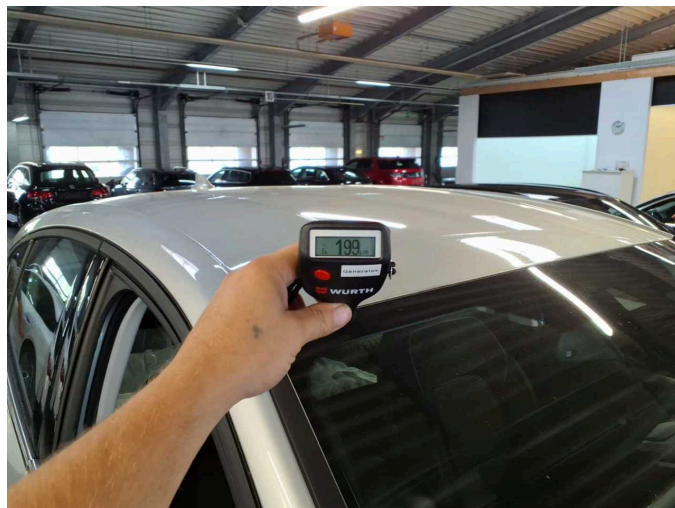
1	Roof, Professionally carried out, Invoice of repair done Non-existent
2	Boot lid / rear door, Professionally carried out, Invoice of repair done Non-existent
3	Mudguard - left side, Professionally carried out, Invoice of repair done Non-existent
4	Mudguard - right side, Professionally carried out, Invoice of repair done Non-existent
5	Bonnet, Professionally carried out, Invoice of repair done Non-existent
6	Side panel - rear left side, Professionally carried out, Invoice of repair done Non-existent
7	Side panel - rear right side, Professionally carried out, Invoice of repair done Non-existent
8	Door - rear left side, Professionally carried out, Invoice of repair done Non-existent
9	Door - rear right side, Professionally carried out, Invoice of repair done Non-existent
10	Door - front left side, Professionally carried out, Invoice of repair done Non-existent
11	Door - front right side, Professionally carried out, Invoice of repair done Non-existent

Roof	199 µm	Boot lid / rear door	221 µm
Mudguard - left side	176 µm	Mudguard - right side	186 µm
Bonnet	198 µm	Side panel - rear left side	188 µm
Side panel - rear right side	176 µm	Door - rear left side	179 µm
Door - rear right side	184 µm	Door - front left side	199 µm
Door - front right side	179 µm

**Repainting 1:** Roof

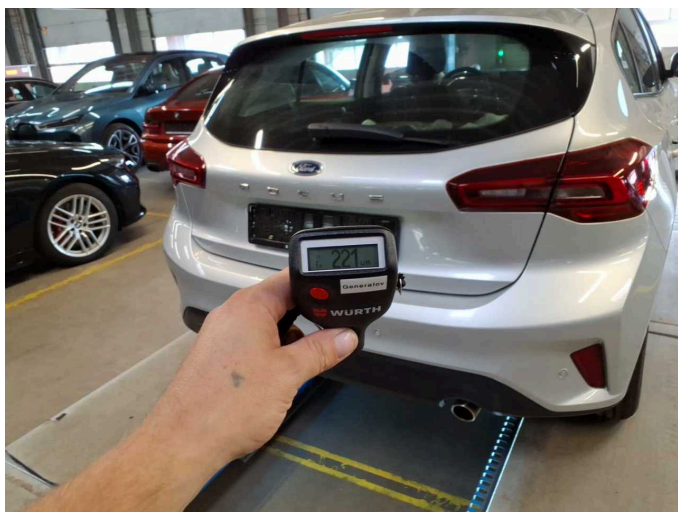
**Repainting 2:** Boot lid / rear door

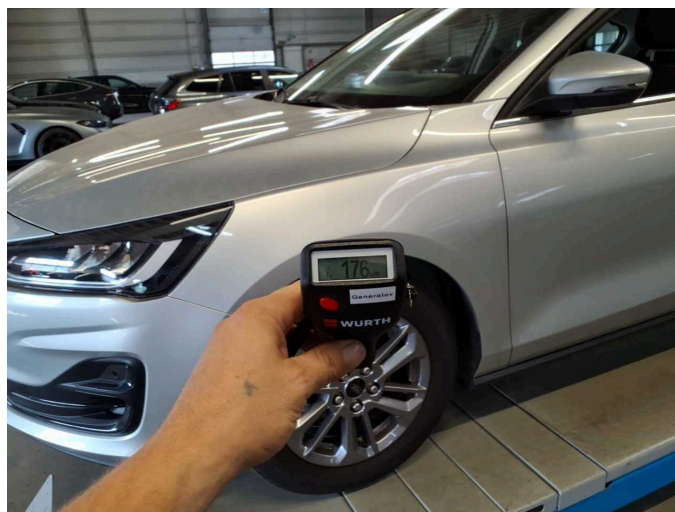
**Repainting 3:** Mudguard - left side

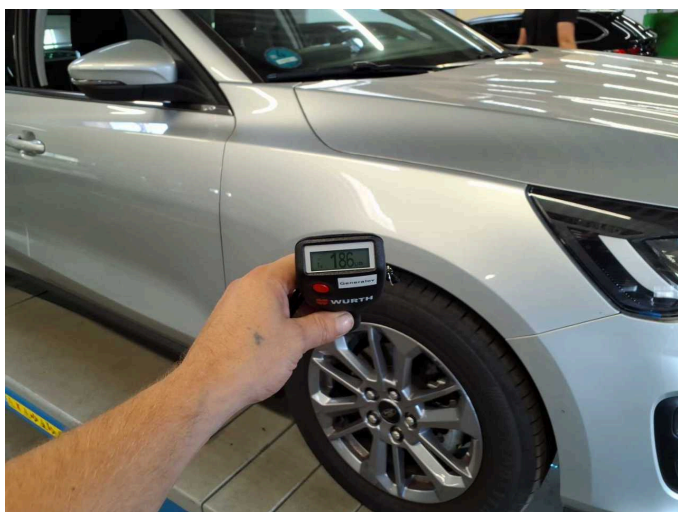
**Repainting 4:** Mudguard - right side

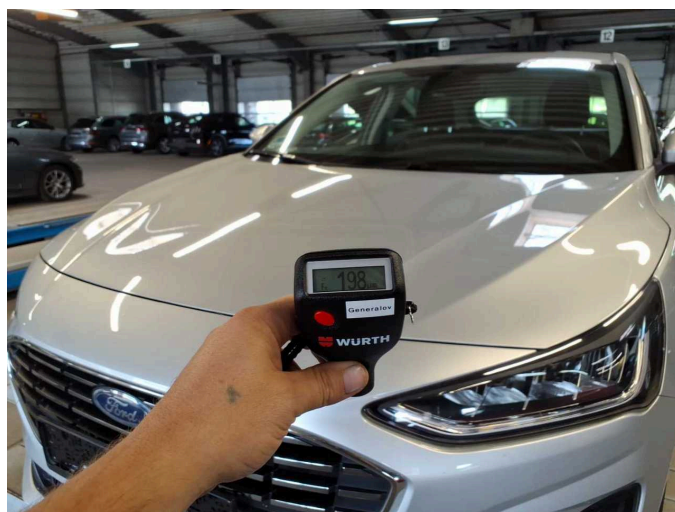
**Repainting 5:** Bonnet

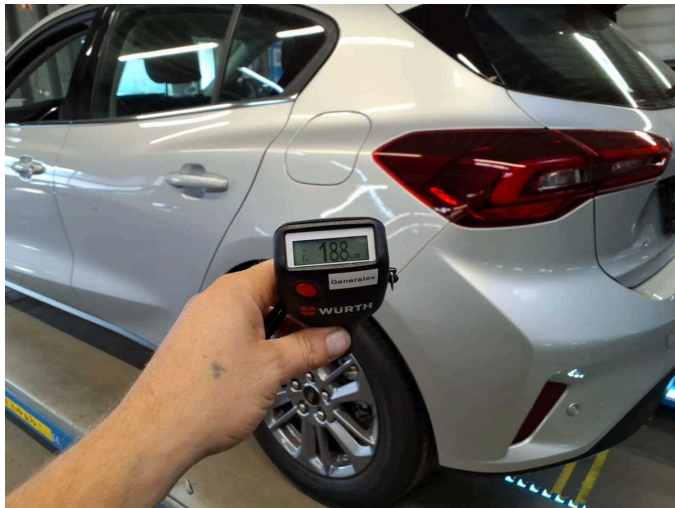
**Repainting 6:** Side panel - rear left side

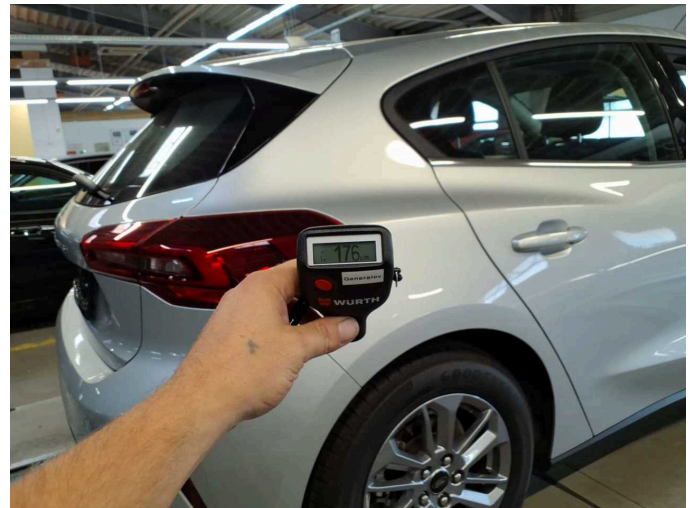
**Repainting 7:** Side panel - rear right side

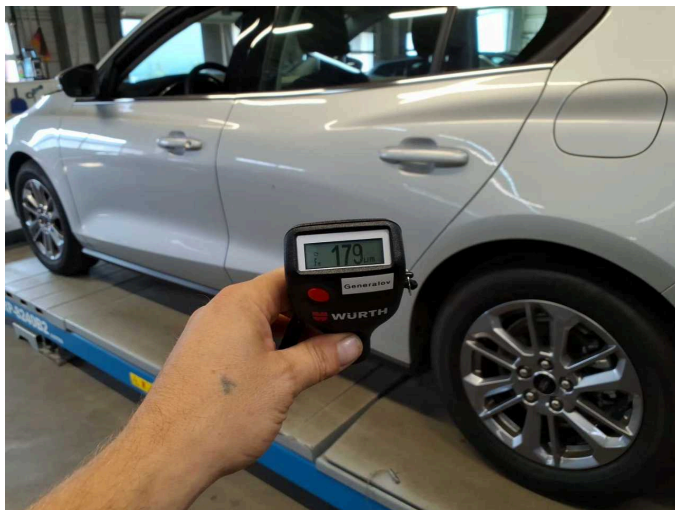
**Repainting 8:** Door - rear left side

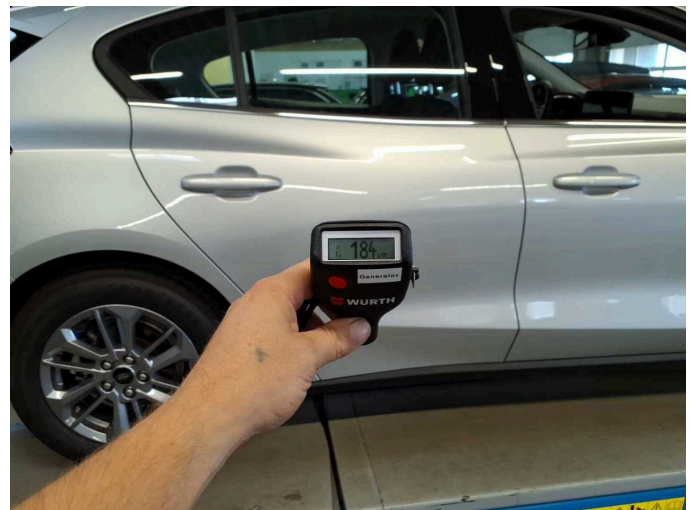
**Repainting 9:** Door - rear right side

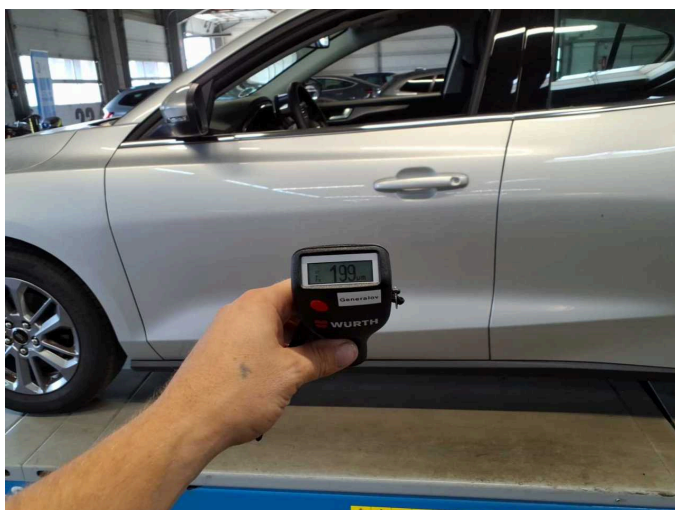
**Repainting 10:** Door - front left side

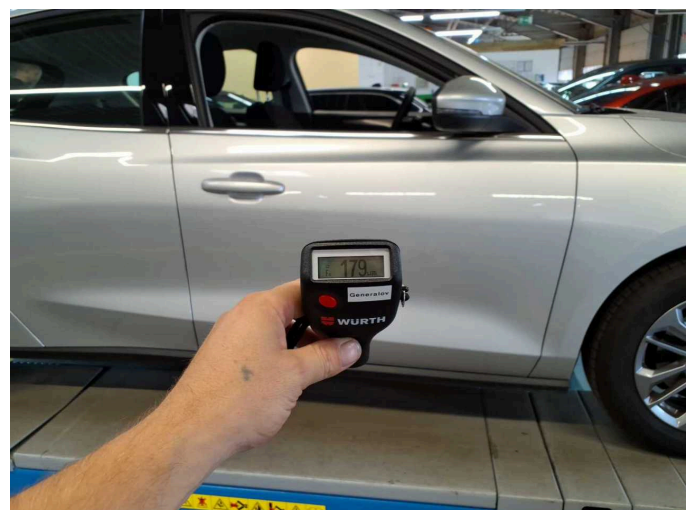
**Repainting 11:** Door - front right side
