Expertise

Protocol number: 40807328
Order No. / Reference: 25019778
Inspection date: 28 Jul 2025

Manufacturer: Ford

Model: Focus 1.0 EcoBoost Start-Stopp-System TITANIUM

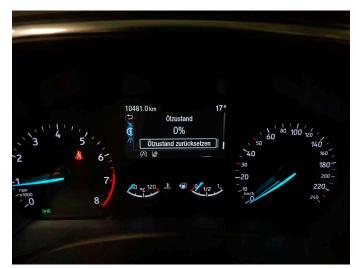
Damage 1: Misc.: Inspection / maintenance - Due - Perform

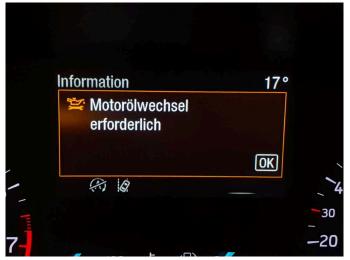
Damage 1: Misc.: Inspection / maintenance - Due - Perform

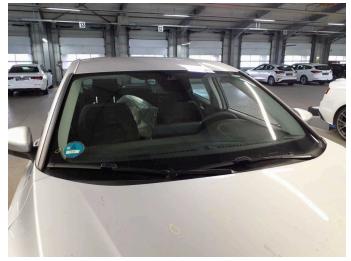
Damage 2: Vehicle glazing: Windscreen with lane departure assistant - Stone chips - Replace

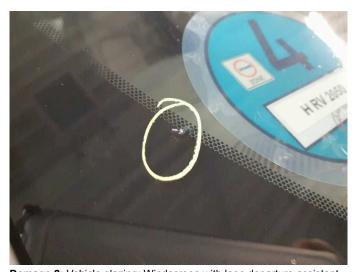
Damage 2: Vehicle glazing: Windscreen with lane departure assistant - Stone chips - Replace

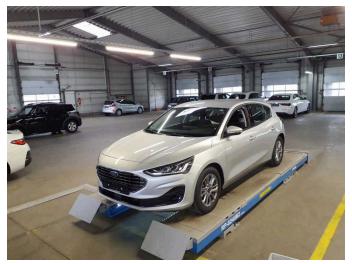
Damage 3: Body: Body - Damage by hail - Smooth repair work

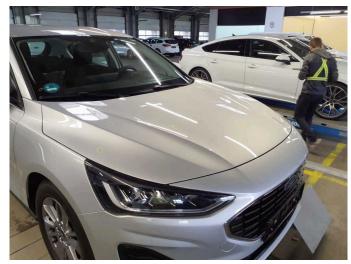
Damage 3: Body: Body - Damage by hail - Smooth repair work

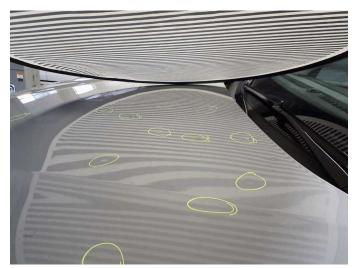
Damage 3: Body: Body - Damage by hail - Smooth repair work

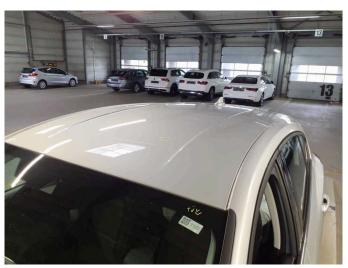
Damage 3: Body: Body - Damage by hail - Smooth repair work

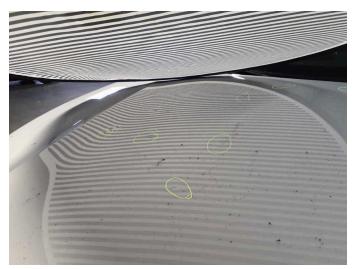
Damage 3: Body: Body - Damage by hail - Smooth repair work

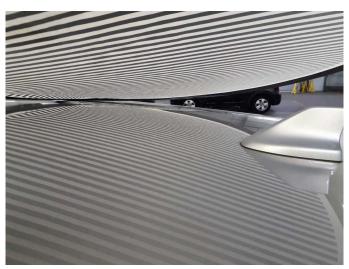
Damage 3: Body: Body - Damage by hail - Smooth repair work

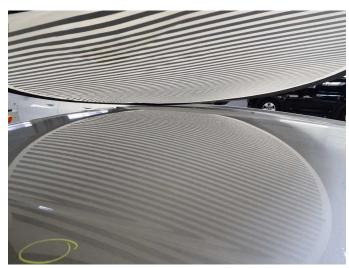
Damage 3: Body: Body - Damage by hail - Smooth repair work

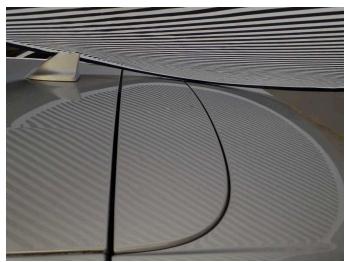
Damage 3: Body: Body - Damage by hail - Smooth repair work

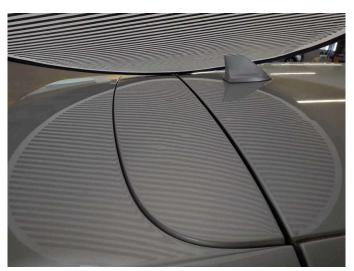
Damage 3: Body: Body - Damage by hail - Smooth repair work

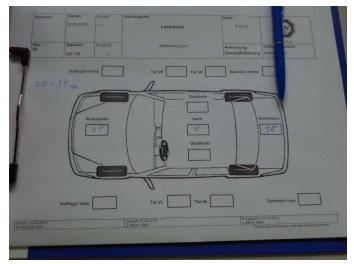
Damage 3: Body: Body - Damage by hail - Smooth repair work
