# FORD Focus 2018 SW Diesel Focus SW 1.5 ecoblue ST-Line s&s 120cv

VIN NO WF0PXXGCHPKC42710 Registration Number FV440VH

## **Inspection Report Summary**

Customer	BCA Lodi	Report Number	P20250923161240
Inspection Date / Place	2025-09-23 / BCA Lodi	Cosmetic Grade	3

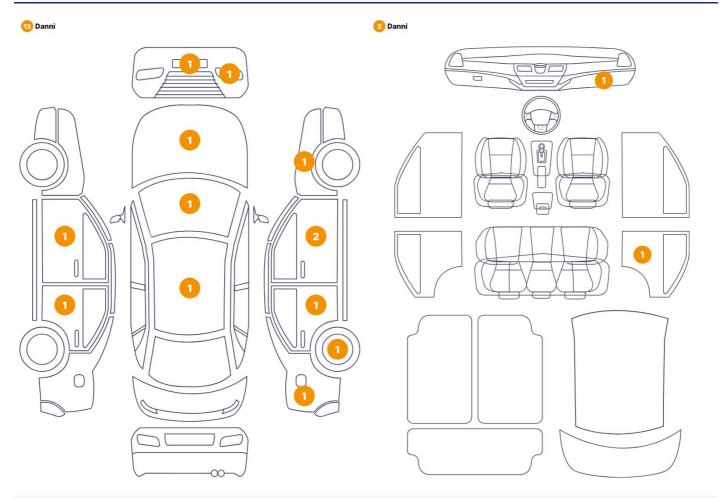
Component	Damage	Comments
1	Fender / Front Right	Bodywork / Poor Previous Repair	
2	Door / Front Right	Bodywork / Poor Previous Repair	
3	Door / Back Right	Bodywork / Poor Previous Repair	
4	Rim / Back Right	Out of Bodywork / Scratch	
5	Fender / Back Right	Bodywork / Poor Previous Repair	
6	Pillar / Front Right	Bodywork / Poor Previous Repair	
7	Front Light / Front Right	Glass Break	
8	Bumper / Front	Bodywork / Poor Previous Repair	
9	Hood	Paint / Chipping	
10	Windshield / Front	Glass Break / Impact	
11	Door / Back Left	Bodywork / Dent	
12	Door / Front Left	Paint / Scratch / Line

13	Roof	Bodywork / Poor Previous Repair
14	Panel Filling / Back Right	Interior / Scratched
15	Dashboard / Front	Interior / Scratched

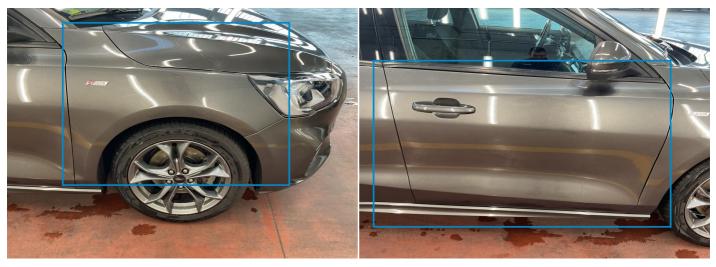
1. Fender / Front Right Bodywork / Poor Previous Repair -

2. Door / Front Right Bodywork / Poor Previous Repair -

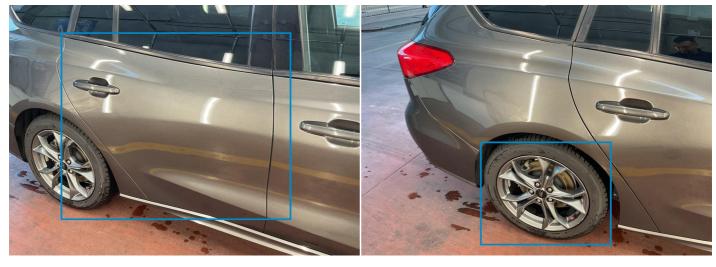
3. Door / Back Right Bodywork / Poor Previous Repair -

4. Rim / Back Right
Out of Bodywork / Scratch -

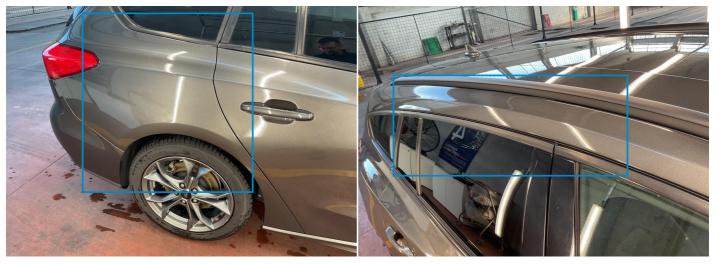
5. Fender / Back Right Bodywork / Poor Previous Repair -

6. Pillar / Front Right Bodywork / Poor Previous Repair -

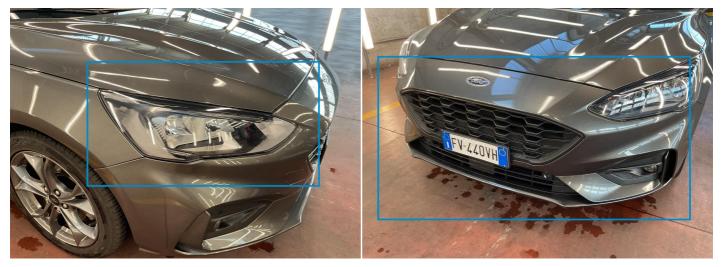
7. Front Light / Front Right Glass Break -

8. Bumper / Front Bodywork / Poor Previous Repair -

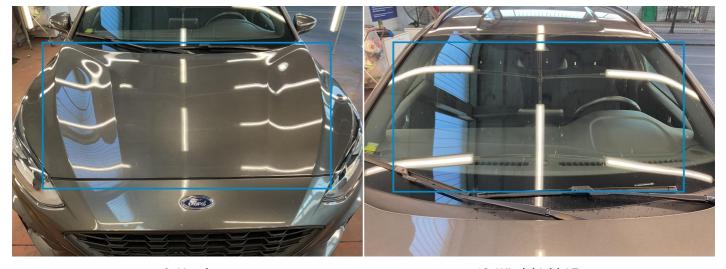
9. Hood Paint / Chipping -

10. Windshield / Front Glass Break / Impact -

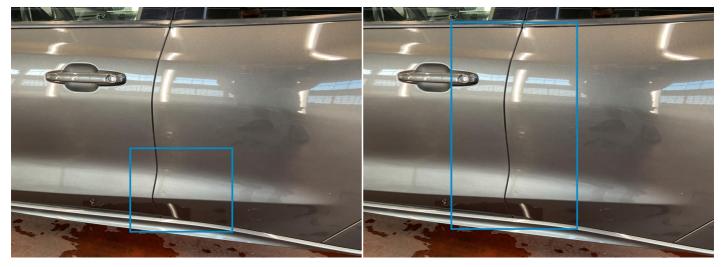
11. Door / Back Left Bodywork / Dent -

12. Door / Front Left Paint / Scratch / Line -

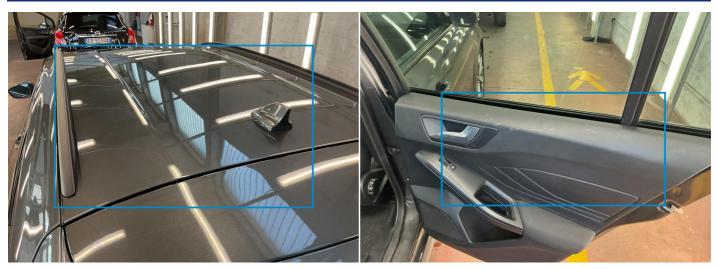
13. Roof Bodywork / Poor Previous Repair -

14. Panel Filling / Back Right Interior / Scratched -

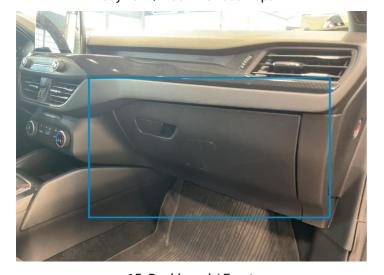
15. Dashboard / Front Interior / Scratched -
