Expertise

Protocol number: 39768565  
Order No. / Reference: 24769021  
Inspection date: 13 May 2025

Manufacturer: Ford

Model: Focus Turnier 1.5 EcoBlue Start-Stopp-System Aut. ACTIVE

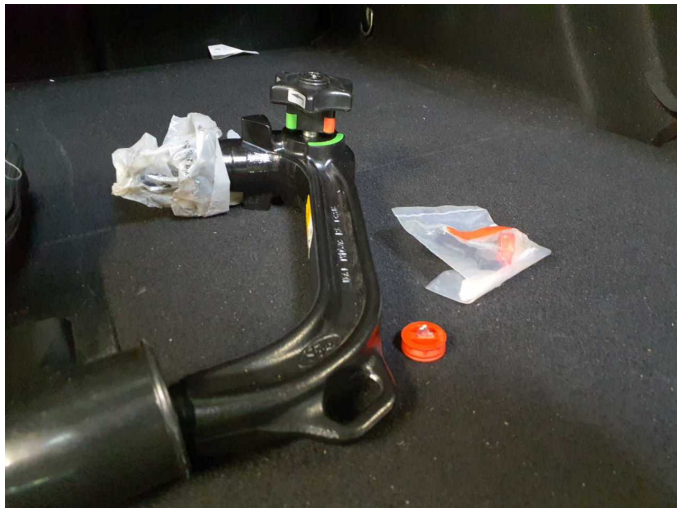
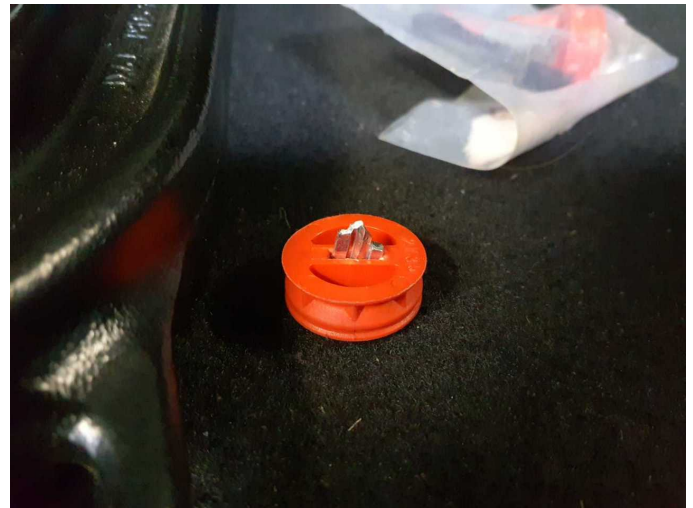
| No. | Component group | Description |
|---|---|---|
| 1 | Rear of vehicle | Key trailer hitch - Broken / torn - Replace |

**Damage 1:** Rear of vehicle: Key trailer hitch - Broken / torn - Replace

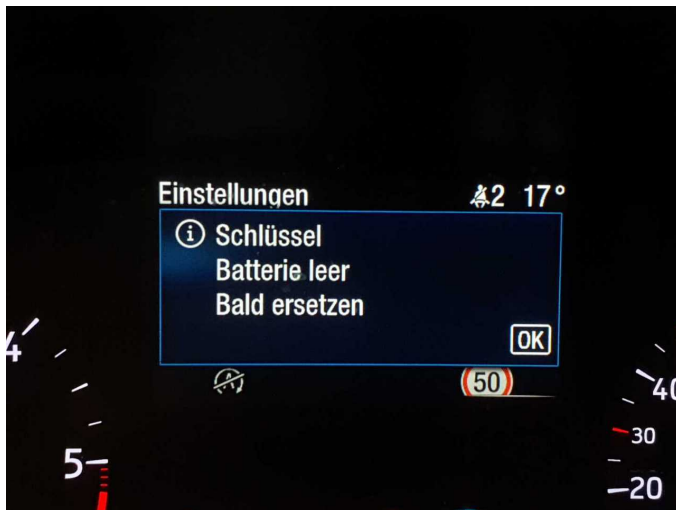
| No. | Component group | Description |
|---|---|---|
| 2 | Equipment | Vehicle key (Batterie) - Empty - Replace |

**Damage 2:** Equipment: Vehicle key (Batterie) - Empty - Replace

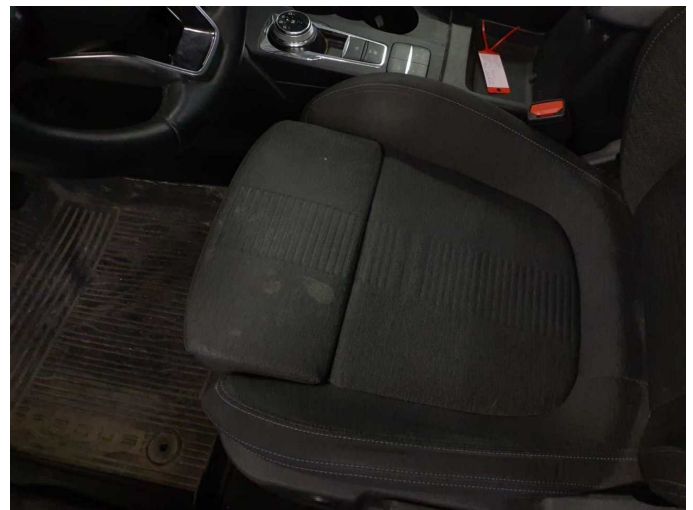
| No. | Component group | Description |
|---|---|---|
| 3 | Seat - front | Seat cover - left side - Soiled - Clean |

**Damage 3:** Seat - front: Seat cover - left side - Soiled - Clean

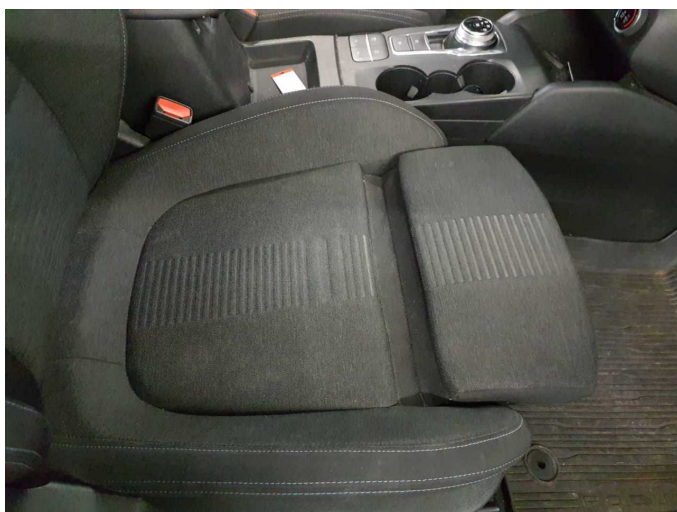
| No. | Component group | Description |
|---|---|---|
| 4 | Seat - front | Seat cover - right side - Soiled - Clean |

**Damage 4:** Seat - front: Seat cover - right side - Soiled - Clean

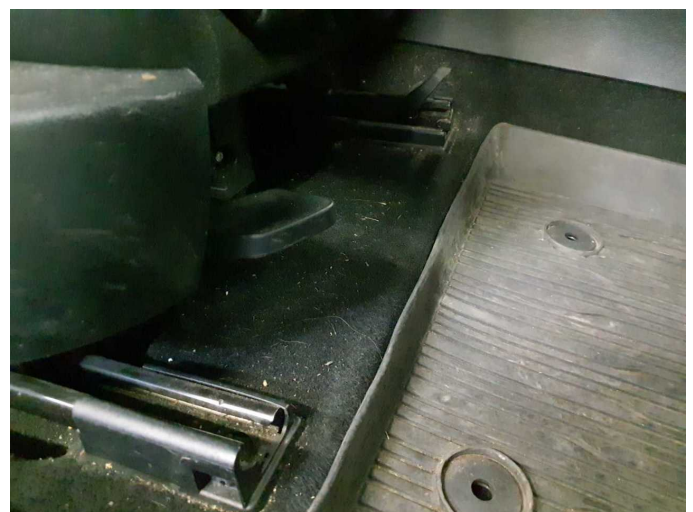
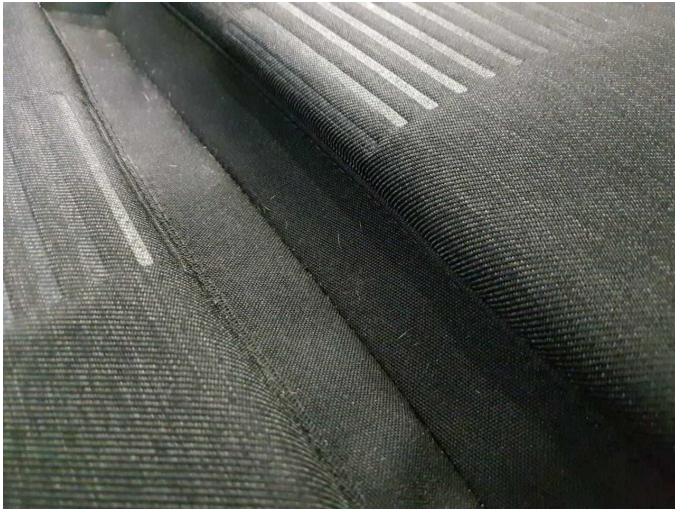
| No. | Component group | Description |
|---|---|---|
| 5 | Interior | Interior - Odour - Ozone treatment |

**Damage 5:** Interior: Interior - Odour - Ozone treatment

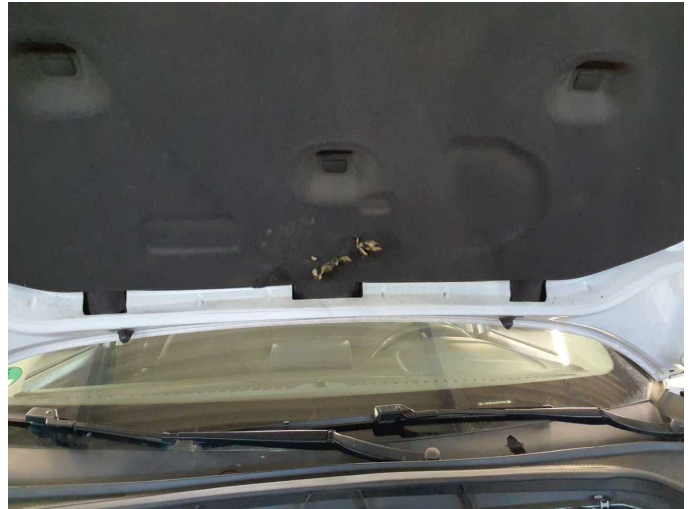
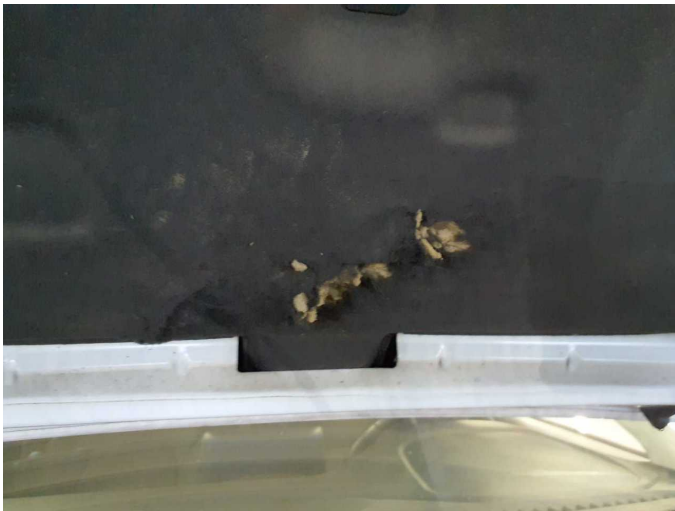
| No. | Component group | Description |
|---|---|---|
| 6 | Bonnet | Insulation lining - Holes - Replace |

**Damage 6:** Bonnet: Insulation lining - Holes - Replace

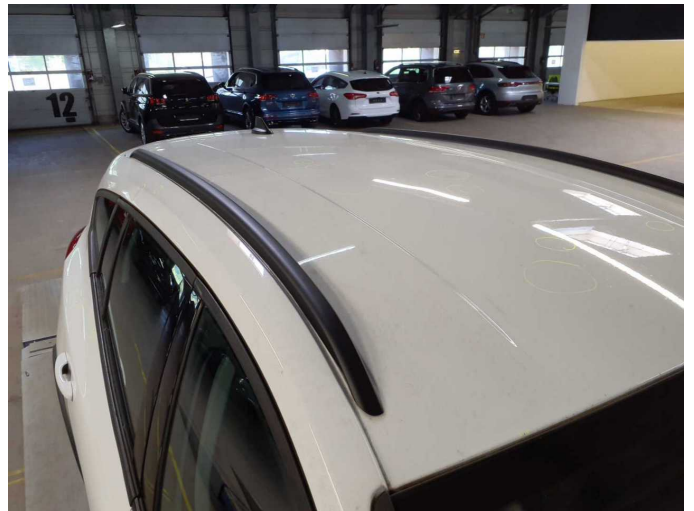
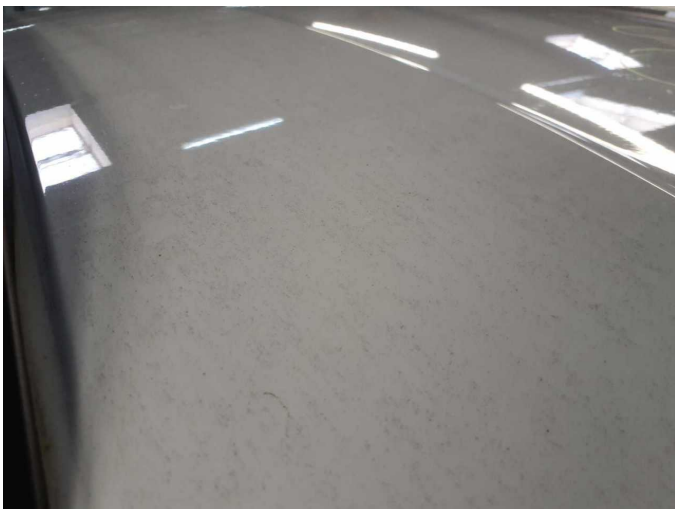
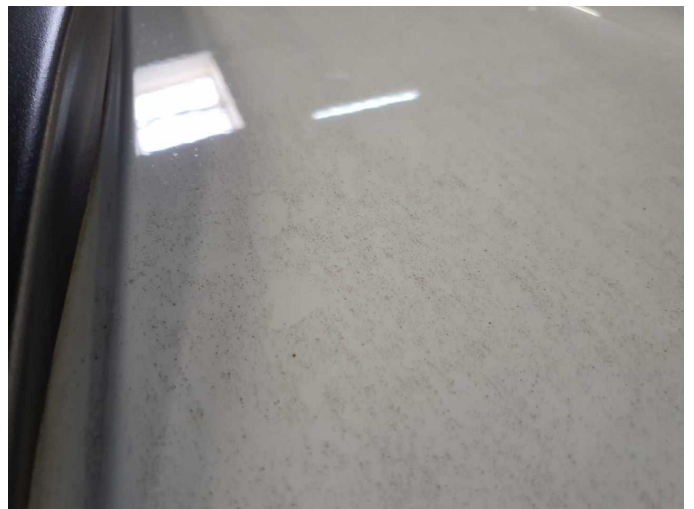
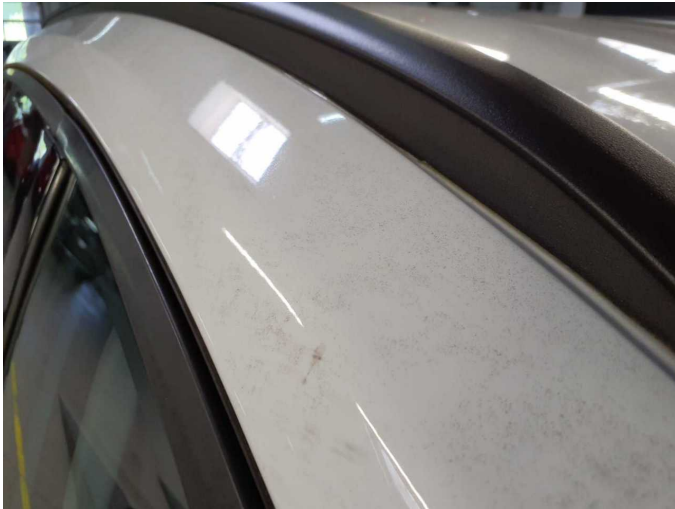
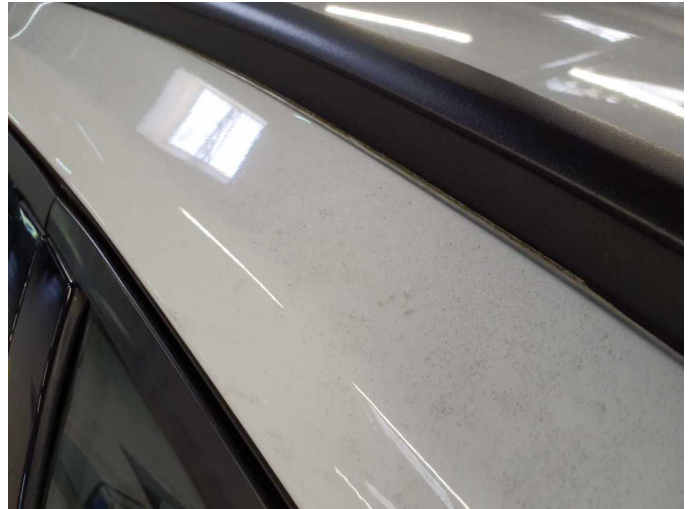
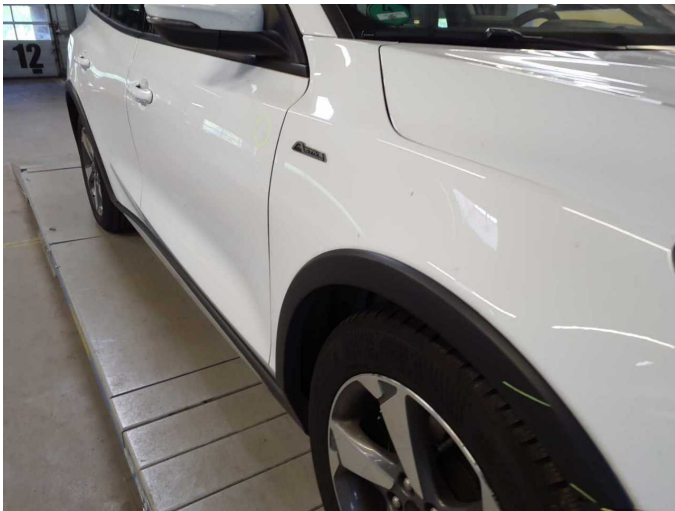
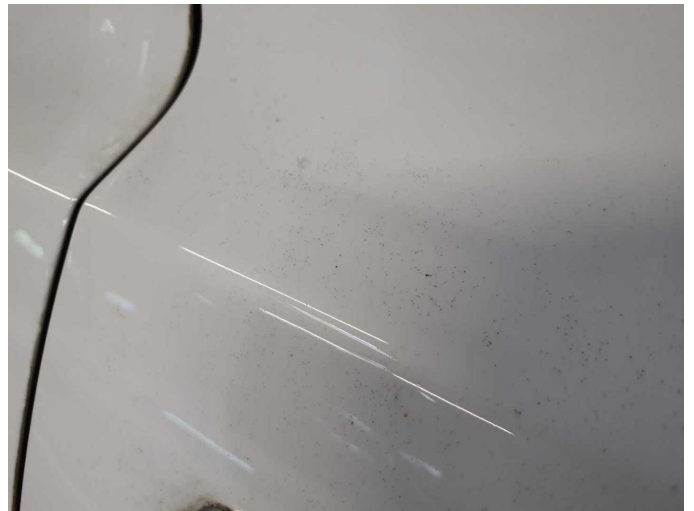
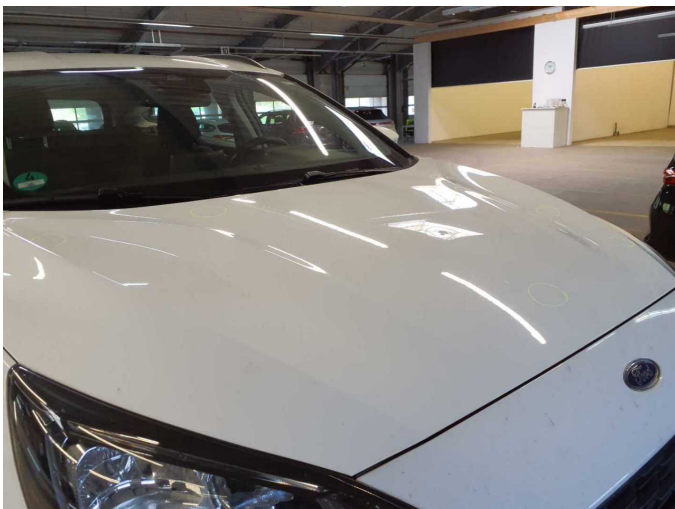
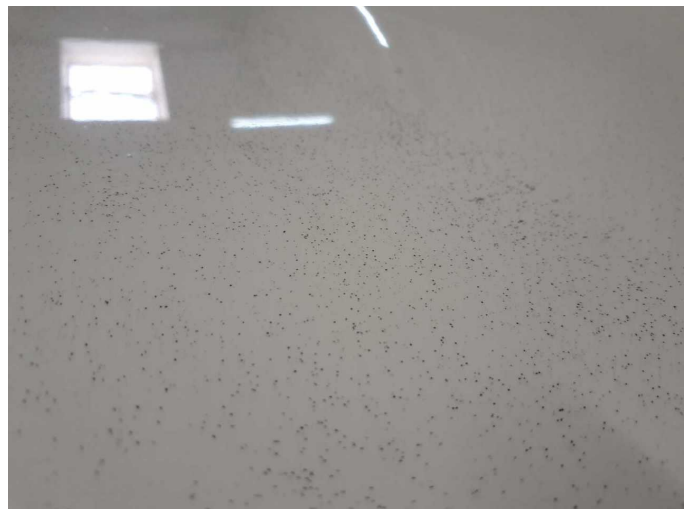
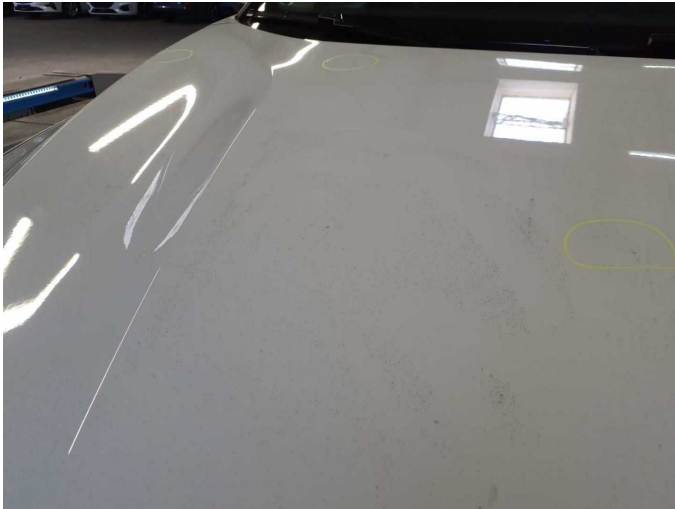
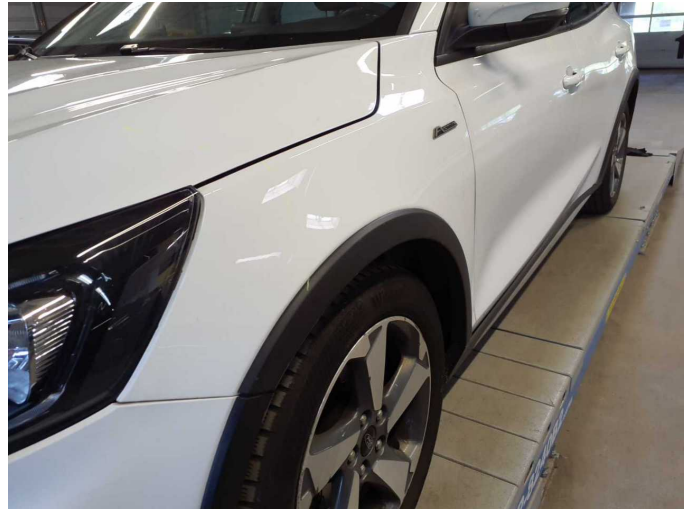
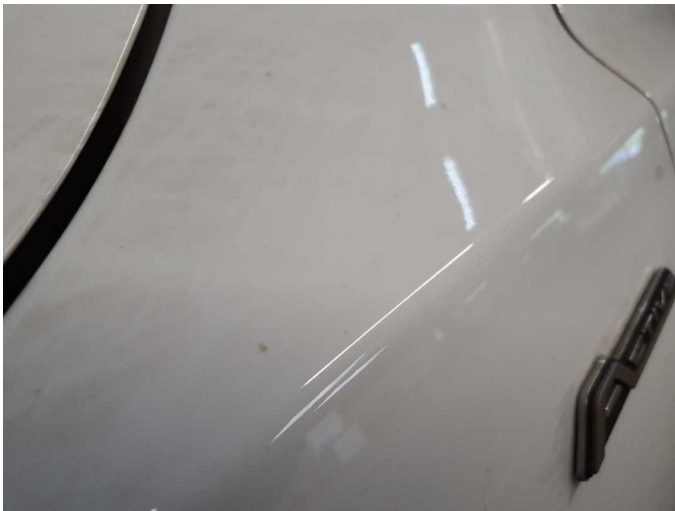
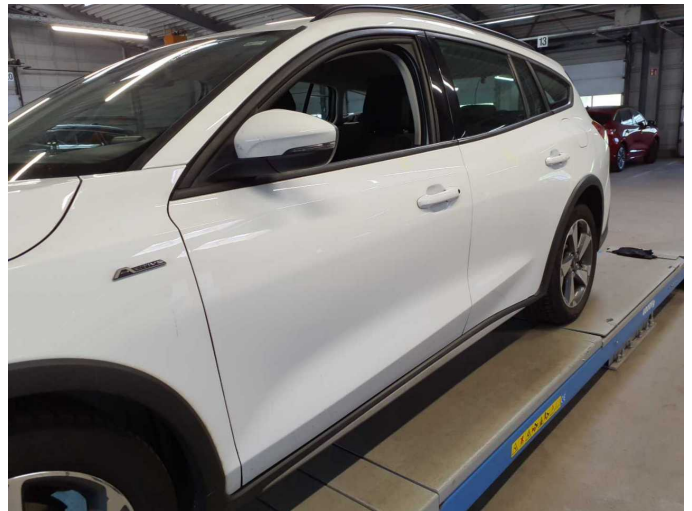
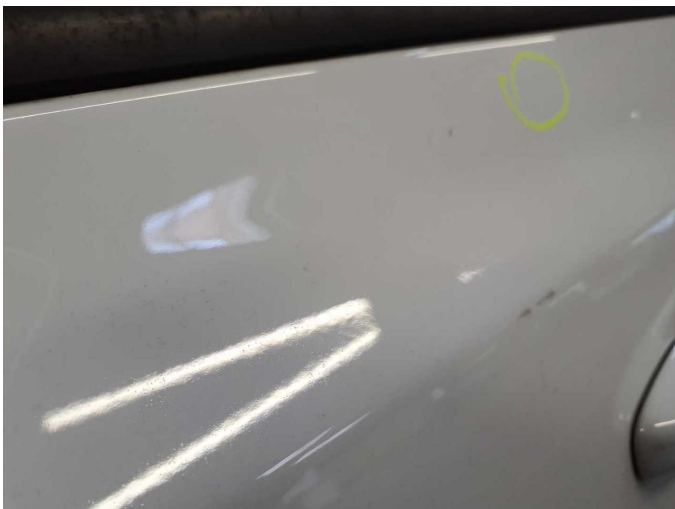
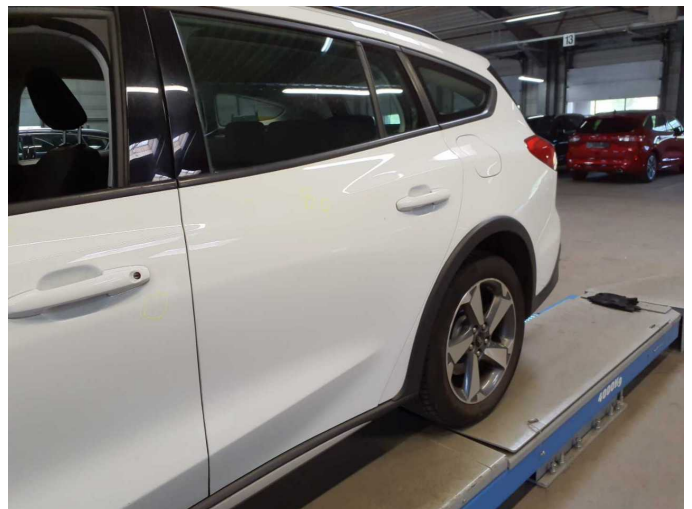
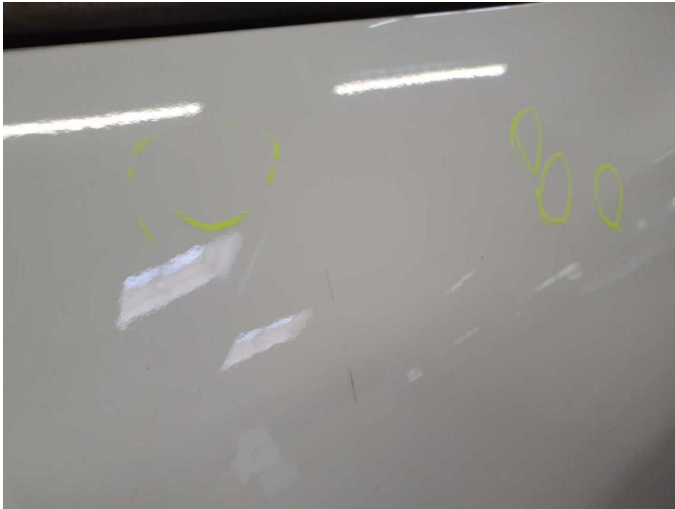
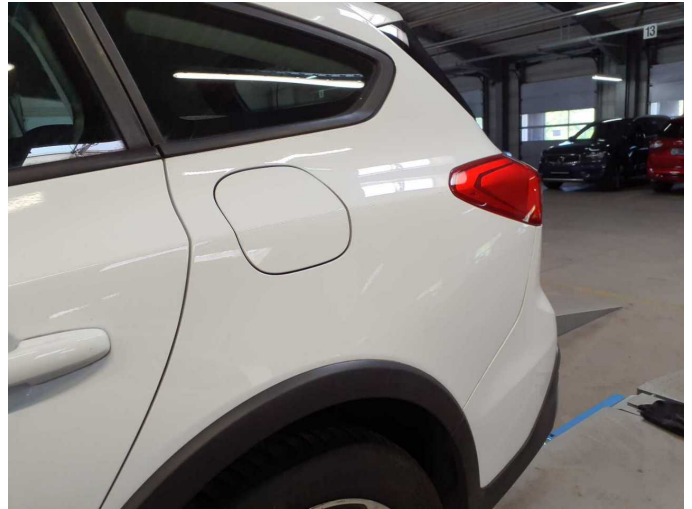
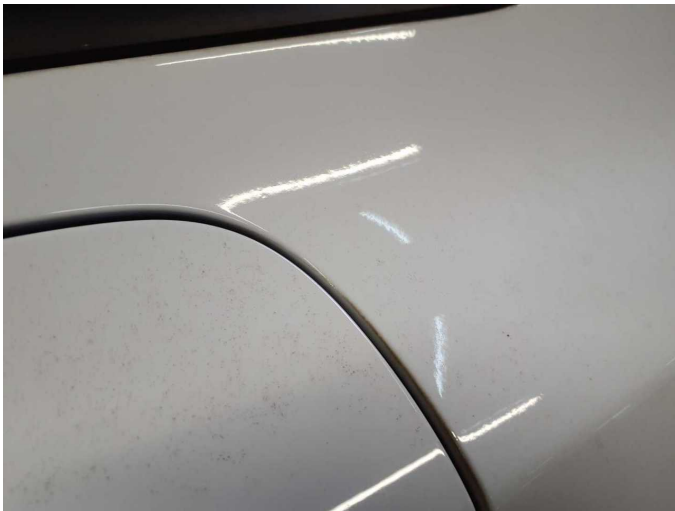
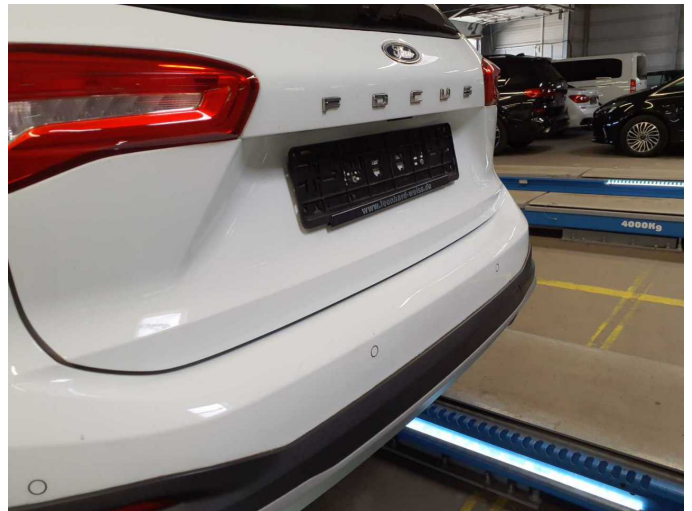
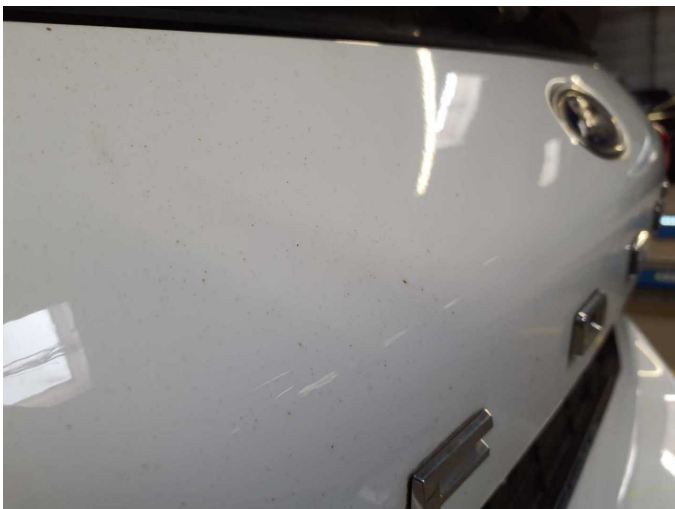
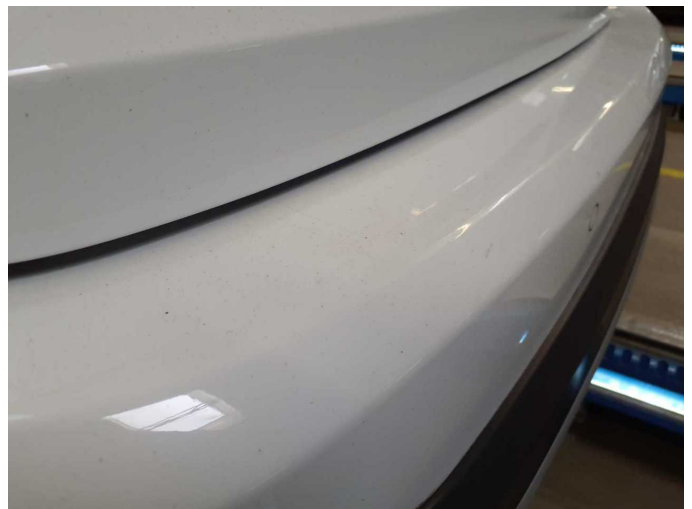
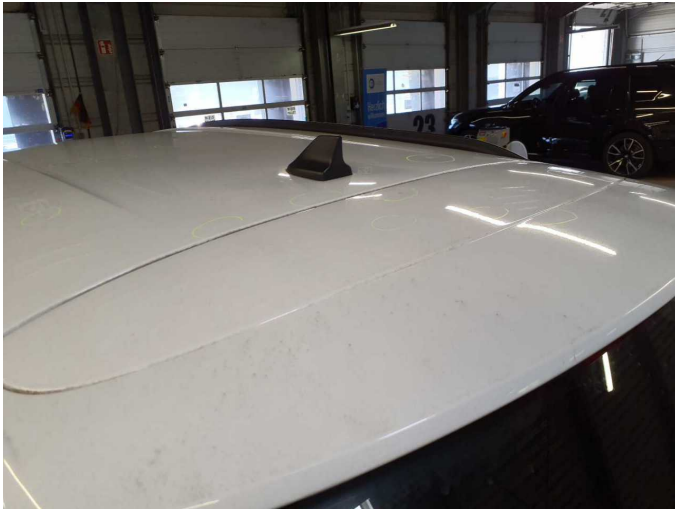
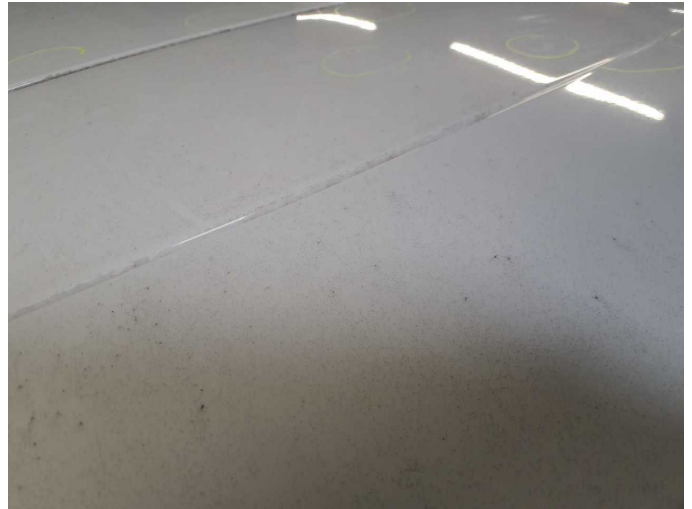
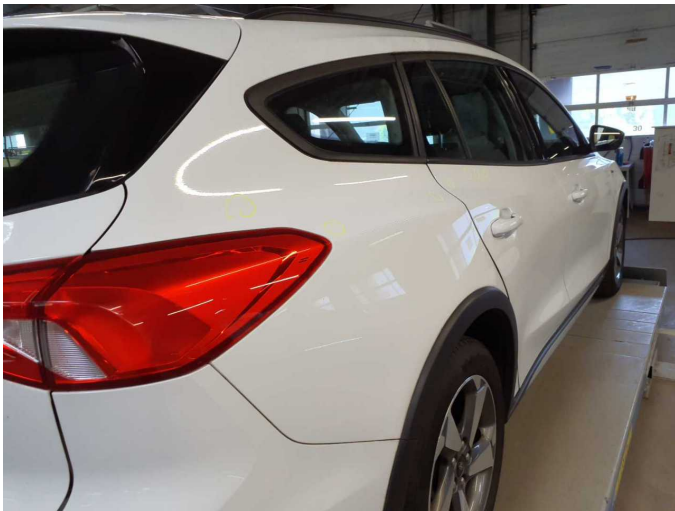
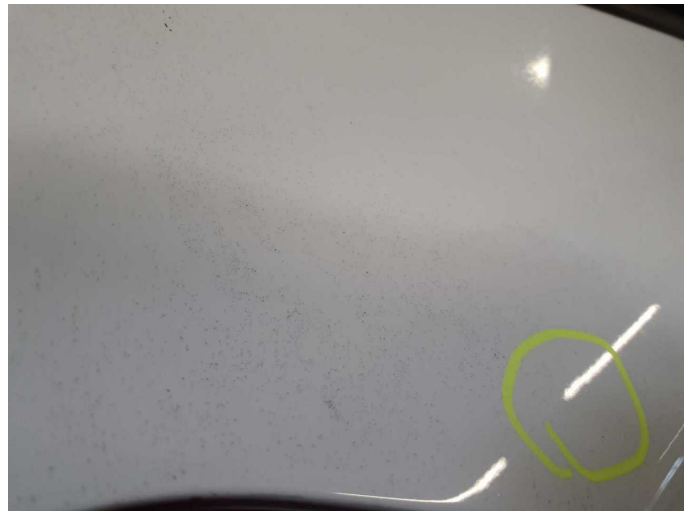
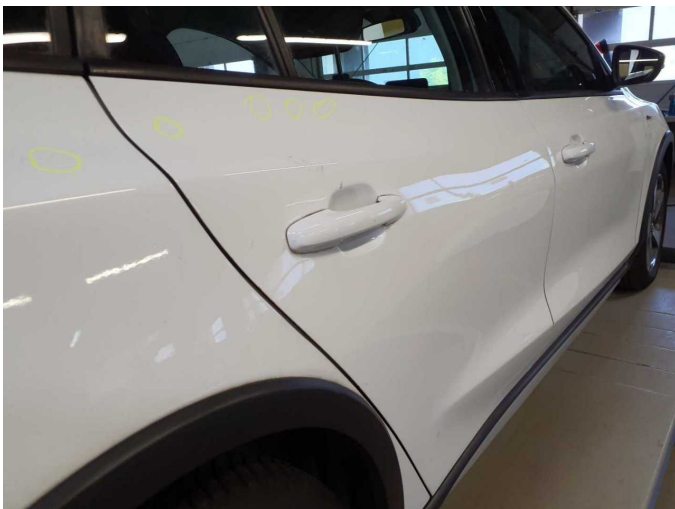
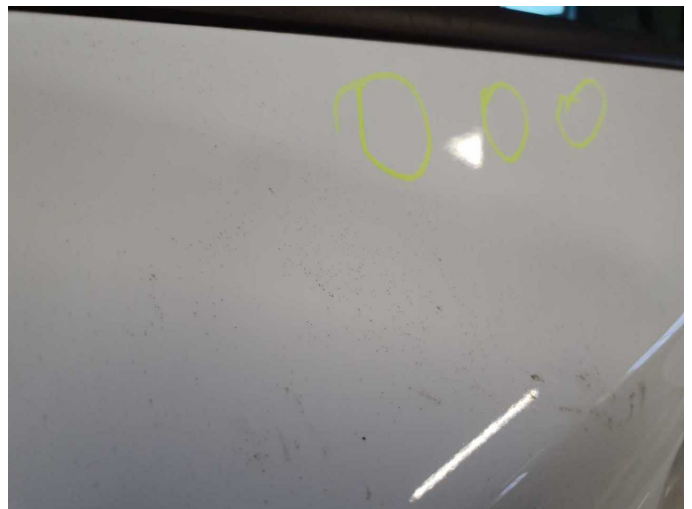
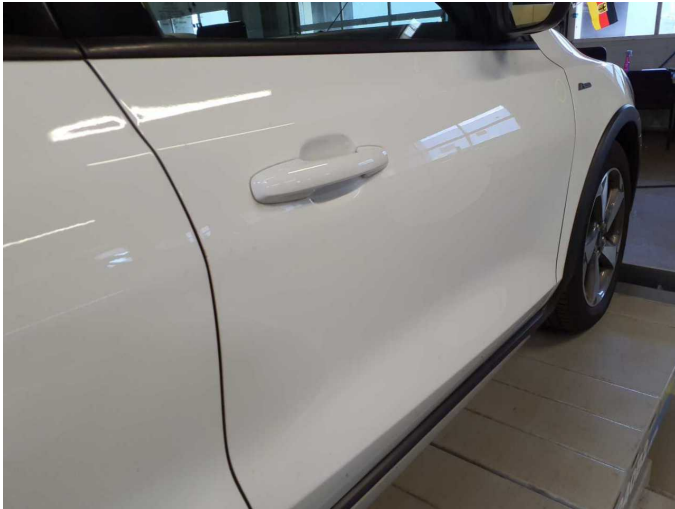
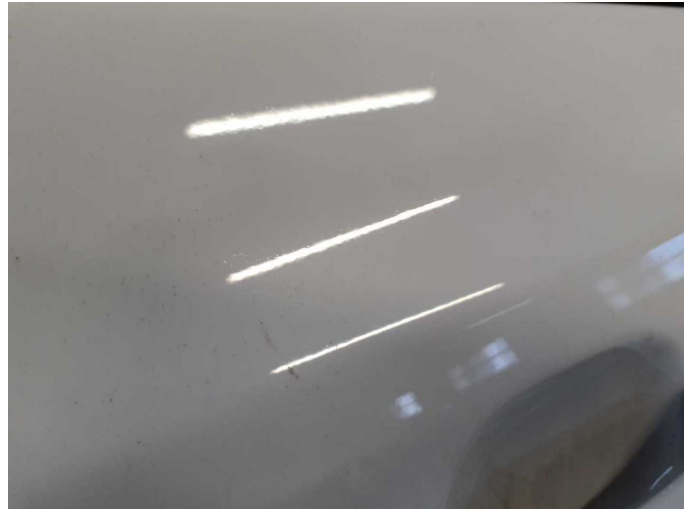
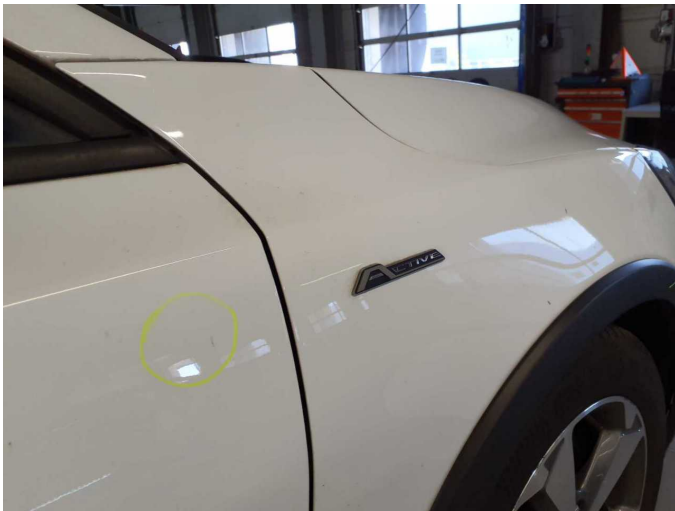
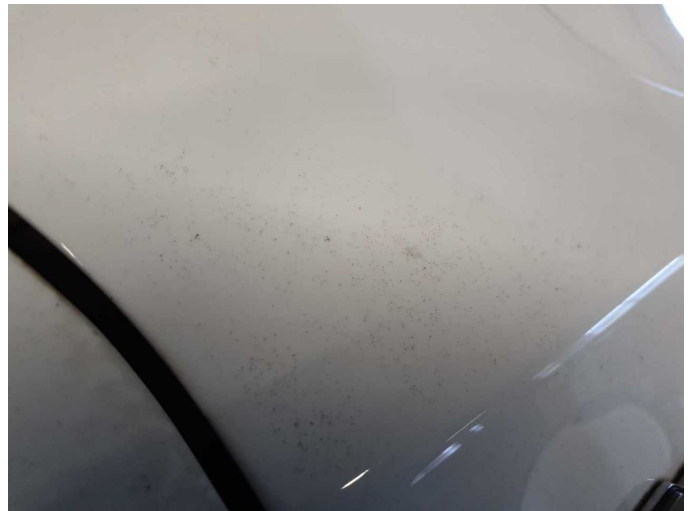
| No. | Component group | Description |
|---|---|---|
| 7 | Body | Body - Soiled - Conditioning |

**Damage 7:** Body: Body - Soiled - Conditioning

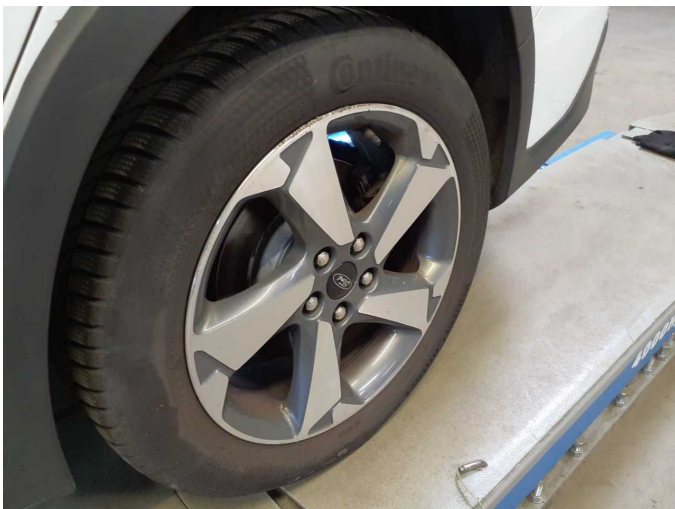
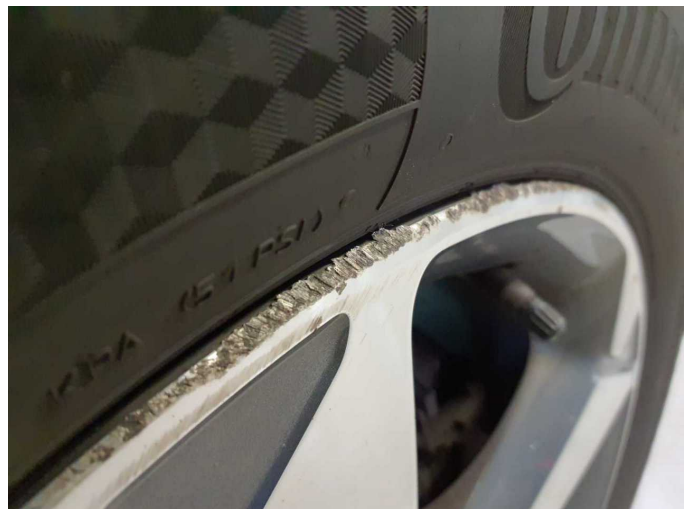
| No. | Component group | Description |
|---|---|---|
| 8 | Wheel / tyres | Alloy rim - rear left side (Materialabtrag) - Damaged - Replace |

**Damage 8:** Wheel / tyres: Alloy rim - rear left side (Materialabtrag) - Damaged - Replace

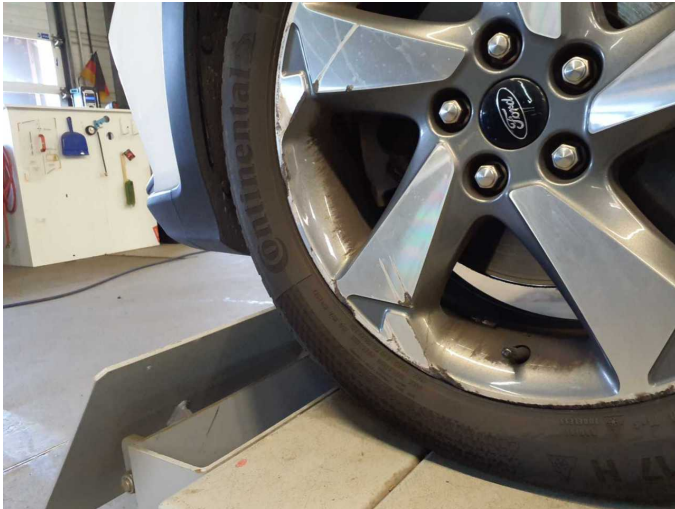
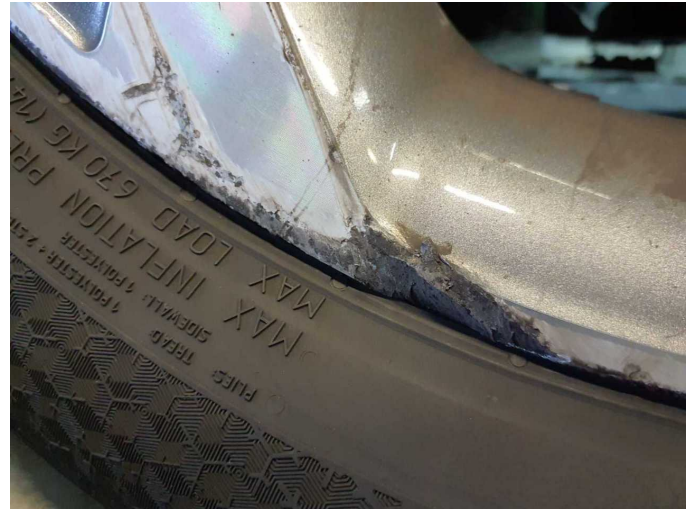
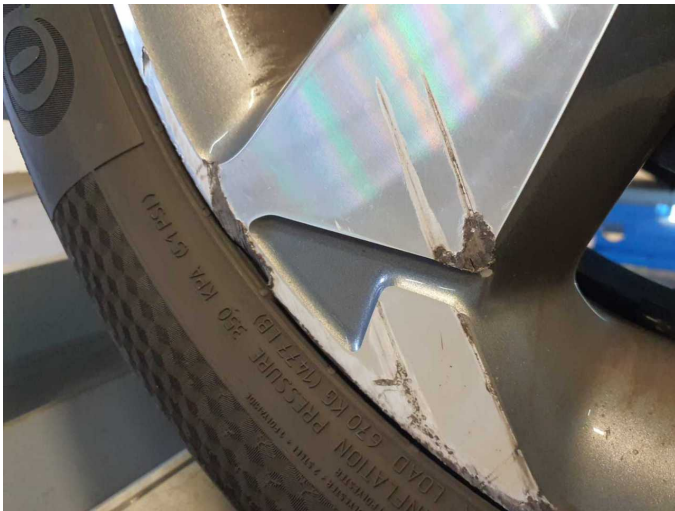
| No. | Component group | Description |
|---|---|---|
| 9 | Wheel / tyres | Alloy rim - front left side (Materialabtrag) - Damaged - Replace |

**Damage 9:** Wheel / tyres: Alloy rim - front left side (Materialabtrag) - Damaged - Replace

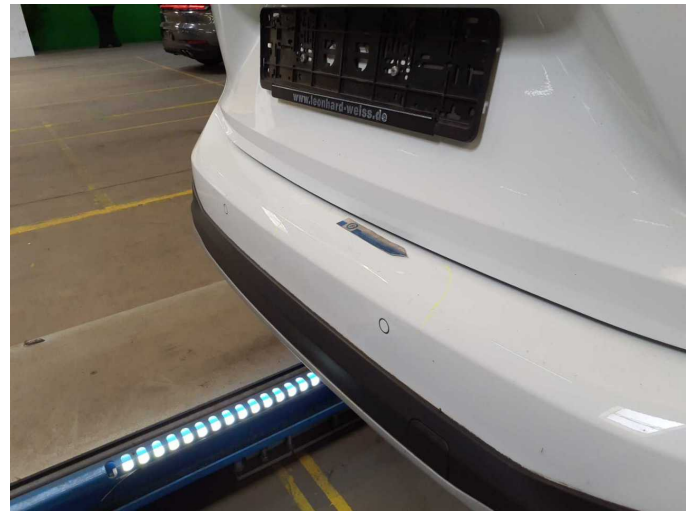
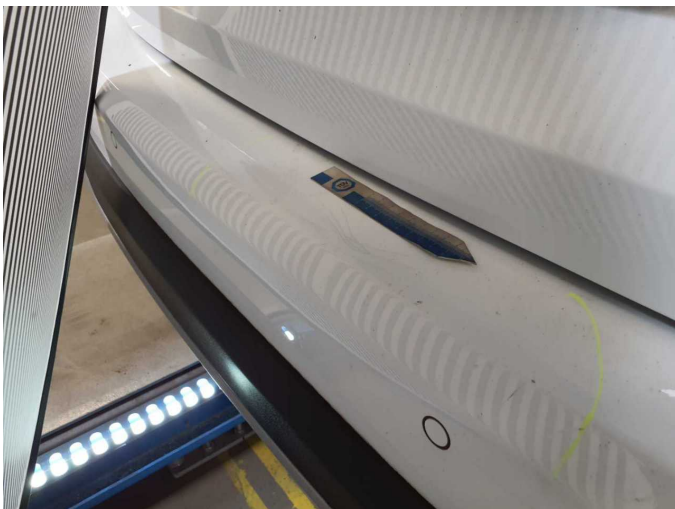
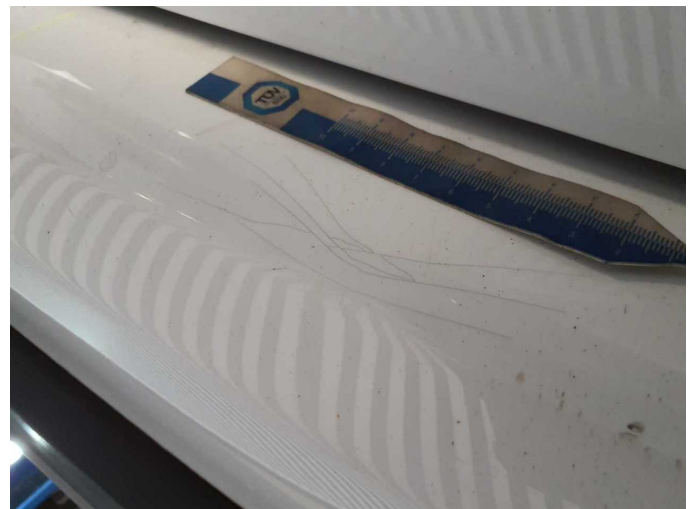
| No. | Component group | Description |
|---|---|---|
| 10 | Rear bumper | Rear bumper (verformt) - Scratched - Repair and paint |

**Damage 10:** Rear bumper: Rear bumper (verformt) - Scratched - Repair and paint

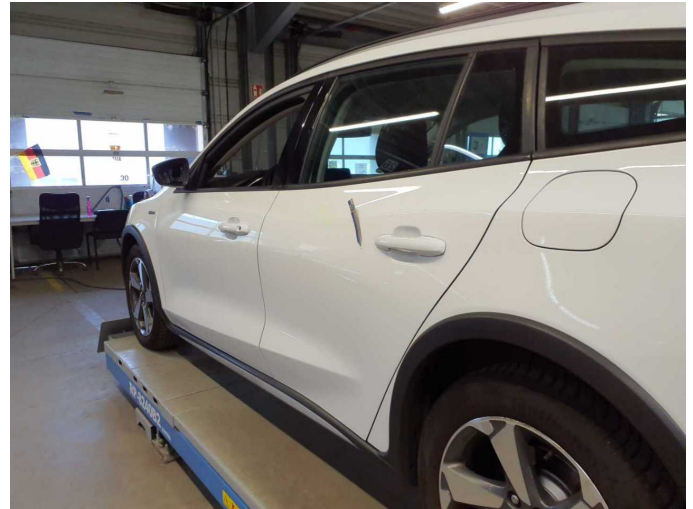
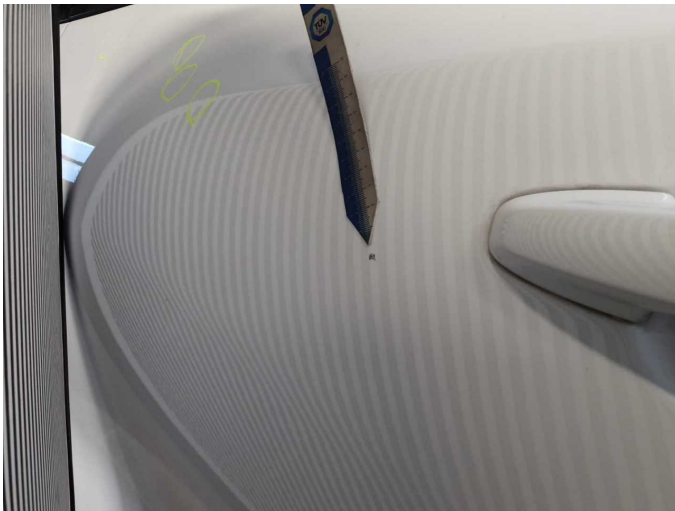
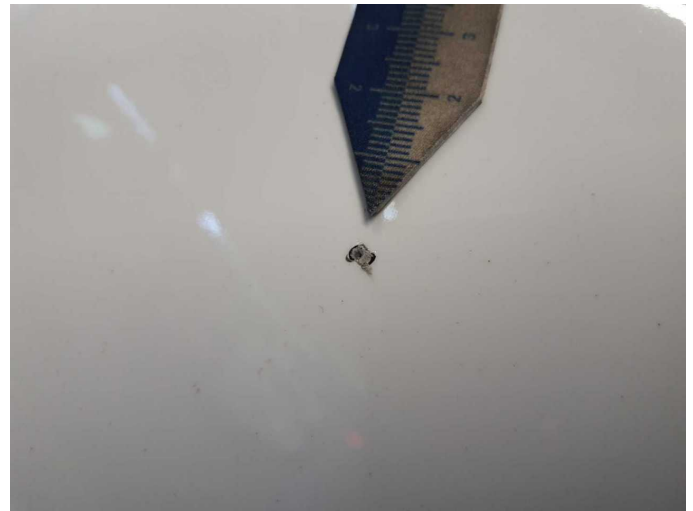
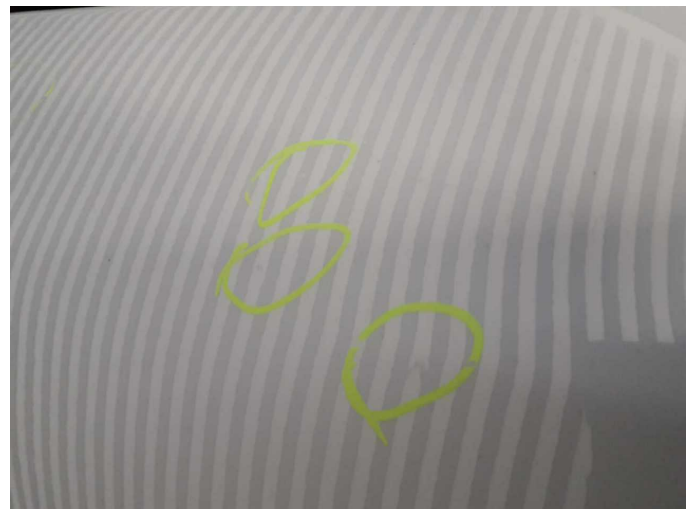
| No. | Component group | Description |
|---|---|---|
| 11 | Door - rear left side | Door - Dent / paintcoat damage - Repair and paint |

**Damage 11:** Door - rear left side: Door - Dent / paintcoat damage - Repair and paint
