Expertise

Protocol number: 39768565  
Order No. / Reference: 24769021  
Inspection date: 13 May 2025

Manufacturer: Ford

Model: Focus Turnier 1.5 EcoBlue Start-Stopp-System Aut. ACTIVE

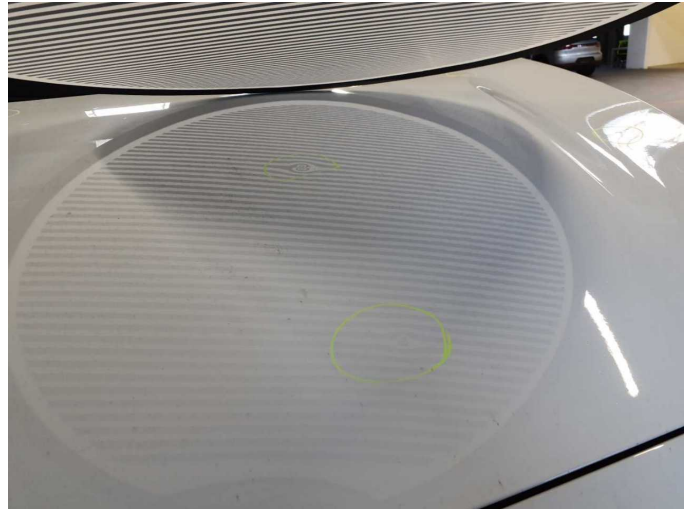
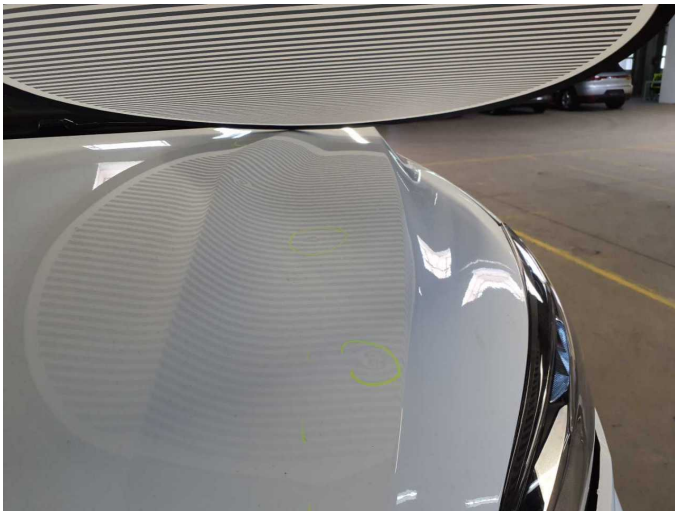
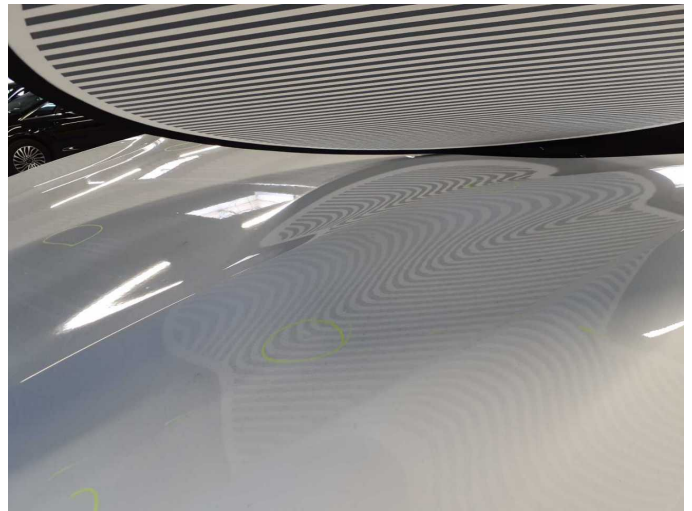
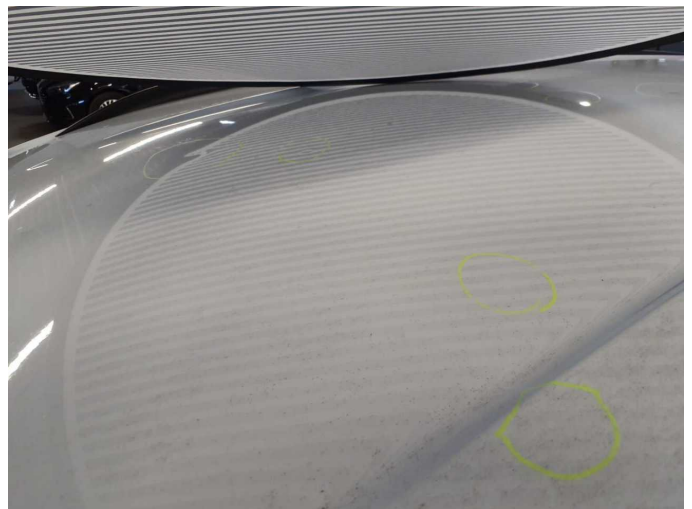
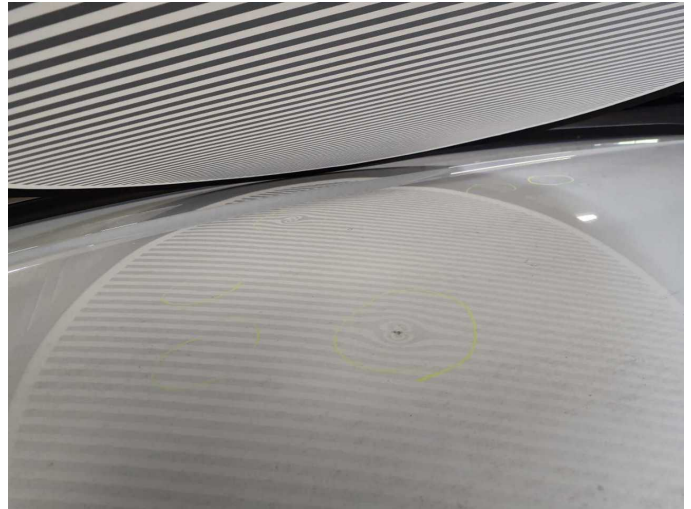
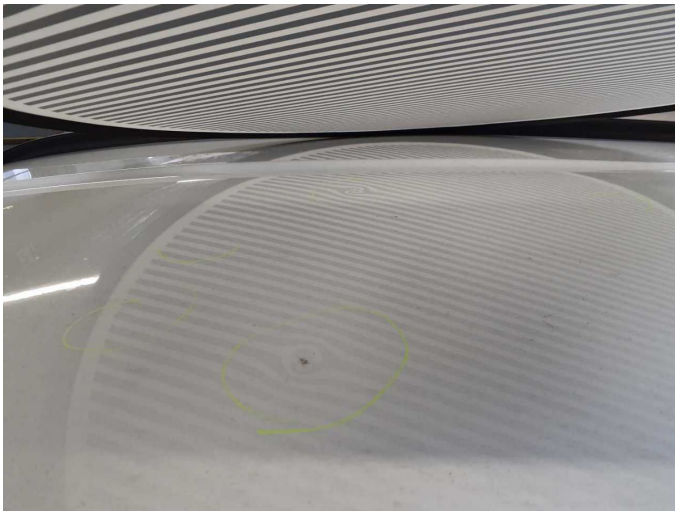
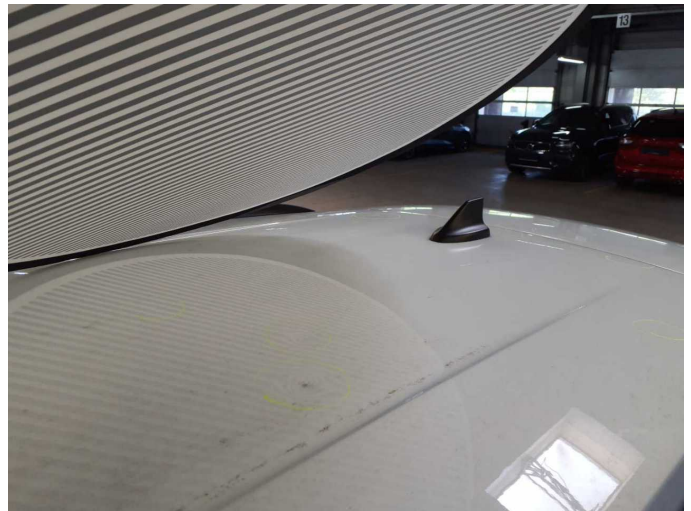
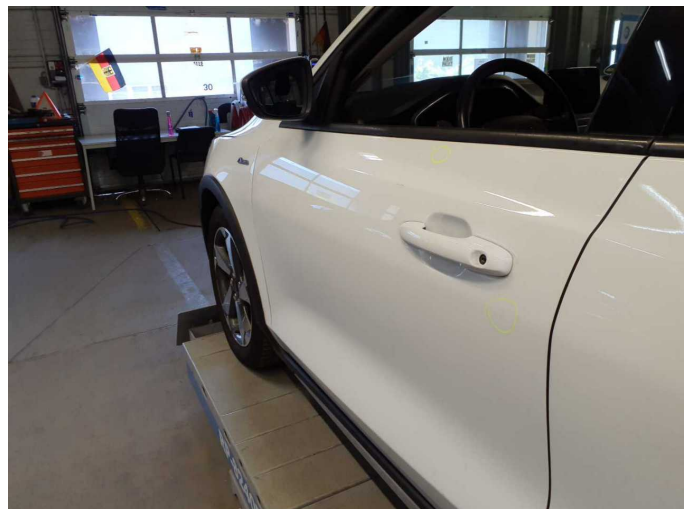
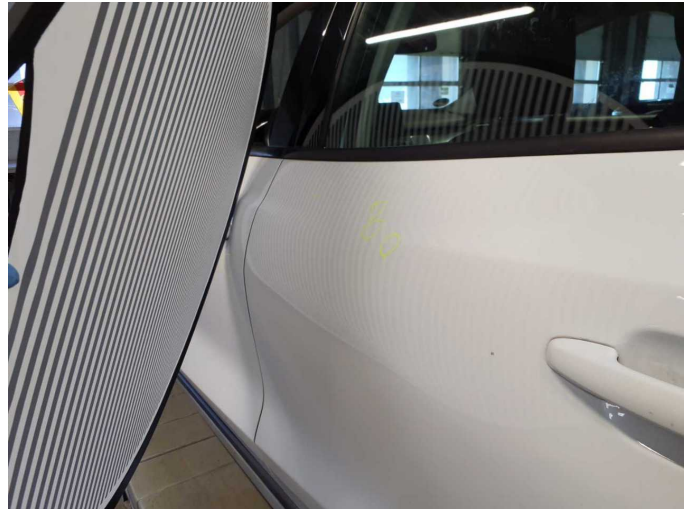
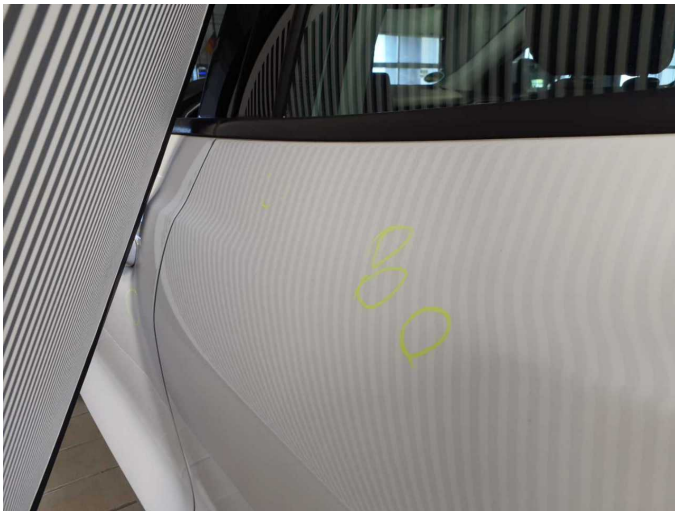
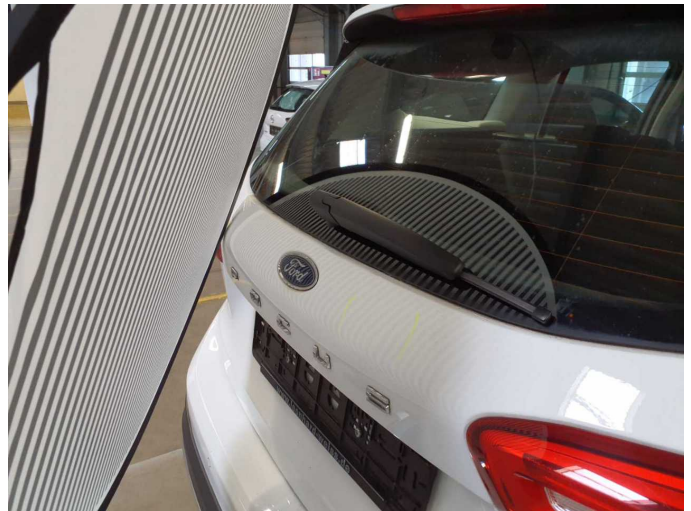
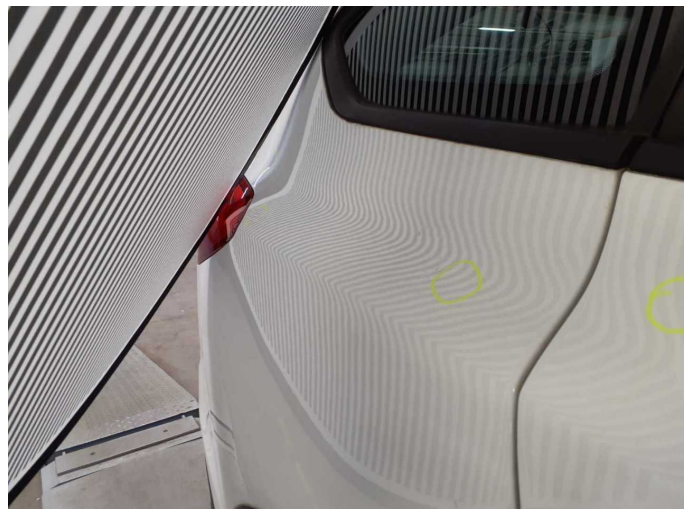
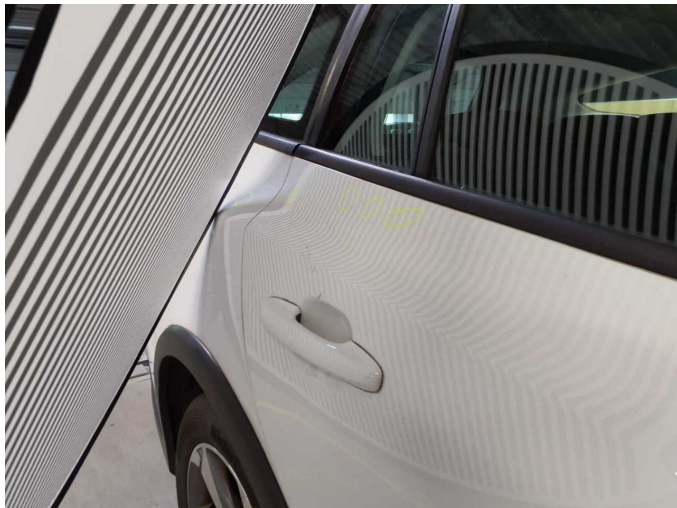
| No. | Component group | Description |
|---|---|---|
| 12 | Body | Body - Damage by hail - repair according to calculation |

Fahrzeug hat starken Hagelschaden.

Die beigefügte Reparaturkostenkalkulation wurde nach bestem Wissen und Gewissen im demontagefreien Zustand erstellt. Es können Mehrkosten und somit Abweichung der für den Hagelschaden ausgewiesener Reparaturkosten nicht ausgeschlossen werden.

**Damage 12:** Body: Body - Damage by hail - repair according to calculation

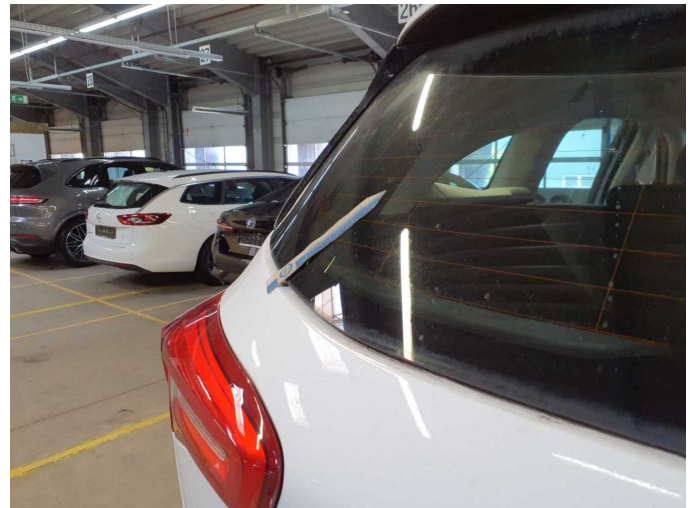
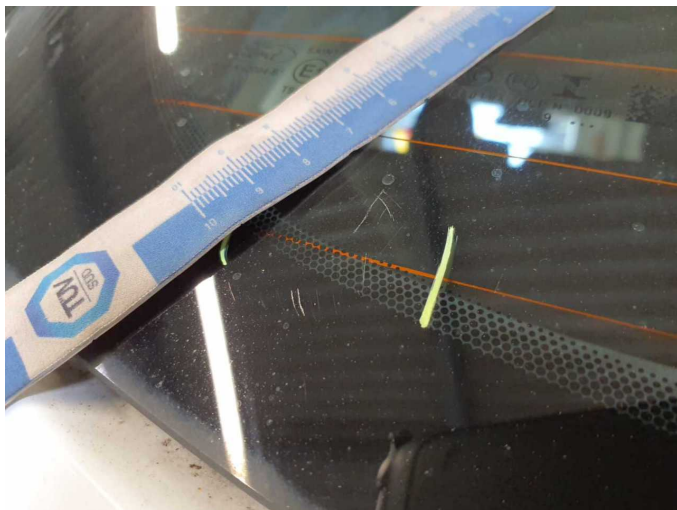
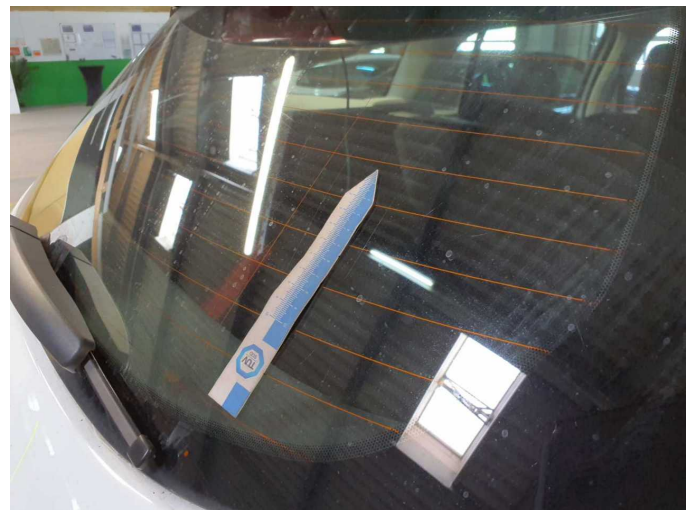
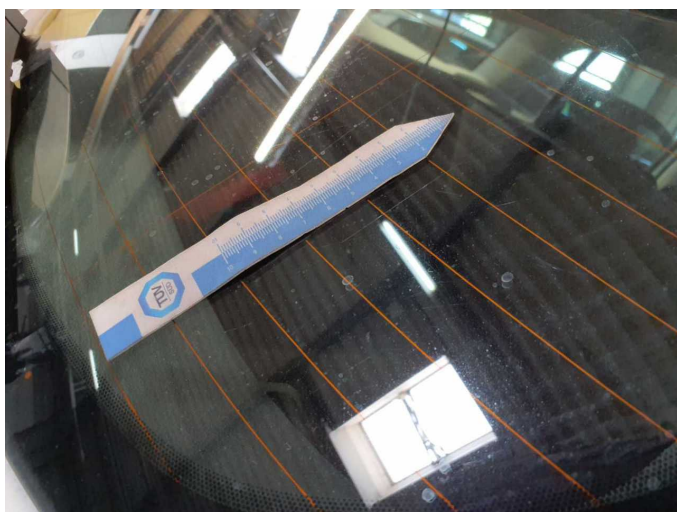
| No. | Component group | Description |
|---|---|---|
| 8 | Vehicle glazing | Rear window - Scratched - No deduction |

**Wear and tear 8:** Vehicle glazing: Rear window - Scratched - No deduction

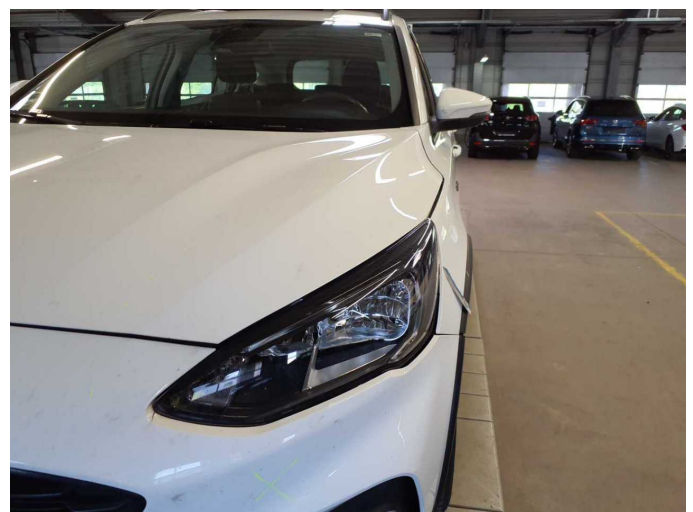
- 1 Front, Side - left

Motorhaube und Korflügel zeigen Fehlstellung, deshalb wurde eine Vermessung im Unfall mitaufgenommen.

**Accident 1:** Front, Side - left
