Expertise

Protocol number: 41201849
Order No. / Reference: 25049247
Inspection date: 25 Aug 2025

Model: Focus Turnier 1.5 EcoBlue Start-Stopp-System Aut. TITANIUM

VIN: WF0PXXGCHPLK03408

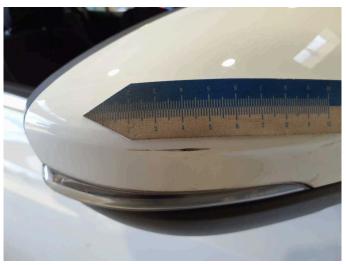
Damage 1: Wing mirror - right side: Cap - Scratch(es) - Smart repair

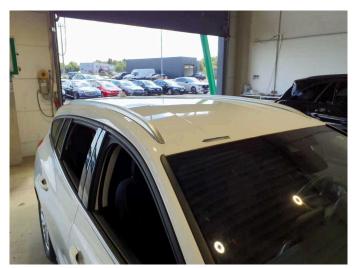
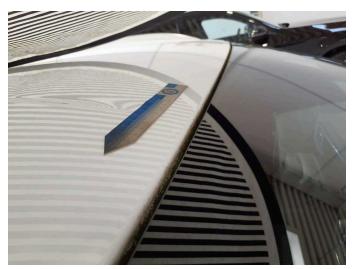
Damage 3: Roof: Roof - dent(s) - Smart repair

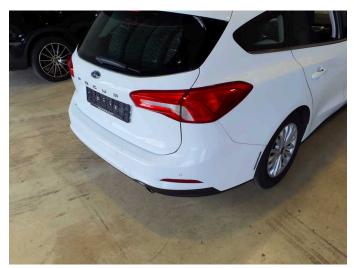
Damage 4: Rear bumper: Rear bumper - Scratch(es) - Smart repair
