FORD FOCUS CLIPPER: 1YDB589

Limited Technical Inspection

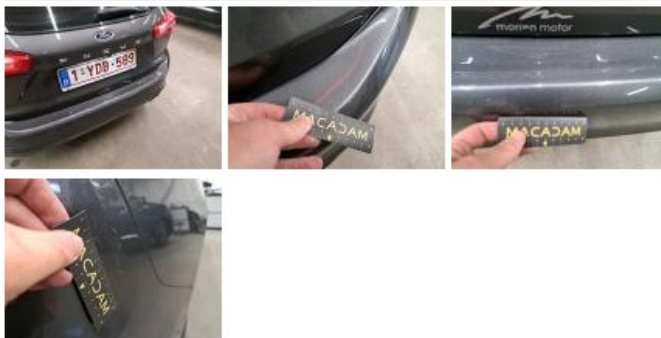
Bumper R, Scratch(es), Acceptable
