Expertise

Protocol number: 41806384
Order number / reference: 25242393
Inspection date: 2 Oct 2025

Manufacturer: Ford

Model: Focus Turnier 1.5 EcoBlue Start-Stopp-System
COOL&CONNECT

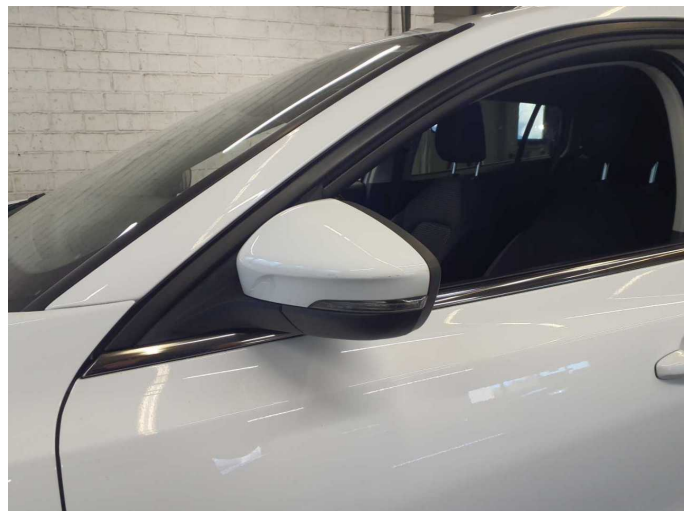
Damage 1: Wing mirror - left side: Cap - Scratch(es) - Smart repair

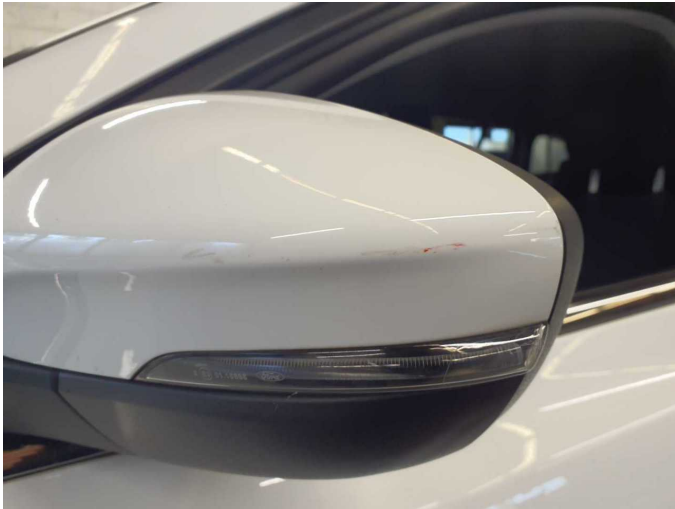
Damage 1: Wing mirror - left side: Cap - Scratch(es) - Smart repair

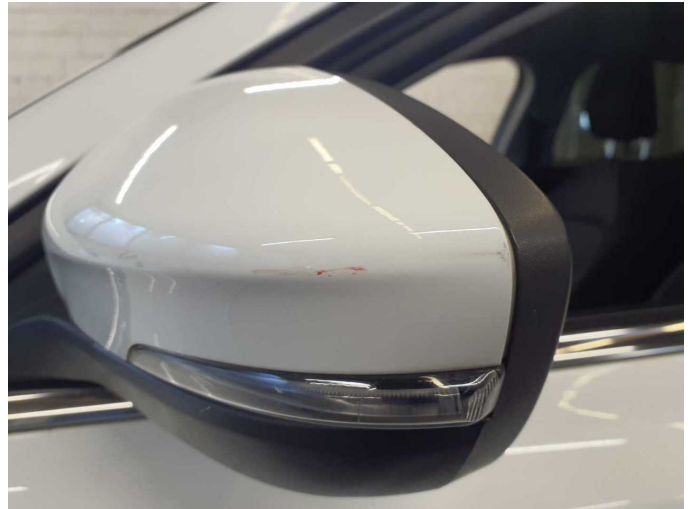
Damage 1: Wing mirror - left side: Cap - Scratch(es) - Smart repair

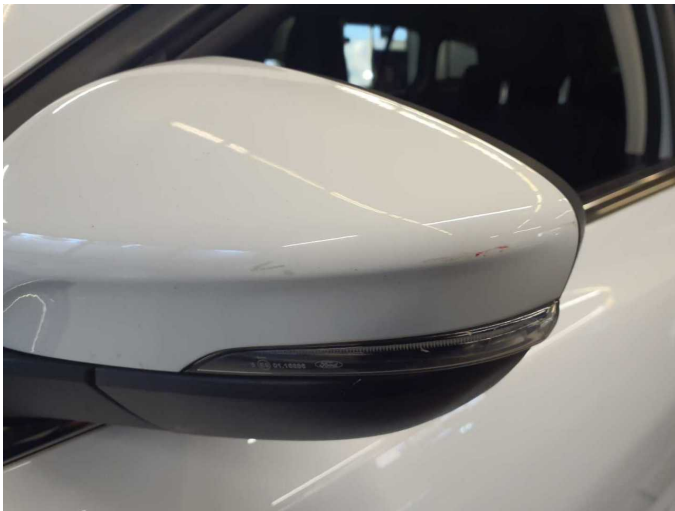
Damage 1: Wing mirror - left side: Cap - Scratch(es) - Smart repair

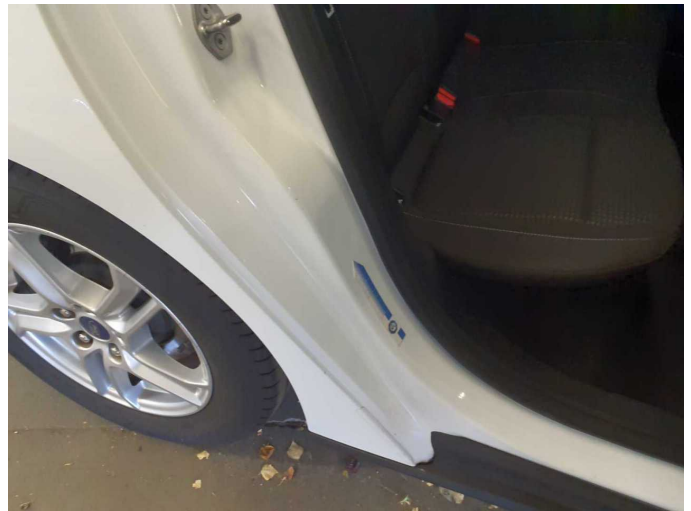
Damage 2: Side panel - rear right side: Sill (2) - dent(s) - Smart repair

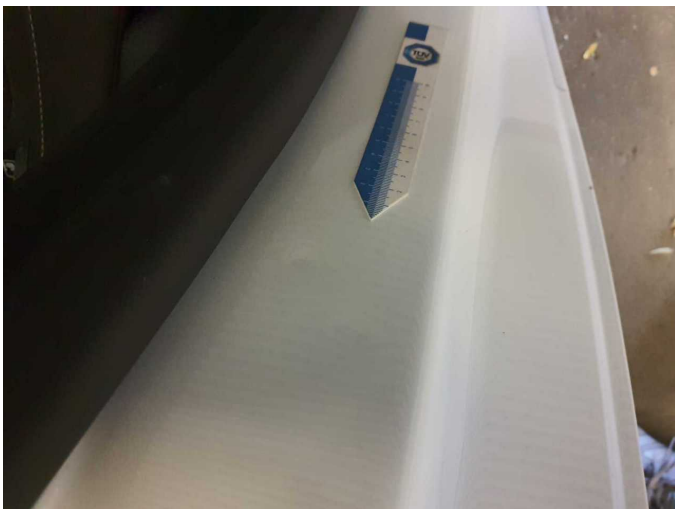
Damage 2: Side panel - rear right side: Sill (2) - dent(s) - Smart repair

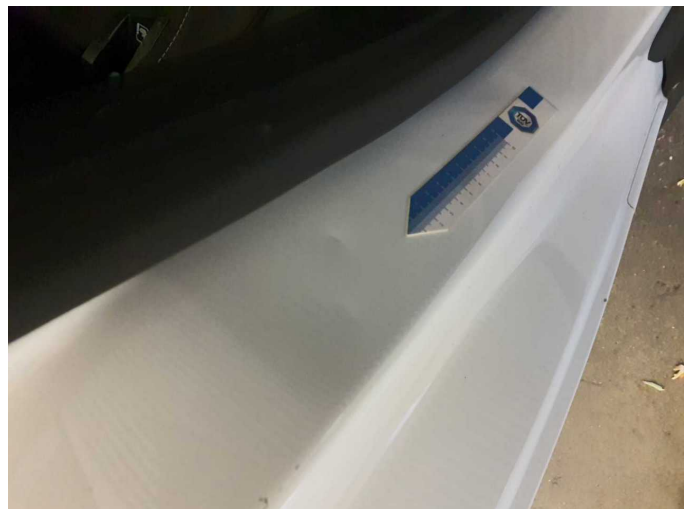
Damage 2: Side panel - rear right side: Sill (2) - dent(s) - Smart repair

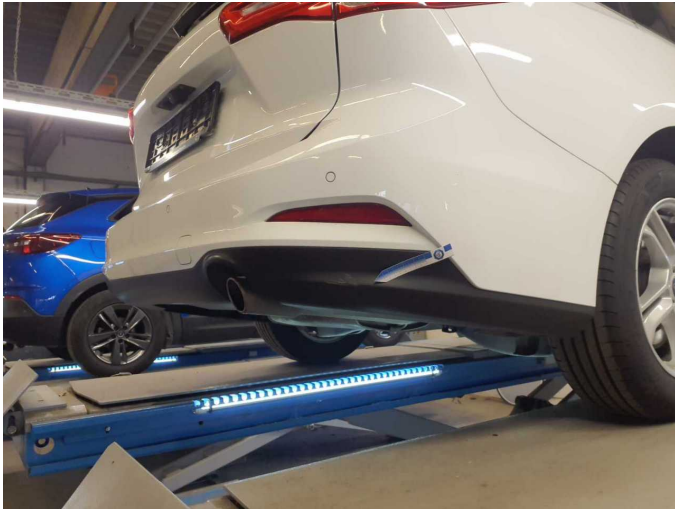
Damage 3: Rear bumper: Spoiler - Scratch(es) - Replace

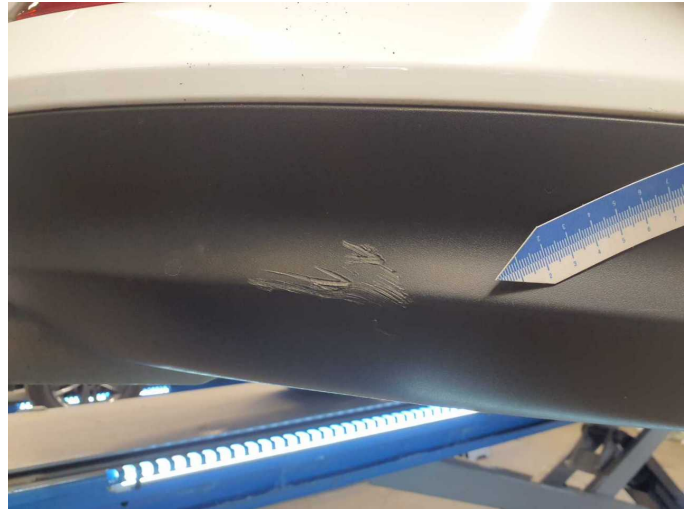
Damage 3: Rear bumper: Spoiler - Scratch(es) - Replace

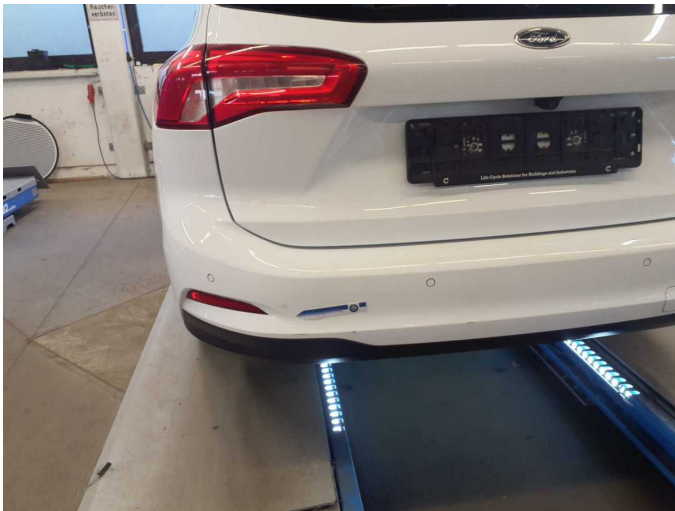
Damage 4: Rear bumper: Rear bumper - Scratch(es) - Paint

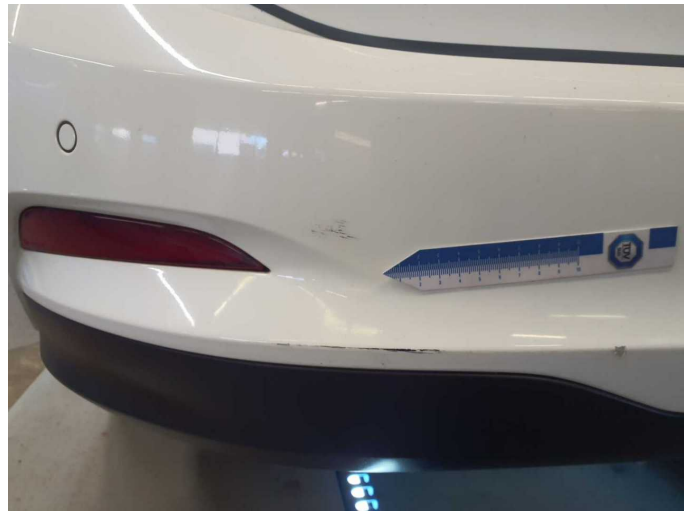
Damage 4: Rear bumper: Rear bumper - Scratch(es) - Paint

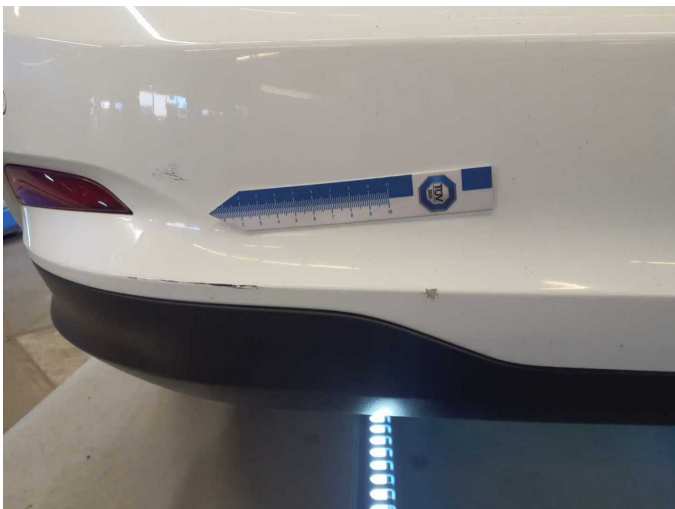
Damage 4: Rear bumper: Rear bumper - Scratch(es) - Paint

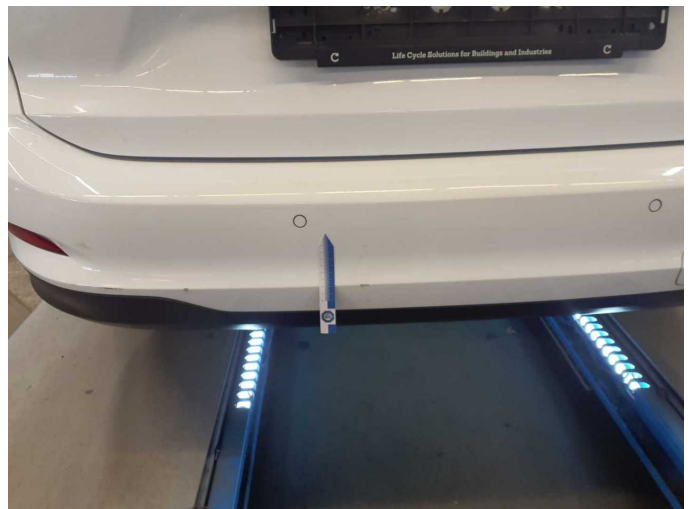
Damage 4: Rear bumper: Rear bumper - Scratch(es) - Paint

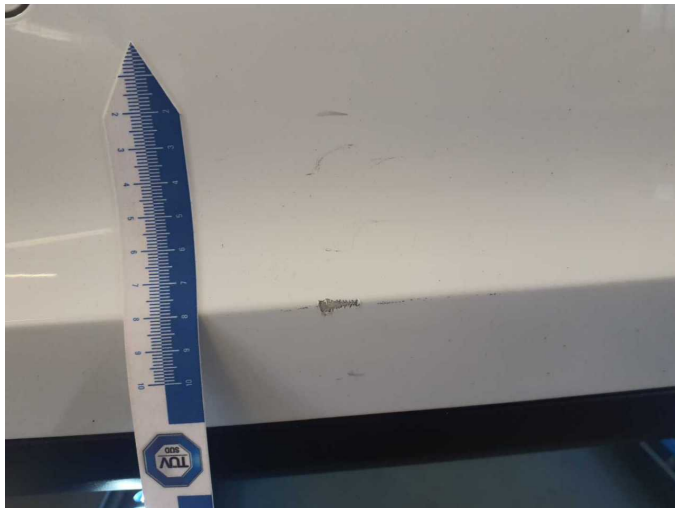
Damage 4: Rear bumper: Rear bumper - Scratch(es) - Paint

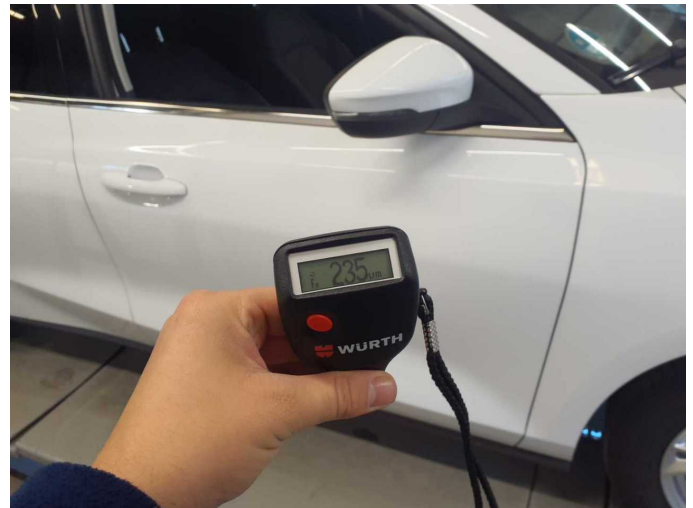
No.	Repainting
1	Boot lid / rear door, Door - rear right side, Door - front right side, Professionally carried out, Invoice of repair done Non-existent

Repainting 1: Boot lid / rear door, Door - rear right side, Door - front right side

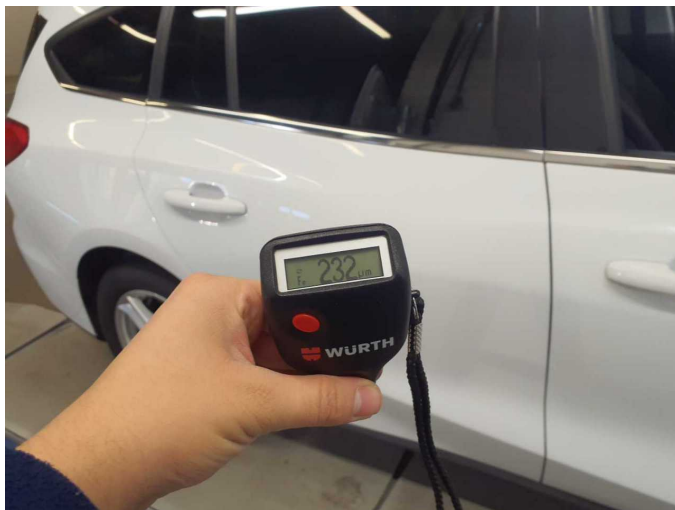
Repainting 1: Boot lid / rear door, Door - rear right side, Door - front right side

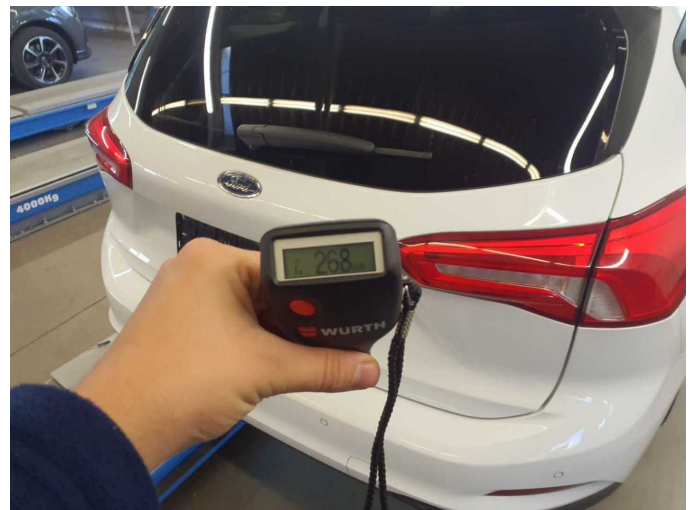
Repainting 1: Boot lid / rear door, Door - rear right side, Door - front right side
