Expertise

Protocol number: 41320665  
Order No. / Reference: 25144793  
Inspection date: 27 Aug 2025

| Manufacturer: Ford | Model: Focus Turnier 2.0 EcoBlue Start-Stopp-System Aut. TITANIUM |
| VIN: WF0PXXGCHPLL32849 | |

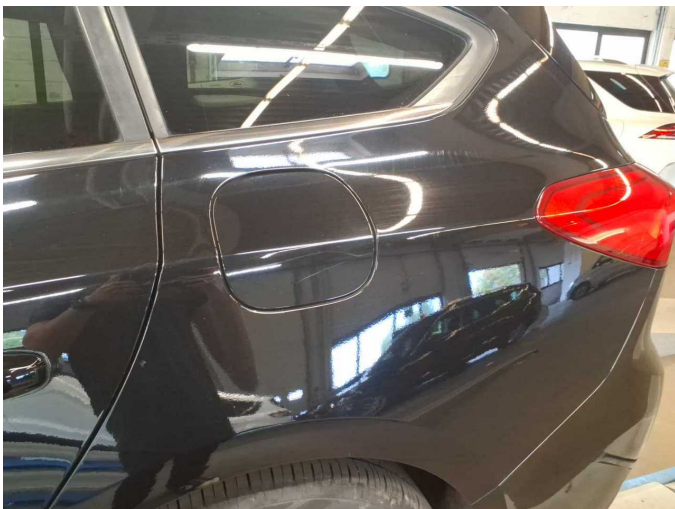
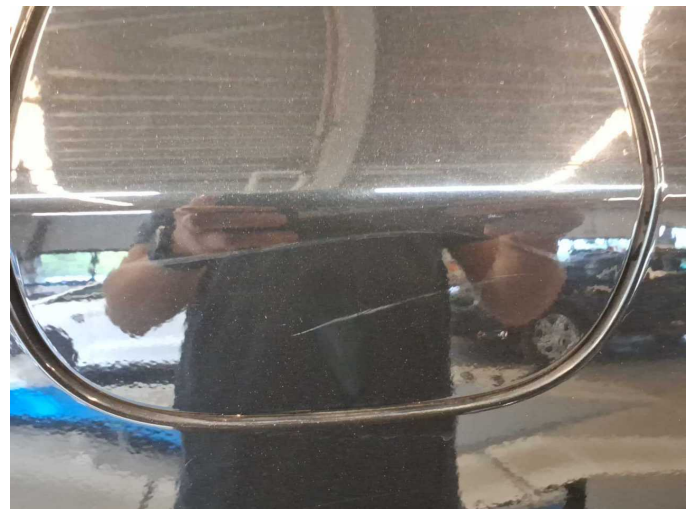
| No. | Component group | Description |
|---|---|---|
| 1 | Fuel system | Tank flap - Scratch(es) - Smart repair |

Damage 1: Fuel system: Tank flap - Scratch(es) - Smart repair

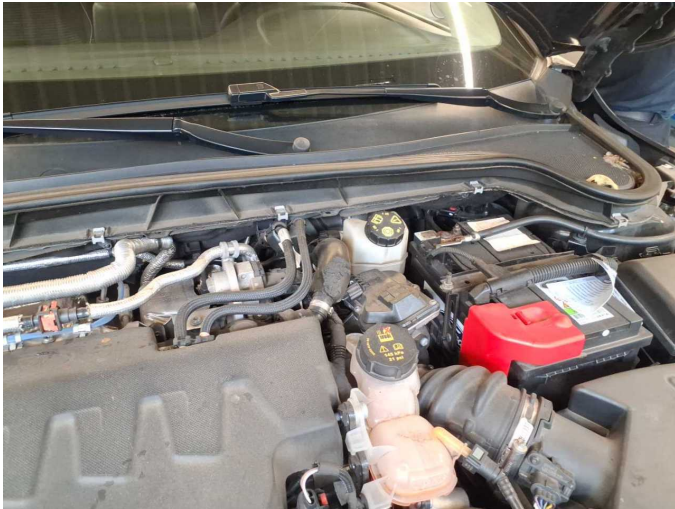
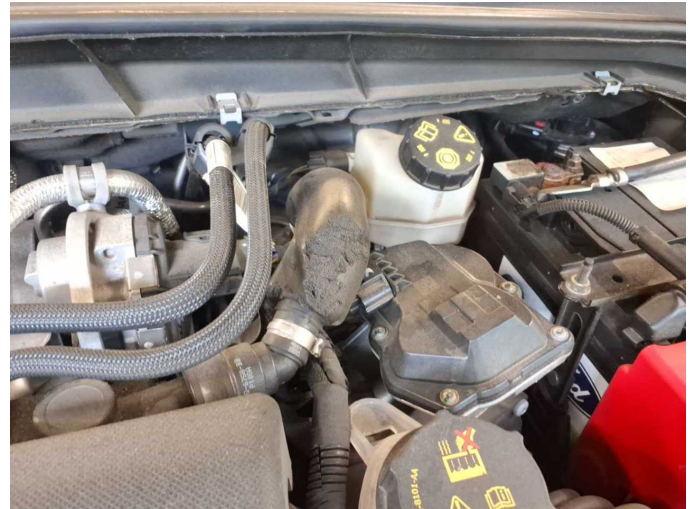
| No. | Component group | Description |
|---|---|---|
| 2 | Engine | Engine (Rohr Ölabscheider) - Damage caused by marten / rodent - Replace |

Marderschaden im Motorraum-weitere nicht sichtbare Schäden nicht ausgeschlossen

**Damage 2:** Engine: Engine (Rohr Ölabscheider) - Damage caused by marten / rodent - Replace

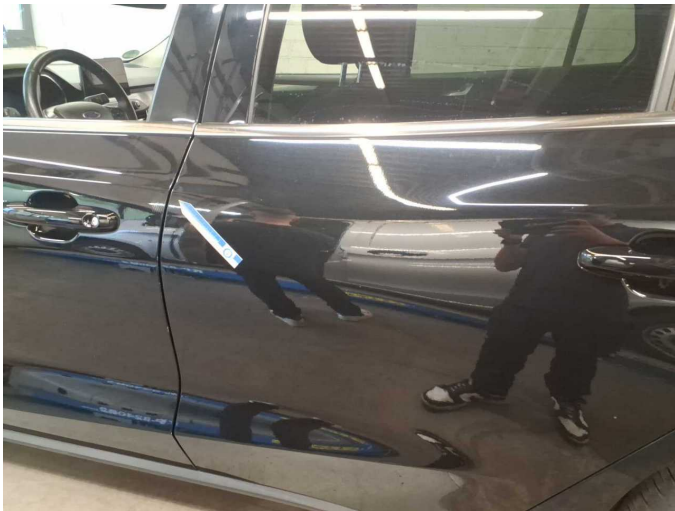
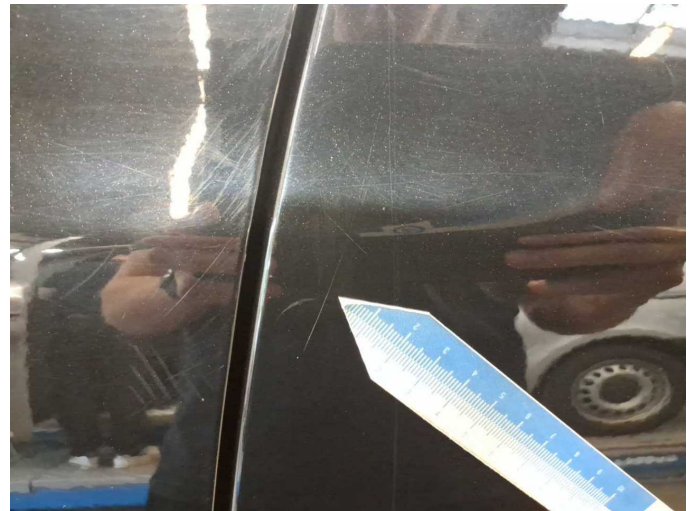
| No. | Component group | Description |
|---|---|---|
| 3 | Door - rear left side | Door - Scratch(es) - Smart repair |

**Damage 3:** Door - rear left side: Door - Scratch(es) - Smart repair

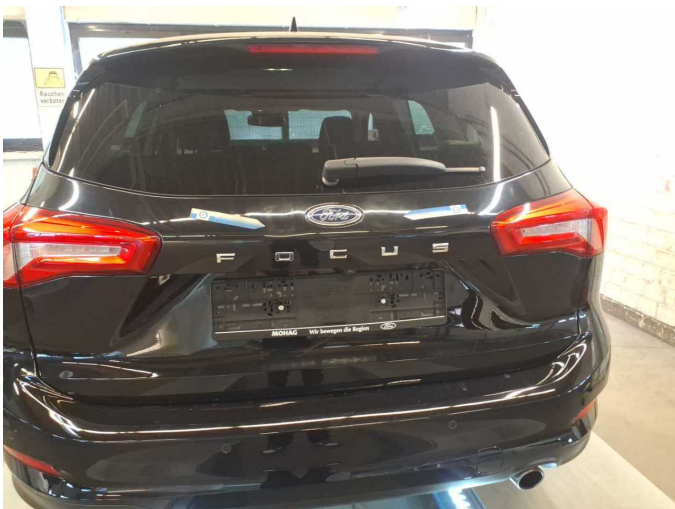
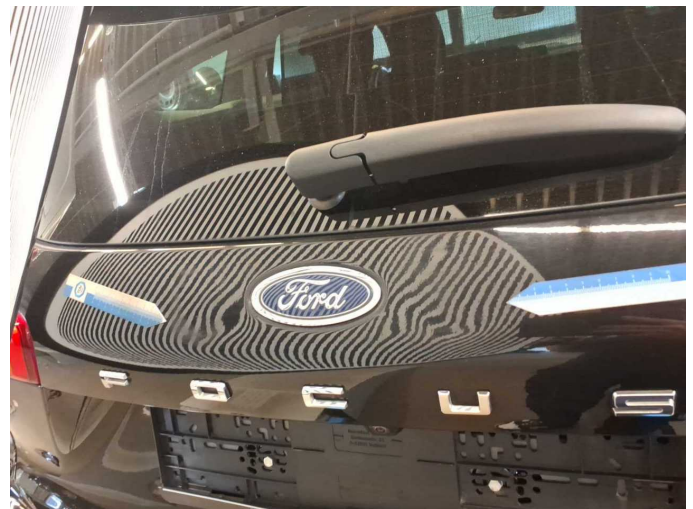
| No. | Component group | Description |
|---|---|---|
| 4 | Boot lid / rear door | Boot lid - dent(s) - Smooth repair work |

**Damage 4:** Boot lid / rear door: Boot lid - dent(s) - Smooth repair work

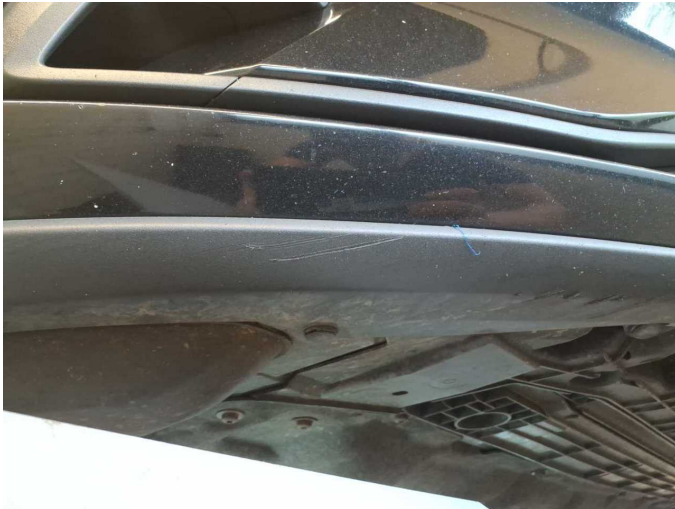
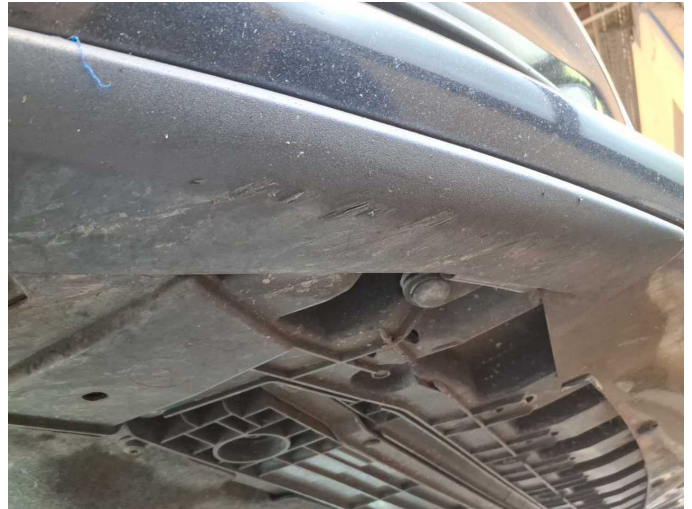
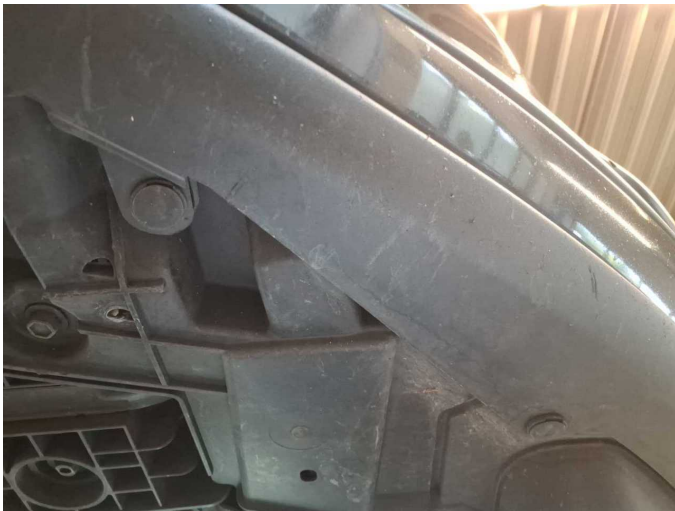
| No. | Component group | Description |
|---|---|---|
| 5 | Front bumper | Spoiler (Links und Rechts) - Scratch(es) - Replace |

**Damage 5:** Front bumper: Spoiler (Links und Rechts) - Scratch(es) - Replace

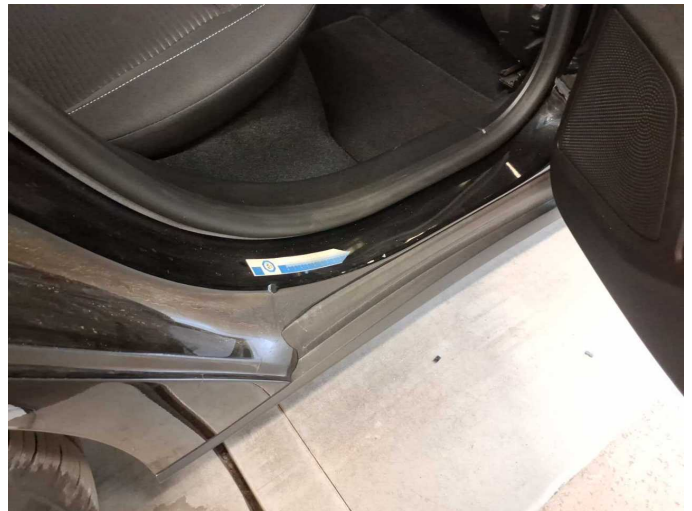
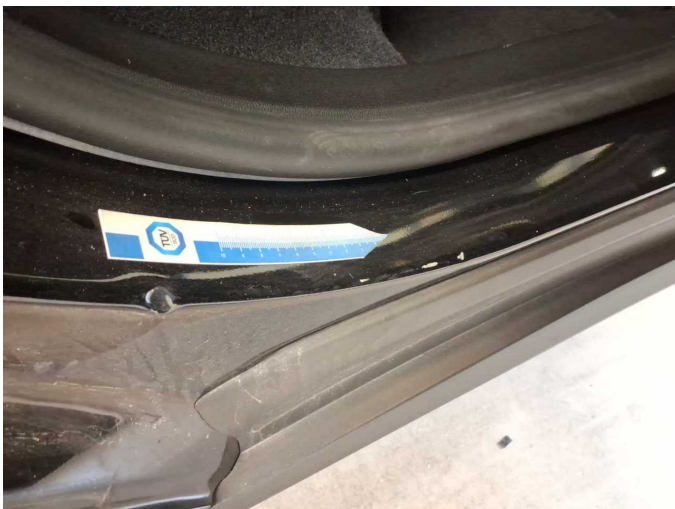
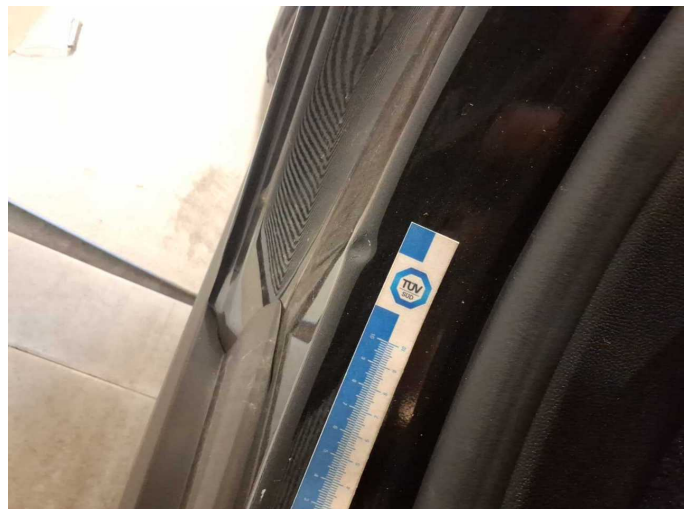
| No. | Component group | Description |
|---|---|---|
| 6 | Side panel - rear right side | Sill - Dent / paintcoat damage - Smart repair |

**Damage 6:** Side panel - rear right side: Sill - Dent / paintcoat damage - Smart repair

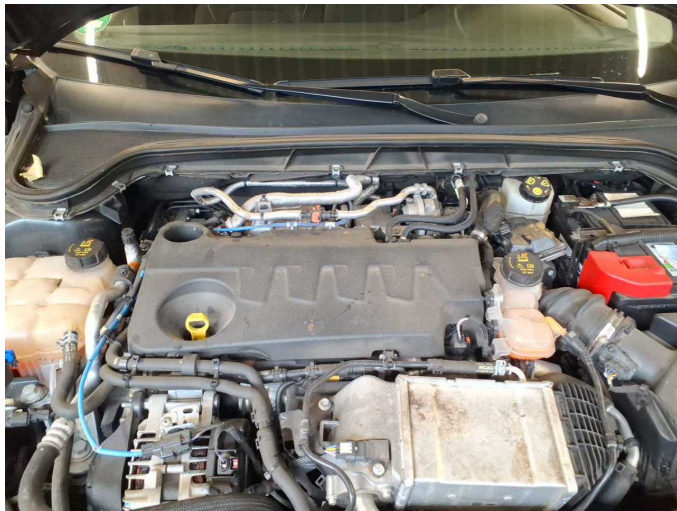
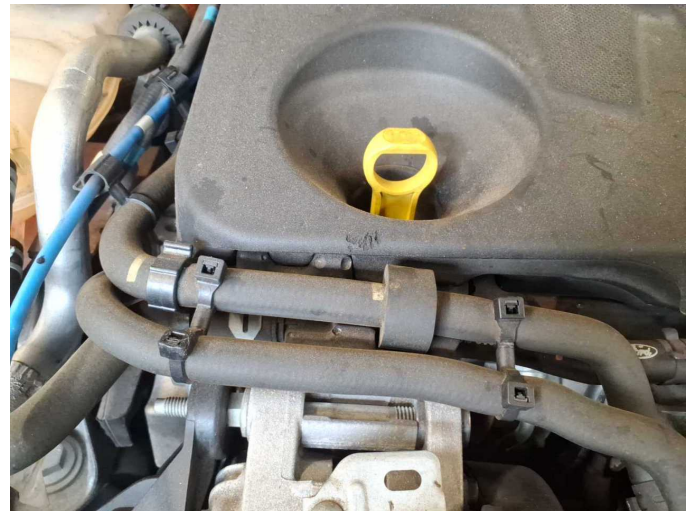
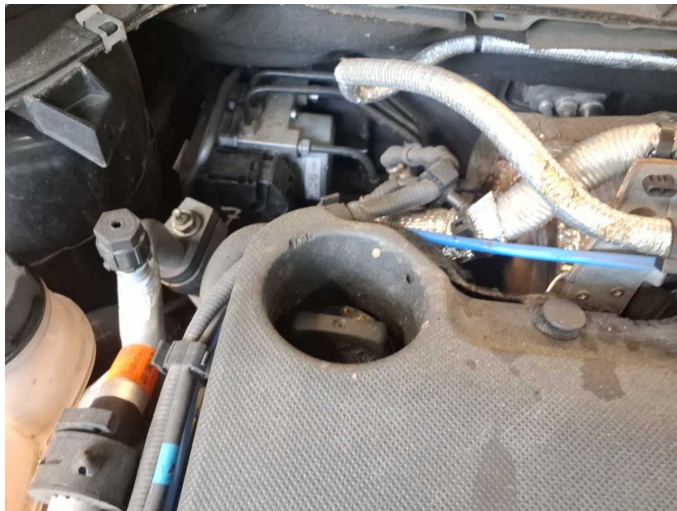
| No. | Component group | Description |
|---|---|---|
| 7 | Engine | Engine cover - top / cover - Damage caused by marten / rodent - Replace |

**Damage 7:** Engine: Engine cover - top / cover - Damage caused by marten / rodent - Replace

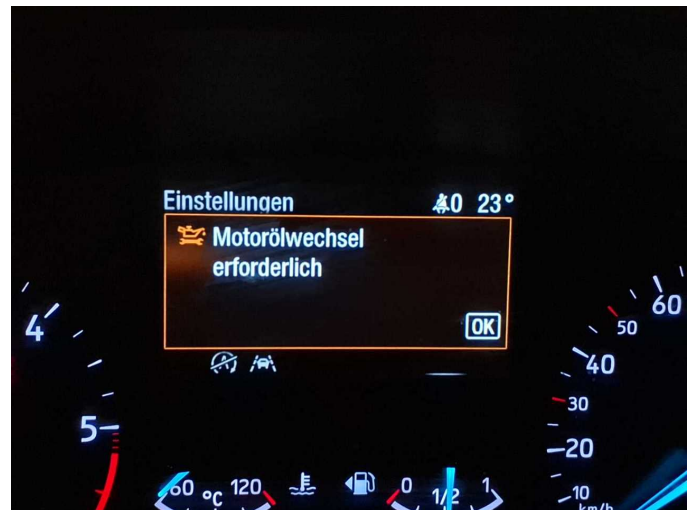
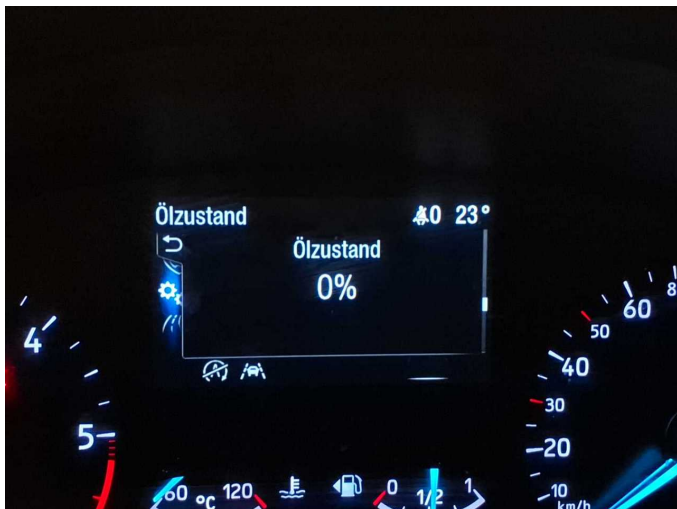
| No. | Component group | Description |
|---|---|---|
| 8 | Misc. | Inspection / maintenance - Due - Perform |

**Damage 8:** Misc.: Inspection / maintenance - Due - Perform

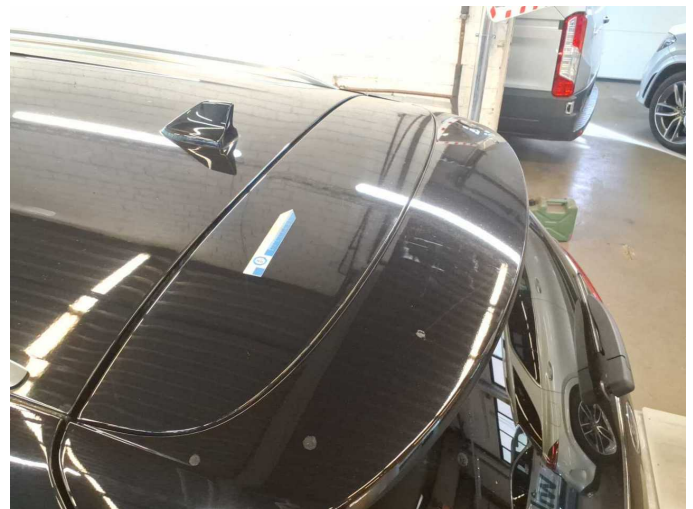
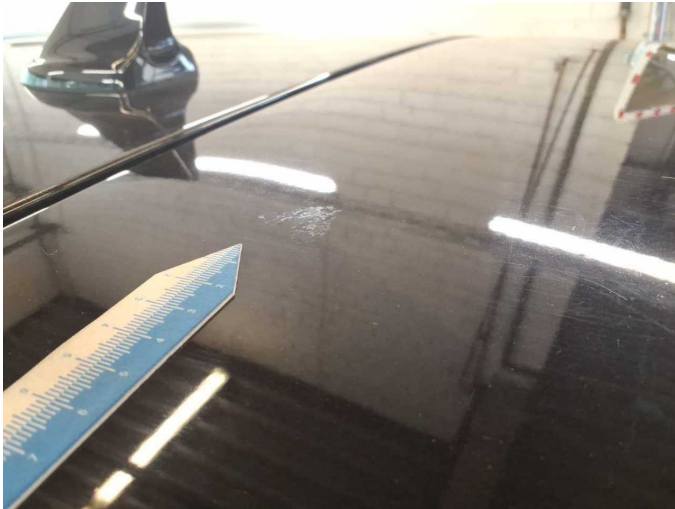
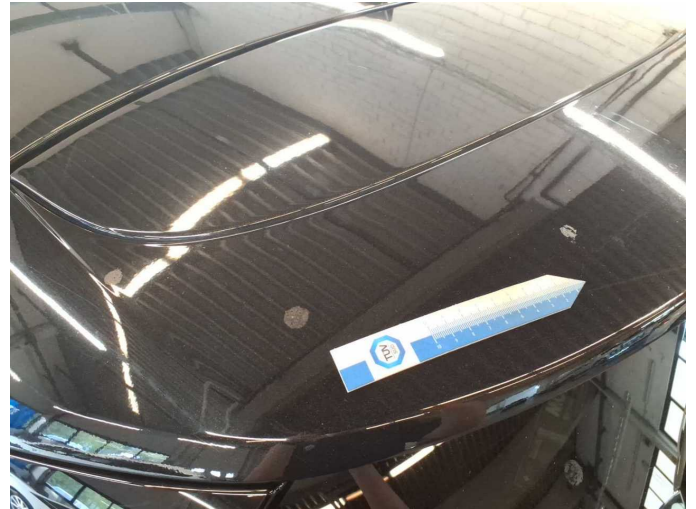
| No. | Component group | Description |
|---|---|---|
| 9 | Boot lid / rear door | Rear spoiler (Anätzung) - Paint defect - Paint |

**Damage 9:** Boot lid / rear door: Rear spoiler (Anätzung) - Paint defect - Paint

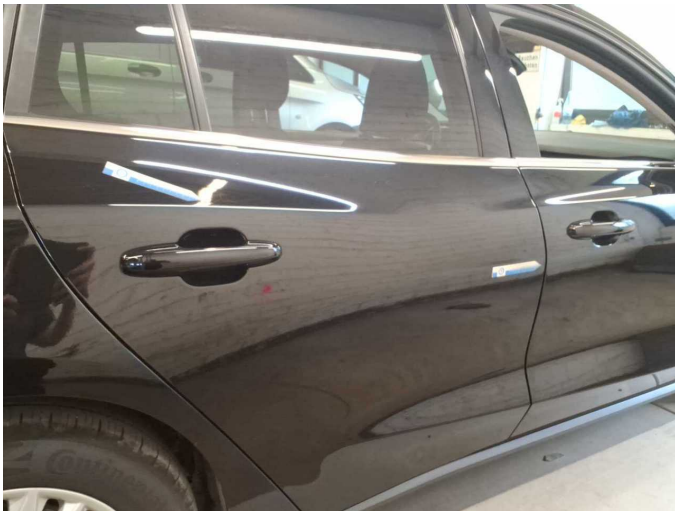
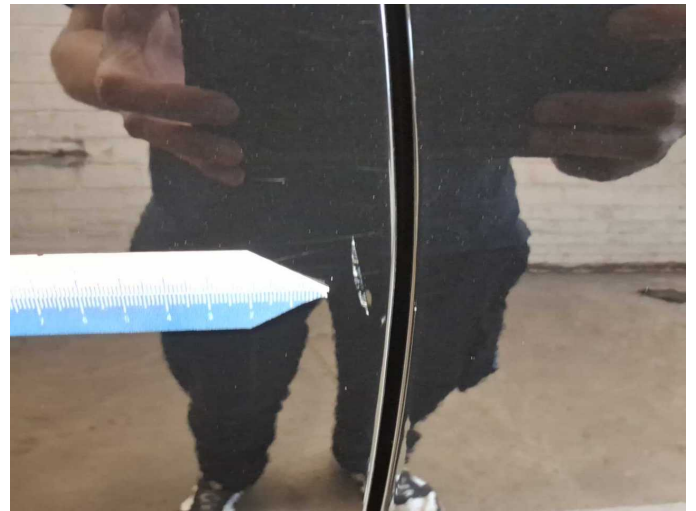
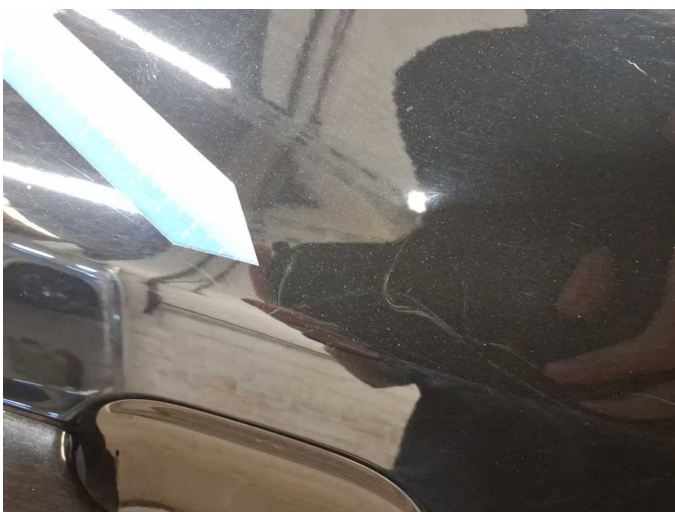
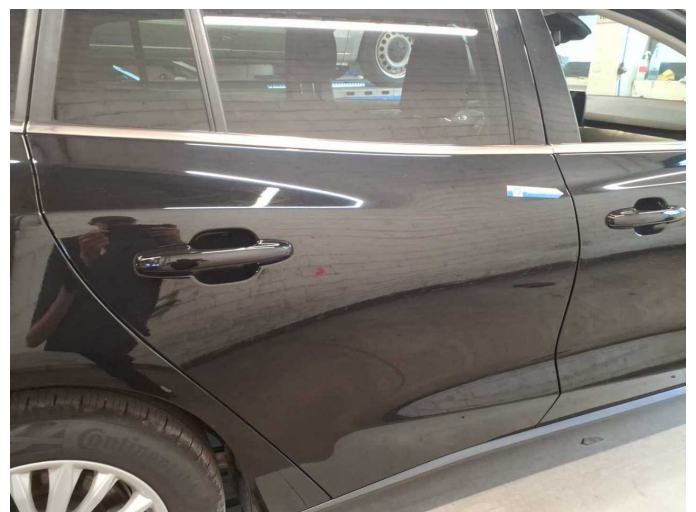
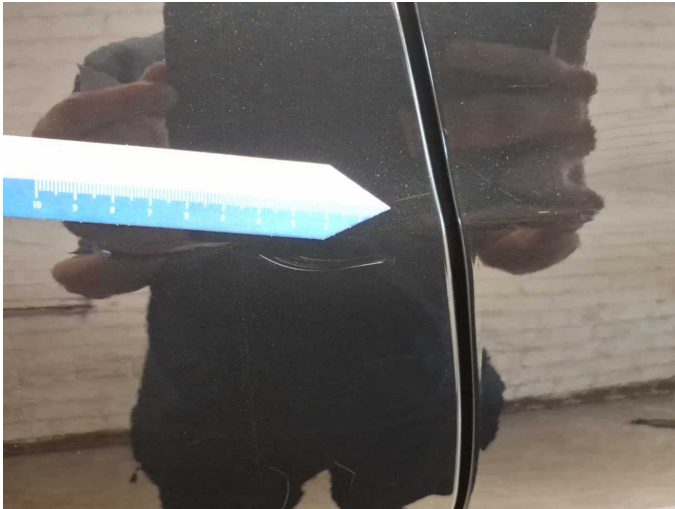
| No. | Component group | Description |
|---|---|---|
| 10 | Door - rear right side | Door - Scratch(es) - Paint |

**Damage 10:** Door - rear right side: Door - Scratch(es) - Paint

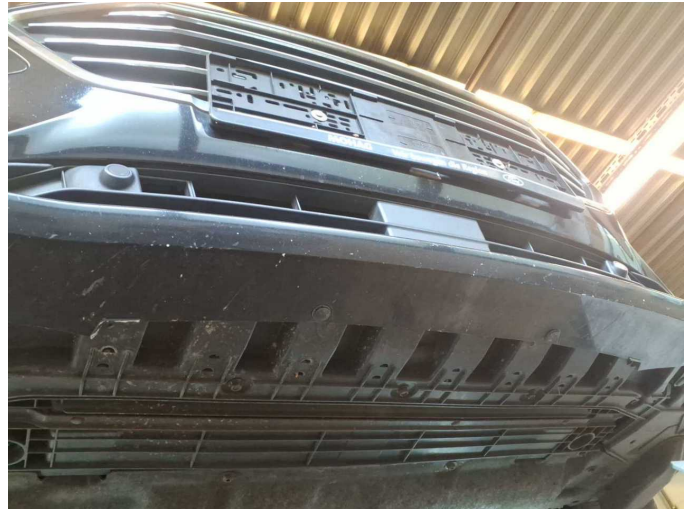
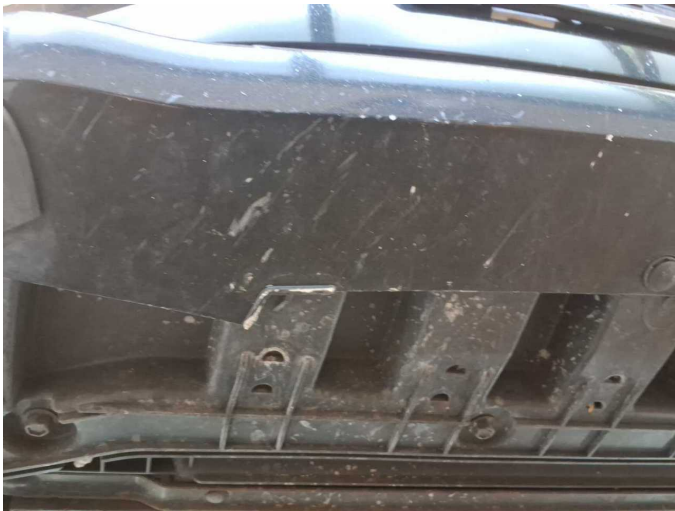
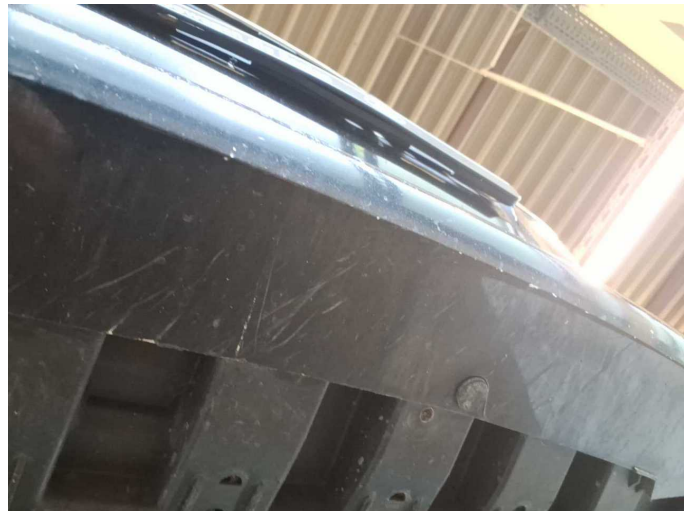
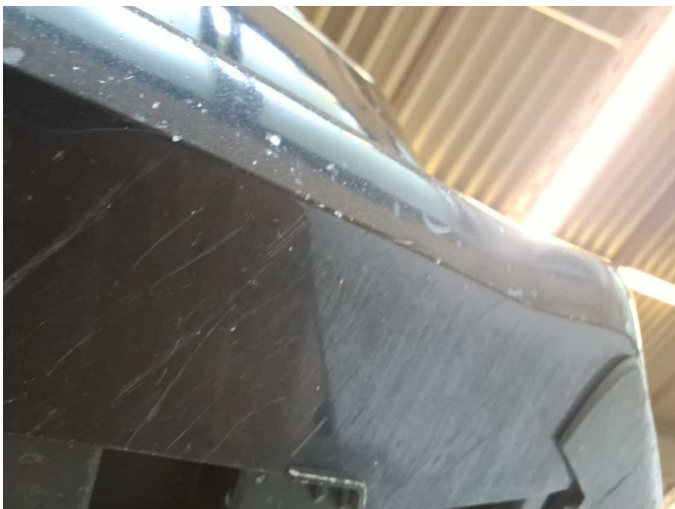
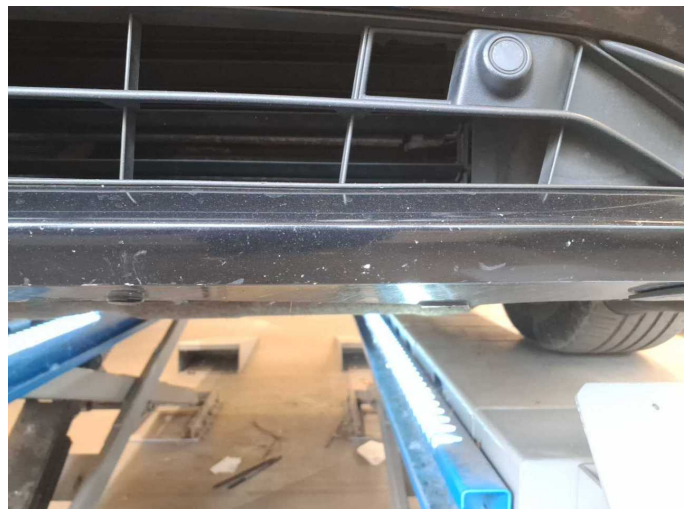
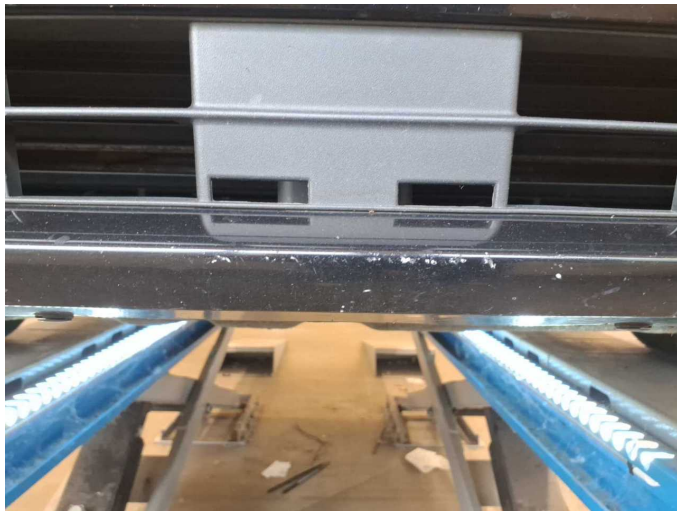
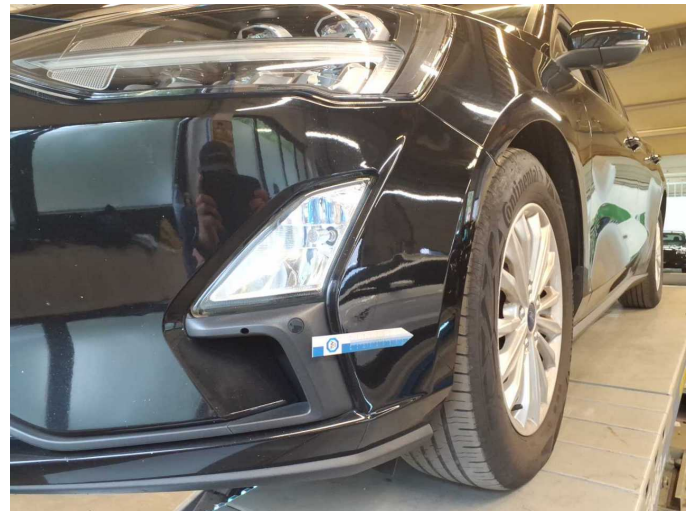
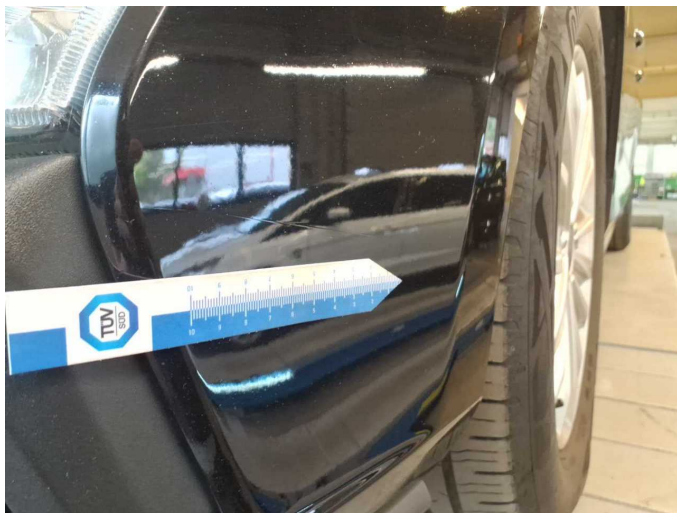
| No. | Component group | Description |
|---|---|---|
| 11 | Front bumper | Front bumper - Scratch(es) - Paint |

**Damage 11:** Front bumper: Front bumper - Scratch(es) - Paint

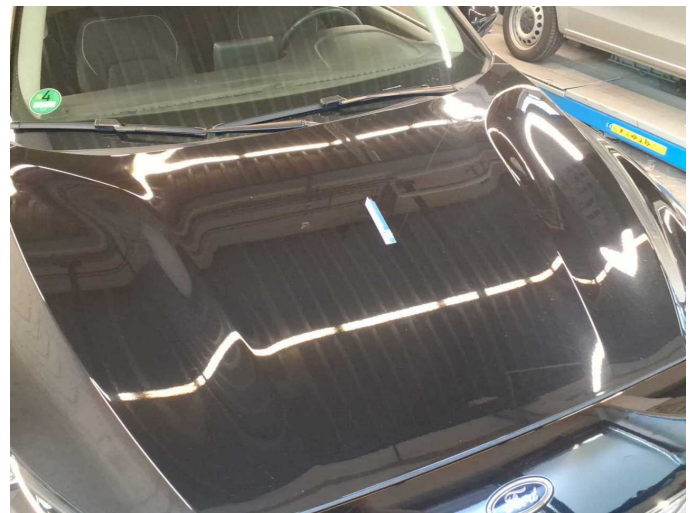
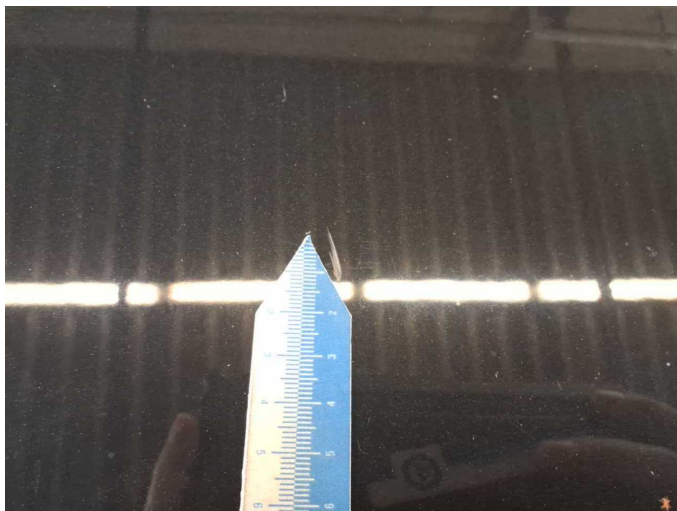
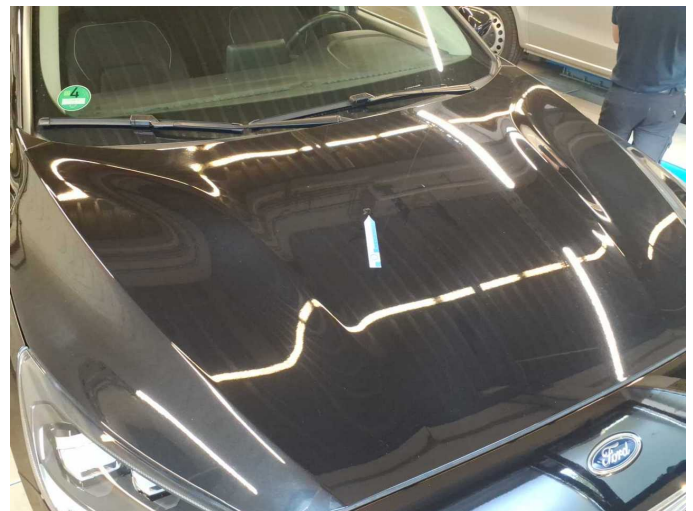
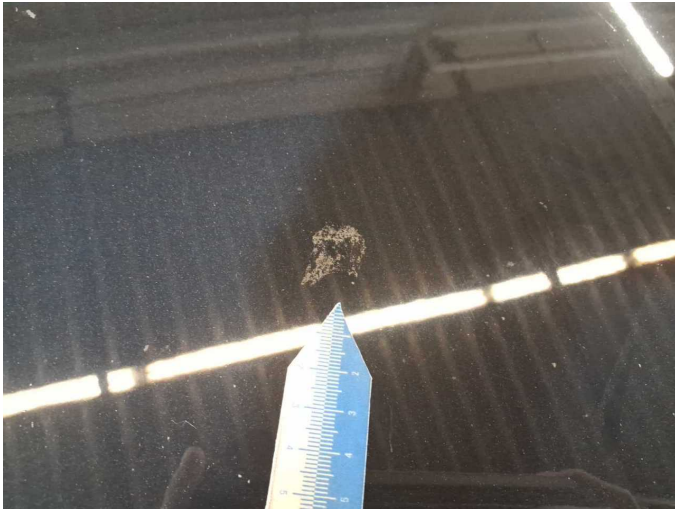
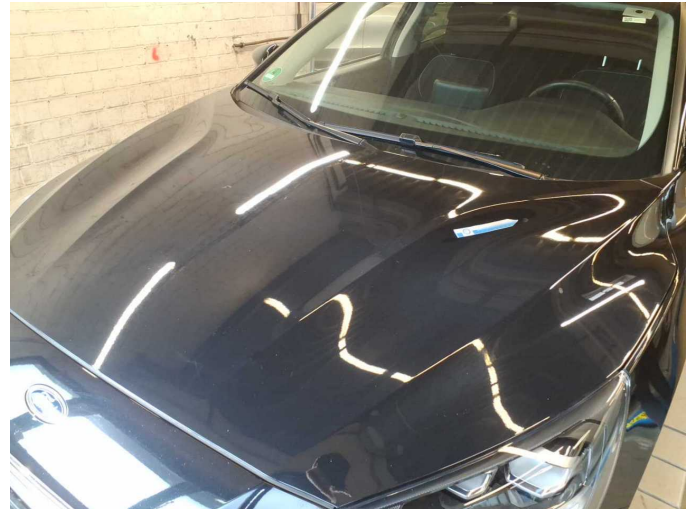
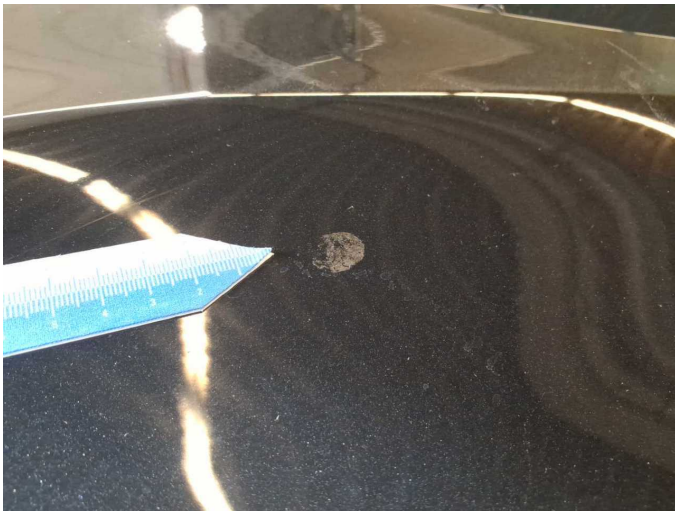
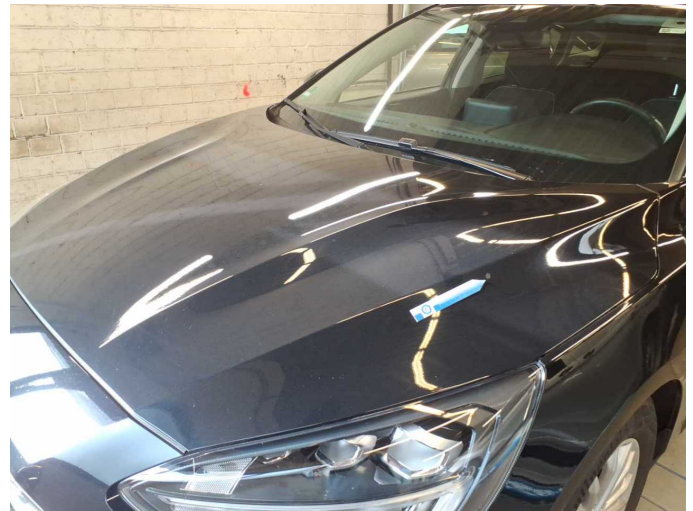
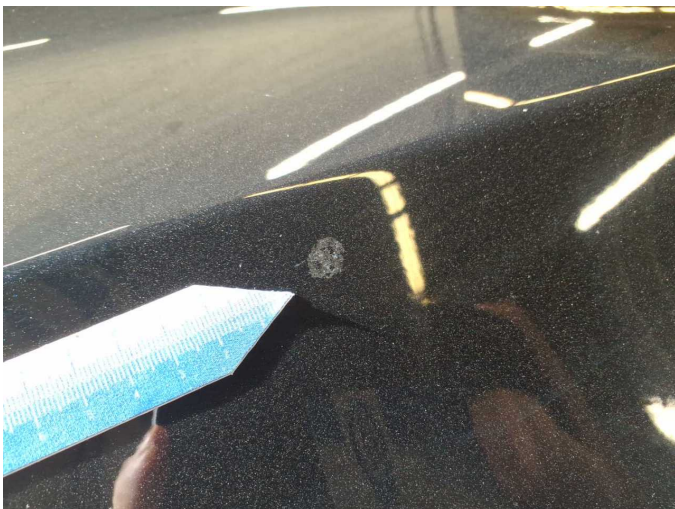
| No. | Component group | Description |
|---|---|---|
| 12 | Bonnet | Bonnet (Vogelkotverätzung + Kratzer) - Paint defect - Paint |

**Damage 12:** Bonnet: Bonnet (Vogelkotverätzung + Kratzer) - Paint defect - Paint

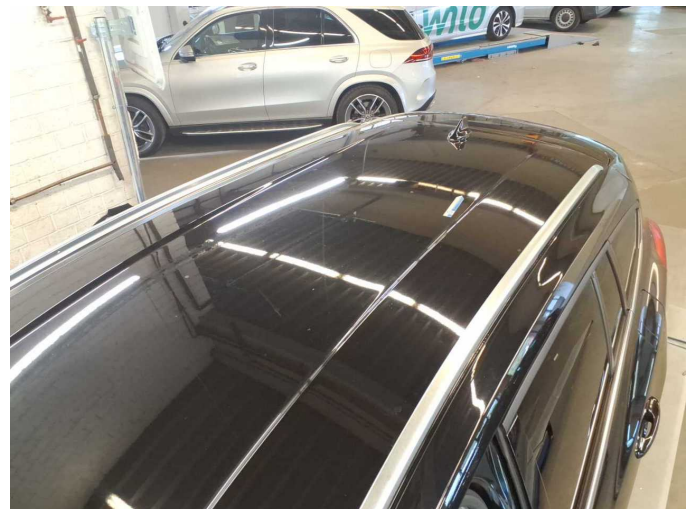
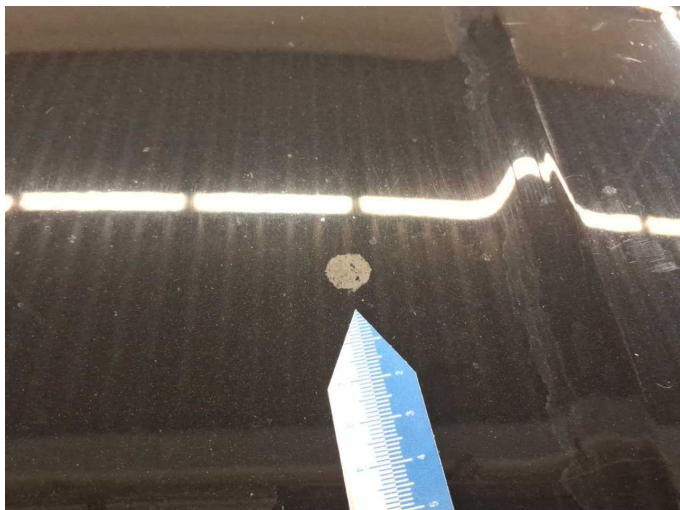
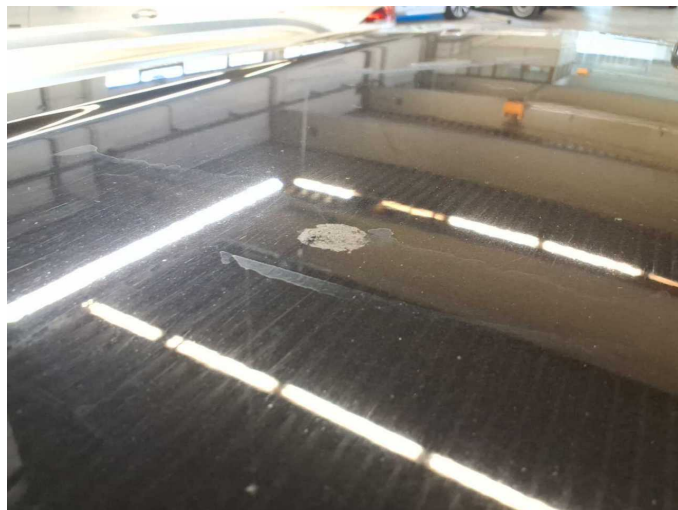
| No. | Component group | Description |
|---|---|---|
| 13 | Roof | Roof (Vogelkotverätzung) - Paint defect - Paint |

**Damage 13:** Roof: Roof (Vogelkotverätzung) - Paint defect - Paint
