## status report

#### Ford Focus Turnier Titanium

| Vehicle identification number | <b>WF0PXXGCHPLL50197</b> | mileage read: | <b>41646 km</b> |

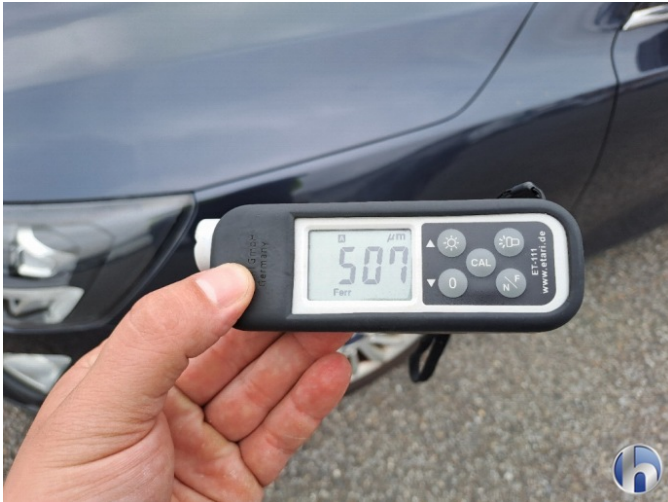
| component | Damage | Rep kind |
|---|---|---|
| 1. Front fender - left | Subsequently painted | acceptable |

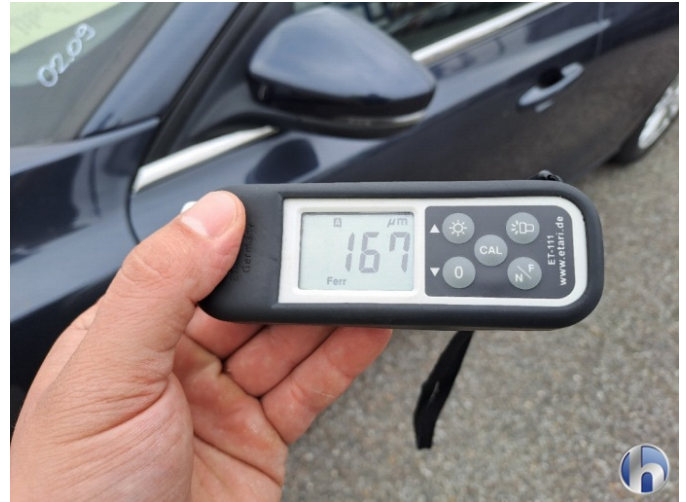
| component | Damage | Rep kind |
|---|---|---|
| 2. Front door - left | Subsequently painted | acceptable |

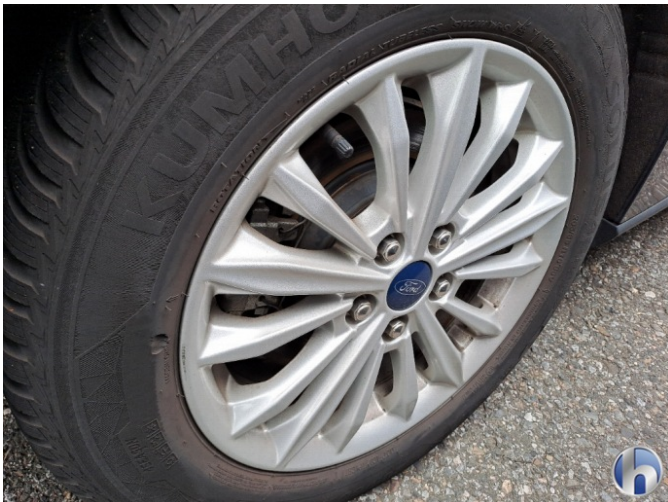
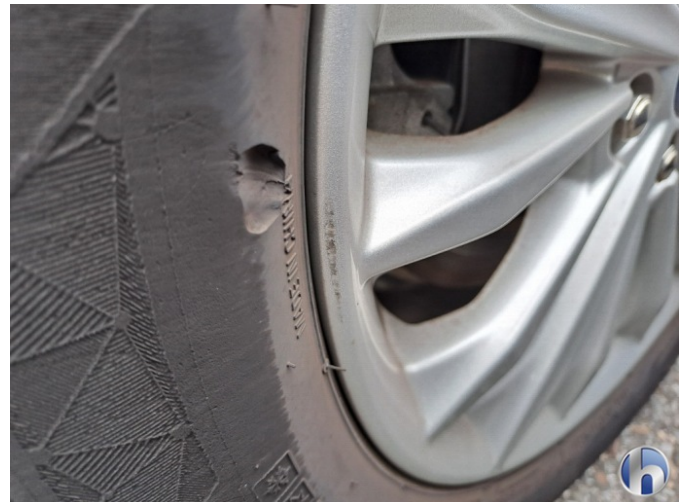
| component | Damage | Rep kind |
|---|---|---|
| 3. Rim rear - right | Damaged | Smart repair |

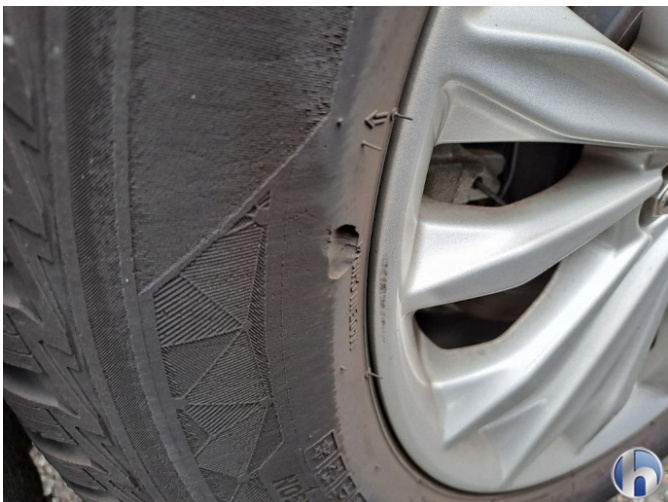
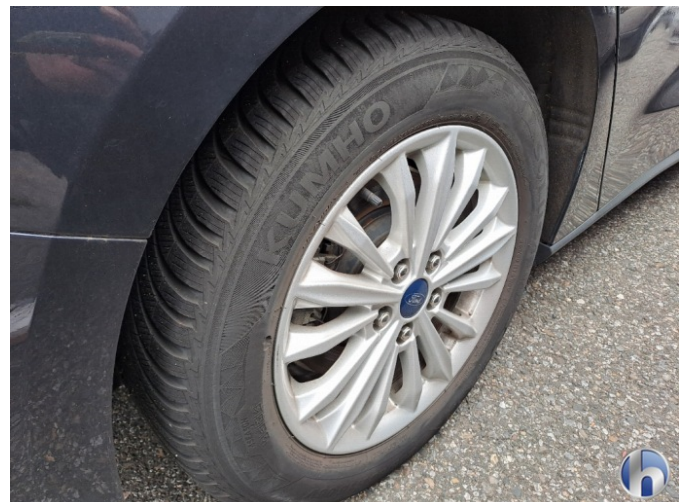
**Note Road Safe:** Reifen hr beschädigt.

| component | Damage | Rep kind |
|---|---|---|
| 4. tire rear - right | Damaged | Replace |

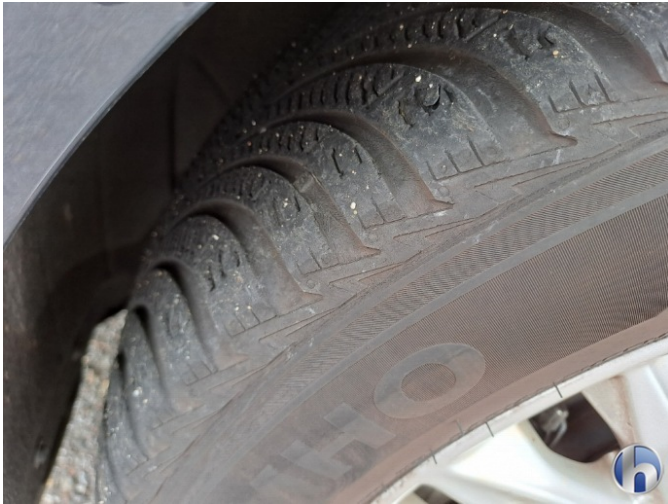
| component | Damage | Rep kind |
|---|---|---|
| 5. tire front - right | Worn | Replace |

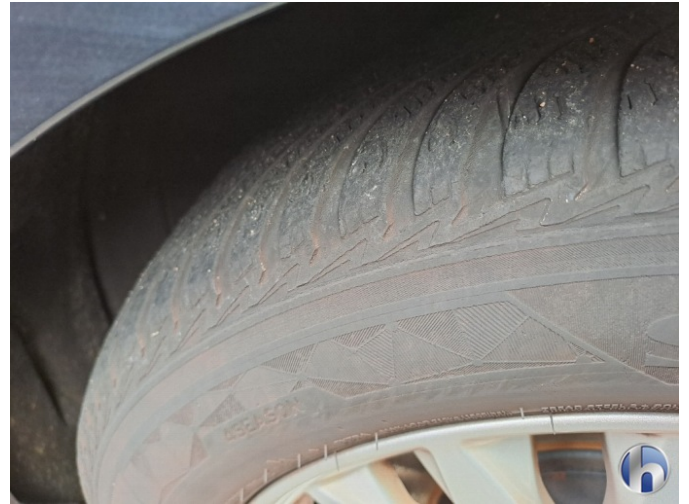
| component | Damage | Rep kind |
|---|---|---|
| 6. tire front - right | Worn | Replace |

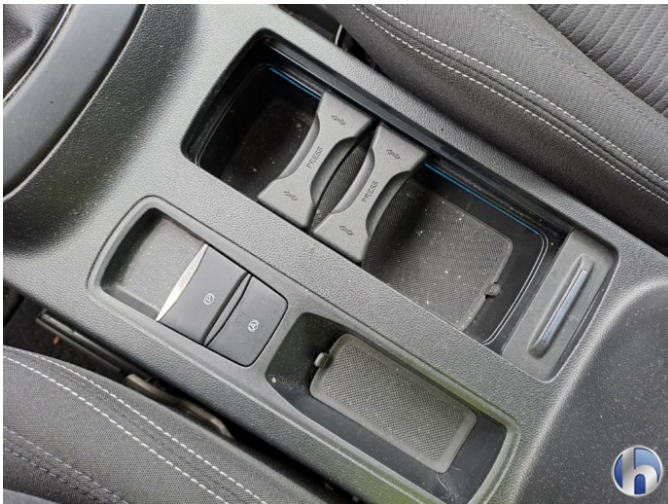
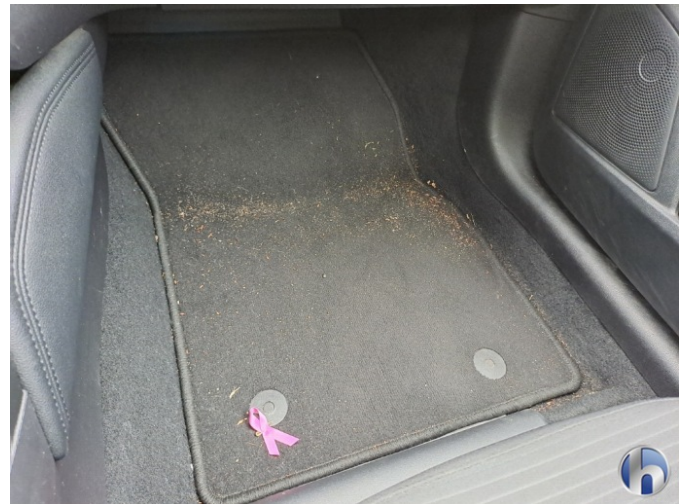
| component | Damage | Rep kind |
|---|---|---|
| 8. | Dirty | |

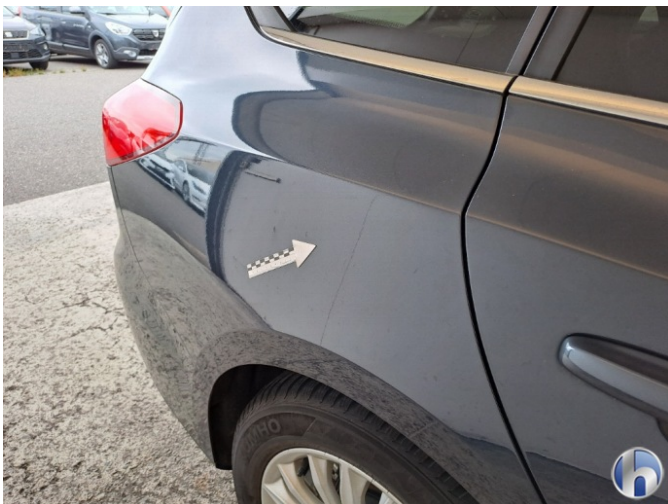
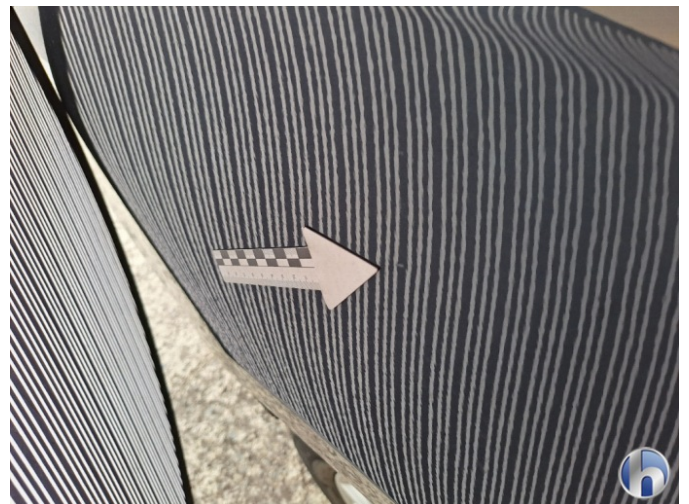
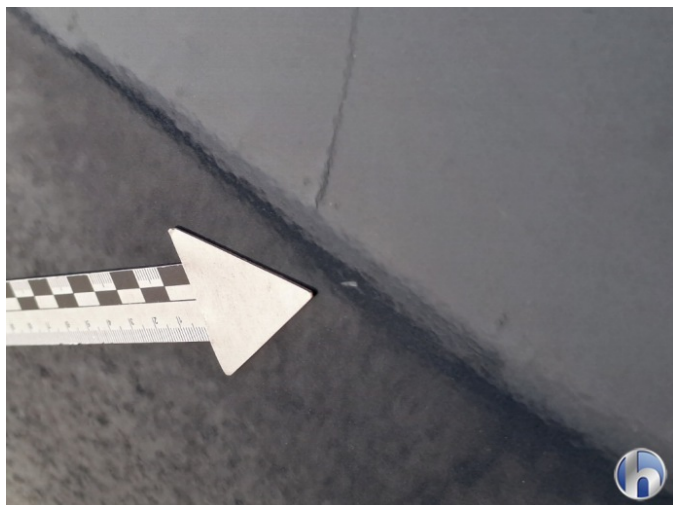
| component | Damage | Rep kind |
|---|---|---|
| 9. Sidewall - Rear - right | | Refurbish and paint |

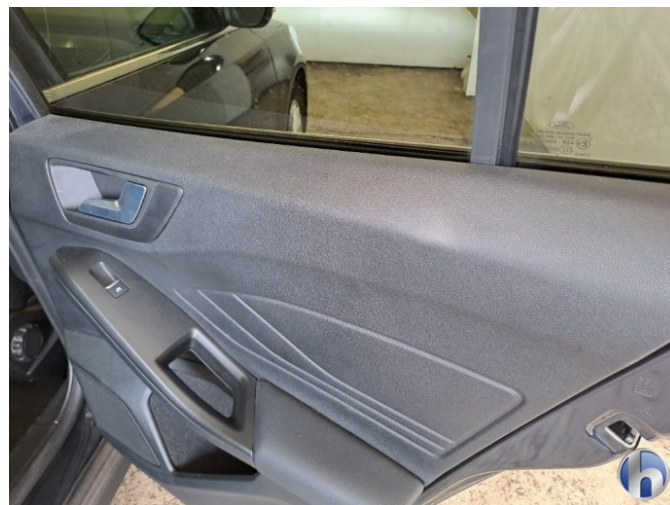
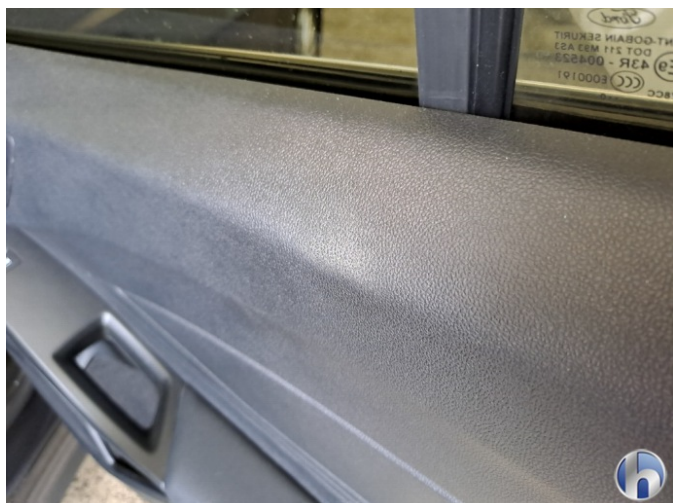
| component | Damage | Rep kind |
|---|---|---|
| 10. Door trim Rear - right | Stain | |

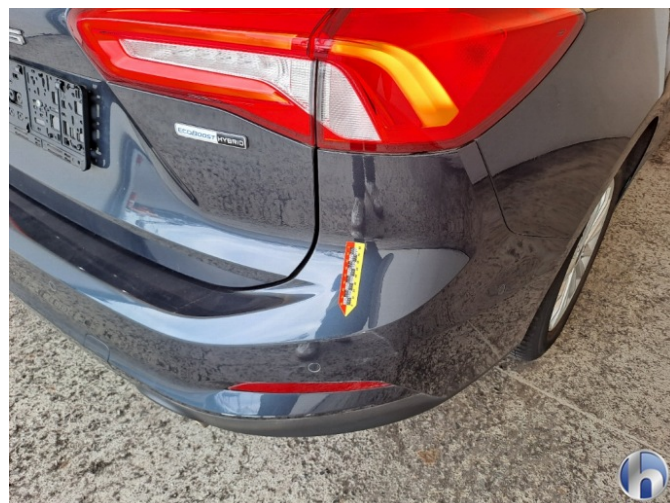
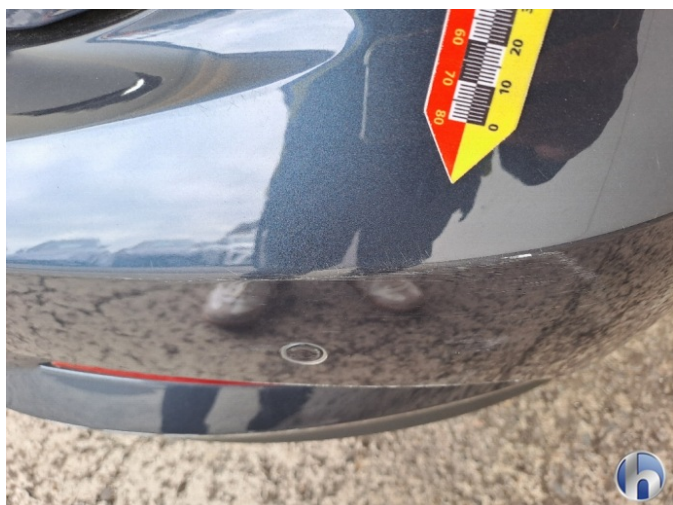
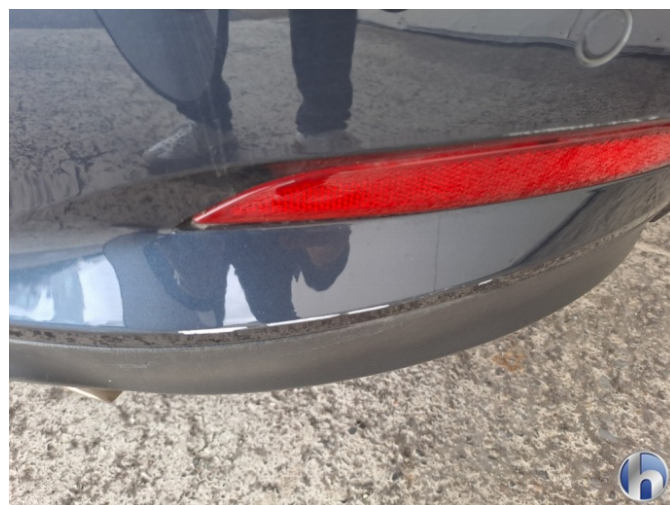
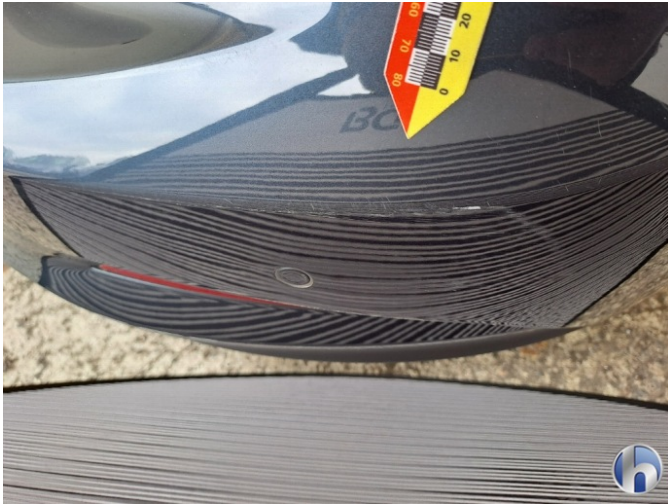
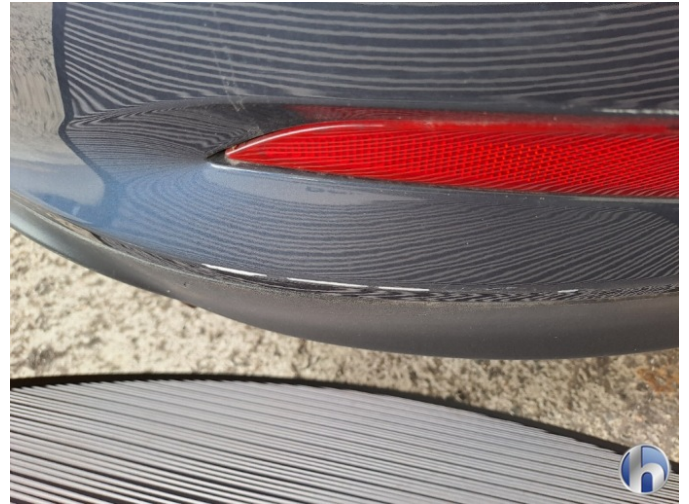
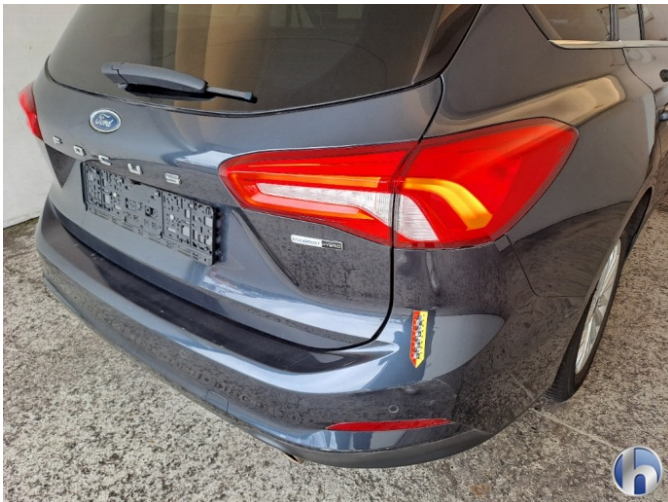
| component | Damage | Rep kind |
|---|---|---|
| 11. Rear bumper | Scratch(es) | Refurbish and paint |

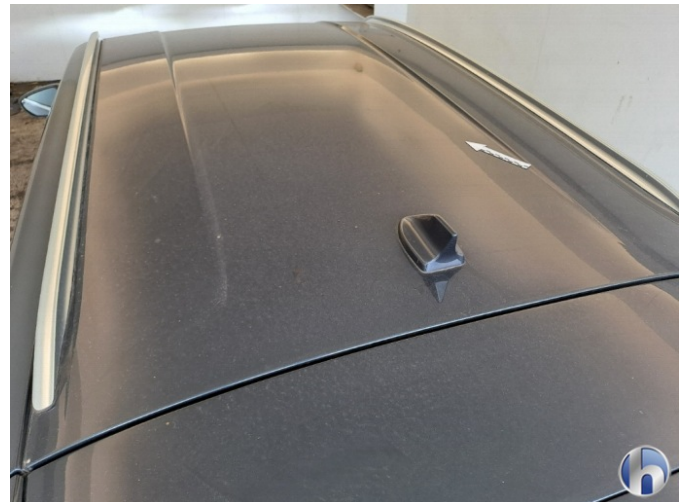
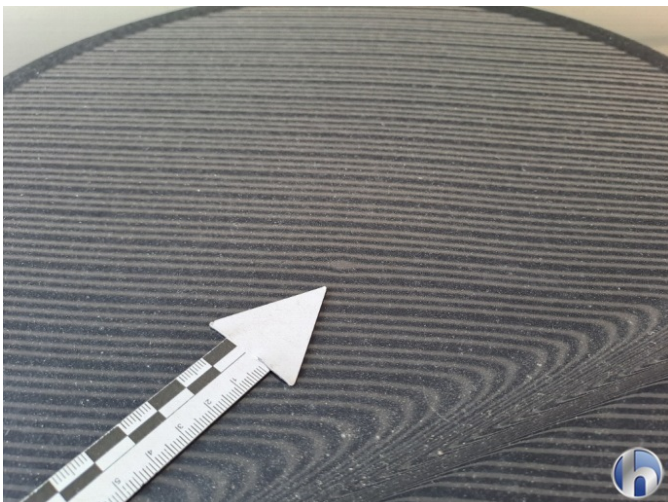
| component | Damage | Rep kind |
|---|---|---|
| 12. roof | Delle | Smart repair |

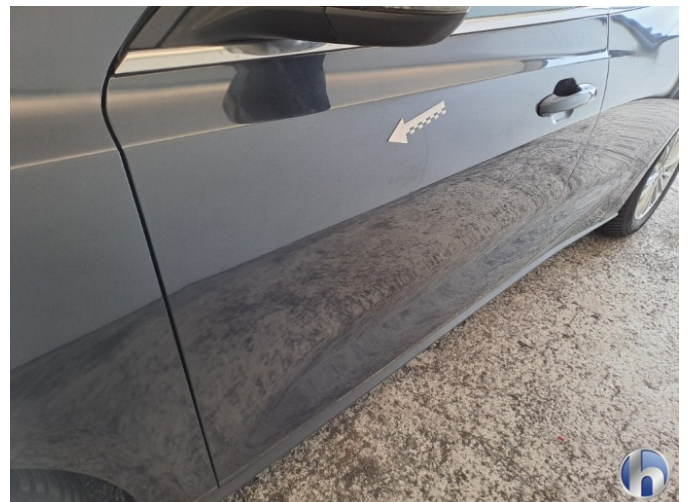
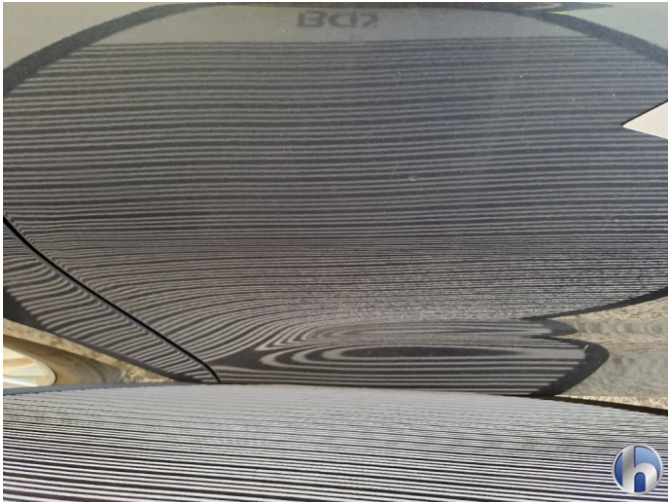
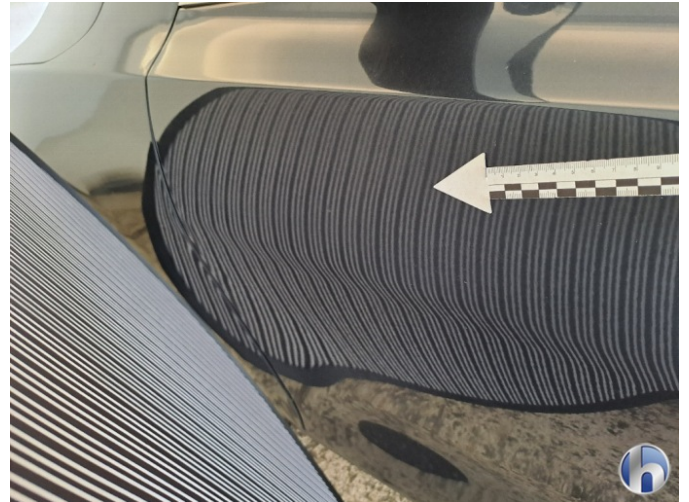
| component | Damage | Rep kind |
|---|---|---|
| 13. Front door - left | Execution defect | Paint |

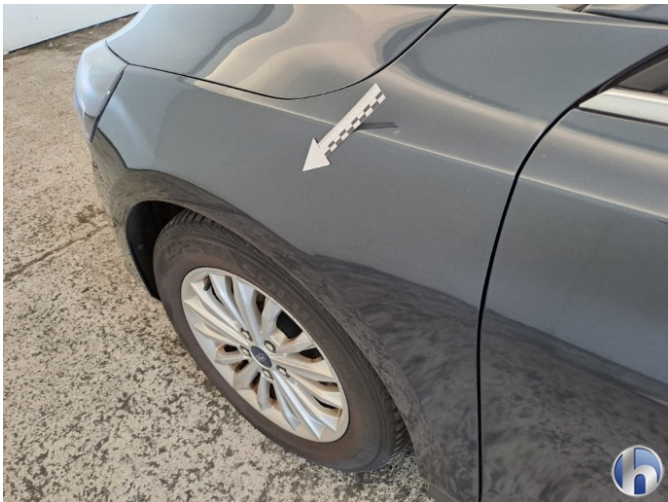
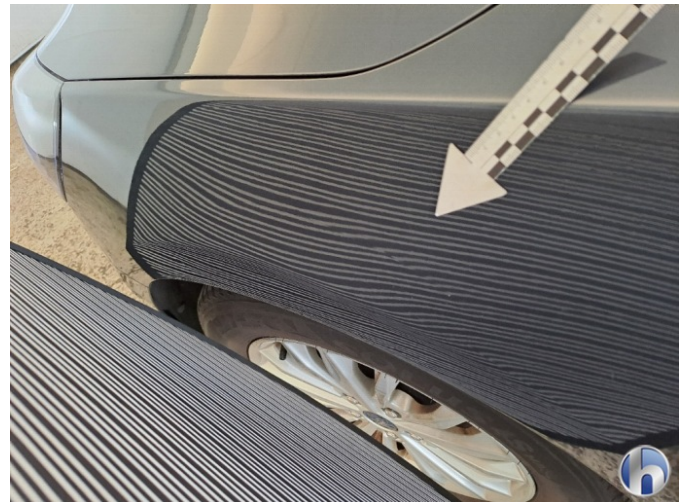
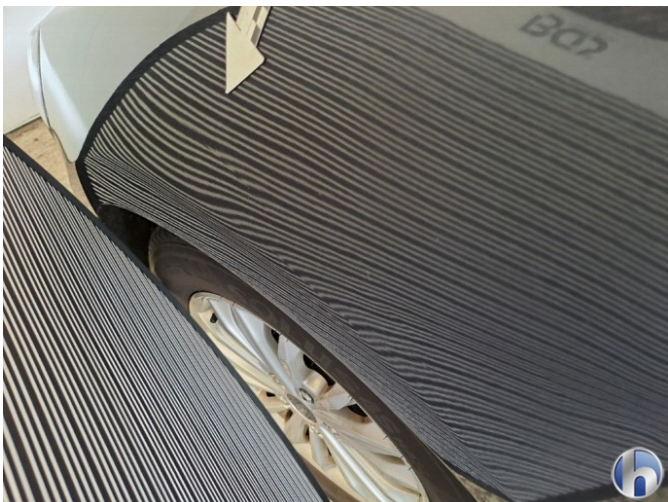
| component | Damage | Rep kind |
|---|---|---|
| 14. Front fender - left | Execution defect | Refurbish and paint |

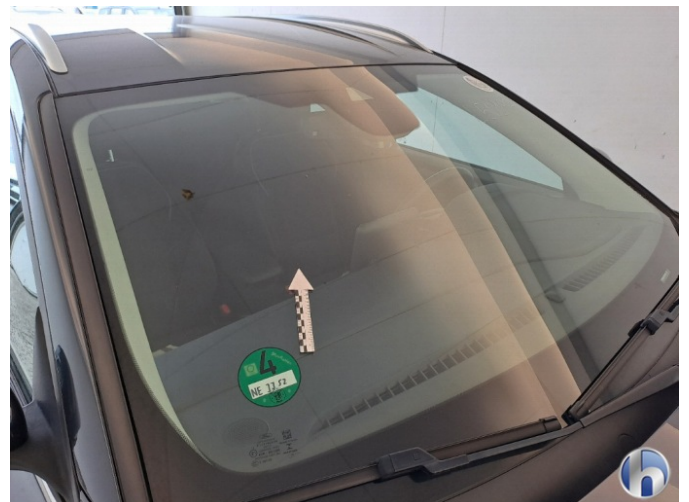
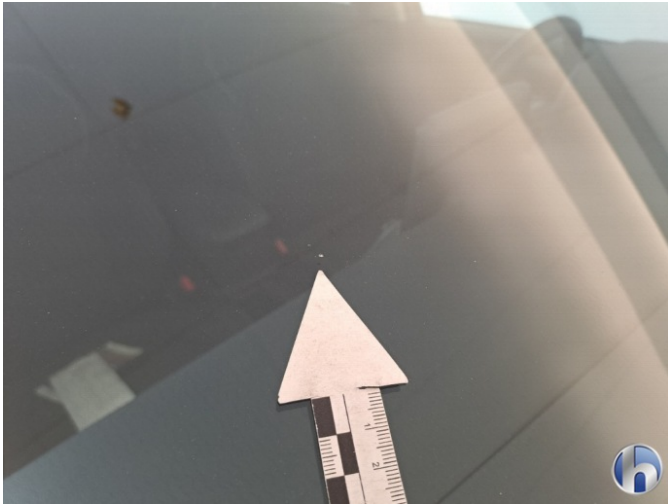
| component | Damage | Rep kind |
|---|---|---|
| 15. Windshield | Wear and tear | acceptable |
