Expertise

Protocol number: 41228497
Order No. / Reference: 25116988
Inspection date: 25 Aug 2025

Manufacturer: Ford	Model: Focus Turnier 1.5 EcoBlue Start-Stopp-System Aut. TITANIUM
VIN: WF0PXXGCHPLR53023

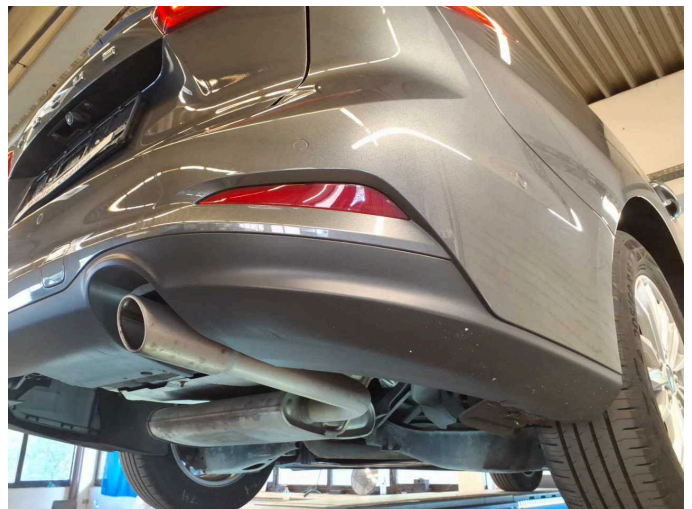
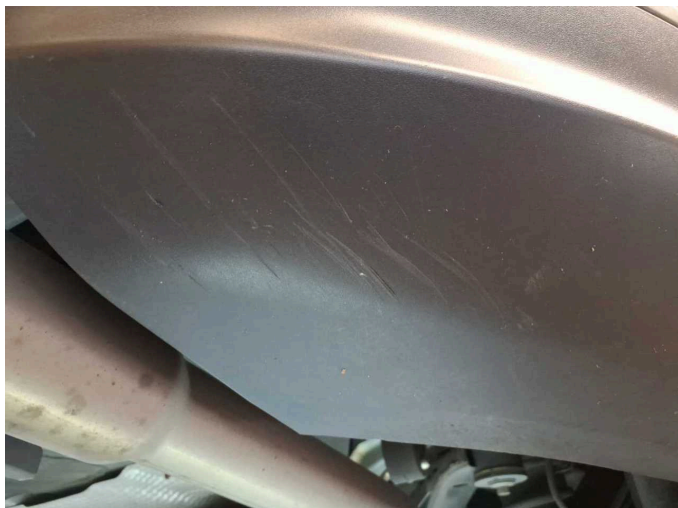
Damage 1: Rear bumper: Spoiler - Scratch(es) - Smart repair

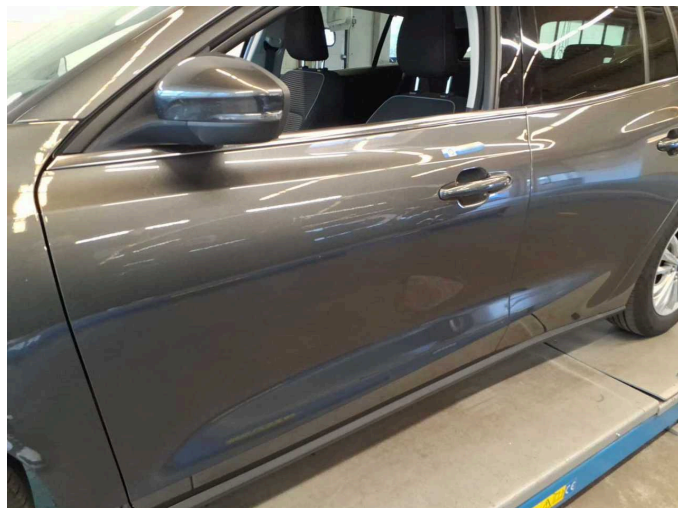
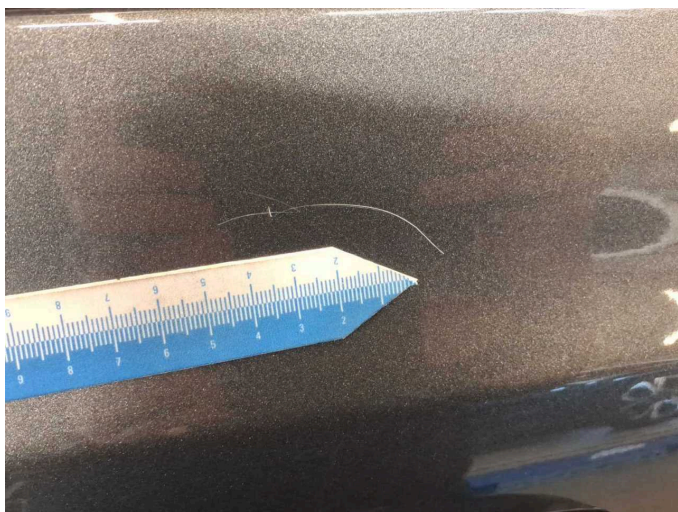
Damage 2: Door - front left side: Door - Scratch(es) - Smart repair

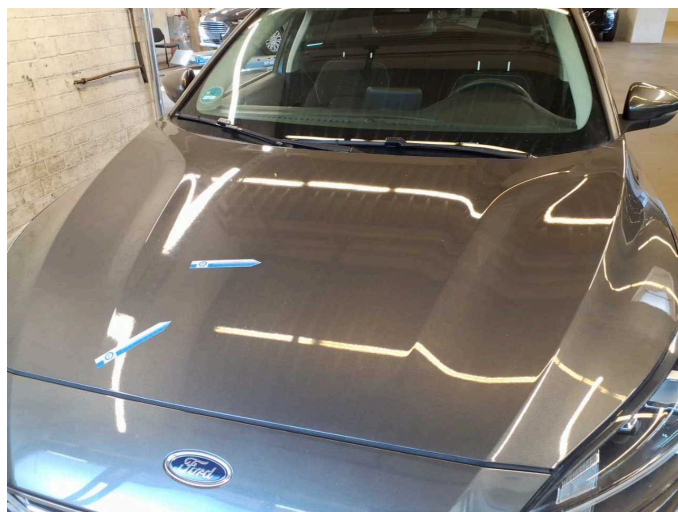
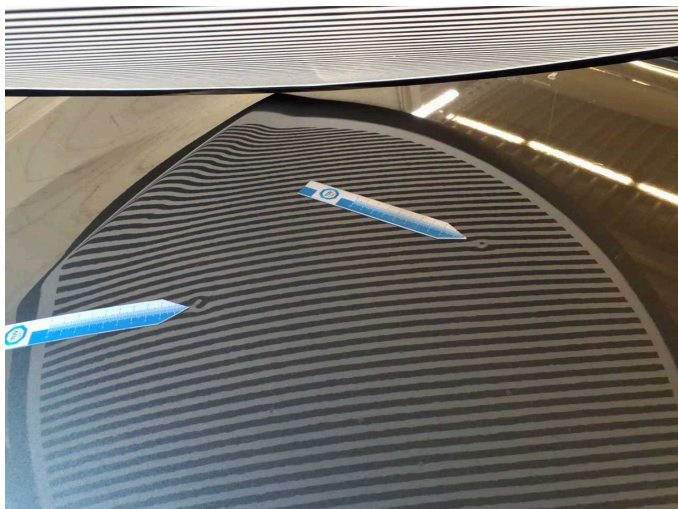
Damage 3: Bonnet: Bonnet - dent(s) - Smooth repair work

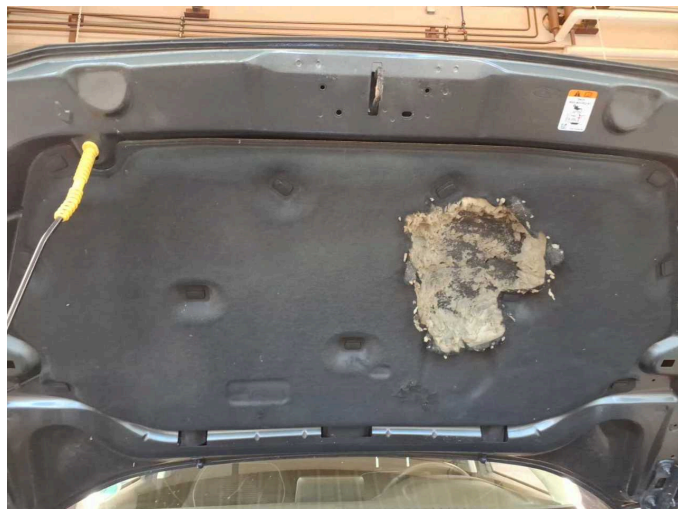
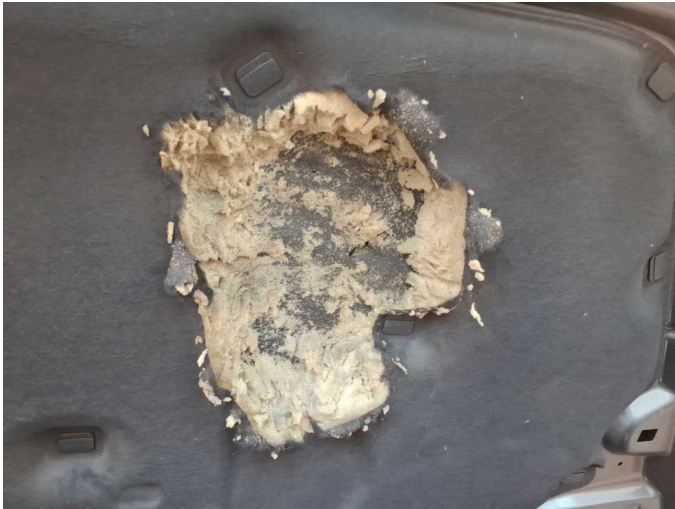
Damage 4: Bonnet: Insulation lining - Damage caused by marten / rodent
- Replace

Damage 4: Bonnet: Insulation lining - Damage caused by marten / rodent - Replace

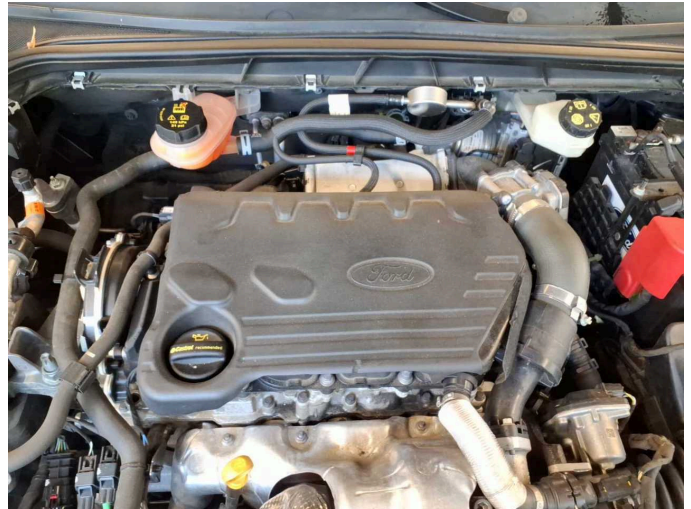
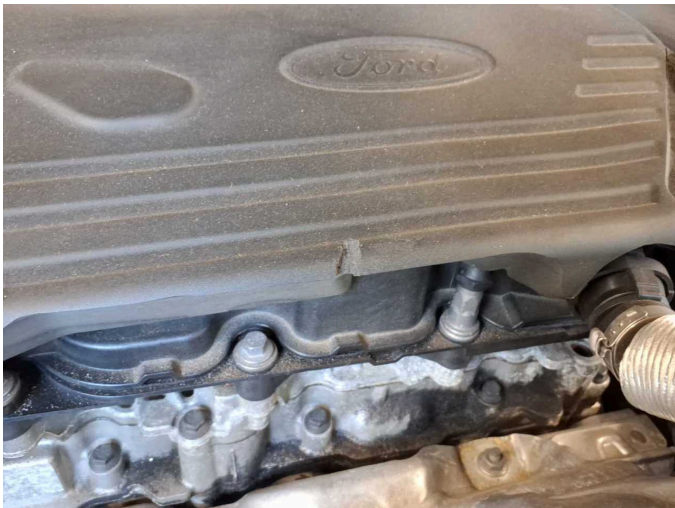
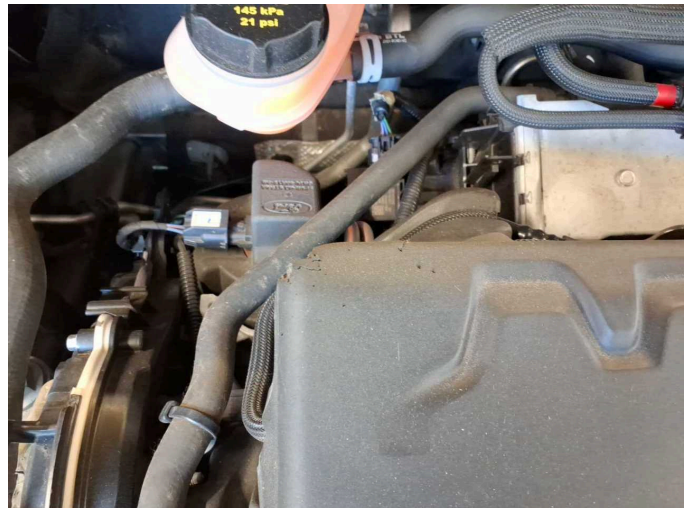
Damage 5: Engine: Engine cover - top / cover - Damage caused by marten / rodent - Replace

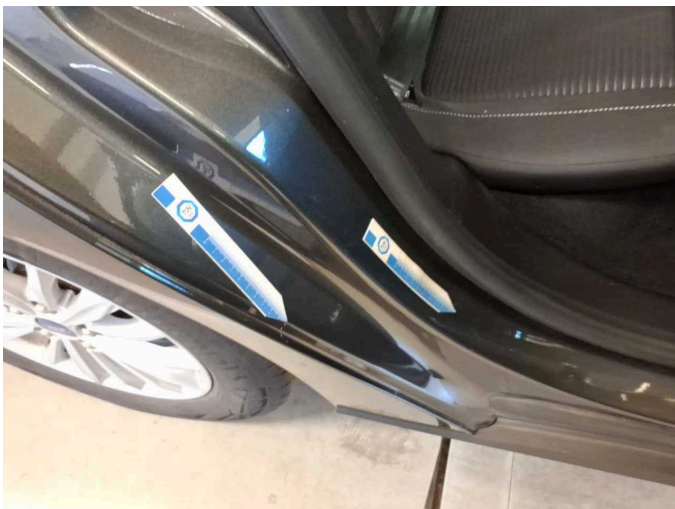
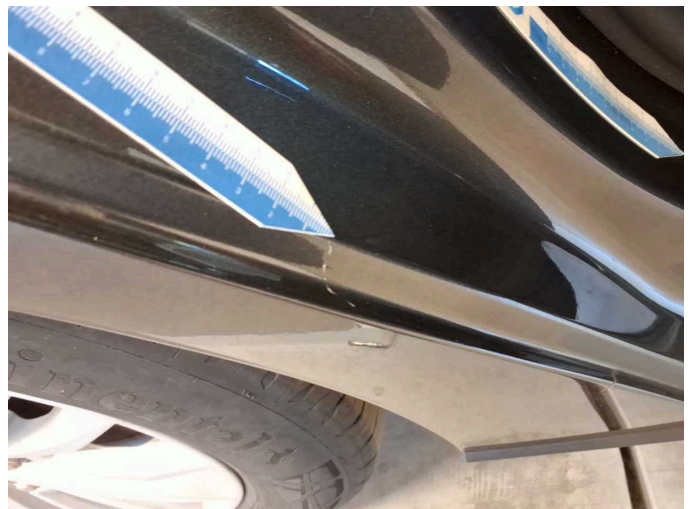
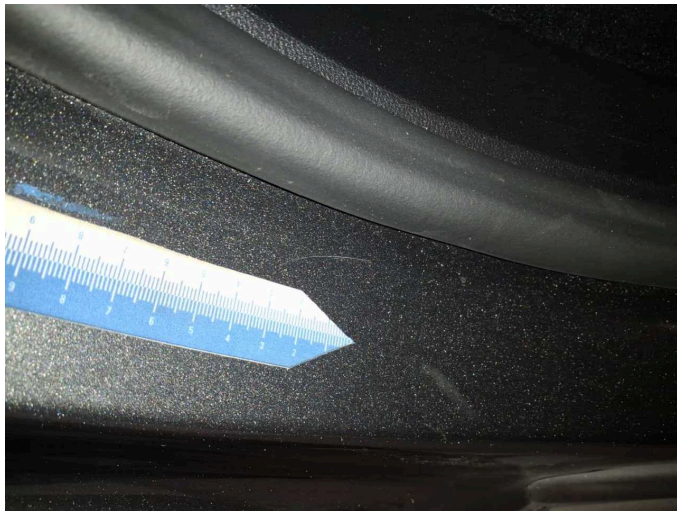
Damage 6: Side panel - rear right side: Sill - Scratch(es) - Smart repair

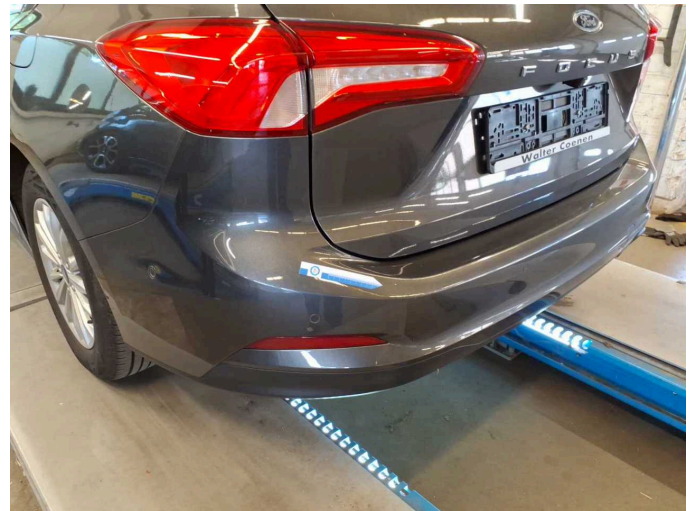
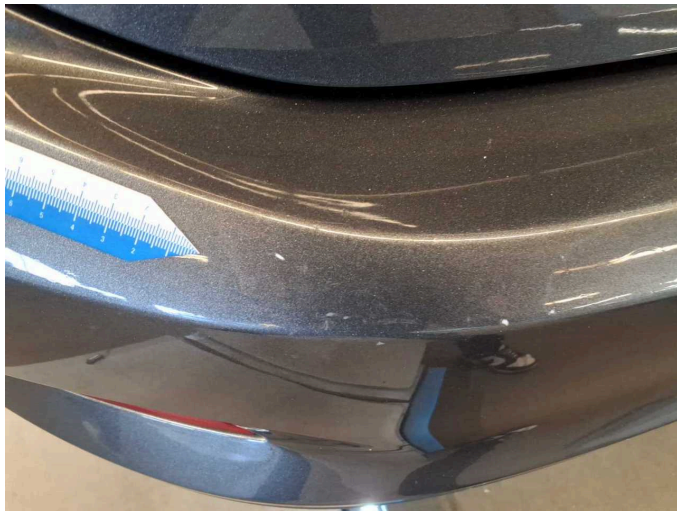
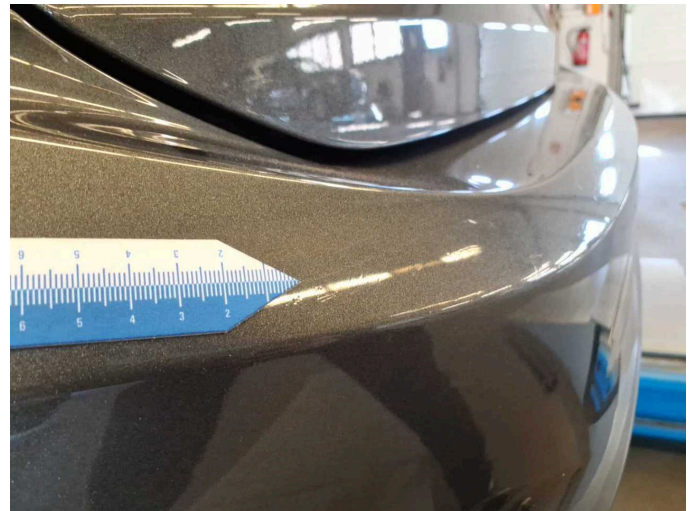
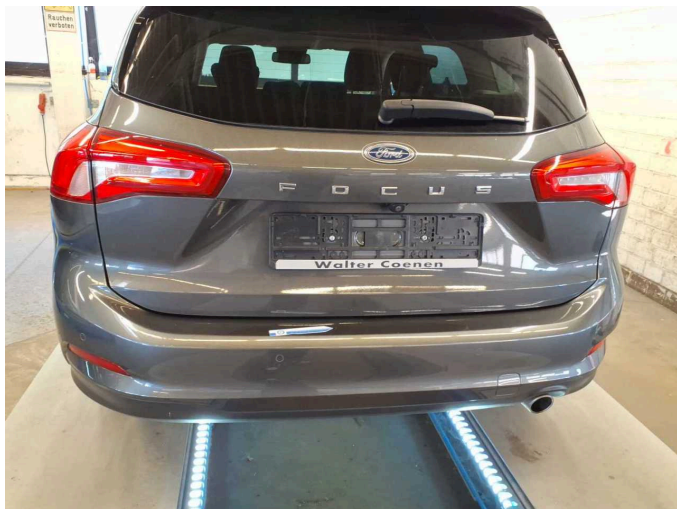
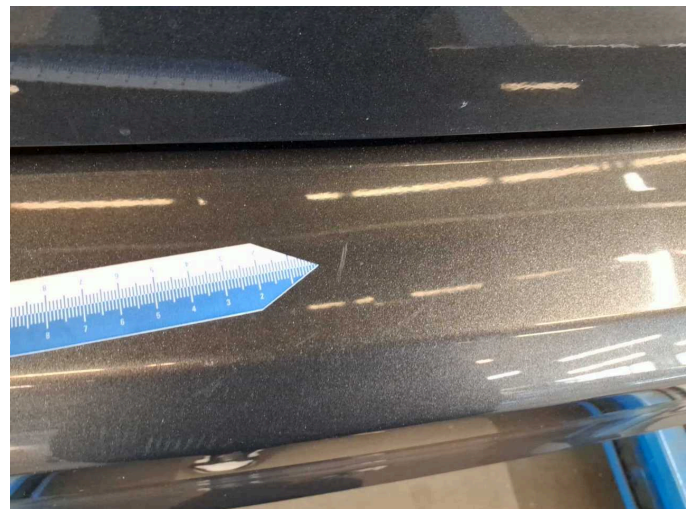
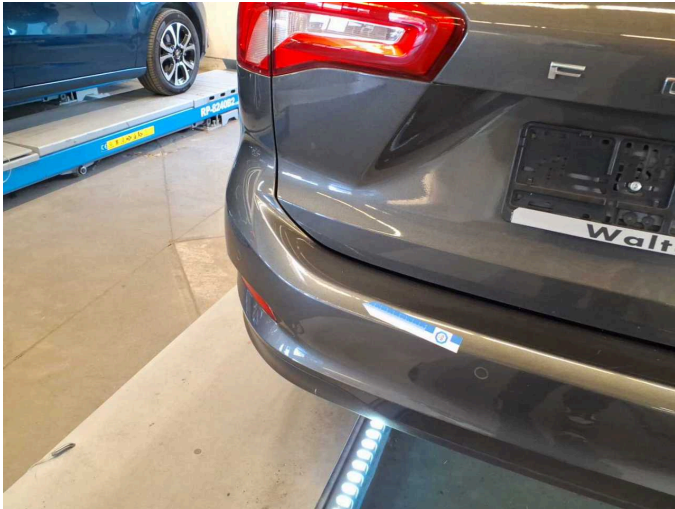
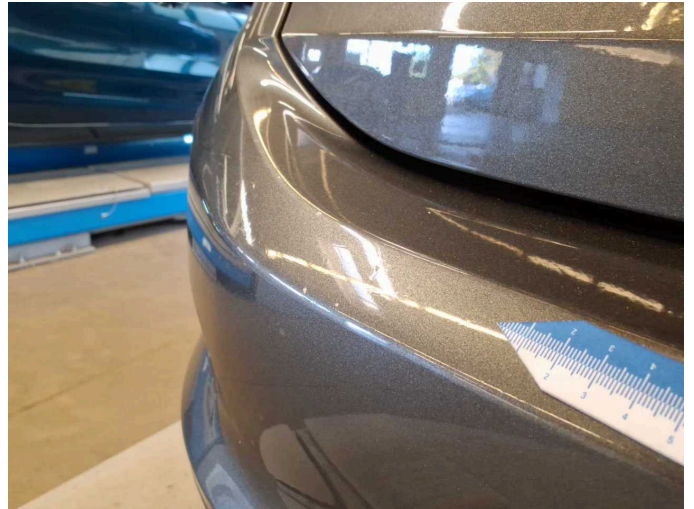
Damage 7: Rear bumper: Rear bumper - Scratch(es) - Smart repair

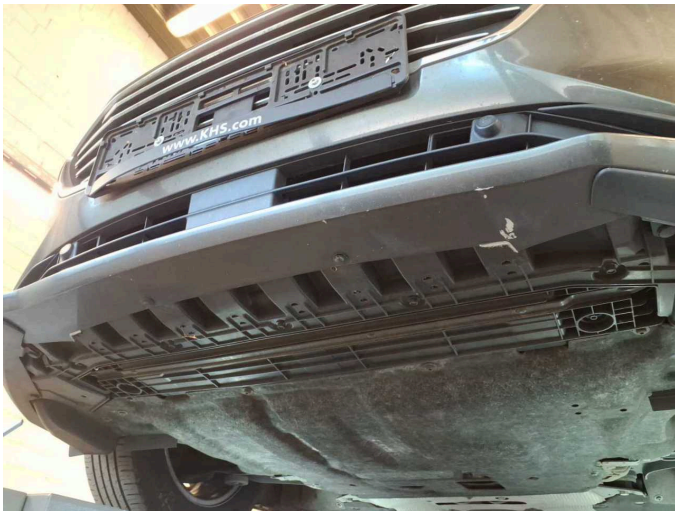
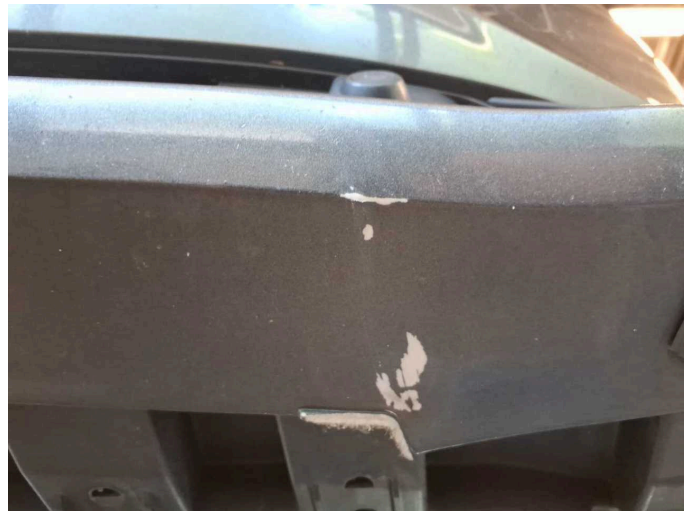
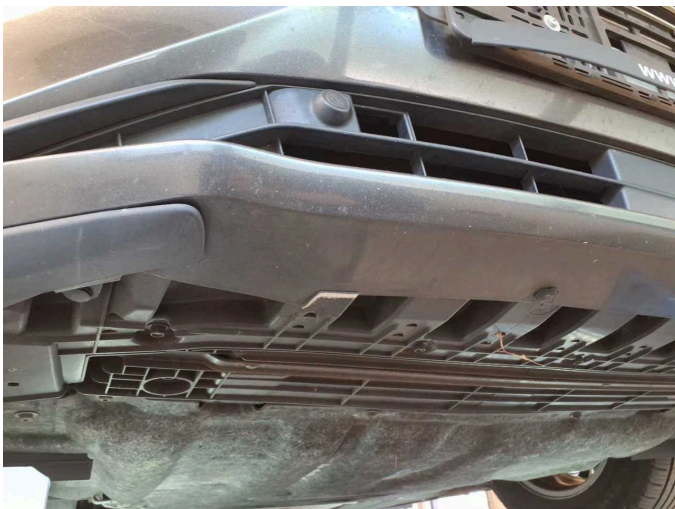
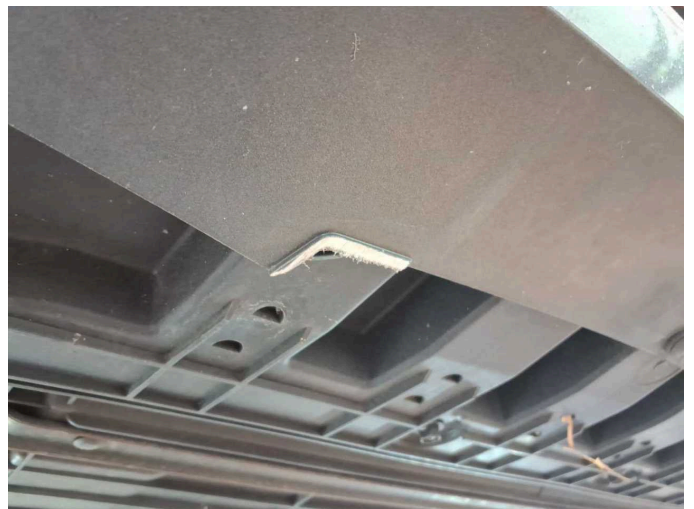
Damage 8: Front bumper: Front bumper - Scratch(es) - Smart repair

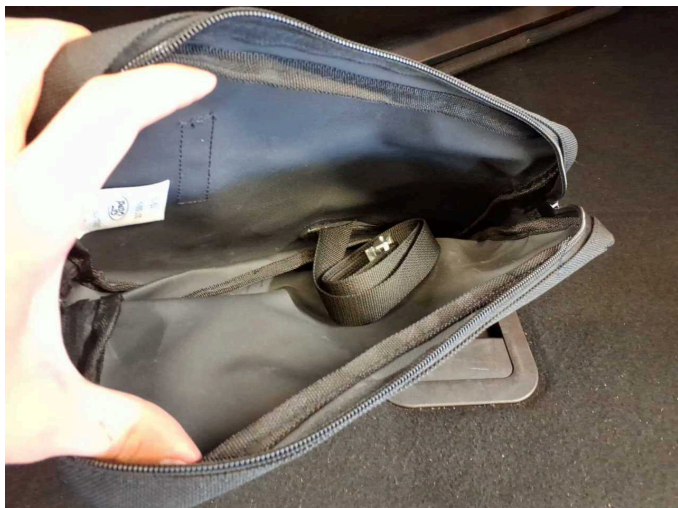
Missing part 1: Rear of vehicle: Trailer hitch - removable - Missing - Replace
