Expertise

Protocol number: 41172775
Order No. / Reference: 25124946
Inspection date: 21 Aug 2025

| Manufacturer: Ford | Model: Focus Turnier 1.5 EcoBlue Start-Stopp-System Aut. ACTIVE |
| VIN: WF0PXXGCHPMD11689 | |

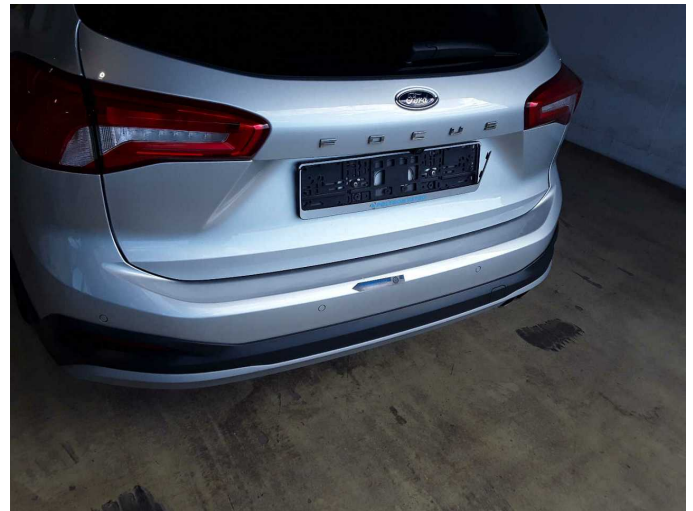
| No. | Component group | Description |
|---|---|---|
| 1 | Rear bumper | Rear bumper - Scratch(es) - Loss in value |

Damage 1: Rear bumper: Rear bumper - Scratch(es) - Loss in value

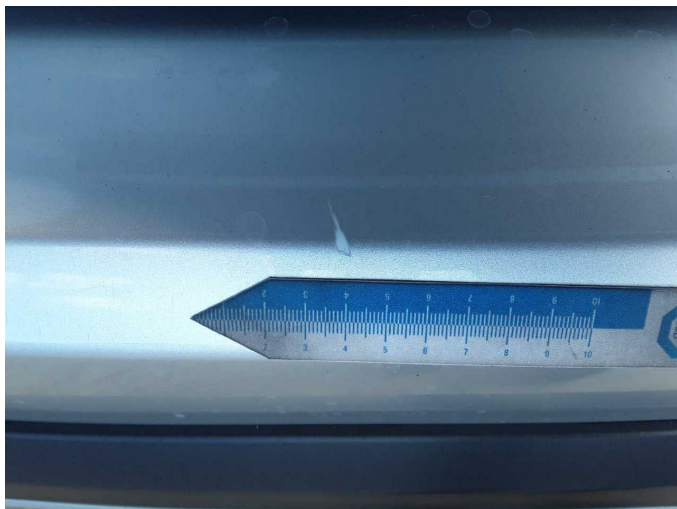
Damage 1: Rear bumper: Rear bumper - Scratch(es) - Loss in value

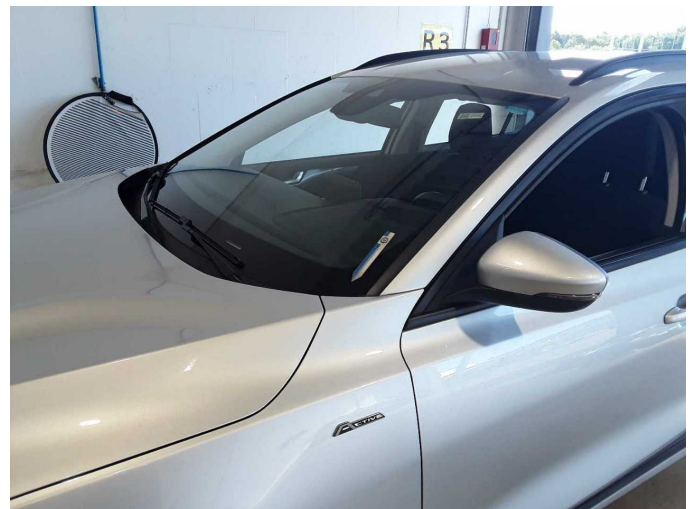
| No. | Component group | Description |
|---|---|---|
| 2 | Vehicle glazing | Windscreen - Broken / torn - Replace |

Damage 2: Vehicle glazing: Windscreen - Broken / torn - Replace

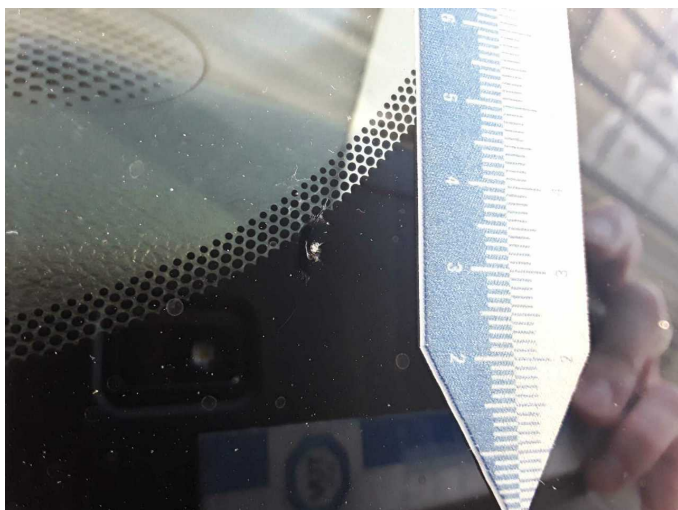
Damage 2: Vehicle glazing: Windscreen - Broken / torn - Replace

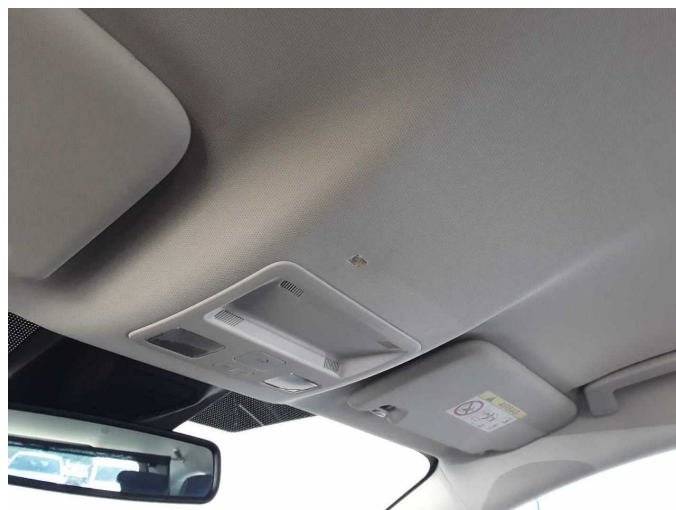
| No. | Component group | Description |
|---|---|---|
| 3 | Trim / covers | Roof lining - Damaged - Replace |

Damage 3: Trim / covers: Roof lining - Damaged - Replace

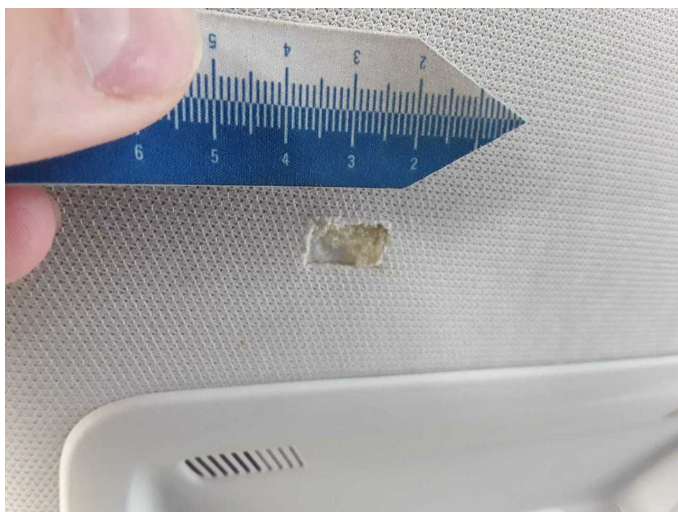
Damage 3: Trim / covers: Roof lining - Damaged - Replace
