Expertise

Protocol number: 41603061
Order No. / Reference: 25212629
Inspection date: 18 Sept 2025

Manufacturer: Ford	Model: Focus Turnier 1.5 EcoBlue Start-Stopp-System Aut. COOL&CONNECT
VIN: WF0PXXGCHPNM79480

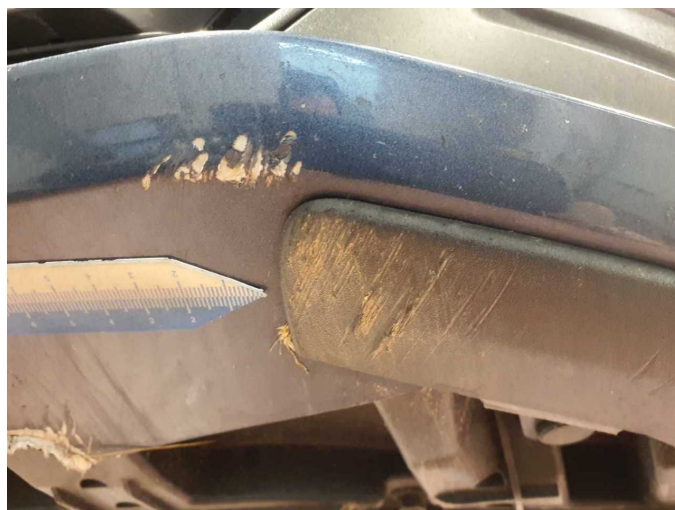
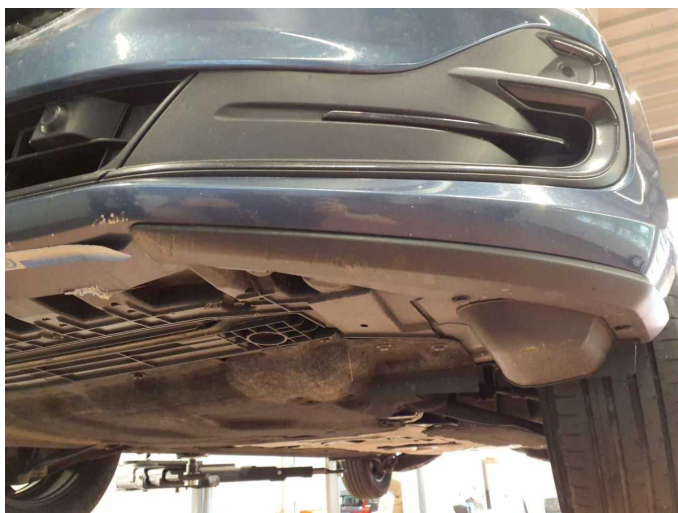
Damage 1: Body: Underbody panelling - Scratched - Replace

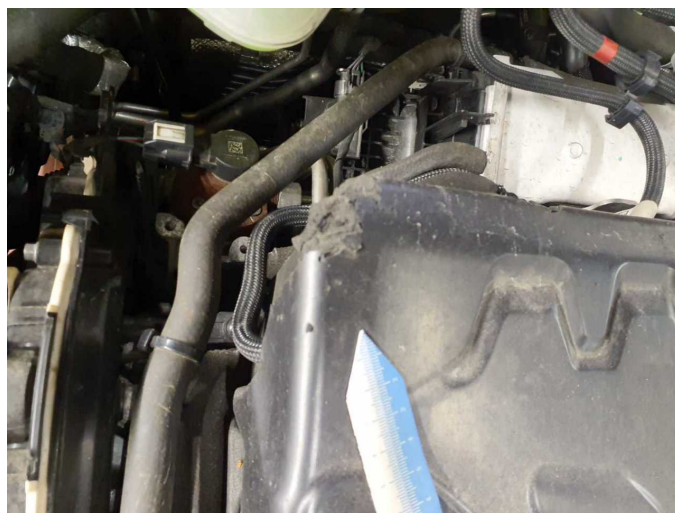
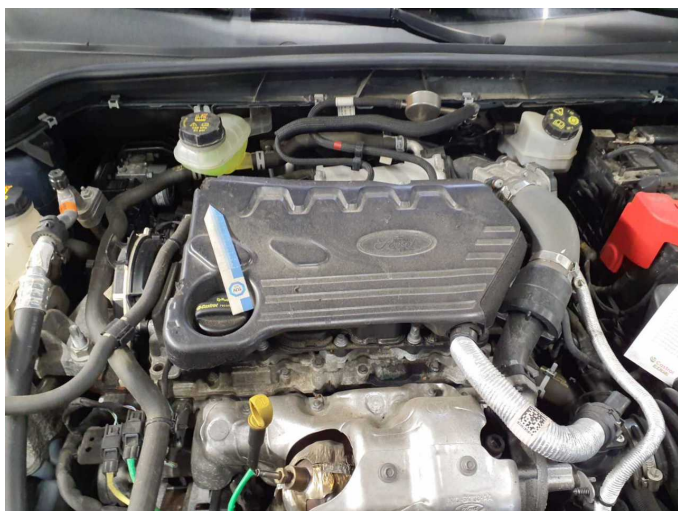
Damage 2: Engine: Engine cover - top / cover - Damage caused by marten / rodent - Replace

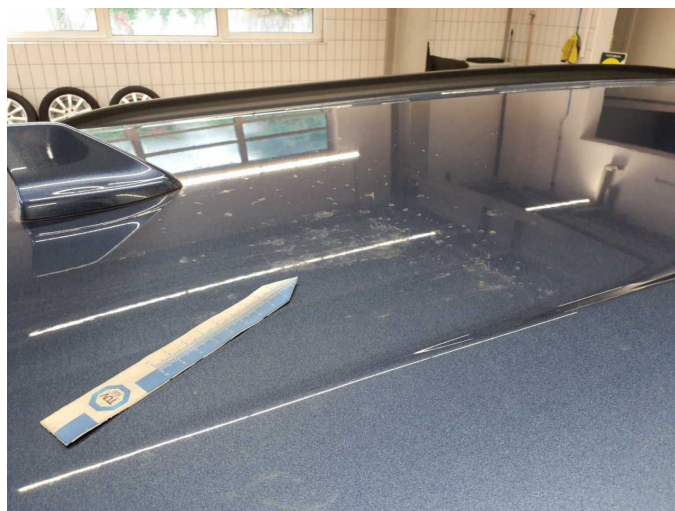
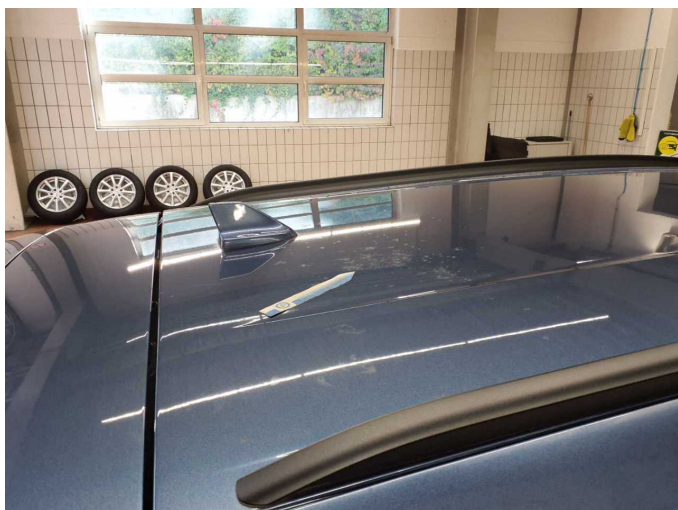
Damage 3: Roof: Roof (Verätzung) - Soiled - Conditioning

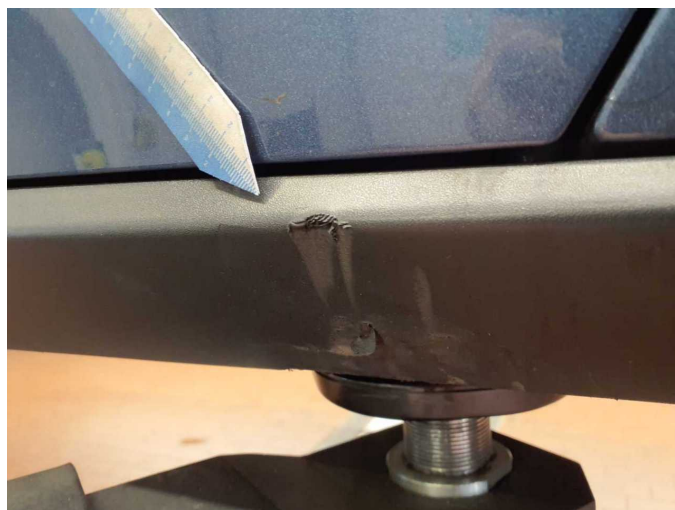
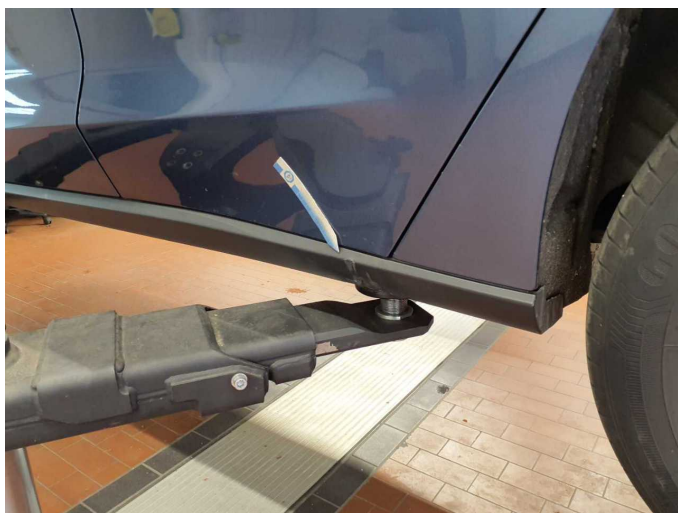
Damage 4: Sill - left side: Trim - Scratched - Replace

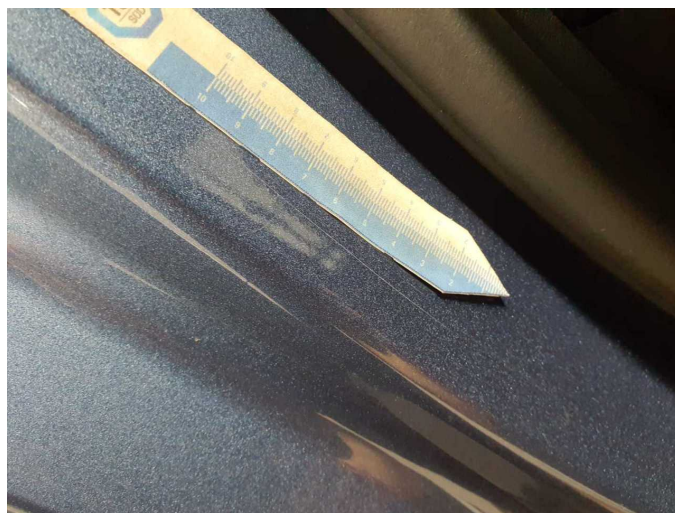
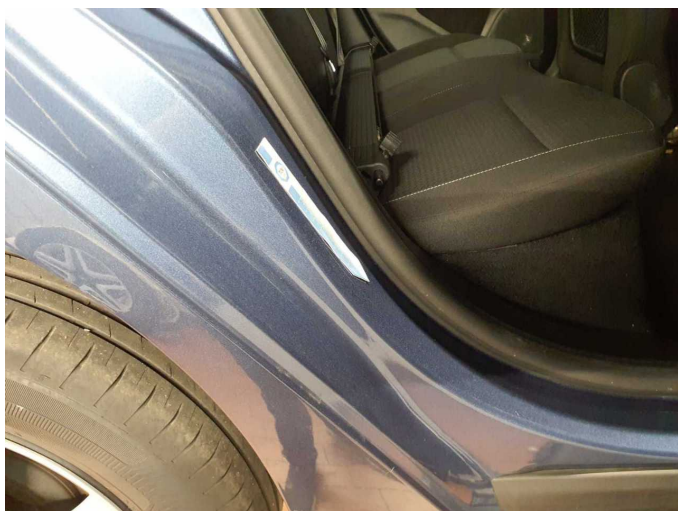
Damage 5: Side panel - rear right side: Sill - Scratch(es) - Smart repair

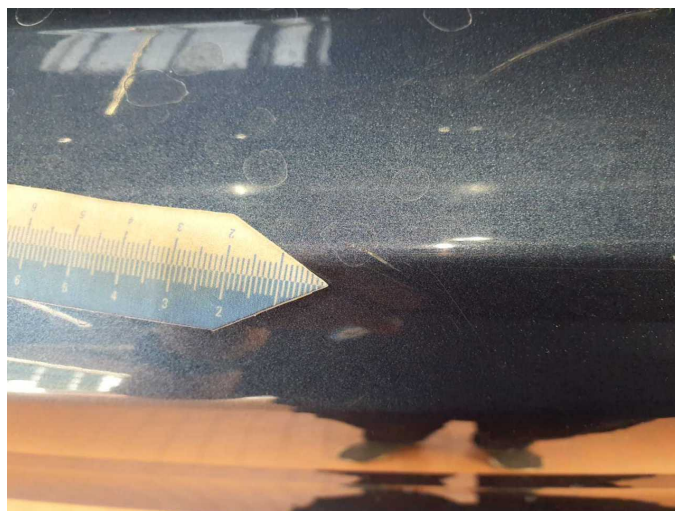
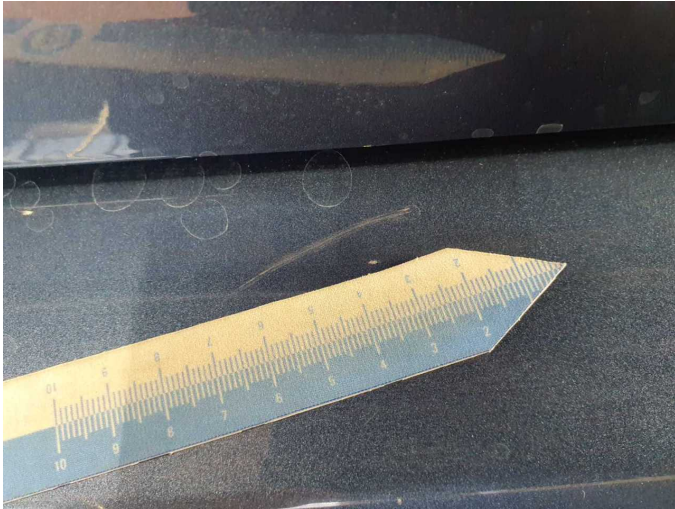
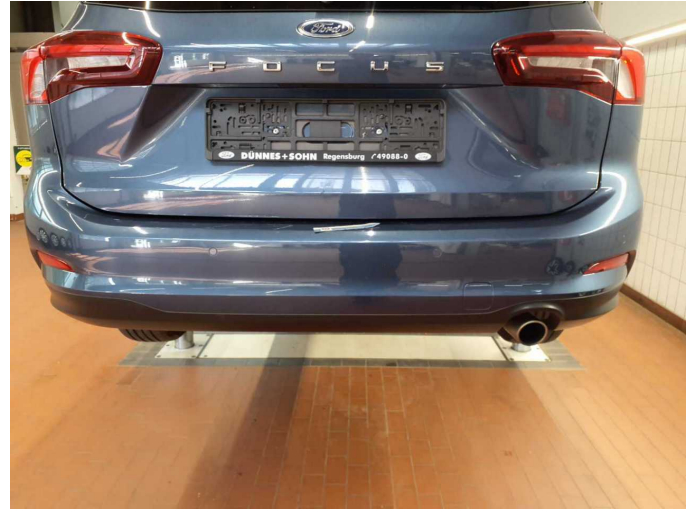
Damage 6: Rear bumper: Rear bumper - Scratch(es) - Smart repair

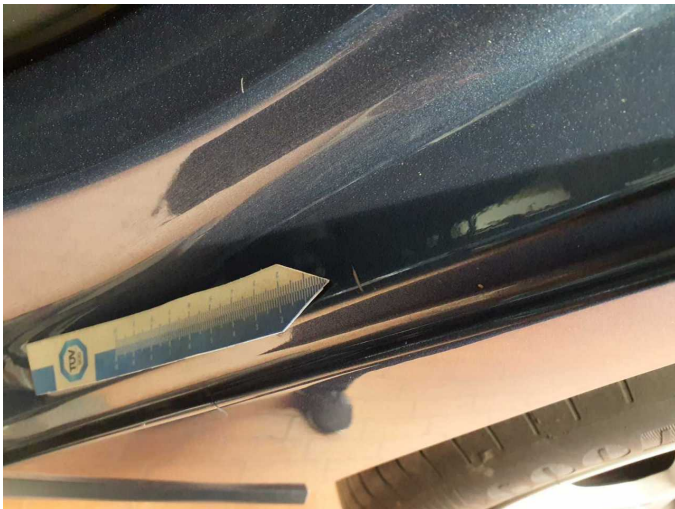
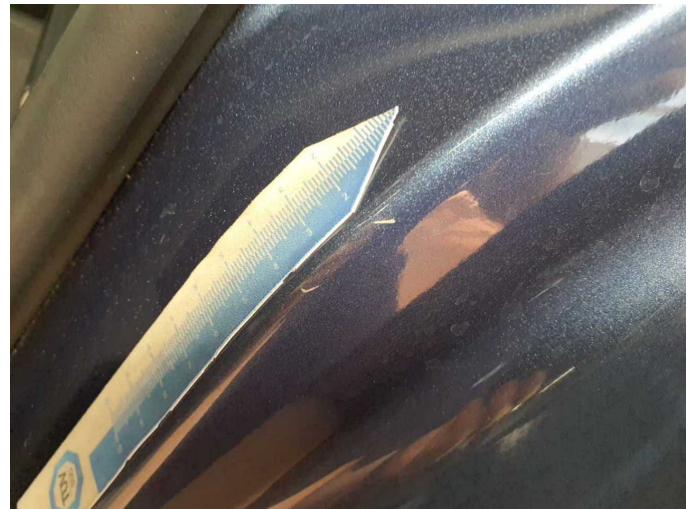
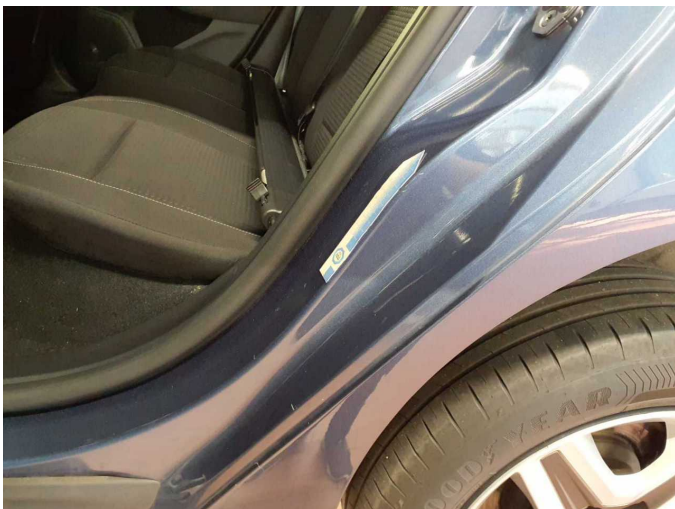
Damage 7: Side panel - rear left side: Sill - Scratch(es) - Smart repair

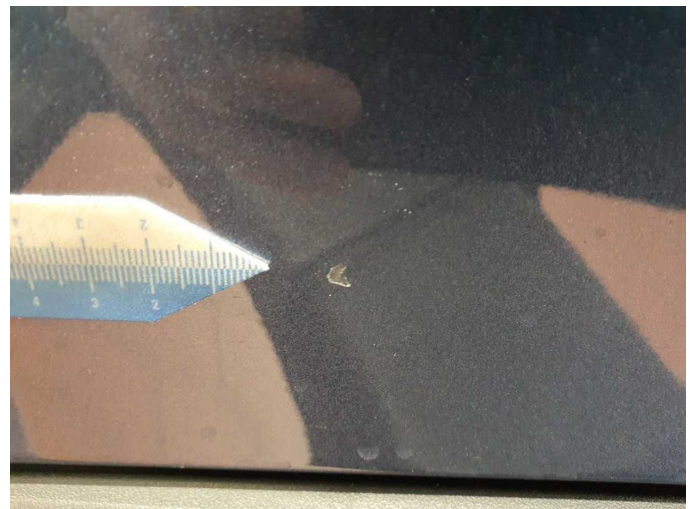
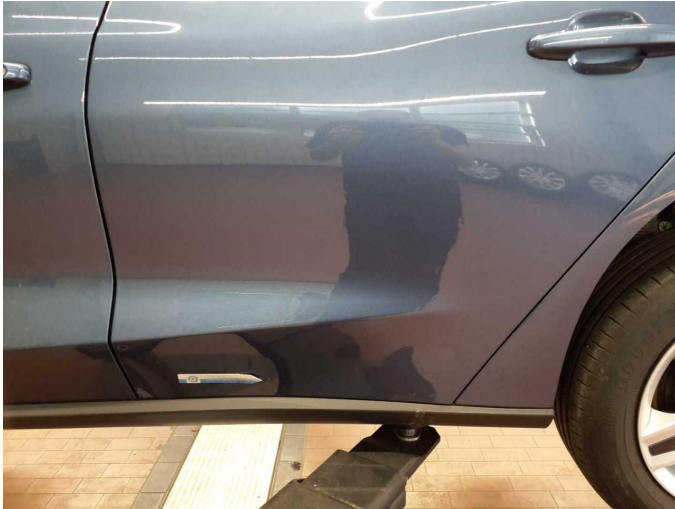
Damage 8: Door - rear left side: Door - Scratch(es) - Smart repair

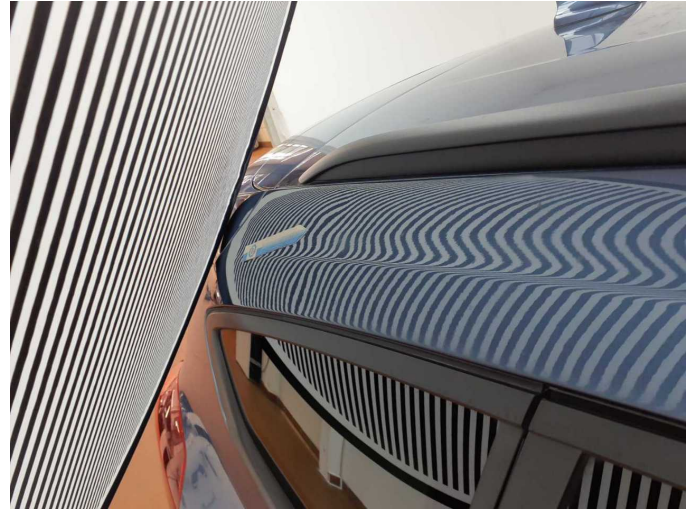
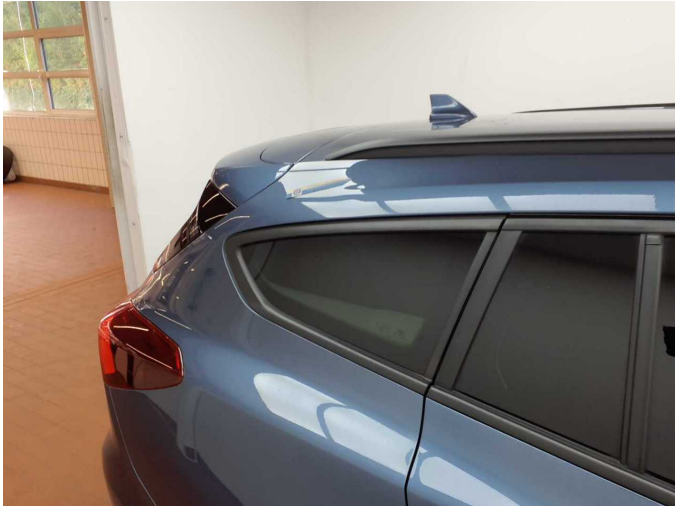
Damage 9: Side panel - rear right side: Side panel - dent(s) - Repair and paint

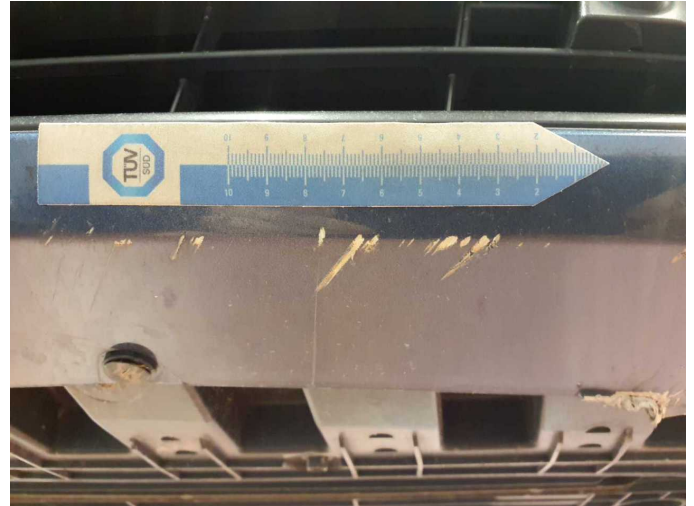
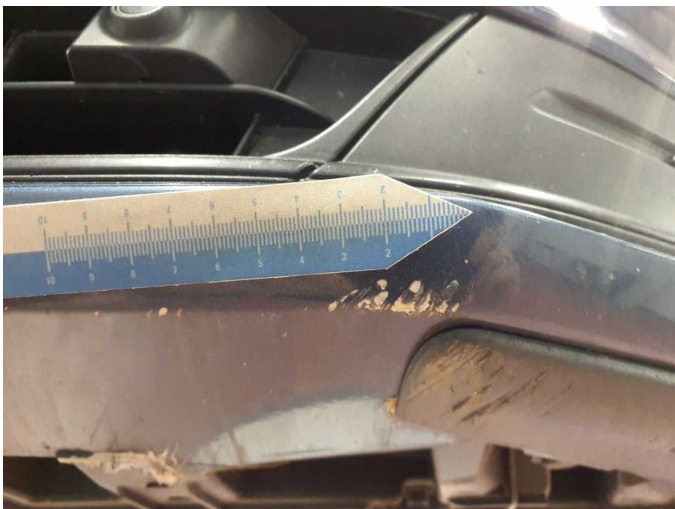
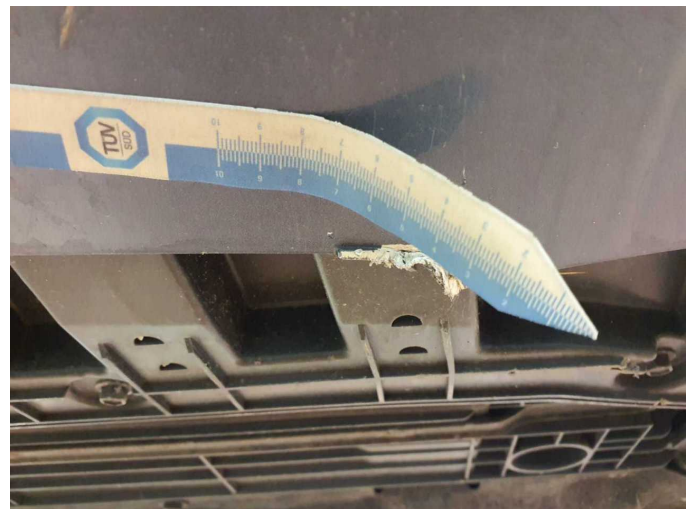
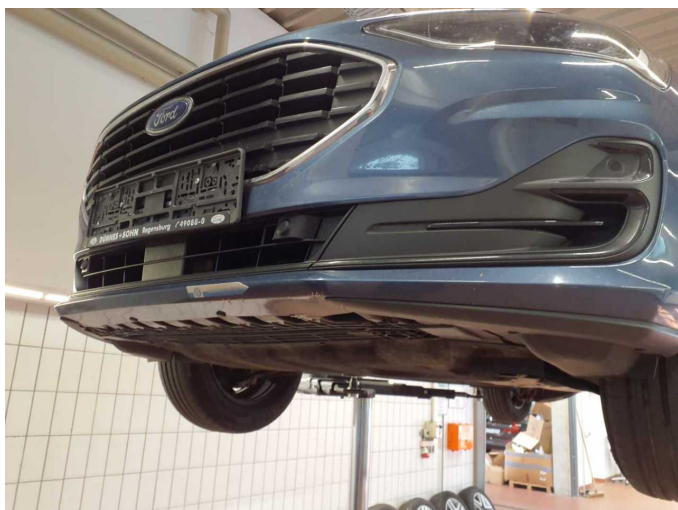
Damage 10: Front bumper: Front bumper - Scratched - Paint

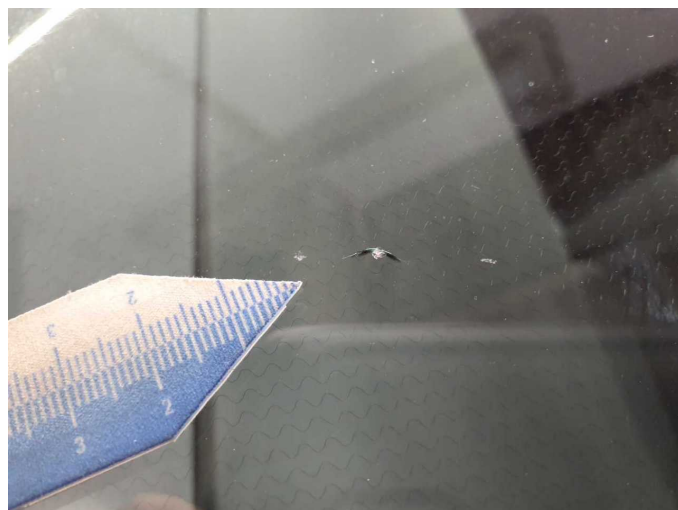
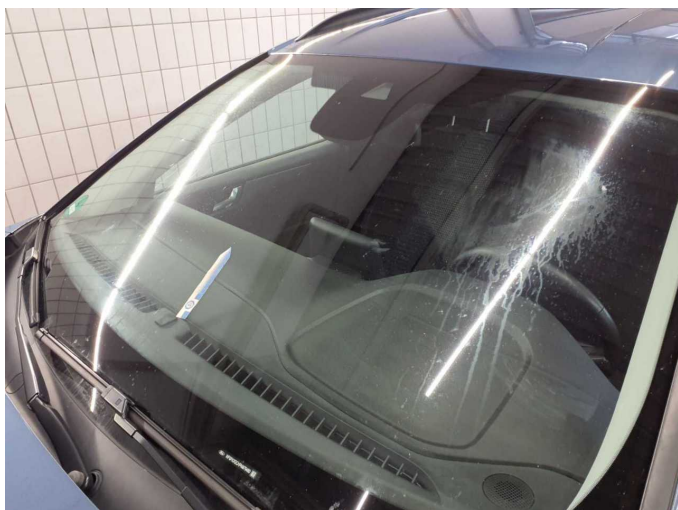
Damage 11: Vehicle glazing: Windscreen (Frontscheibenheizung) - Stone chips - Replace

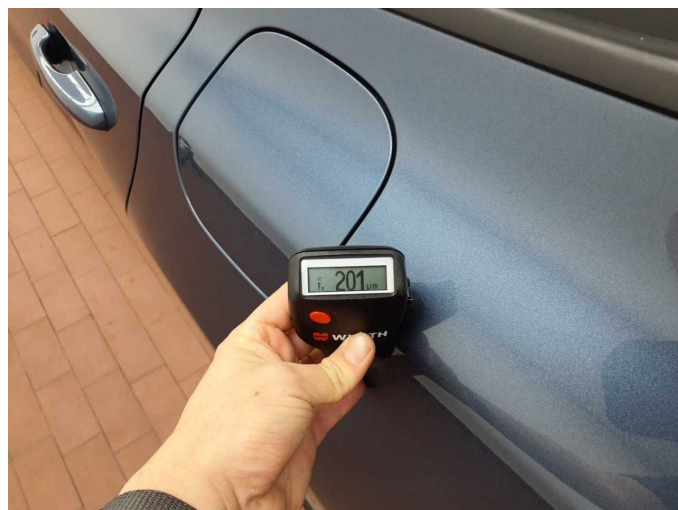
Repainting 1: Side panel - rear left side

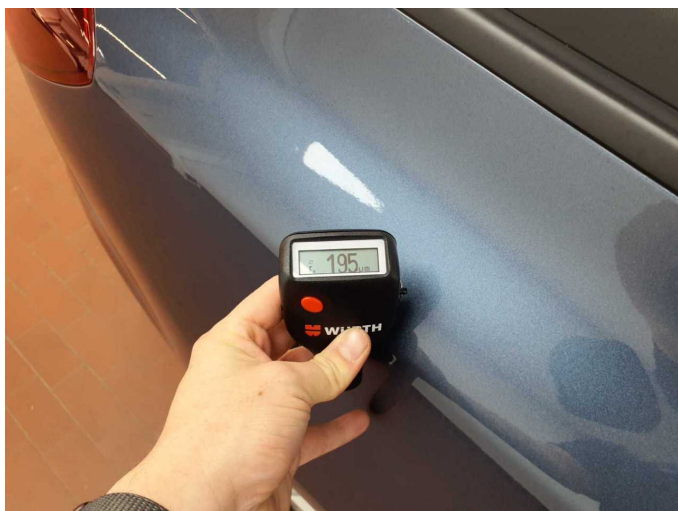
Repainting 2: Side panel - rear right side

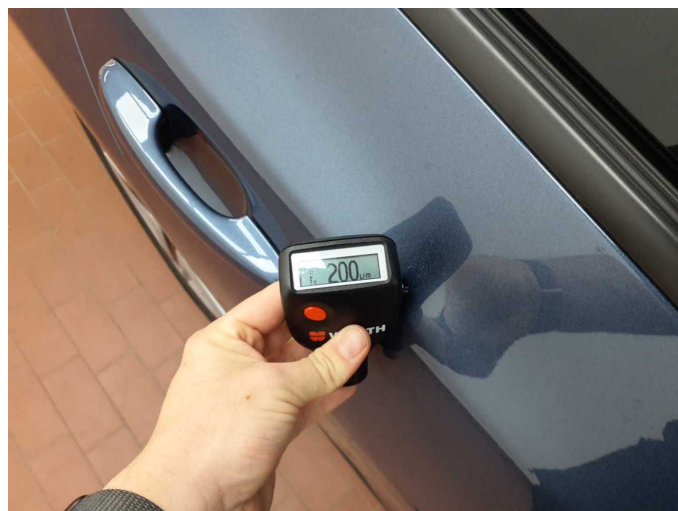
Repainting 3: Door - rear right side

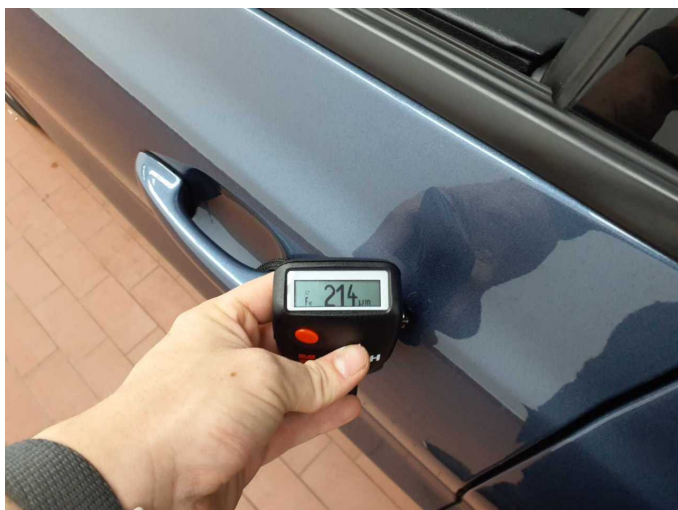
Repainting 4: Door - front left side
