Expertise

Protocol number: 41511527 Order No. / Reference: 25173372 Inspection date: 10 Sept 2025

Model: Focus Turnier 1.5 EcoBlue Start-Stopp-System Aut.

VIN: WF0PXXGCHPNM79486

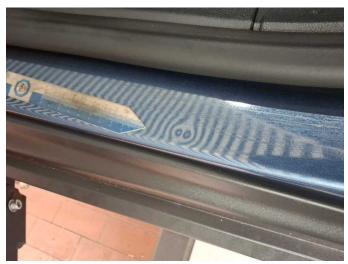
Damage 1: Sill - left side: Sill - dent(s) - Smart repair

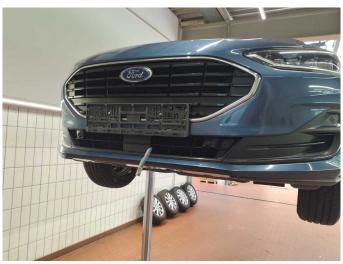
Damage 2: Front bumper: Air-inlet grille - Broken / torn - Replace

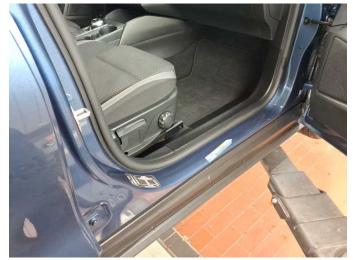
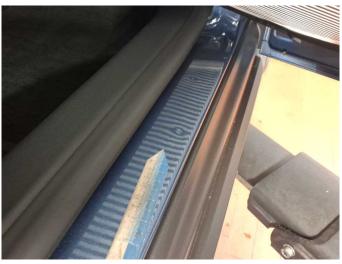
Damage 3: Sill - right side: Sill (2 Dellen) - dent(s) - Smart repair

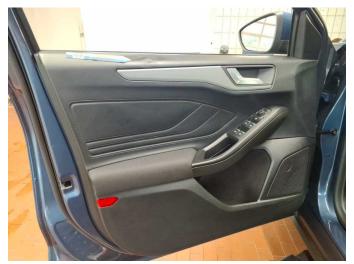
Damage 4: Trim / covers: Door trim - front left side - dent(s) - Smart

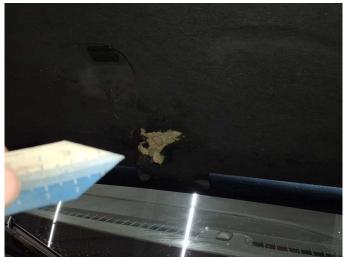
- Durch den Marderschaden im Bereich des Motorraums, können Mehrkosten durch nicht ersichtliche Schäden entstehen.
- Winterradsatz ist kein Bestandteil des Auslieferumfangs.

Damage 5: Bonnet: Insulation lining - Damage caused by marten / rodent Damage 5: Bonnet: Insulation lining - Damage caused by marten / rodent - Replace

- Replace

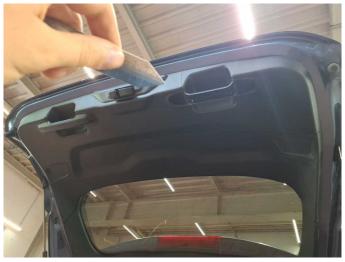
Damage 6: Trim / covers: Boot lid - interior trim - Damaged - Replace

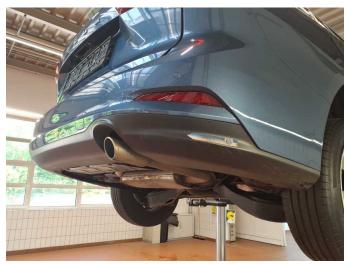
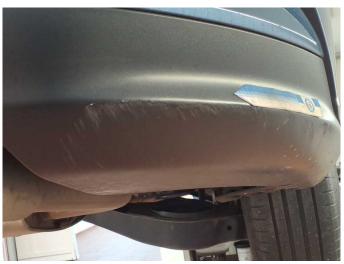
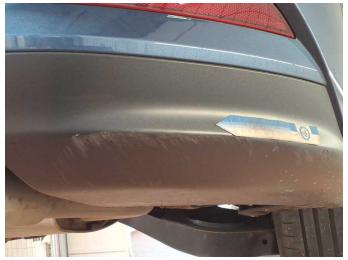
Damage 7: Rear bumper: Spoiler - Scratched - Replace

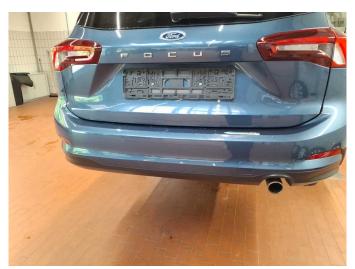
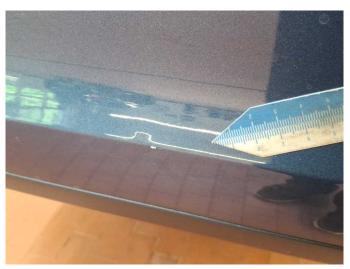
Damage 8: Rear bumper: Rear bumper - Scratched - Paint

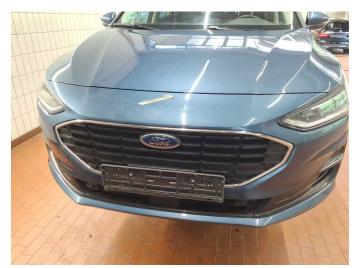
Damage 9: Front bumper: Front bumper - Scratched - Paint

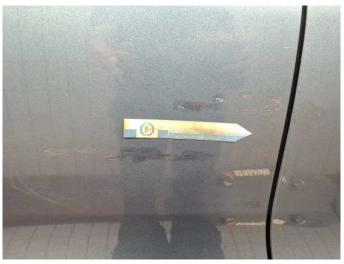
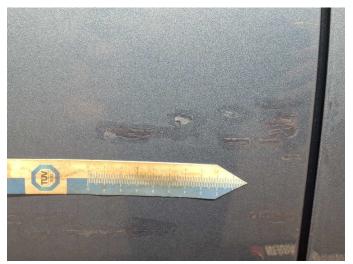
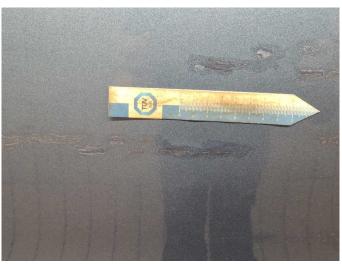
Damage 10: Door - rear right side: Door - Scratched - Paint

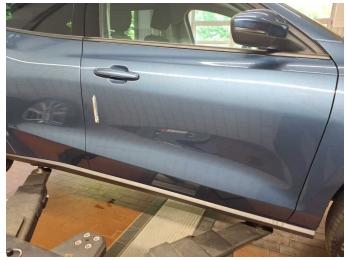
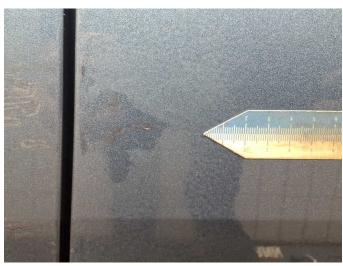
Damage 11: Door - front right side: Door - Scratched - Paint
