Expertise

Protocol number: 41666784
Order No. / Reference: 25212609
Inspection date: 19 Sept 2025

Manufacturer: Ford	Model: Focus Turnier 1.5 EcoBlue Start-Stopp-System Aut. COOL&CONNECT
VIN: WF0PXXGCHPNM80117

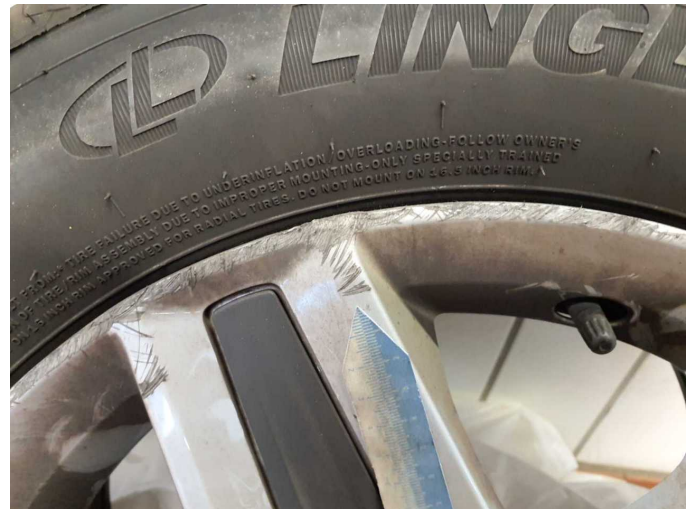
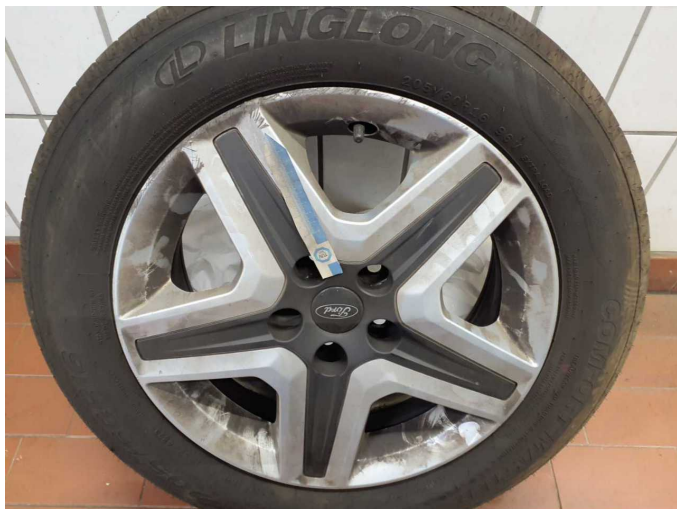
Damage 1: 2nd wheel set: 1 wheel cover - Scratched - Replace

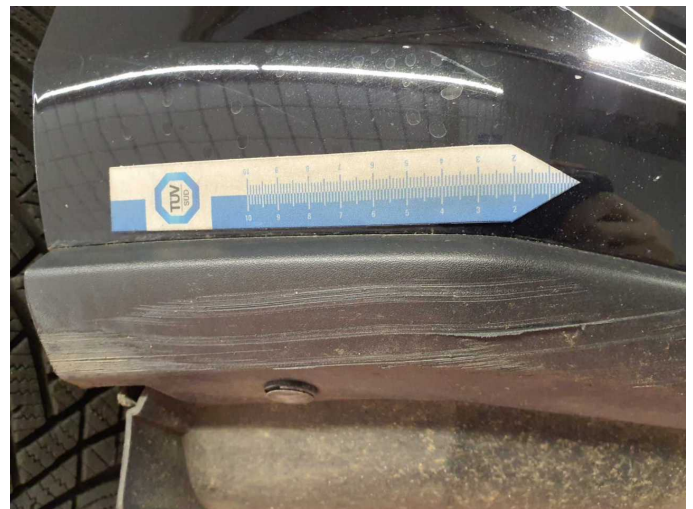
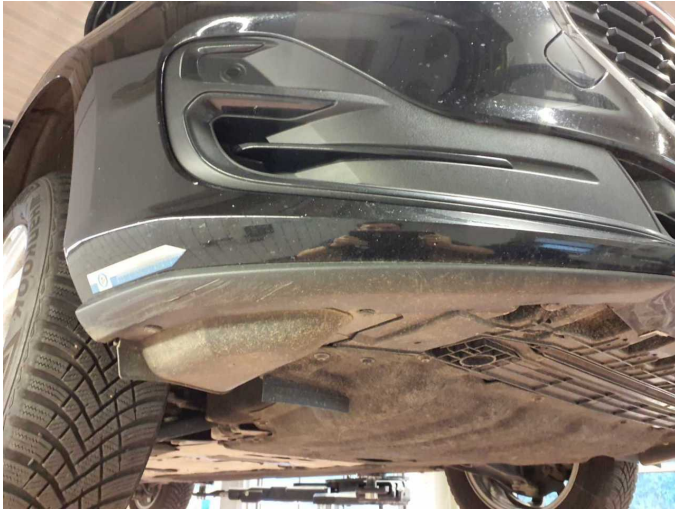
Damage 2: Front bumper: Spoiler - Scratched - Replace

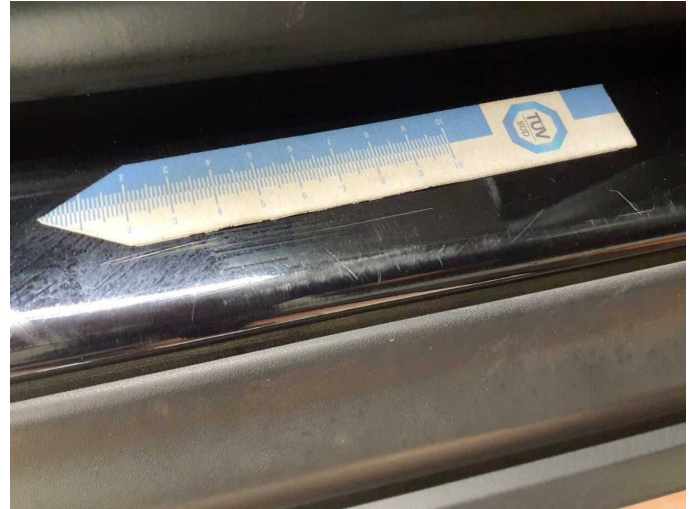
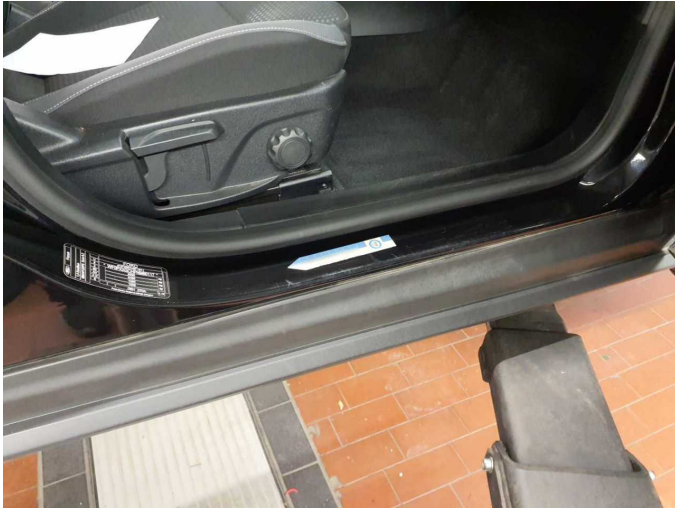
Damage 3: Sill - right side: Sill - Scratch(es) - Smart repair

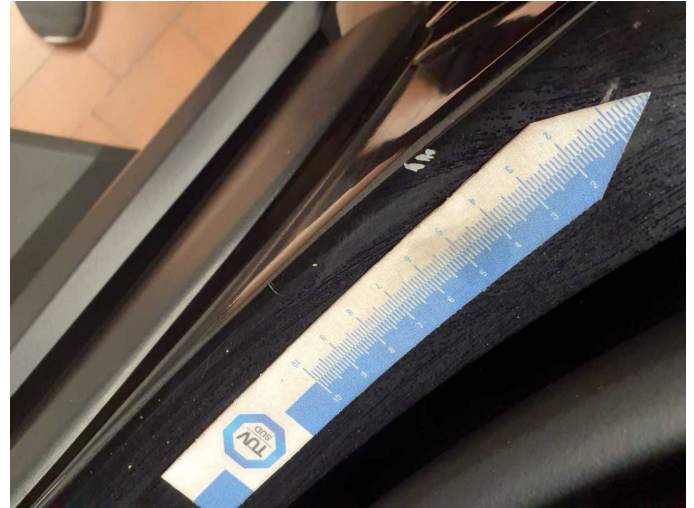
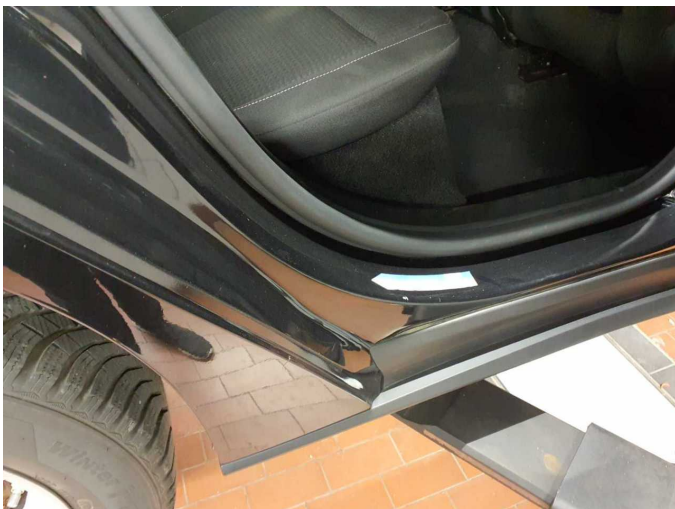
Damage 4: Side panel - rear right side: Sill - Scratch(es) - Smart repair

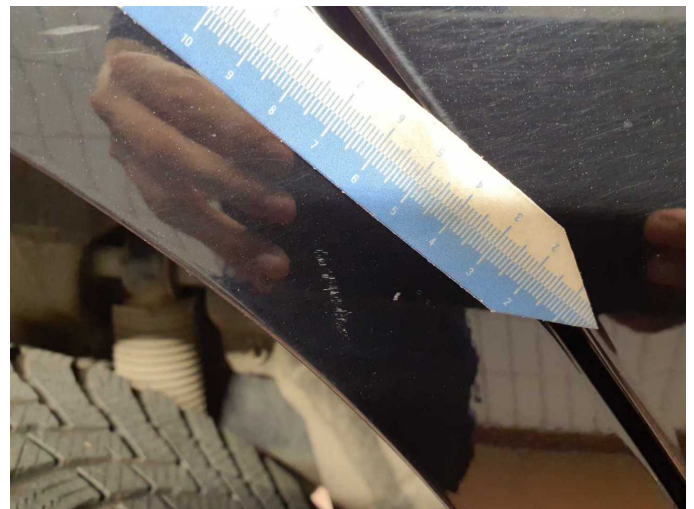
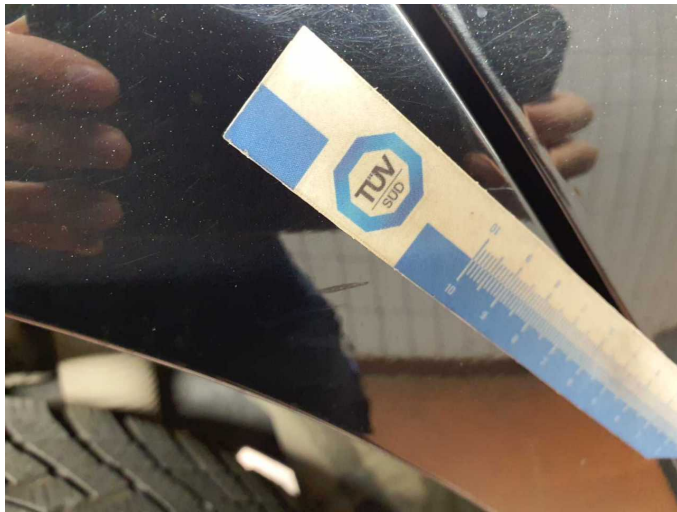
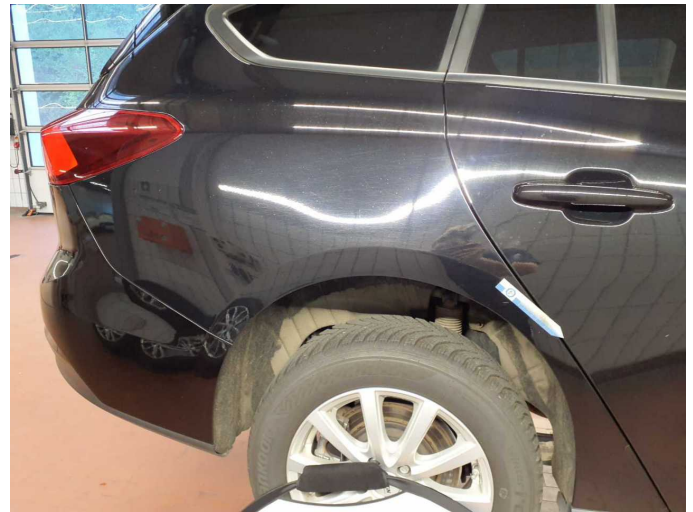
Damage 5: Side panel - rear right side: Side panel - Scratch(es) - Smart repair

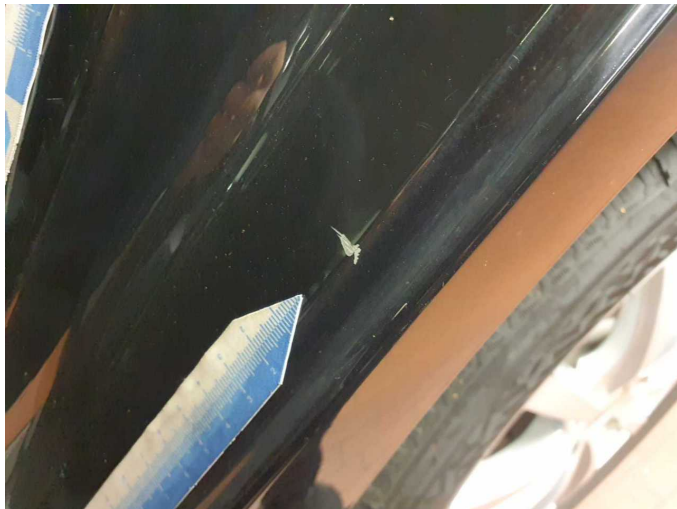
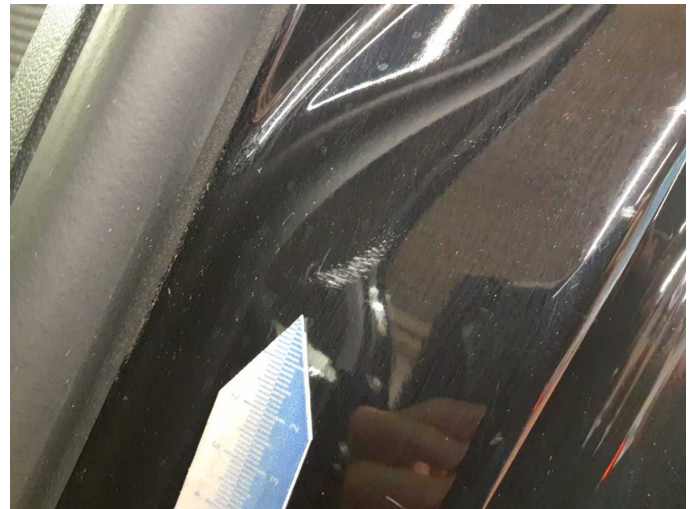
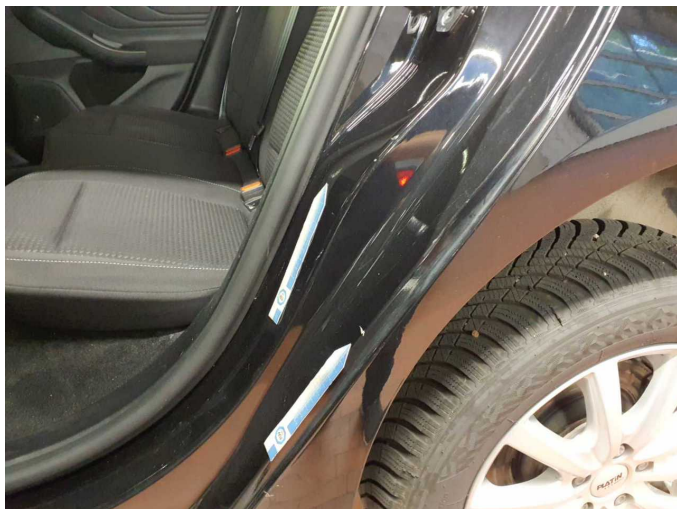
Damage 6: Side panel - rear left side: Sill - Scratch(es) - Smart repair

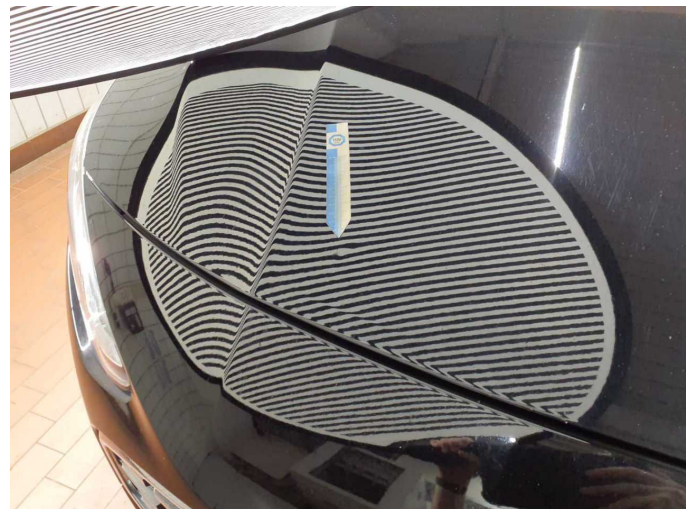
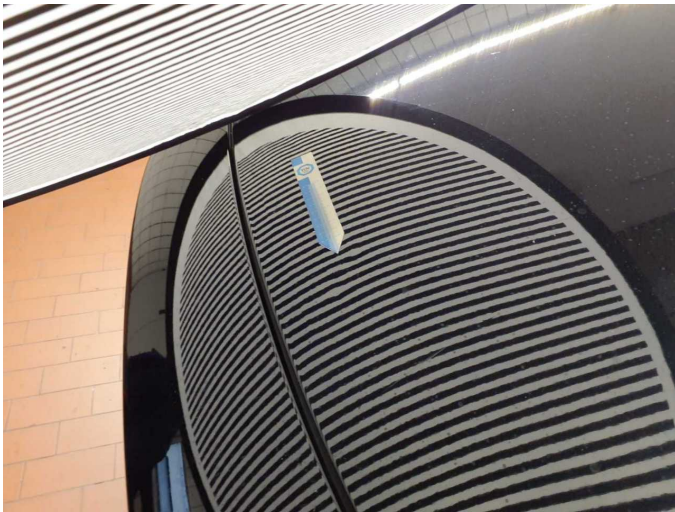
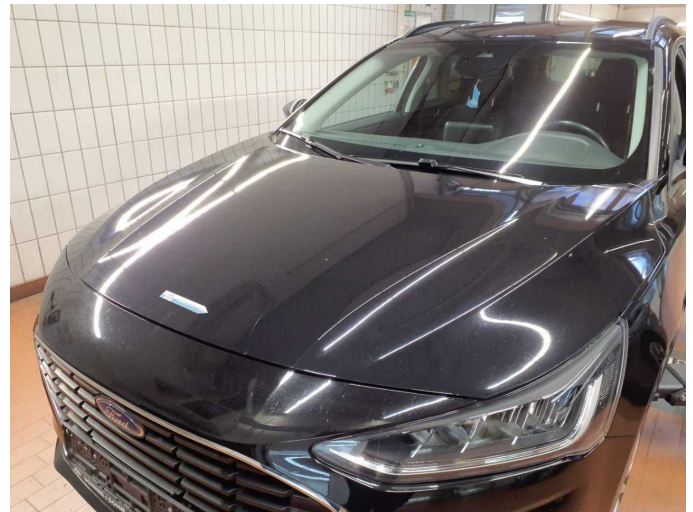
Damage 8: Bonnet: Bonnet - dent(s) - Smooth repair work

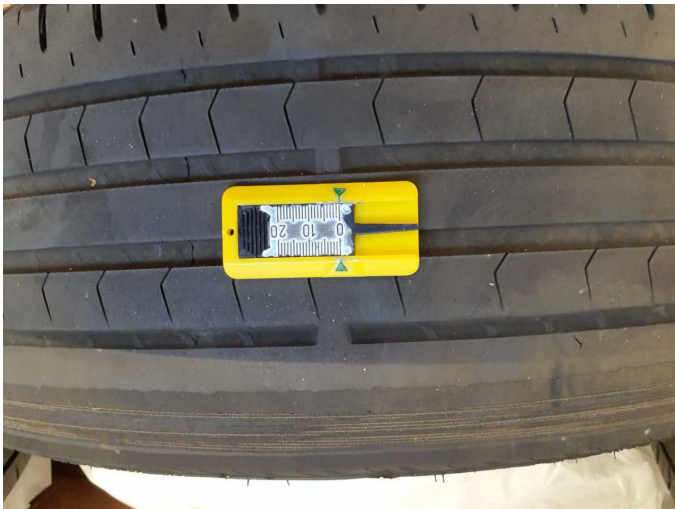
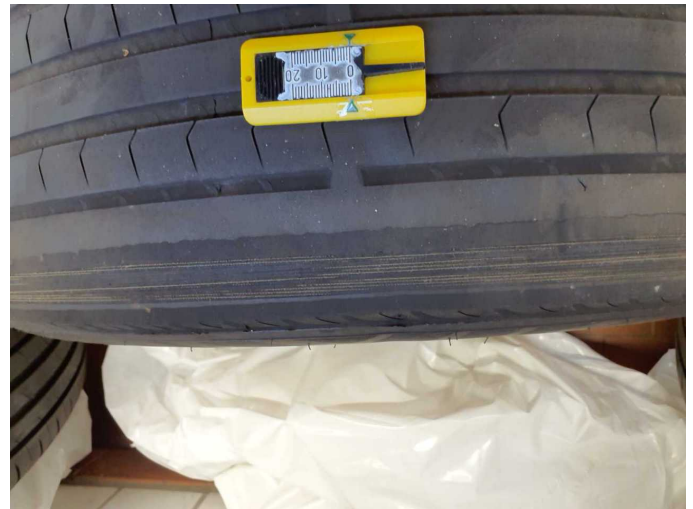
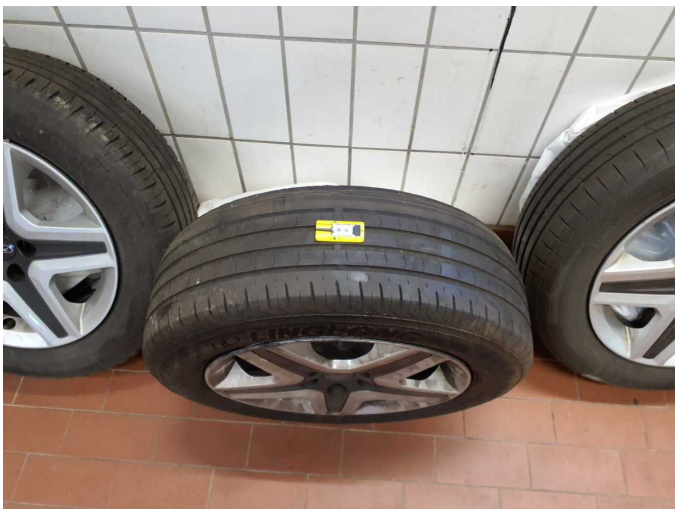
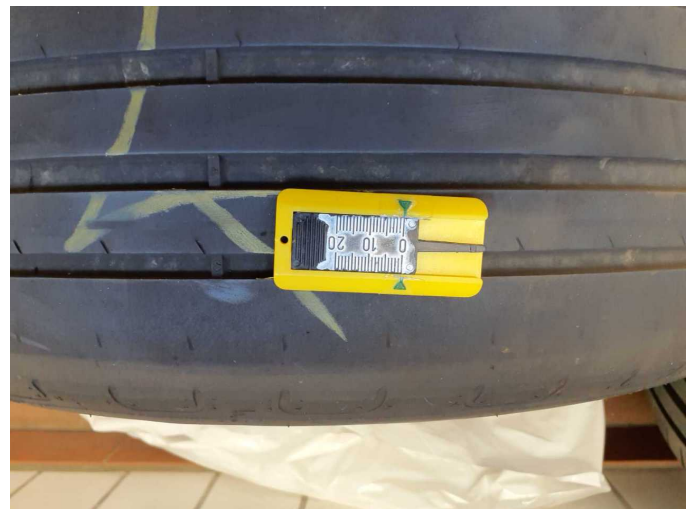
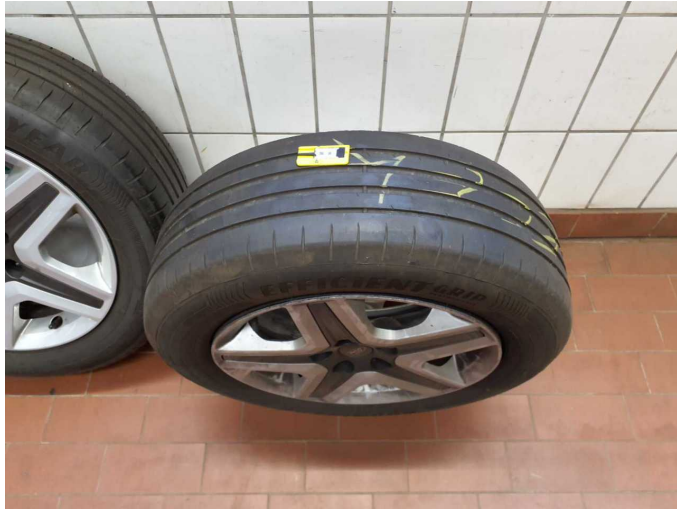
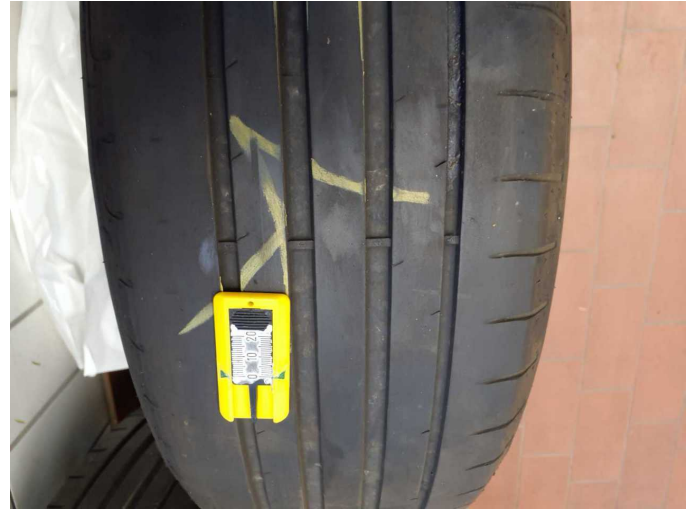
Damage 9: 2nd wheel set: 2 tyres (Einseitigabgefahren) - Worn - Replace

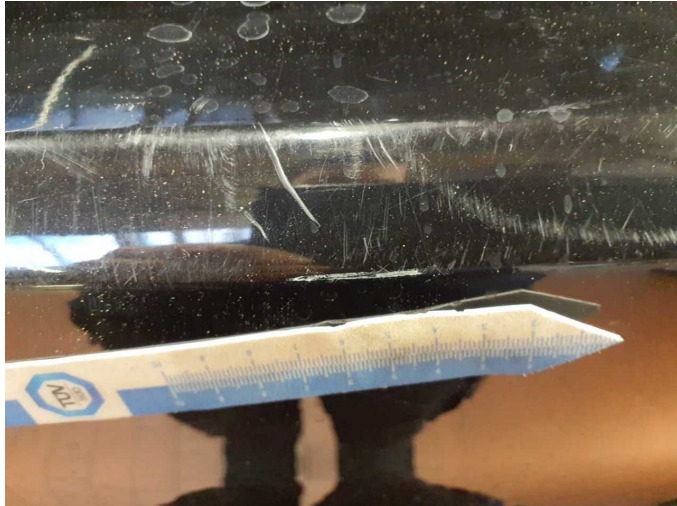
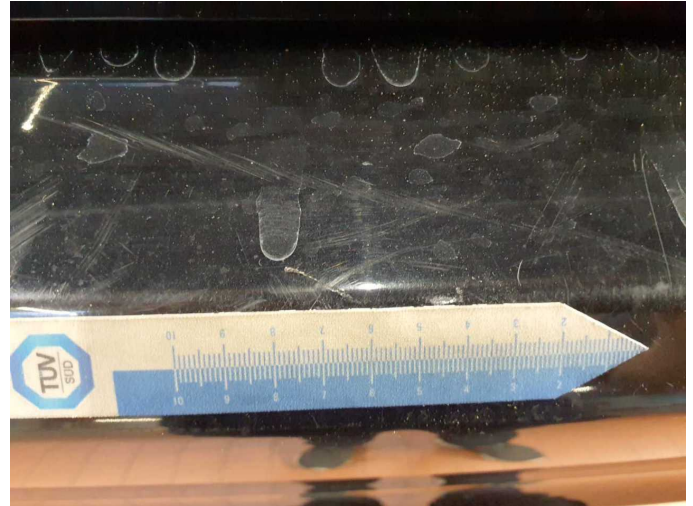
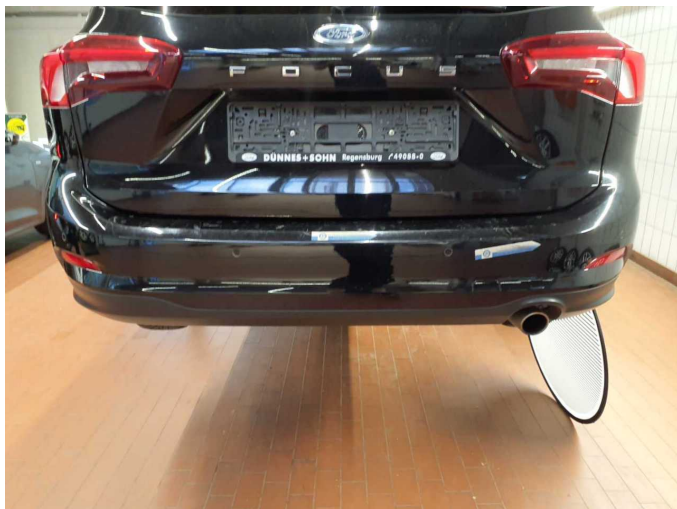
Damage 10: Rear bumper: Rear bumper - Scratch(es) - Paint

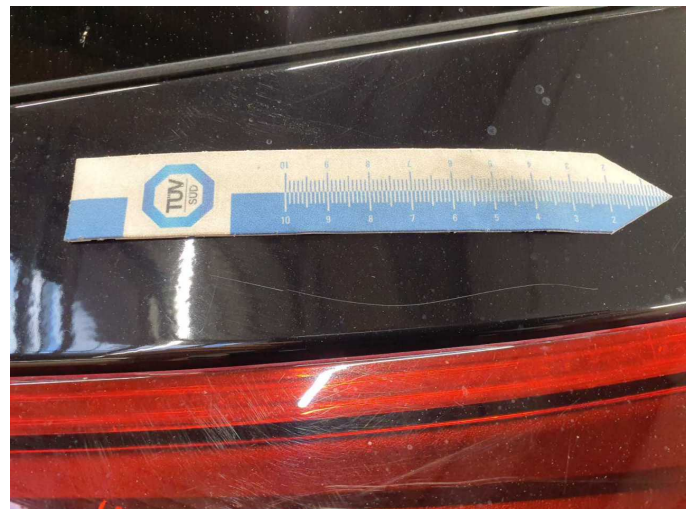
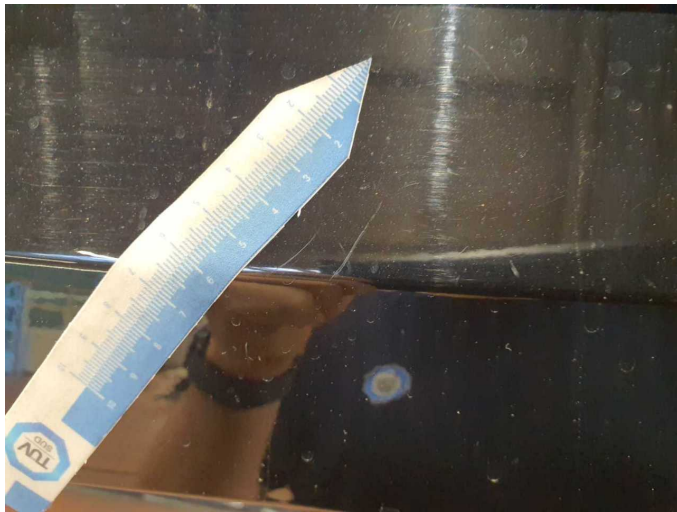
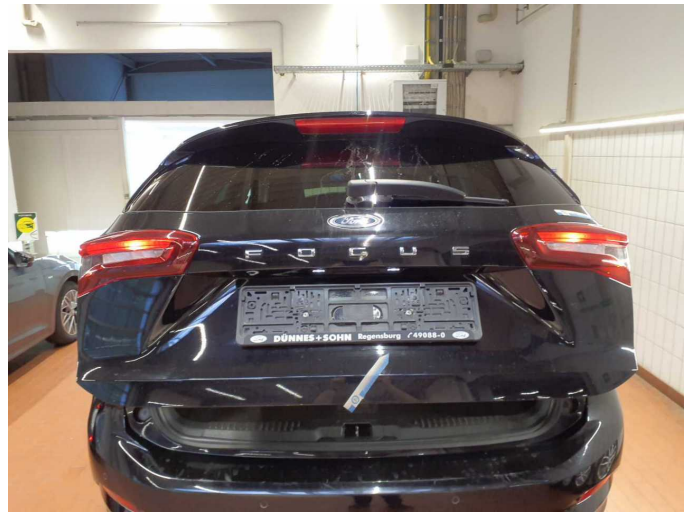
Damage 11: Boot lid / rear door: Boot lid - Scratch(es) - Paint

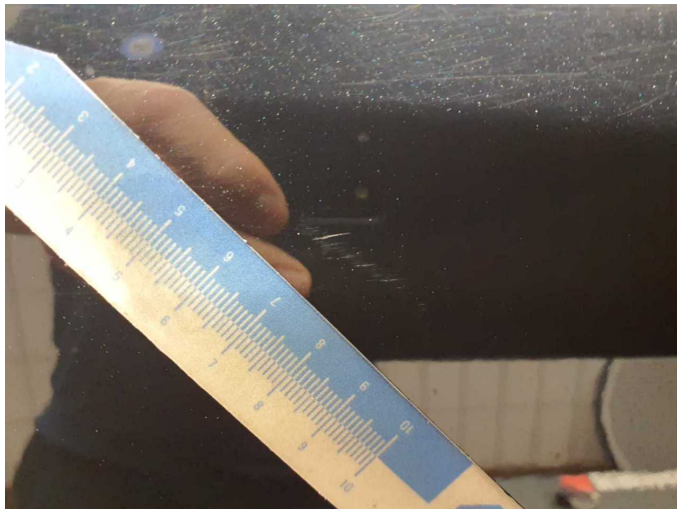
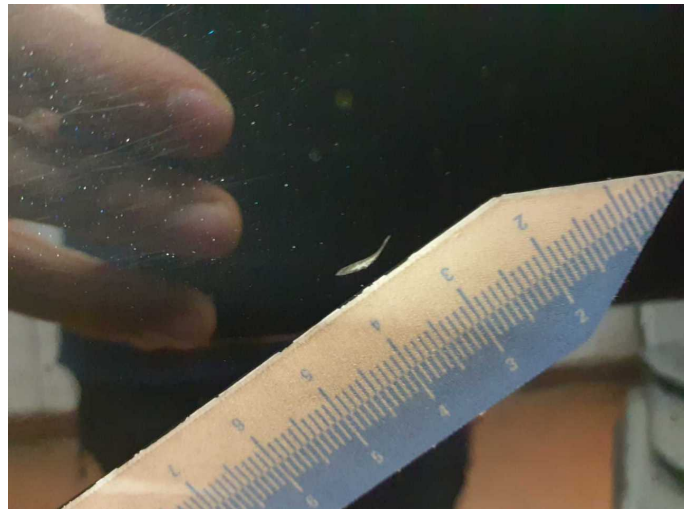
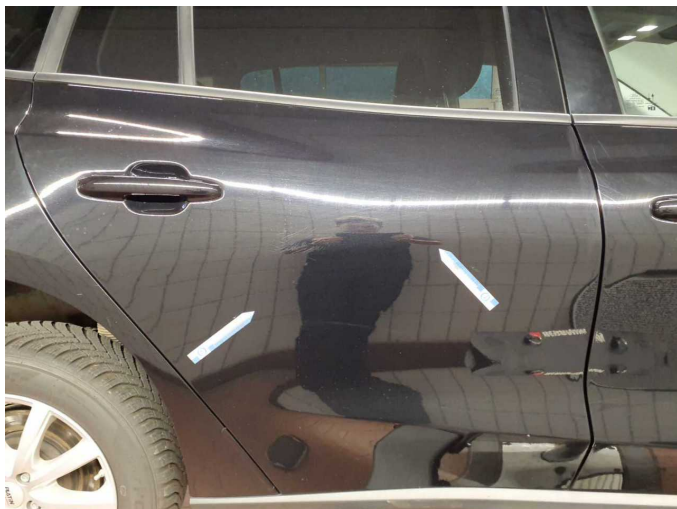
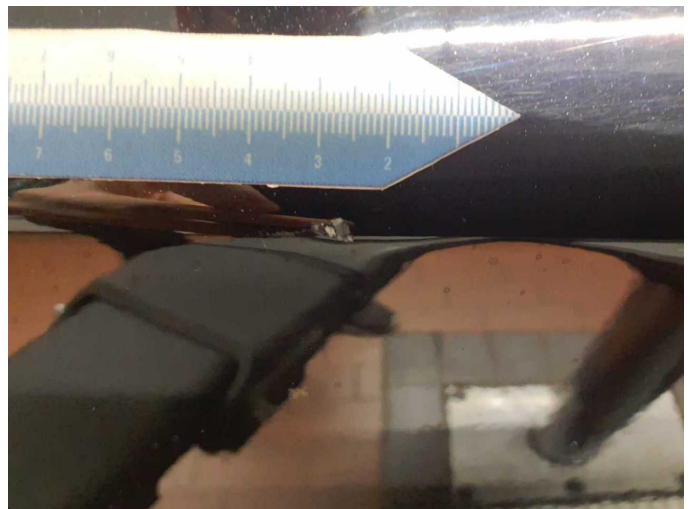
Damage 12: Door - rear right side: Door - Scratch(es) - Paint

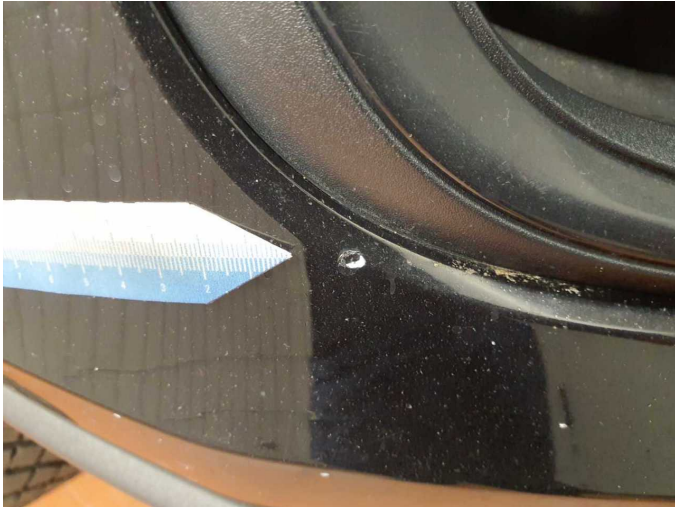
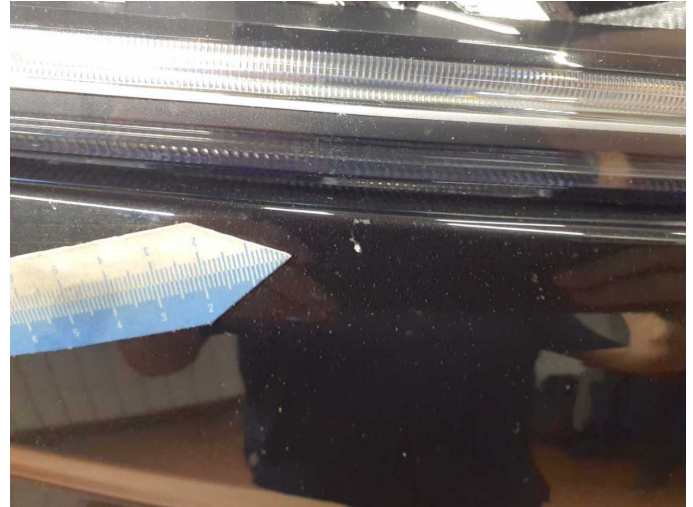
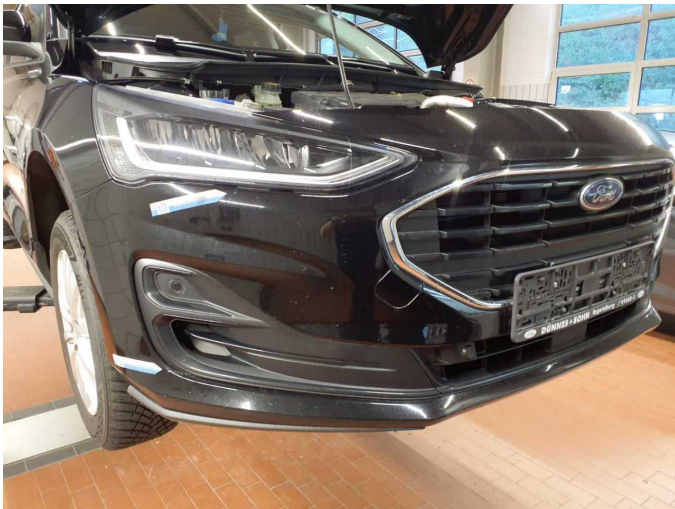
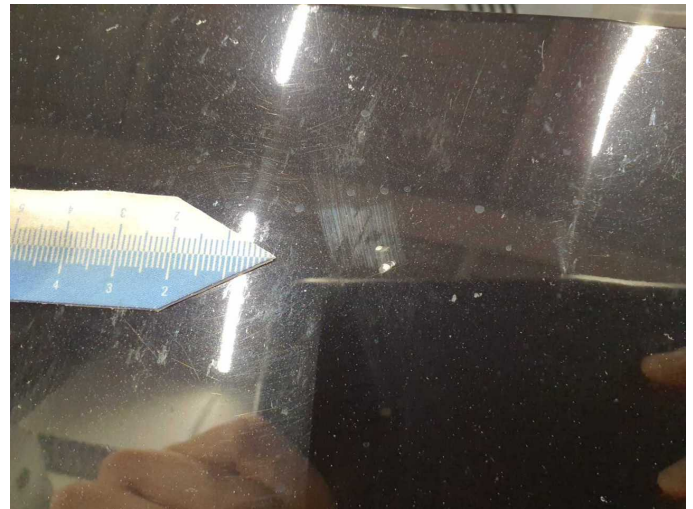
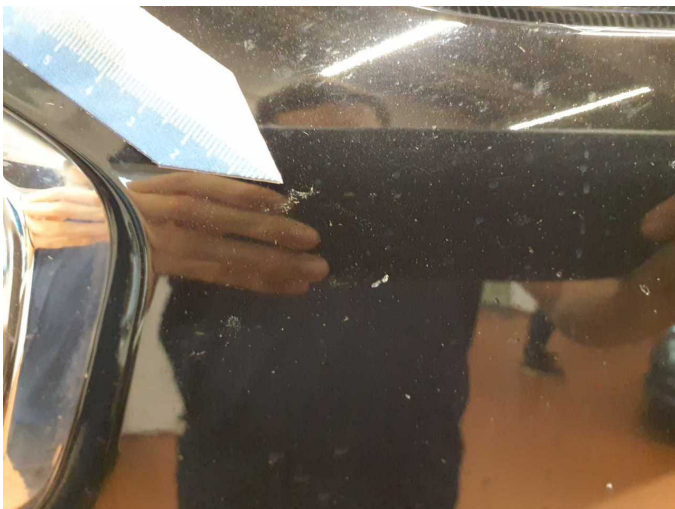
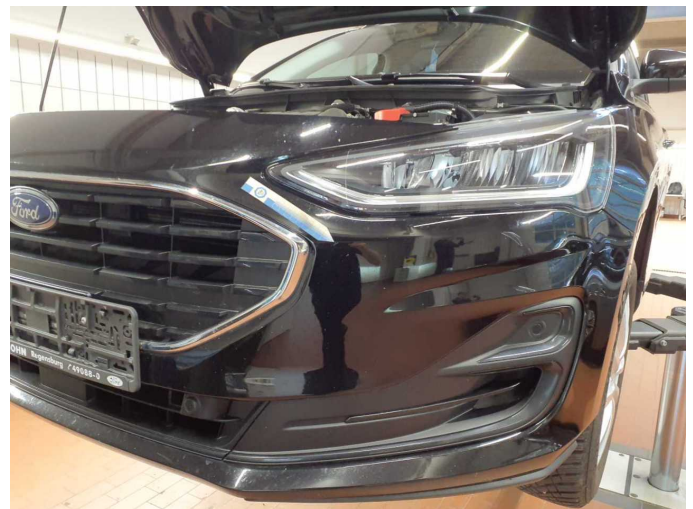
Damage 13: Front bumper: Front bumper - Stone chips - Paint

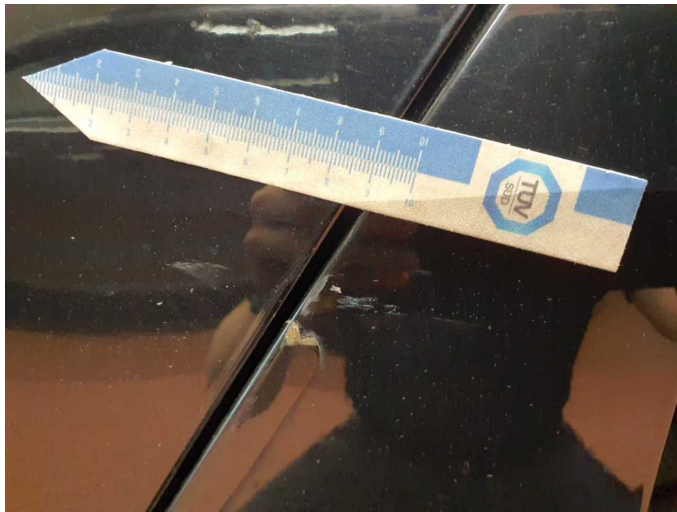
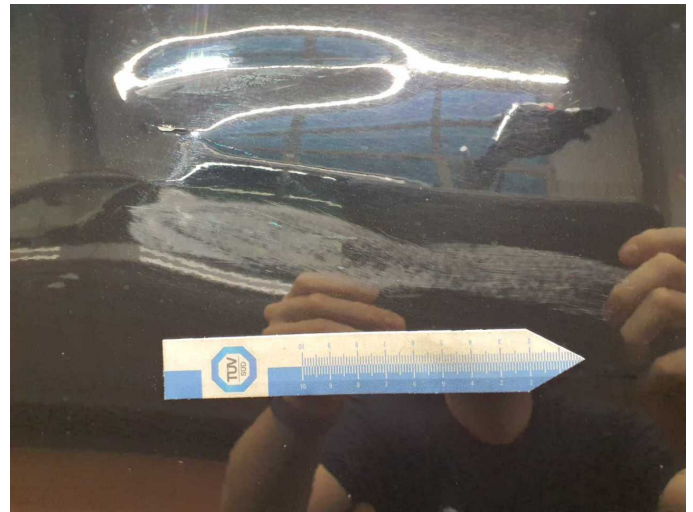
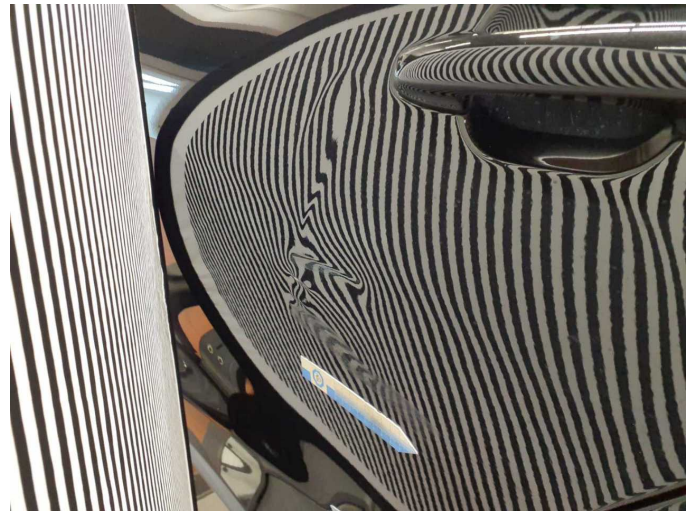
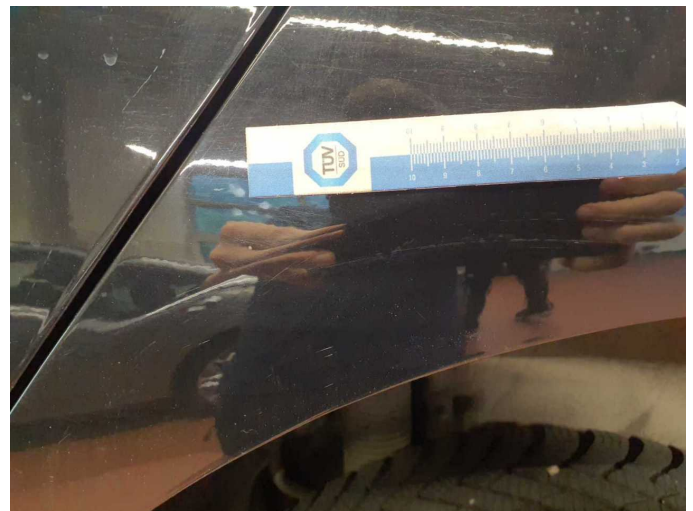
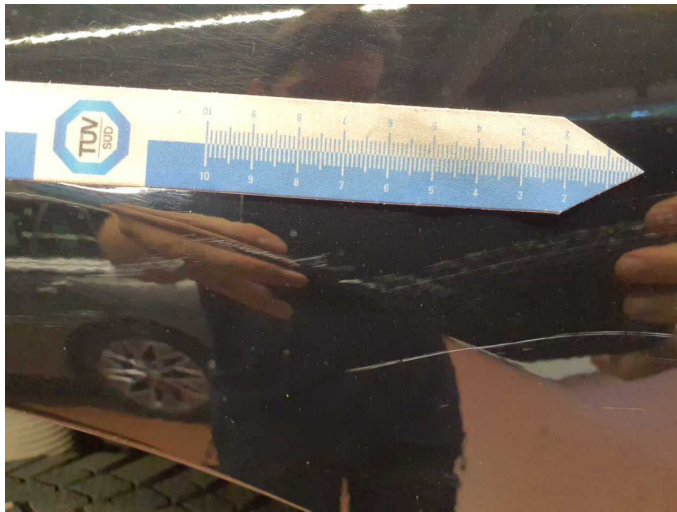
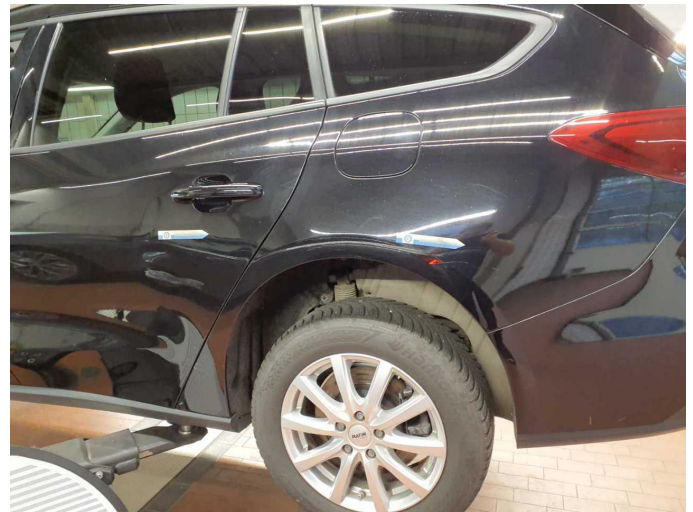
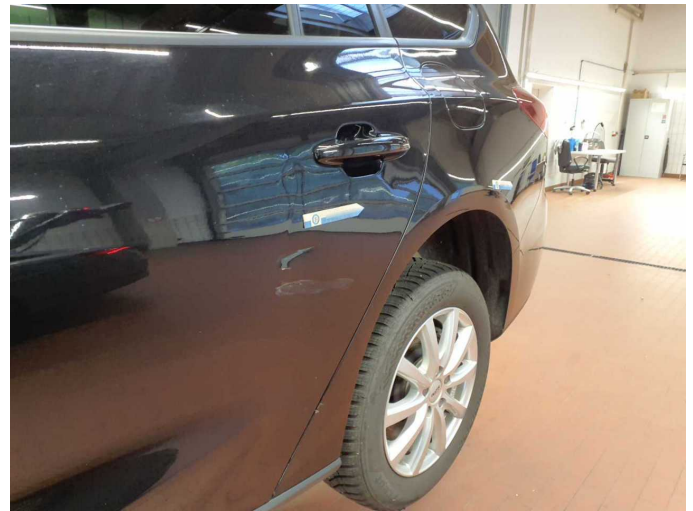
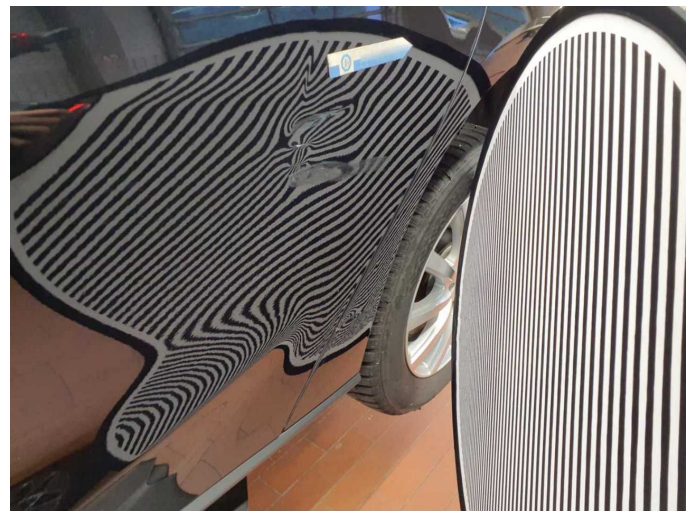
Accident 1: Side - left
