Expertise

Protocol number: 41588399  
Order No. / Reference: 25173473  
Inspection date: 10 Sept 2025

Manufacturer: Ford

Model: Focus Turnier 1.5 EcoBlue Start-Stopp-System Aut.  
COOL&CONNECT

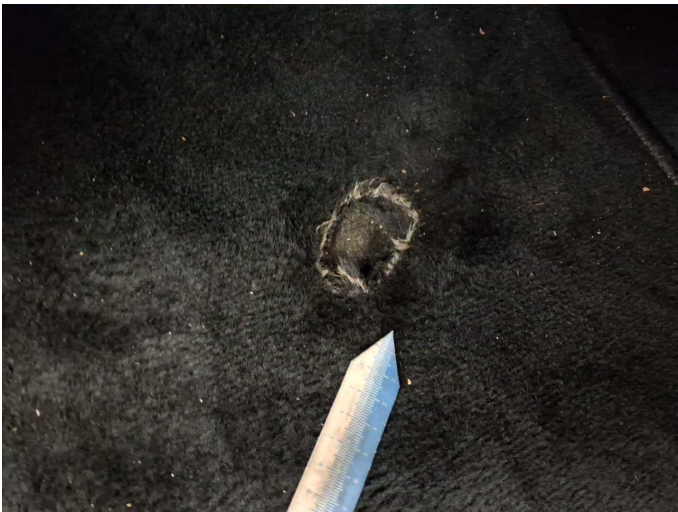
Damage 1: Trim / covers: Floor mats - Holes - Replace

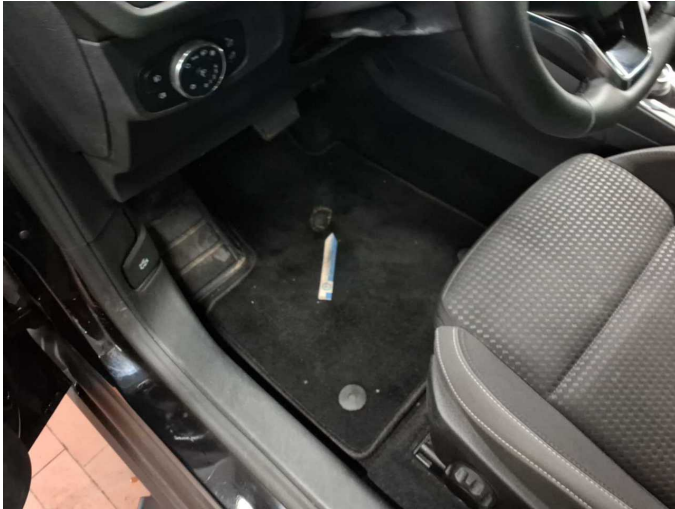
**Damage 1:** Trim / covers: Floor mats - Holes - Replace

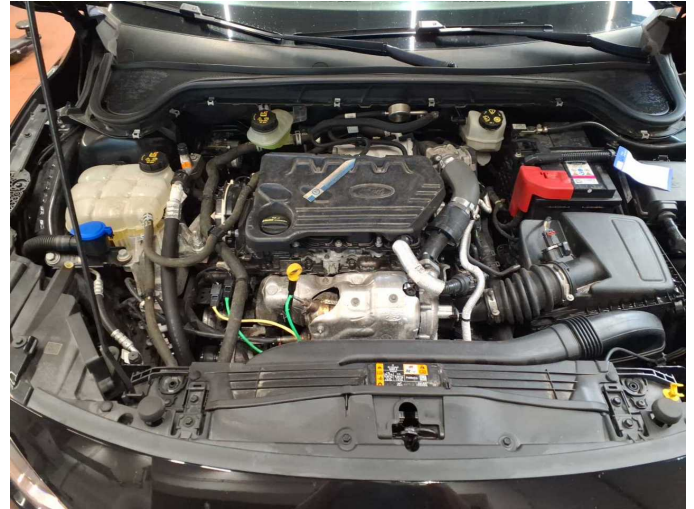
Durch den Marderschaden im Bereich des Motorraums, können Mehrkosten durch nicht ersichtliche Schäden entstehen.

**Damage 2:** Engine: Engine cover - Damage caused by marten / rodent - Replace

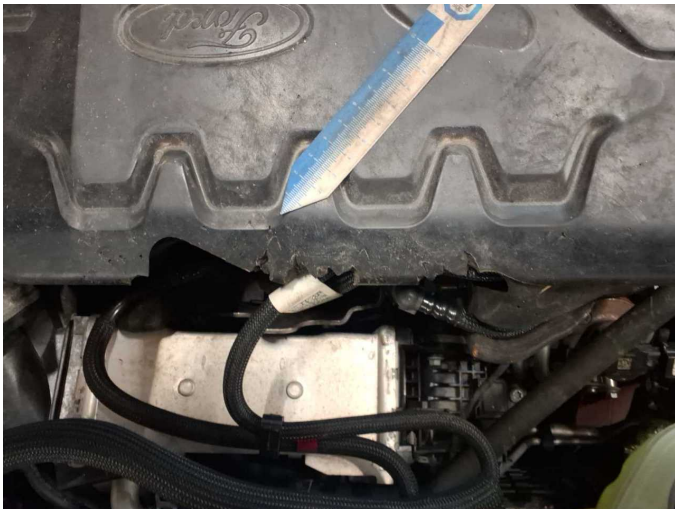
**Damage 2:** Engine: Engine cover - Damage caused by marten / rodent - Replace

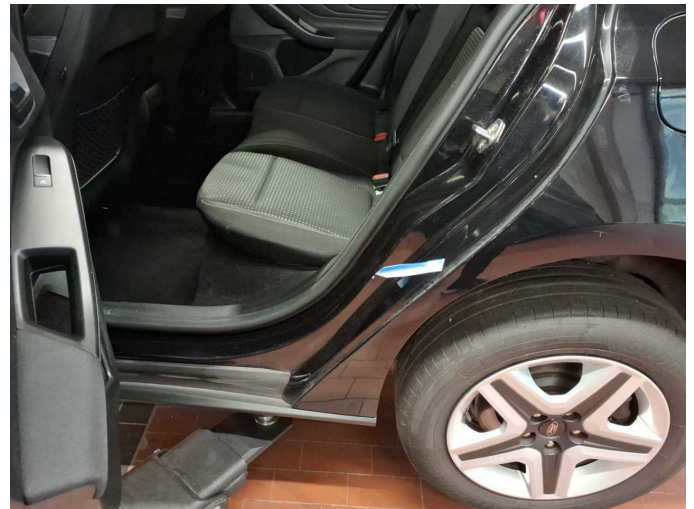
**Damage 3:** Side panel - rear left side: Sill - Scratch(es) - Smart repair

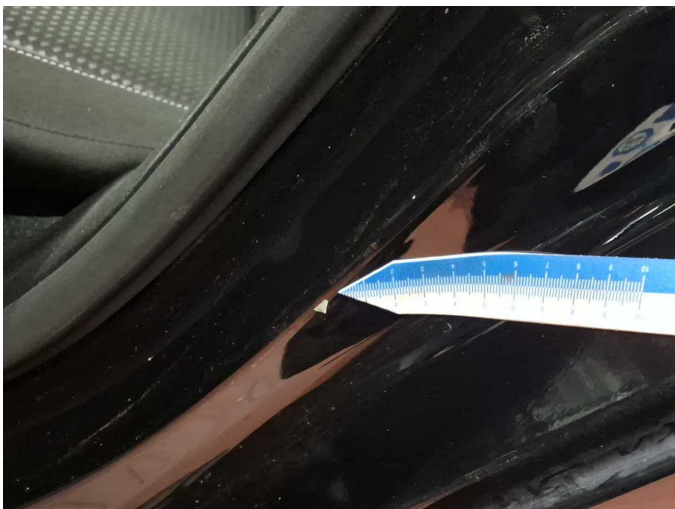
**Damage 3:** Side panel - rear left side: Sill - Scratch(es) - Smart repair

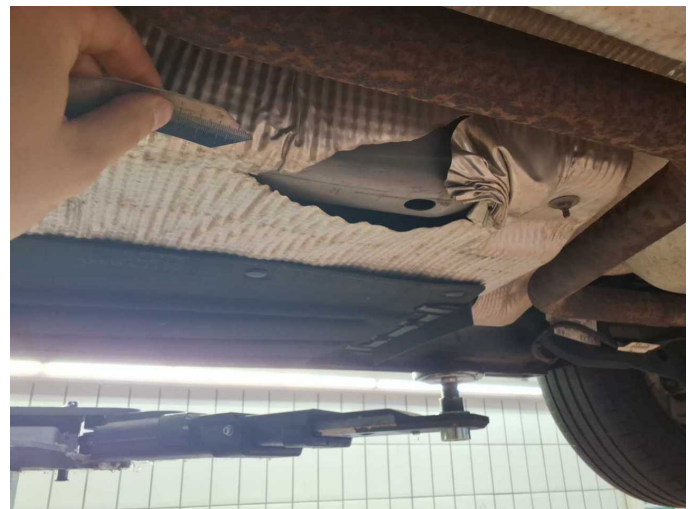
**Damage 4:** Exhaust system: Heat shield - Broken / torn - Replace

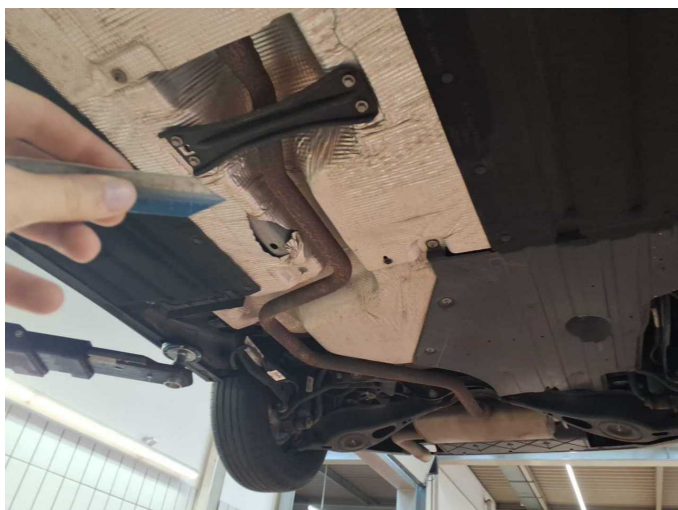
**Damage 4:** Exhaust system: Heat shield - Broken / torn - Replace

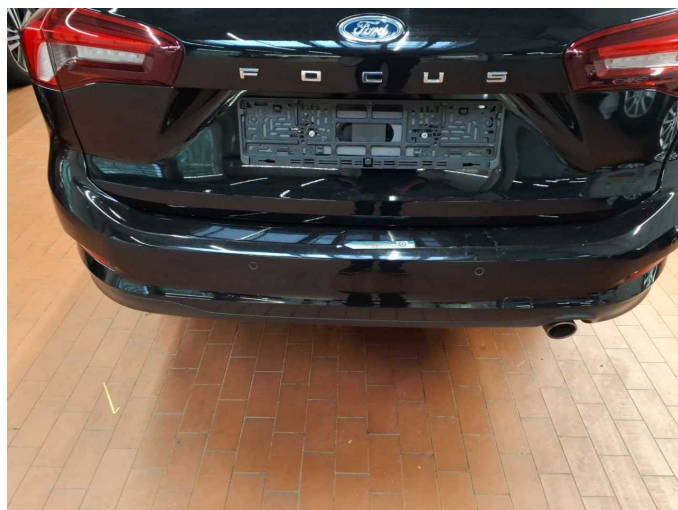
**Damage 5:** Rear bumper: Rear bumper - Scratch(es) - Smart repair

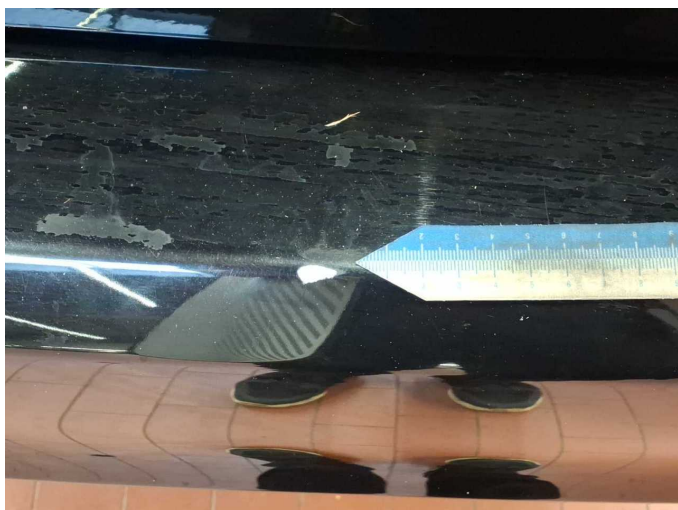
**Damage 5:** Rear bumper: Rear bumper - Scratch(es) - Smart repair

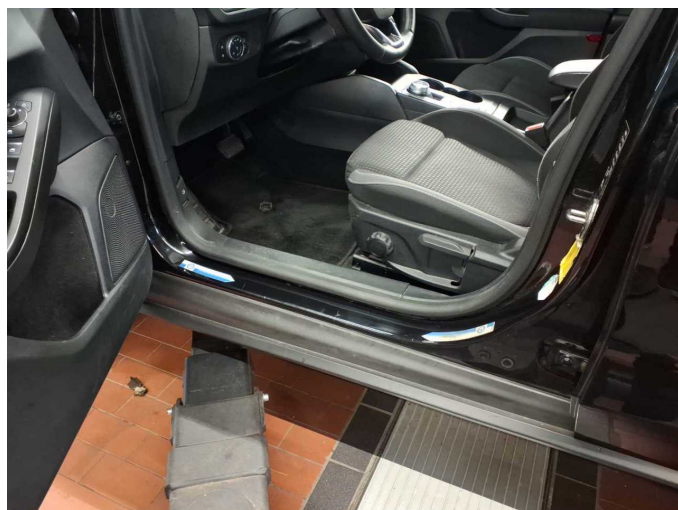
**Damage 6:** Sill - left side: Sill - Scratch(es) - Smart repair

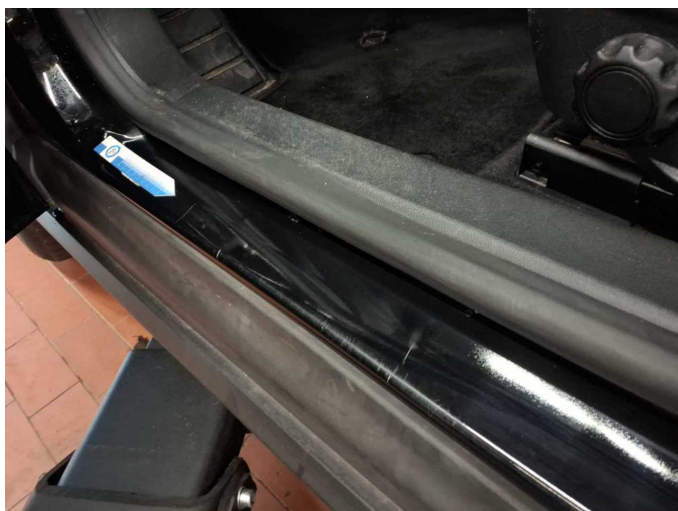
**Damage 6:** Sill - left side: Sill - Scratch(es) - Smart repair

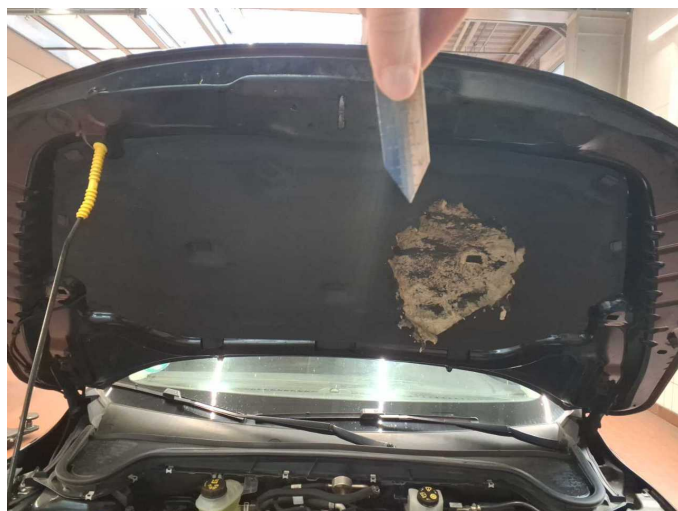
**Damage 7:** Bonnet: Insulation lining - Damage caused by marten / rodent - Replace

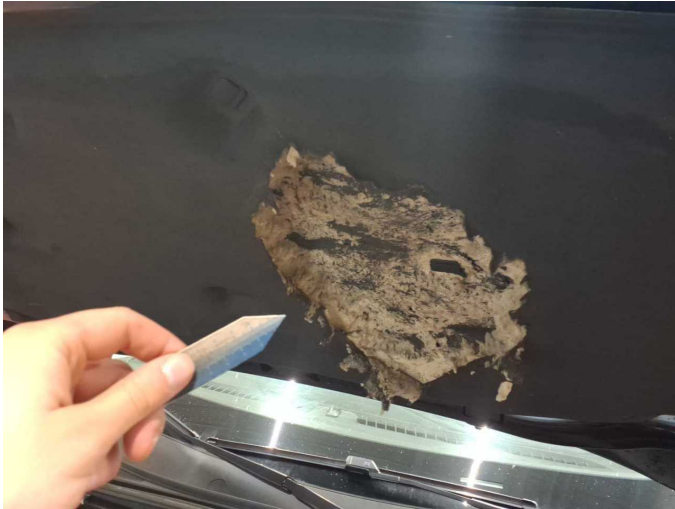
**Damage 7:** Bonnet: Insulation lining - Damage caused by marten / rodent  
- Replace

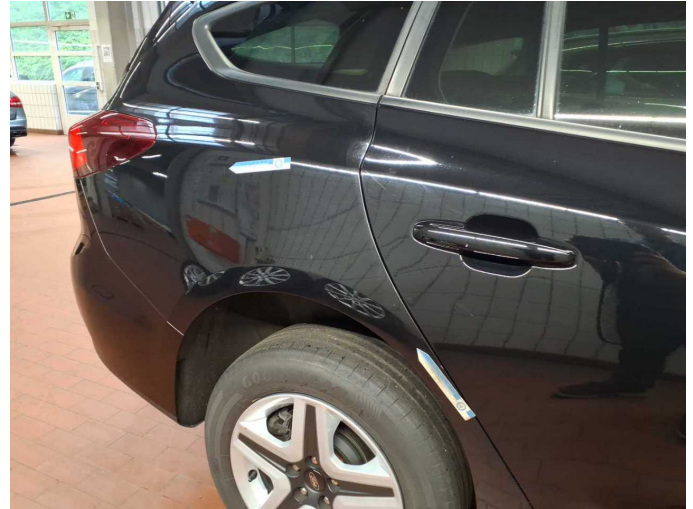
**Damage 8:** Side panel - rear right side: Side panel (+ aufbereiten) -  
Scratch(es) - Smart repair

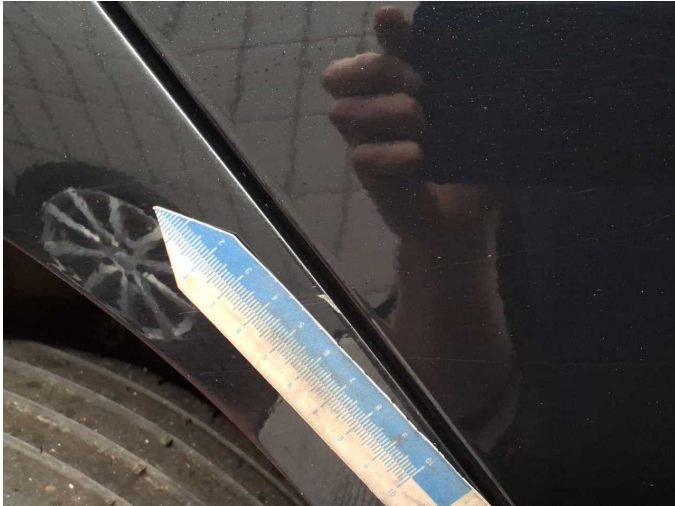
**Damage 8:** Side panel - rear right side: Side panel (+ aufbereiten) -  
Scratch(es) - Smart repair

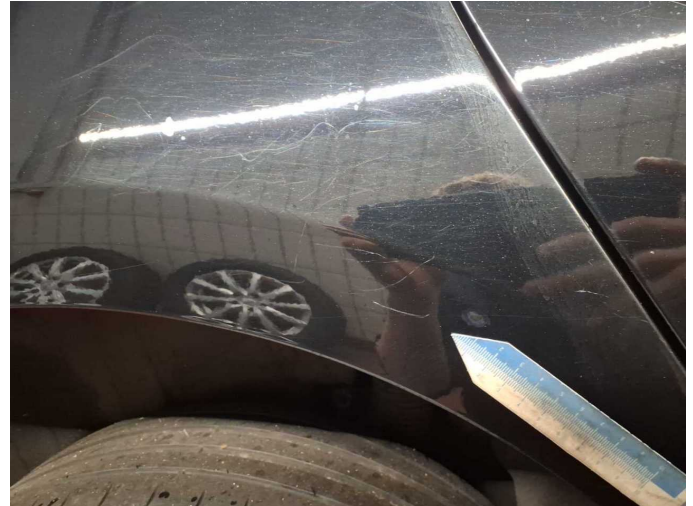
**Damage 8:** Side panel - rear right side: Side panel (+ aufbereiten) -  
Scratch(es) - Smart repair

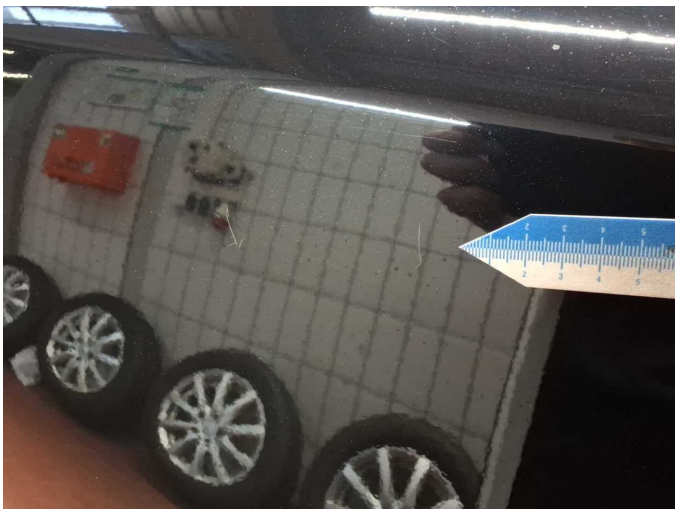
**Damage 8:** Side panel - rear right side: Side panel (+ aufbereiten) -  
Scratch(es) - Smart repair

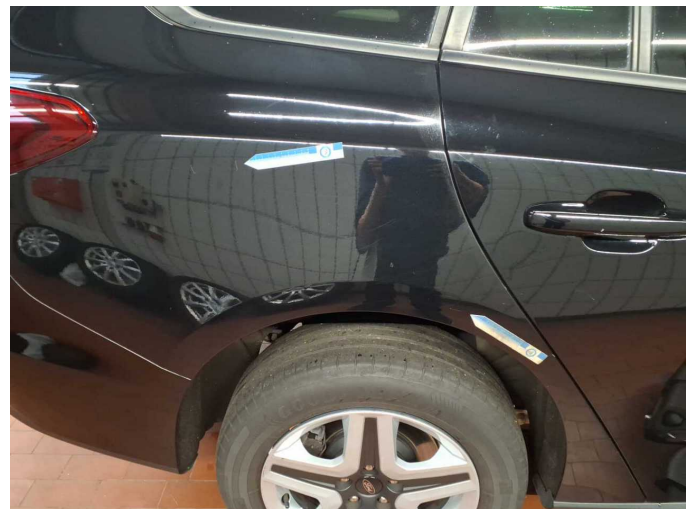
**Damage 8:** Side panel - rear right side: Side panel (+ aufbereiten) -  
Scratch(es) - Smart repair

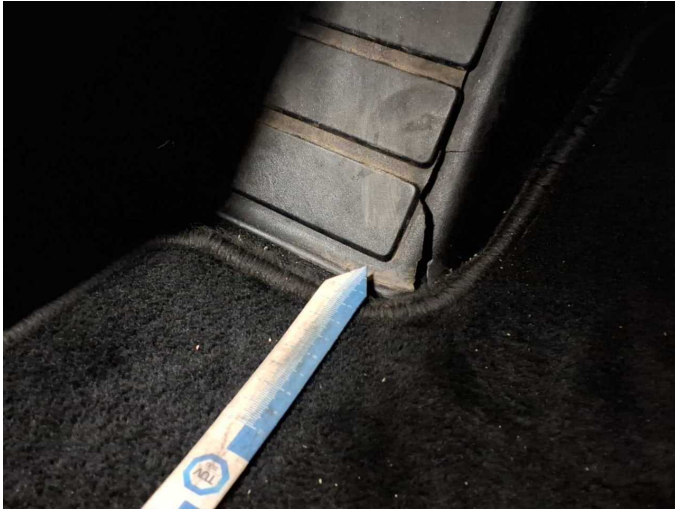
**Damage 9:** Trim / covers: Floor covering - front left side (Fußablage) - Broken / torn - Loss in value

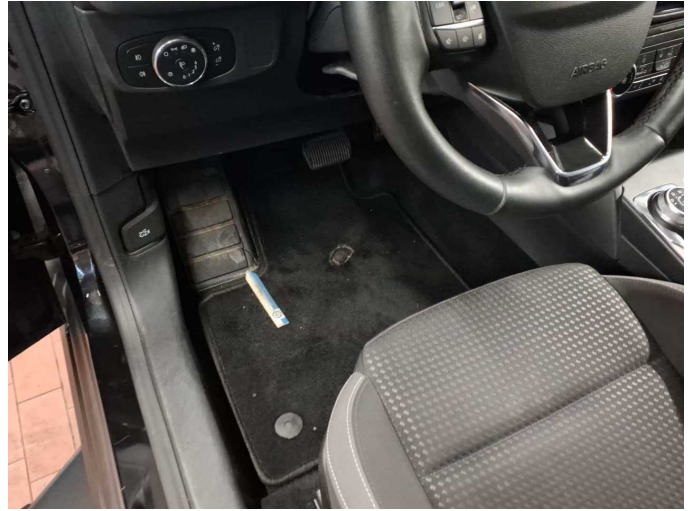
**Damage 9:** Trim / covers: Floor covering - front left side (Fußablage) - Broken / torn - Loss in value

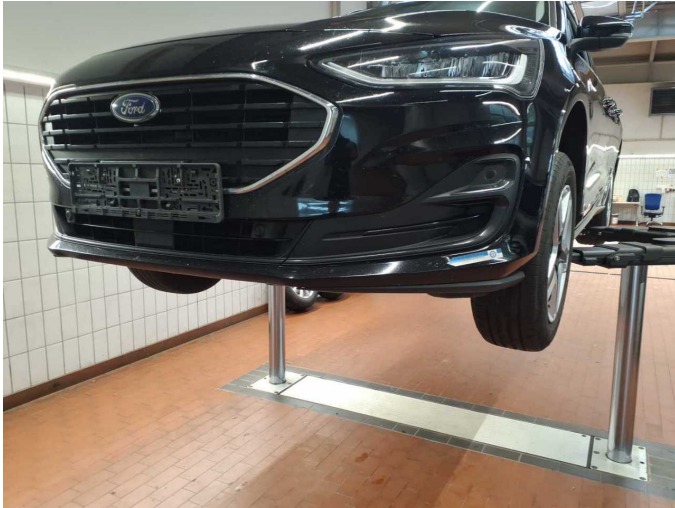
**Damage 10:** Front bumper: Front bumper - Stone chips - Paint

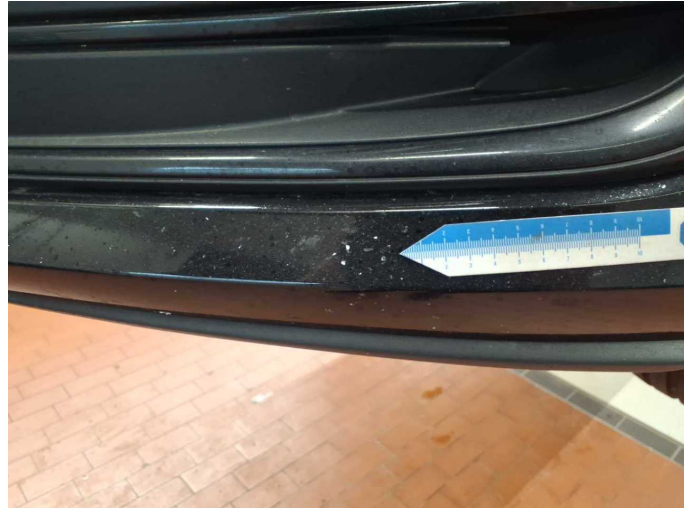
**Damage 10:** Front bumper: Front bumper - Stone chips - Paint

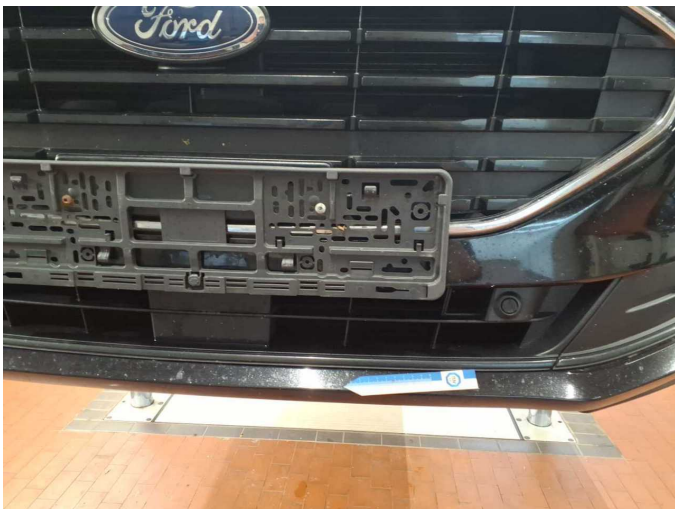
**Damage 10:** Front bumper: Front bumper - Stone chips - Paint

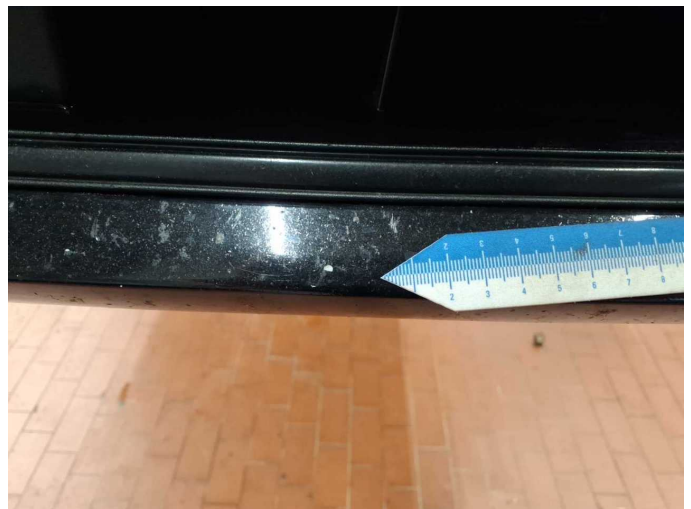
**Damage 10:** Front bumper: Front bumper - Stone chips - Paint

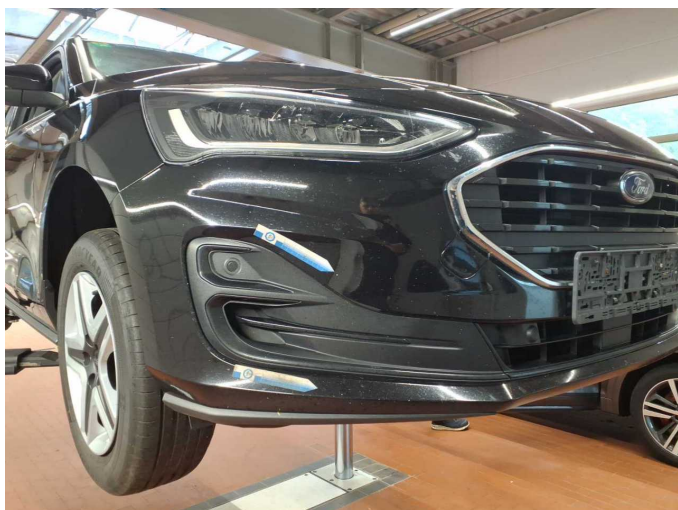
**Damage 10:** Front bumper: Front bumper - Stone chips - Paint

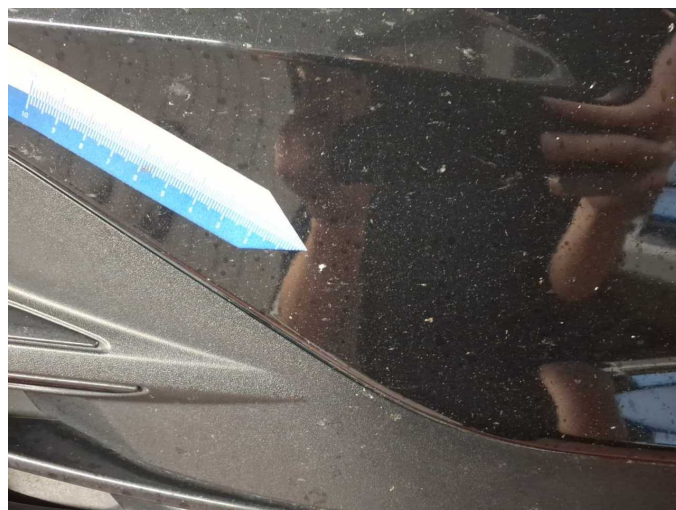
**Damage 10:** Front bumper: Front bumper - Stone chips - Paint

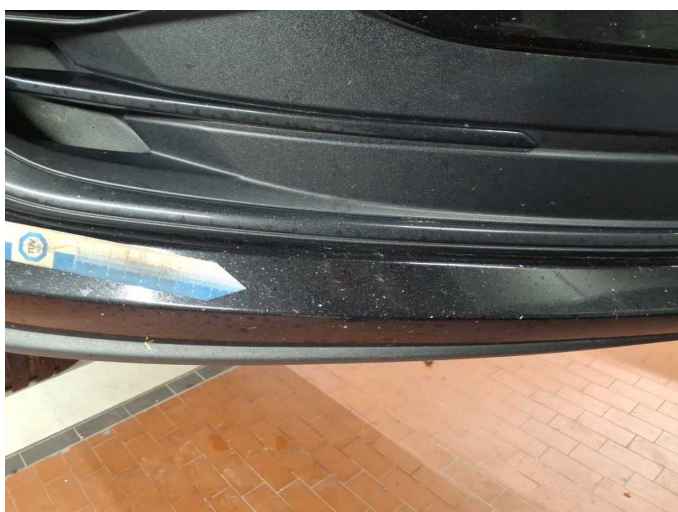
**Damage 10:** Front bumper: Front bumper - Stone chips - Paint

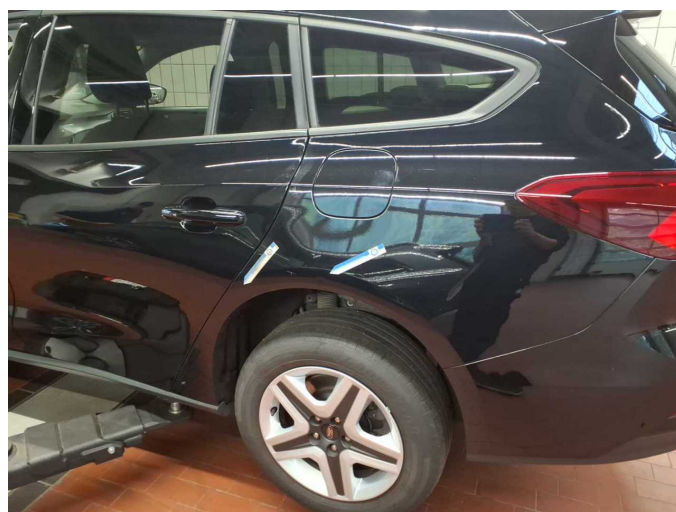
**Damage 11:** Side panel - rear left side: Side panel - Dent / paintcoat damage - Repair and paint

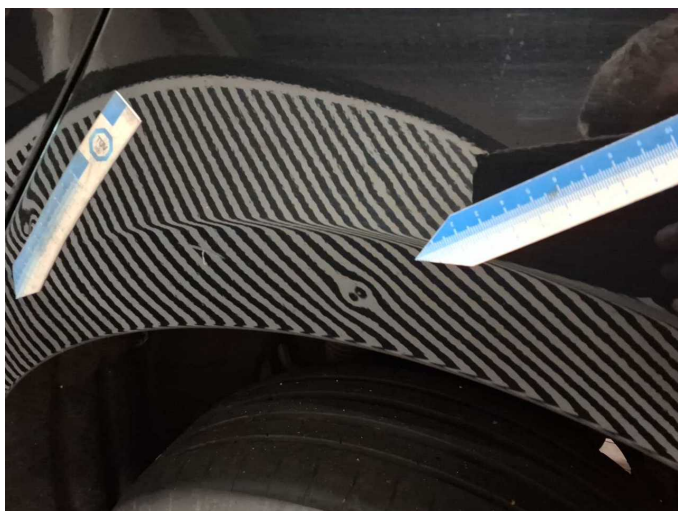
**Damage 11:** Side panel - rear left side: Side panel - Dent / paintcoat damage - Repair and paint

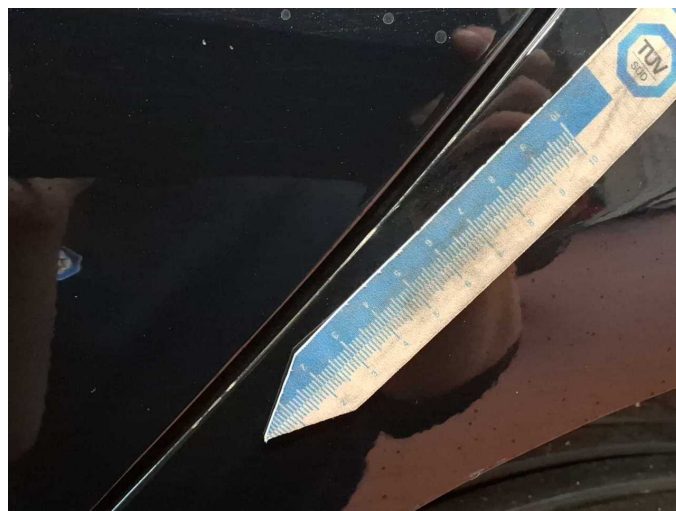
**Damage 11:** Side panel - rear left side: Side panel - Dent / paintcoat damage - Repair and paint

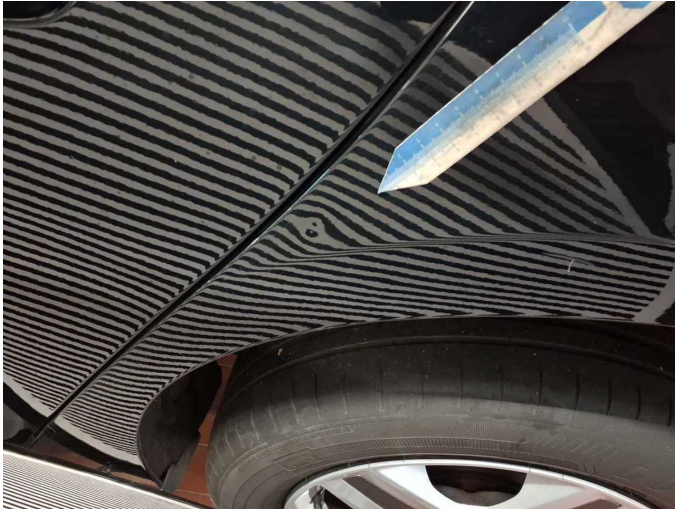
**Damage 11:** Side panel - rear left side: Side panel - Dent / paintcoat damage - Repair and paint

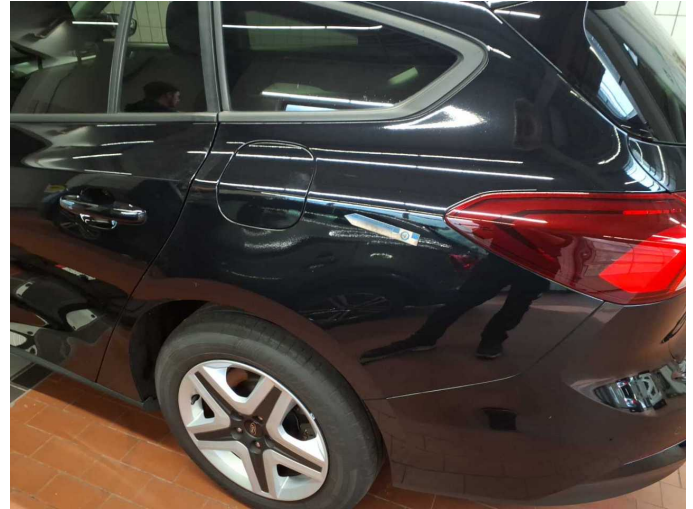
**Damage 11:** Side panel - rear left side: Side panel - Dent / paintcoat damage - Repair and paint

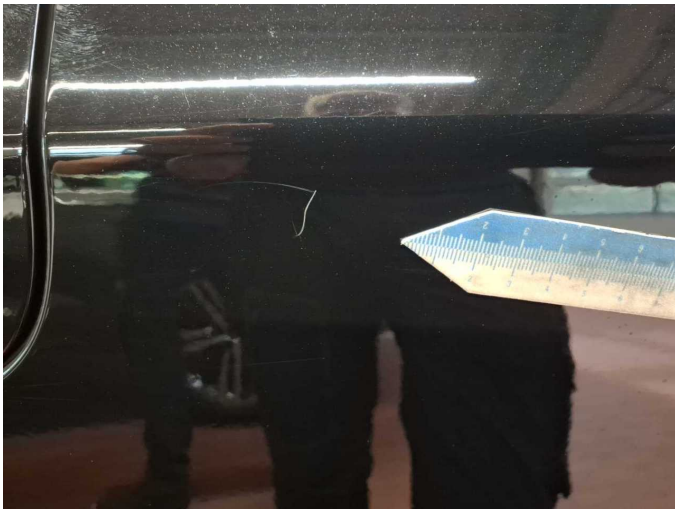
**Damage 11:** Side panel - rear left side: Side panel - Dent / paintcoat damage - Repair and paint

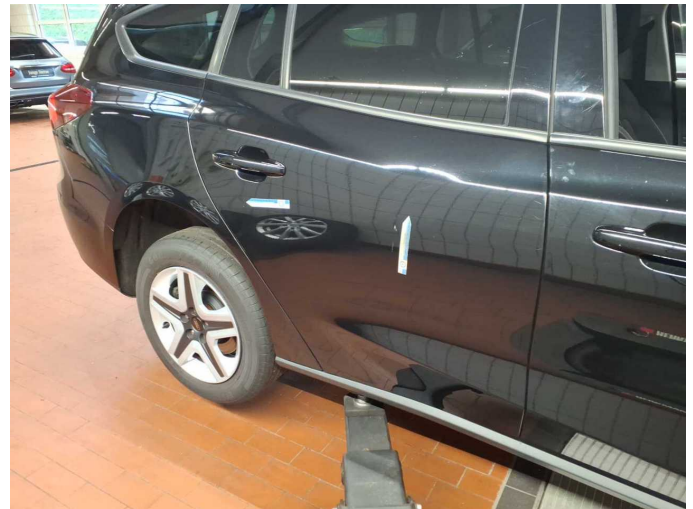
**Damage 12:** Door - rear right side: Door - Dent / paintcoat damage - Repair and paint

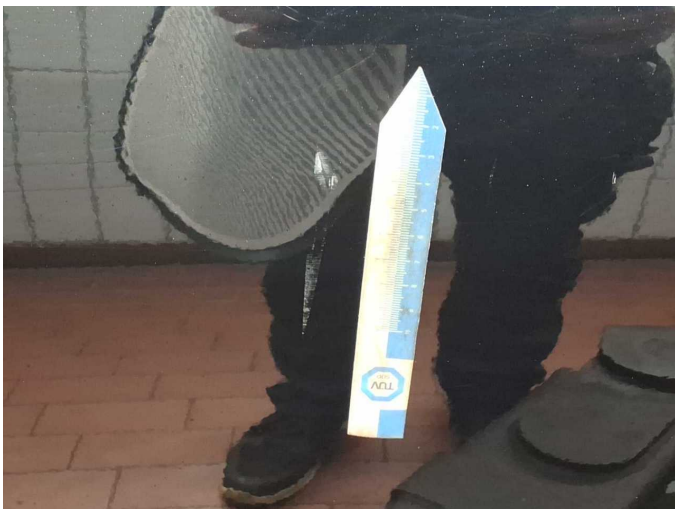
**Damage 12:** Door - rear right side: Door - Dent / paintcoat damage - Repair and paint

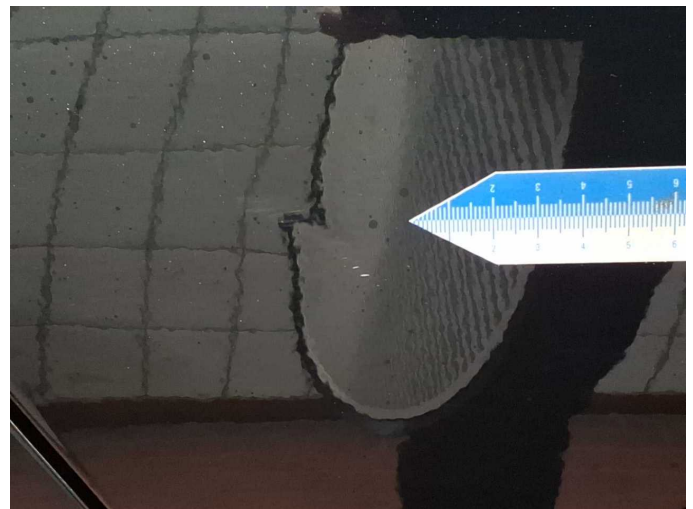
**Damage 12:** Door - rear right side: Door - Dent / paintcoat damage - Repair and paint

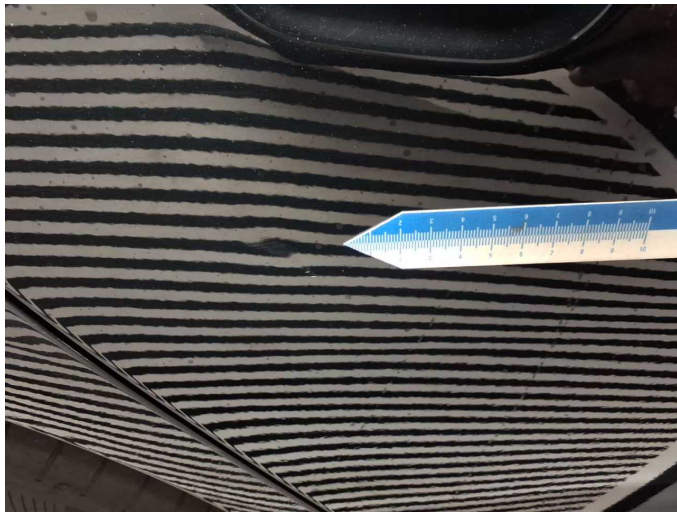
**Damage 12:** Door - rear right side: Door - Dent / paintcoat damage - Repair and paint

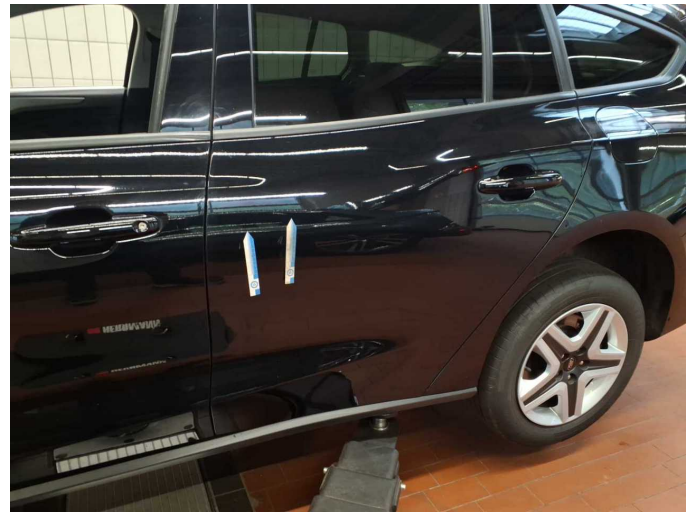
**Damage 13:** Door - rear left side: Door - Scratch(es) - Paint

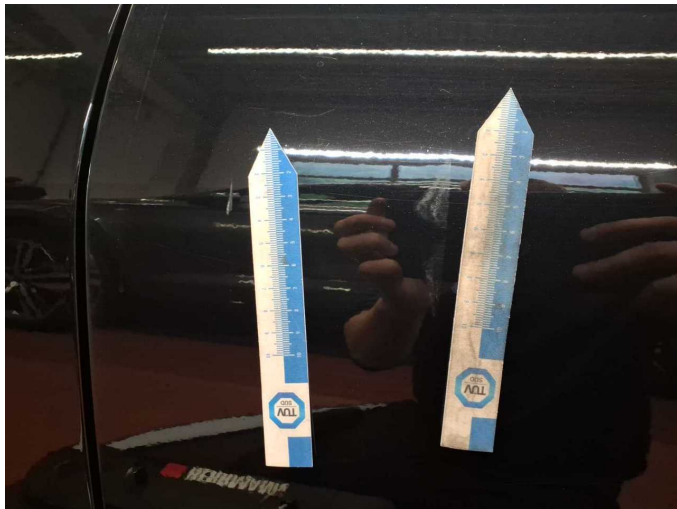
**Damage 13:** Door - rear left side: Door - Scratch(es) - Paint

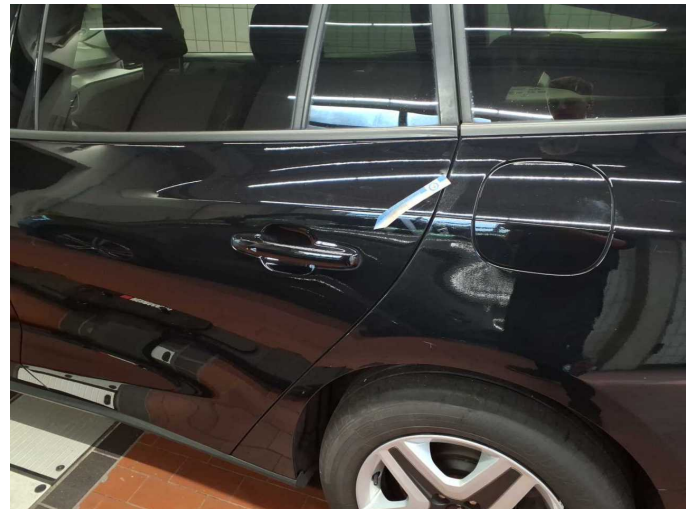
**Damage 13:** Door - rear left side: Door - Scratch(es) - Paint

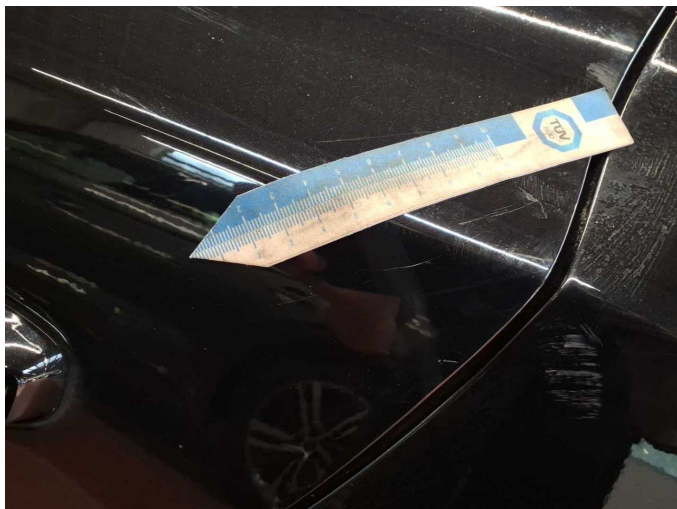
**Damage 13:** Door - rear left side: Door - Scratch(es) - Paint

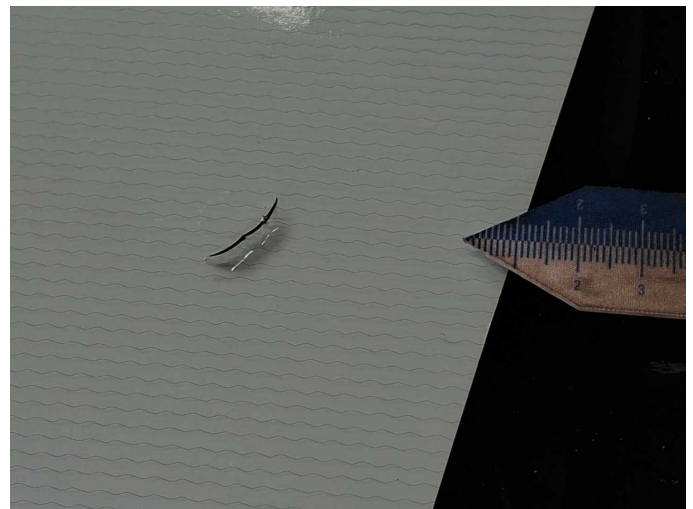
**Damage 14:** Vehicle glazing: Windscreen - Stone chips - Replace

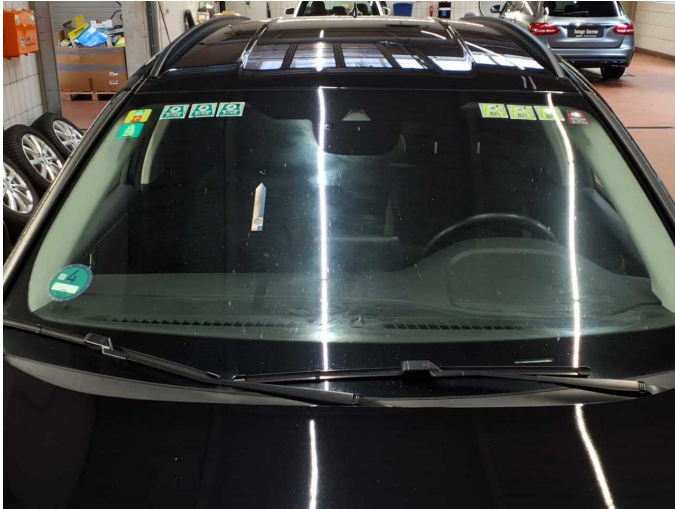
**Damage 14:** Vehicle glazing: Windscreen - Stone chips - Replace

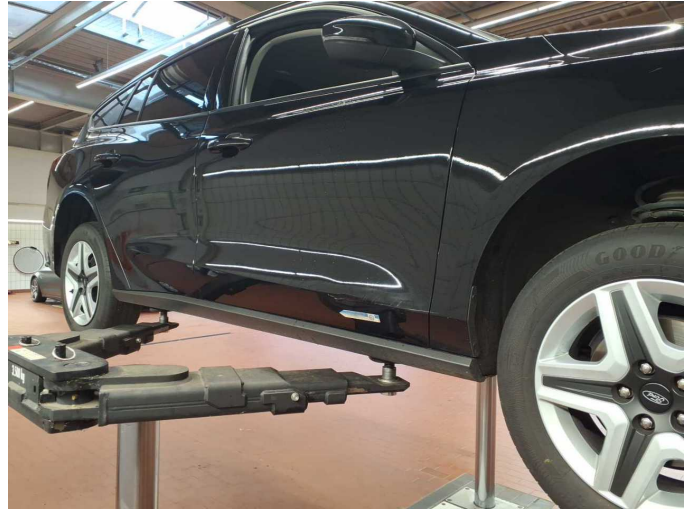
**Damage 15:** Door - front right side: Door - Deformed - Replace

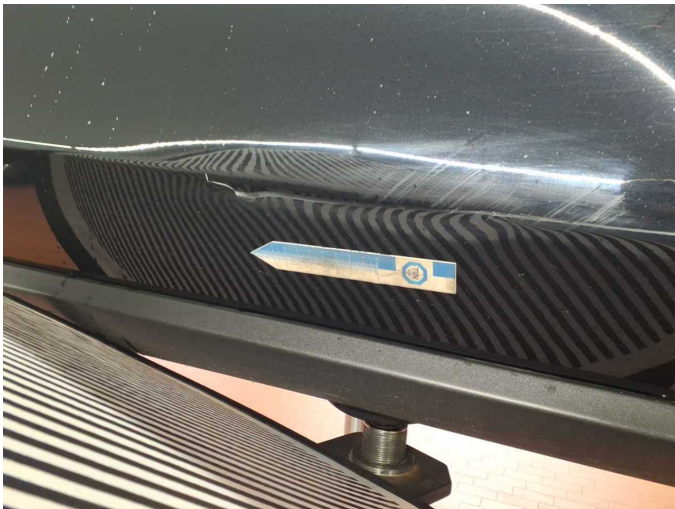
**Damage 15:** Door - front right side: Door - Deformed - Replace

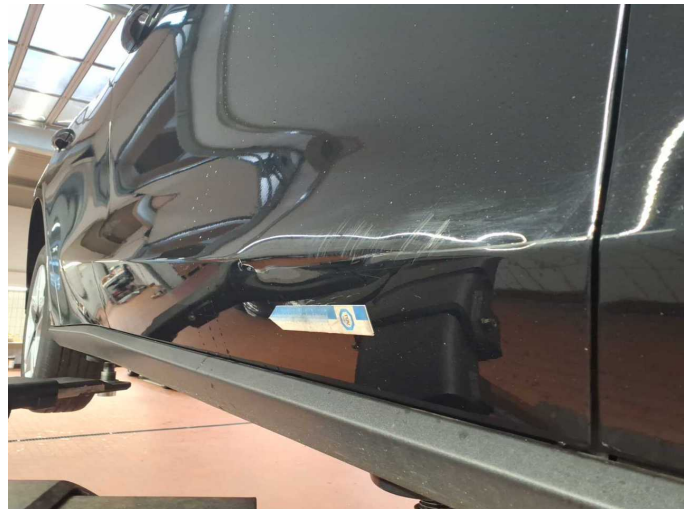
**Damage 15:** Door - front right side: Door - Deformed - Replace

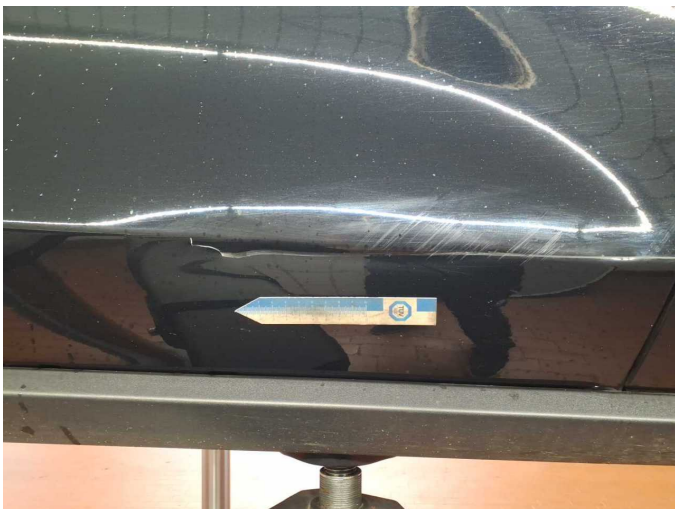
**Damage 15:** Door - front right side: Door - Deformed - Replace

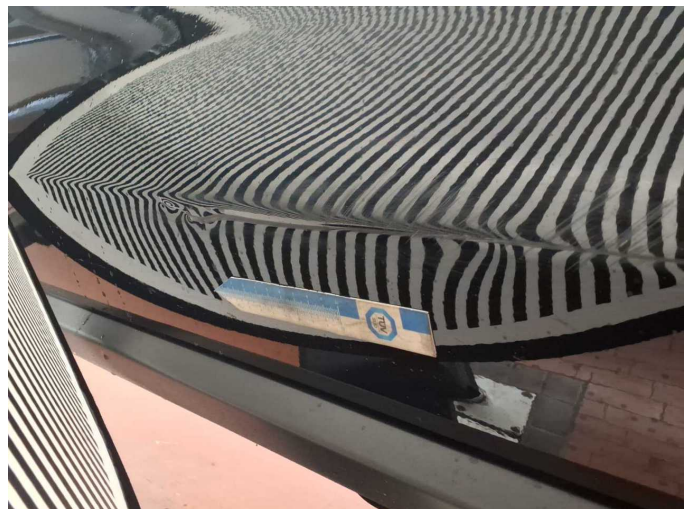
**Damage 15:** Door - front right side: Door - Deformed - Replace
