Expertise

Protocol number: 41607676  
Order No. / Reference: 25212548  
Inspection date: 17 Sept 2025

Manufacturer: Ford	Model: Focus Turnier 1.5 EcoBlue Start-Stopp-System Aut. COOL&CONNECT
VIN: WF0PXXGCHPNM80135

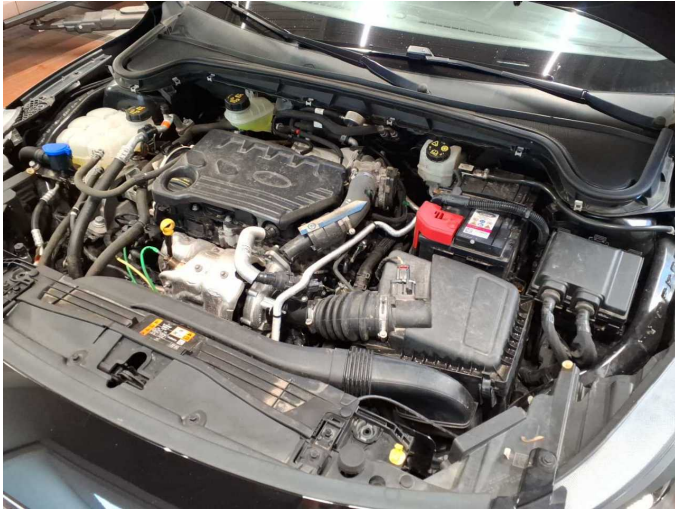
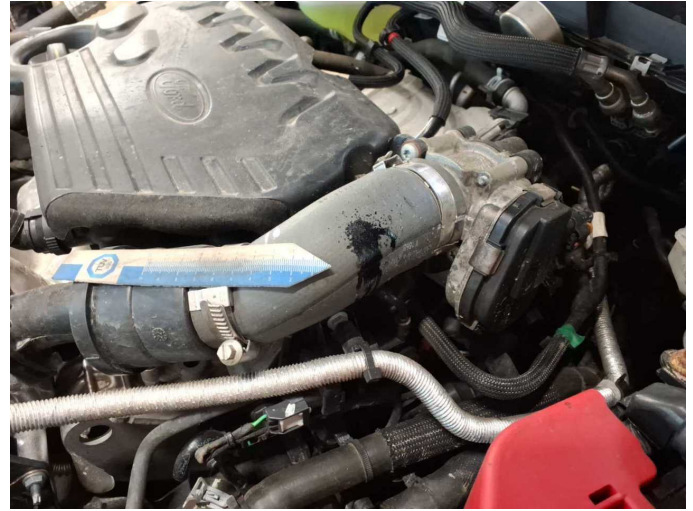
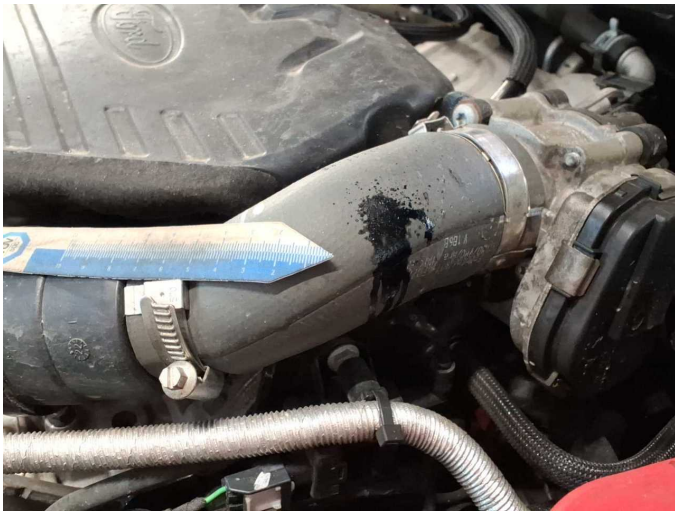
**Damage 1:** Engine: Hose turbocharger (Mehrkosten möglich) - Damage caused by marten / rodent - Replace

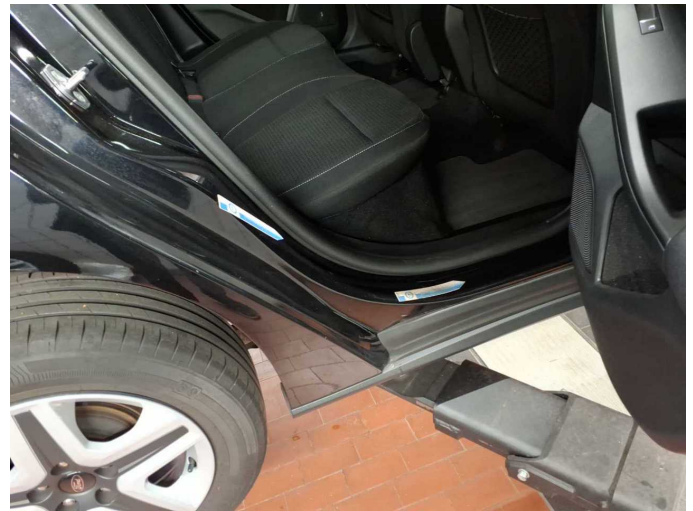
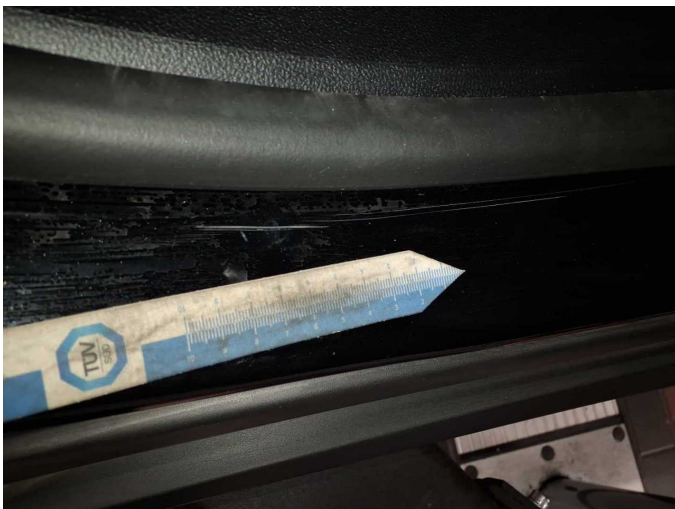
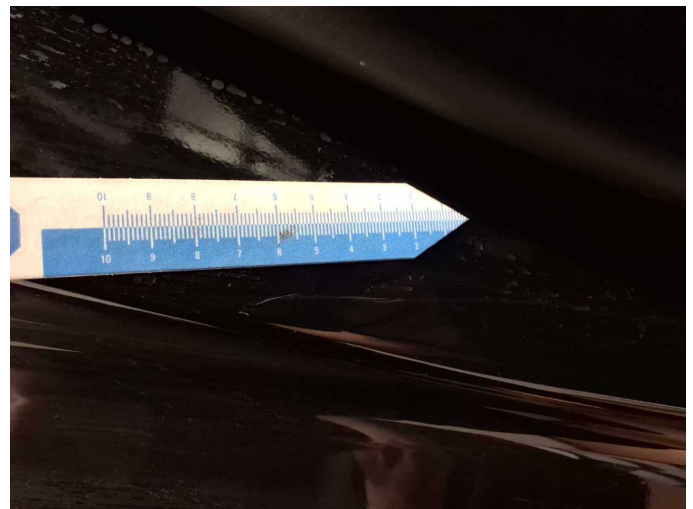
**Damage 3:** Side panel - rear right side: Sill - Scratch(es) - Smart repair

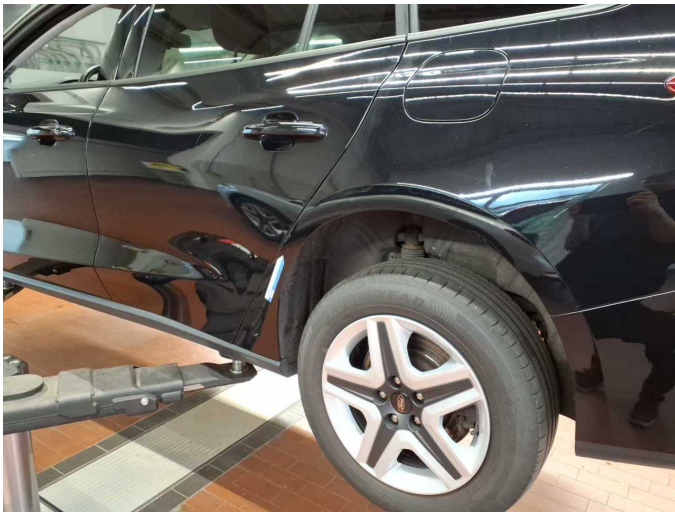
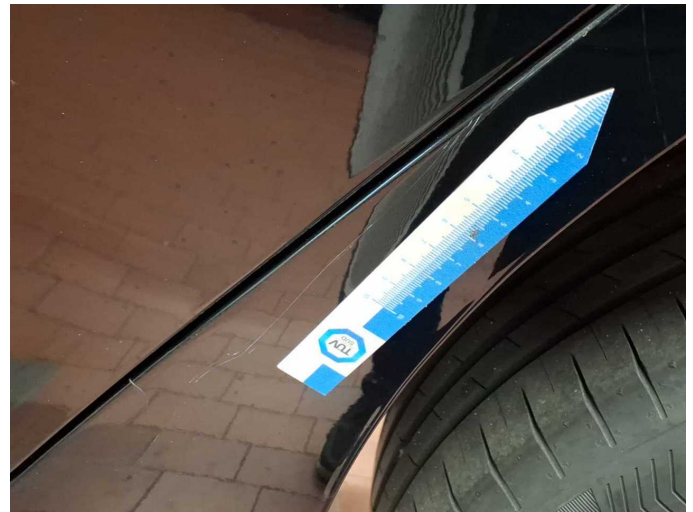
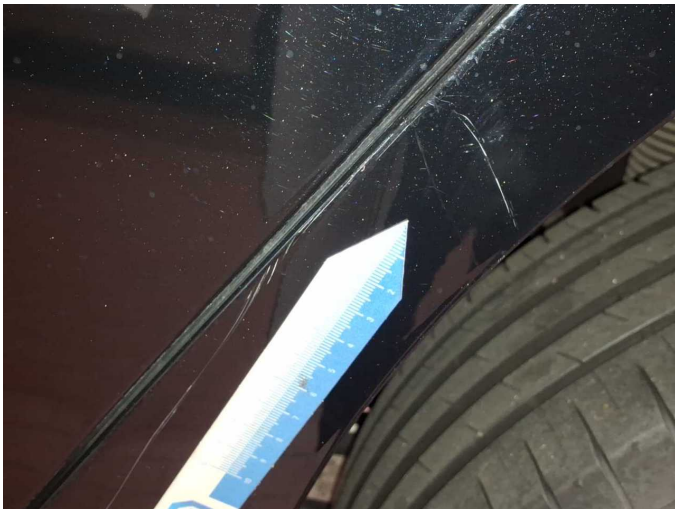
**Damage 4:** Side panel - rear left side: Side panel - Scratch(es) - Smart repair

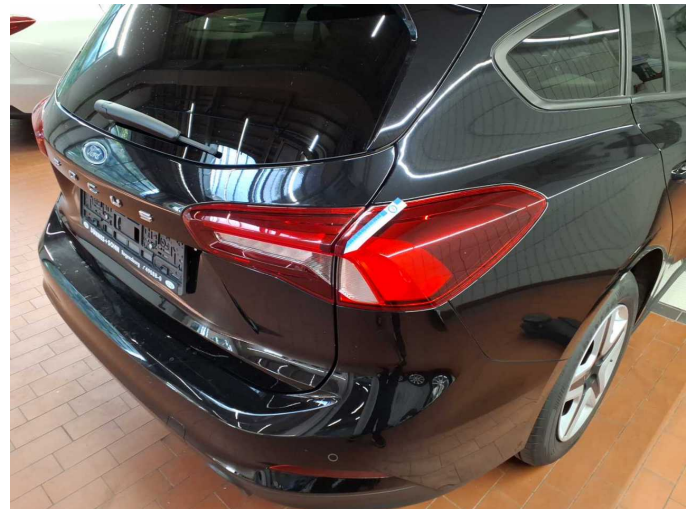
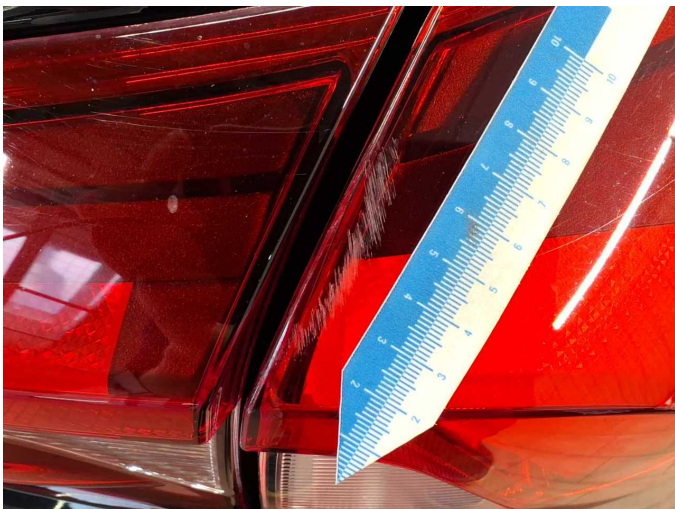
**Damage 5:** Tail light: Tail lamp - right side - Scratched - Replace

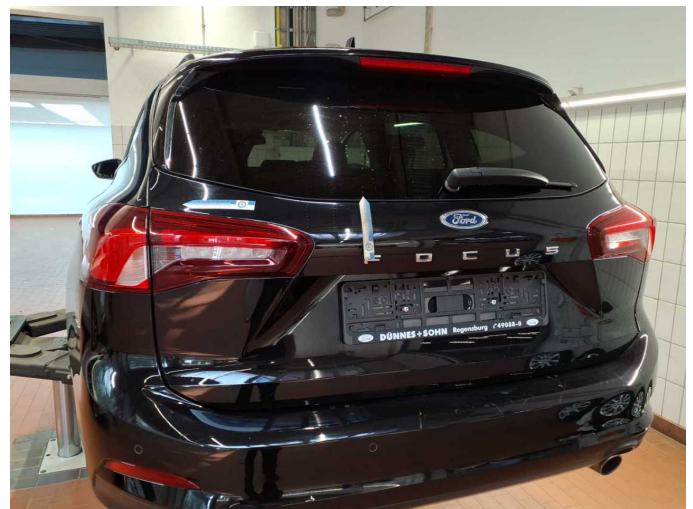
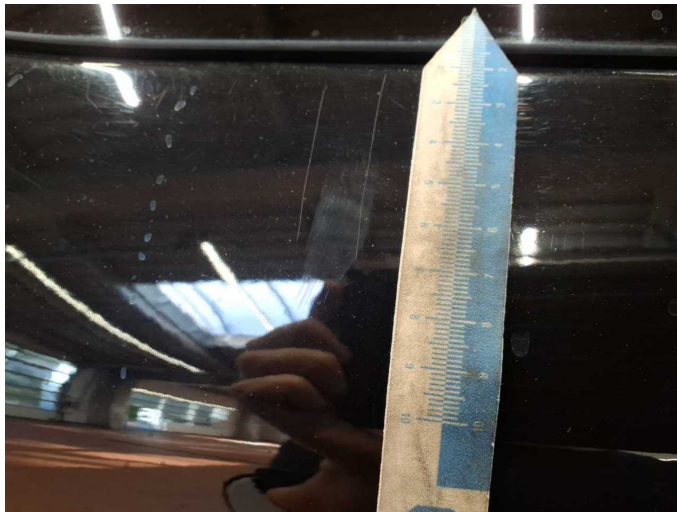
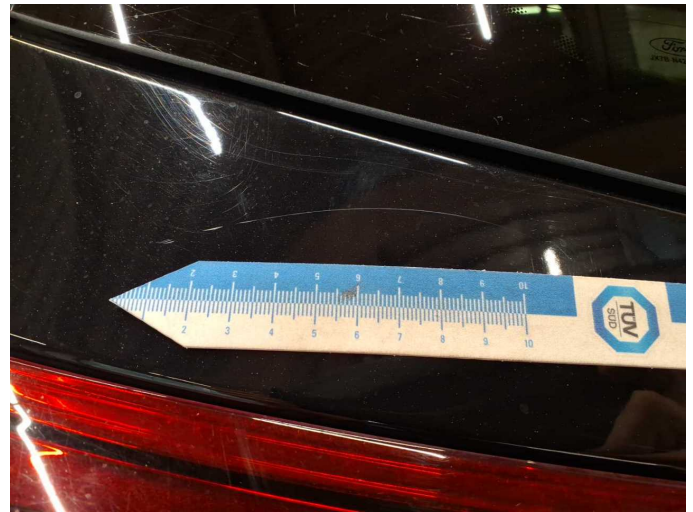
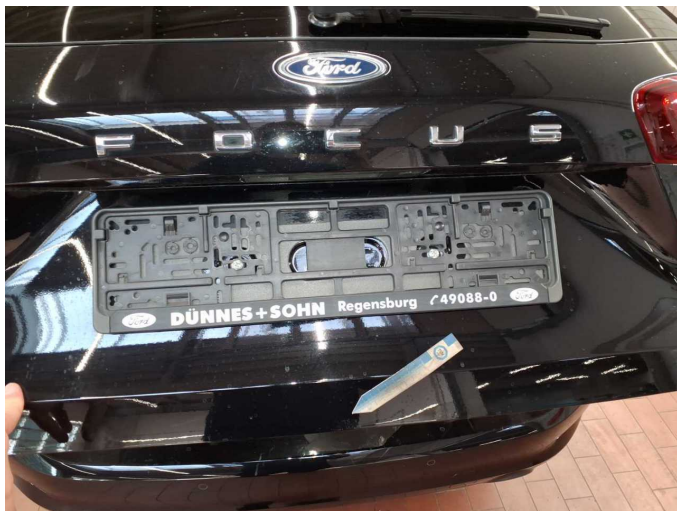
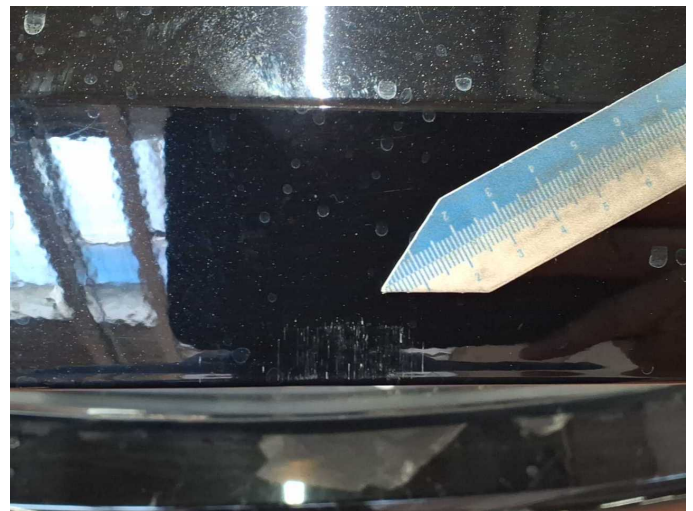
**Damage 6:** Boot lid / rear door: Boot lid - Scratch(es) - Paint

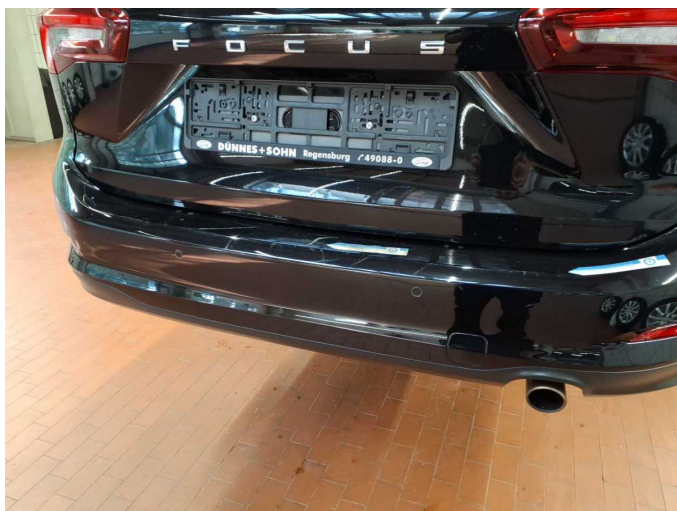
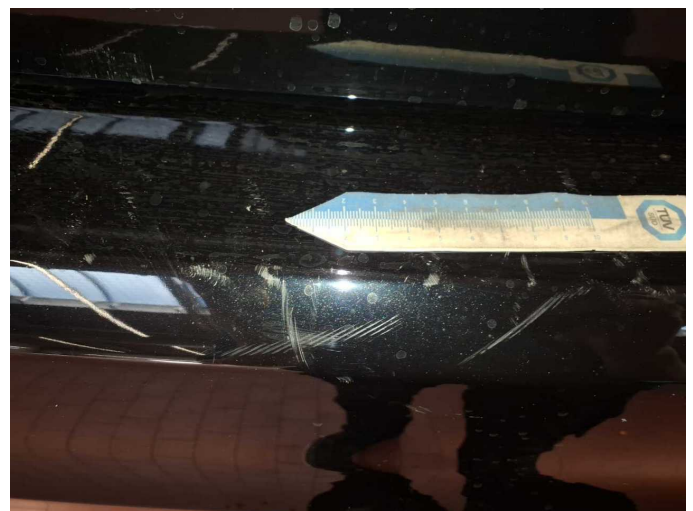
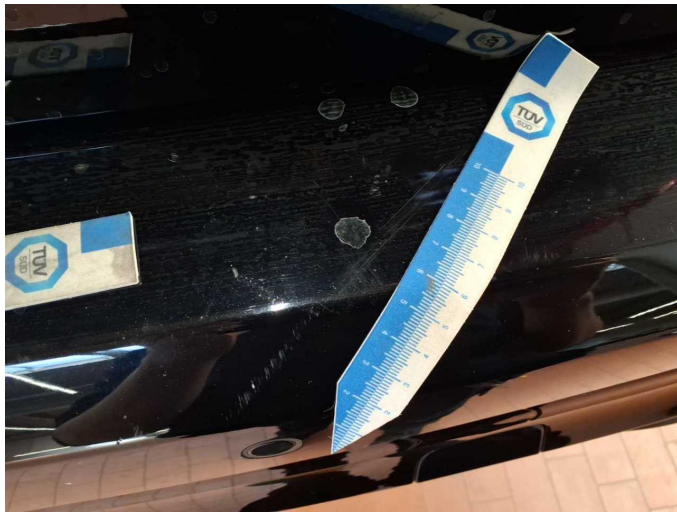
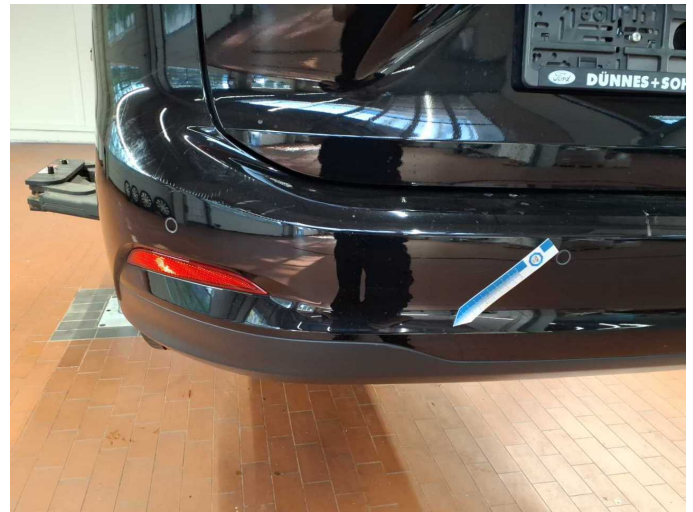
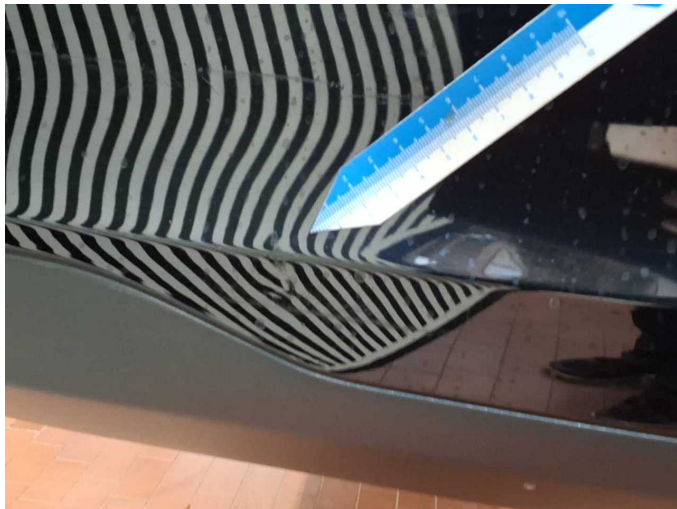
**Damage 7:** Rear bumper: Rear bumper - Dent / paintcoat damage - Repair and paint

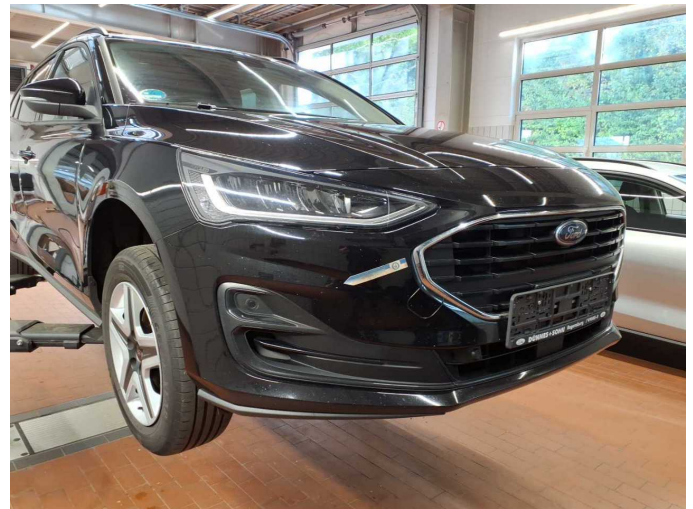
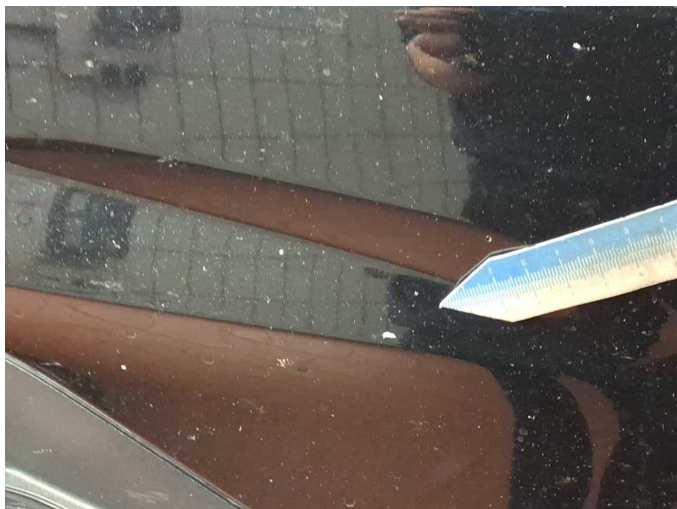
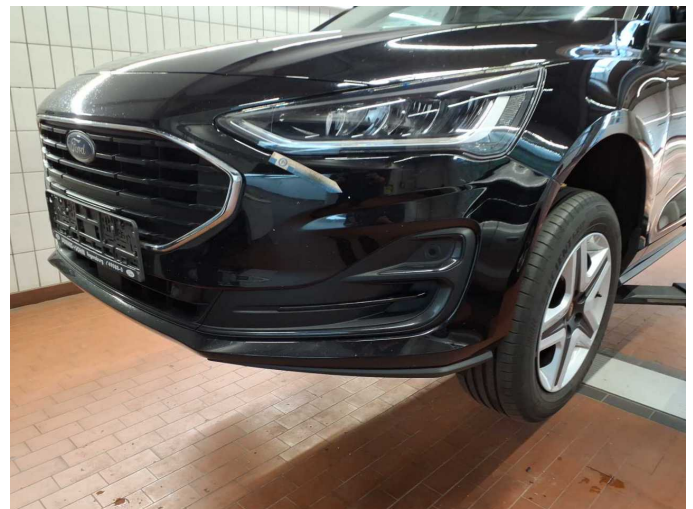
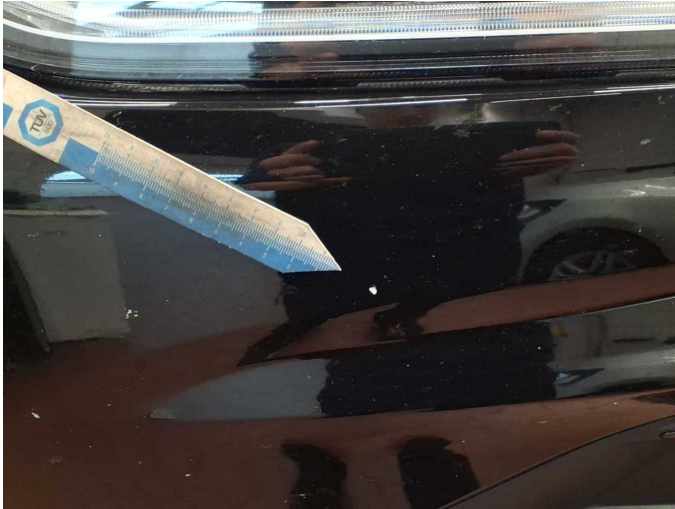
**Damage 8:** Front bumper: Front bumper - Stone chips - Paint

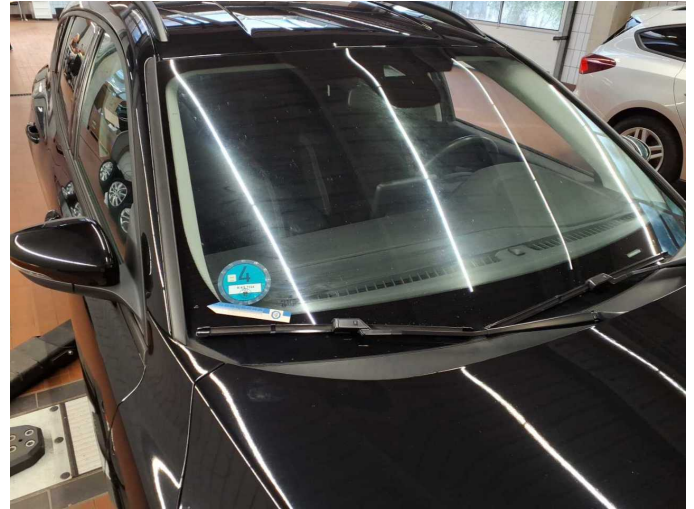
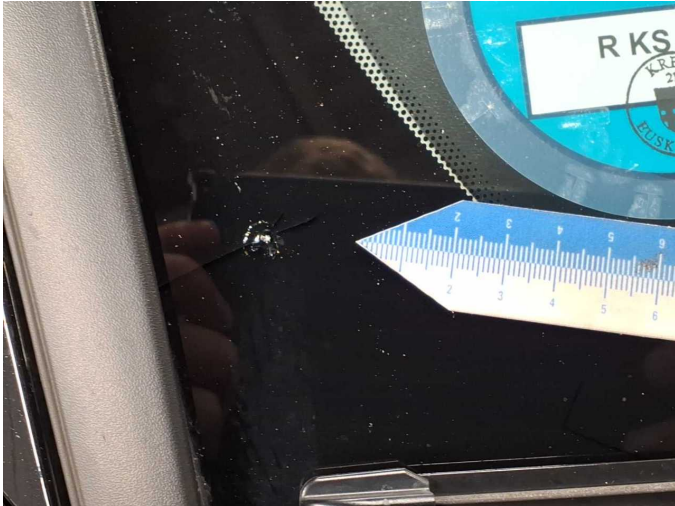
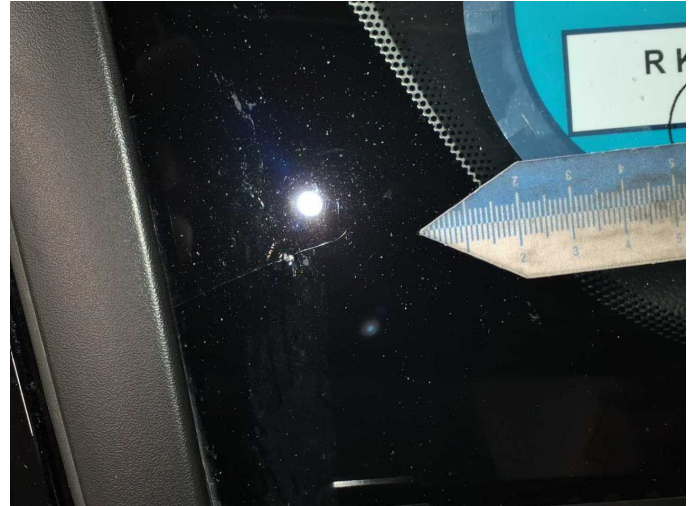
**Damage 9:** Vehicle glazing: Windscreen - Stone chips - Replace
