Expertise

Protocol number: 41458643
Order No. / Reference: 25179421
Inspection date: 9 Sept 2025

Manufacturer: Ford

Model: Focus Turnier 1.5 EcoBlue Start-Stopp-System Aut. TITANIUM
STYLE

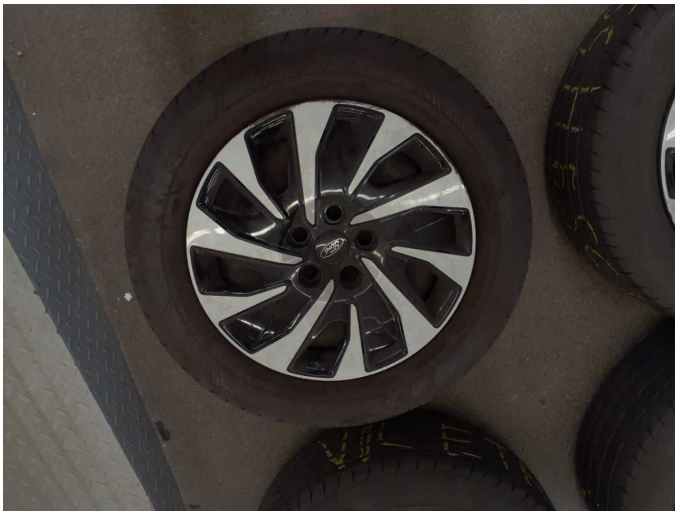
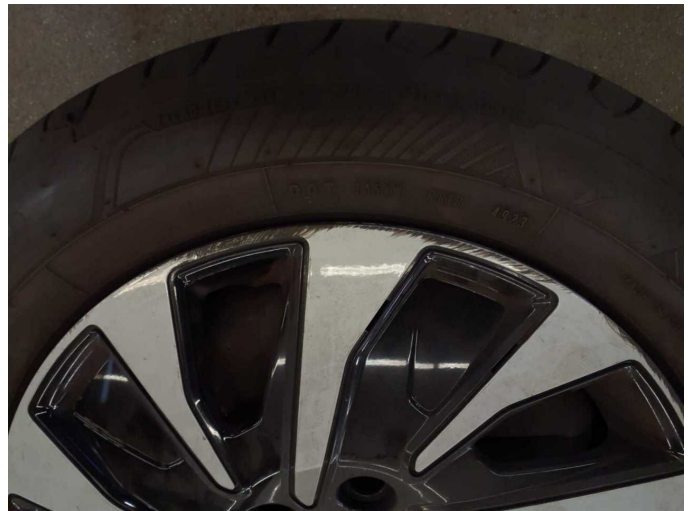
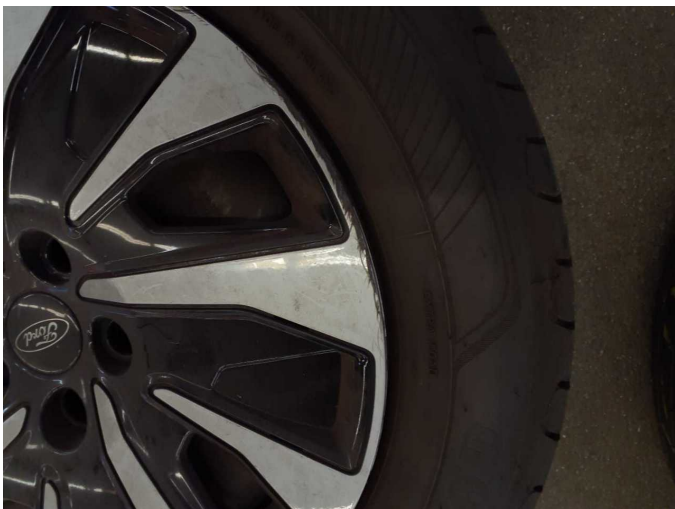
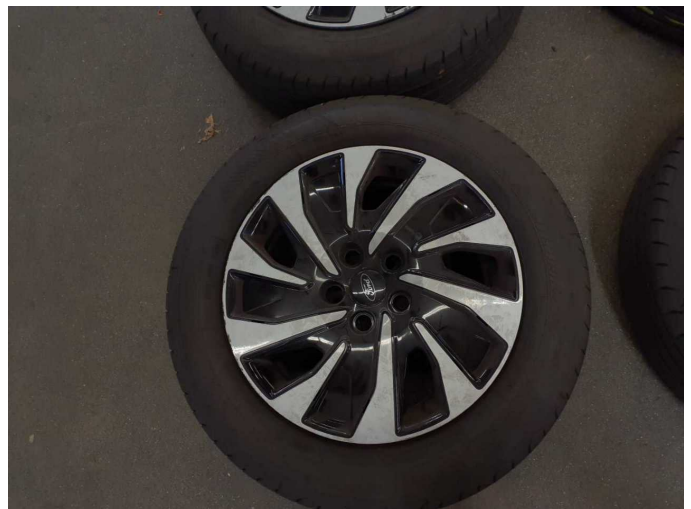
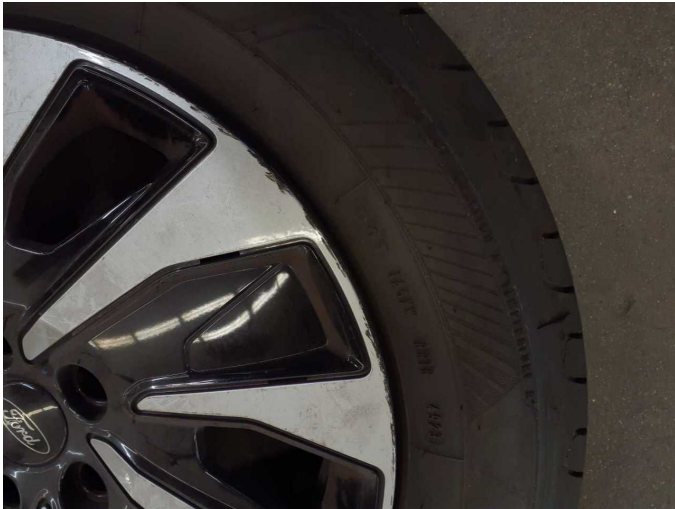
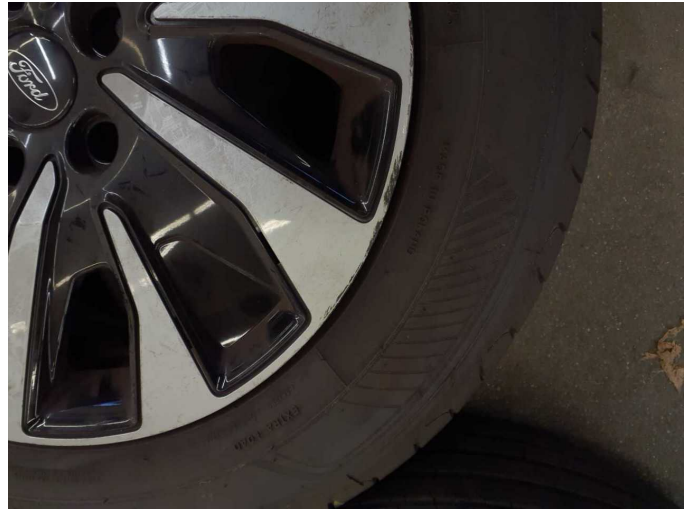
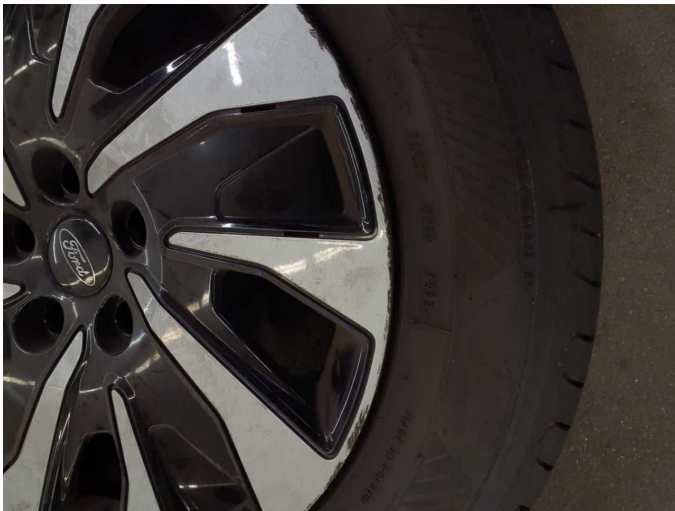
Damage 1: 2nd wheel set: 2 wheel covers - Scratched - Replace

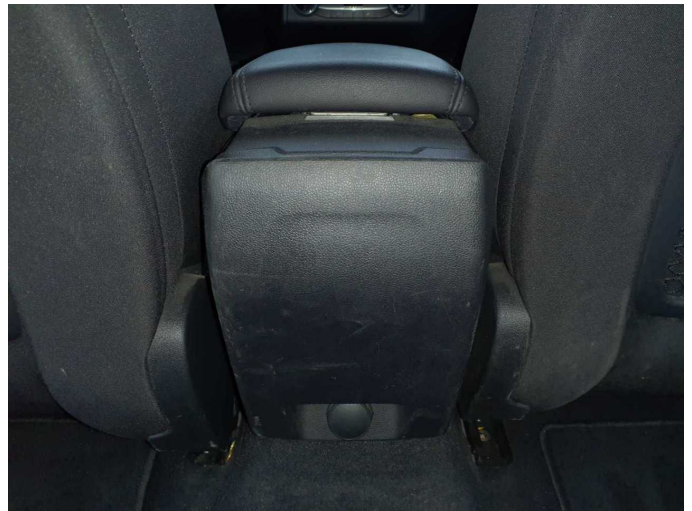
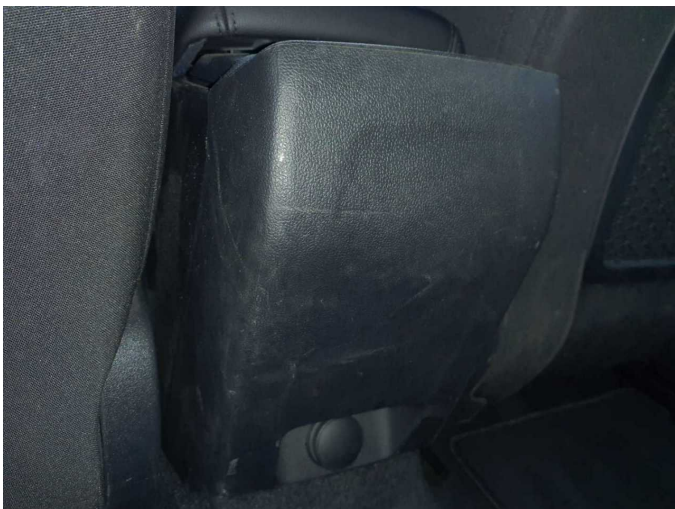
Damage 2: Instrument panel: Centre console - rear - Scratch(es) - Loss in value

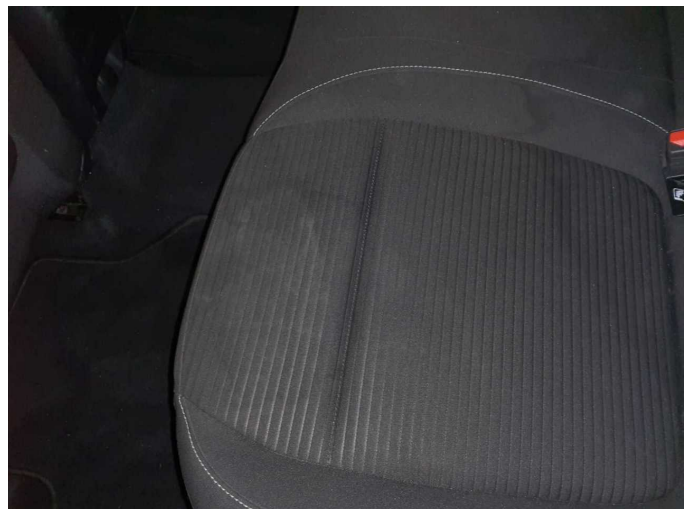
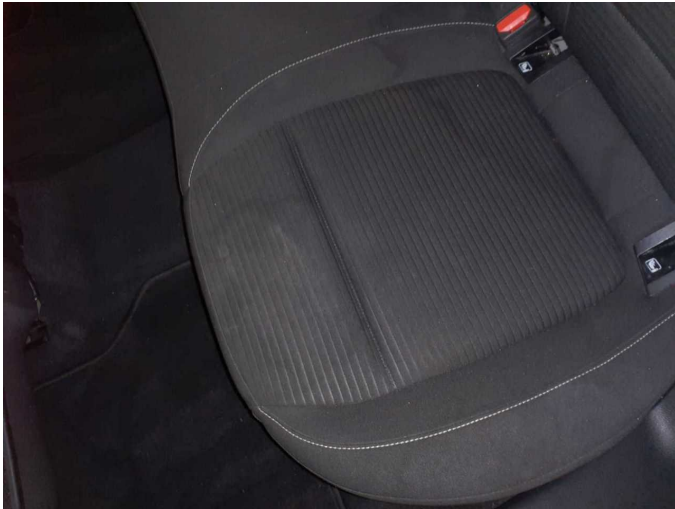
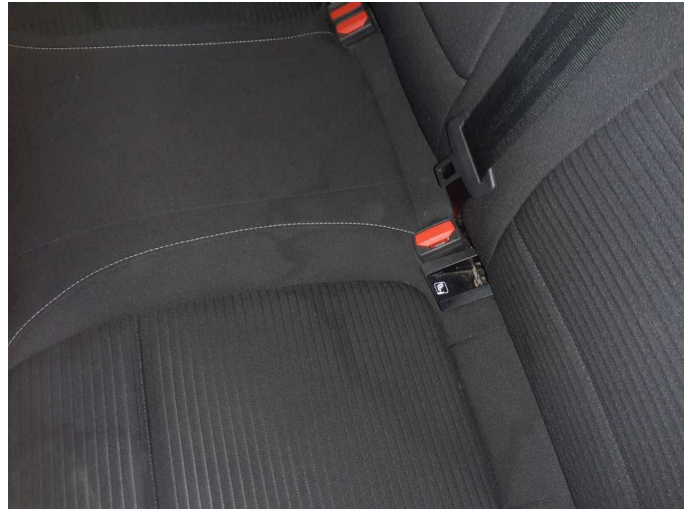
Damage 3: Seat - rear: Upholstery - Soiled - Conditioning

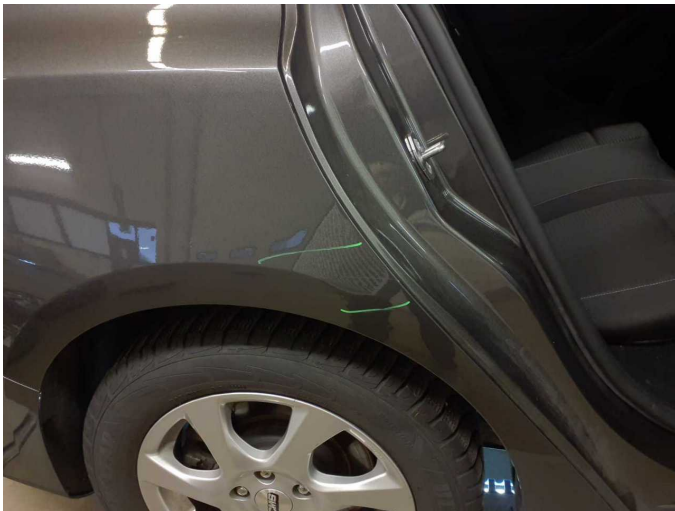
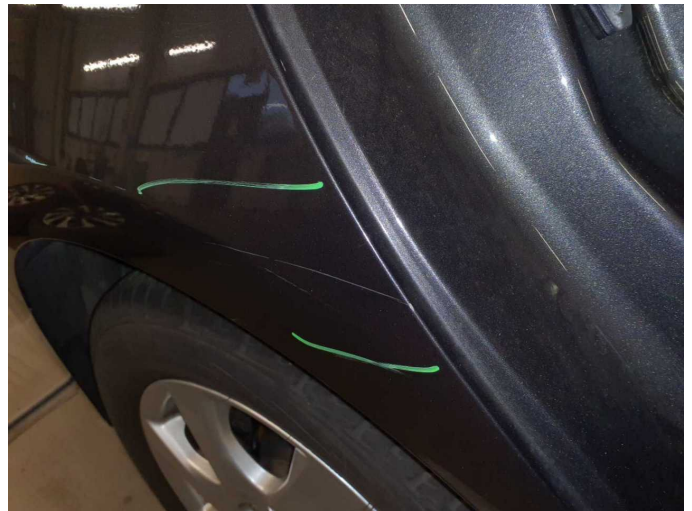
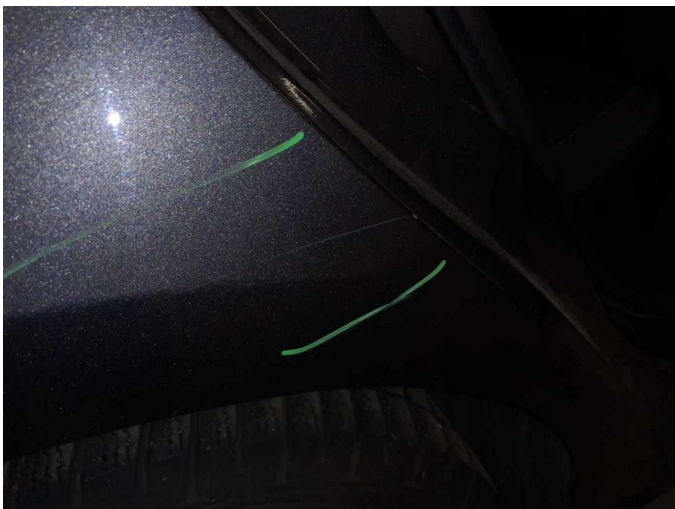
Damage 4: Side panel - rear right side: Side panel - Scratch(es) - Smart repair

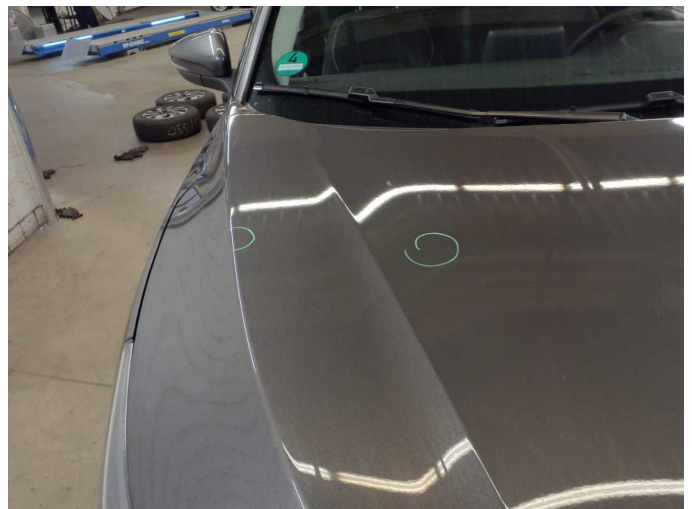
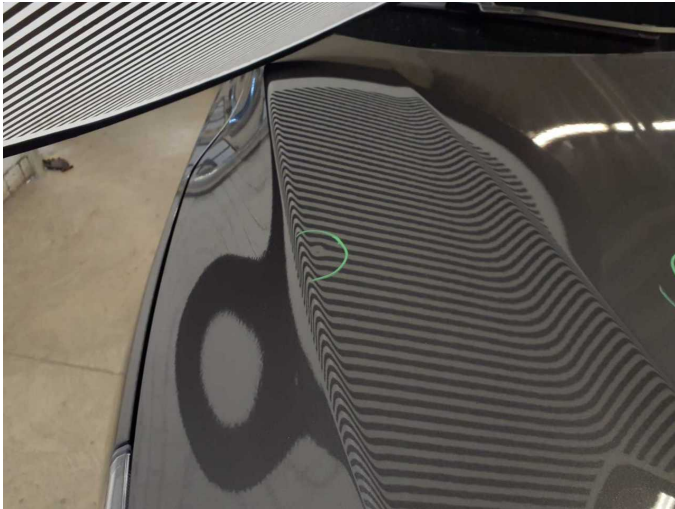
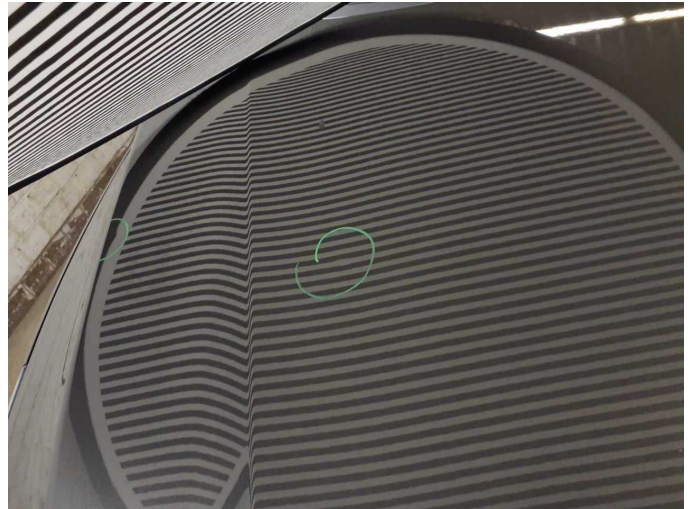
Damage 5: Bonnet: Bonnet - dent(s) - Smooth repair work

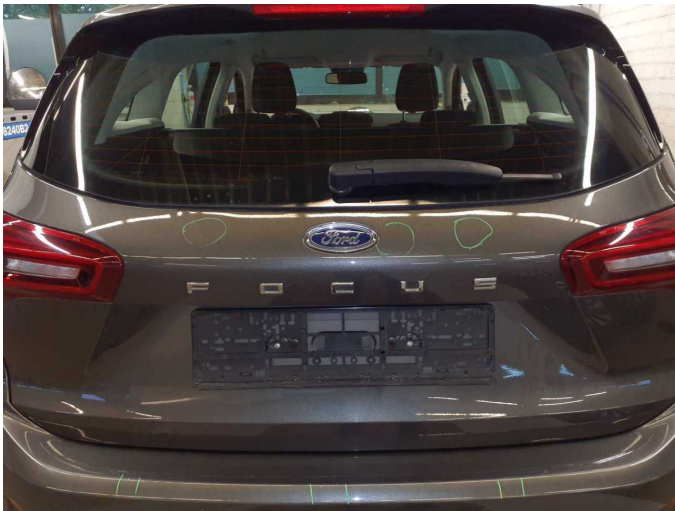
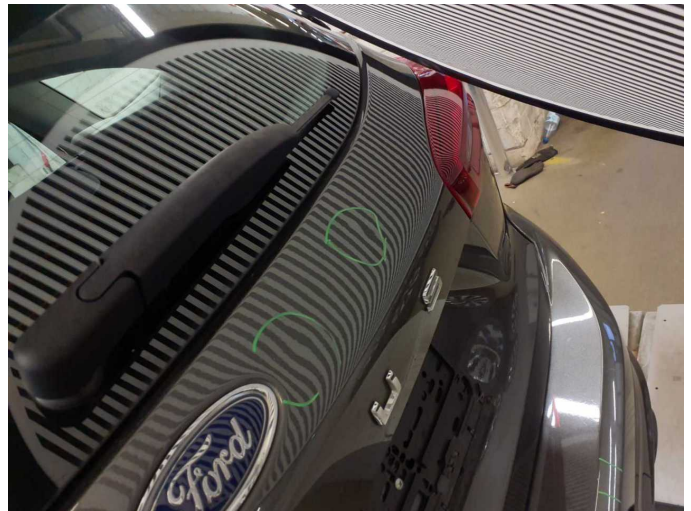
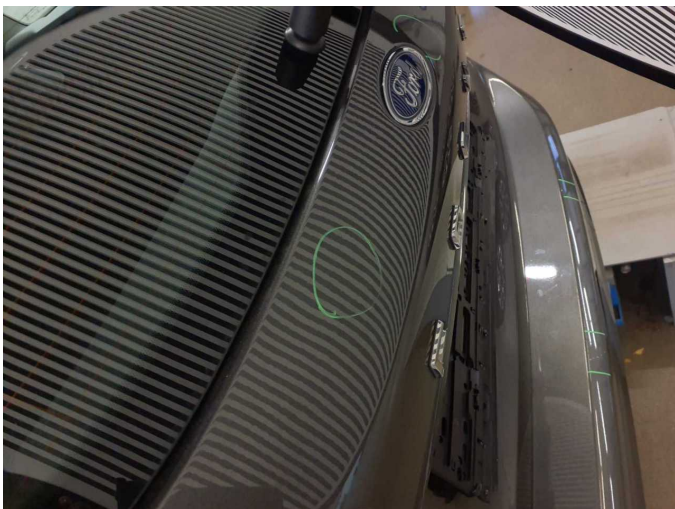
Damage 6: Boot lid / rear door: Boot lid - dent(s) - Smooth repair work
