Expertise

Protocol number: 41133370
Order No. / Reference: 24997112
Inspection date: 13 Aug 2025

Manufacturer: Ford	Model: Focus Turnier 1.5 EcoBlue Start-Stopp-System Aut. TITANIUM
VIN: WF0PXXGCHPPD61571

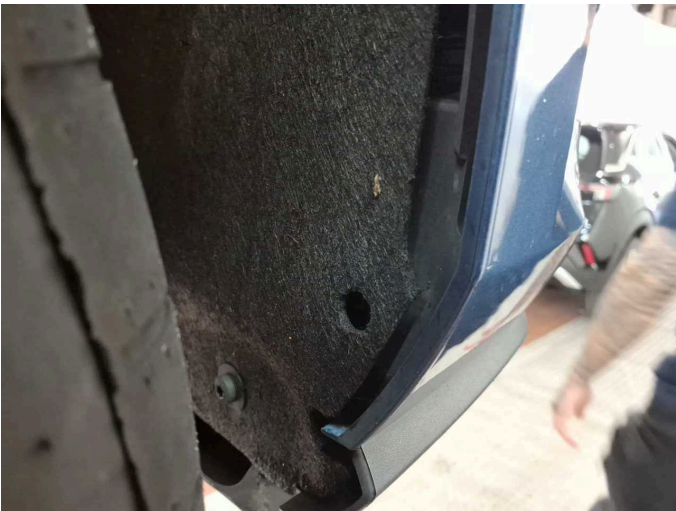
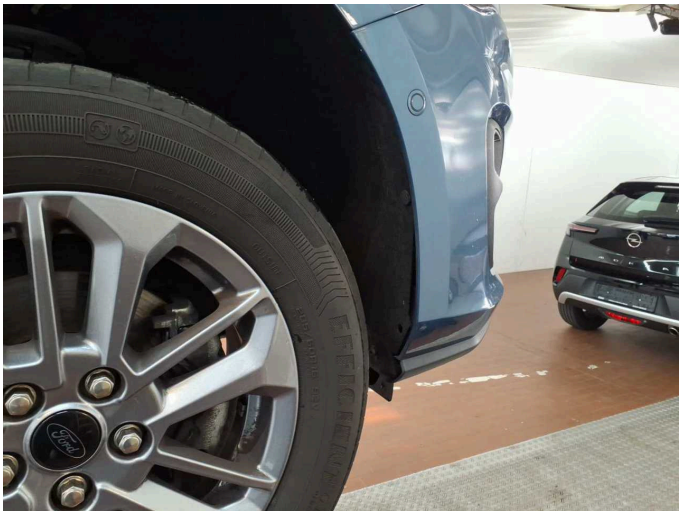
Damage 1: Body: Wheel well - front right side (Klip fehlt) - Missing - Replace

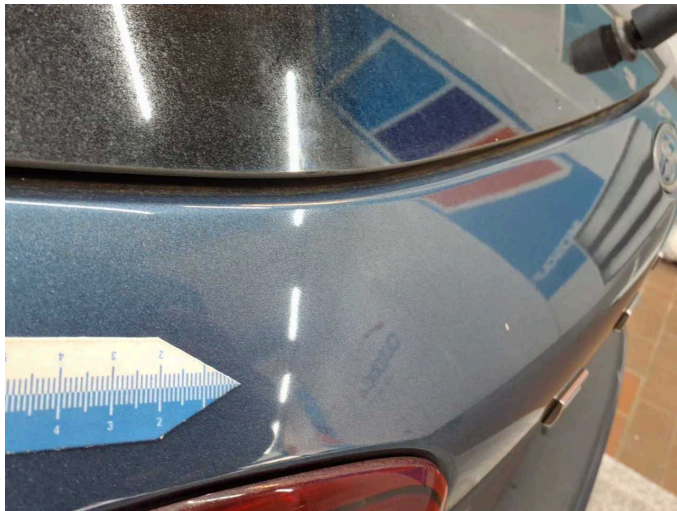
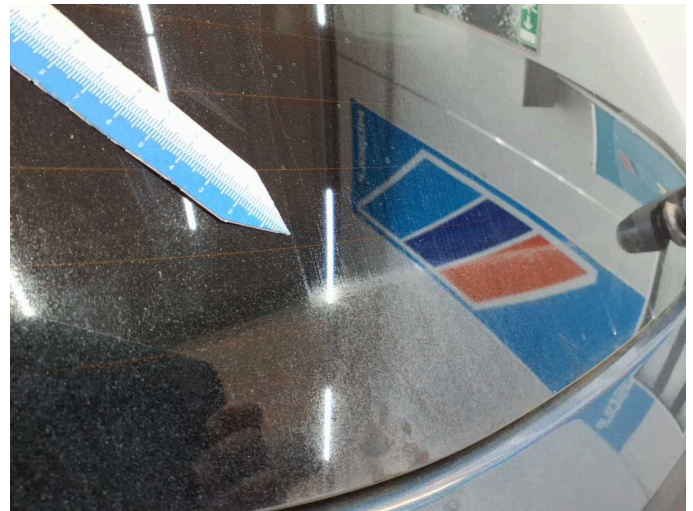
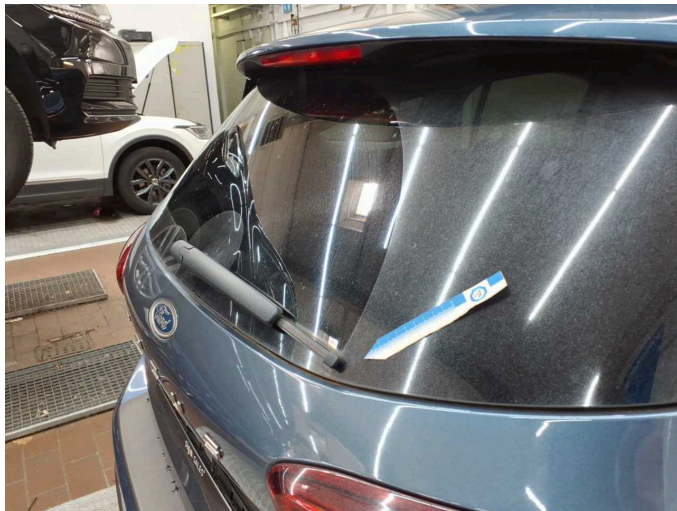
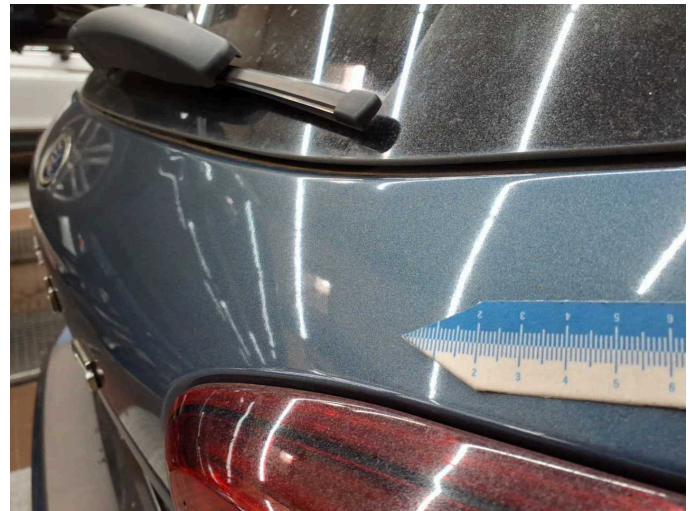
Damage 2: Boot lid / rear door: Boot lid (Anhaftungen, Harz) - Soiled - Conditioning

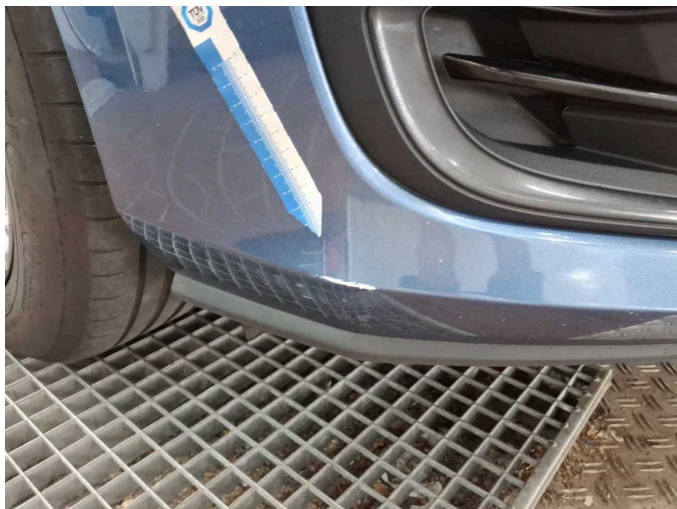
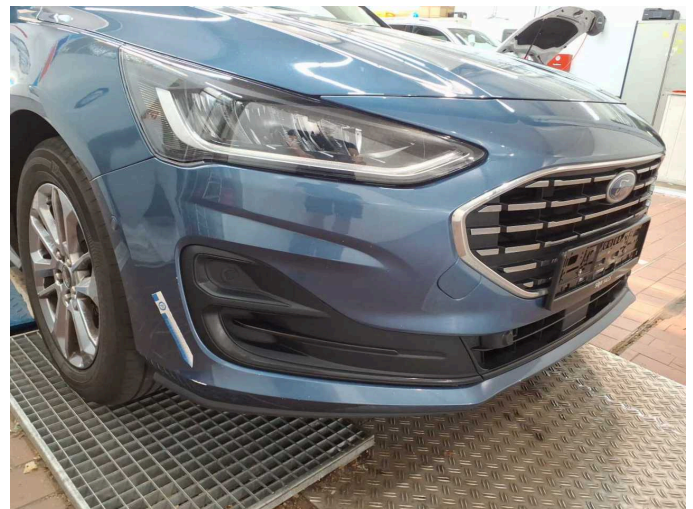
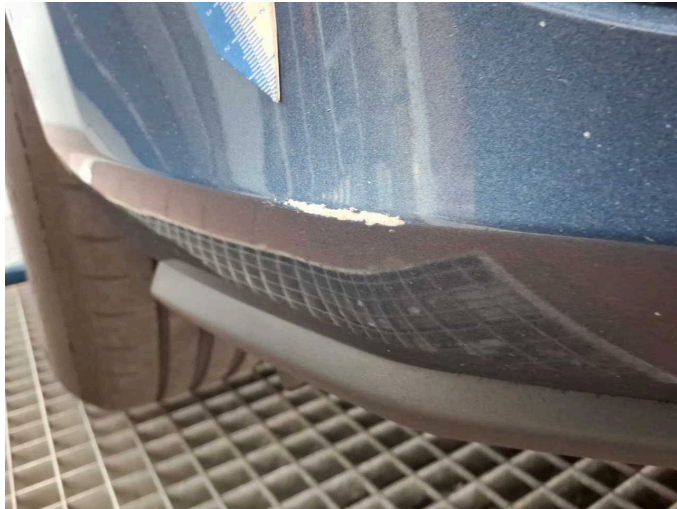
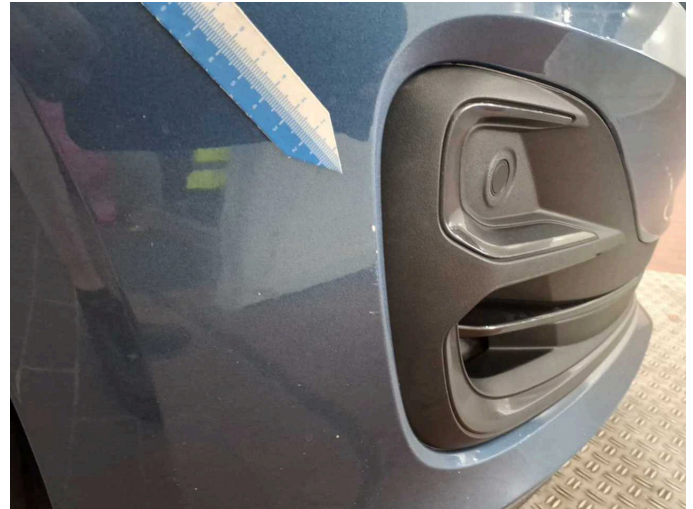
Damage 3: Front bumper: Front bumper - Scratched - Paint

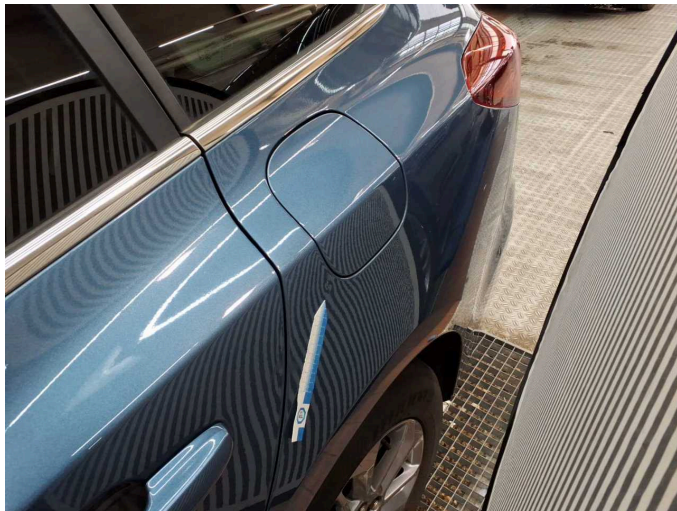
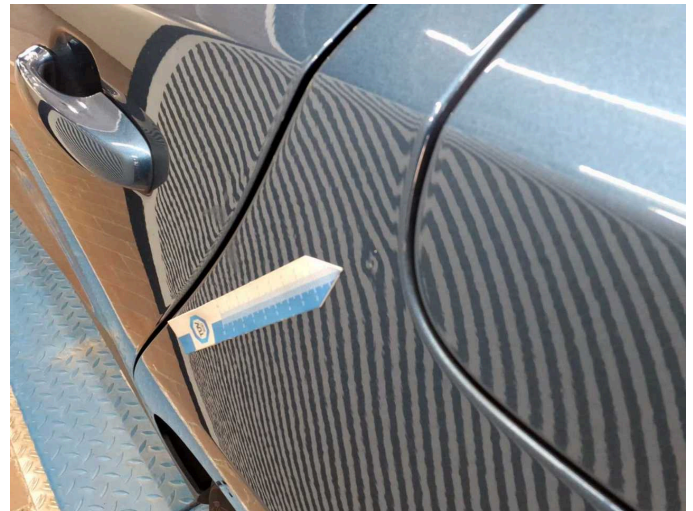
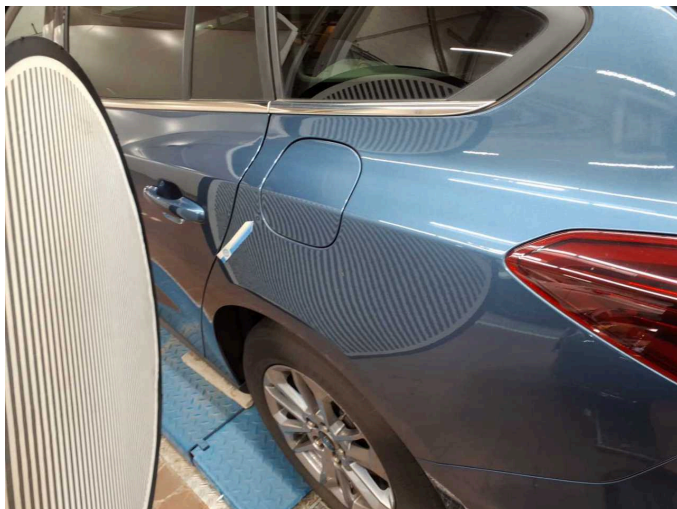
Damage 4: Side panel - rear left side: Side panel - Dent / paintcoat damage - Repair and paint

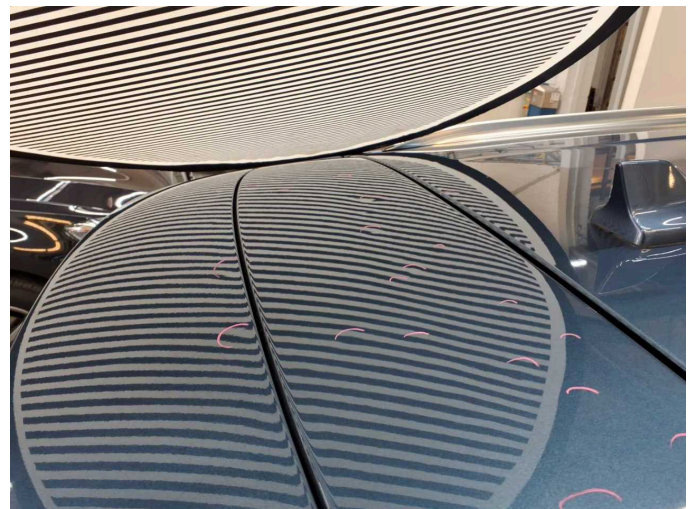
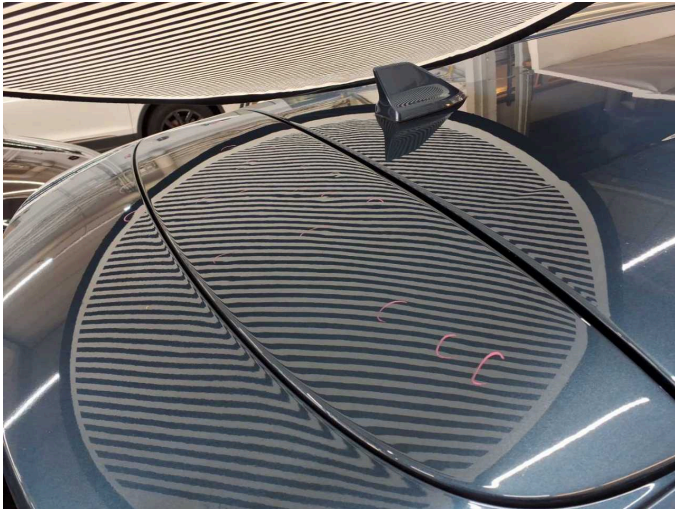
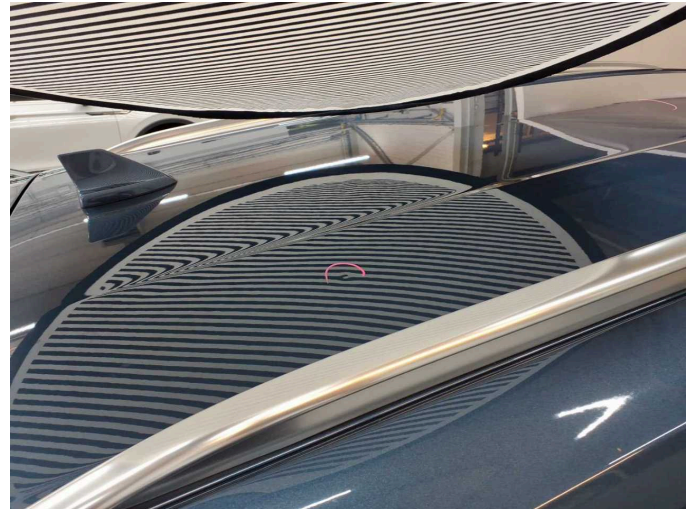
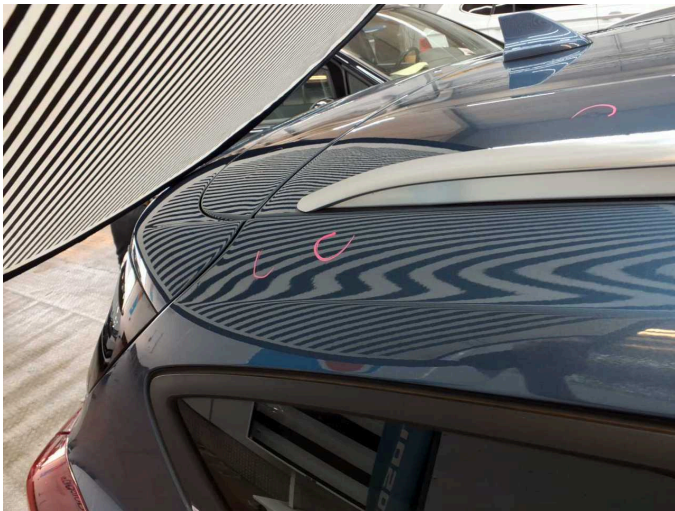
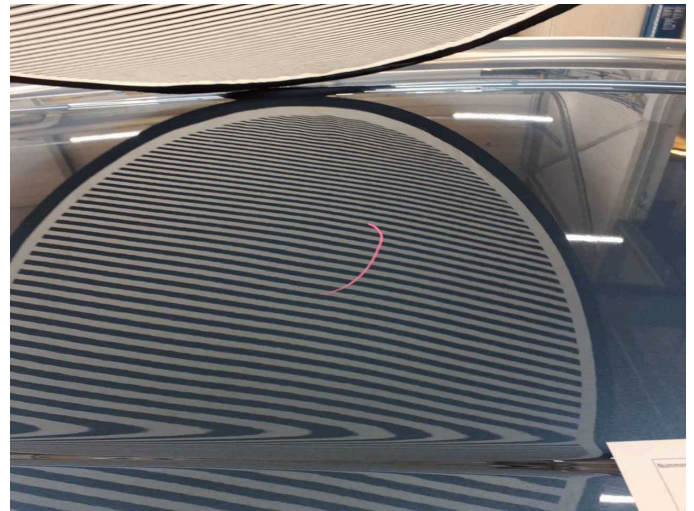
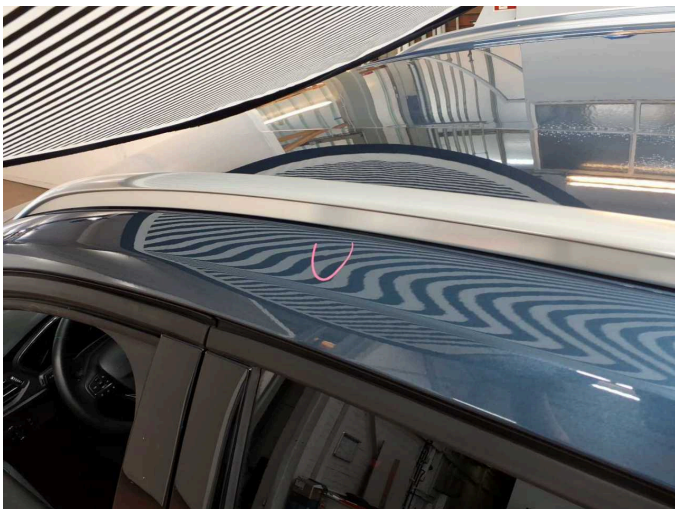
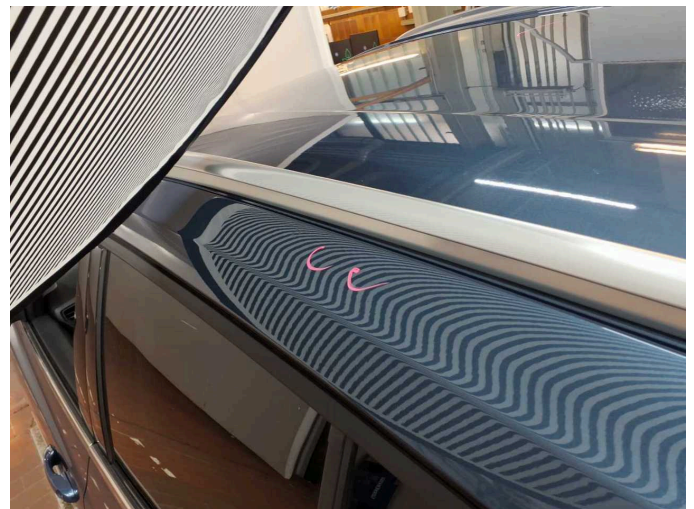
Die beigefügte Reparaturkostenkalkulation wurde nach bestem Wissen und Gewissen im demontagefreien Zustand erstellt. Es können Mehrkosten und somit Abweichung der für den Hagelschaden ausgewiesener Reparaturkosten nicht ausgeschlossen werden.

Damage 5: Body: Body - Damage by hail - repair according to calculation

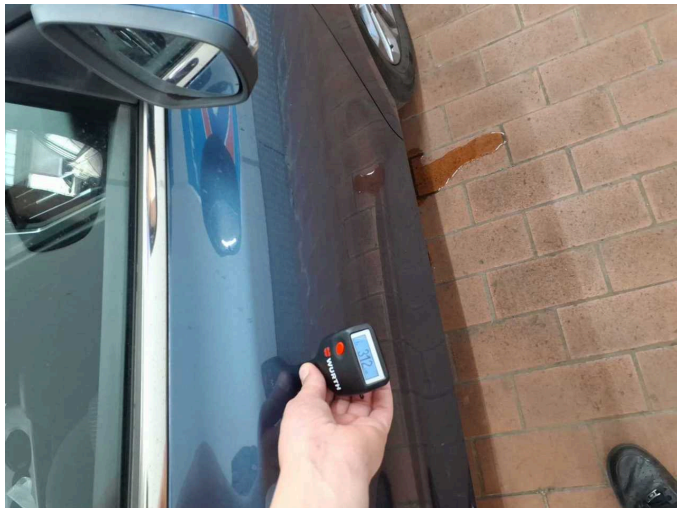
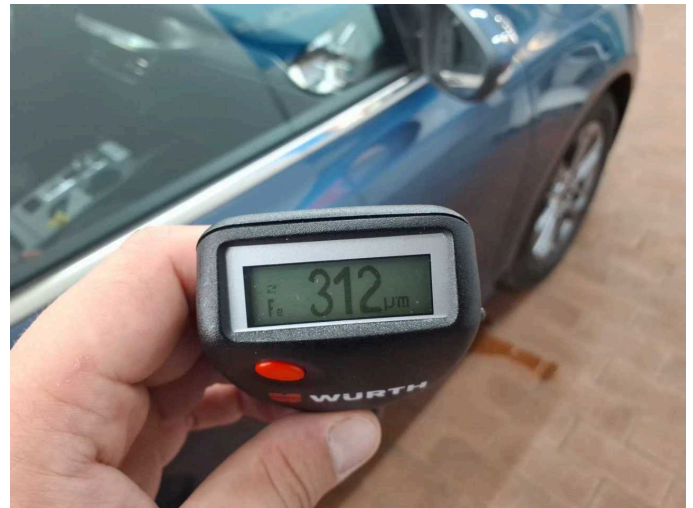
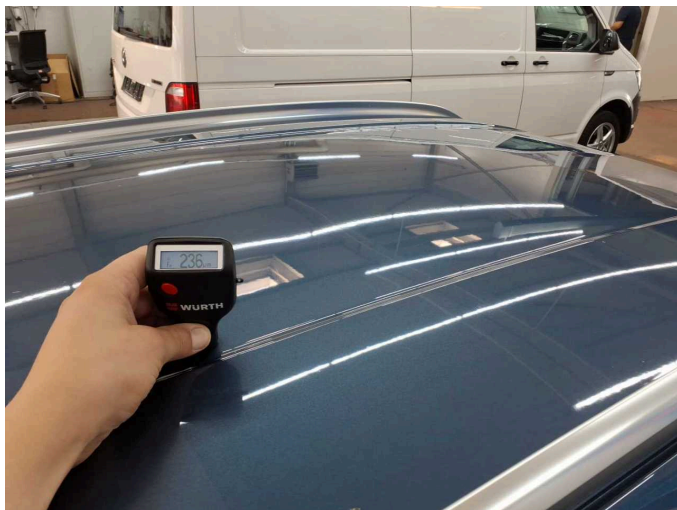
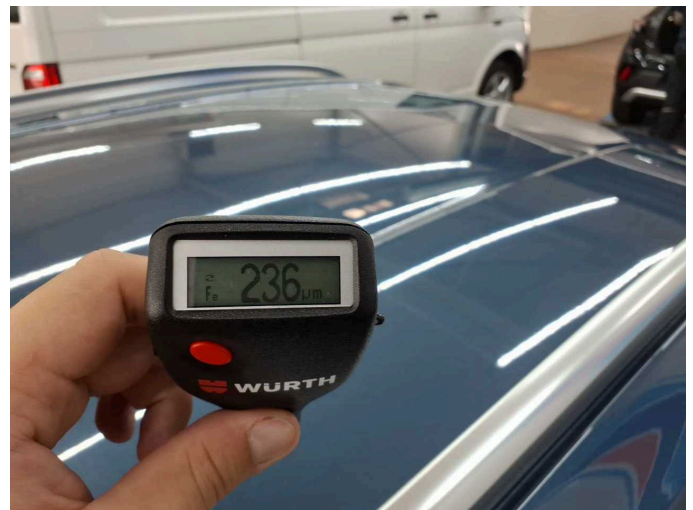
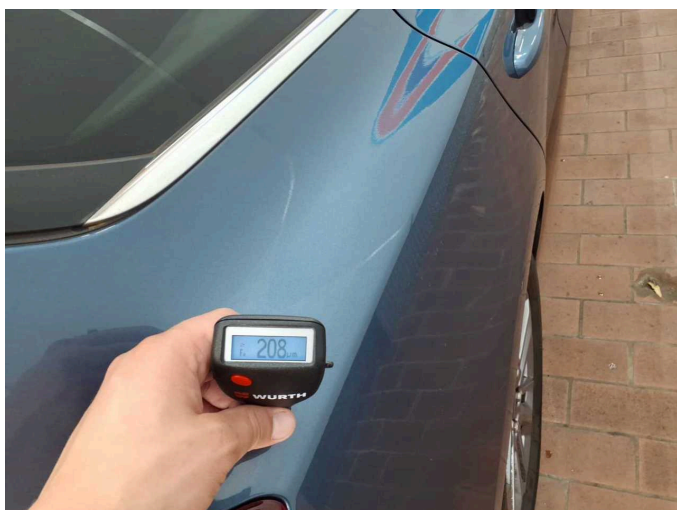
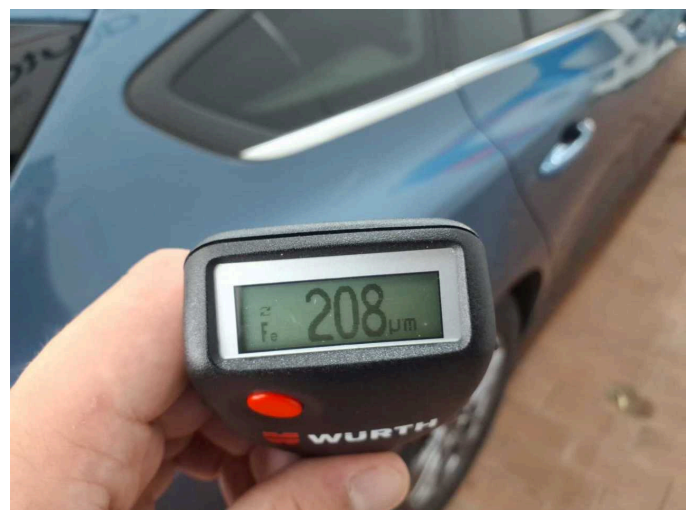
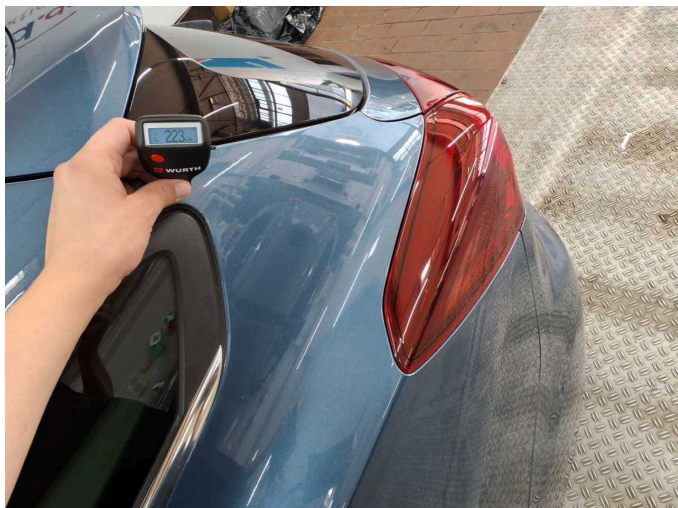
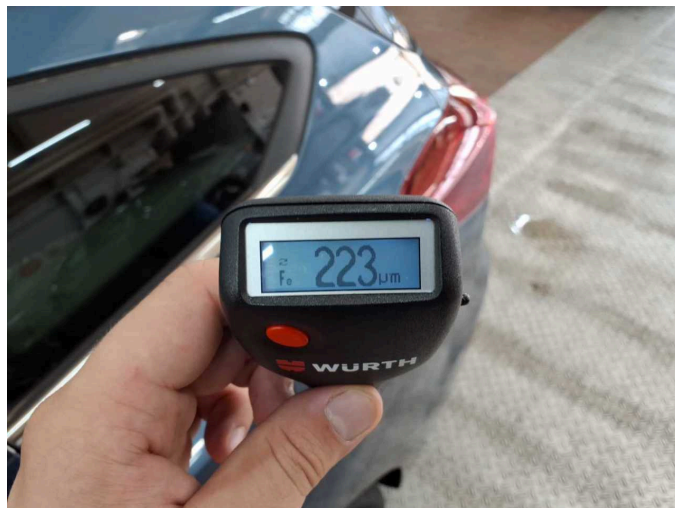
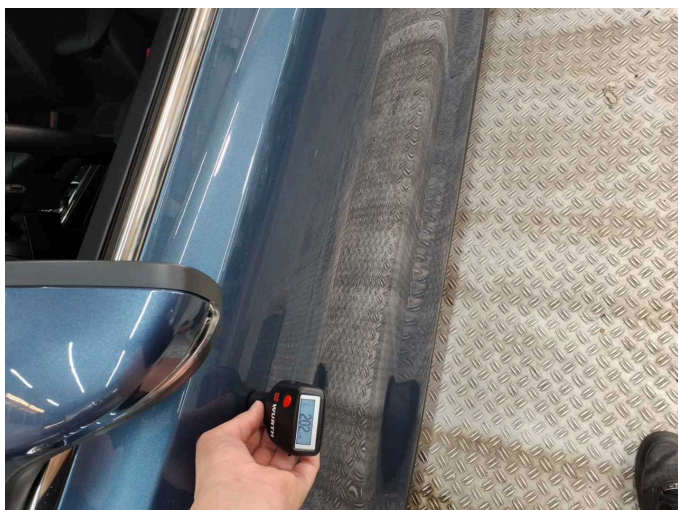
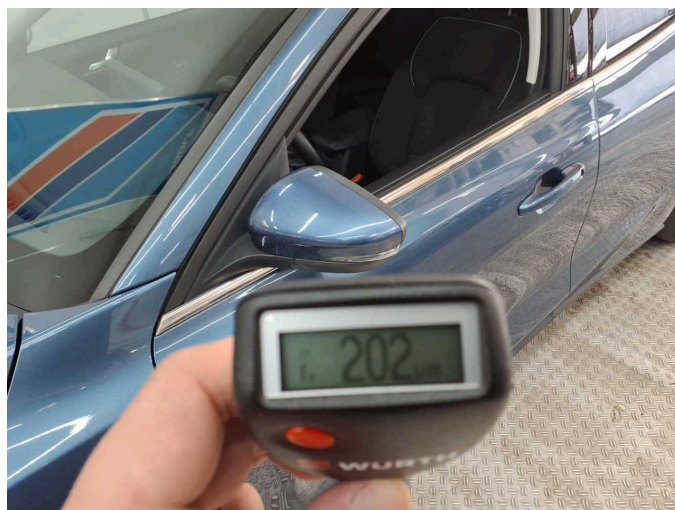
Roof	236 µm	Side panel - rear left side	223 µm
Side panel - rear right side	208 µm	Door - front left side	202 µm
Door - front right side	312 µm

Gesamte Karosserie erhöhte Lackdicke 160-230

Repainting 1: Roof, Side panel - rear left side, Side panel - rear right side, Door - front left side, Door - front right side
