Expertise

Protocol number: 41249780  
Order No. / Reference: 24997112-1  
Inspection date: 13 Aug 2025

Manufacturer: Ford

Model: Focus Turnier 1.5 EcoBlue Start-Stopp-System Aut. TITANIUM

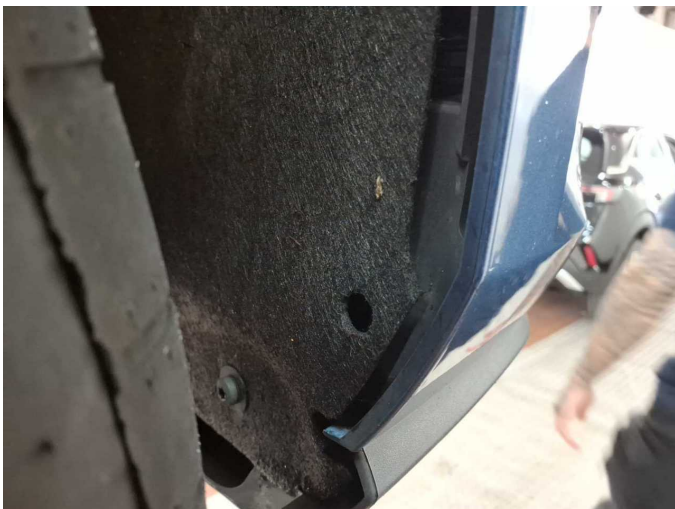
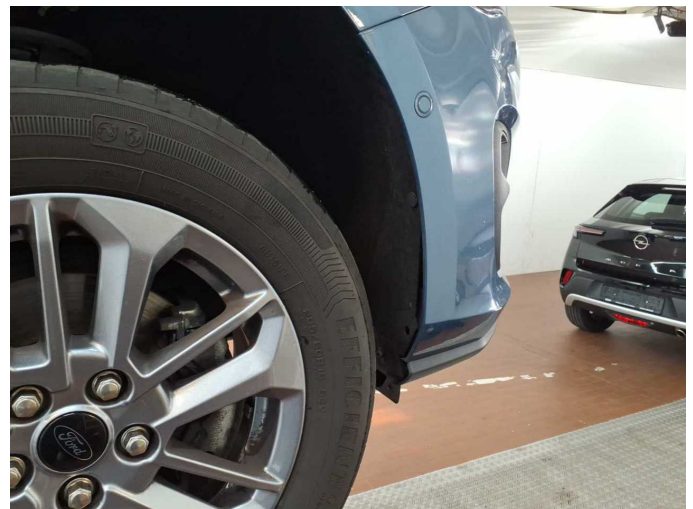
| No. | Component group | Description |
|---|---|---|
| 1 | Body | Wheel well - front right side (Klip fehlt) - Missing - Replace |

**Damage 1:** Body: Wheel well - front right side (Klip fehlt) - Missing - Replace

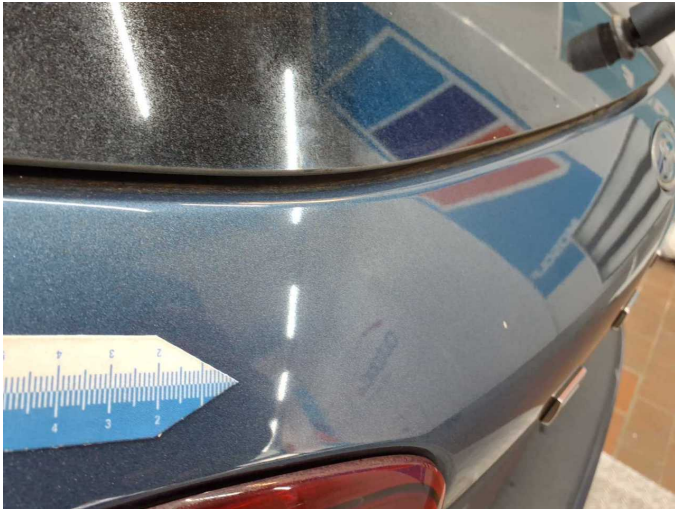
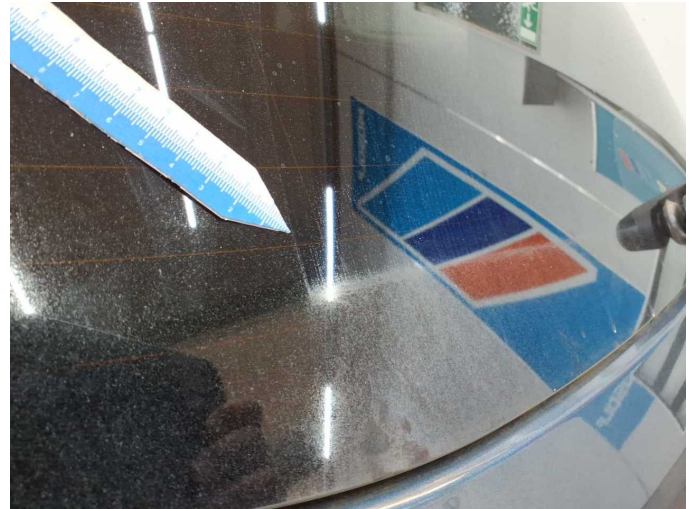
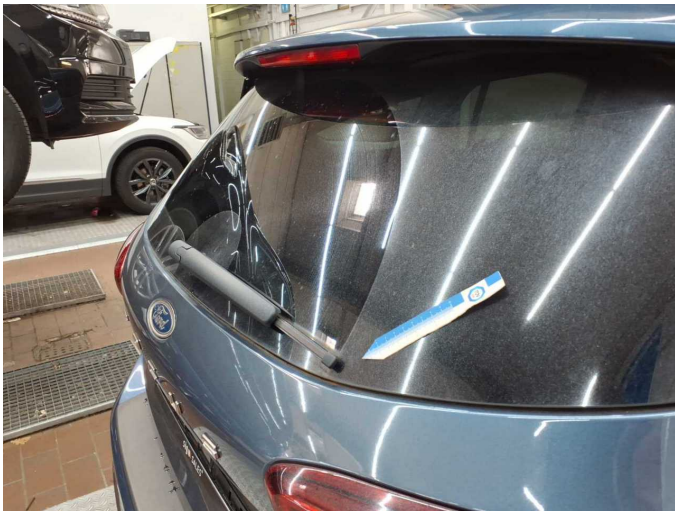
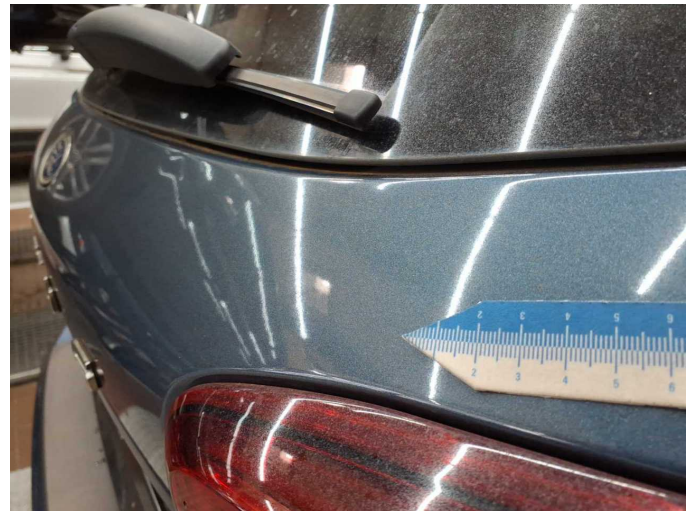
| No. | Component group | Description |
|---|---|---|
| 2 | Boot lid / rear door | Boot lid (Anhaftungen, Harz) - Soiled - Conditioning |

**Damage 2:** Boot lid / rear door: Boot lid (Anhaftungen, Harz) - Soiled - Conditioning

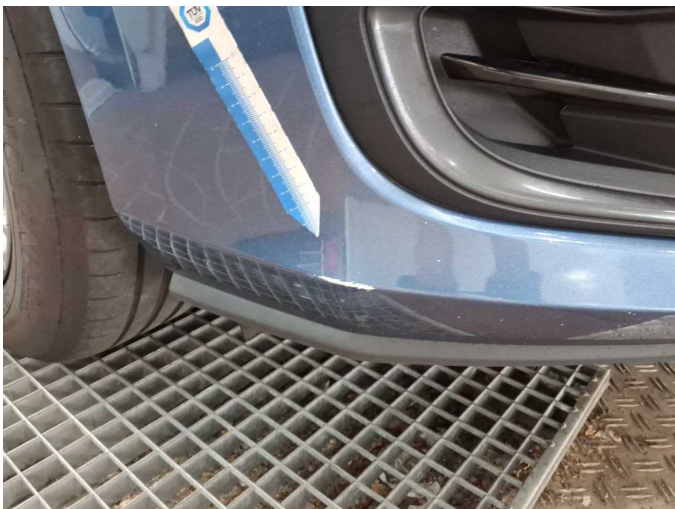
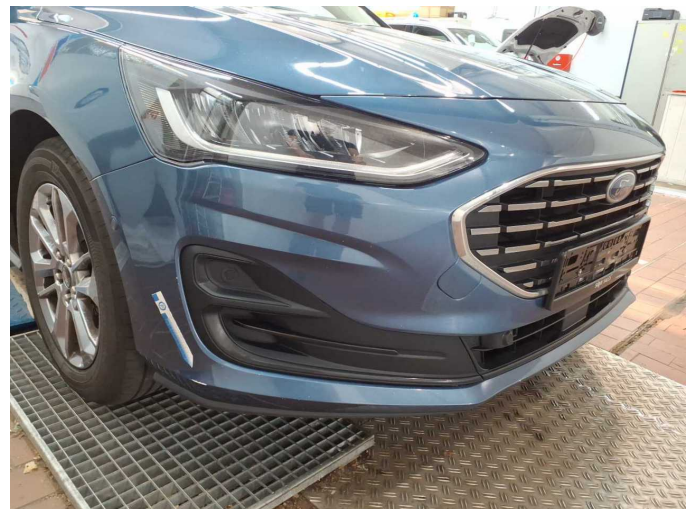
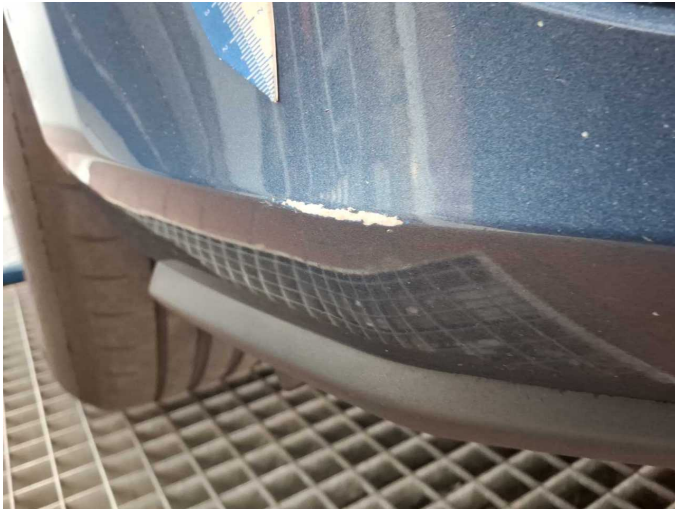
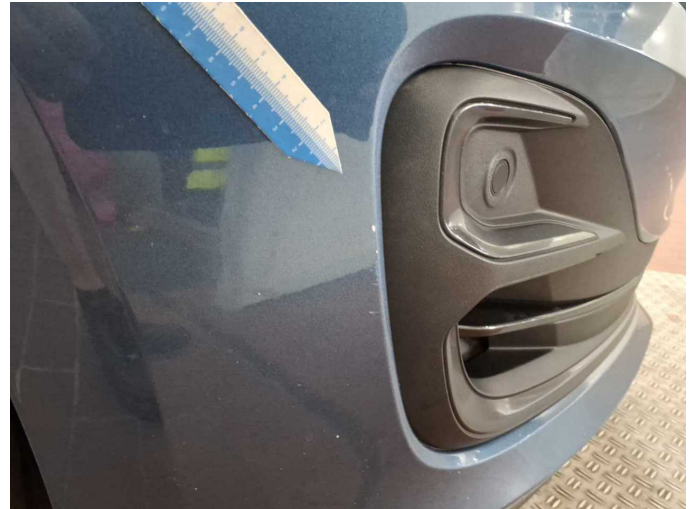
| No. | Component group | Description |
|---|---|---|
| 3 | Front bumper | Front bumper - Scratched - Paint |

**Damage 3:** Front bumper: Front bumper - Scratched - Paint

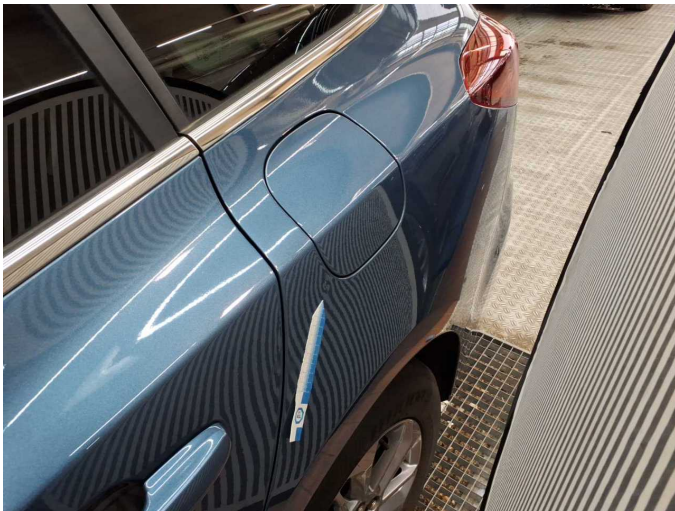
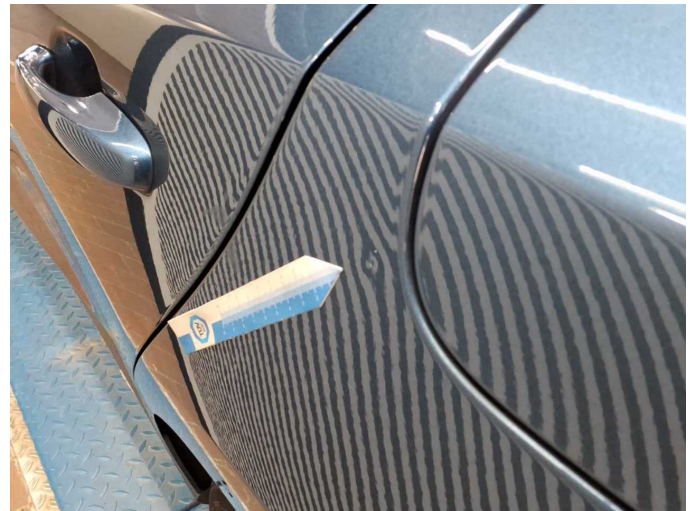
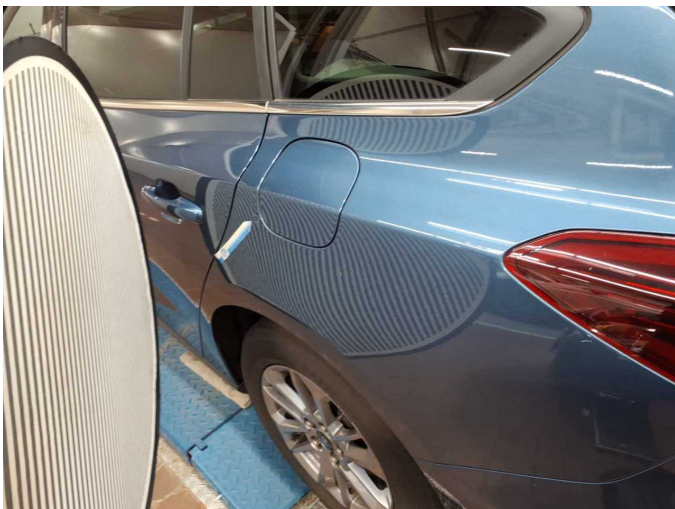
| No. | Component group | Description |
|---|---|---|
| 4 | Side panel - rear left side | Side panel - Dent / paintcoat damage - Repair and paint |

**Damage 4:** Side panel - rear left side: Side panel - Dent / paintcoat damage - Repair and paint

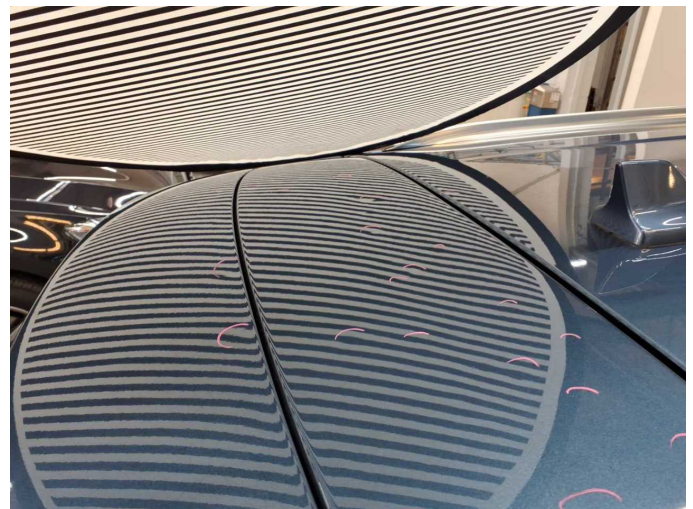
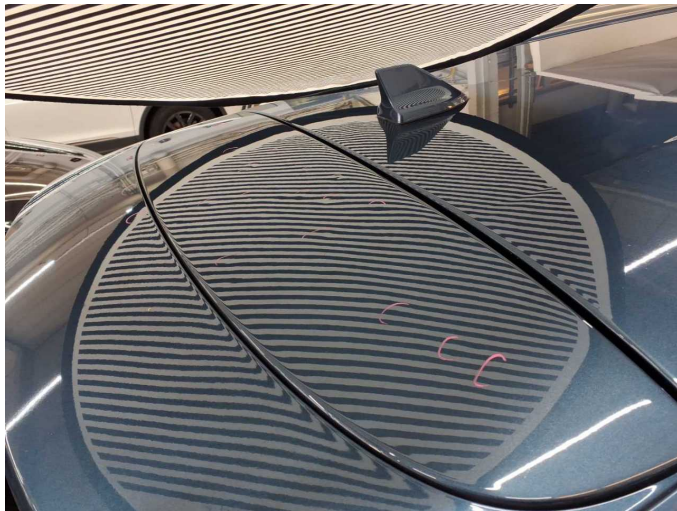
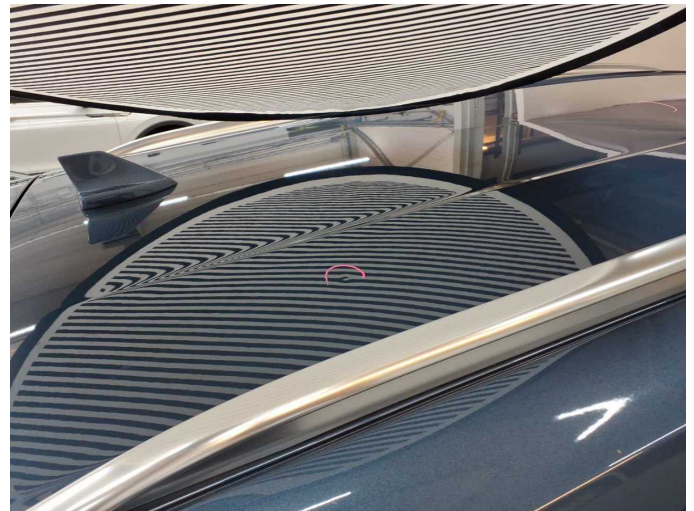
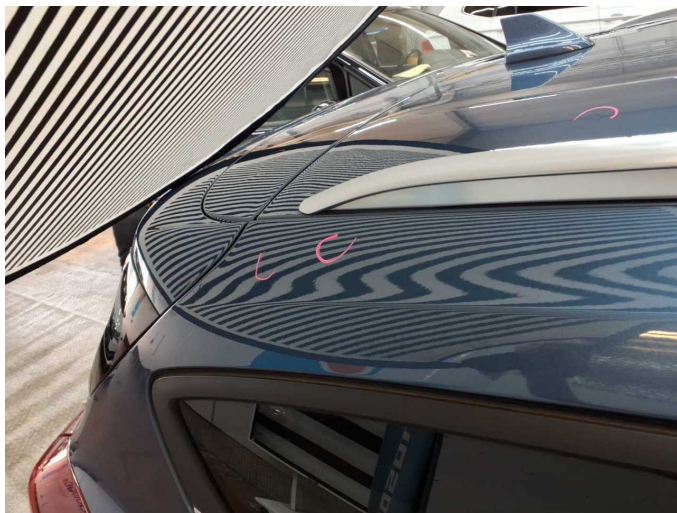
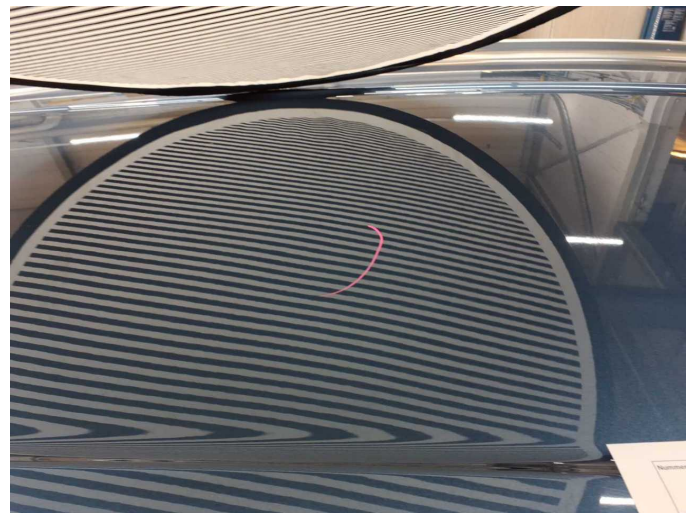
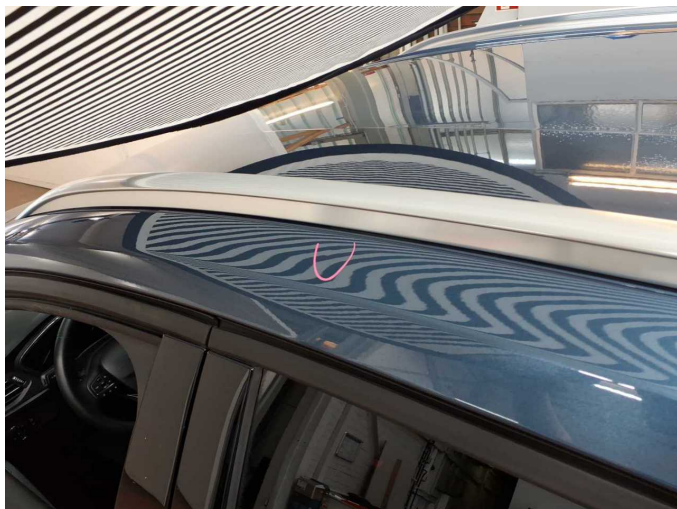
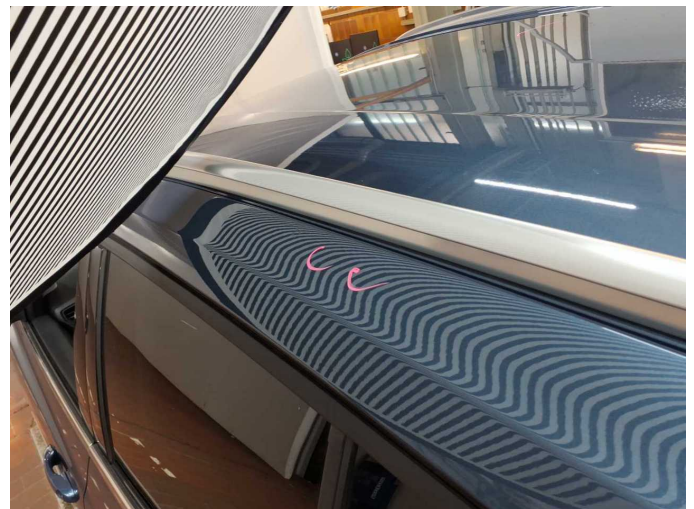
| No. | Component group | Description |
|---|---|---|
| 5 | Body | Body - Damage by hail - repair according to calculation |

Die beigefügte Reparaturkostenkalkulation wurde nach bestem Wissen und Gewissen im demontagefreien Zustand erstellt. Es können Mehrkosten und somit Abweichung der für den Hagelschaden ausgewiesener Reparaturkosten nicht ausgeschlossen werden.

**Damage 5:** Body: Body - Damage by hail - repair according to calculation

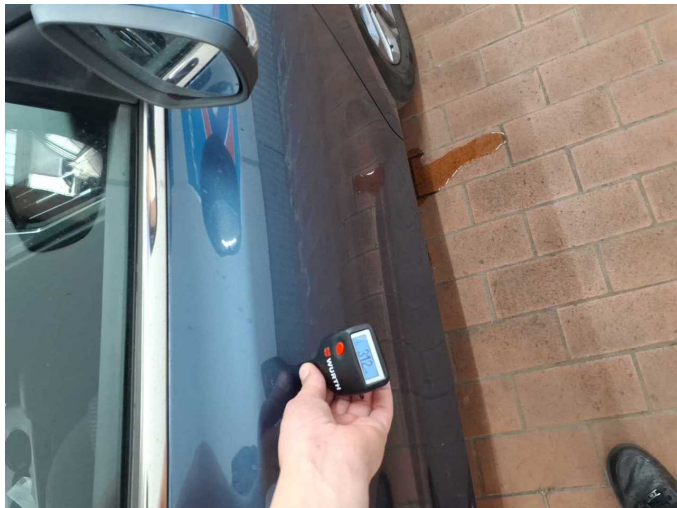
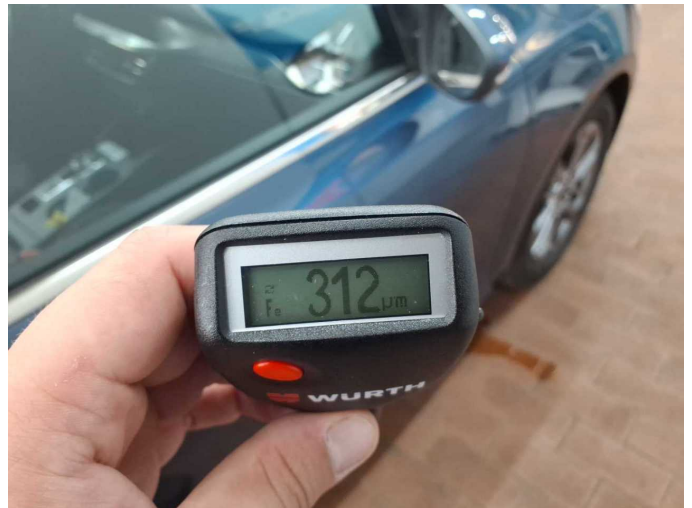
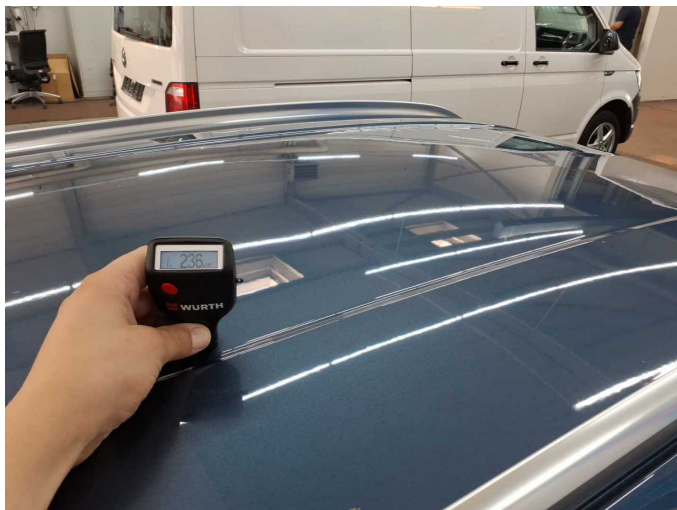
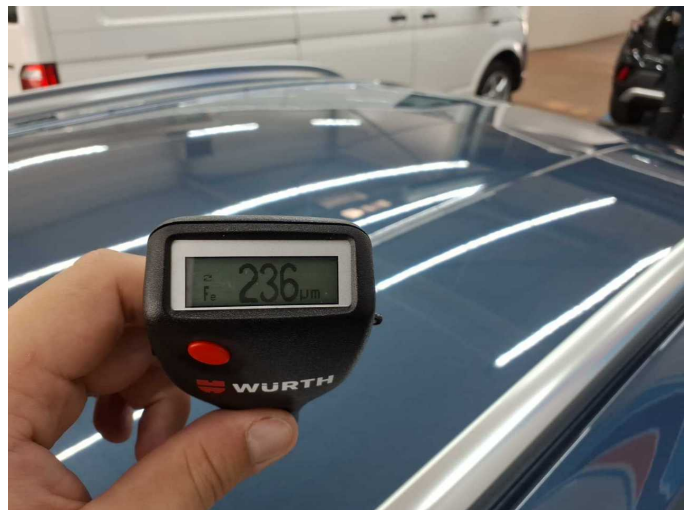
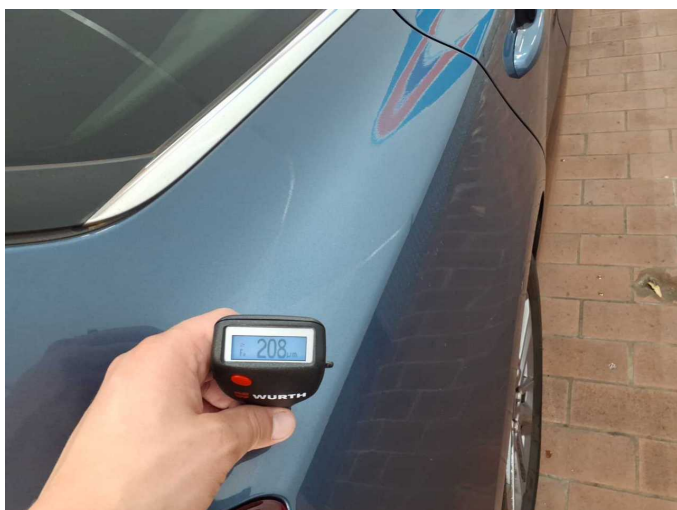
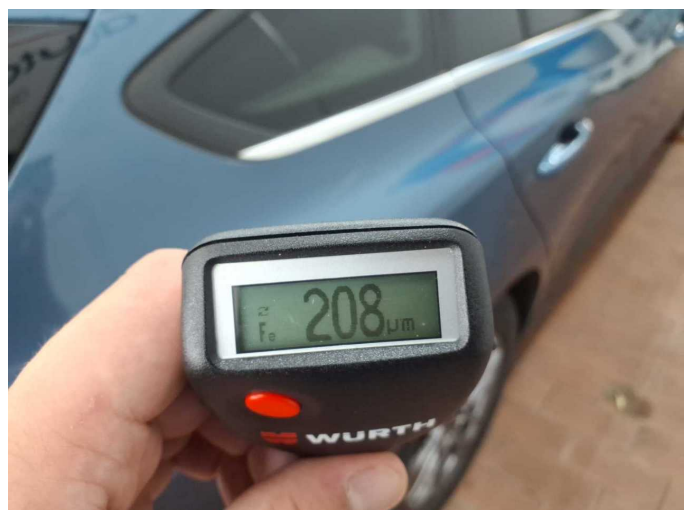
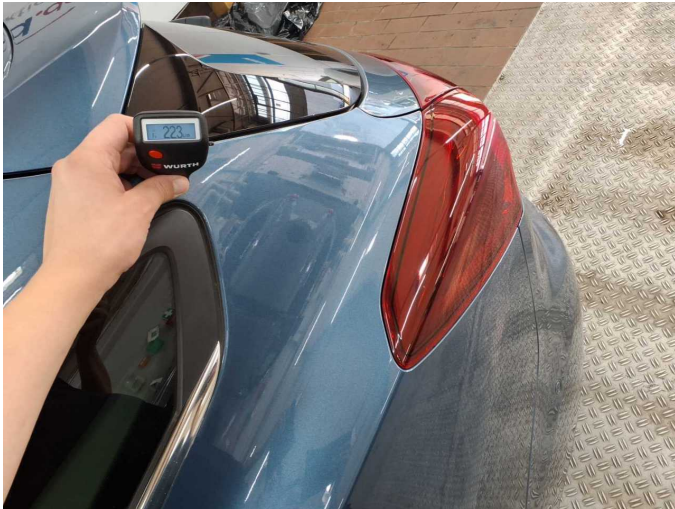
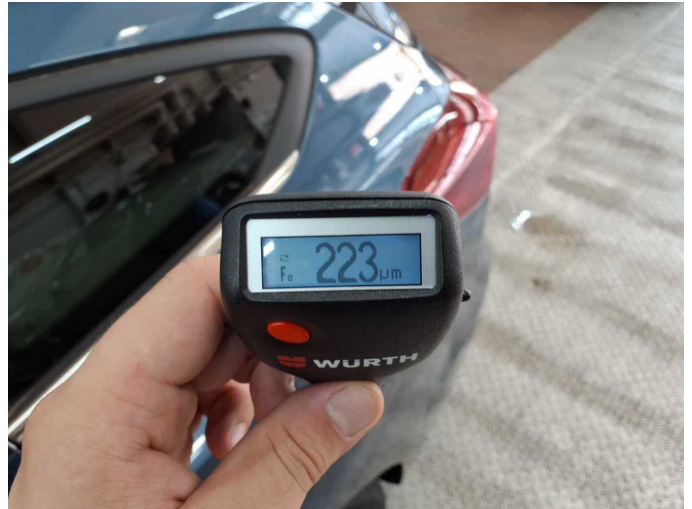
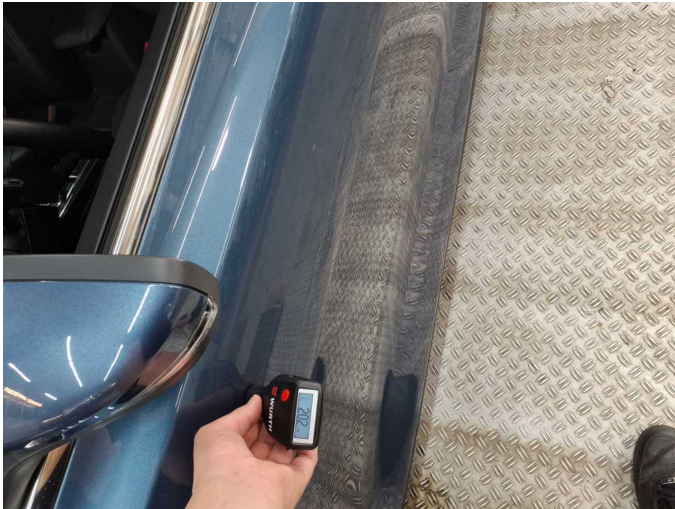
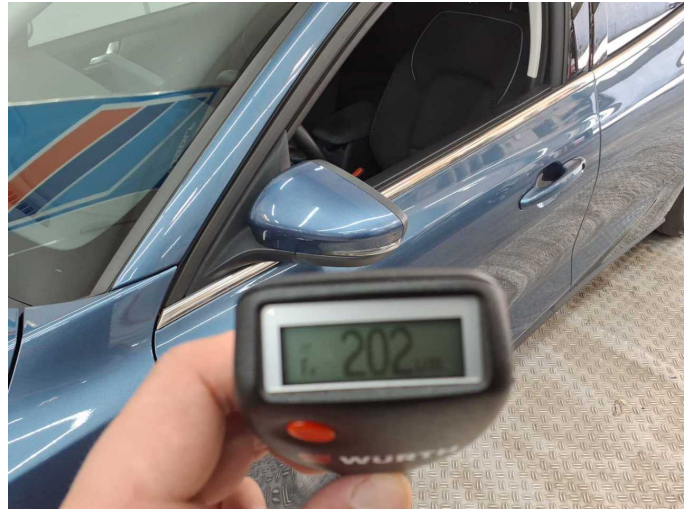
| No. | Repainting |
|---|---|
| 1 | Roof, Side panel - rear left side, Side panel - rear right side, Door - front left side, Door - front right side, Professionally carried out, Invoice of repair done Non-existent |

| Roof | 236 µm | Side panel - rear left side | 223 µm |
| Side panel - rear right side | 208 µm | Door - front left side | 202 µm |
| Door - front right side | 312 µm | | |

Gesamte Karosserie erhöhte Lackdicke 160-230

**Repainting 1:** Roof, Side panel - rear left side, Side panel - rear right side, Door - front left side, Door - front right side
