Expertise

Protocol number: 41201578
Order No. / Reference: 25080866
Inspection date: 26 Aug 2025

| Manufacturer: Ford | Model: Focus Turnier 1.5 EcoBlue Start-Stopp-System Aut. TITANIUM |
| VIN: WF0PXXGCHPPL02560 | |

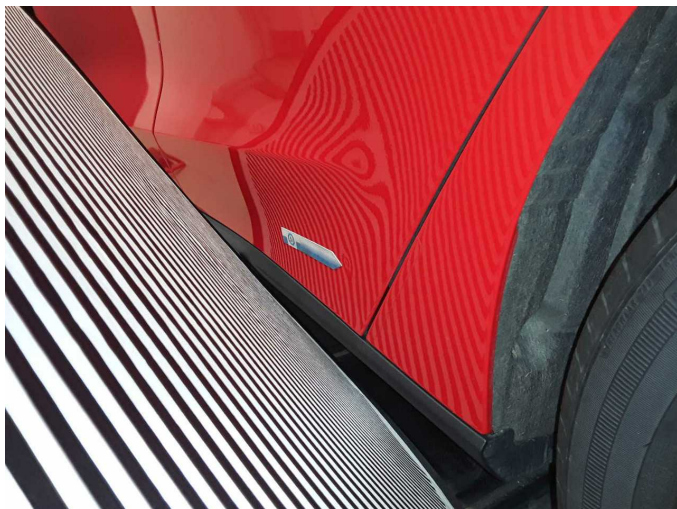
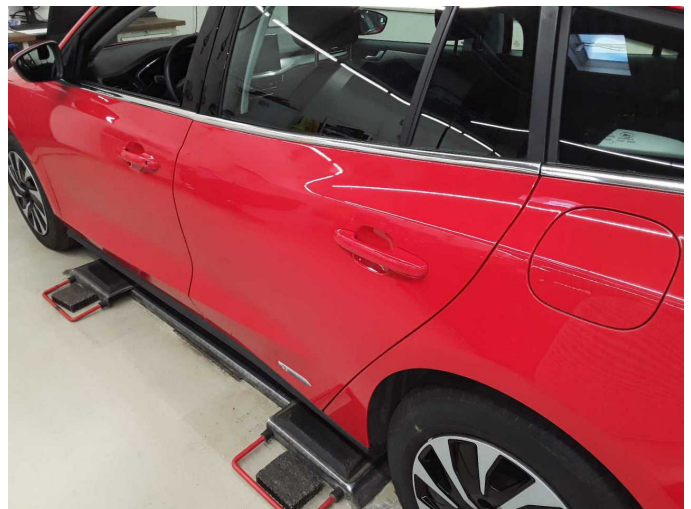
| No. | Component group | Description |
|---|---|---|
| 2 | Door - rear left side | Door - dent(s) - Smooth repair work |

Damage 2: Door - rear left side: Door - dent(s) - Smooth repair work

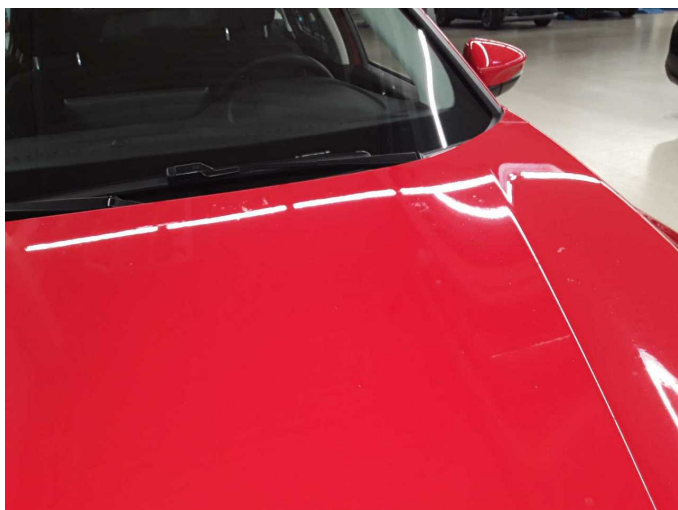
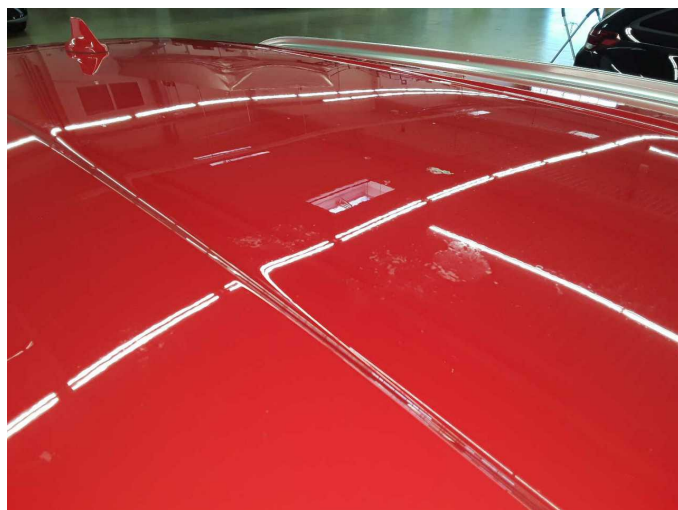
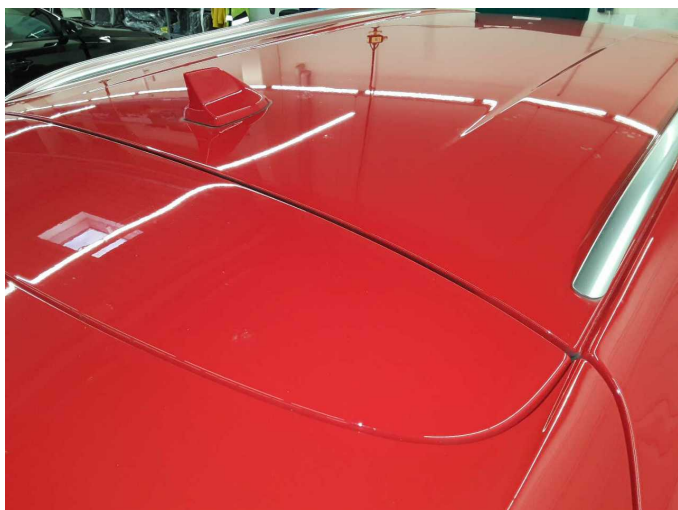
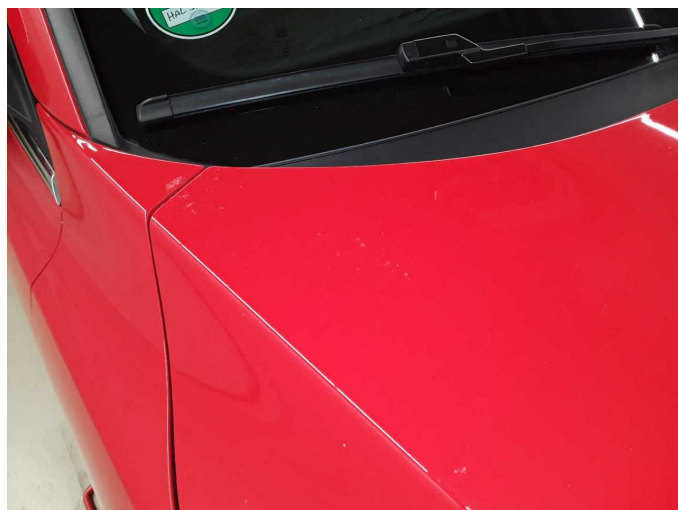
| No. | Component group | Description |
|---|---|---|
| 5 | Body | Body (Verschmutzt und) - Scratch(es) - No deduction |

Wear and tear 5: Body: Body (Verschmutzt und) - Scratch(es) - No deduction

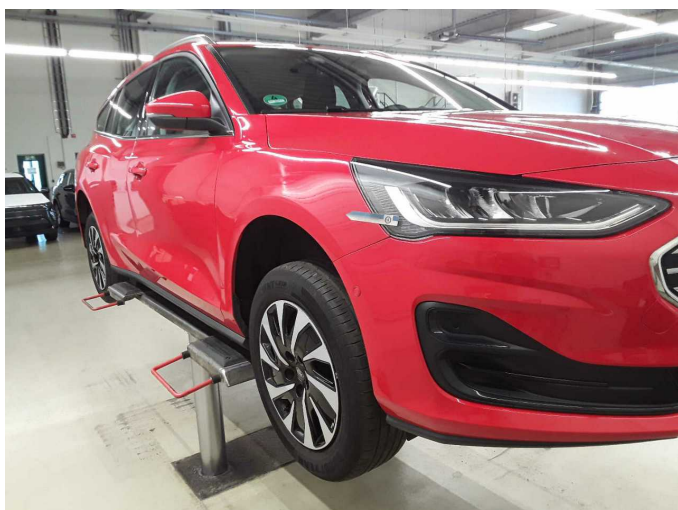
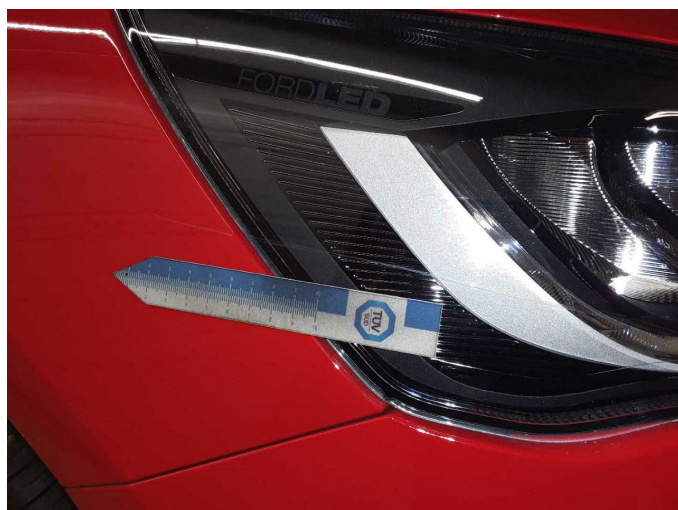
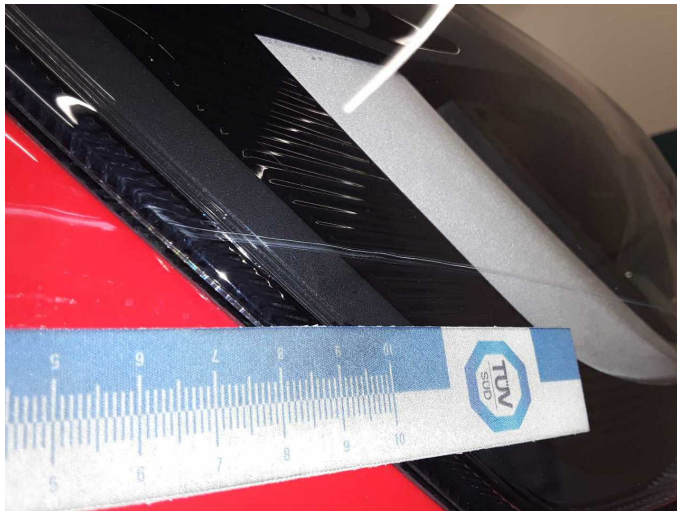
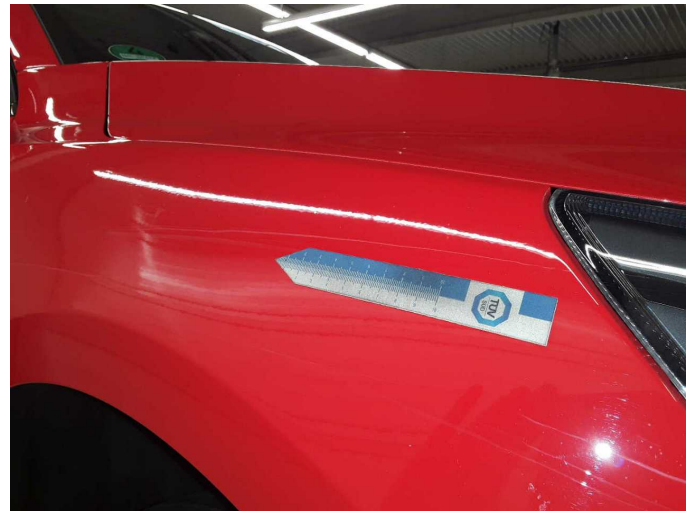
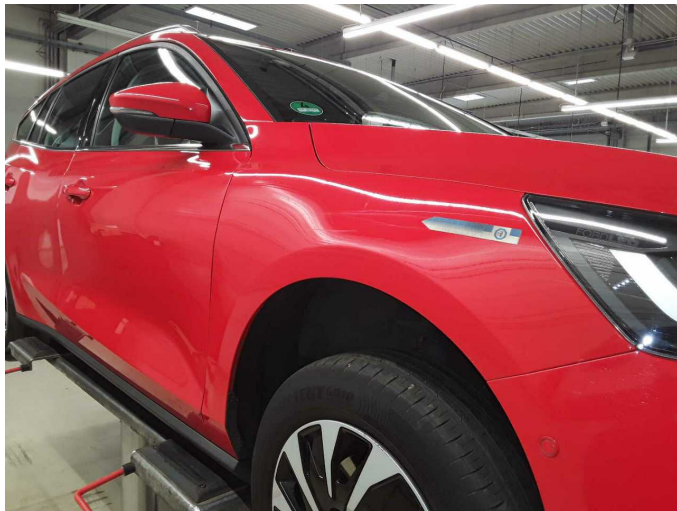
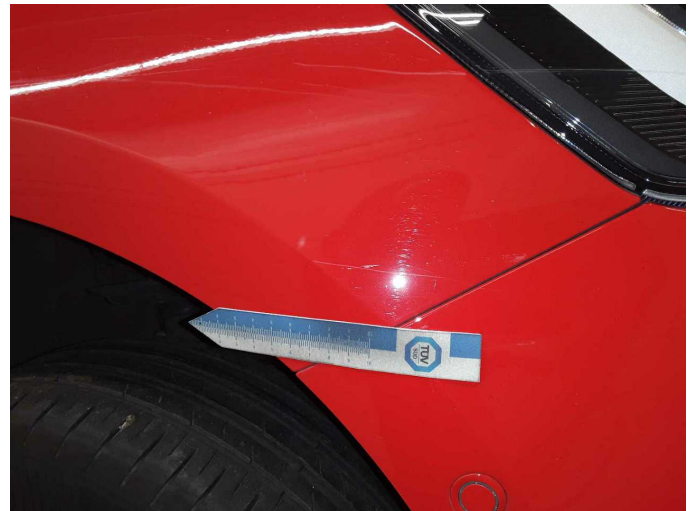
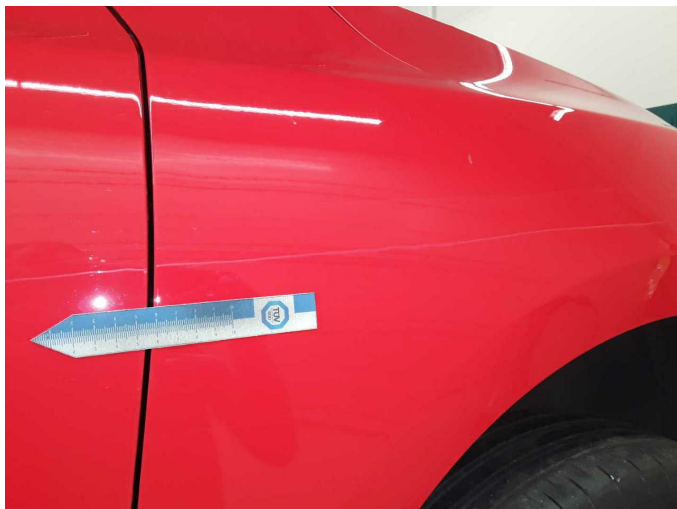
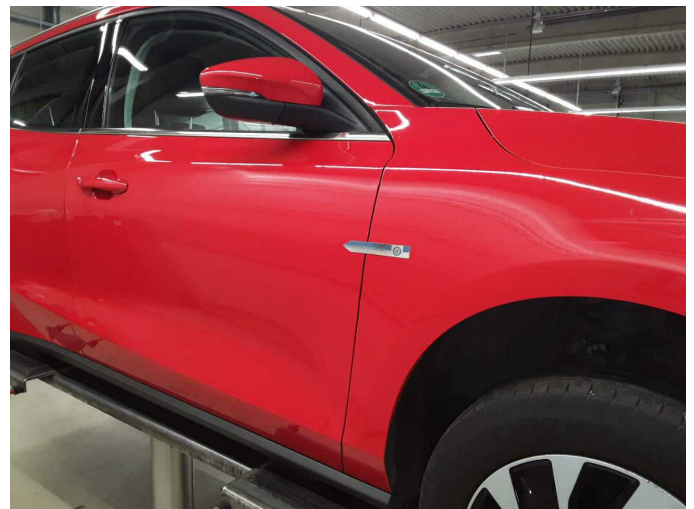
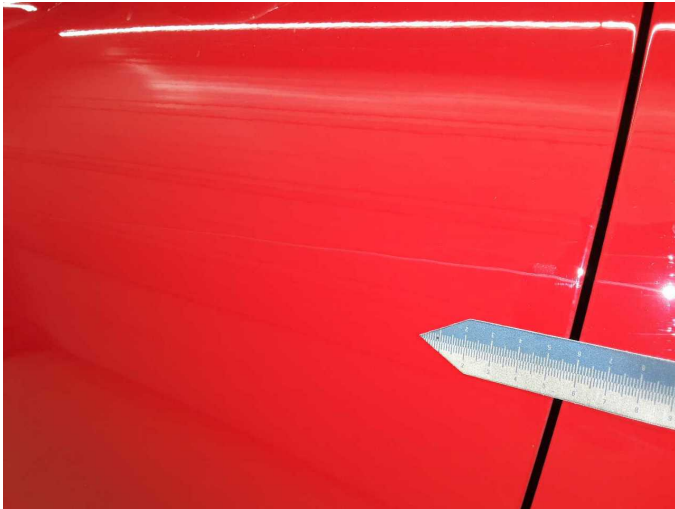
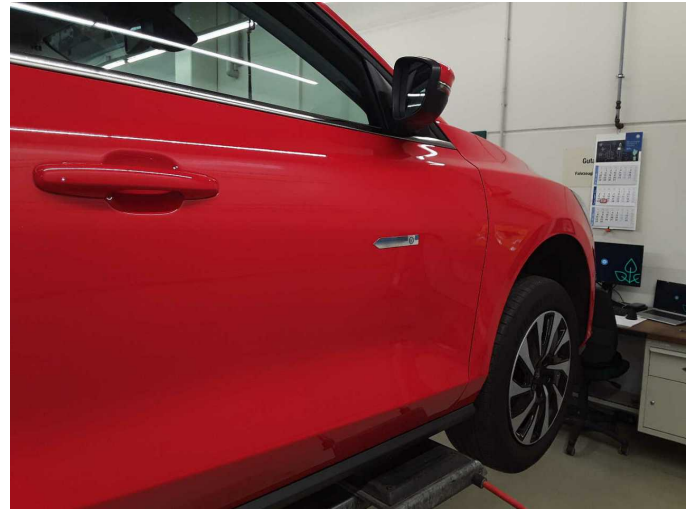
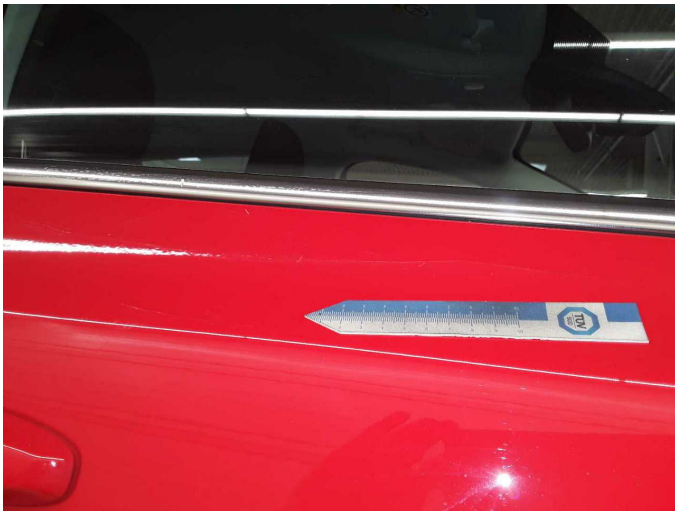
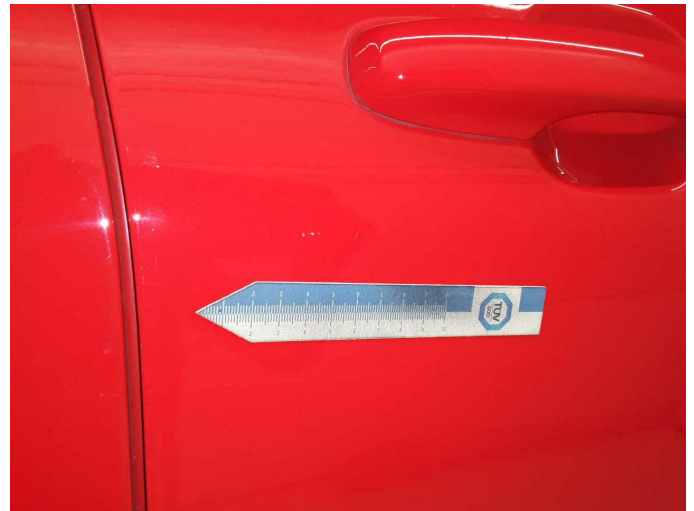
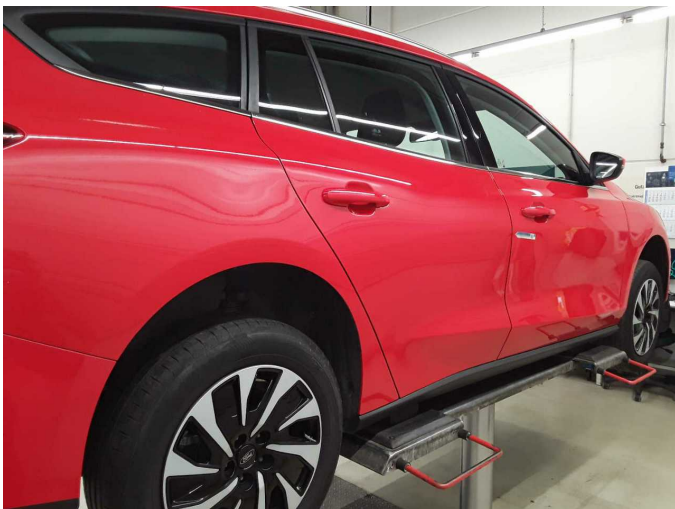
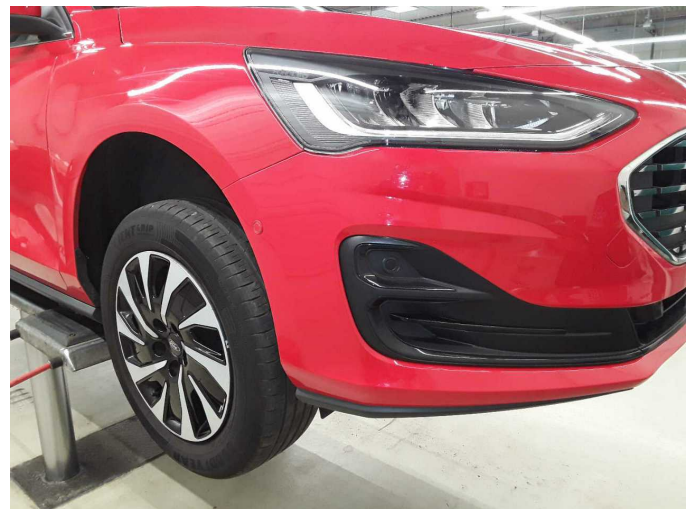
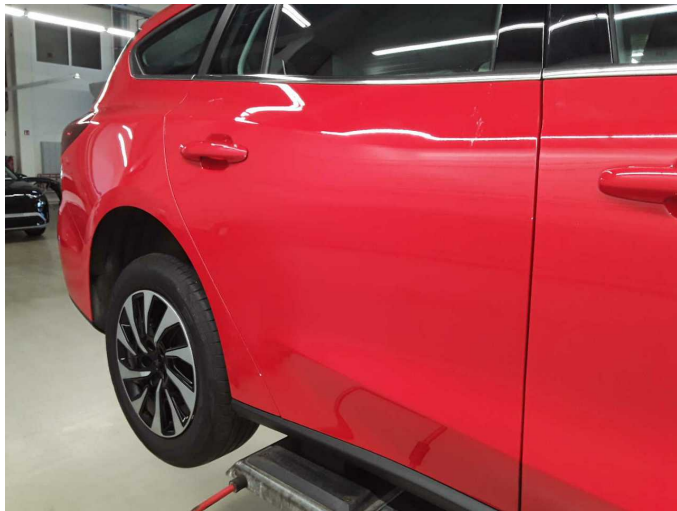
| No. | Accident |
|---|---|
| 1 | Side right |

Non-repaired previous damages were found at the vehicle. The necessary repair costs are listed in the expert report or if necessary, are listed in detail in a separately enclosed repair cost calculation.

Accident 1: Side right

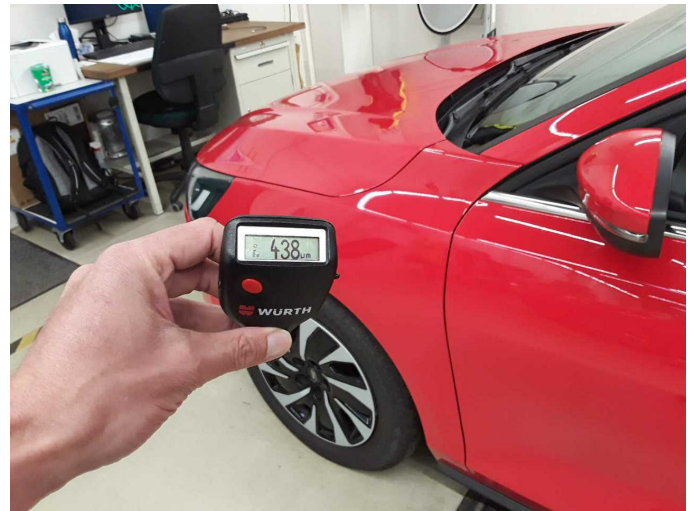
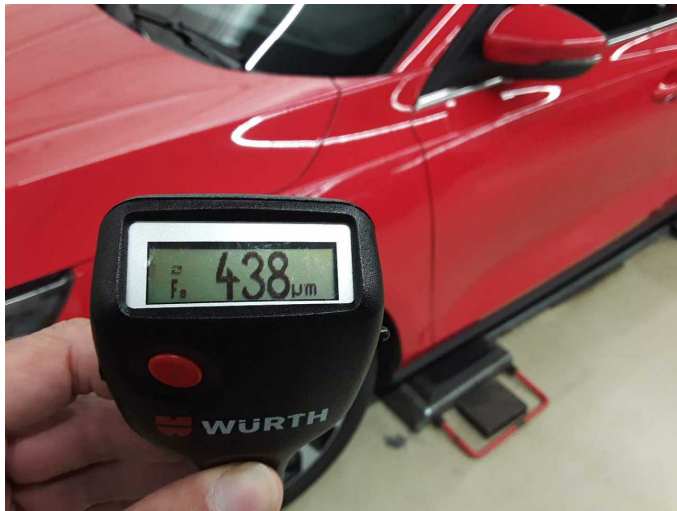
| No. | Repainting |
|---|---|
| 1 | Mudguard - left side, Door - rear left side, Door - rear right side, Door - front left side, Professionally carried out |

Mudguard - left side: 438 µm

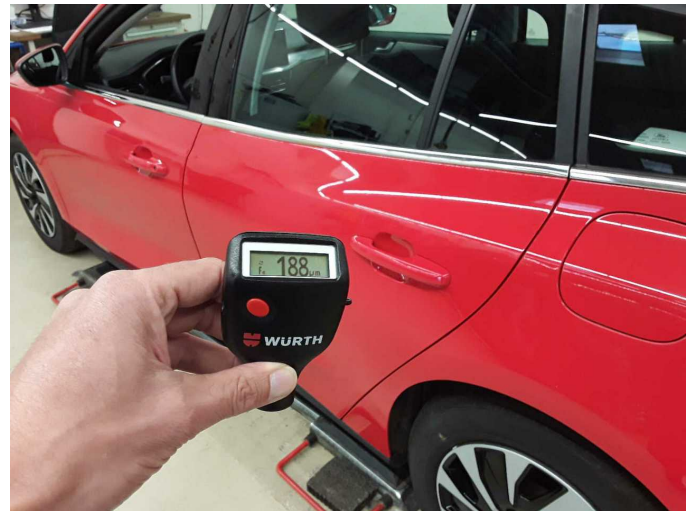
Door - rear left side: 188 µm

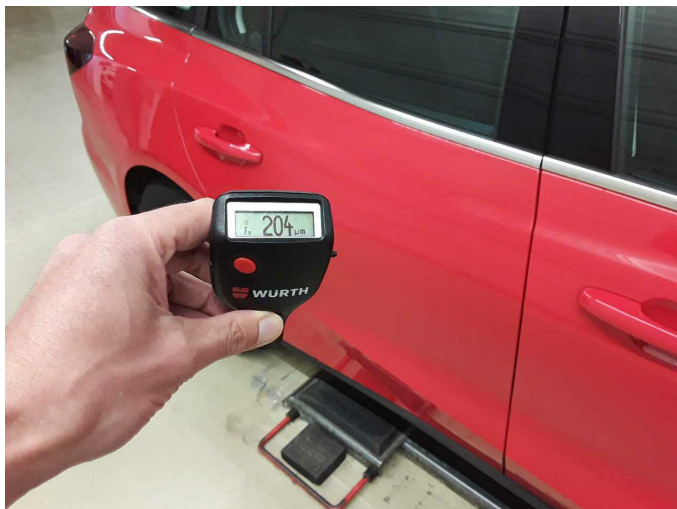
Door - rear right side: 204 µm

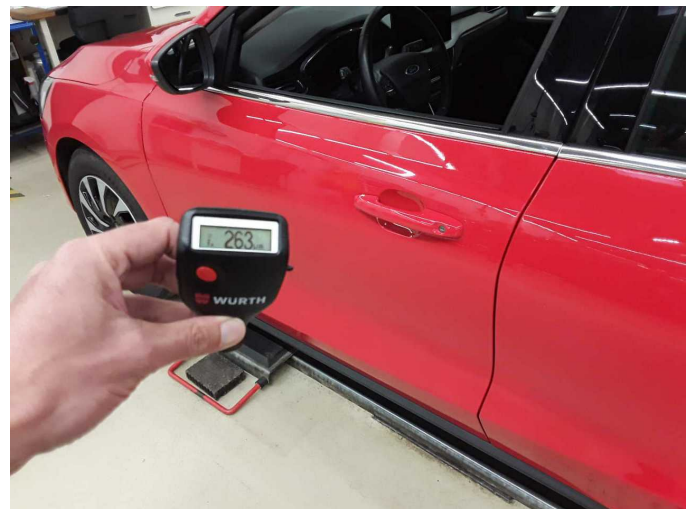
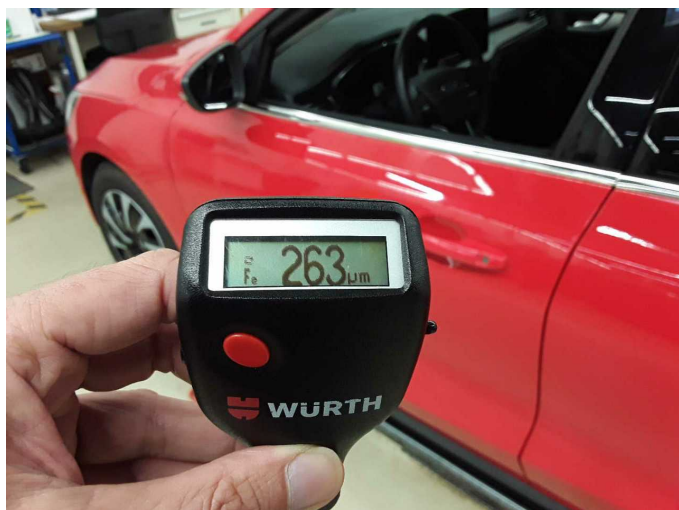
Door - front left side: 263 µm
