Expertise

Protocol number: 41479737
Order No. / Reference: 25096794
Inspection date: 11 Sept 2025

Manufacturer: Ford	Model: Focus Turnier 1.5 EcoBlue Start-Stopp-System Aut. TITANIUM
VIN: WF0PXXGCHPPL85797

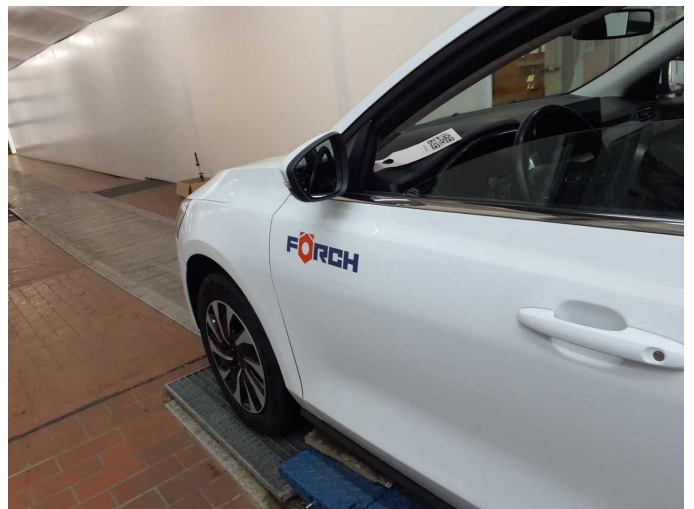
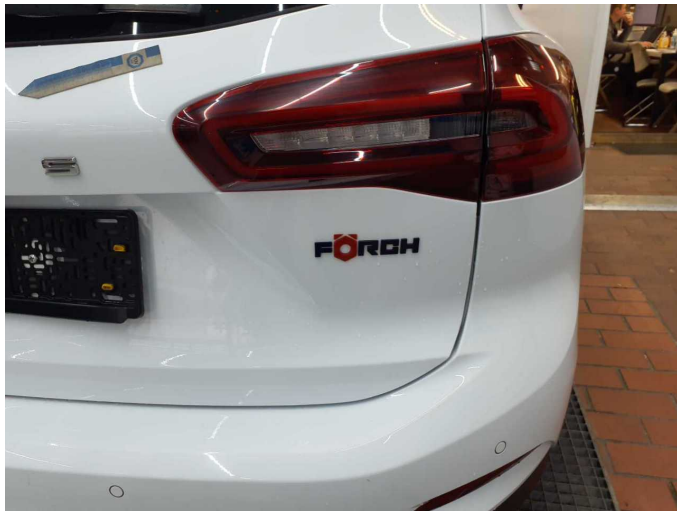
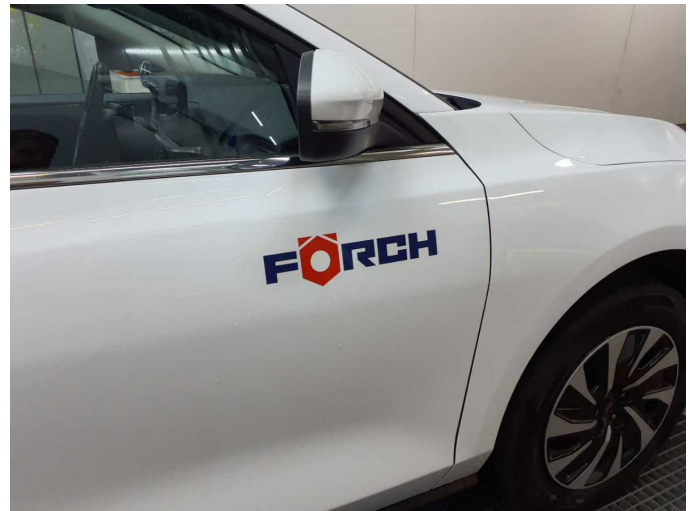
No.	Component group	Description
1	Body	Body - Glued / labelled - De-glue / neutralise

Damage 1: Body: Body - Glued / labelled - De-glue / neutralise

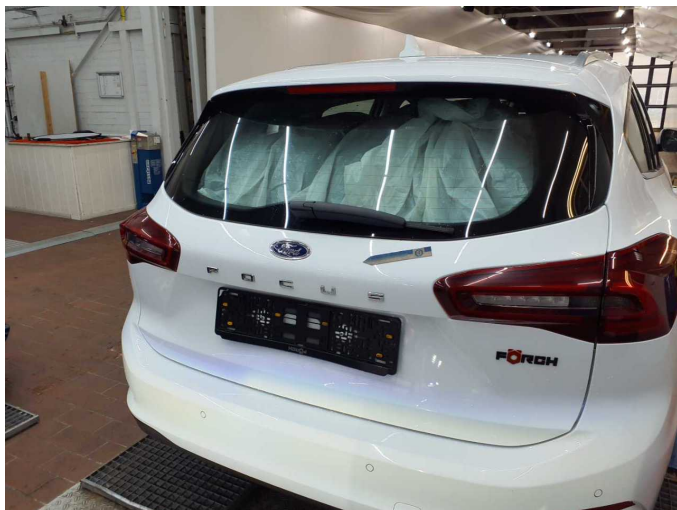
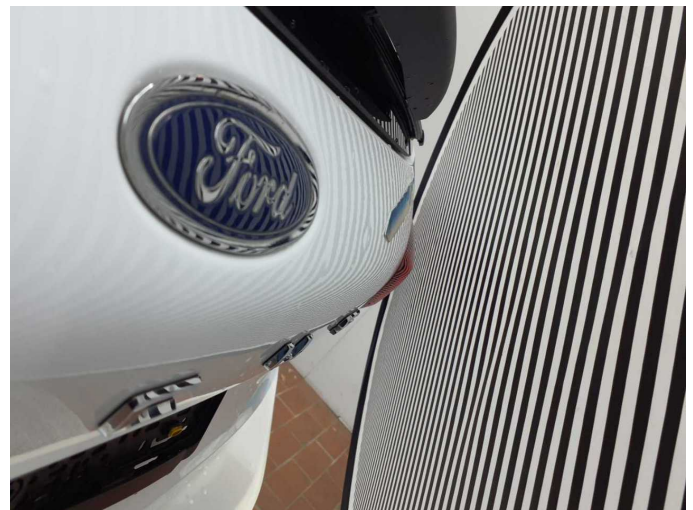
No.	Component group	Description
1	Body	Body - Scratch(es) - No deduction
2	Boot lid / rear door	Boot lid - dent(s) - No deduction

Wear and tear 2: Boot lid / rear door: Boot lid - dent(s) - No deduction

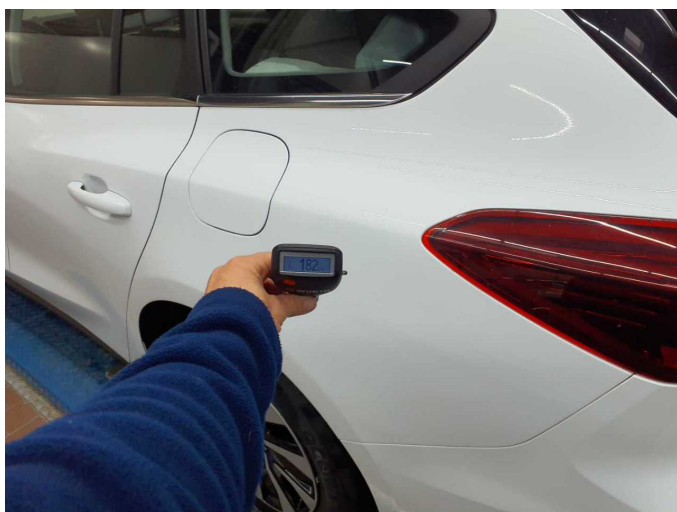
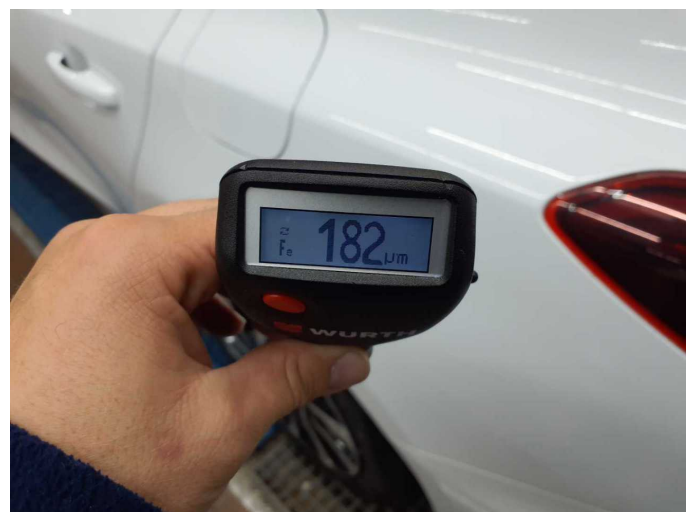
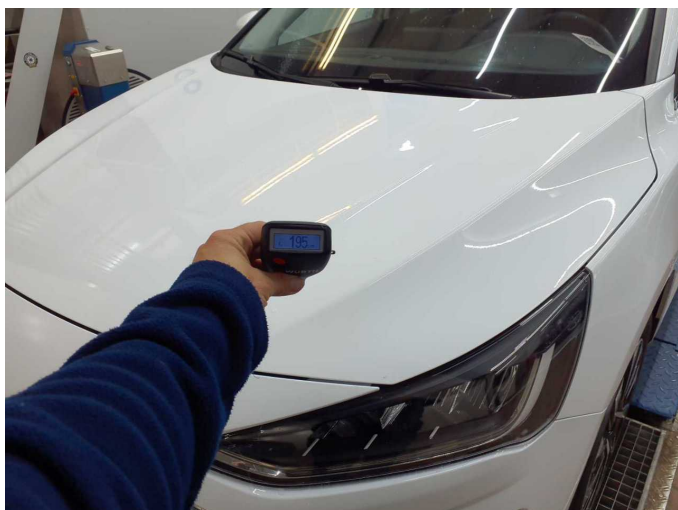
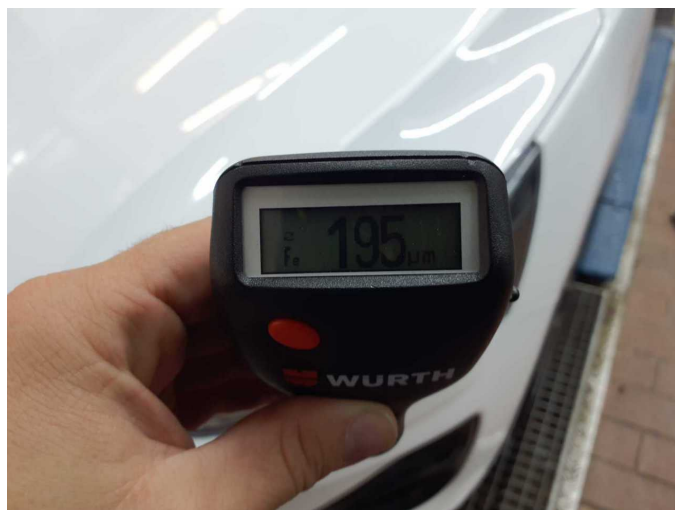
No.	Repainting
1	Bonnet, Side panel - rear left side, Professionally carried out, Invoice of repair done Non-existent

Bonnet	195 µm	Side panel - rear left side	182 µm
--------	--------	-----------------------------	--------

Repainting 1: Bonnet, Side panel - rear left side
