Expertise

Protocol number: 40913244
Order No. / Reference: 25028666
Inspection date: 25 Jul 2025

| Manufacturer: Ford | Model: Focus Turnier 1.5 EcoBlue Start-Stopp-System Aut. TITANIUM |
| VIN: WF0PXXGCHPPL86908 | |

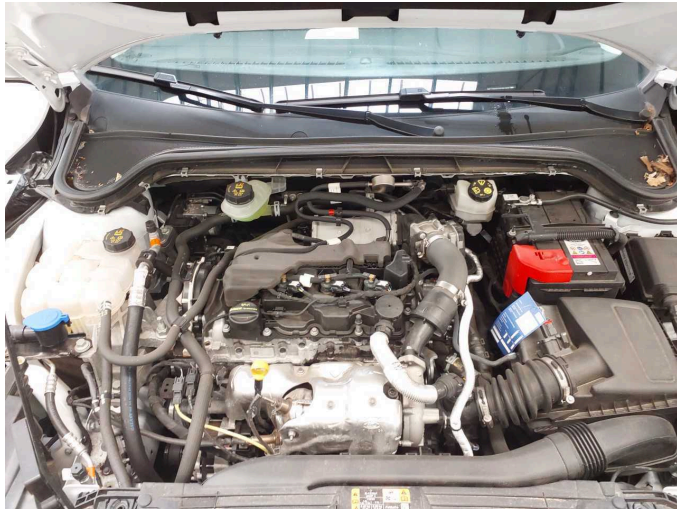
| No. | Component group | Description |
|---|---|--|
| 1 | Engine | Engine cover - top / cover - Missing - Replace |

Damage 1: Engine: Engine cover - top / cover - Missing - Replace

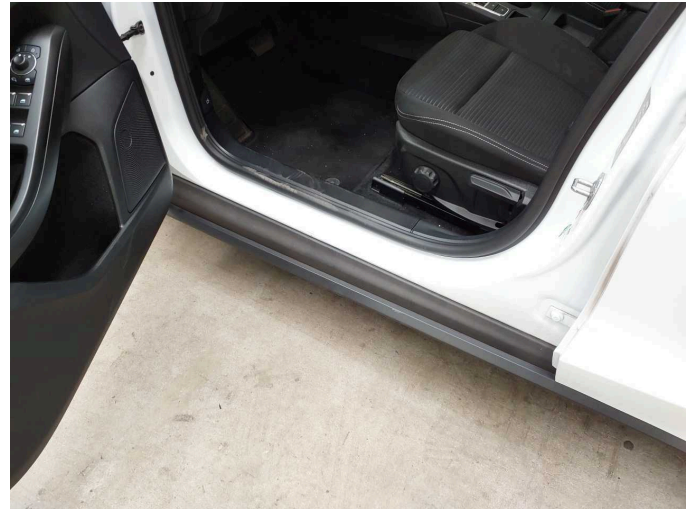
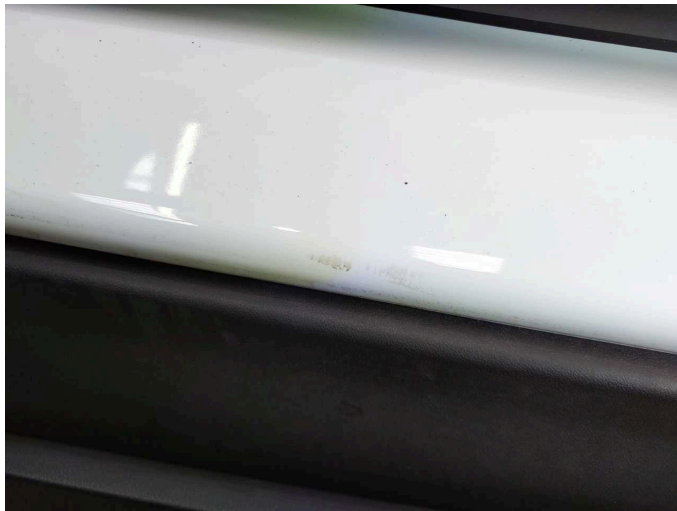
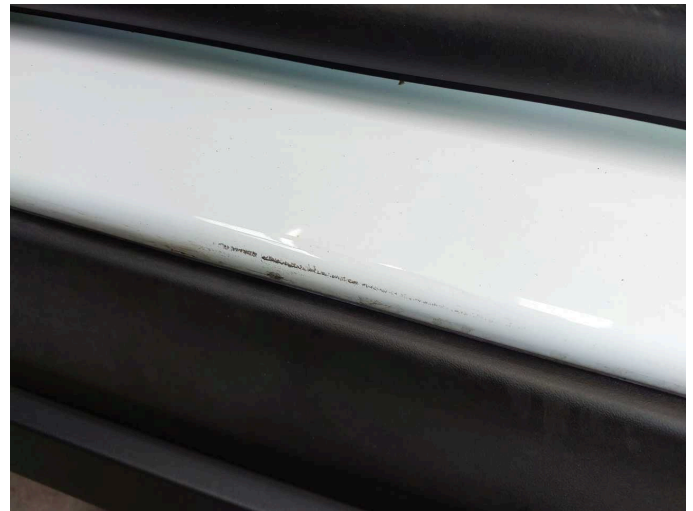
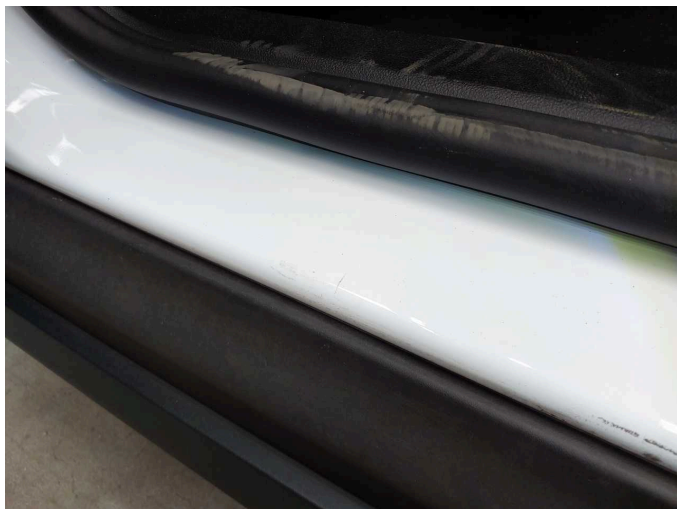
| No. | Component group | Description |
|---|---|--|
| 2 | Sill - left side | Sill - Scratch(es) - Smart repair |

Damage 2: Sill - left side: Sill - Scratch(es) - Smart repair

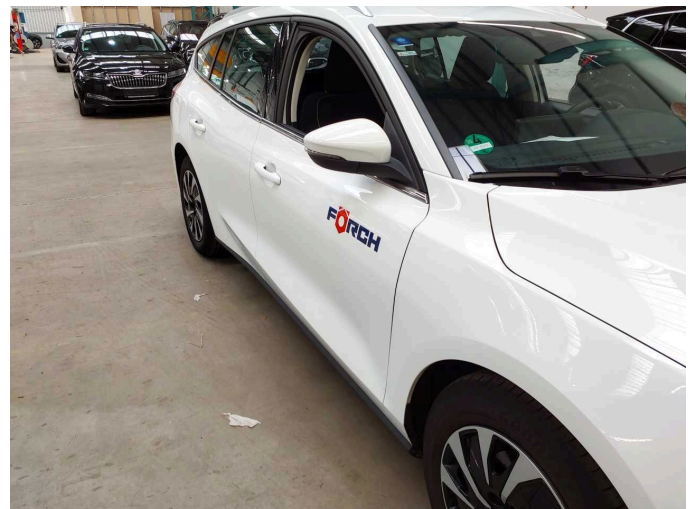
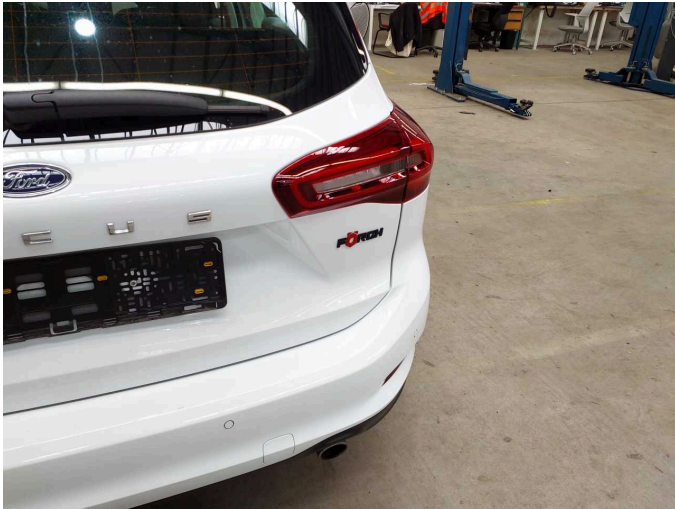
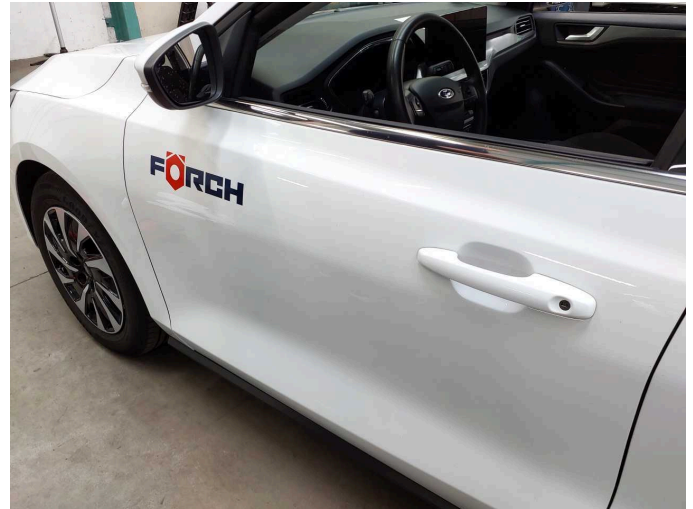
| No. | Component group | Description |
|---|---|--|
| 3 | Body | Body - Glued / labelled - De-glue / neutralise |

Damage 3: Body: Body - Glued / labelled - De-glue / neutralise

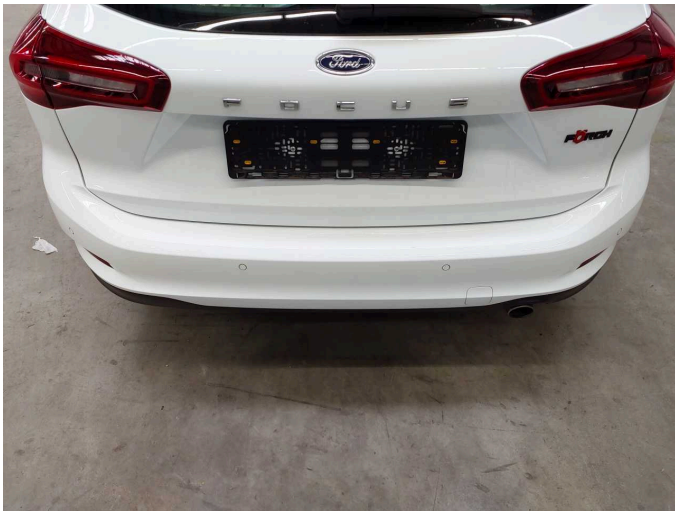
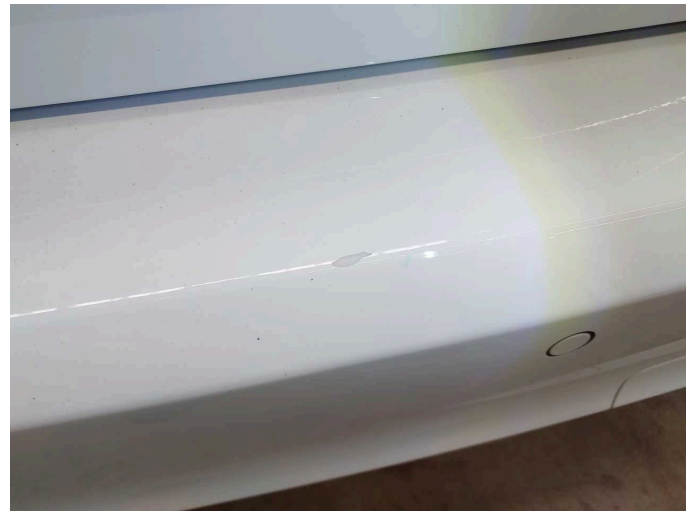
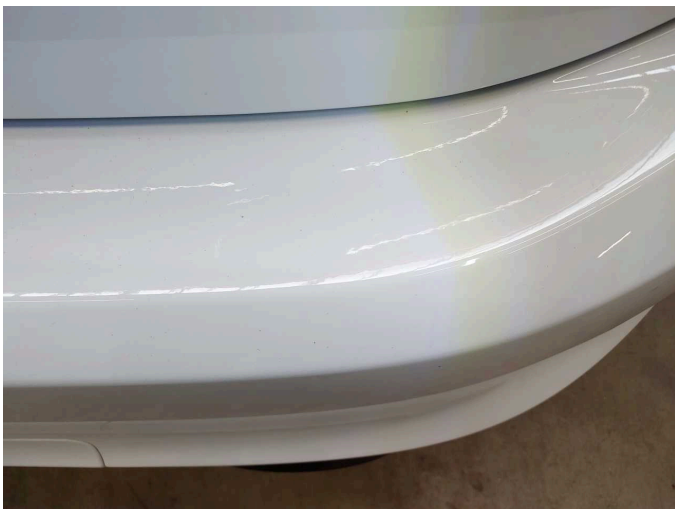
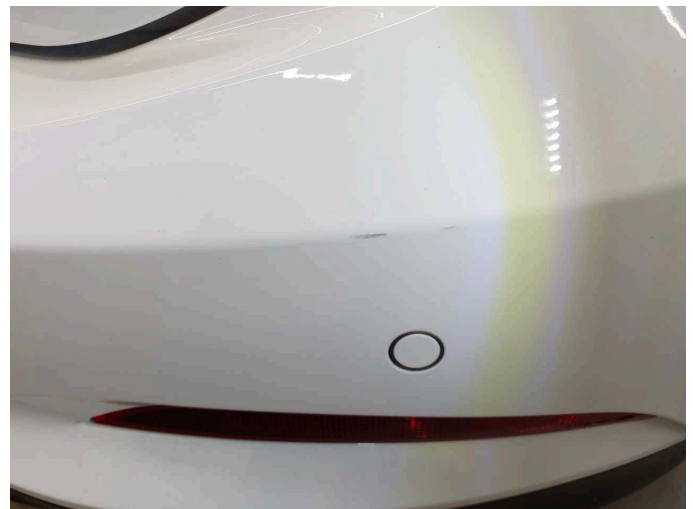
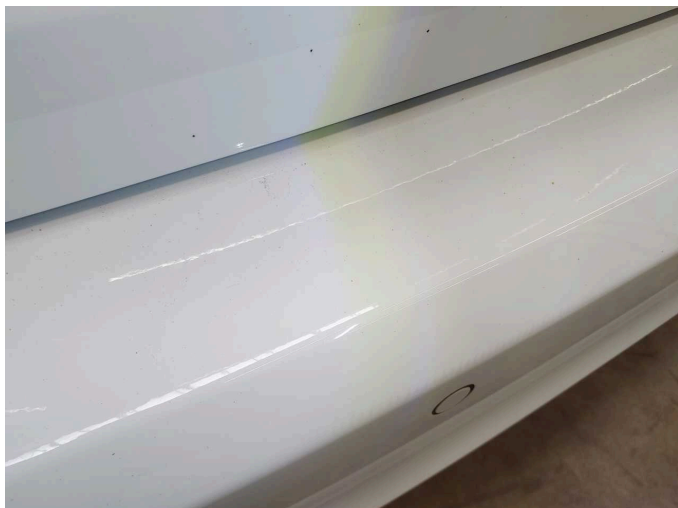
| No. | Component group | Description |
|---|---|--|
| 4 | Rear bumper | Rear bumper - Scratch(es) - Paint |

Damage 4: Rear bumper: Rear bumper - Scratch(es) - Paint

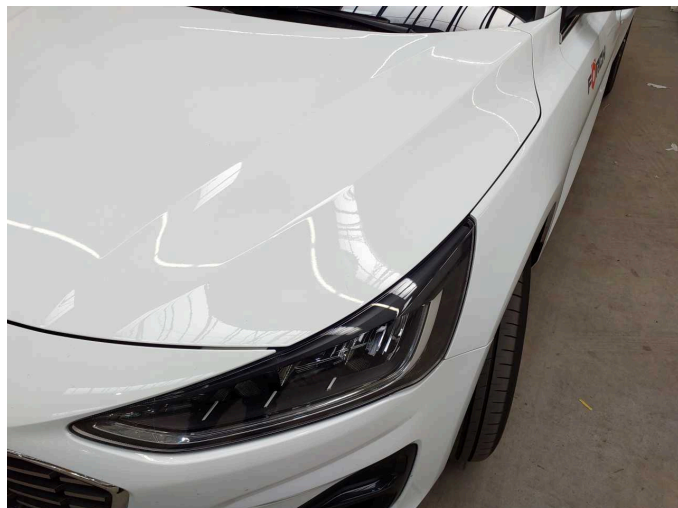
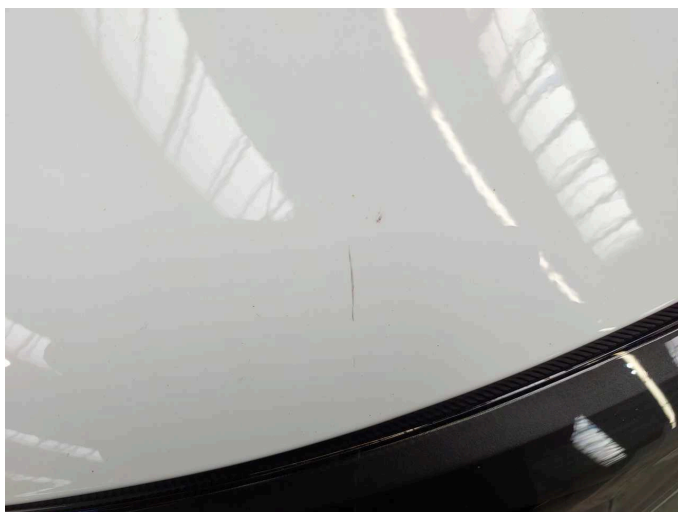
| No. | Component group | Description |
|---|---|--|
| 5 | Bonnet | Bonnet - Scratched - Paint |

Damage 5: Bonnet: Bonnet - Scratched - Paint
