FORD TRANSIT (30)
TRANSIT CUSTOM FOURGON 280 L1H1 2.0
ECOBBLUE 110 CH TREND

VIN NO WF0RXXTA1RRA42413
Registration Number GX922QL

Inspection Report Summary

| Customer | BCAuto Encheres | Report Number | P20250902141151 |

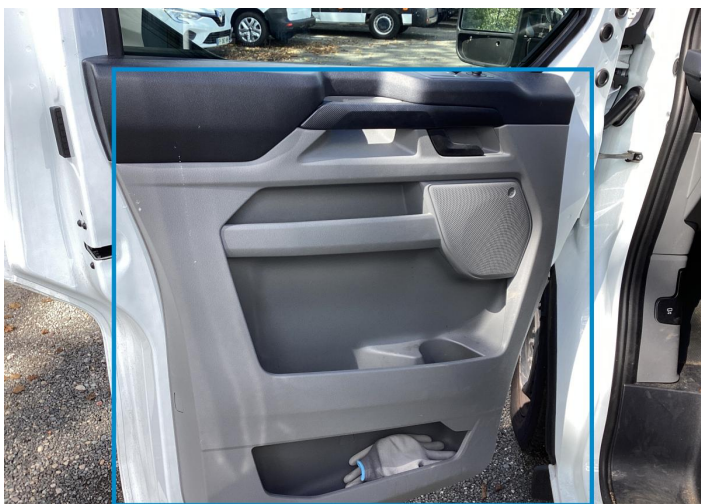
| Component | | Damage | Comments |
|---|---|---|---|
| 1 | Panel Filling / Front Left | Interior / Dirty | |

1. Panel Filling / Front Left
Interior / Dirty -

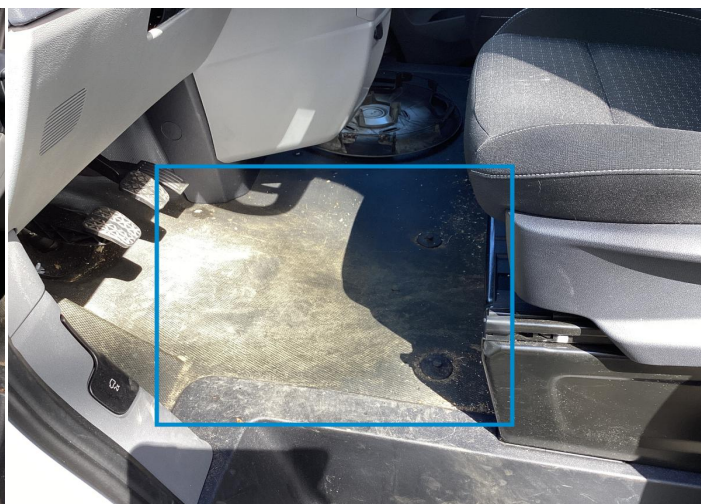
| Component | | Damage | Comments |
|---|---|---|---|
| 2 | Floor Carpet | Interior / Dirty | |

2. Floor Carpet
Interior / Dirty -

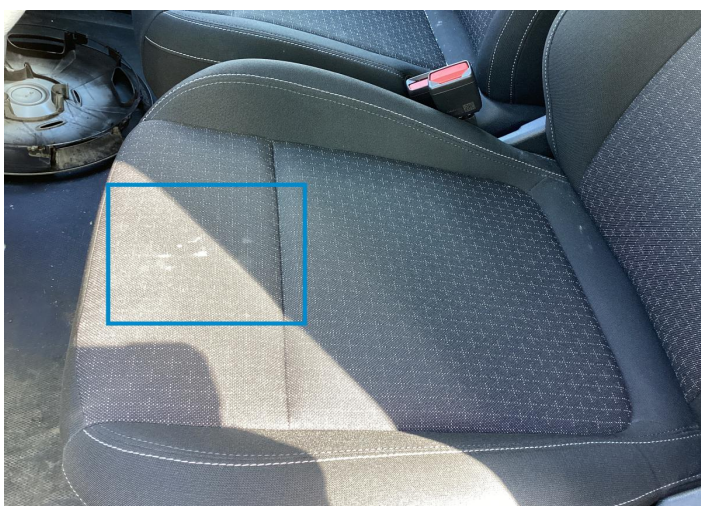
| Component | | Damage | Comments |
|---|---|---|---|
| 3 | Seat Cushion / Front Left | Interior / Stained | |

3. Seat Cushion / Front Left
Interior / Stained -

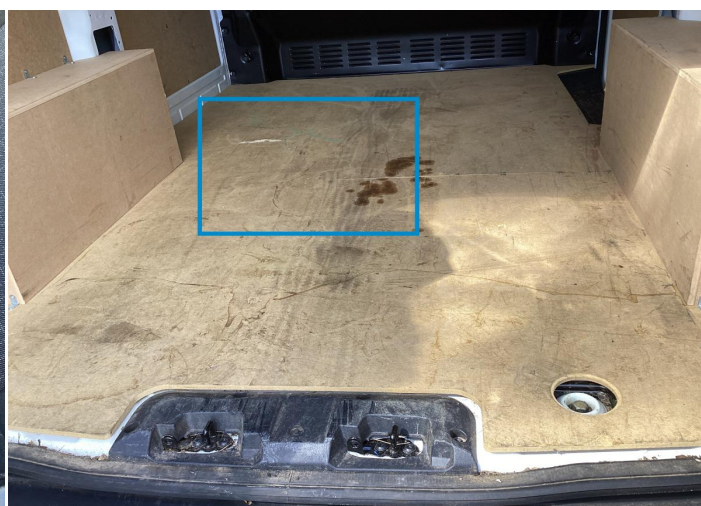
| Component | | Damage | Comments |
|---|---|---|---|
| 4 | Trunk Carpet | Interior / Scraped | |

4. Trunk Carpet
Interior / Scraped -

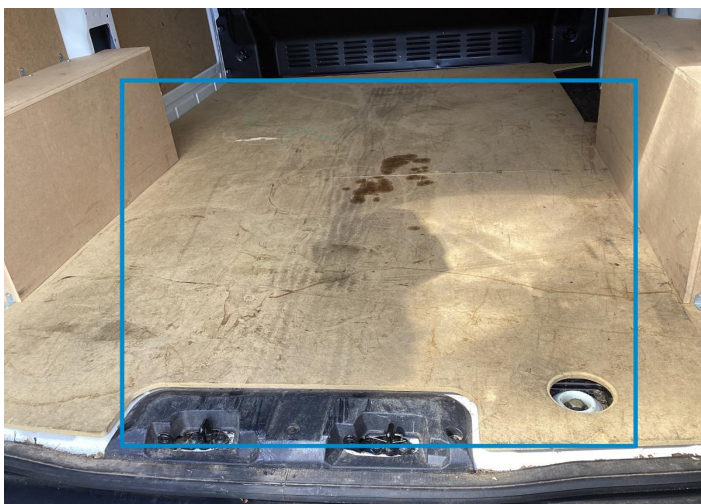
| Component | | Damage | Comments |
|---|---|---|---|
| 5 | Trunk Carpet | Interior / Stained | |

5. Trunk Carpet
Interior / Stained -

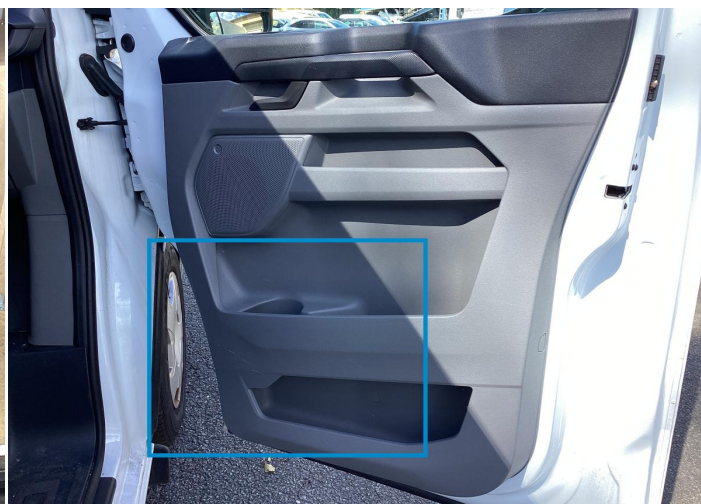
| Component | | Damage | Comments |
|---|---|---|---|
| 6 | Panel Filling / Front Right | Interior / Dirty | |

6. Panel Filling / Front Right
Interior / Dirty -

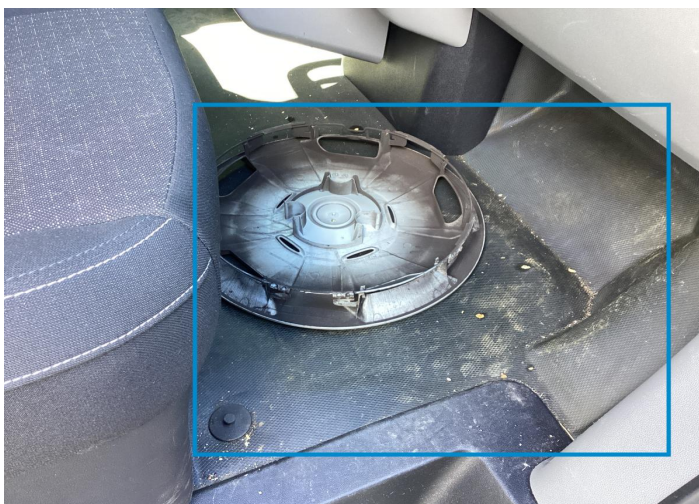
| Component | | Damage | Comments |
|---|---|---|---|
| 7 | Floor Carpet | Interior / Dirty | |

7. Floor Carpet
Interior / Dirty -

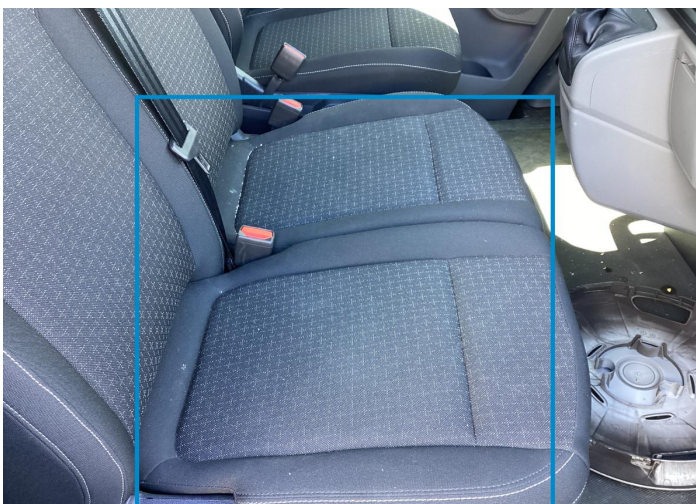
| Component | | Damage | Comments |
|---|---|---|---|
| 8 | Seat Cushion / Front Right | Interior / Dirty | |

8. Seat Cushion / Front Right
Interior / Dirty -

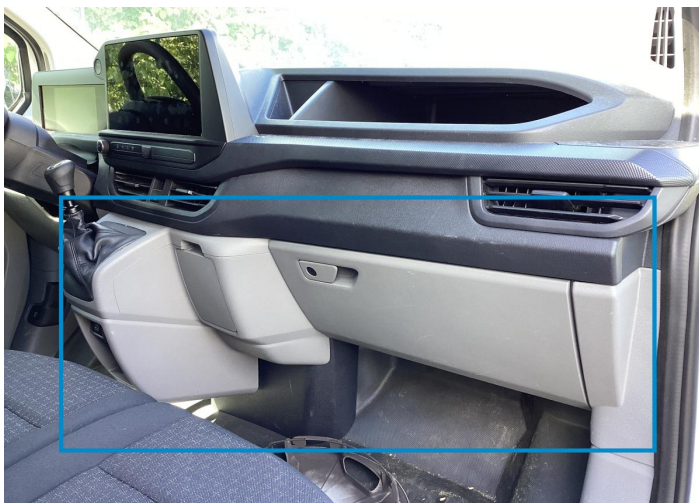
| Component | | Damage | Comments |
|---|---|---|---|
| 9 | Dashboard / Front | Interior / Scraped | |

9. Dashboard / Front
Interior / Scraped -

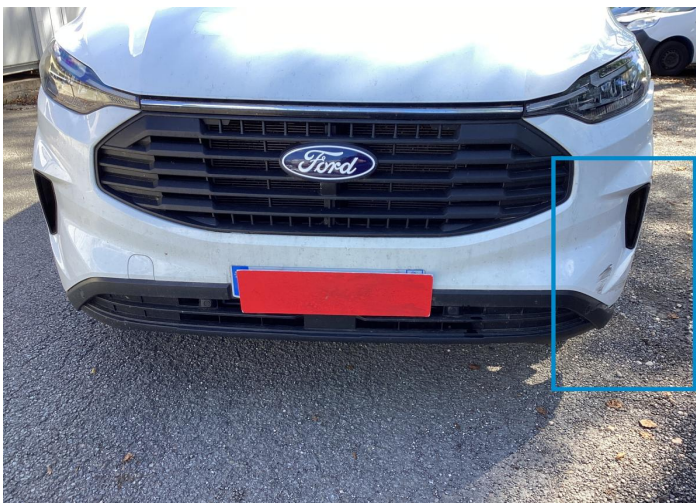
| Component | | Damage | Comments |
|---|---|---|---|
| 10 | Bumper / Front | Bodywork / Dent / Deformation | |

10. Bumper / Front
Bodywork / Dent / Deformation -

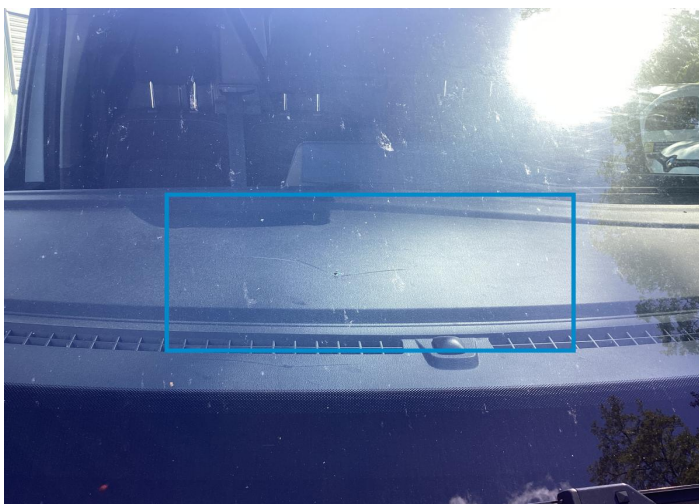
| Component | | Damage | Comments |
|---|---|---|---|
| 11 | Windshield / Front | Glass Break | |

11. Windshield / Front
Glass Break -

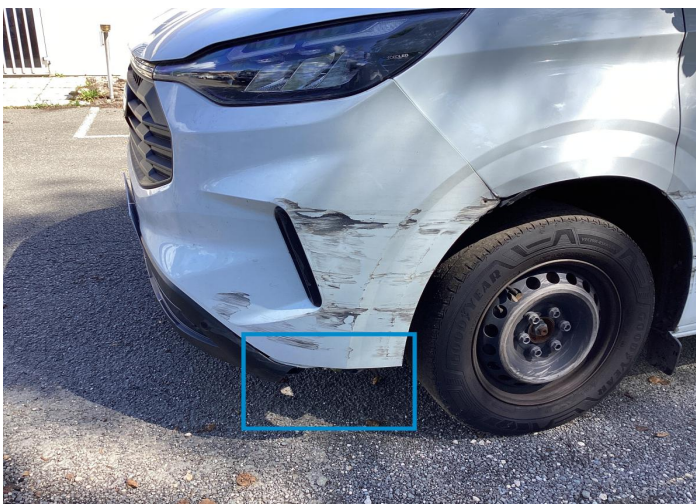
| Component | | Damage | Comments |
|---|---|---|---|
| 12 | Corner Bumper / Front Right | Bodywork / Breakage | |

12. Corner Bumper / Front Right
Bodywork / Breakage -

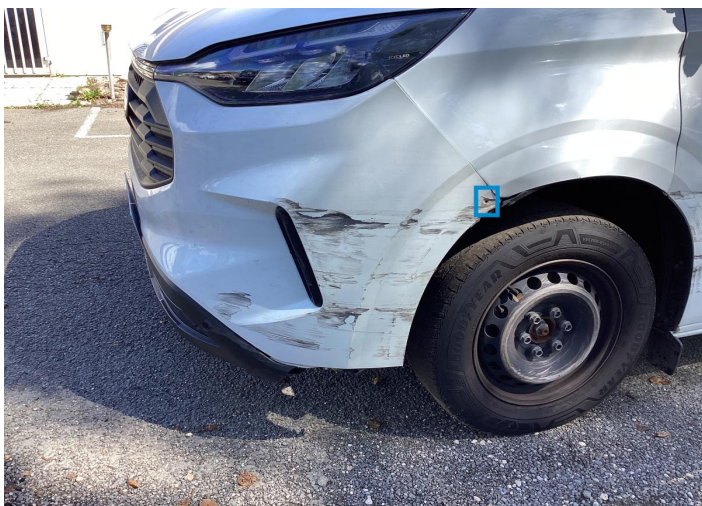
| Component | | Damage | Comments |
|---|---|---|---|
| 13 | Corner Bumper / Front Right | Bodywork / Breakage / Hole | |

13. Corner Bumper / Front Right
Bodywork / Breakage / Hole -

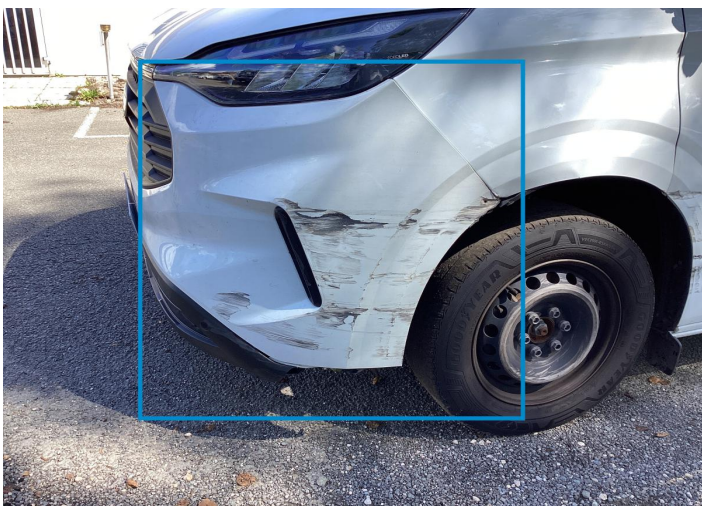
| 14 | Corner Bumper / Front Right | Bodywork / Dent / Deformation |

14. Corner Bumper / Front Right
Bodywork / Dent / Deformation -

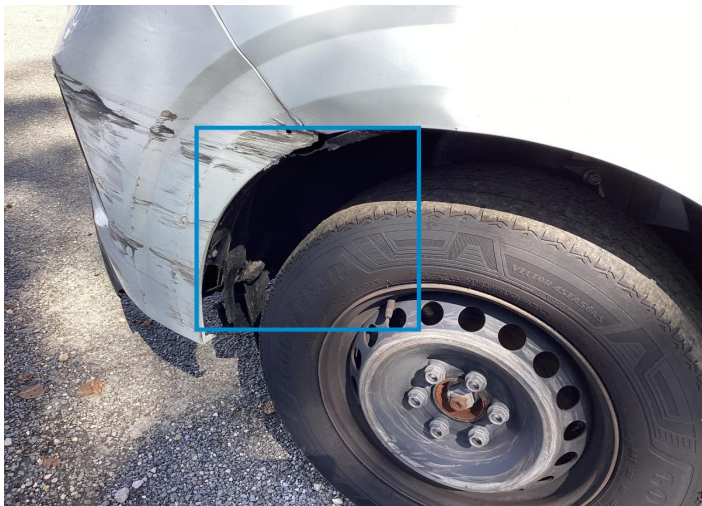
| 15 | Wheel Arch / Front Left | Bodywork / Breakage |

15. Wheel Arch / Front Left
Bodywork / Breakage -

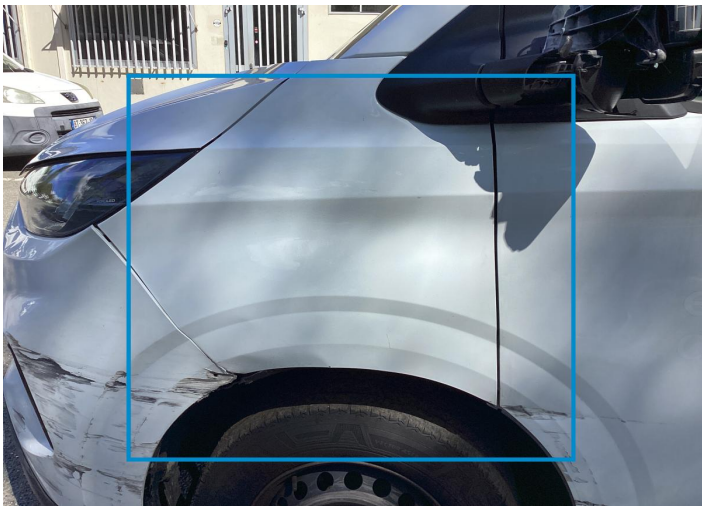
| 16 | Fender / Front Left | Bodywork / Dent / Deformation |

16. Fender / Front Left
Bodywork / Dent / Deformation -

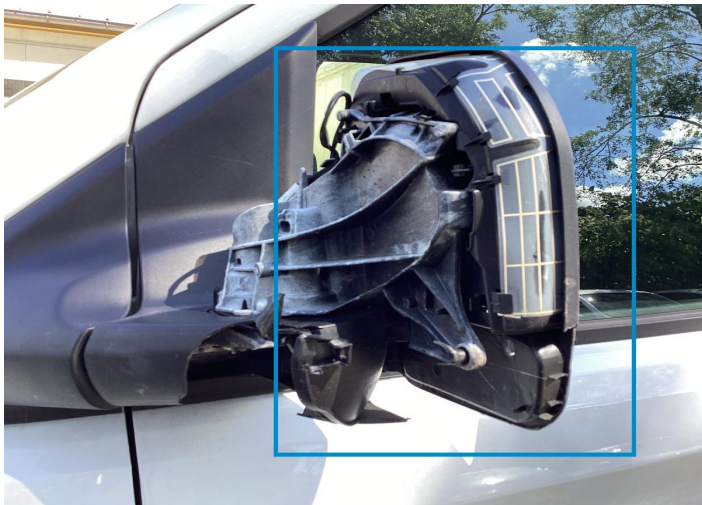
| 17 | Mirror / Front Left | Bodywork / Breakage |

17. Mirror / Front Left
Bodywork / Breakage -

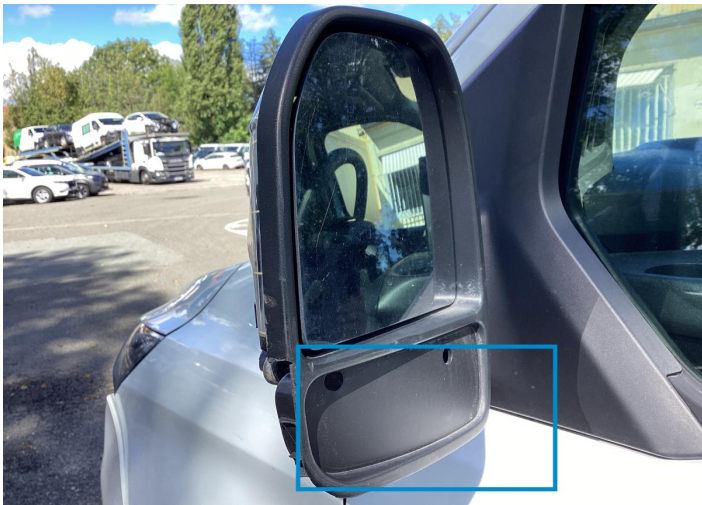
| 18 | Mirror Glass / Front Left | Missing Part |

18. Mirror Glass / Front Left
Missing Part -

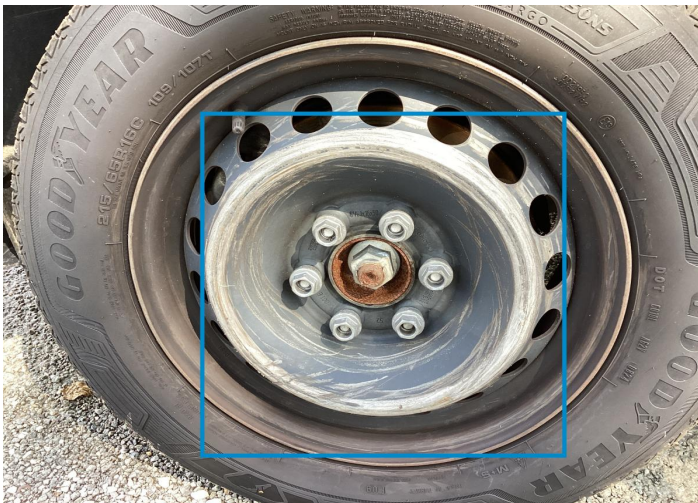
| 19 | Rim / Front Left | Out of Bodywork / Scratch |

19. Rim / Front Left
Out of Bodywork / Scratch -

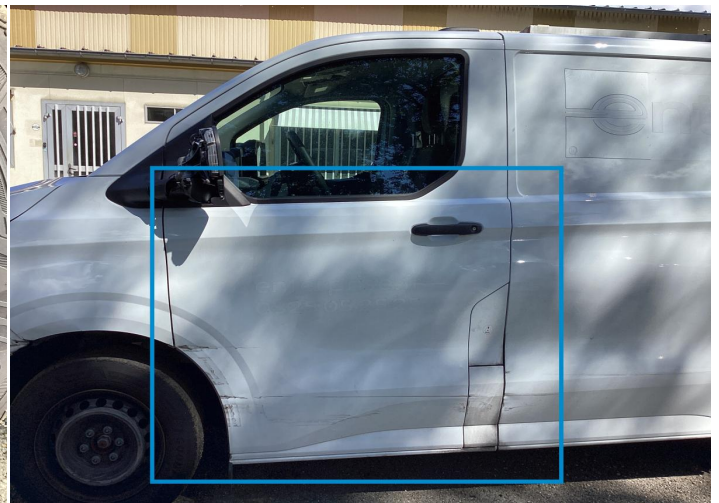
| 20 | Door / Front Left | Bodywork / Dent / Deformation |

20. Door / Front Left
Bodywork / Dent / Deformation -

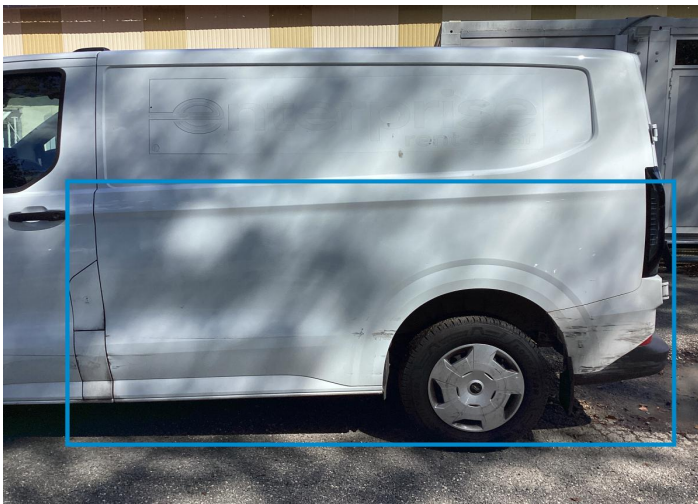
| 21 | Side Panel / Back Left | Bodywork / Dent / Deformation |

21. Side Panel / Back Left
Bodywork / Dent / Deformation -

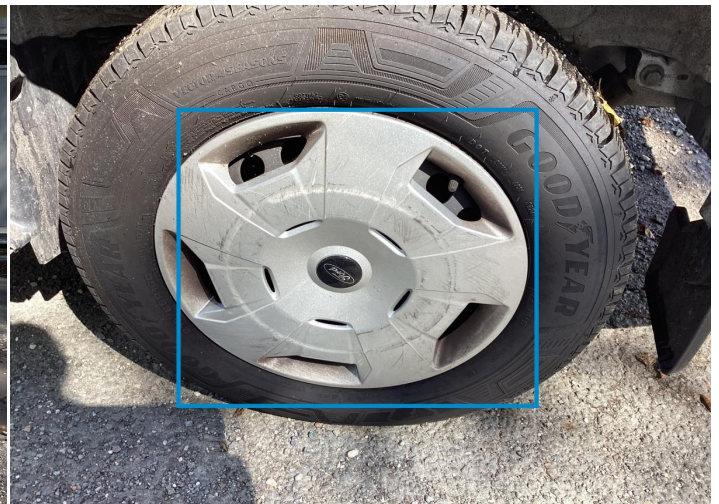
| 22 | Hubcap / Back Left | Out of Bodywork / Scratch |

22. Hubcap / Back Left
Out of Bodywork / Scratch -

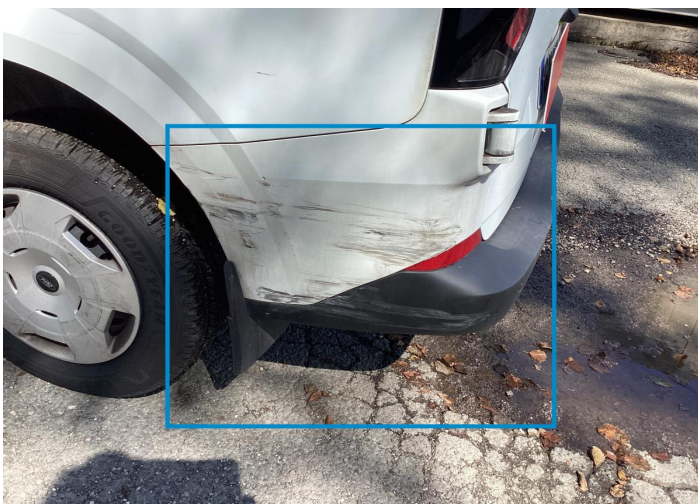
| 23 | Corner Bumper / Back Left | Bodywork / Dent / Deformation |

23. Corner Bumper / Back Left
Bodywork / Dent / Deformation -

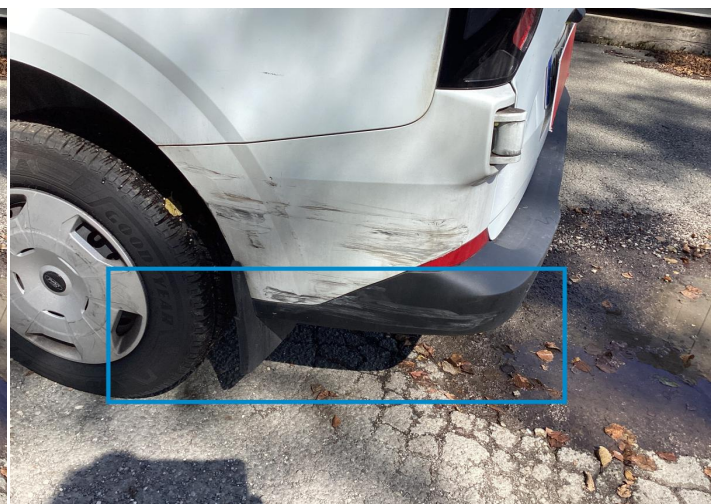
| 24 | Corner Bumper / Back Left | Paint / Scratch / Line |

24. Corner Bumper / Back Left
Paint / Scratch / Line -

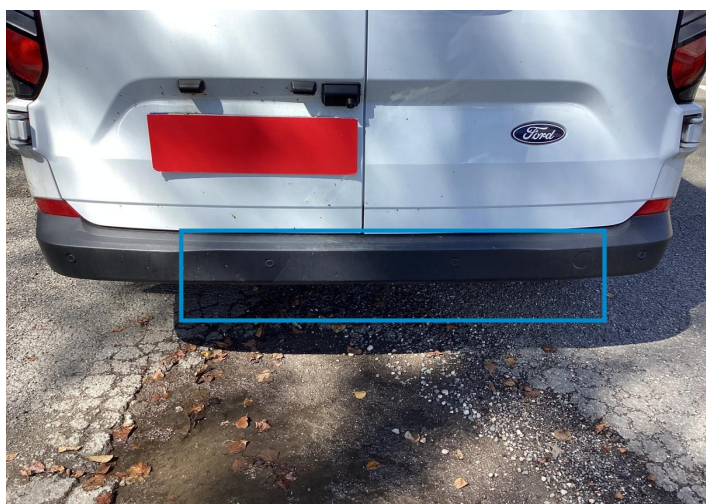
| 25 | Bumper / Back | Paint / Scratch / Line |

25. Bumper / Back
Paint / Scratch / Line -

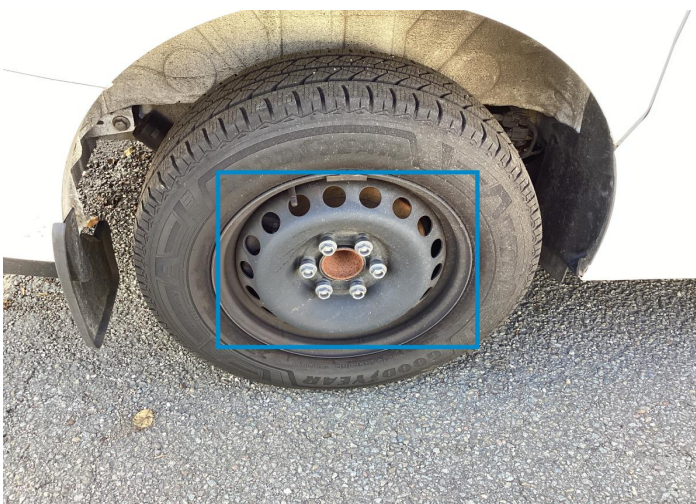
| 26 | Hubcap / Back Right | Missing element hubcap |

26. Hubcap / Back Right
Missing element hubcap -

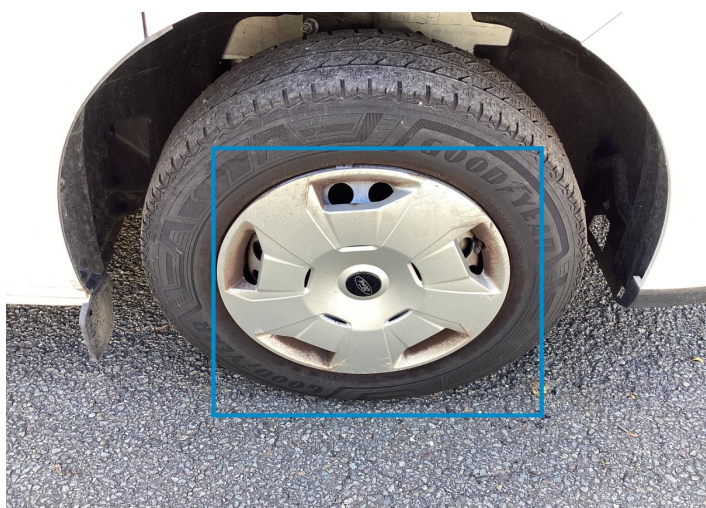
| 27 | Hubcap / Front Right | Out of Bodywork / Scratch |

27. Hubcap / Front Right
Out of Bodywork / Scratch -

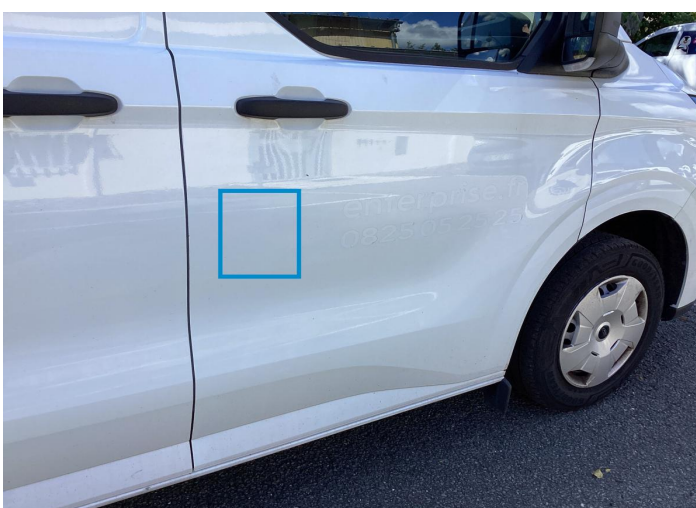
| 28 | Door / Front Right | Bodywork / Dent / Deformation |

28. Door / Front Right
Bodywork / Dent / Deformation -

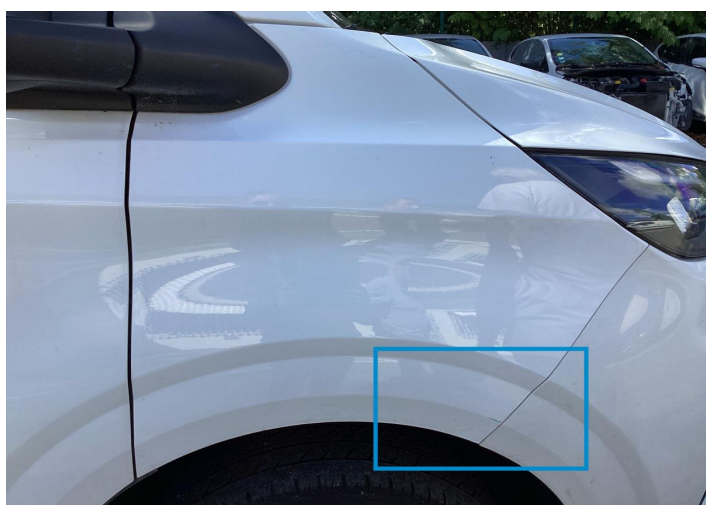
| 29 | Fender / Front Right | Paint / Scratch / Line |

29. Fender / Front Right
Paint / Scratch / Line -
