Expertise

Protocol number: 41600866
Order No. / Reference: 25160454
Inspection date: 17 Sept 2025

Manufacturer: Ford

Model: Transit Connect 220 L1 S&S Trend

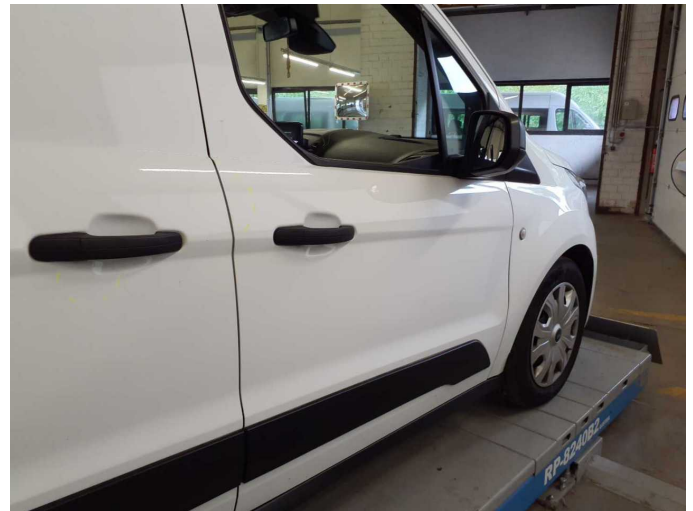
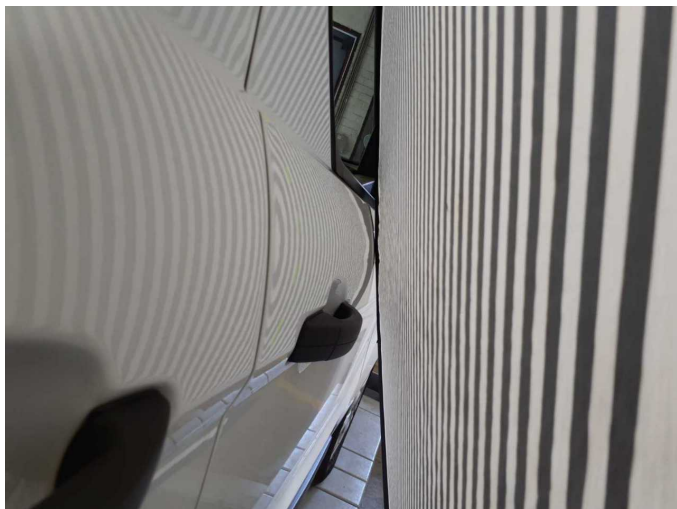
Damage 1: Door - front right side: Door - dent(s) - Smooth repair work

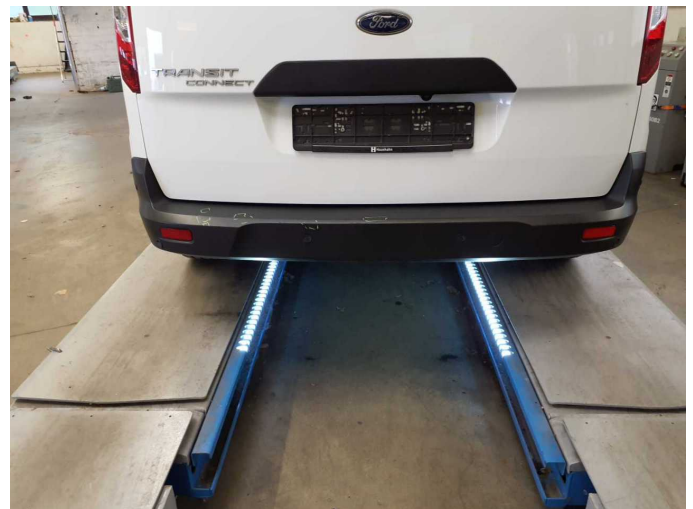
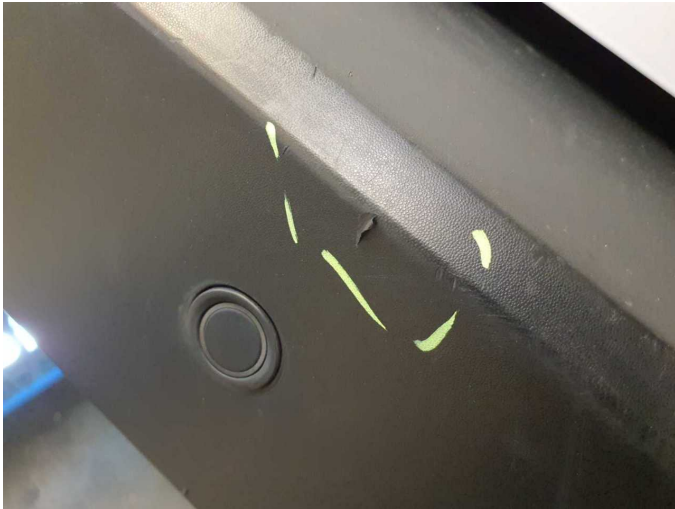
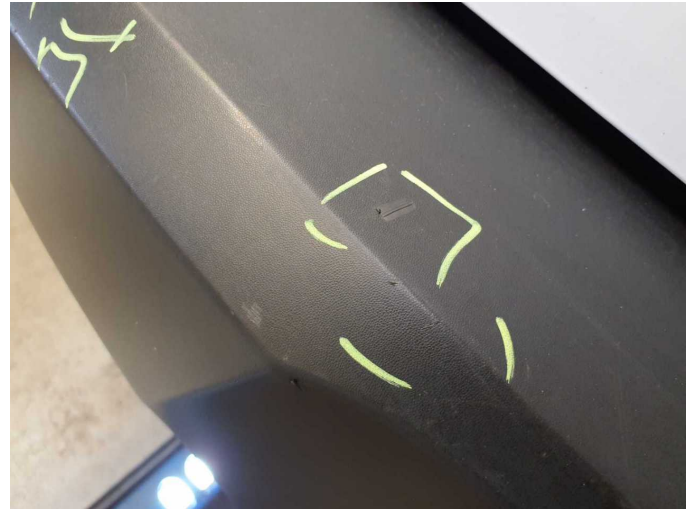
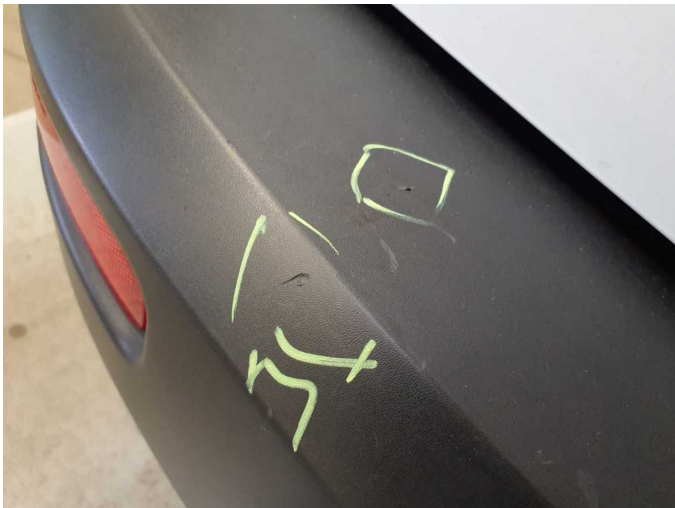
Damage 2: Rear bumper: Rear bumper (Materialabtrag) - Scratched - Loss in value

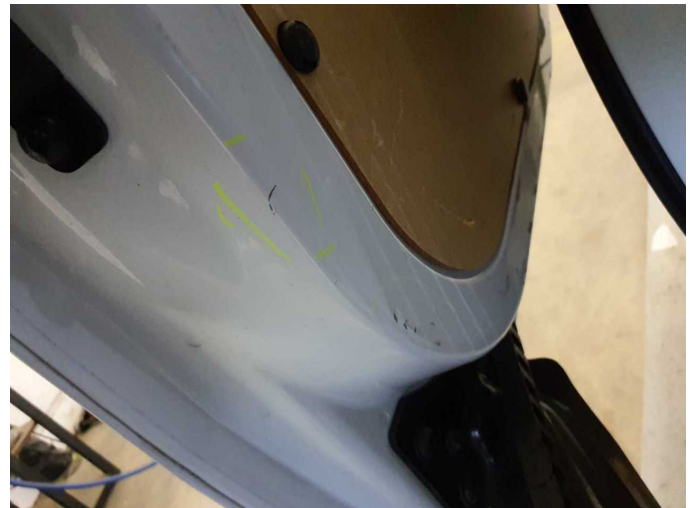
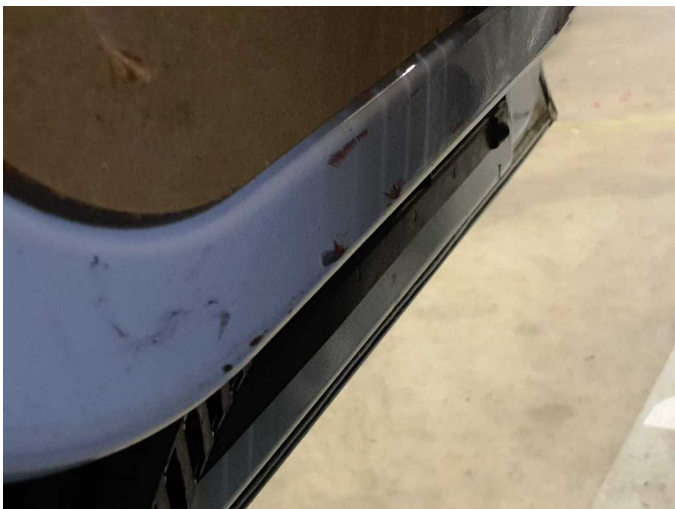
Damage 3: Sliding door, right: Sliding door (innen) - Dent / paintcoat damage - Smart repair

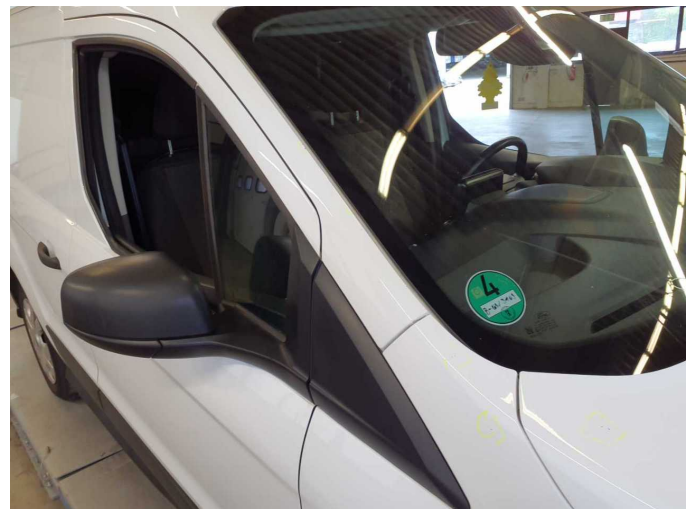
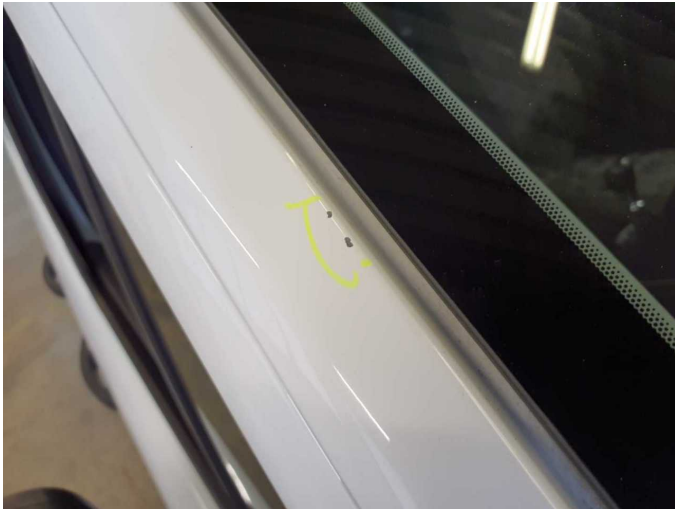
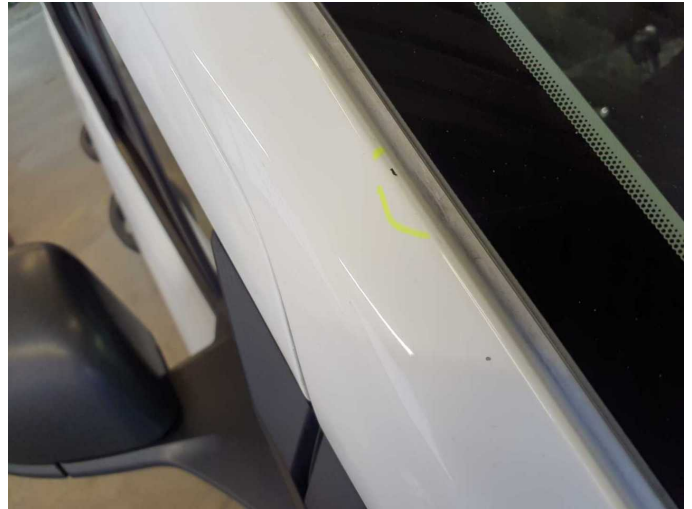
Damage 4: Roof: Roof rail - right side - Stone chips - Smart repair

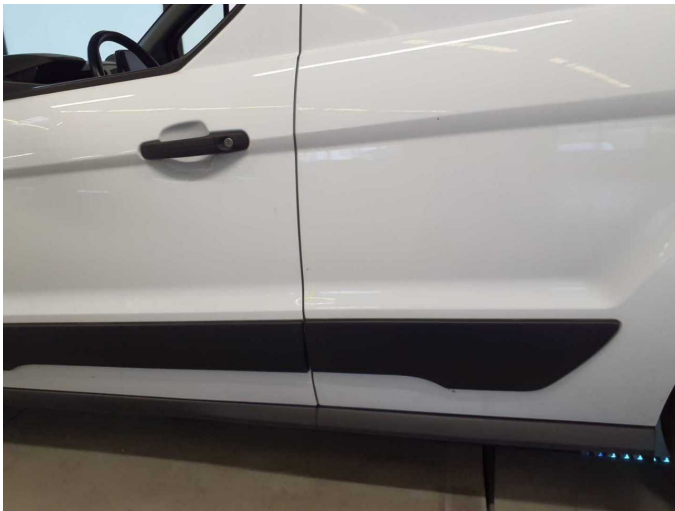
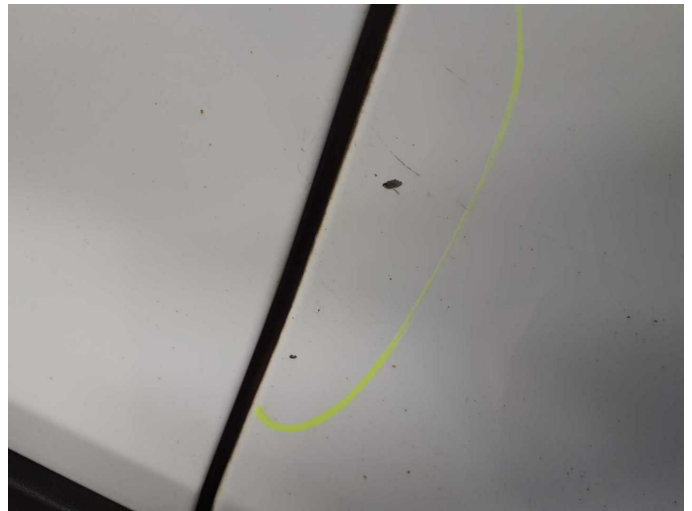
Damage 5: Side panel - rear left side: Side panel - Scratched - Smart repair

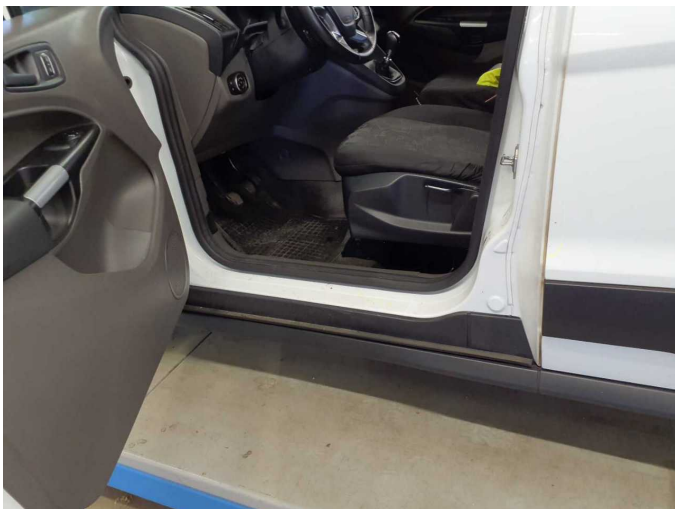
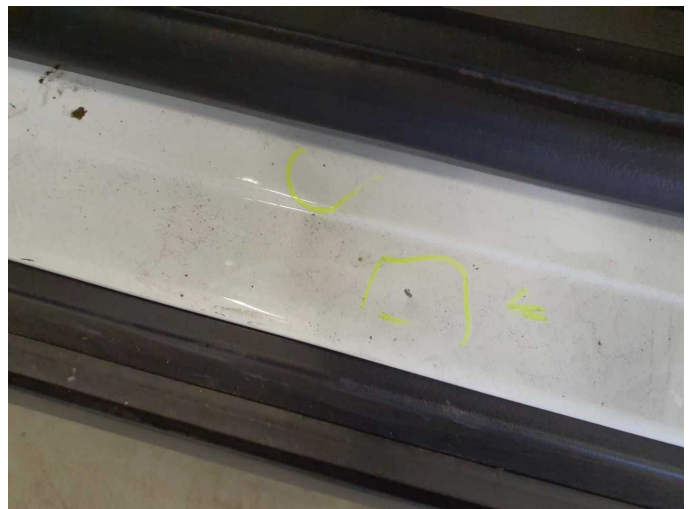
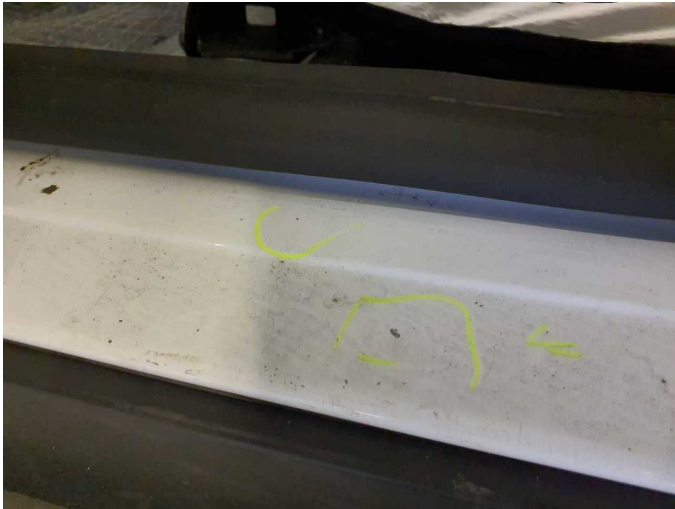
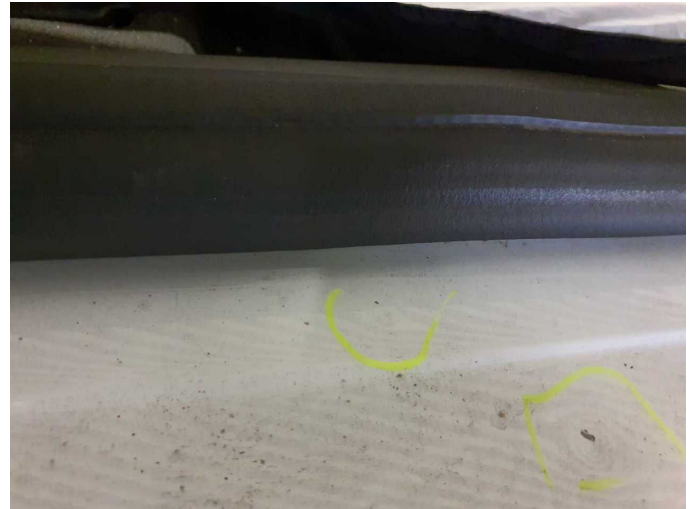
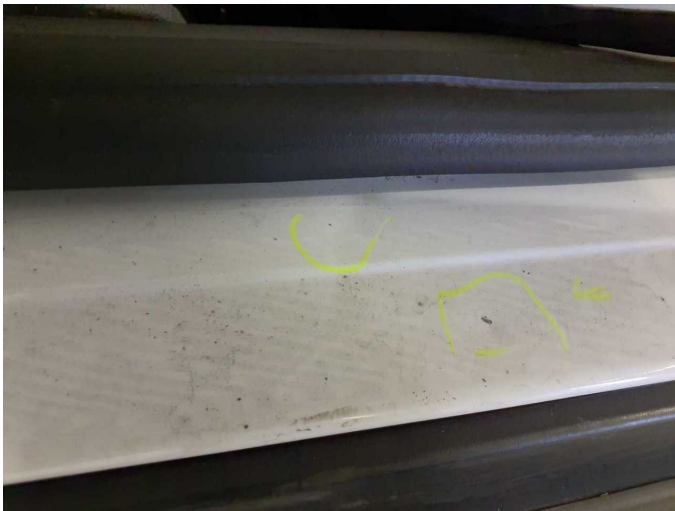
Damage 6: Sill - left side: Sill - Dent / paintcoat damage - Smart repair

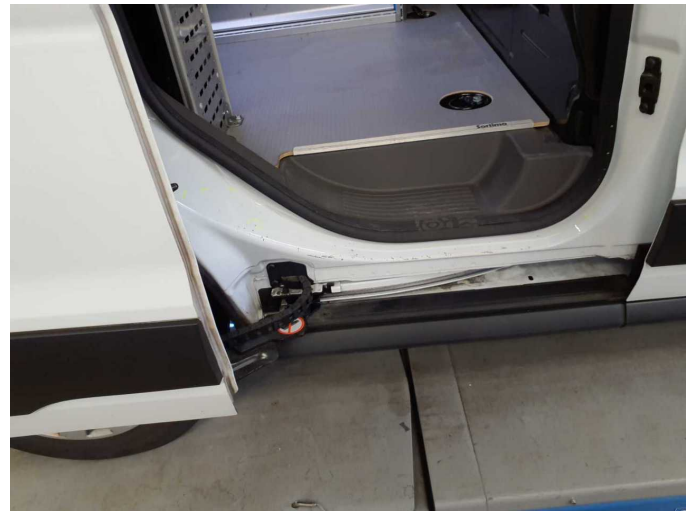
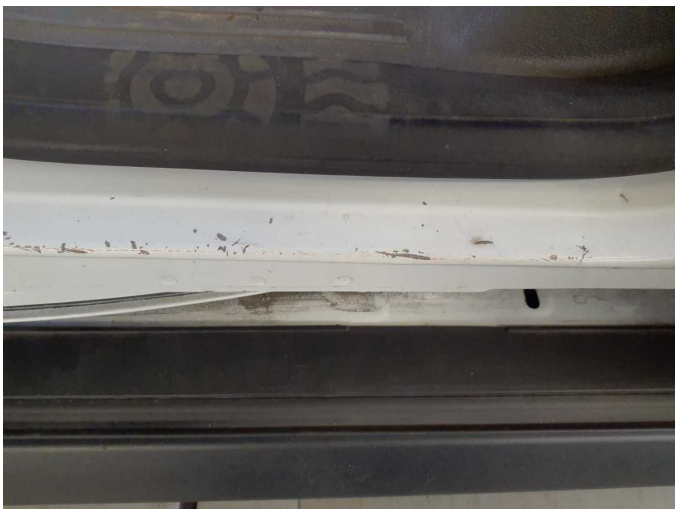
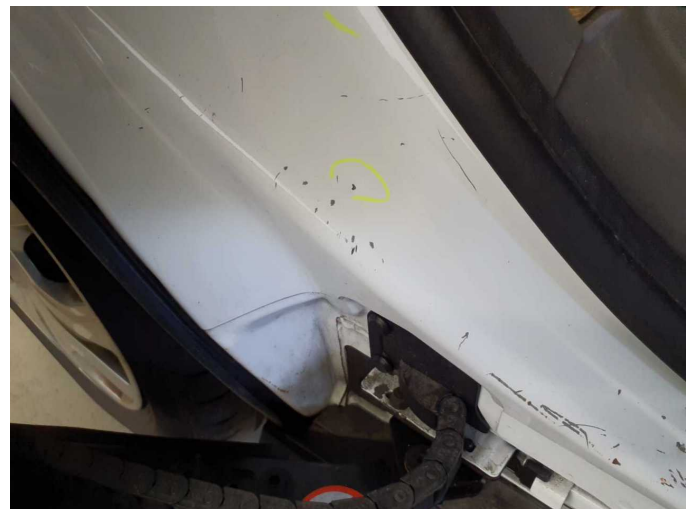
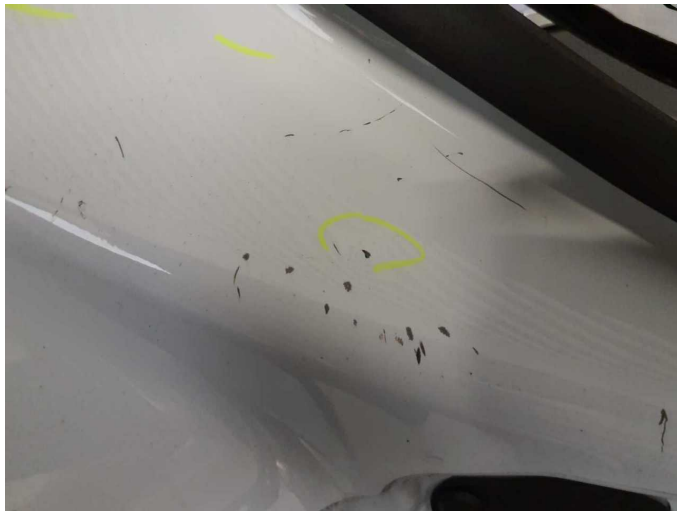
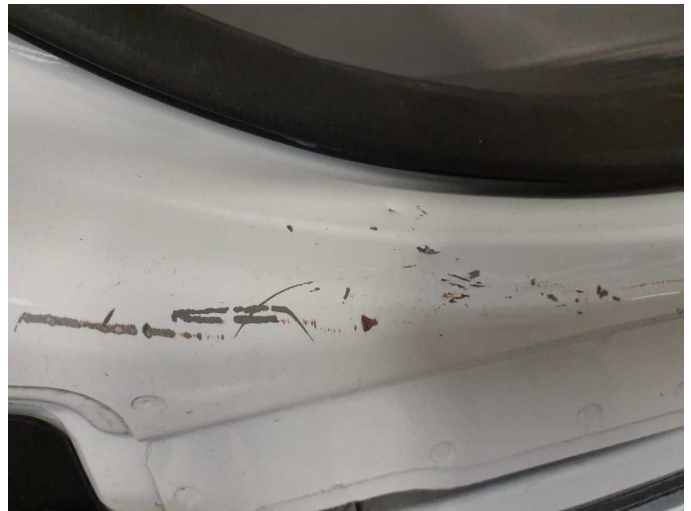
Damage 7: Sill - right side: Cat walk - Dent / paintcoat damage - Smart repair

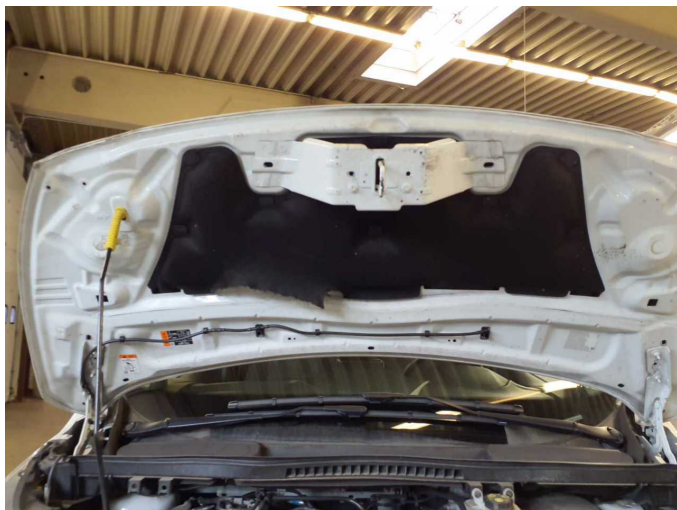
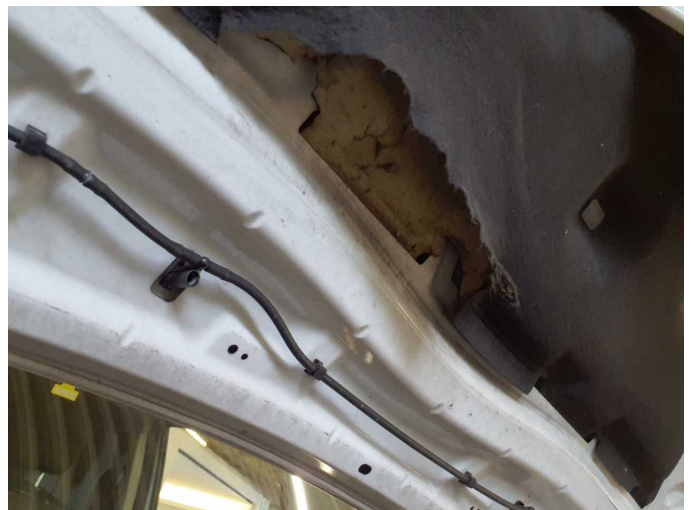
Damage 8: Bonnet: Insulation lining - Damage caused by marten / rodent - Replace

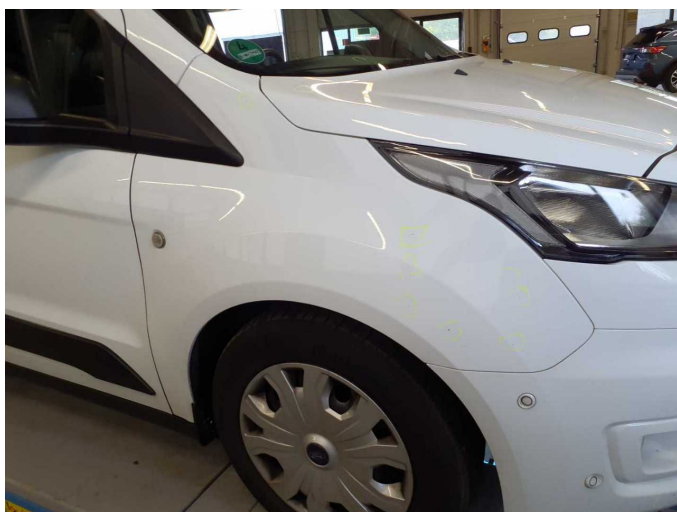
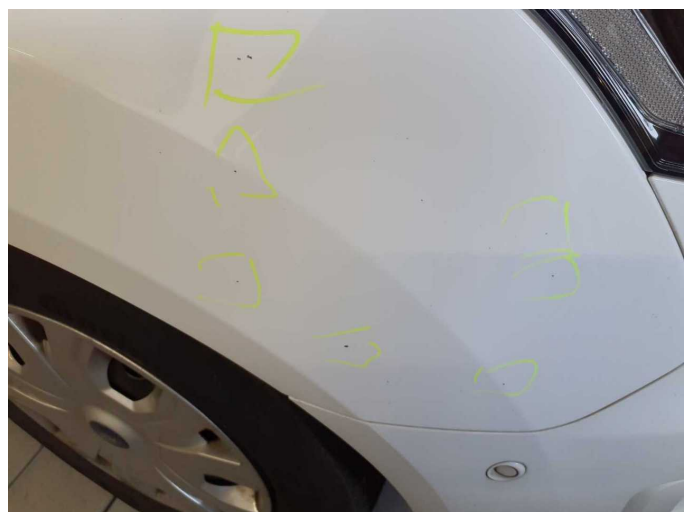
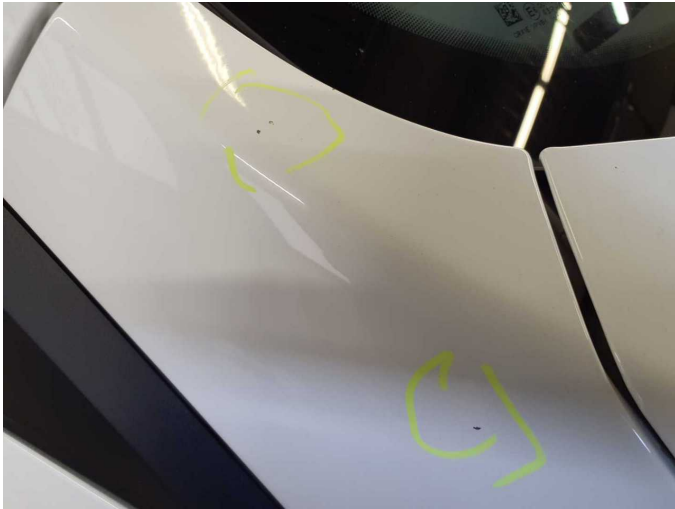
Damage 9: Mudguard - right side: Mudguard - right side - Scratched - Paint

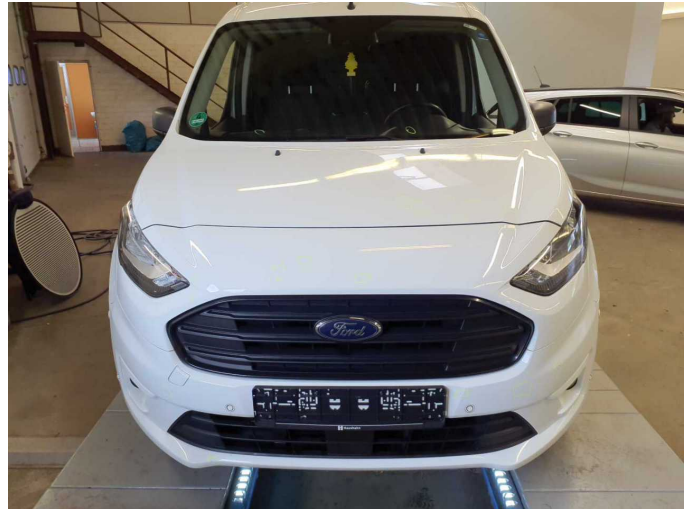
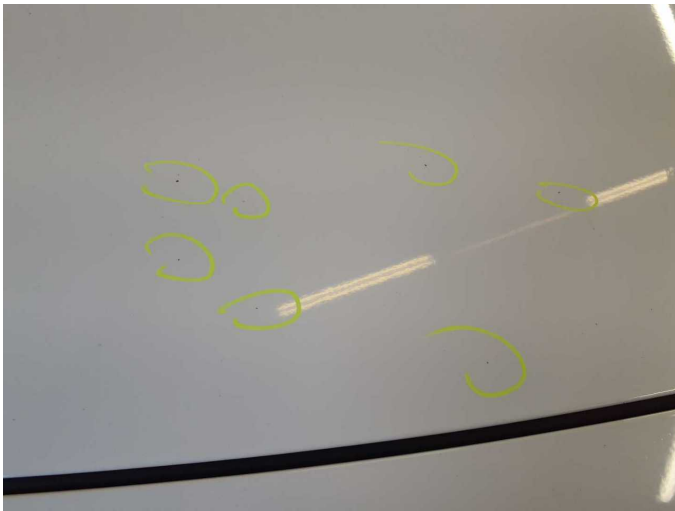
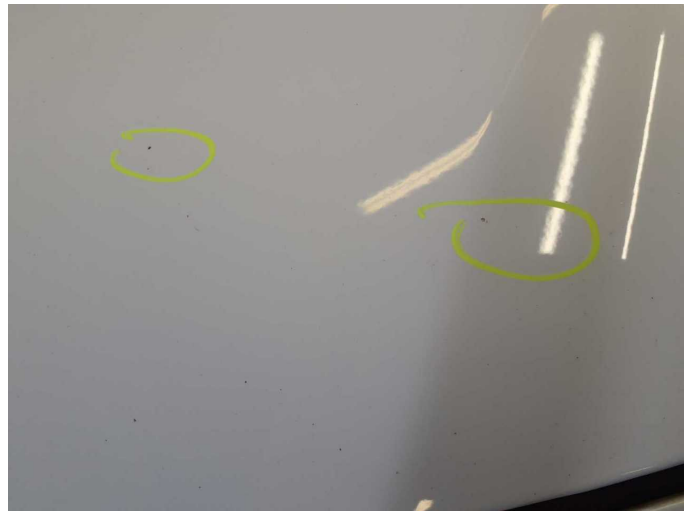
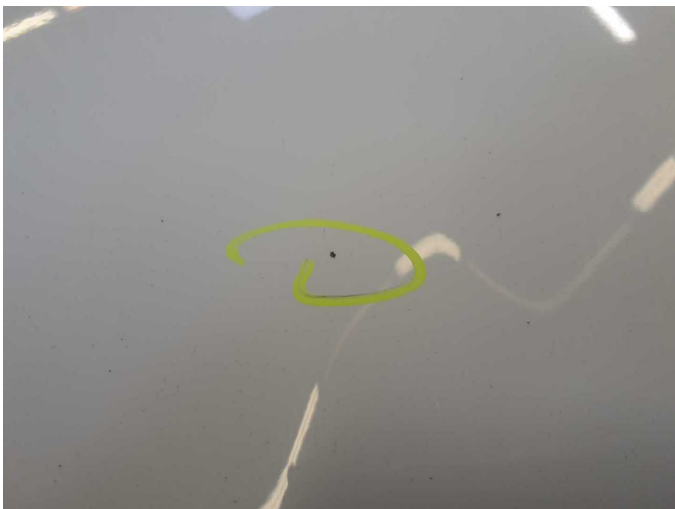
Damage 10: Bonnet: Bonnet - Stone chips - Paint

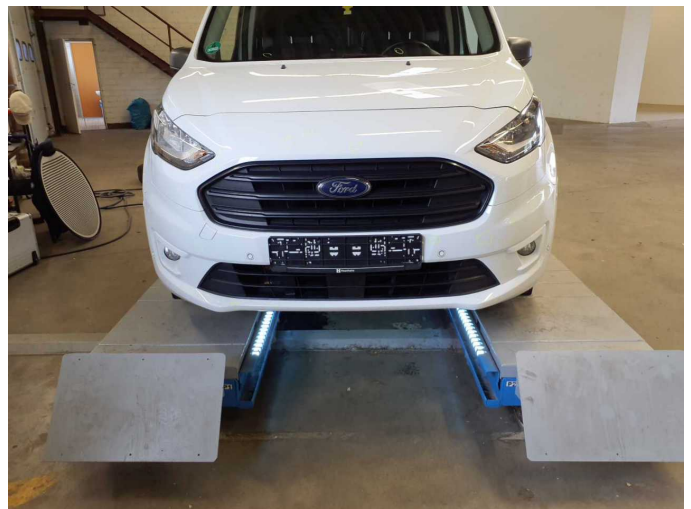
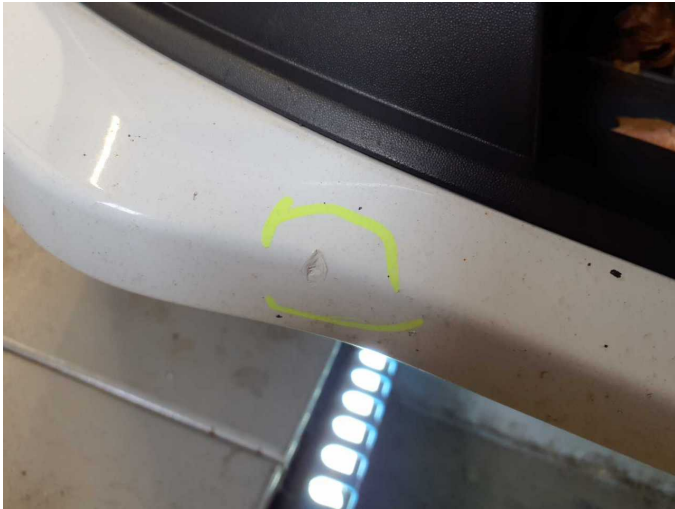
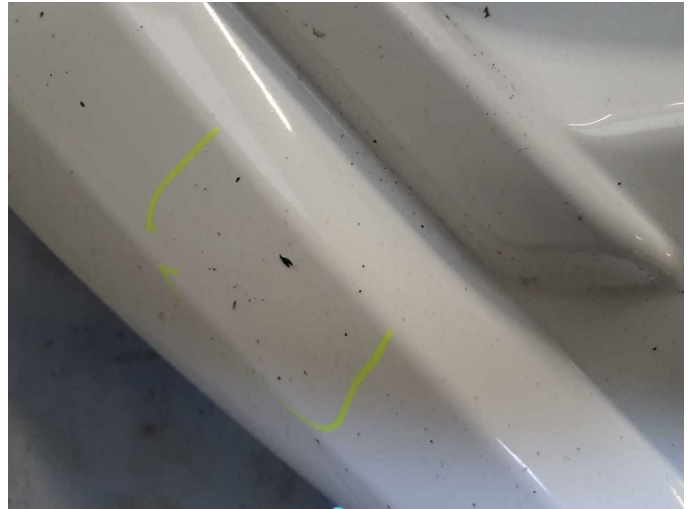
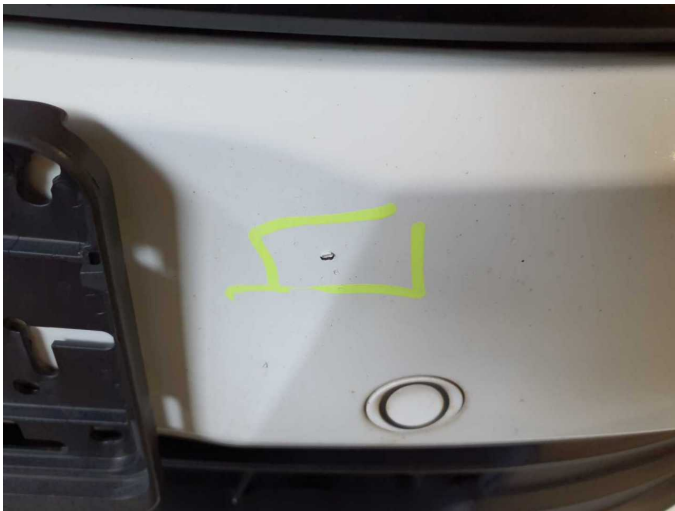
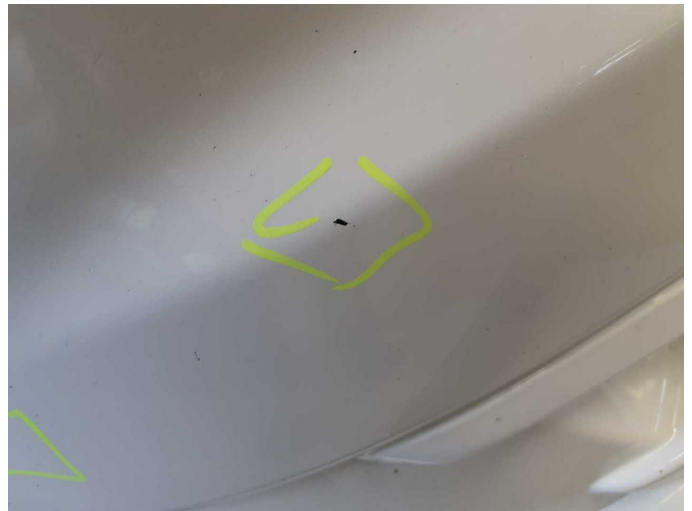
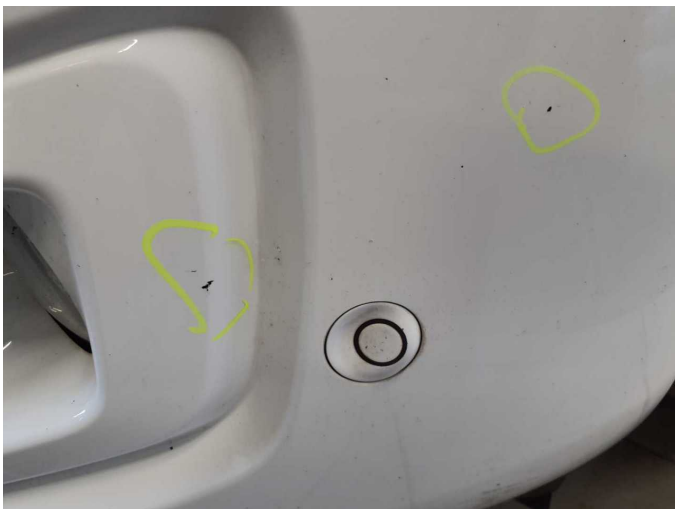
Damage 11: Front bumper: Front bumper - Scratched - Paint

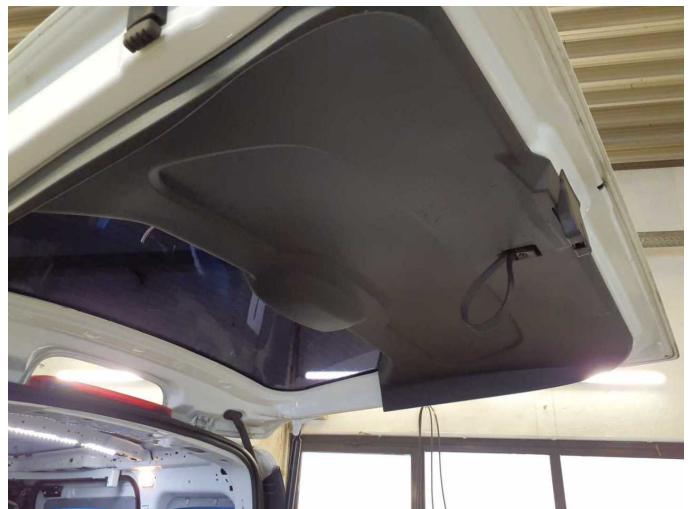
Wear and tear 1: Trim / covers: Boot lid - interior trim - Scratched - No deduction

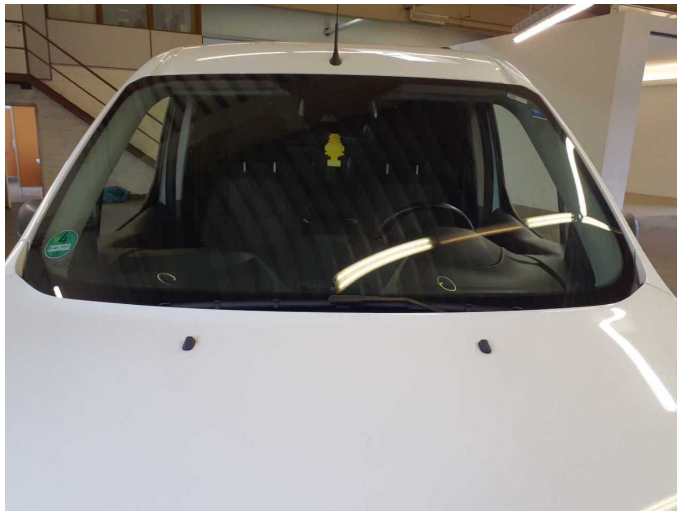
Wear and tear 2: Vehicle glazing: Windscreen - Stone chips - No deduction

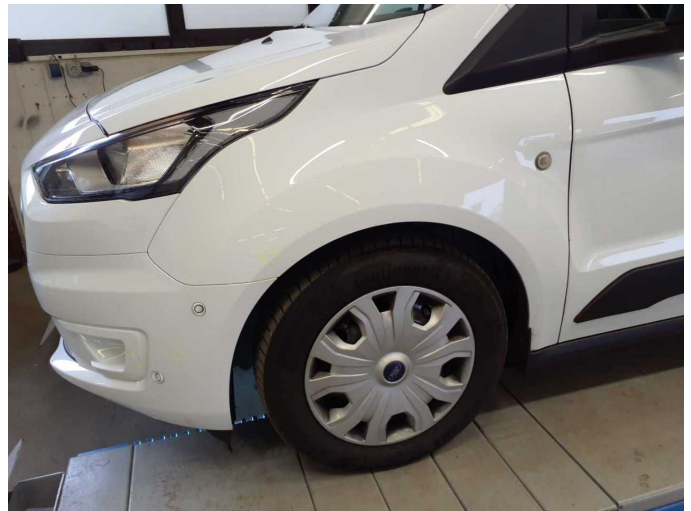
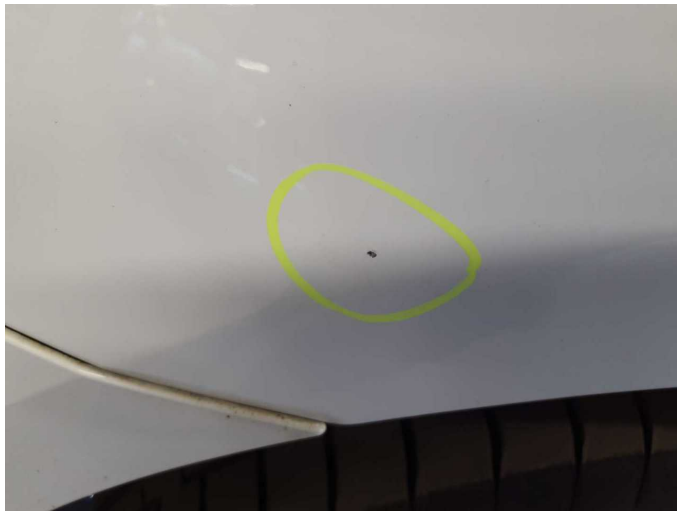
Wear and tear 3: Mudguard - left side: Wheel arch - Stone chips - No deduction

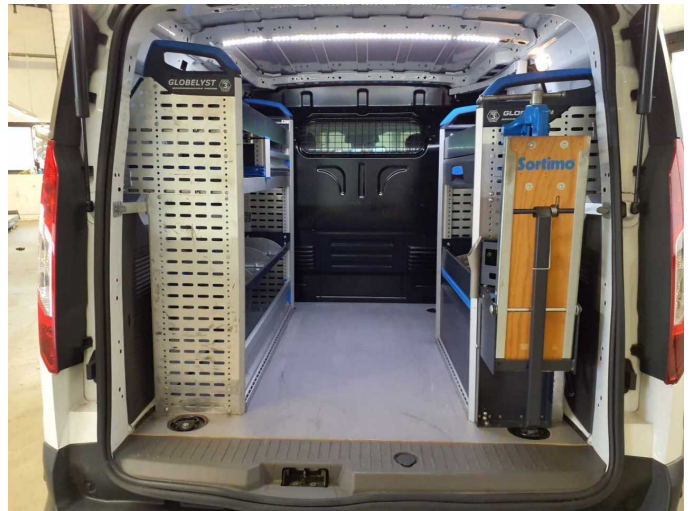
Wear and tear 4: Interior: Cargo area floor - Scratched - No deduction

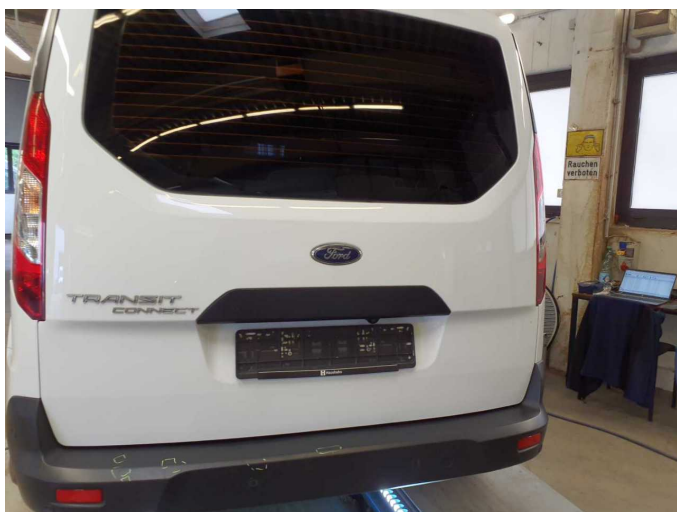
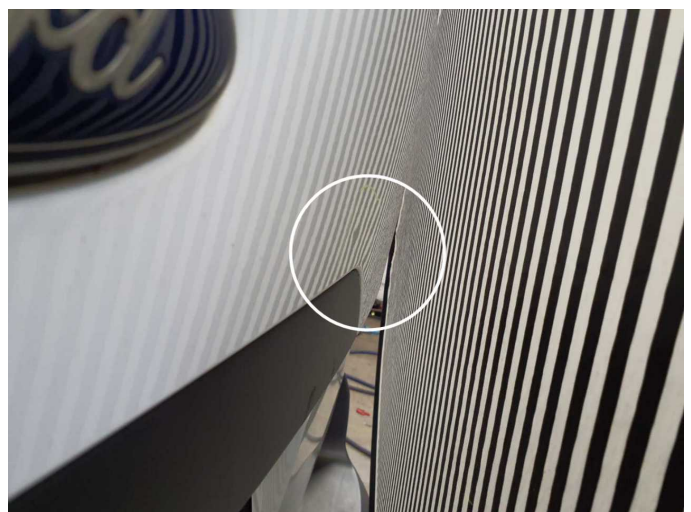
Wear and tear 5: Boot lid / rear door: Boot lid - dent(s) - Smooth repair work

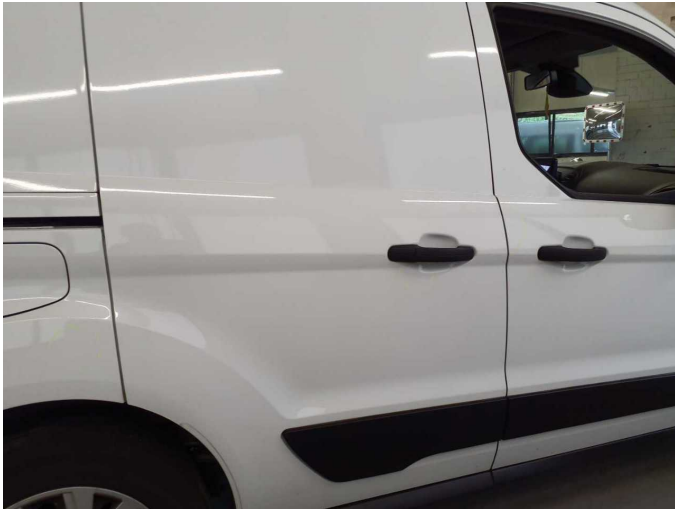
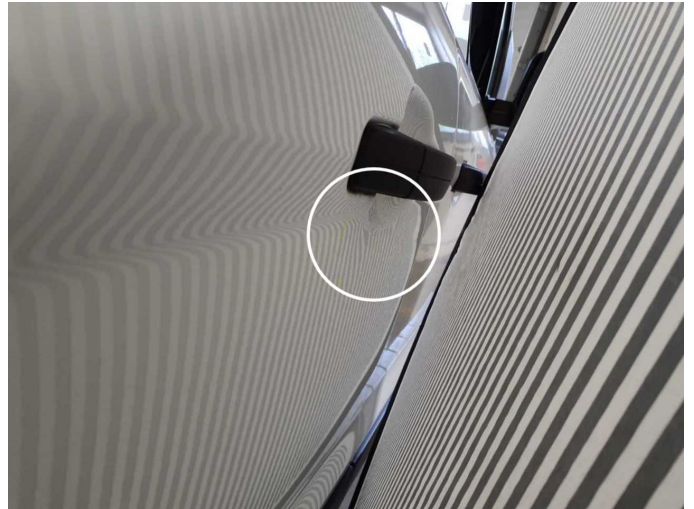
Wear and tear 6: Sliding door, right: Sliding door (außen) - dent(s) - No deduction

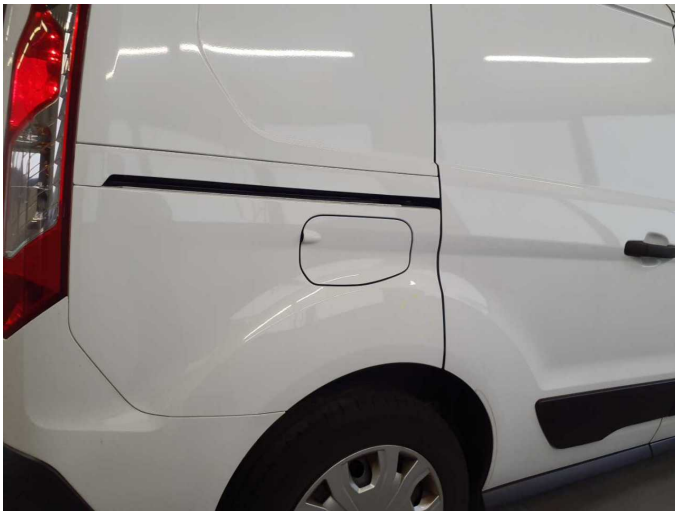
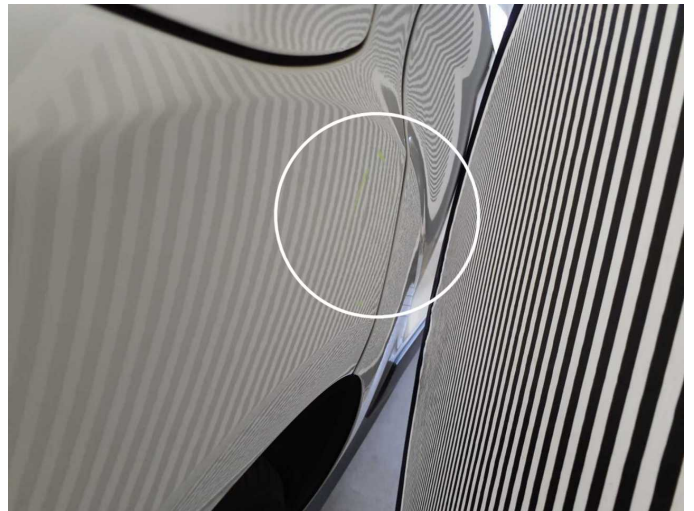
Wear and tear 7: Side panel - rear right side: Wheel arch - dent(s) - Smooth repair work

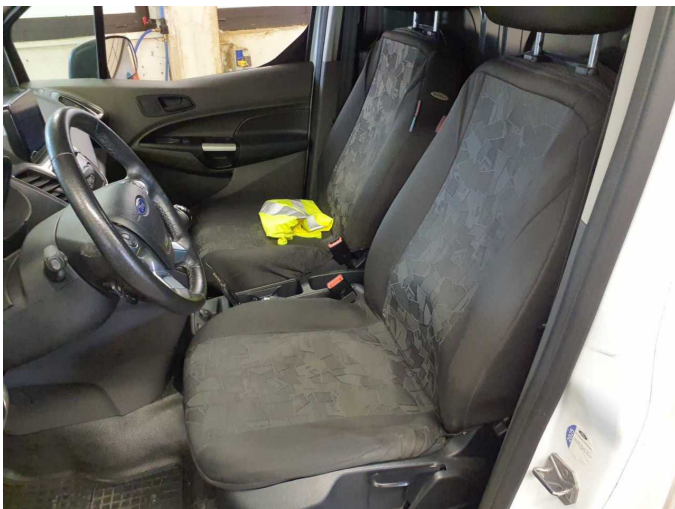
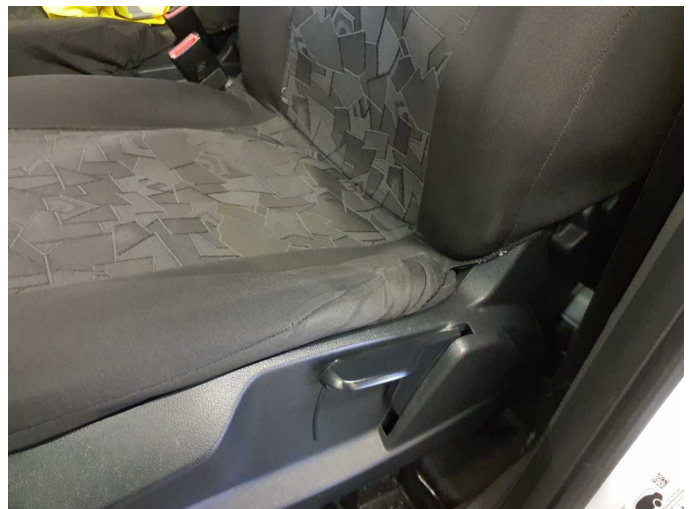
Wear and tear 8: Seat - front: Seat (Sitze haben Schonbezüge) - Differs from the original configuration - No deduction

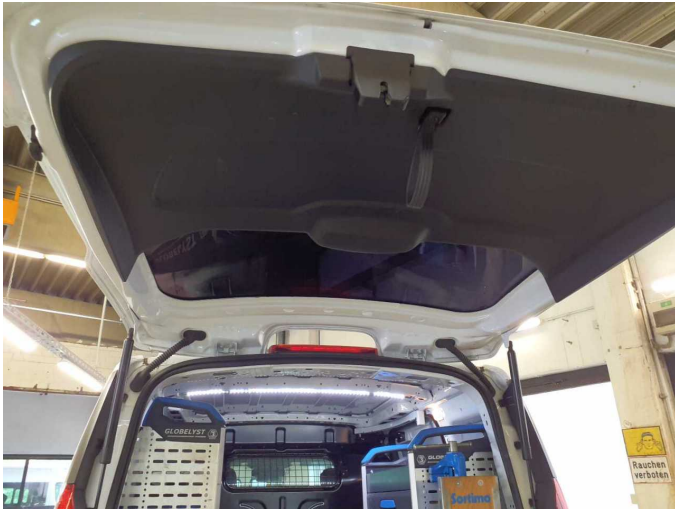
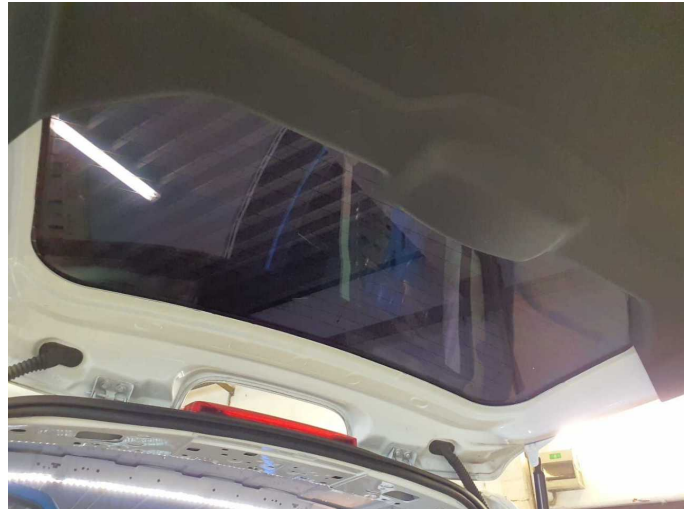
Wear and tear 9: Vehicle glazing: Rear window (Getönt) - Differs from the original configuration - No deduction

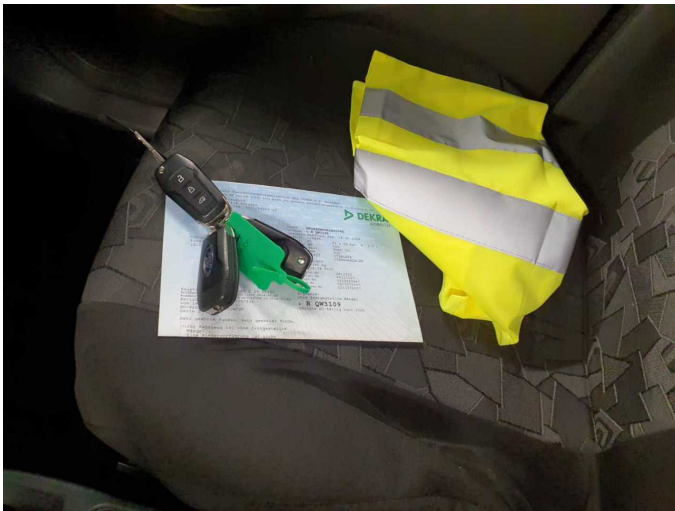
Missing part 1: Documents: Log book - Missing - Replace

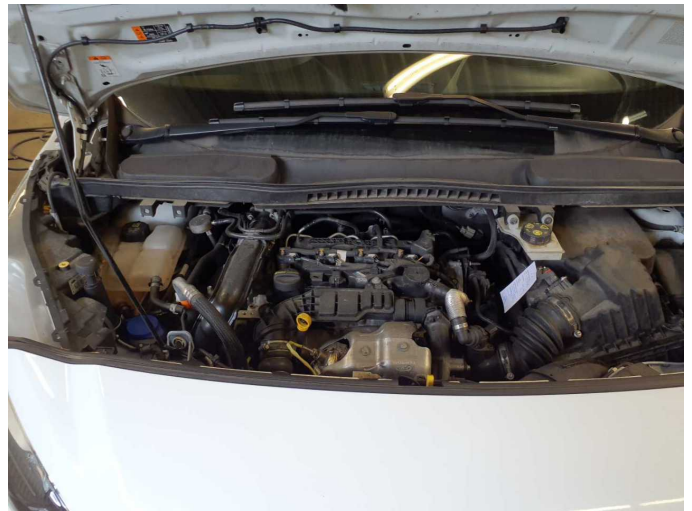
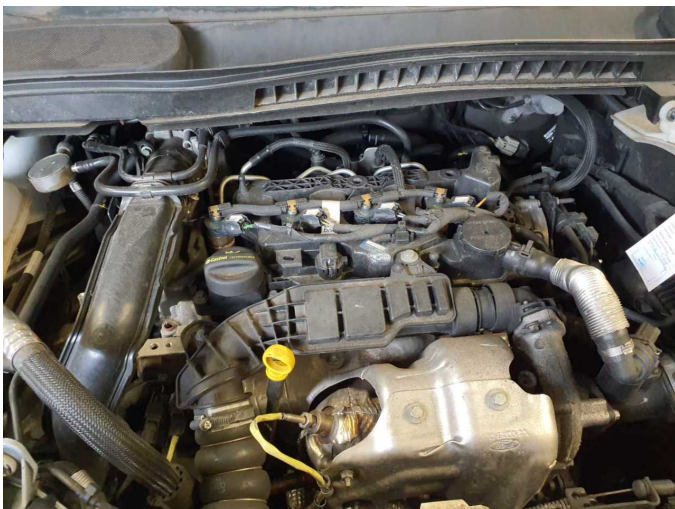
Missing part 2: Engine: Engine cover - Missing - Replace
