Expertise

Protocol number: 41637819
Order No. / Reference: 25254054
Inspection date: 22 Sept 2025

Manufacturer: Ford

Model: Transit Connect 240 L1 Trend

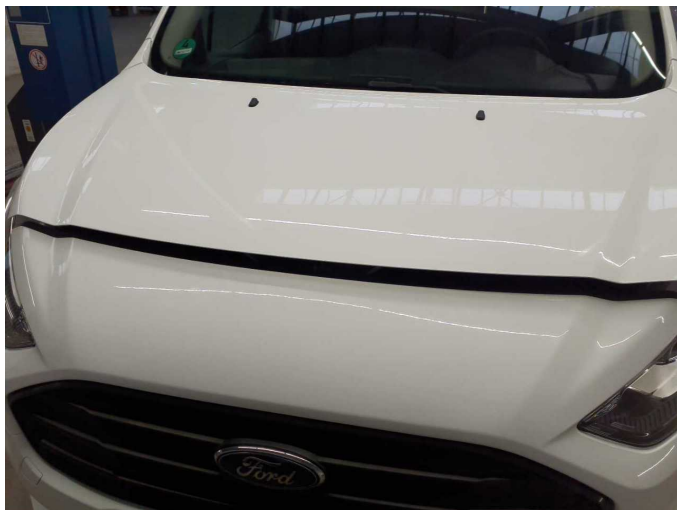
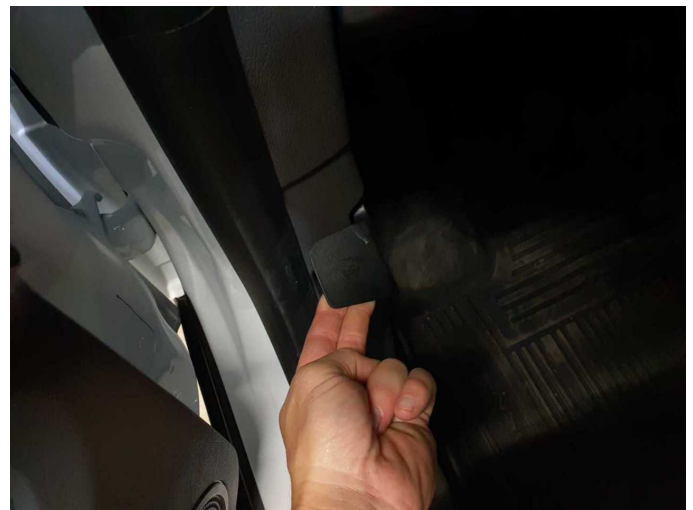
No.	Component group	Description
1	Bonnet	Bonnet (Seilzug gerissen) - Non-operational - Replace
2	Side panel - rear left side	Side panel - Dent / paintcoat damage - Repair and paint

Damage 1: Bonnet: Bonnet (Seilzug gerissen) - Non-operational - Replace

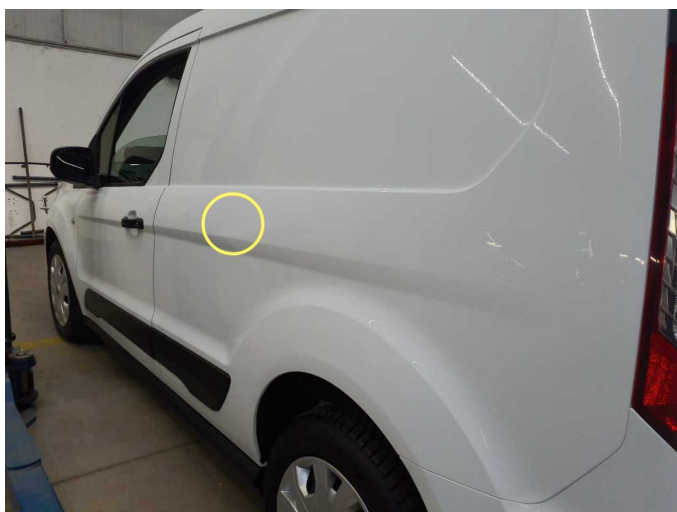
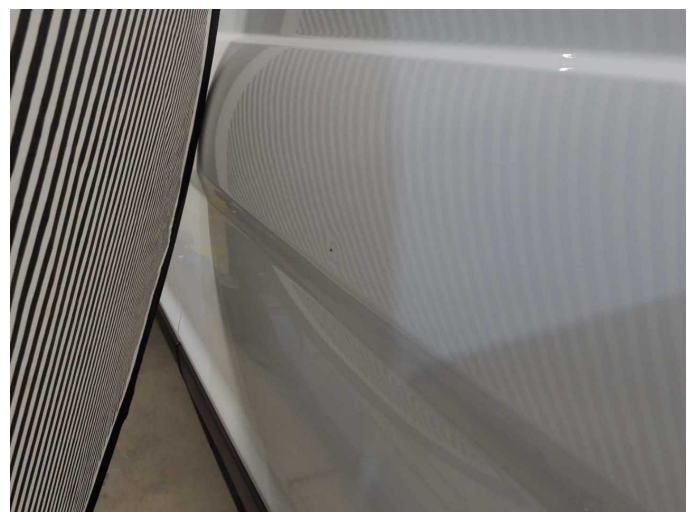
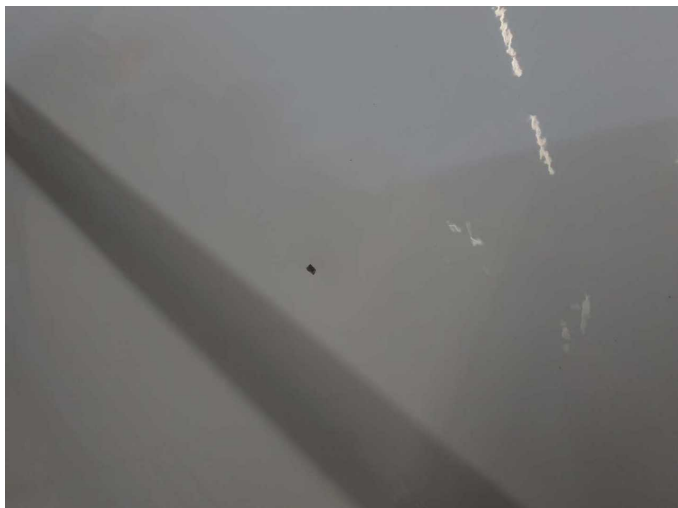
Damage 2: Side panel - rear left side: Side panel - Dent / paintcoat damage - Repair and paint

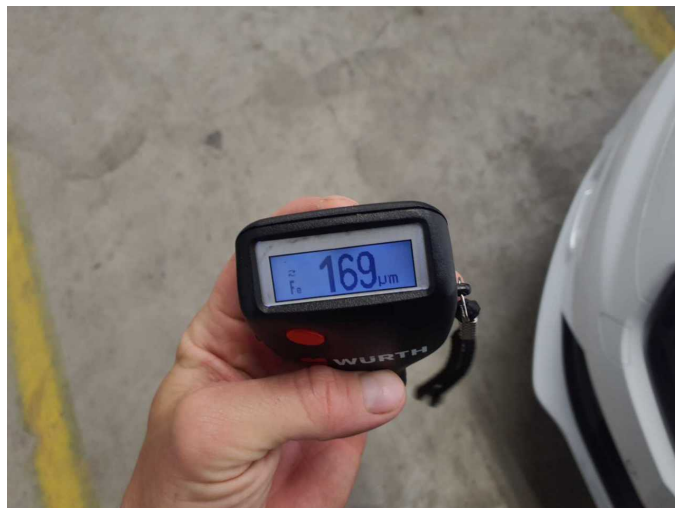
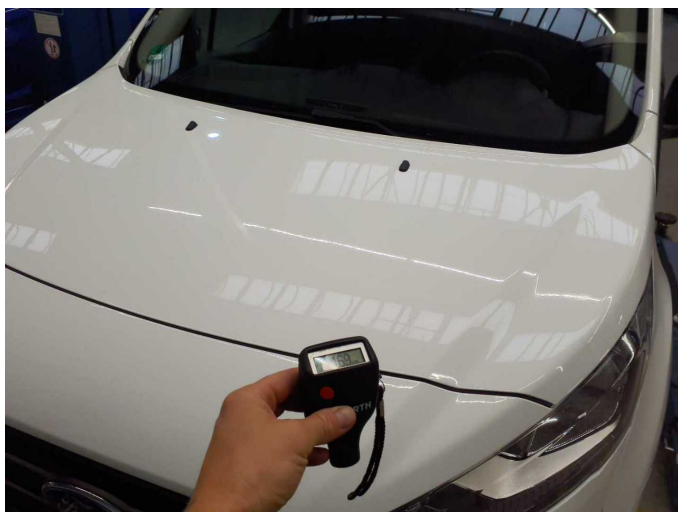
No.	Repainting
1	Bonnet, Professionally carried out, Invoice of repair done

Bonnet	169 µm
--------	--------

Repainting 1: Bonnet
