Expertise

Protocol number: 41618344
Order No. / Reference: 25133157
Inspection date: 18 Sept 2025

Manufacturer: Ford

Model: Transit Connect 240 L2 S&S Trend

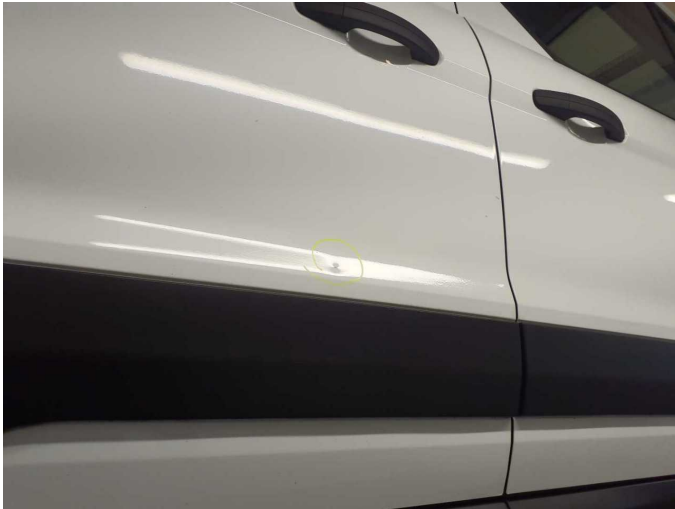
Damage 1: Sliding door, right: Sliding door - Dent / paintcoat damage - Smart repair

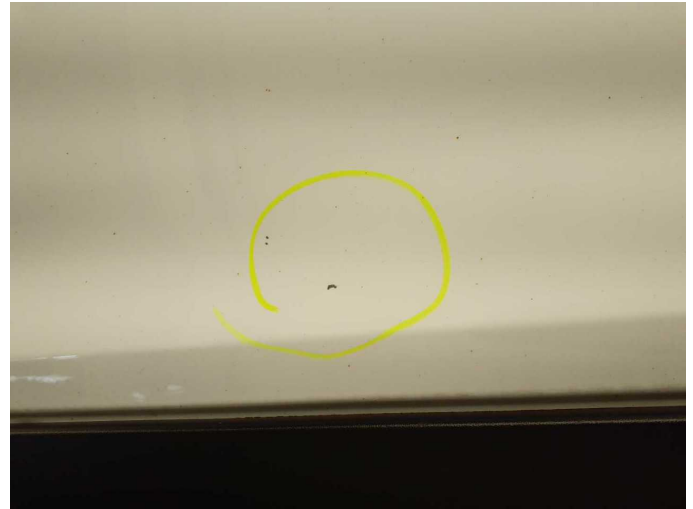
Damage 1: Sliding door, right: Sliding door - Dent / paintcoat damage - Smart repair

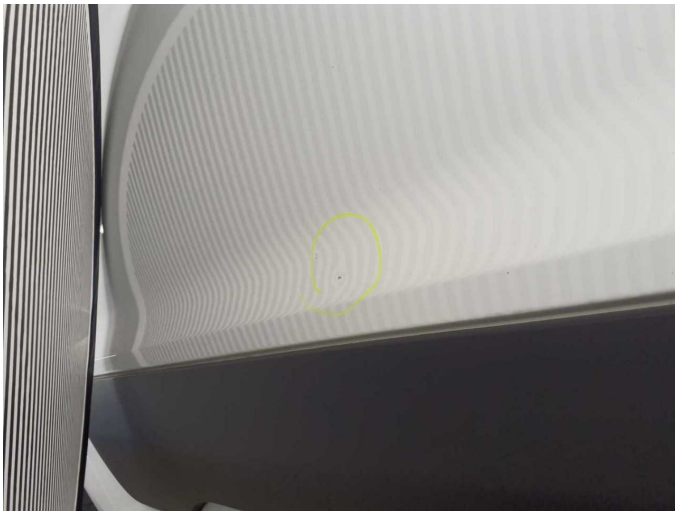
Damage 1: Sliding door, right: Sliding door - Dent / paintcoat damage - Smart repair

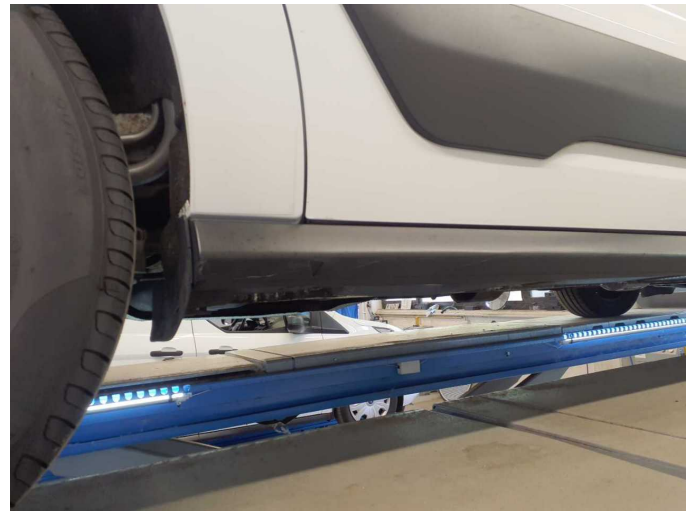
Damage 2: Sill - right side: Sill (hinten) - Scratch(es) - Replace

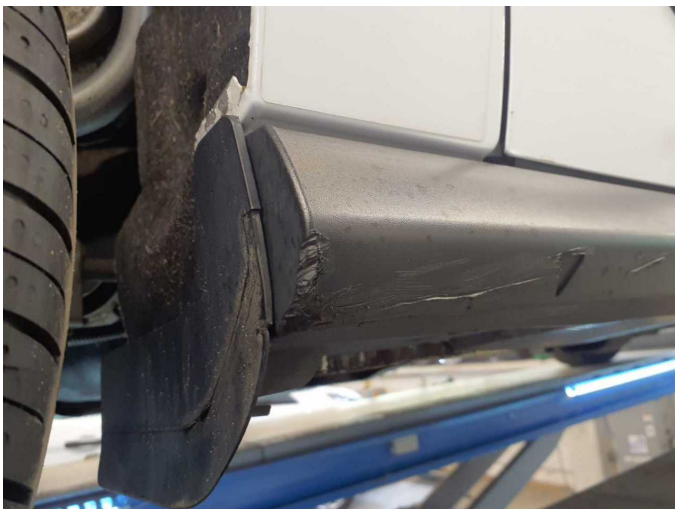
Damage 2: Sill - right side: Sill (hinten) - Scratch(es) - Replace

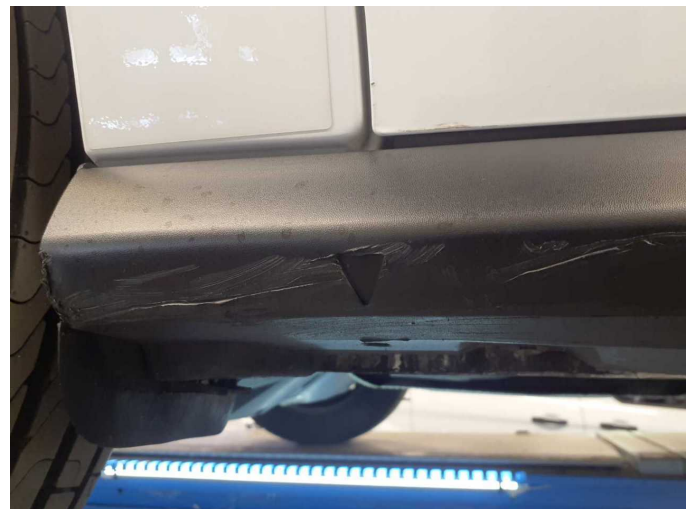
Damage 2: Sill - right side: Sill (hinten) - Scratch(es) - Replace

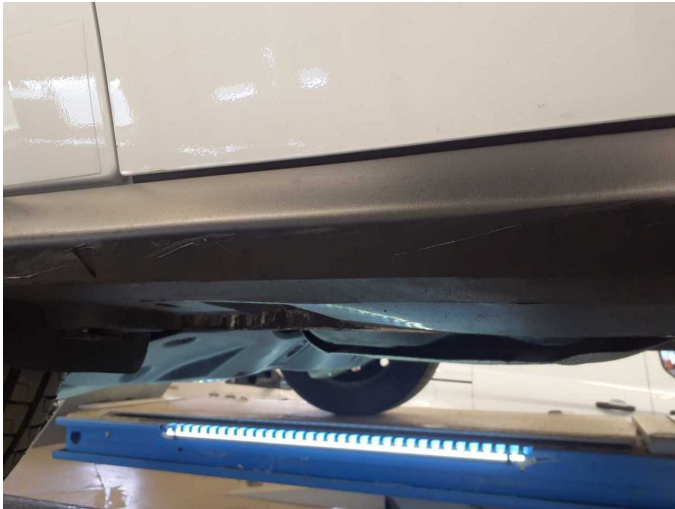
Damage 2: Sill - right side: Sill (hinten) - Scratch(es) - Replace

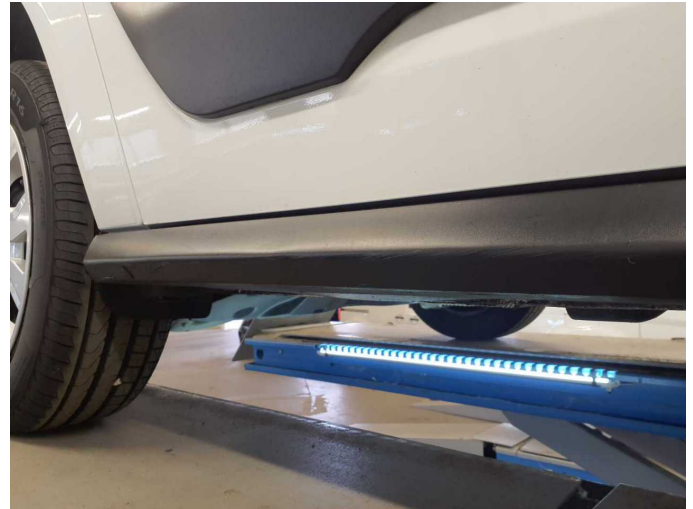
Damage 2: Sill - right side: Sill (hinten) - Scratch(es) - Replace

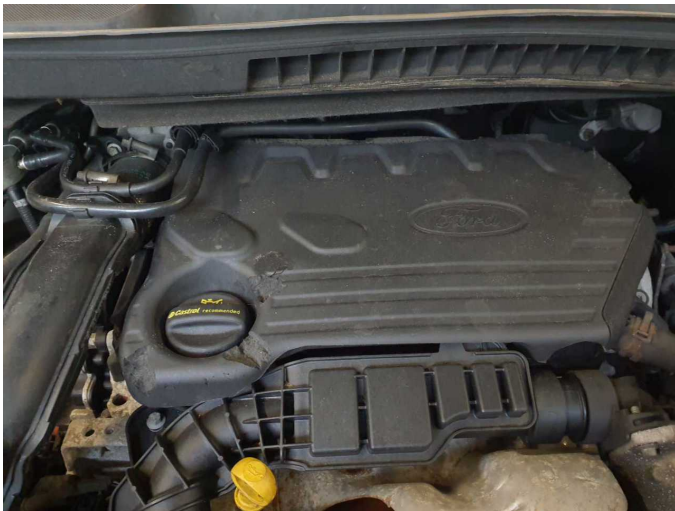
Damage 3: Engine: Engine cover - Damage caused by marten / rodent - Replace

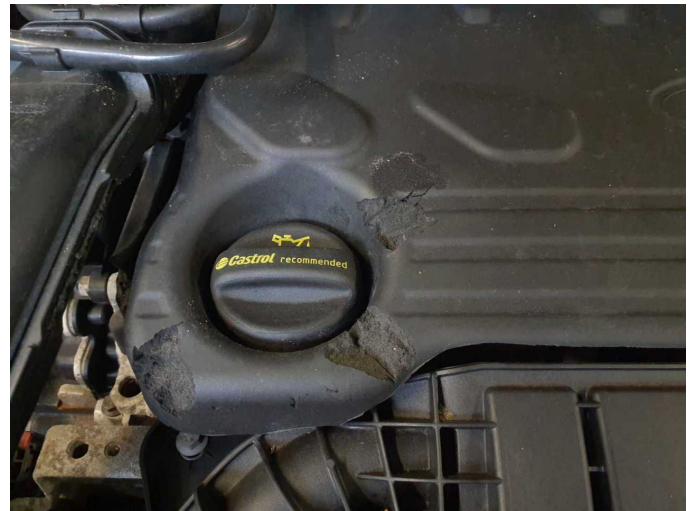
Damage 3: Engine: Engine cover - Damage caused by marten / rodent - Replace

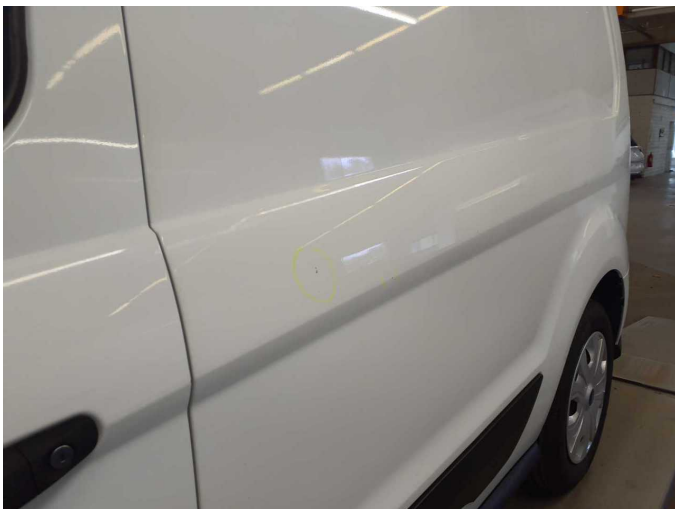
Damage 4: Side panel - rear left side: Side panel (3 Dellen+Kratzer) - Dent / paintcoat damage - Smart repair

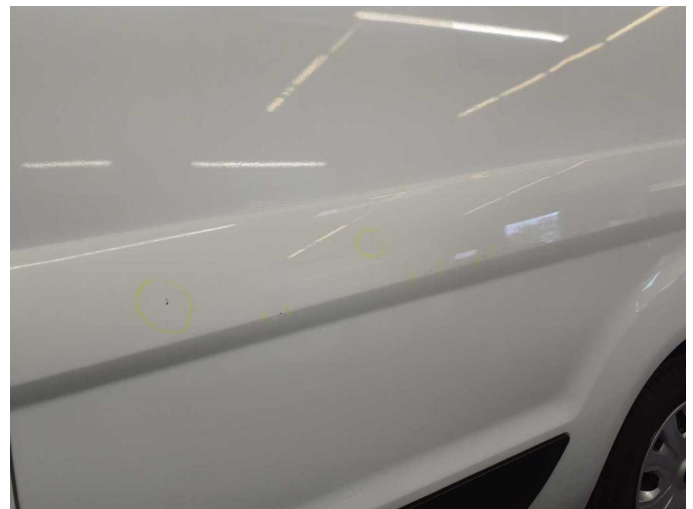
Damage 4: Side panel - rear left side: Side panel (3 Dellen+Kratzer) - Dent / paintcoat damage - Smart repair

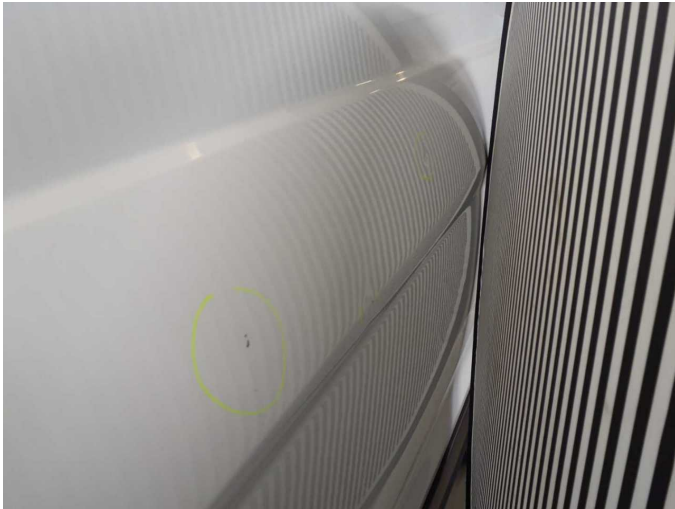
Damage 4: Side panel - rear left side: Side panel (3 Dellen+Kratzer) - Dent / paintcoat damage - Smart repair

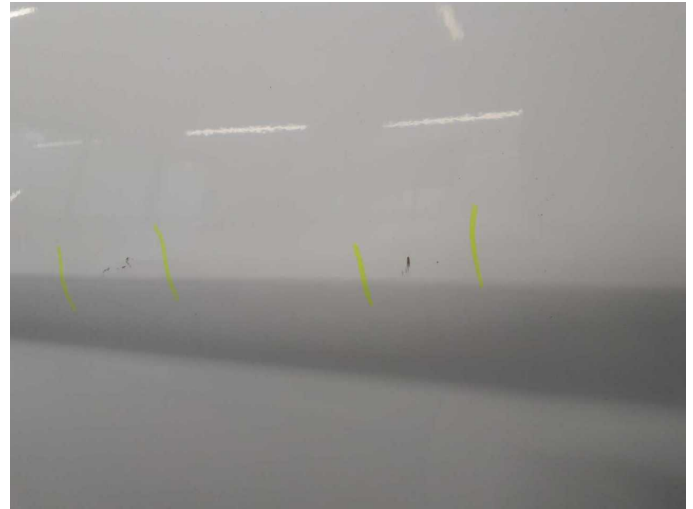
Damage 4: Side panel - rear left side: Side panel (3 Dellen+Kratzer) - Dent / paintcoat damage - Smart repair

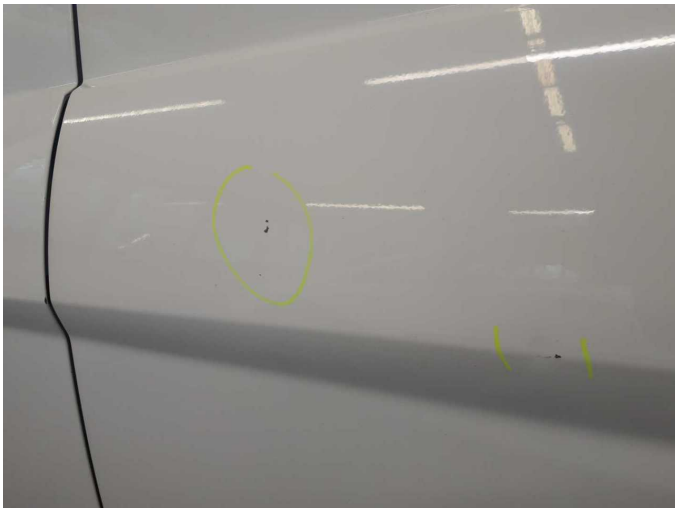
Damage 4: Side panel - rear left side: Side panel (3 Dellen+Kratzer) - Dent / paintcoat damage - Smart repair

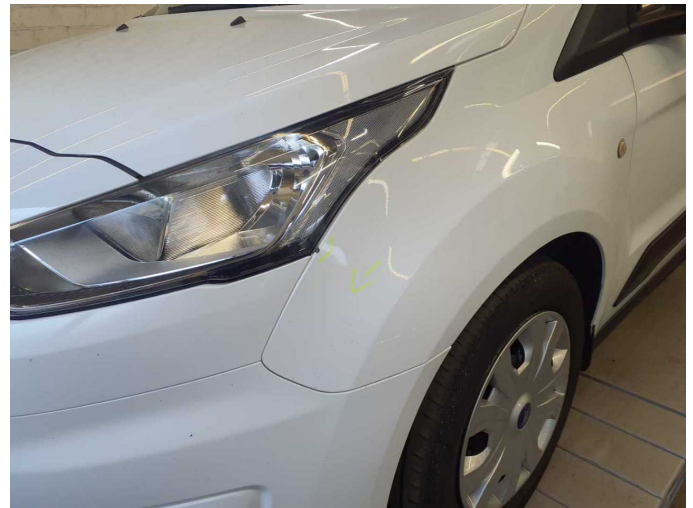
Damage 5: Mudguard - left side: Mudguard - left side (+Steinschläge) - Paint defect - Paint

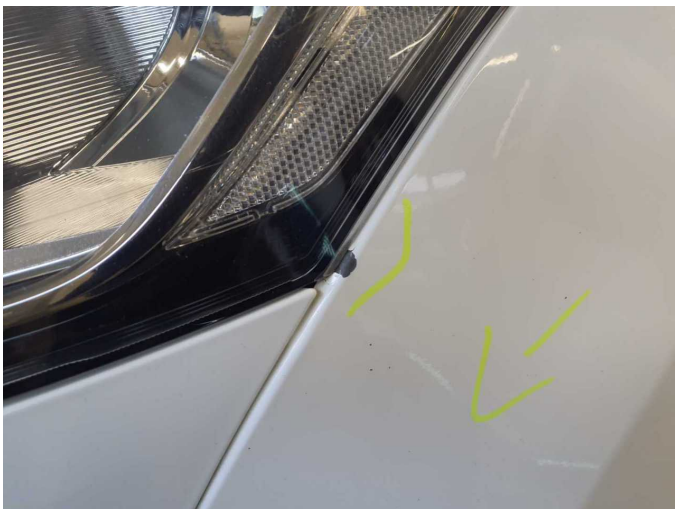
Damage 5: Mudguard - left side: Mudguard - left side (+Steinschläge) - Paint defect - Paint

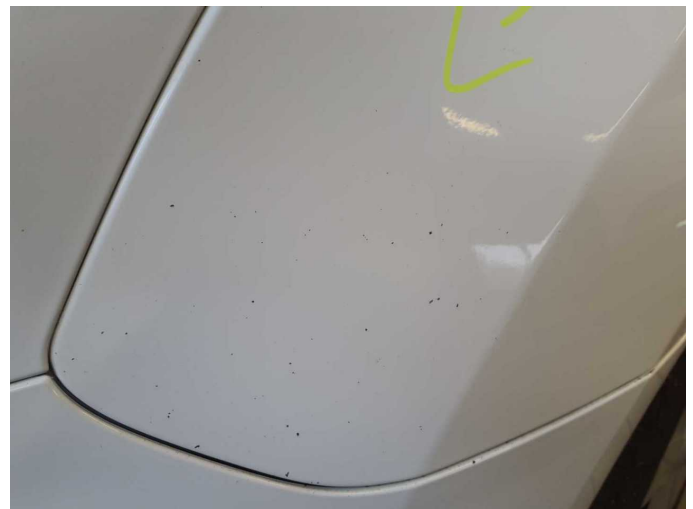
Damage 5: Mudguard - left side: Mudguard - left side (+Steinschläge) - Paint defect - Paint

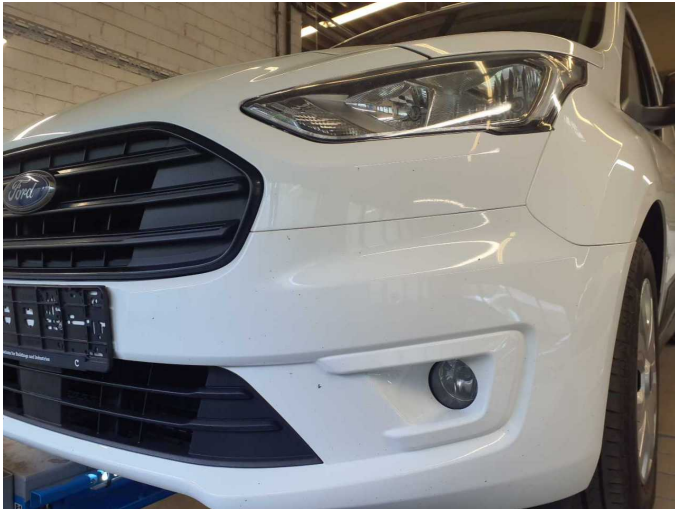
Damage 6: Front bumper: Front bumper (Sandstrahleffekt) - Scratch(es)
- Paint

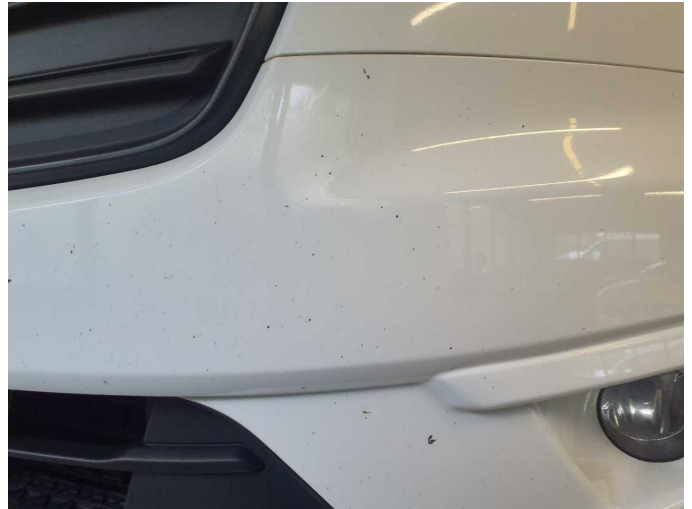
Damage 6: Front bumper: Front bumper (Sandstrahleffekt) - Scratch(es)
- Paint

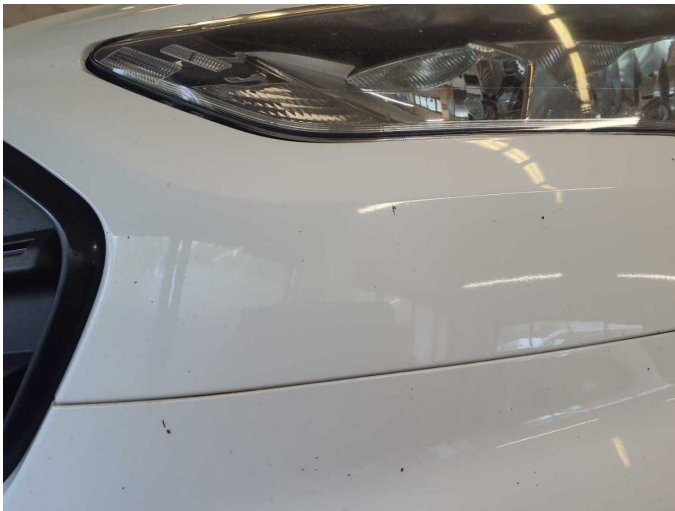
Damage 6: Front bumper: Front bumper (Sandstrahleffekt) - Scratch(es)
- Paint

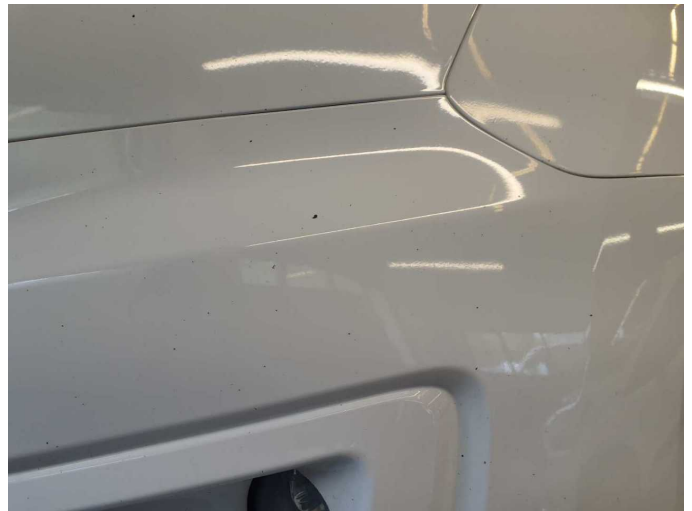
Damage 6: Front bumper: Front bumper (Sandstrahleffekt) - Scratch(es)
- Paint

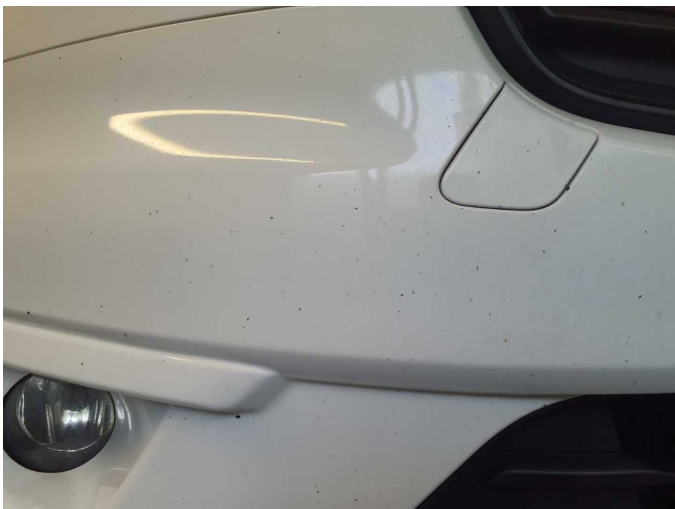
Damage 6: Front bumper: Front bumper (Sandstrahleffekt) - Scratch(es)
- Paint

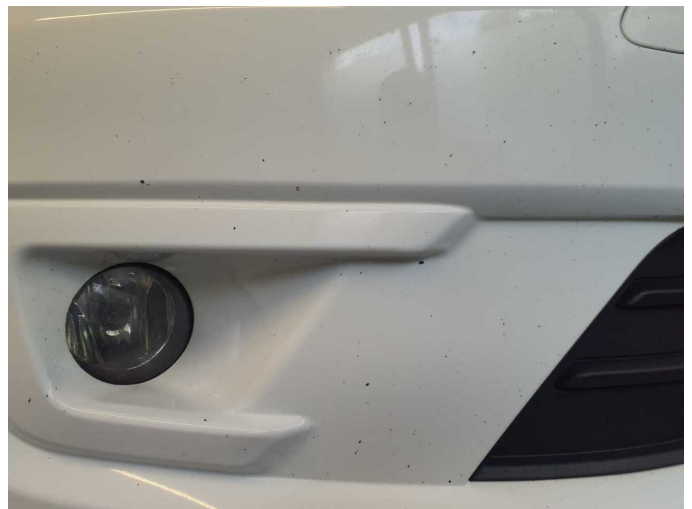
Damage 6: Front bumper: Front bumper (Sandstrahleffekt) - Scratch(es)
- Paint

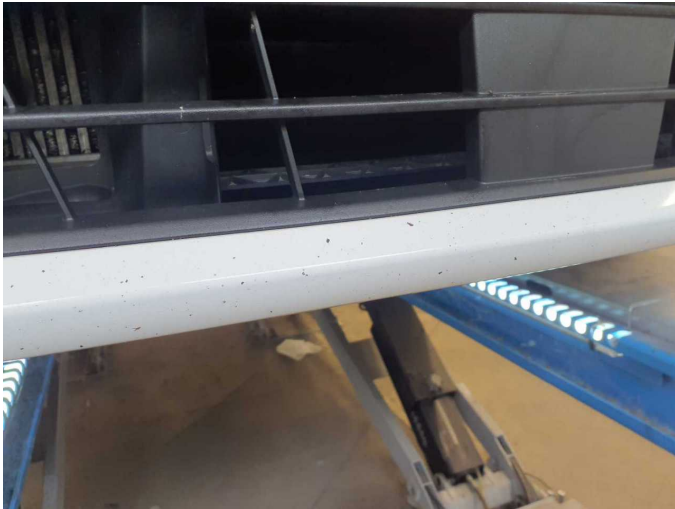
Damage 6: Front bumper: Front bumper (Sandstrahleffekt) - Scratch(es)
- Paint
