Expertise

Protocol number: 41554376  
Order No. / Reference: 25187011  
Inspection date: 17 Sept 2025

Manufacturer: Ford

Model: Transit Connect 240 L2 S&S Trend

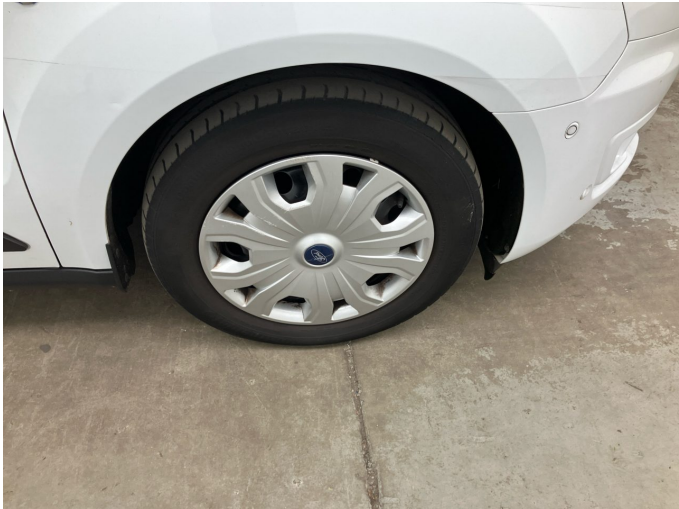
Figure 12: Mounted tyres

#	Tyre size	Type of tyre	Manufacturer	Tread depth
1)	205/60 R16 96H	Summer tyres on Steel rim with wheel cover	Continental	3mm / 3mm
2)	205/60 R16 96H	Summer tyres on Steel rim with wheel cover	Continental	6mm / 6mm

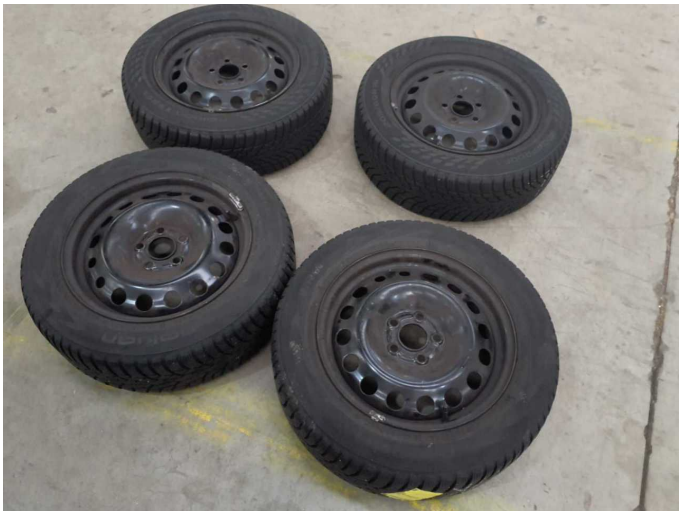
Figure 14: Additional tyres

#	Tyre size	Type of tyre	Manufacturer	Tread depth
1)	205/60 R16 96H	Winter tyres on Steel	Nokian	5mm / 5mm
2)	205/60 R16 96H	Winter tyres on Steel	Nokian	6mm / 6mm

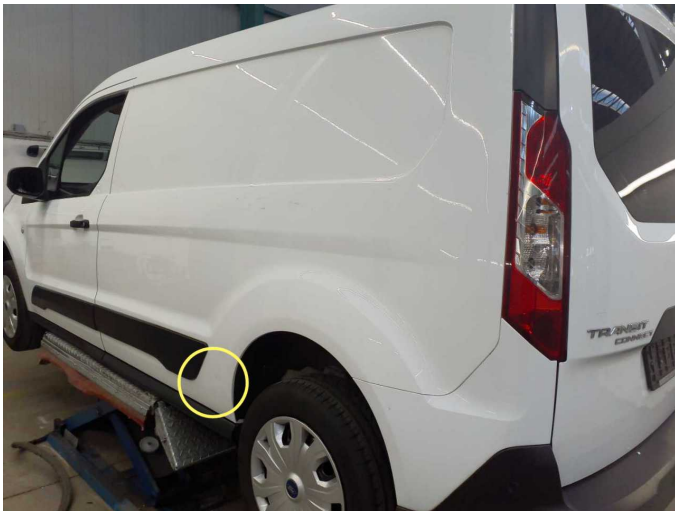
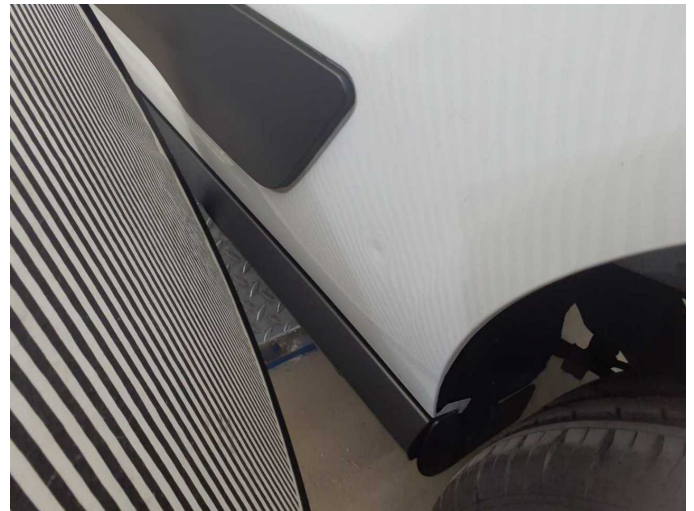
Damage 1: Side panel - rear left side: Side panel - dent(s) - Smooth repair work

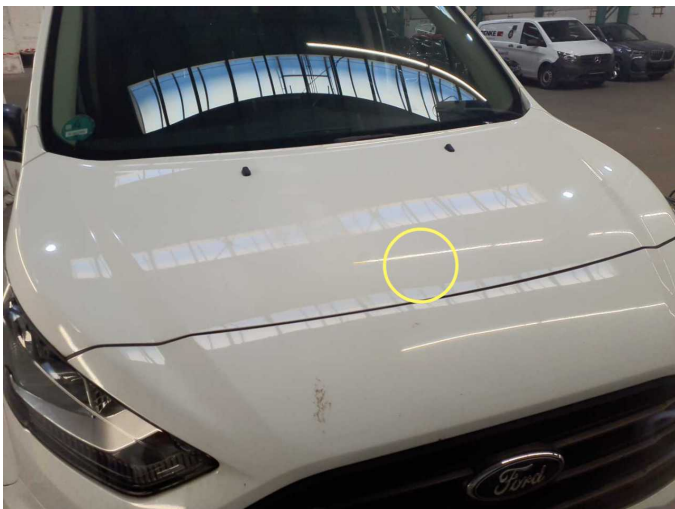
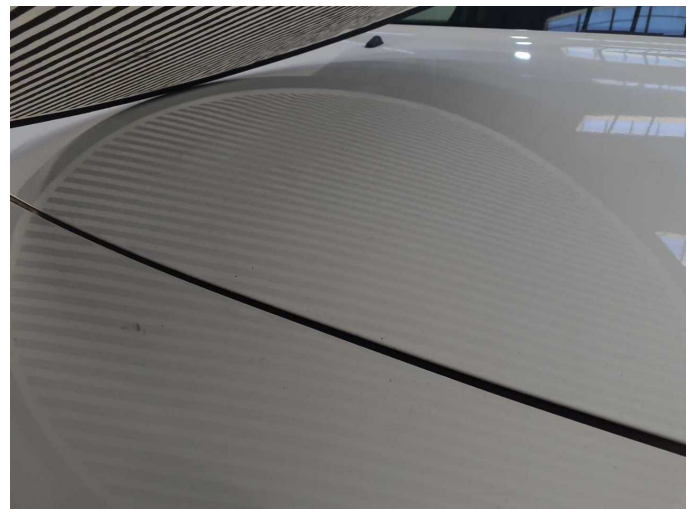
Damage 2: Bonnet: Bonnet - dent(s) - Smooth repair work

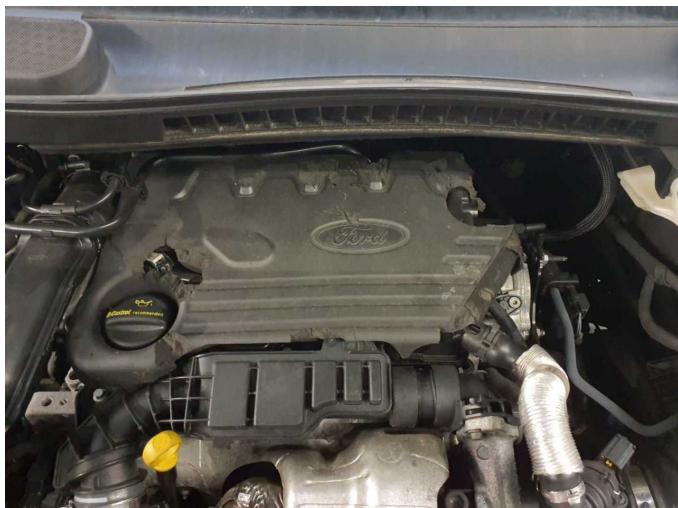
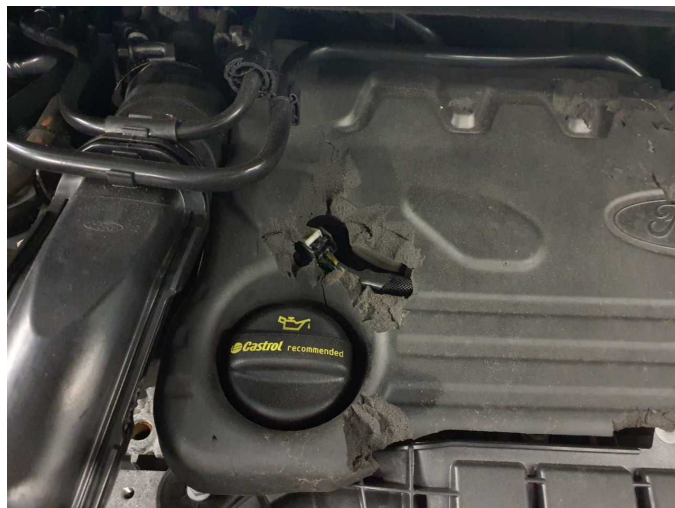
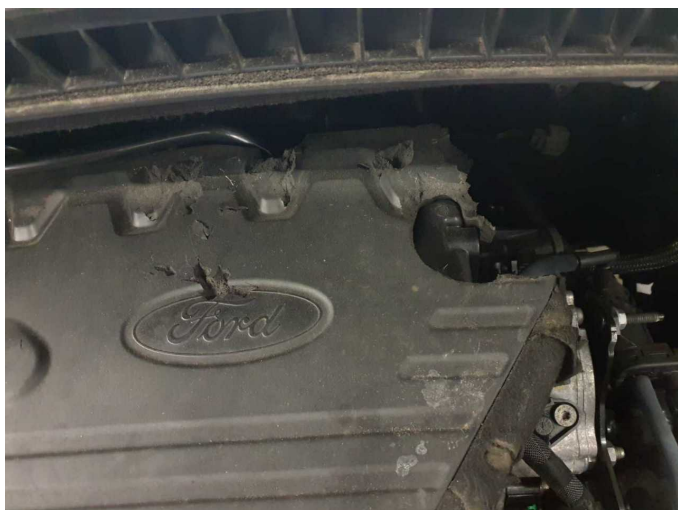
**Damage 3:** Engine: Engine cover - Broken / torn - Replace

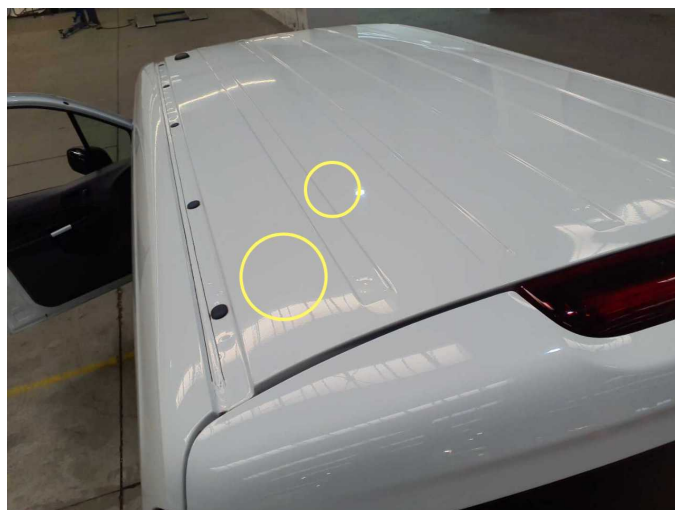
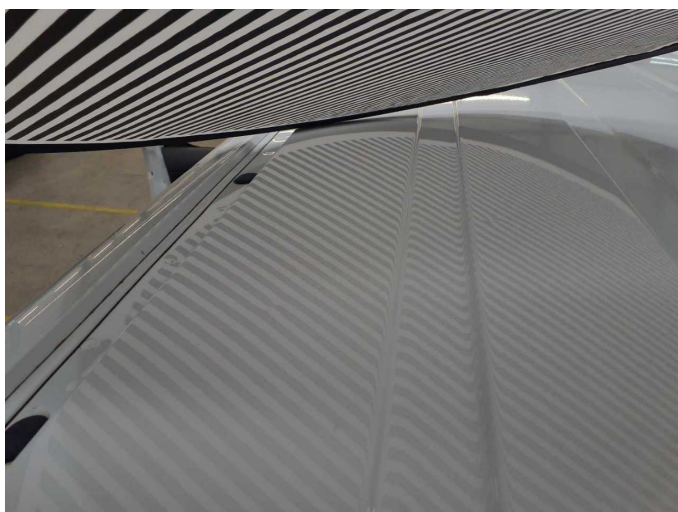
**Damage 4:** Roof: Roof - dent(s) - Smooth repair work

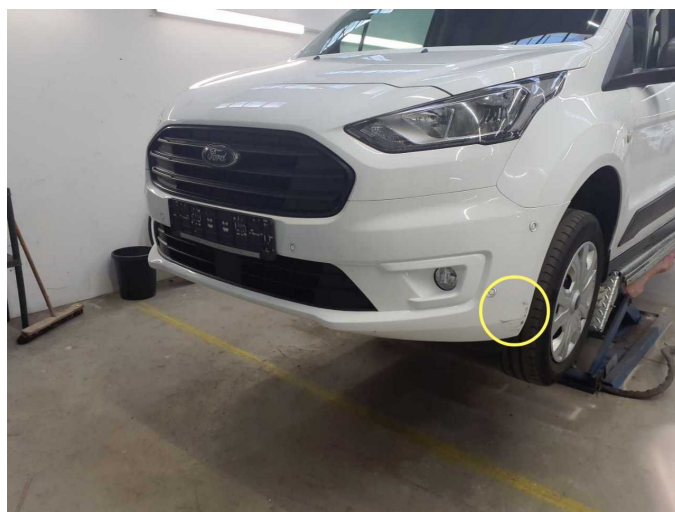
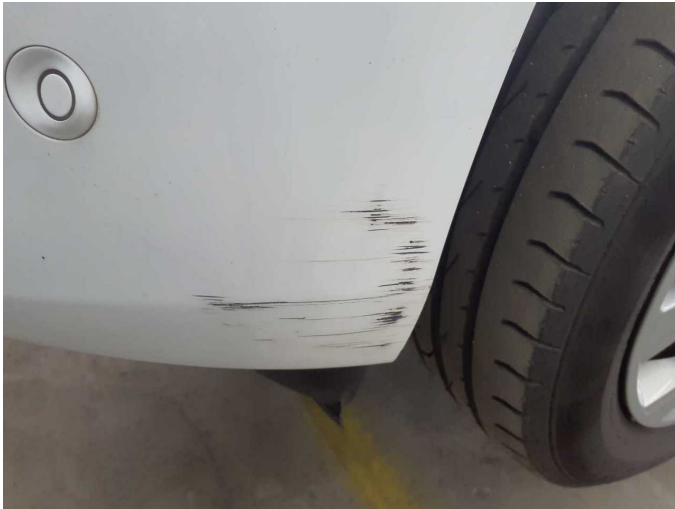
**Damage 5:** Front bumper: Front bumper - Scratched - Paint

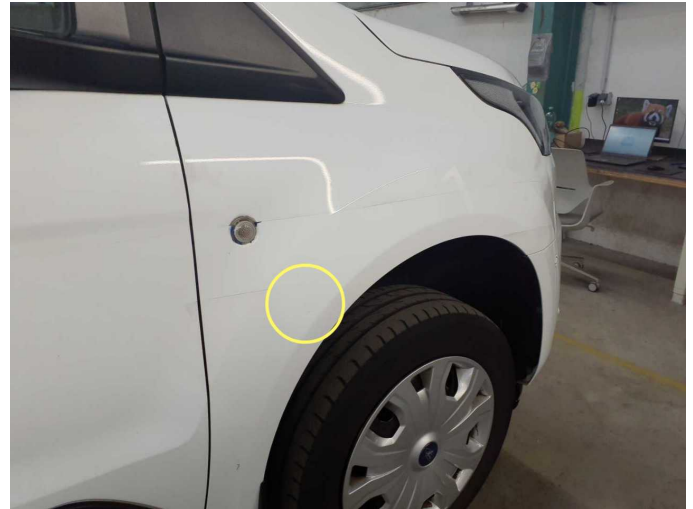
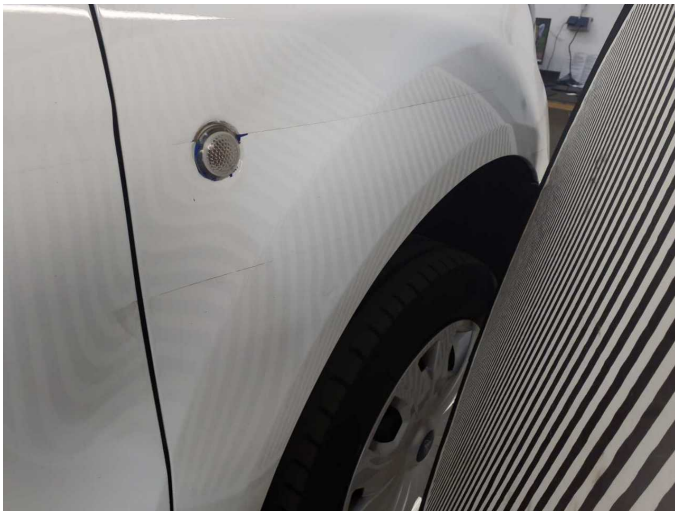
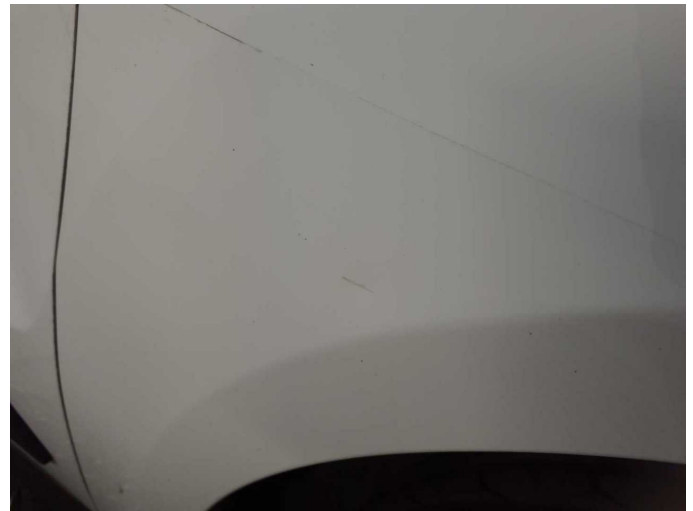
**Damage 6:** Mudguard - right side: Mudguard - right side - Dent / paintcoat damage - Repair and paint

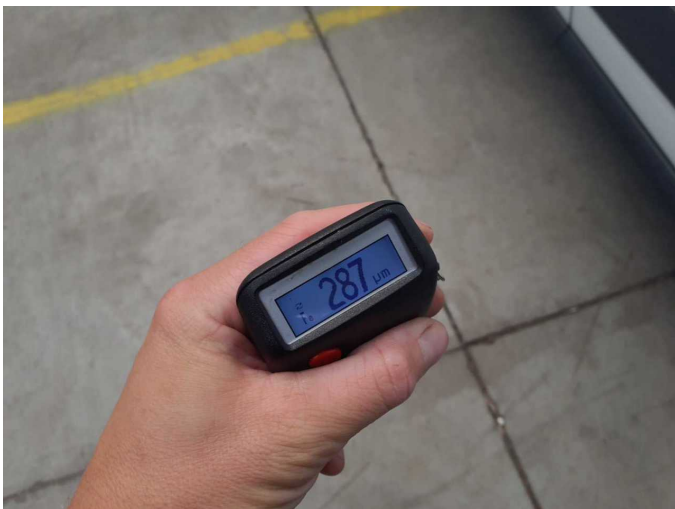
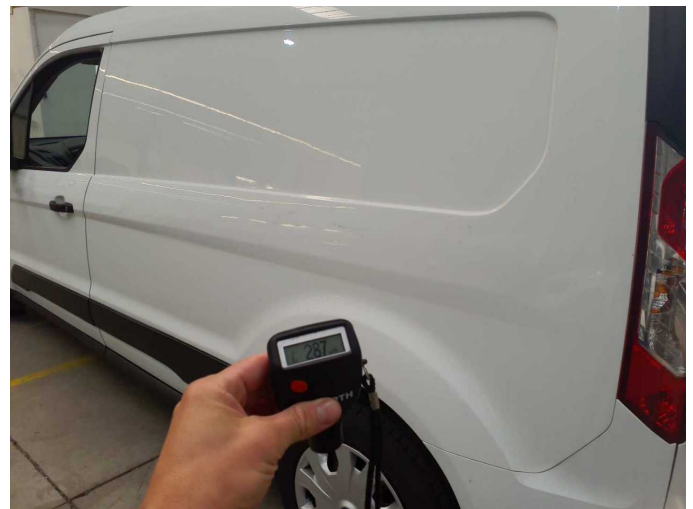
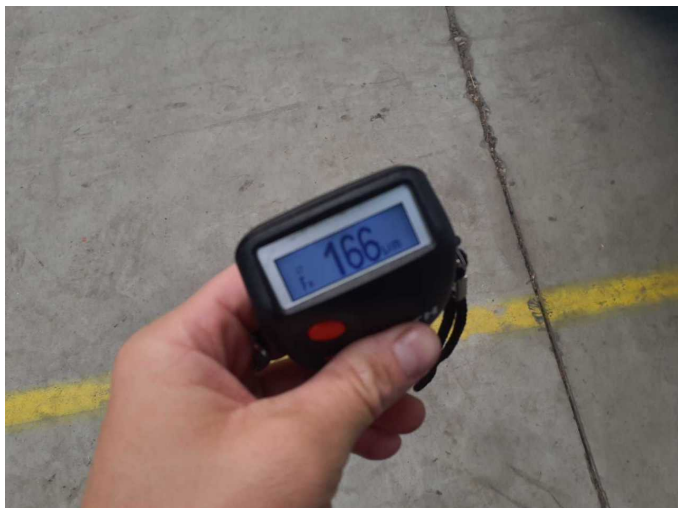
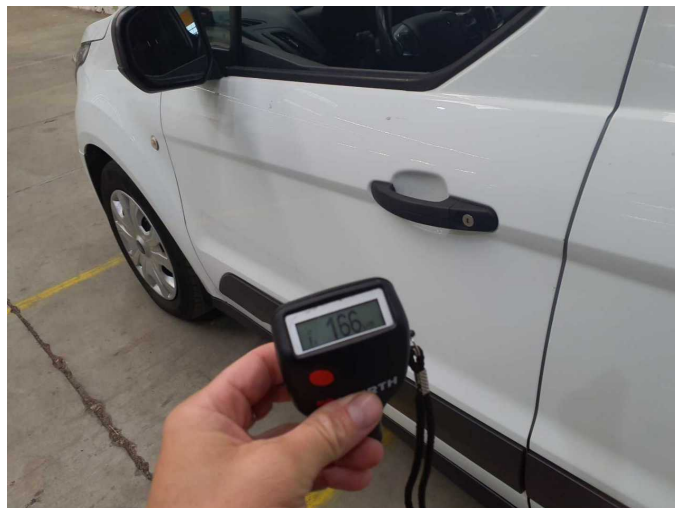
No.	Repainting
1	Side panel - rear left side, Door - front left side, Professionally carried out, Invoice of repair done Non-existent

Side panel - rear left side

287 µm

Door - front left side

166 µm

**Repainting 1:** Side panel - rear left side, Door - front left side
