Expertise

Protocol number: 41548444
Order No. / Reference: 25186879
Inspection date: 16 Sept 2025

Manufacturer: Ford

Model: Transit Connect 240 L2 S&S Trend

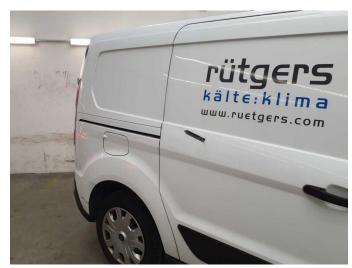
Damage 1: Door - rear right side: Door - dent(s) - Smooth repair work

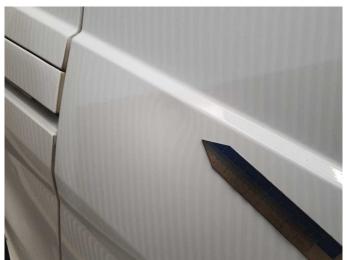
Damage 1: Door - rear right side: Door - dent(s) - Smooth repair work

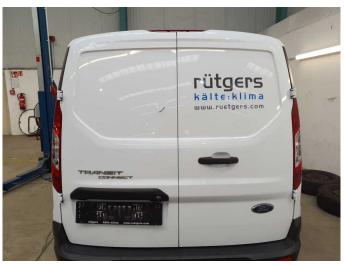
Damage 2: Body: Body - Glued / labelled - De-glue / neutralise

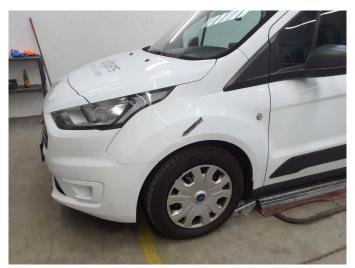
$\textbf{Damage 3:} \ \mathsf{Mudguard - left \ side:} \ \mathsf{Mudguard - left \ side - dent}(s) - \mathsf{Repair} \\ \mathsf{and \ paint}$

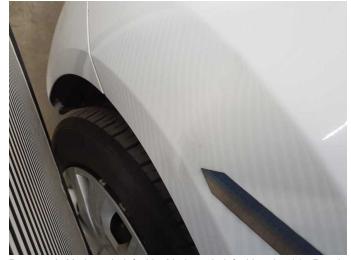
$\textbf{Damage 3:} \ \mathsf{Mudguard - left \ side:} \ \mathsf{Mudguard - left \ side - dent}(s) - \mathsf{Repair} \\ \mathsf{and} \ \mathsf{paint}$

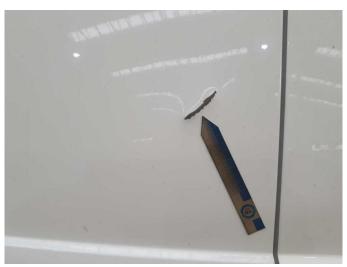
Damage 4: Rear bumper: Rear bumper - Scratched - Repair and paint

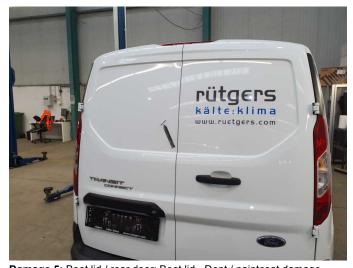
Damage 5: Boot lid / rear door: Boot lid - Dent / paintcoat damage - Repair and paint

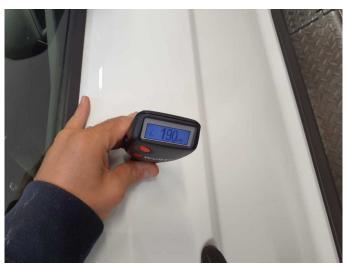
Mudguard - right side 244 μm Door - front right side 190 μm

Repainting 1: Mudguard - right side

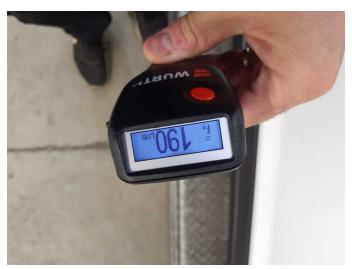
Repainting 2: Door - front right side
