Expertise

Protocol number: 41652352
Order No. / Reference: 25229612
Inspection date: 22 Sept 2025

Manufacturer: Ford	Model: Transit Connect 240 L2 S&S Trend
VIN: WF0SXXWPGSLD02596

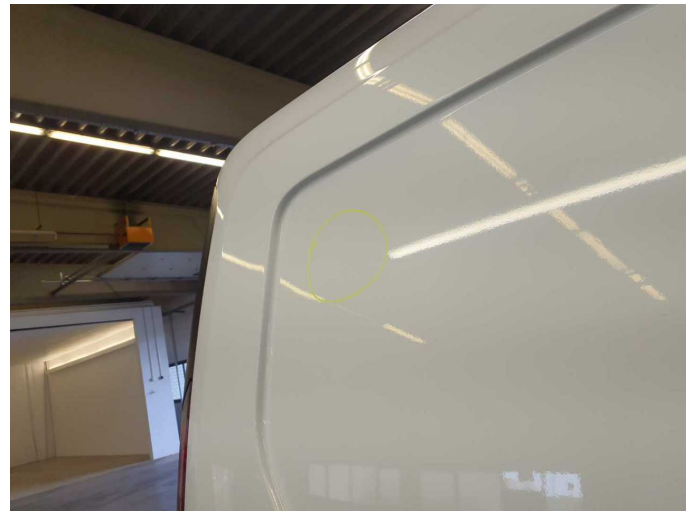
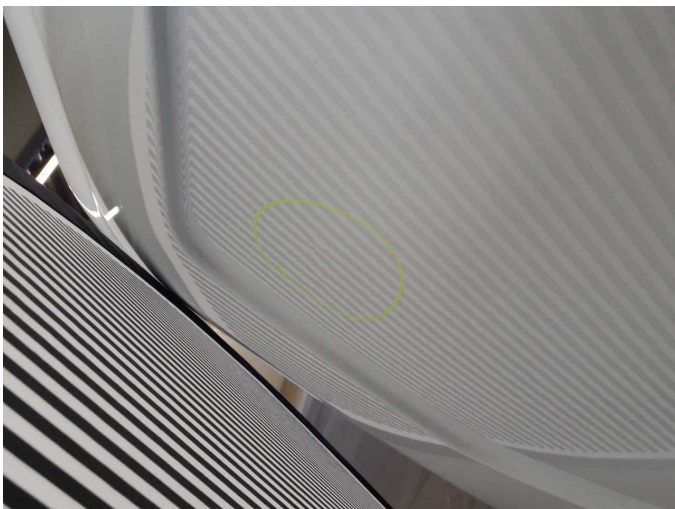
Damage 1: Side panel - rear right side: Side panel (2 Beulen) - dent(s) - Smart repair

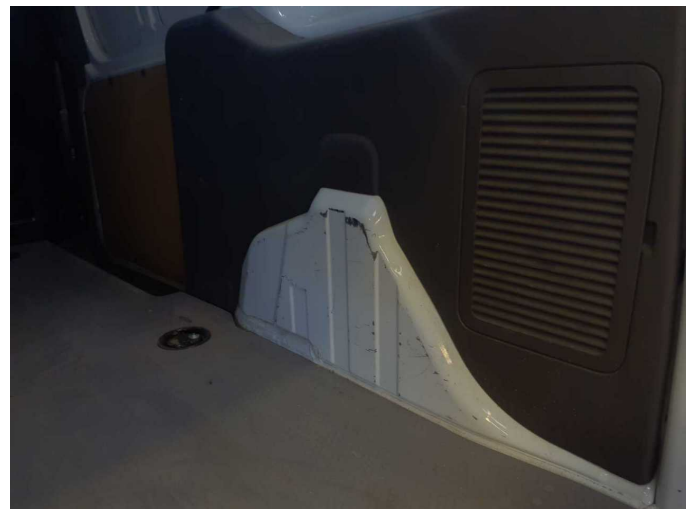
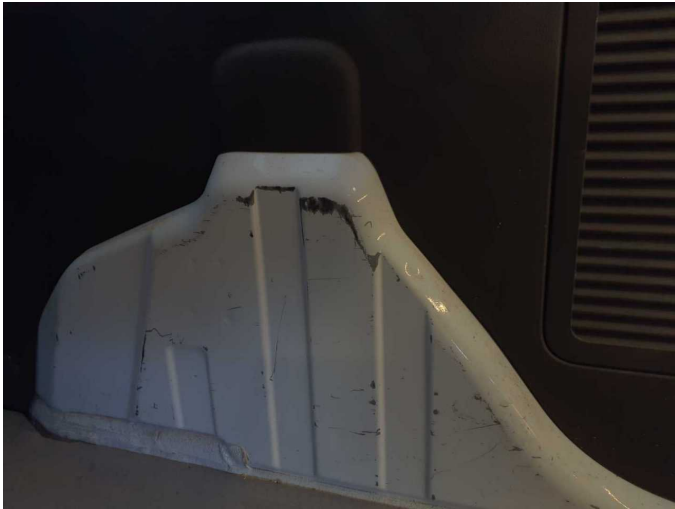
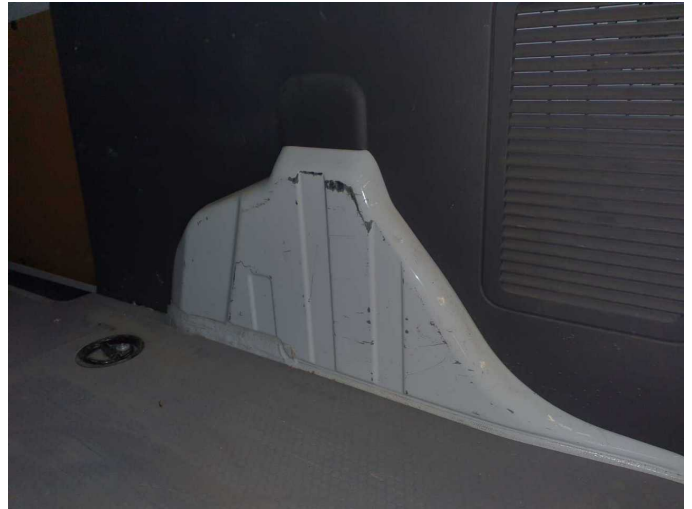
Damage 2: Interior: Cargo space division - Scratch(es) - Smart repair

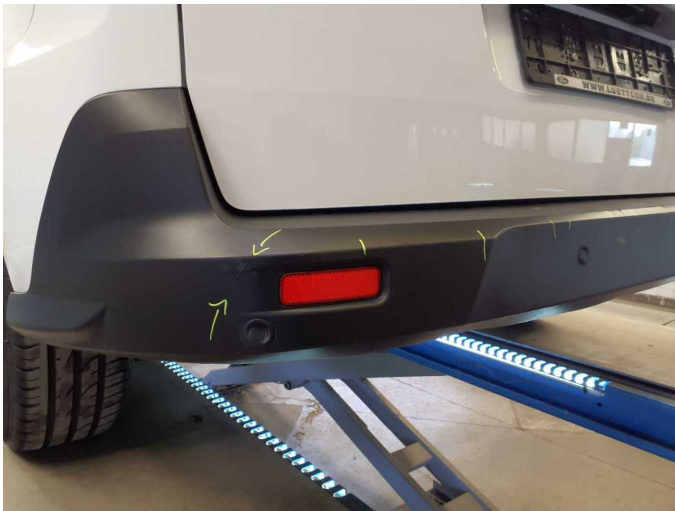
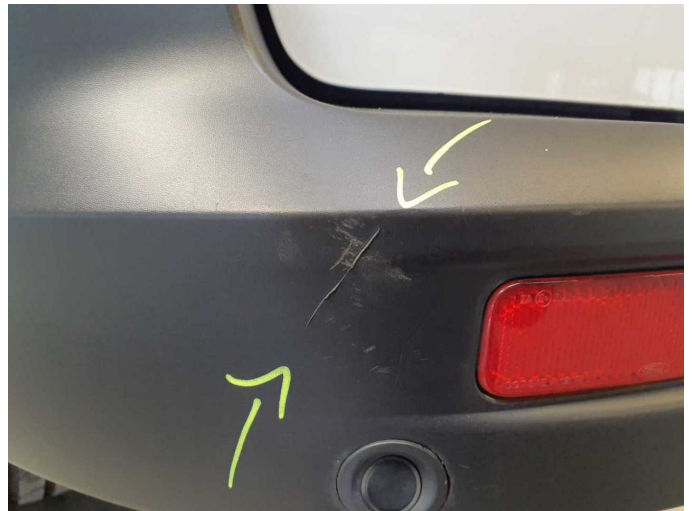
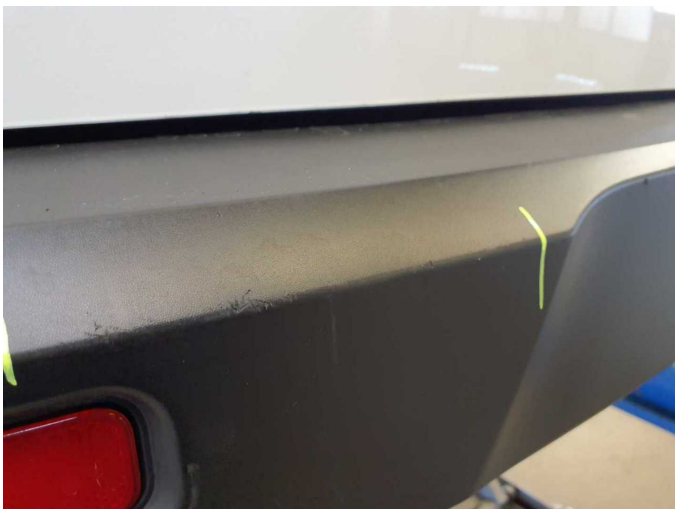
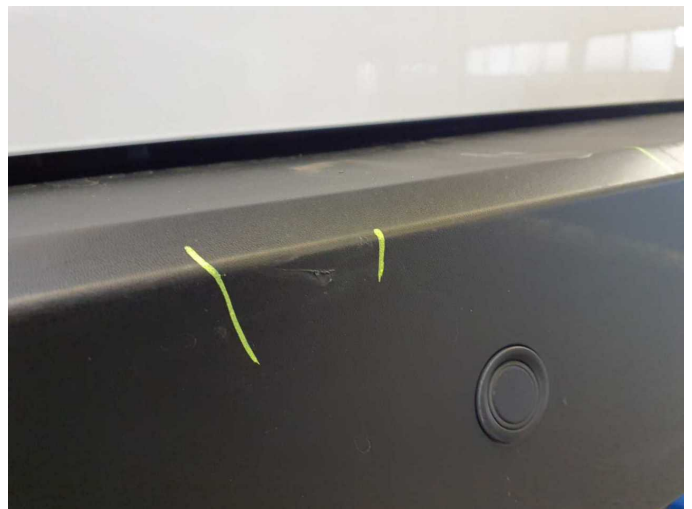
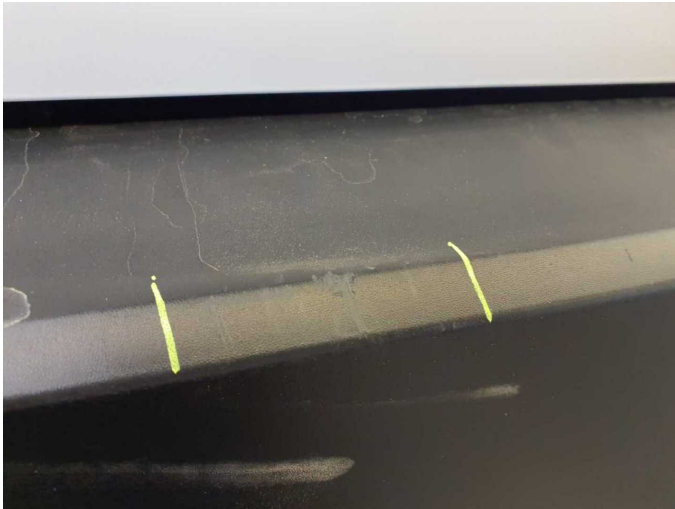
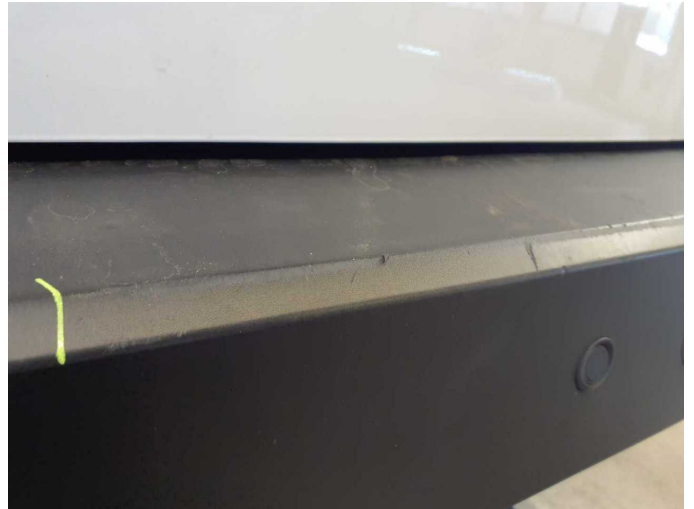
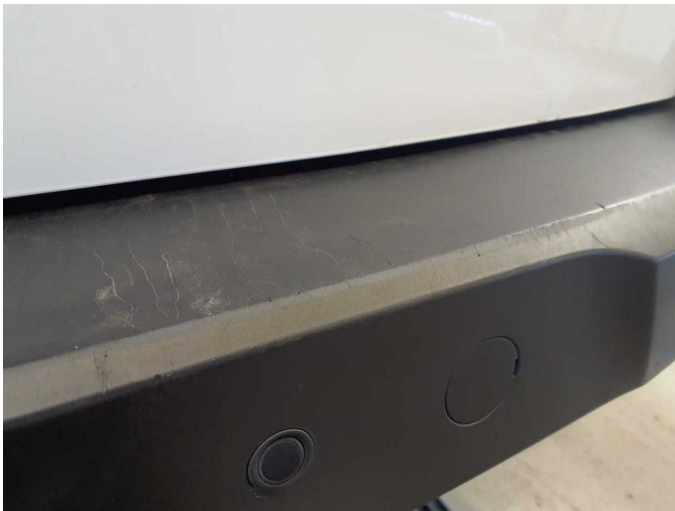
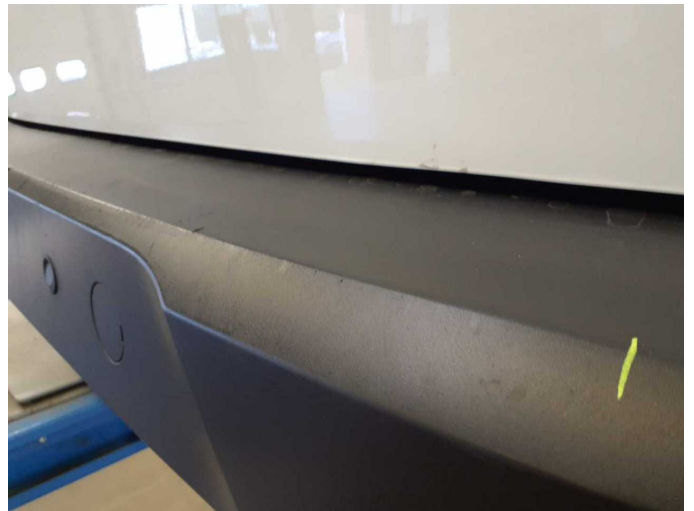
Damage 3: Rear bumper: Rear bumper - Scratch(es) - Loss in value

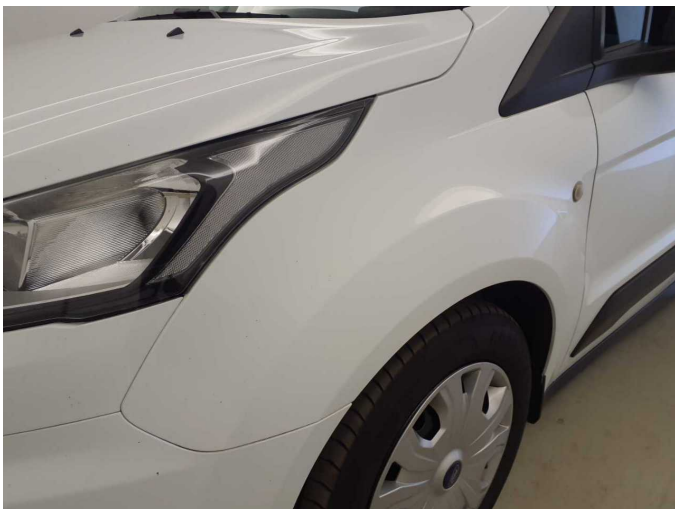
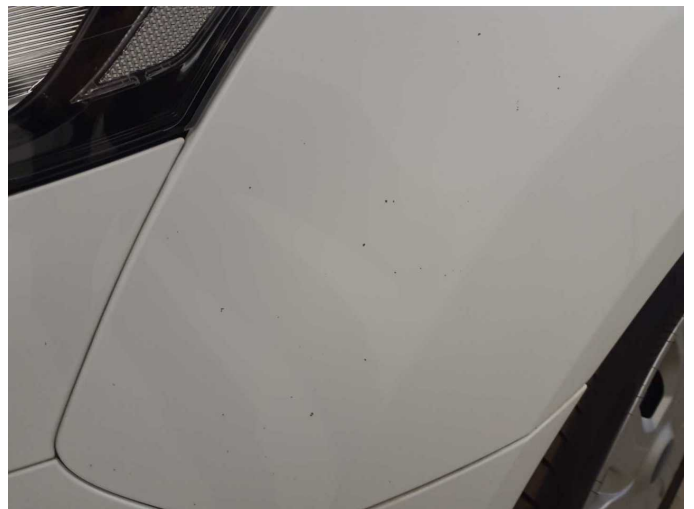
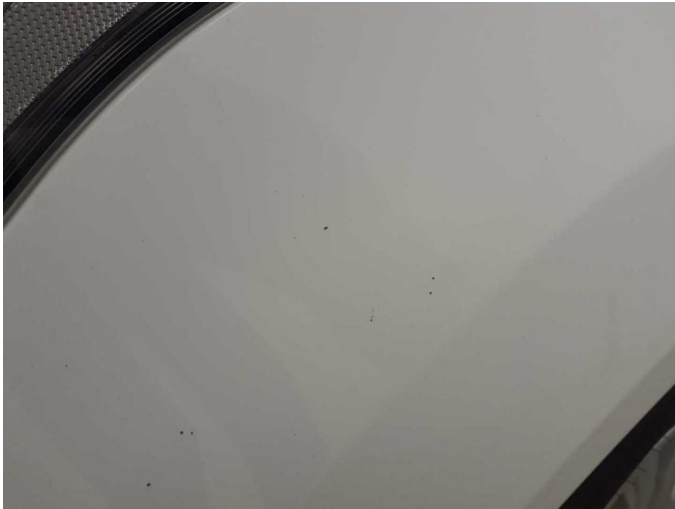
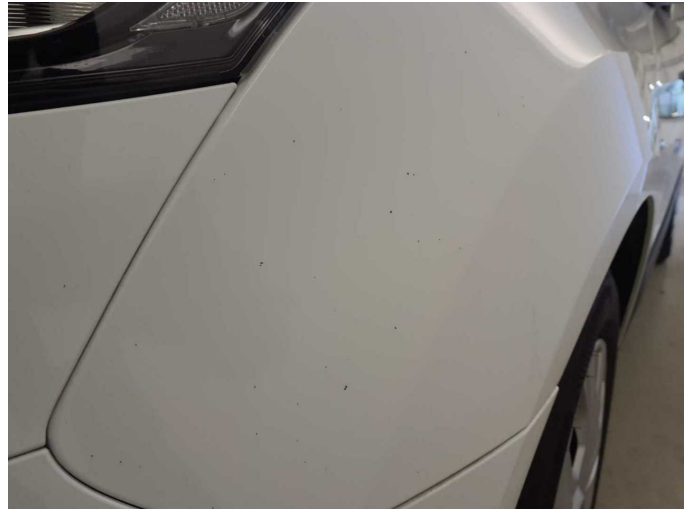
Damage 4: Mudguard - left side: Mudguard - left side - Stone chips - Paint

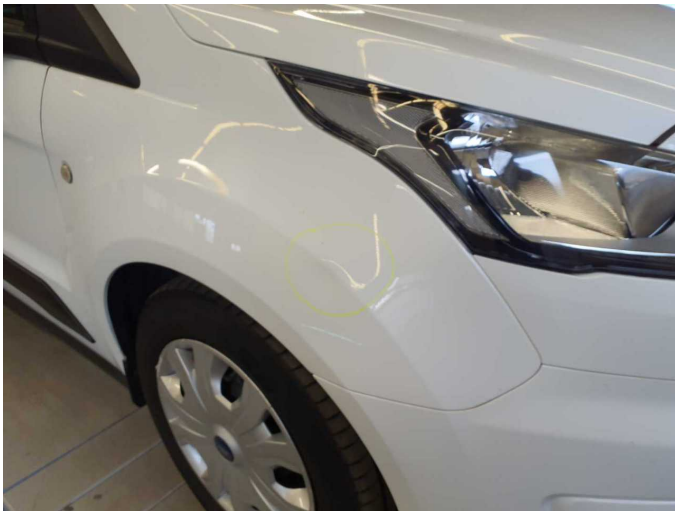
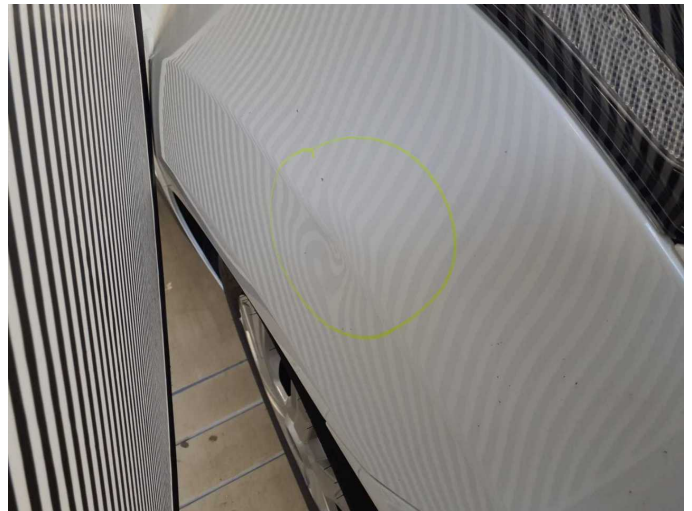
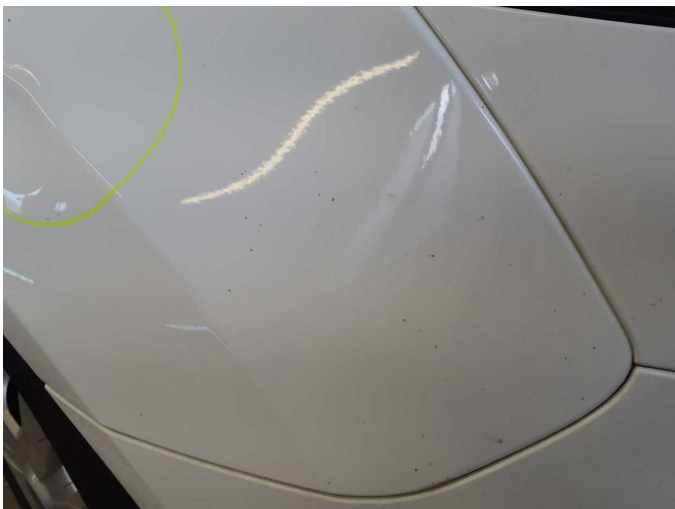
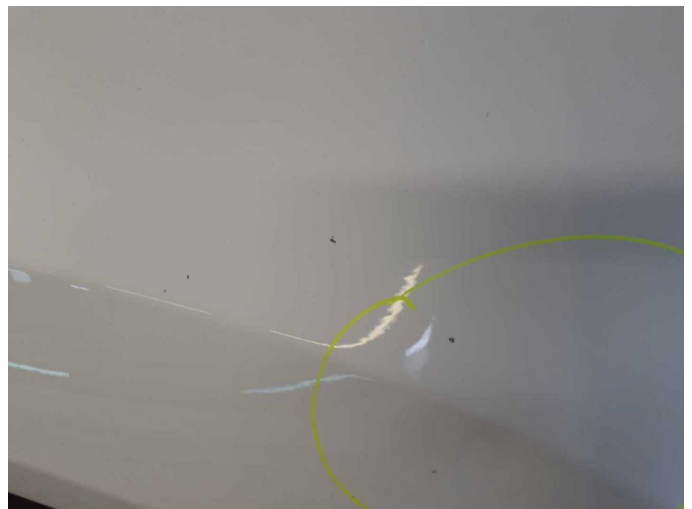
Damage 5: Mudguard - right side: Mudguard - right side (1 Delle+Kratzer) - Stone chips - Repair and paint

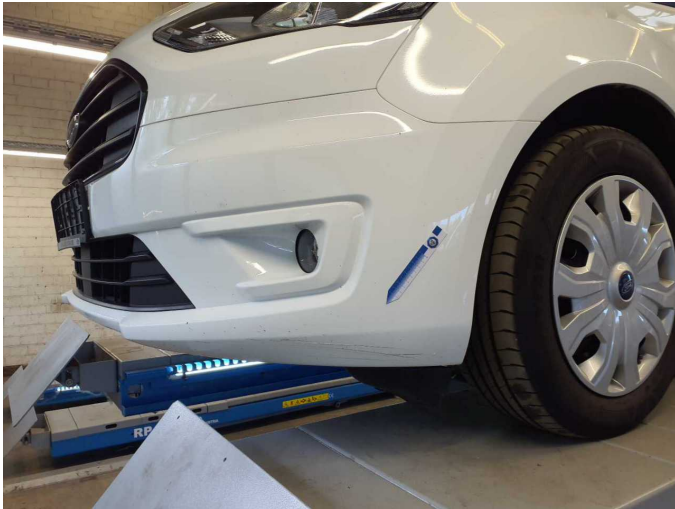
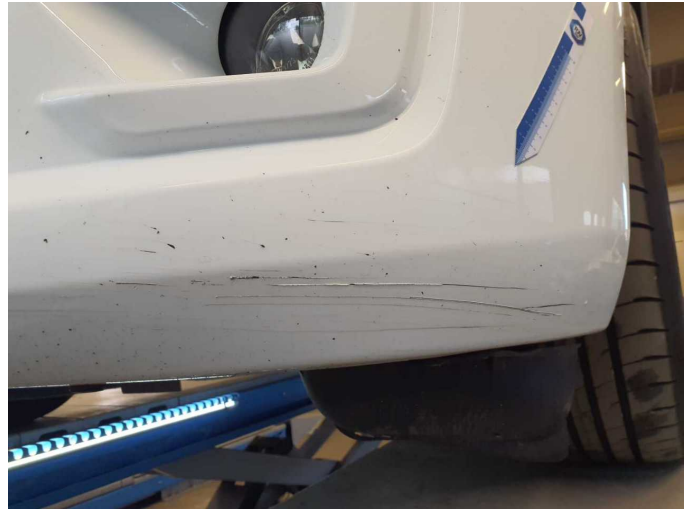
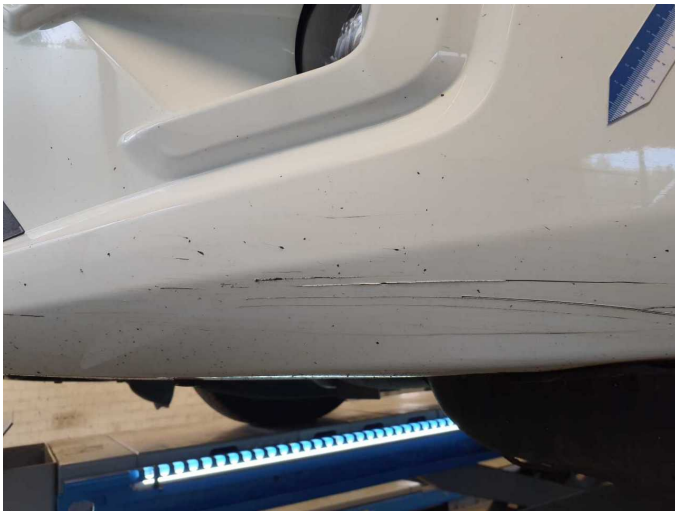
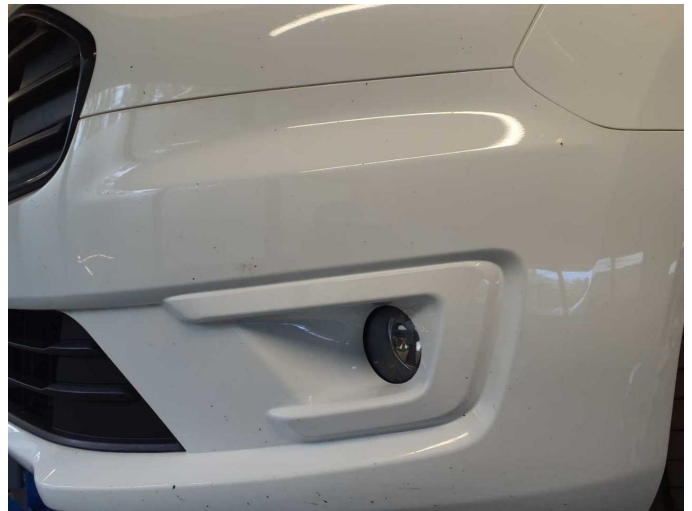
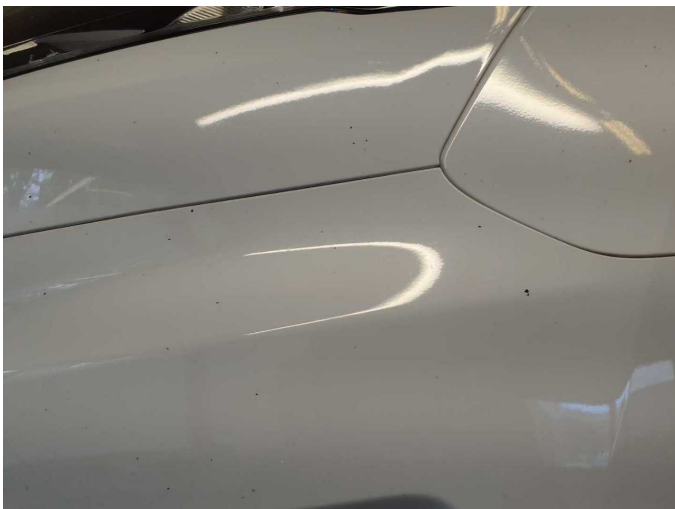
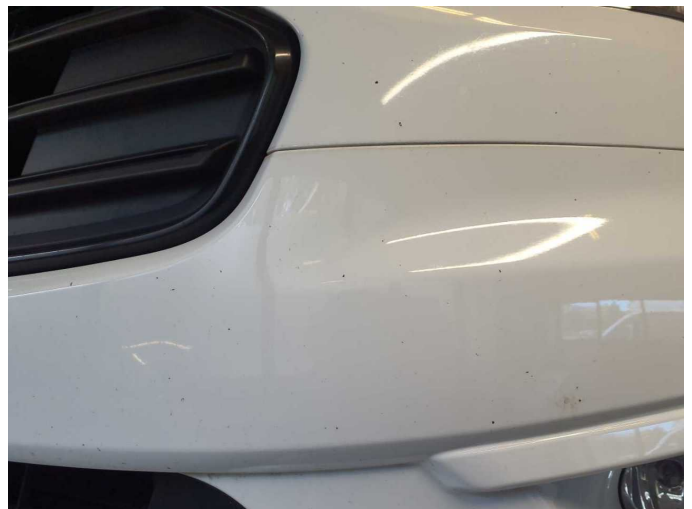
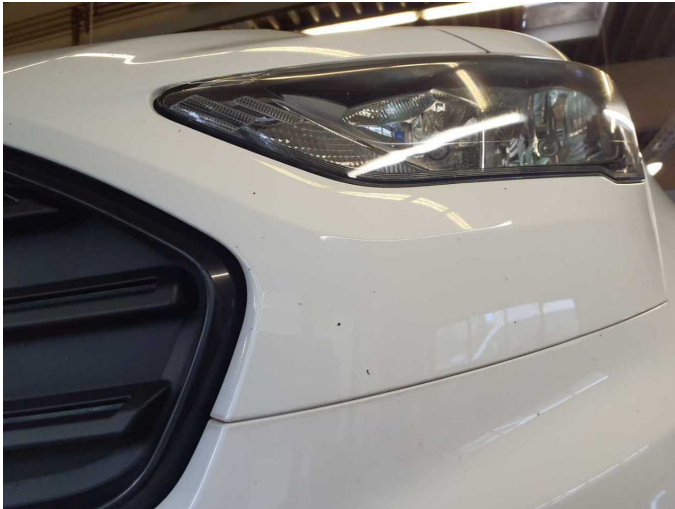
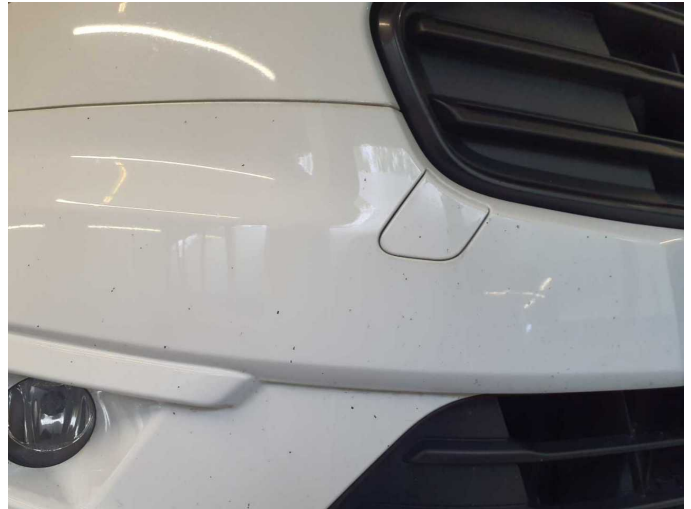
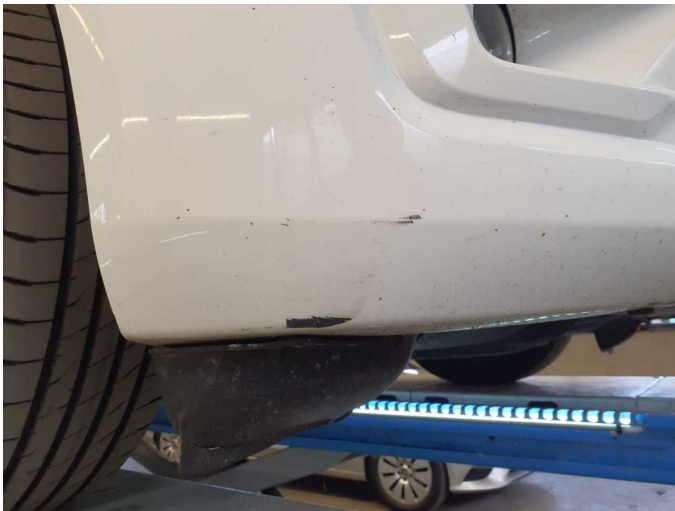
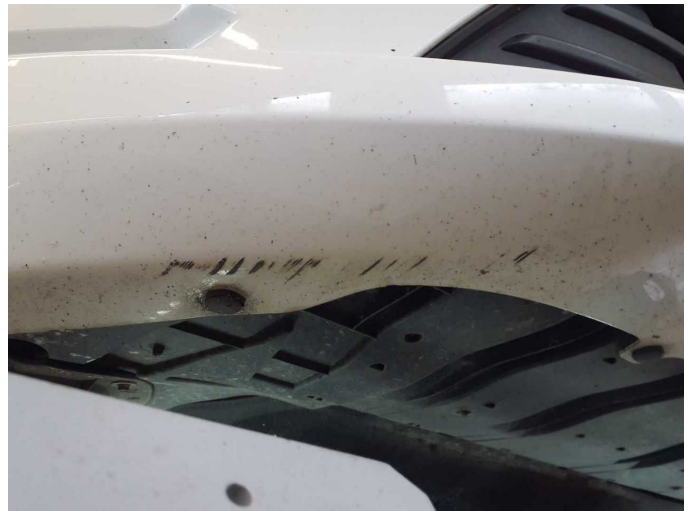
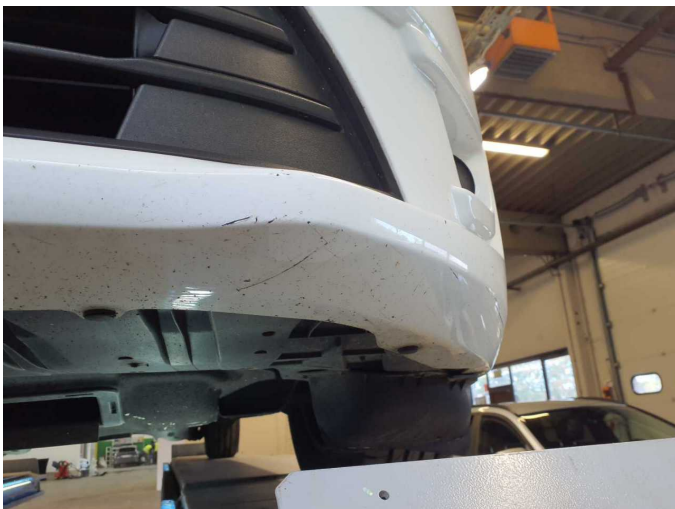
Damage 6: Front bumper: Front bumper (+Sandstrahleffekt) - Scratch(es) - Paint

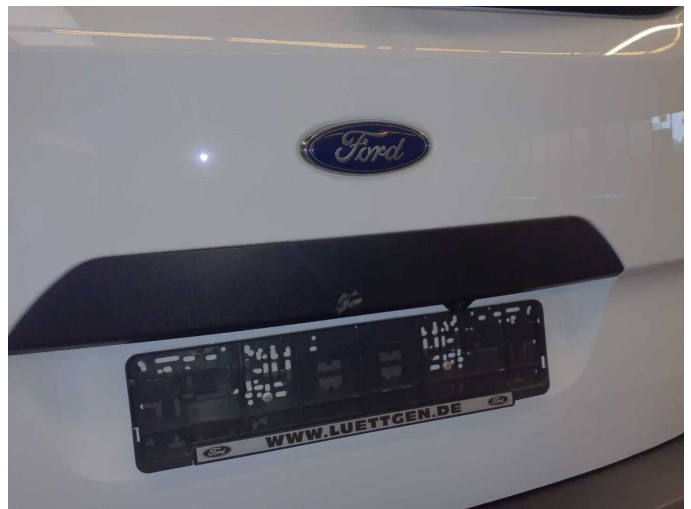
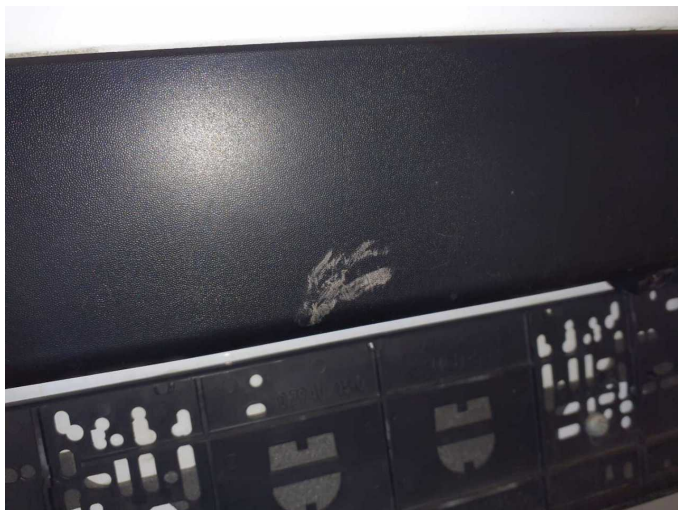
Wear and tear 1: Trim / covers: Brightware / decorative strip - Soiled - No deduction
