Expertise

Protocol number: 41621920
Order No. / Reference: 25229636
Inspection date: 19 Sept 2025

Manufacturer: Ford	Model: Transit Connect 240 L2 S&S Trend
VIN: WF0SXXWPGSLL49953

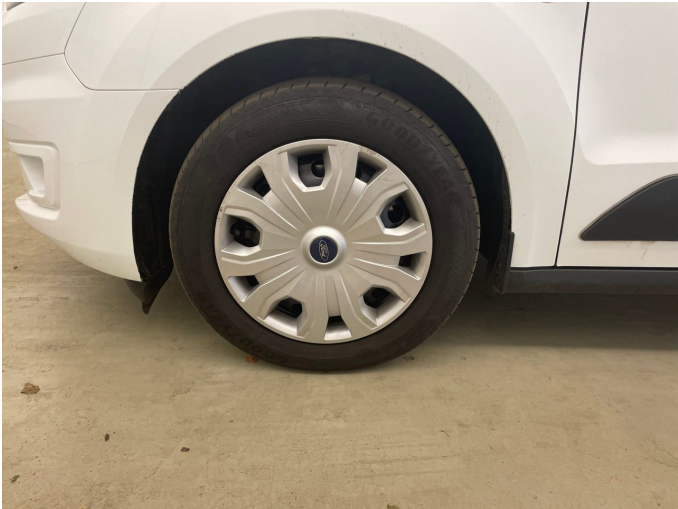
Figure 12: Mounted tyres

#	Tyre size	Type of tyre	Manufacturer	Tread depth
1)	205/60 R16 96V	Summer tyres on Steel rim with wheel cover	Goodyear	5mm / 5mm
2)	205/60 R16 96H	Summer tyres on Steel rim with wheel cover	Continental	6mm / 6mm

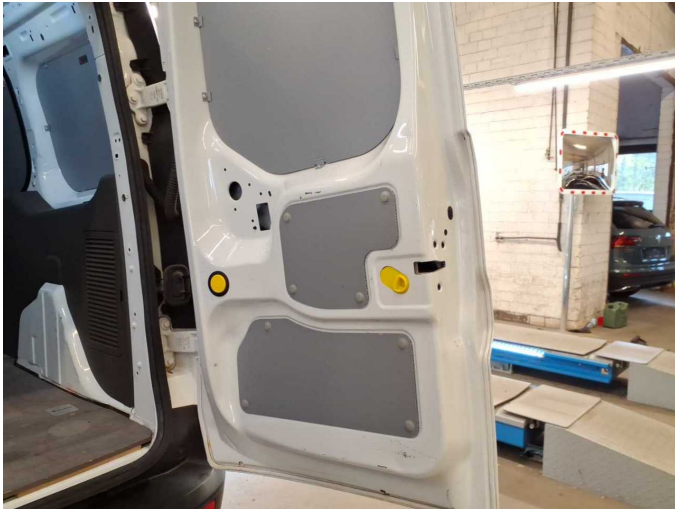
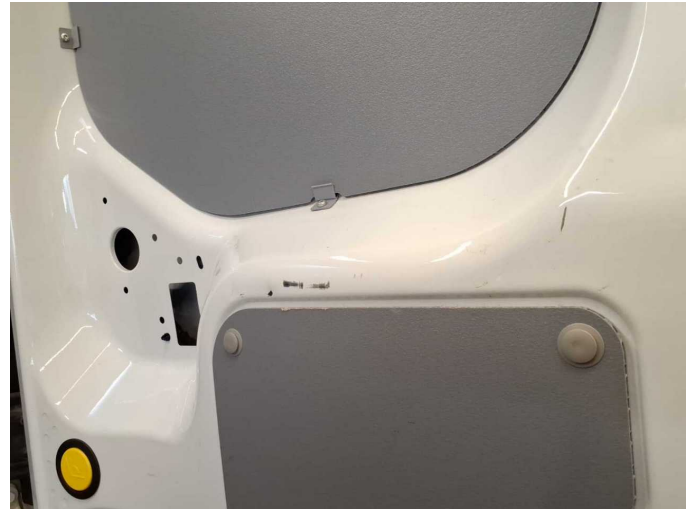
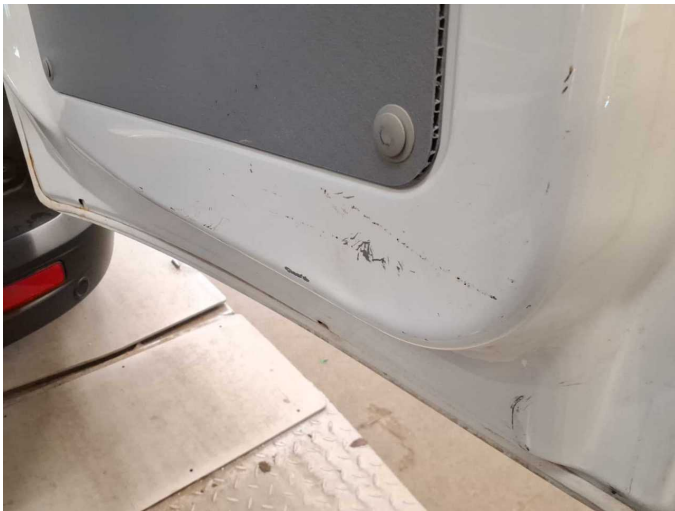
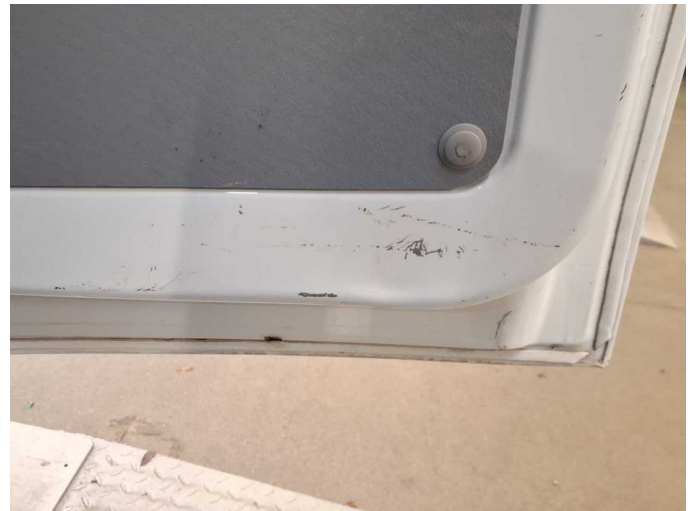
No.	Component group	Description
1	Misc.	Inspection / maintenance - No evidence - No deduction
2	Boot lid / rear door	Boot lid (Rechts innen) - Dent / paintcoat damage - Smart repair
3	Side panel - rear left side	Side panel - Dent / paintcoat damage - Smart repair
4	Front bumper	Front bumper - Stone chips - Paint

Damage 2: Boot lid / rear door: Boot lid (Rechts innen) - Dent / paintcoat damage - Smart repair

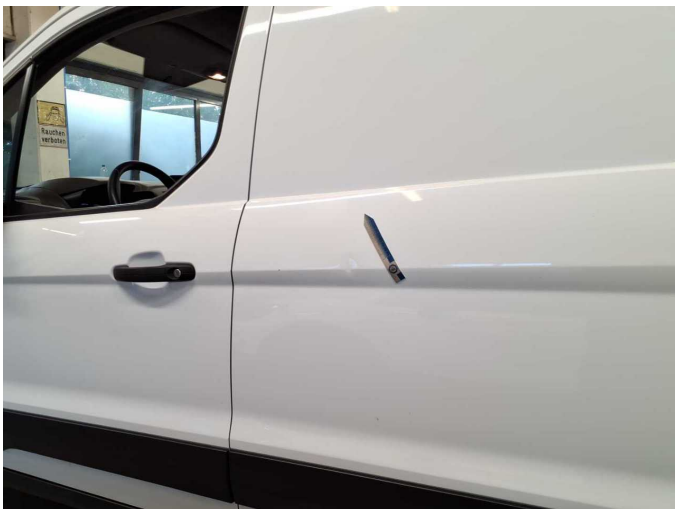
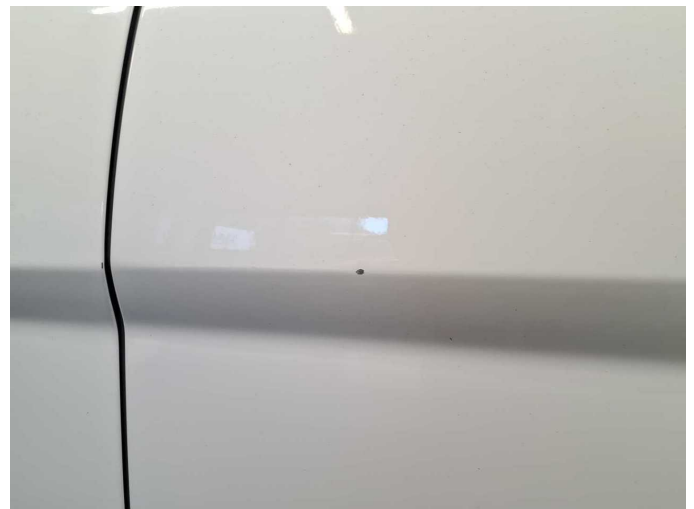
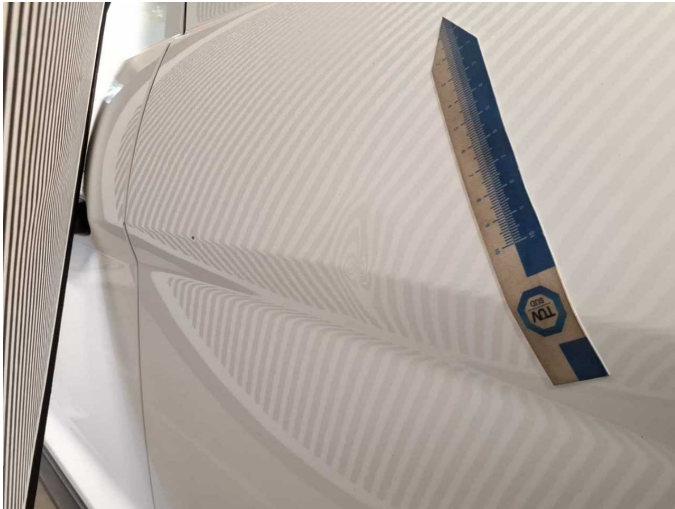
Damage 3: Side panel - rear left side: Side panel - Dent / paintcoat damage - Smart repair

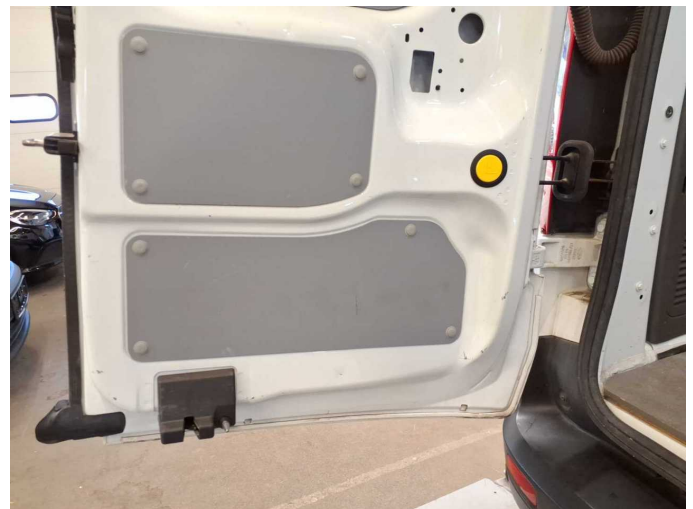
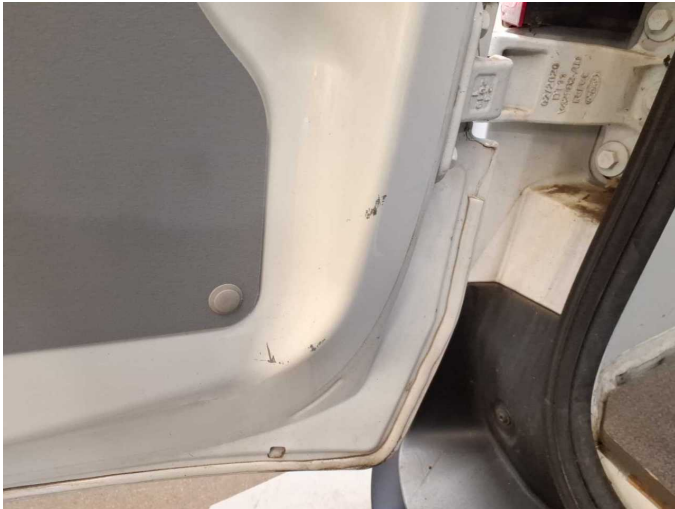
No.	Component group	Description
1	Boot lid / rear door	Boot lid (Links innen) - Scratch(es) - Smart repair

Wear and tear 1: Boot lid / rear door: Boot lid (Links innen) - Scratch(es) - Smart repair

Wear and tear 1: Boot lid / rear door: Boot lid (Links innen) - Scratch(es)
- Smart repair

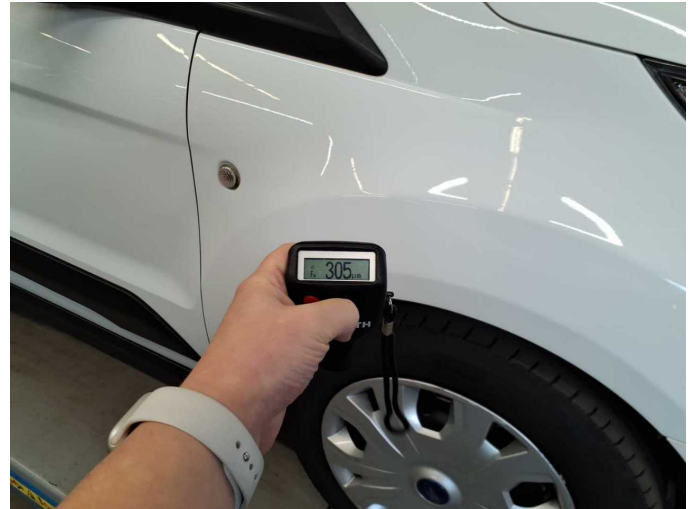
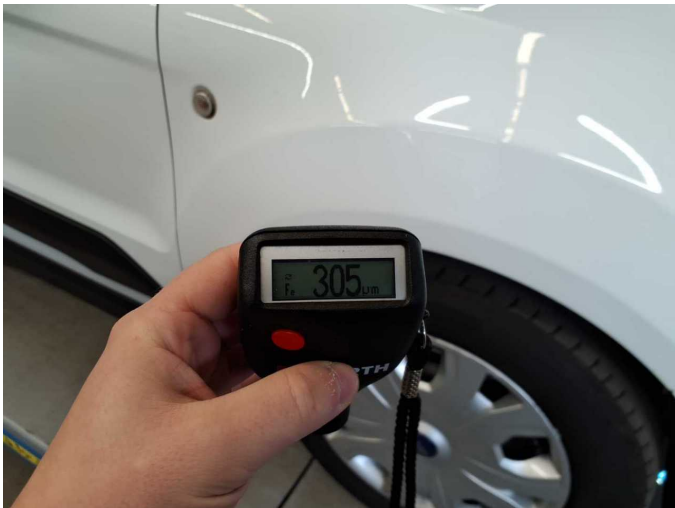
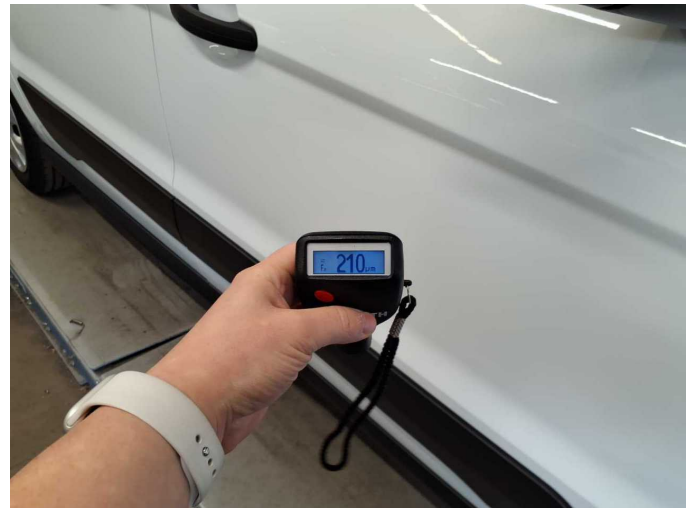
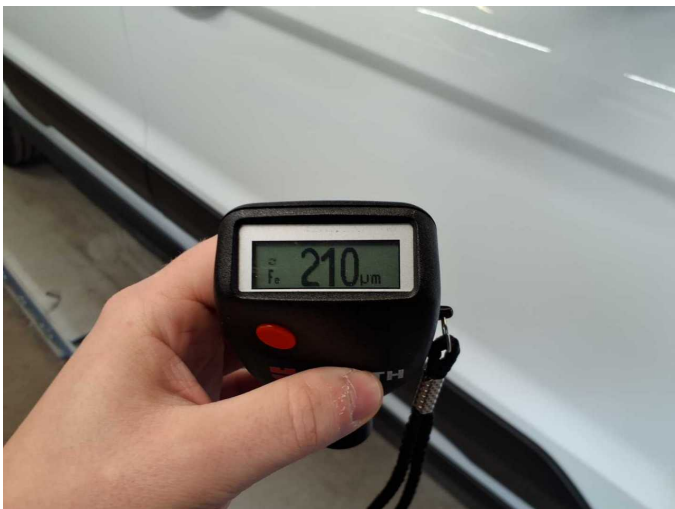
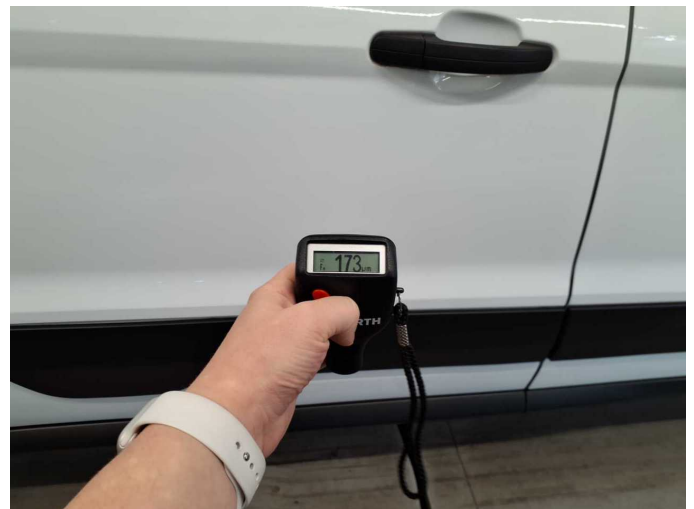
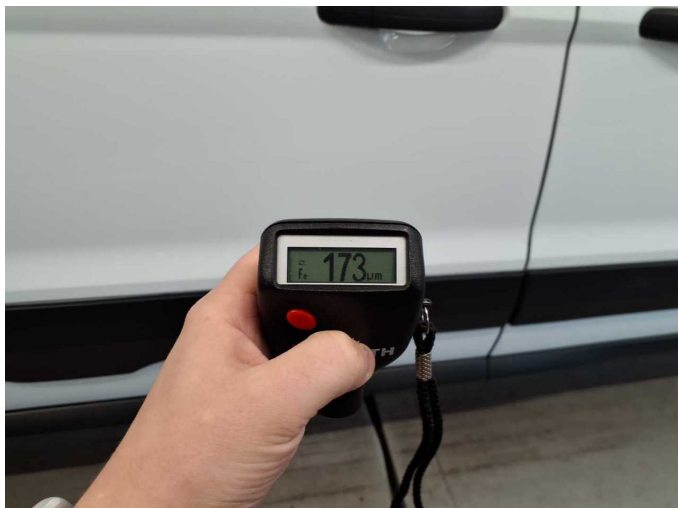
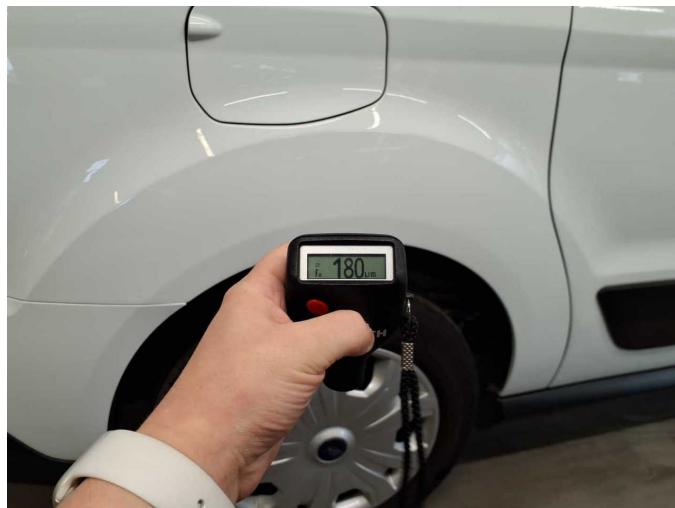
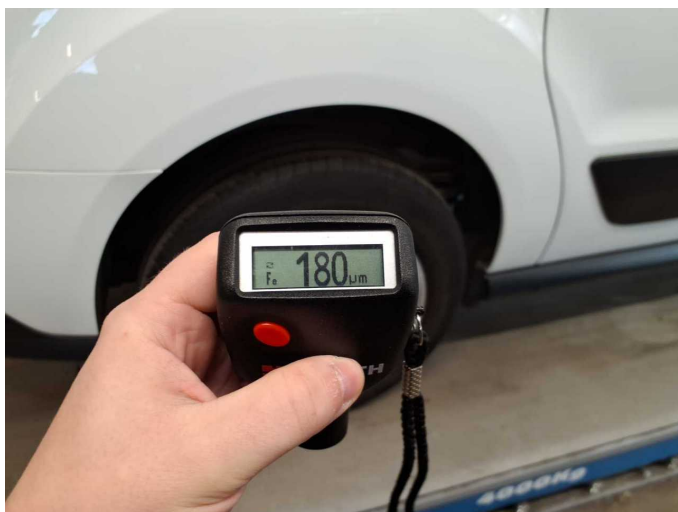
No.	Repainting
1	Mudguard - right side, Side panel - rear right side, Door - rear right side, Door - front right side, Professionally carried out, Invoice of repair done Non-existent

Mudguard - right side	305 µm	Side panel - rear right side	180 µm
Door - rear right side	173 µm	Door - front right side	210 µm

Repainting 1: Mudguard - right side, Side panel - rear right side, Door - rear right side, Door - front right side
