Expertise

Protocol number: 41343510
Order No. / Reference: 25155480
Inspection date: 2 Sept 2025

Manufacturer: Ford

Model: Transit Connect 240 L2 S&S Trend

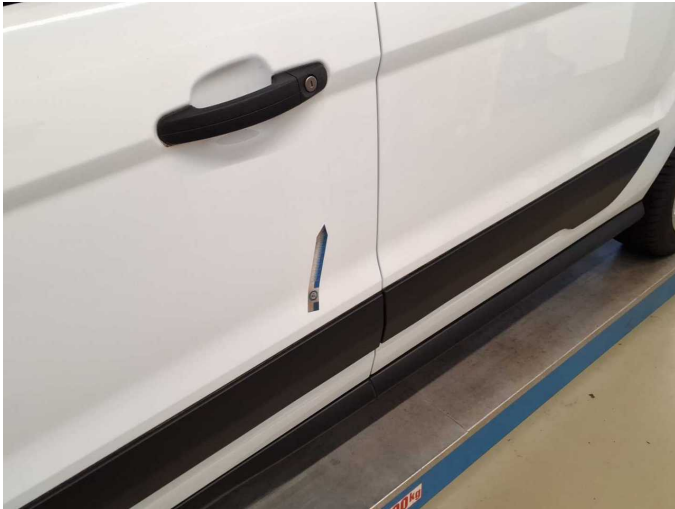
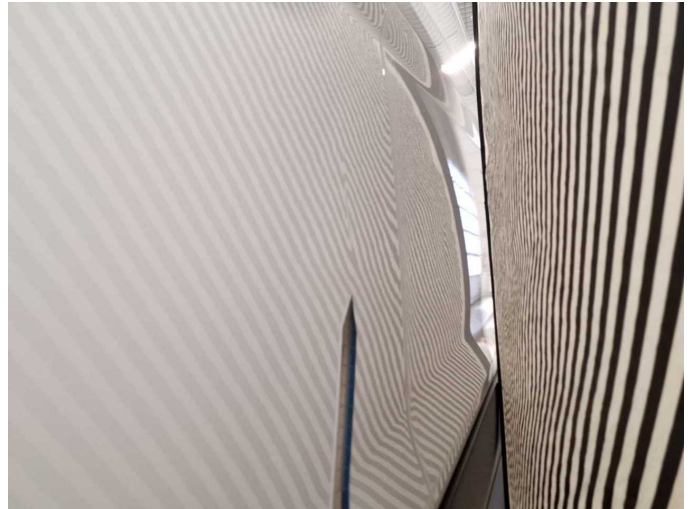
No.	Component group	Description
1	Door - front left side	Door - dent(s) - Smart repair
2	Boot lid / rear door	Rear door - right side - dent(s) - Smart repair
3	Rear bumper	Bumper with Parktronic - Scratched - Smart repair
4	Roof	Roof - dent(s) - Smart repair
5	Side panel - rear left side	Side panel - dent(s) - Smart repair

Damage 1: Door - front left side: Door - dent(s) - Smart repair

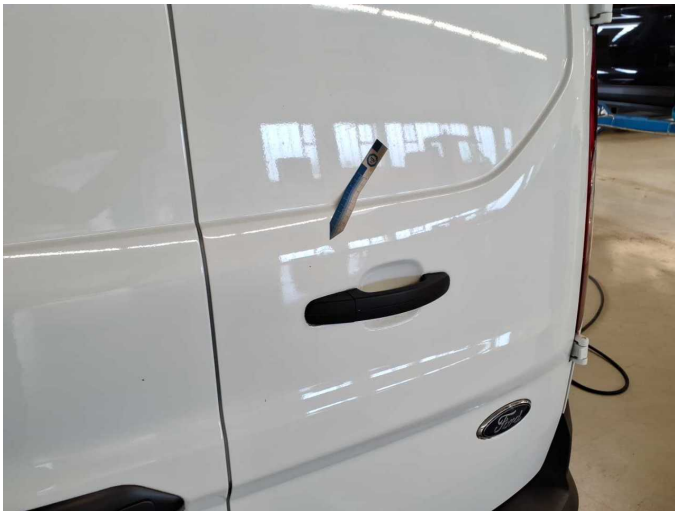
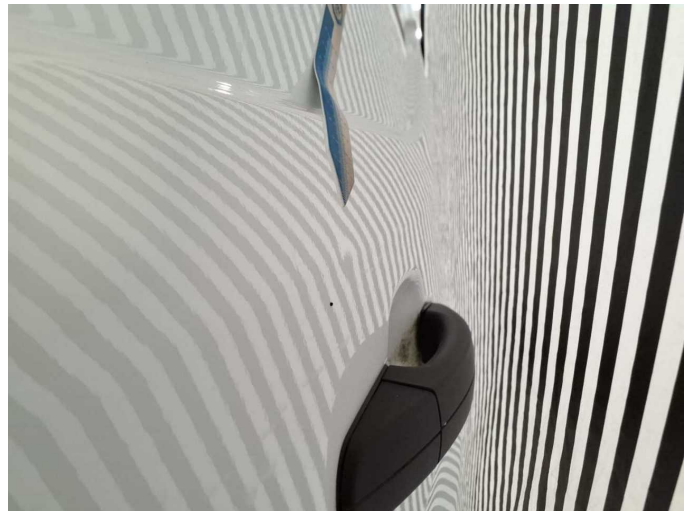
Damage 2: Boot lid / rear door: Rear door - right side - dent(s) - Smart repair

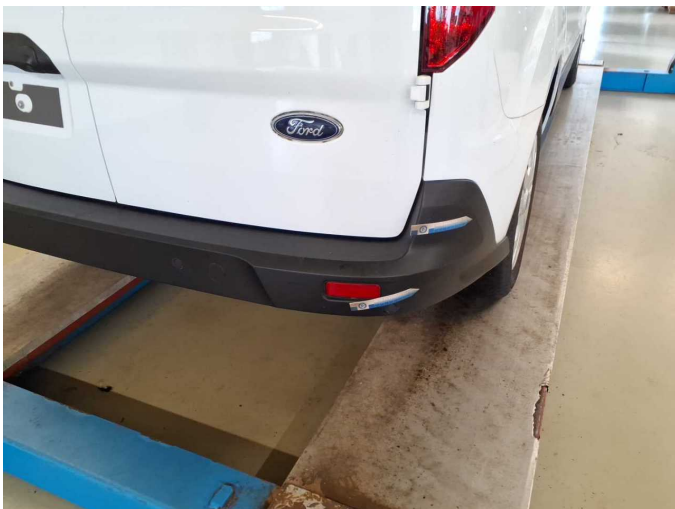
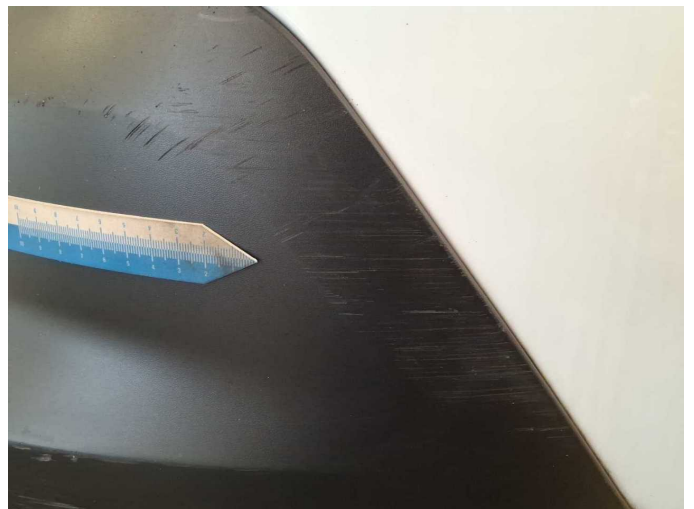
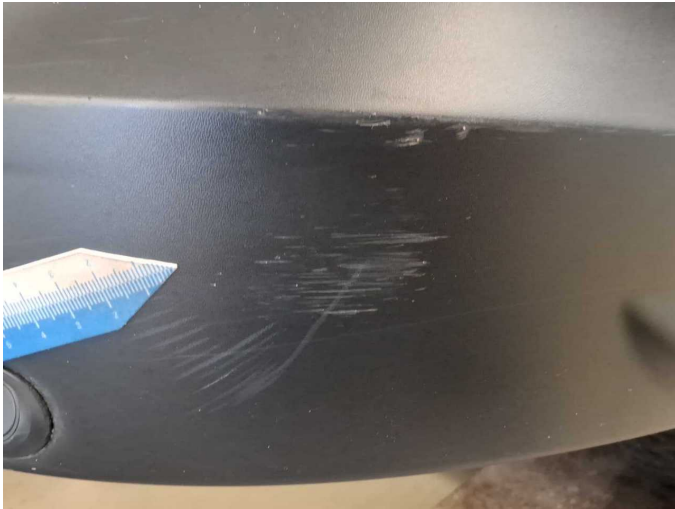
Damage 3: Rear bumper: Bumper with Parktronic - Scratched - Smart repair

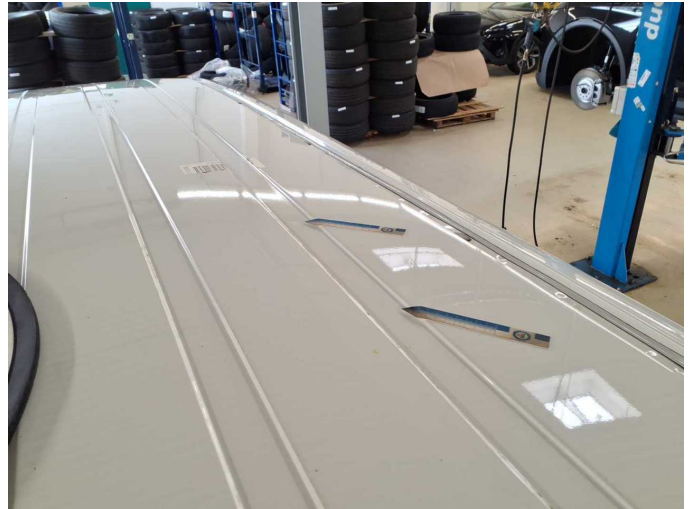
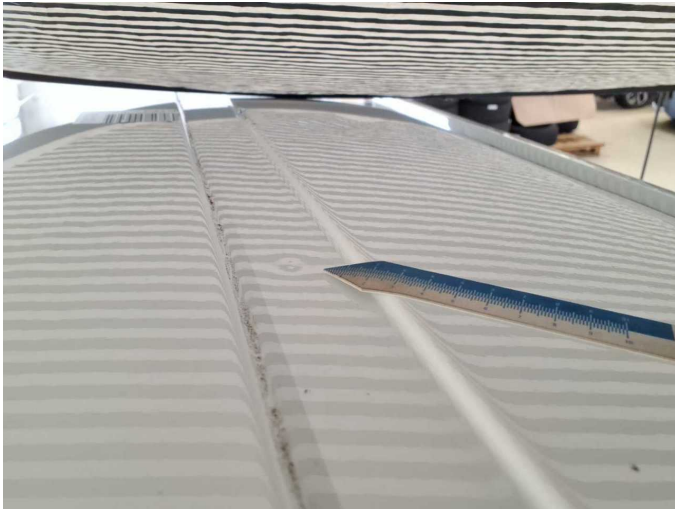
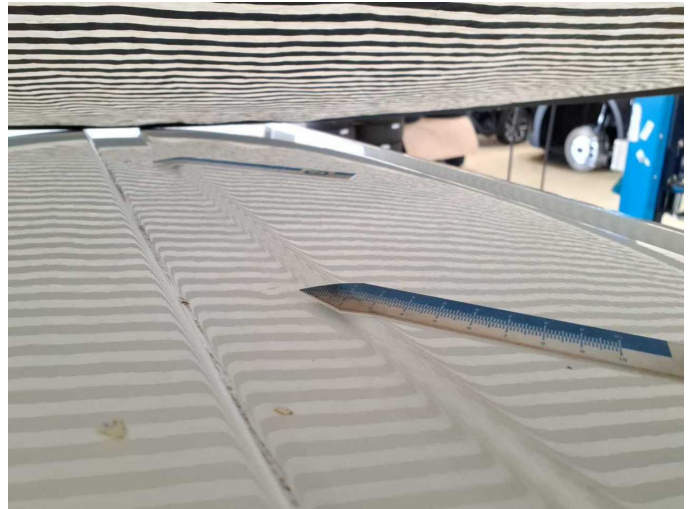
Damage 4: Roof: Roof - dent(s) - Smart repair

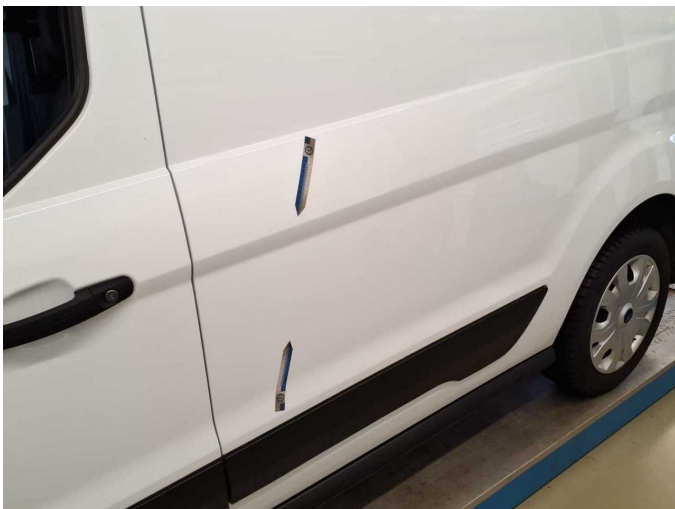
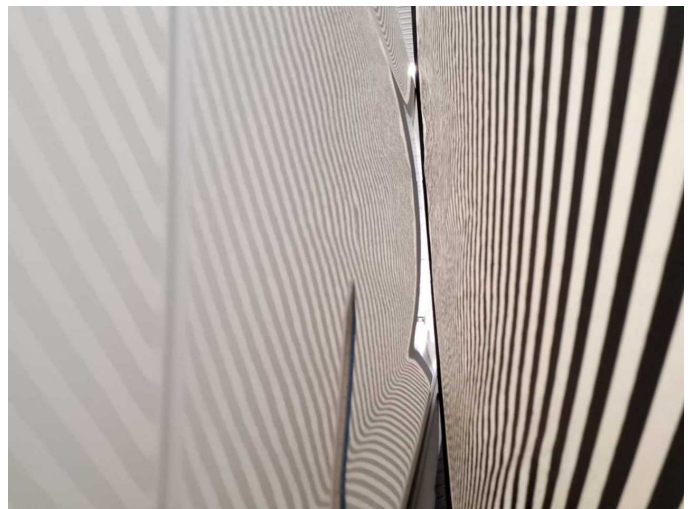
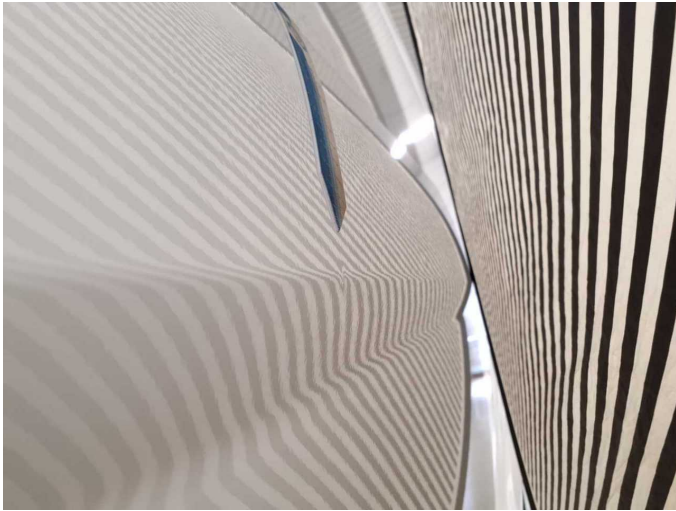
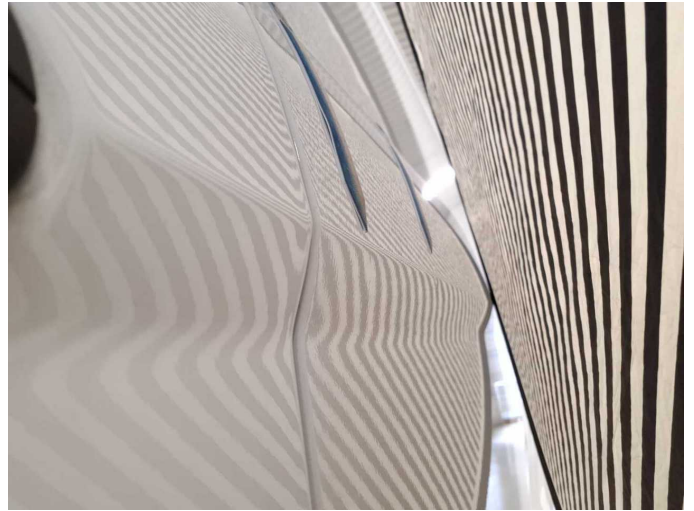
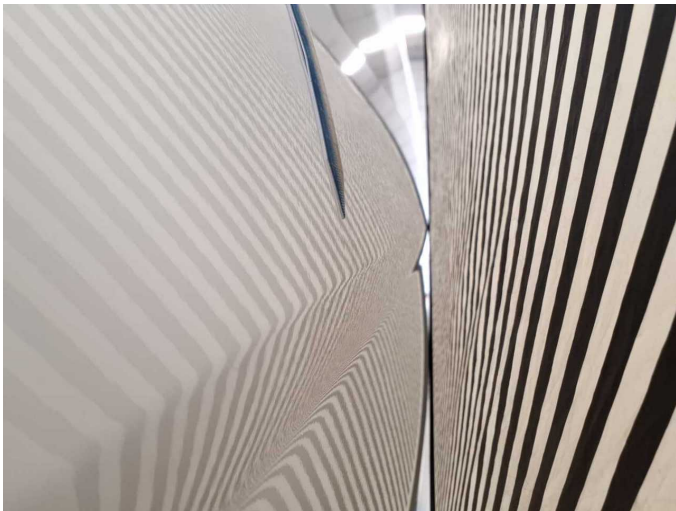
Damage 5: Side panel - rear left side: Side panel - dent(s) - Smart repair

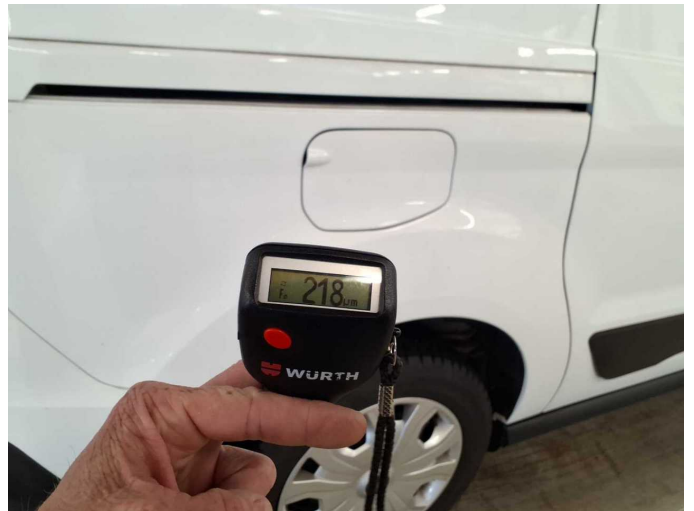
No.	Repainting
1	Side panel - rear right side, Door - rear right side, Professionally carried out

Side panel - rear right side: 218 µm

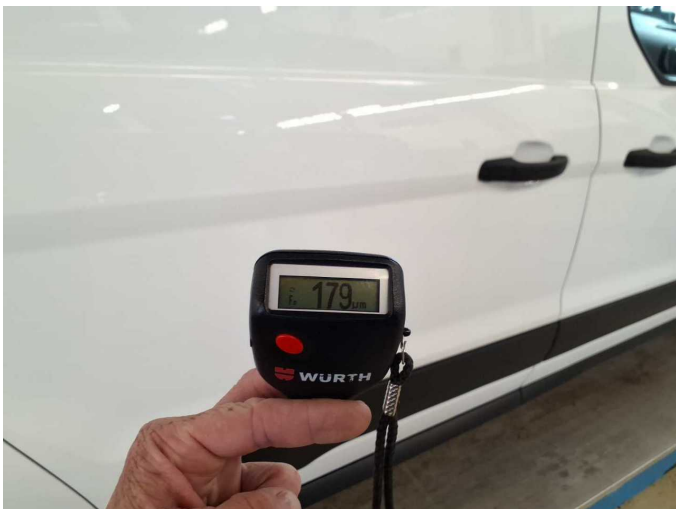
Door - rear right side: 179 µm
