FORD Ka 2009 Diesel  
ka 1.3 tdcI + Esp/Tcs 75cv E5

VIN NO WF0UXXLTRUDM12602  
Registration Number EP208VW

Inspection Report Summary

| Customer | BCA Lodi | Report Number | P20250926111406 |

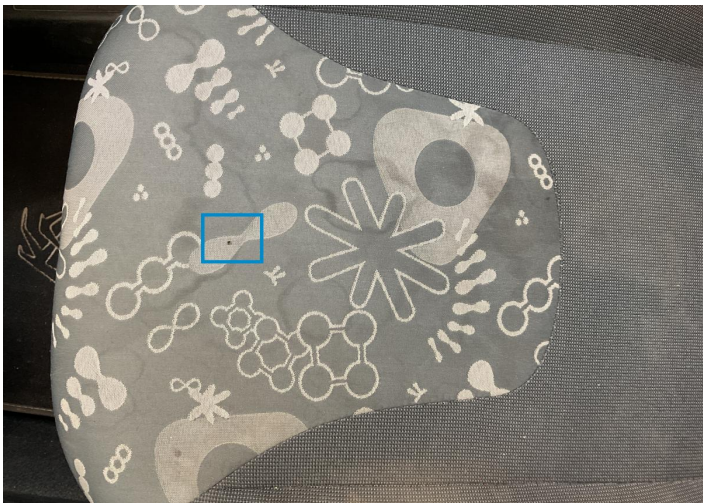
| Component | | Damage | Comments |
|---|---|---|---|
| 1 | Seat Cushion / Front Right | Interior / Burn | |

1. Seat Cushion / Front Right  
Interior / Burn -

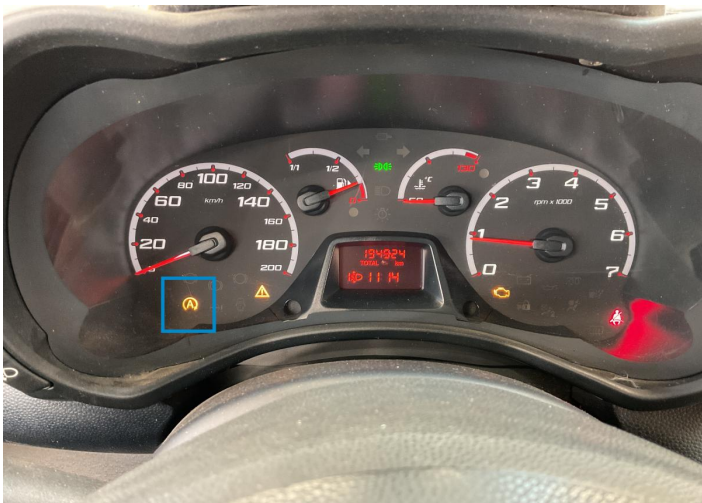
| Component | | Damage | Comments |
|---|---|---|---|
| 2 | Dashboard / Front | Interior / Warning Light ON | |

2. Dashboard / Front  
Interior / Warning Light ON -

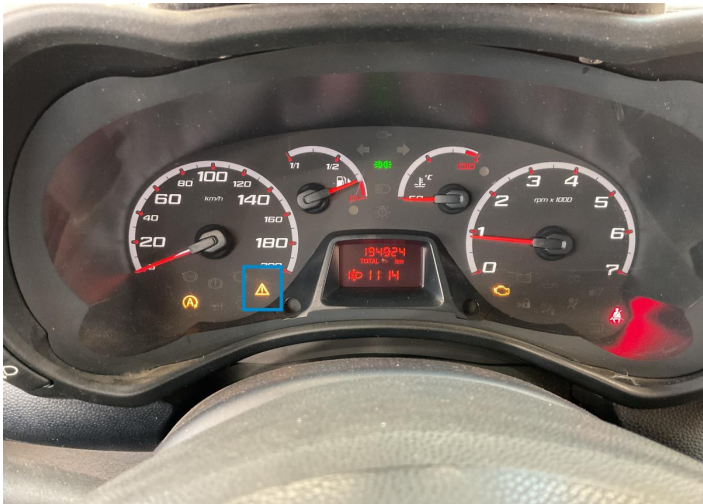
| Component | | Damage | Comments |
|---|---|---|---|
| 3 | Dashboard / Front | Interior / Warning Light ON | |

3. Dashboard / Front  
Interior / Warning Light ON -

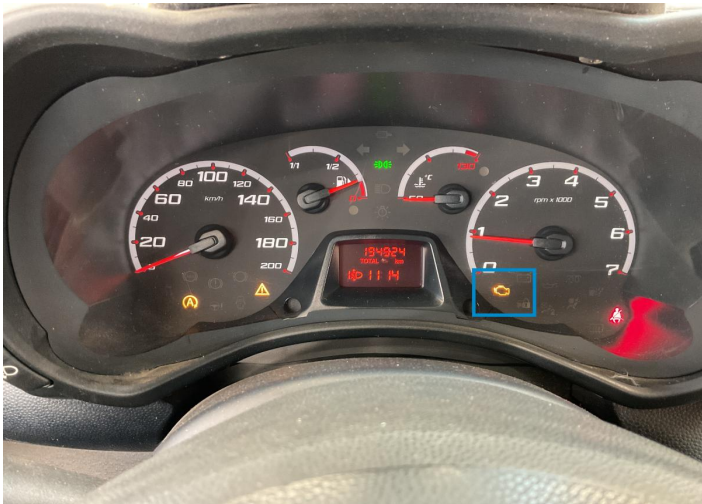
| Component | | Damage | Comments |
|---|---|---|---|
| 4 | Dashboard / Front | Interior / Warning Light ON | |

4. Dashboard / Front  
Interior / Warning Light ON -

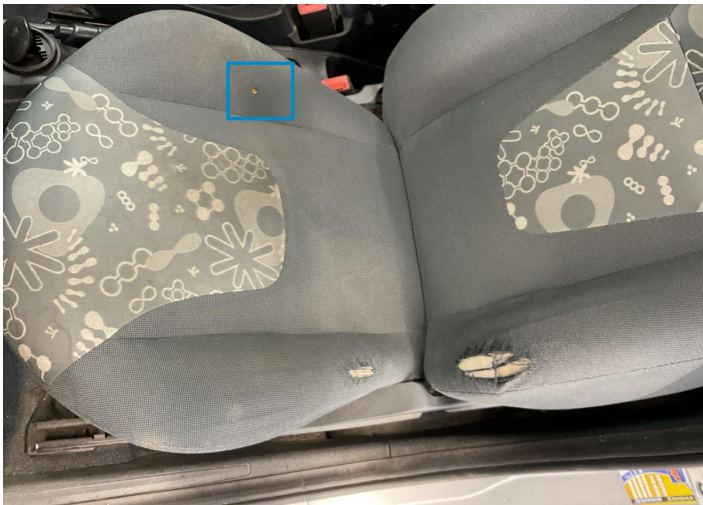
| Component | | Damage | Comments |
|---|---|---|---|
| 5 | Seat / Front Left | Interior / Burn | |

5. Seat / Front Left  
Interior / Burn -

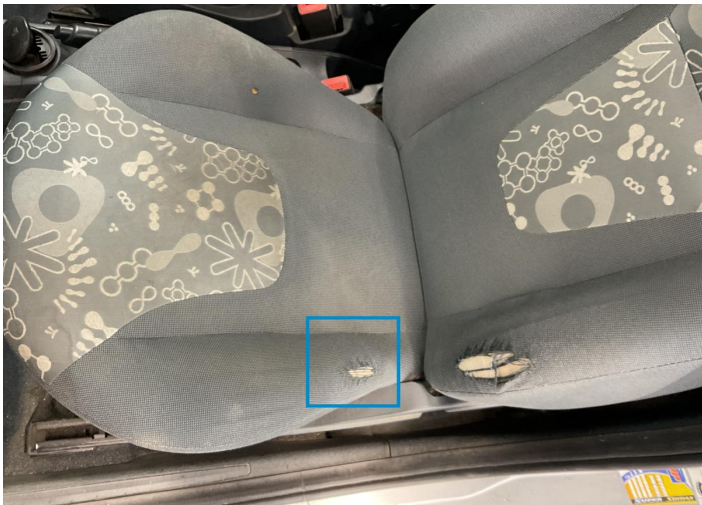
| Component | | Damage | Comments |
|---|---|---|---|
| 6 | Seat / Front Left | Interior / Ripped | |

6. Seat / Front Left  
Interior / Ripped -

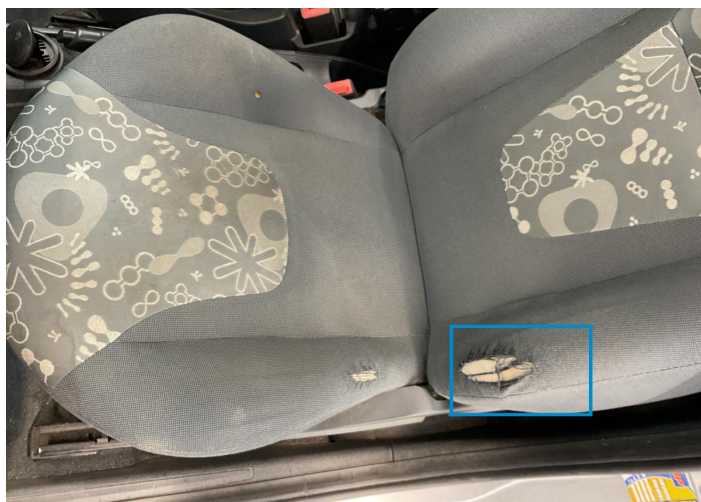
| Component | | Damage | Comments |
|---|---|---|---|
| 7 | Seat / Front Left | Interior / Ripped | |

7. Seat / Front Left  
Interior / Ripped -

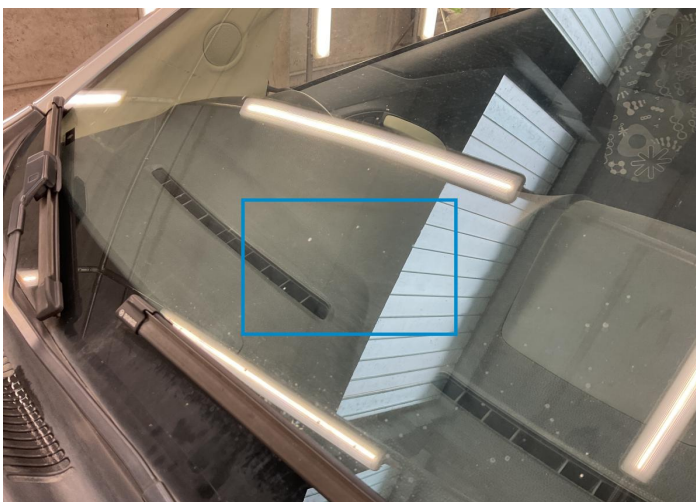
| Component | | Damage | Comments |
|---|---|---|---|
| 8 | Windshield / Front | Glass Break / Impact | |

8. Windshield / Front  
Glass Break / Impact -

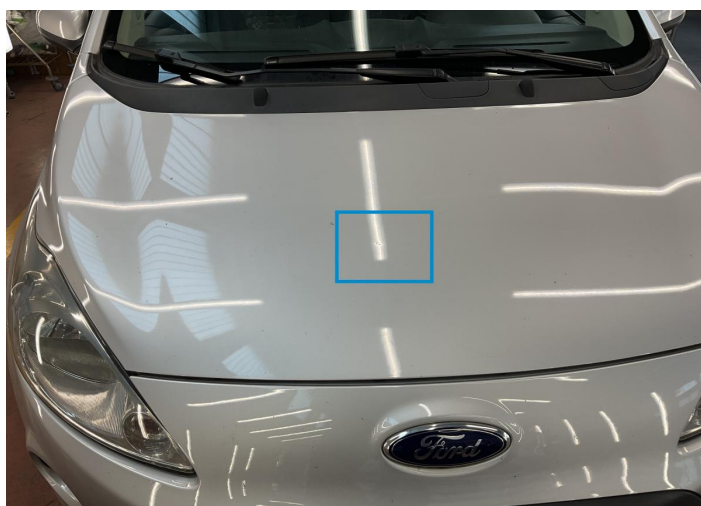
| Component | | Damage | Comments |
|---|---|---|---|
| 9 | Hood | Bodywork / Dent | |

9. Hood  
Bodywork / Dent -

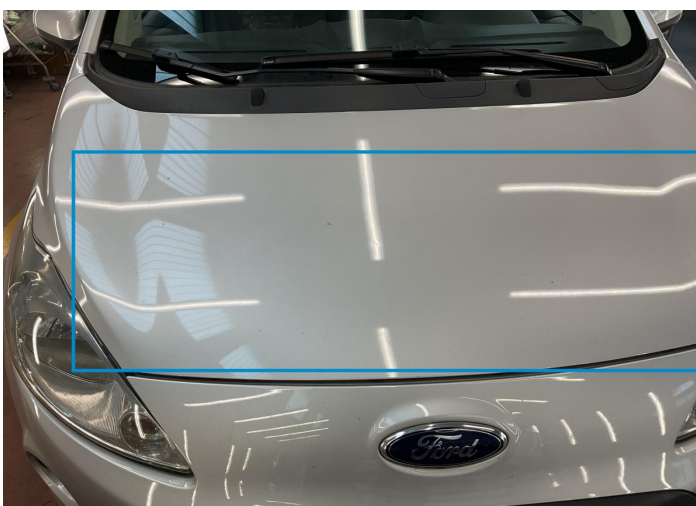
| Component | | Damage | Comments |
|---|---|---|---|
| 10 | Hood | Paint / Chipping | |

10. Hood  
Paint / Chipping -

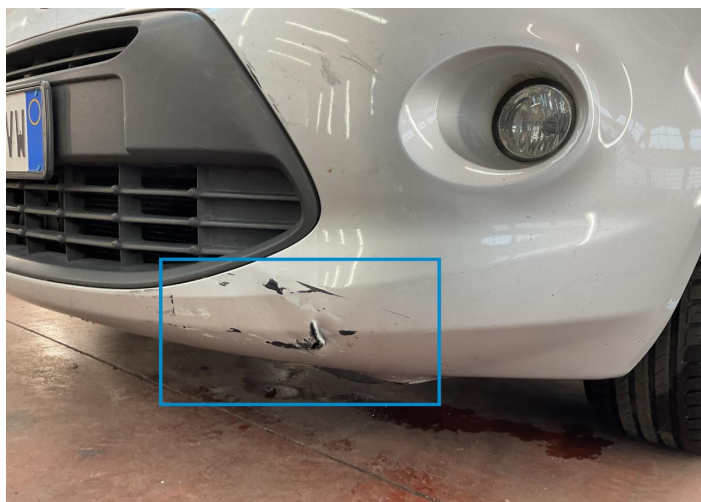
| Component | | Damage | Comments |
|---|---|---|---|
| 11 | Bumper / Front | Bodywork / Breakage | |

11. Bumper / Front  
Bodywork / Breakage -

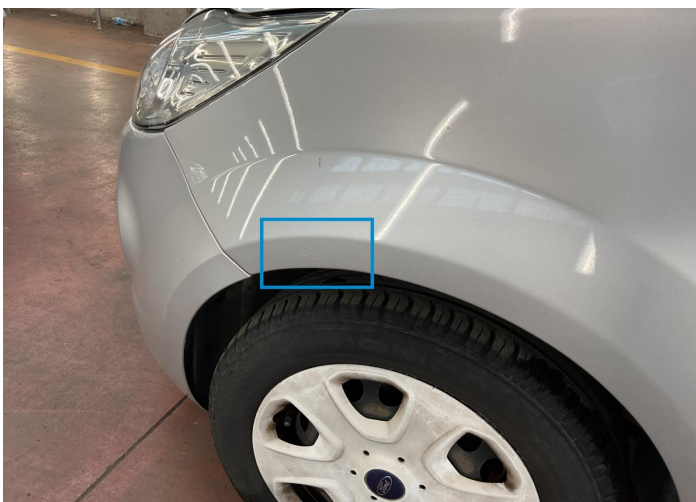
| Component | | Damage | Comments |
|---|---|---|---|
| 12 | Fender / Front Left | Paint / Scratch / Line | |

12. Fender / Front Left  
Paint / Scratch / Line -

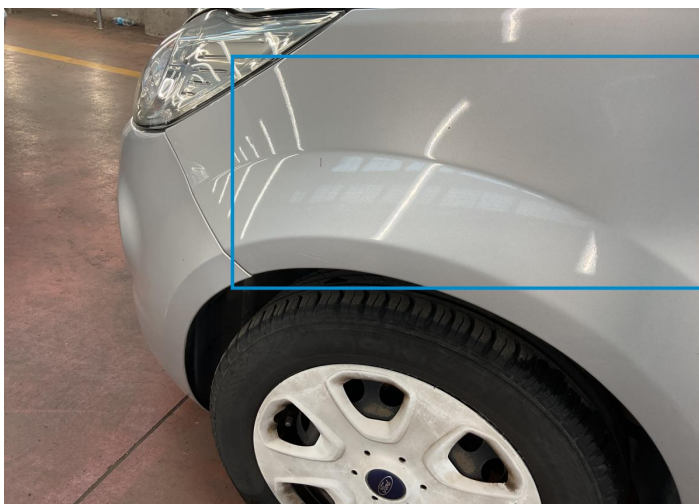
| 13 | Fender / Front Left | Bodywork / Poor Previous Repair |

13. Fender / Front Left  
Bodywork / Poor Previous Repair -

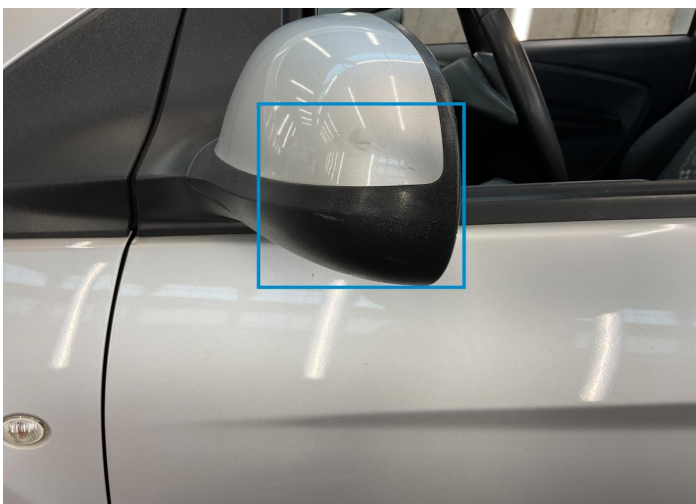
| 14 | Mirror Shell / Front Left | Paint / Scratch / Line |

14. Mirror Shell / Front Left  
Paint / Scratch / Line -

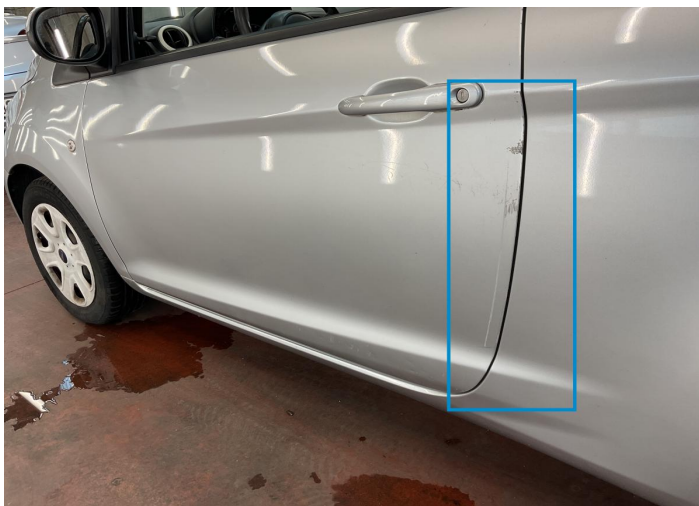
| 15 | Door / Front Left | Bodywork / Dent |

15. Door / Front Left  
Bodywork / Dent -

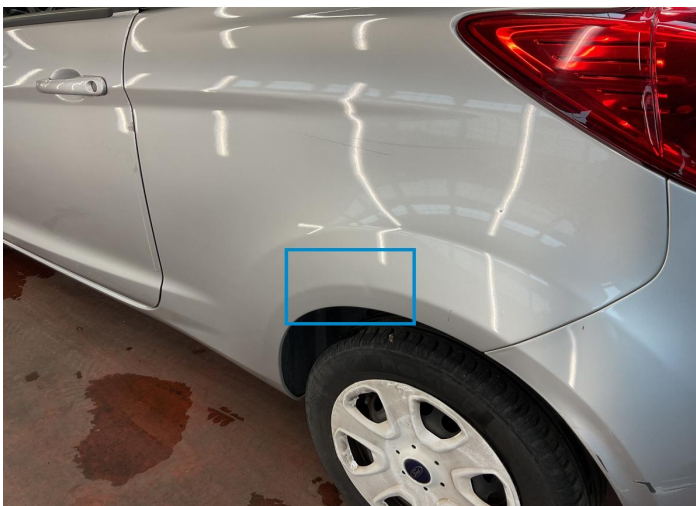
| 16 | Fender / Back Left | Bodywork / Dent |

16. Fender / Back Left  
Bodywork / Dent -

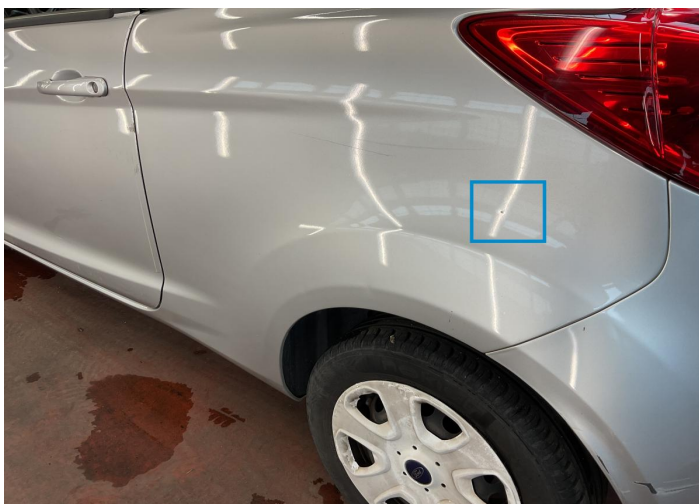
| 17 | Fender / Back Left | Bodywork / Dent |

17. Fender / Back Left  
Bodywork / Dent -

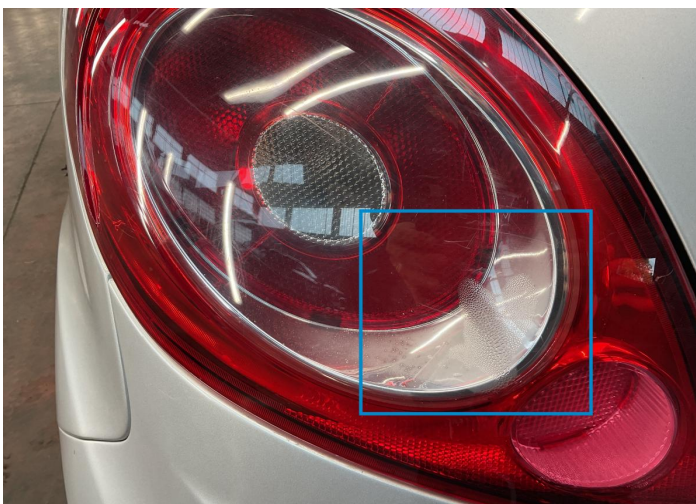
| 18 | Back Light / Left | Glass Break |

18. Back Light / Left  
Glass Break -

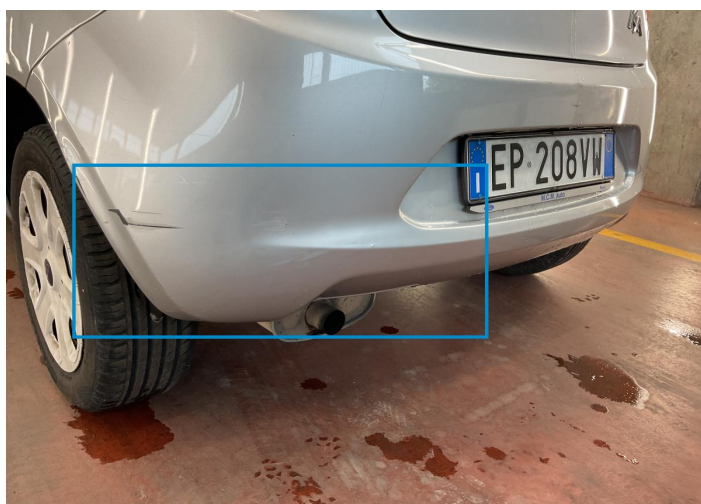
| 19 | Bumper / Back | Bodywork / Dent |

19. Bumper / Back  
Bodywork / Dent -

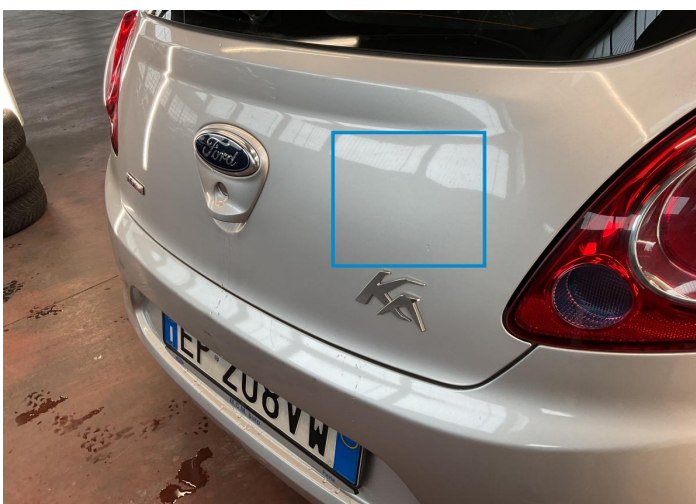
| 20 | Tailgate | Bodywork / Dent |

20. Tailgate  
Bodywork / Dent -

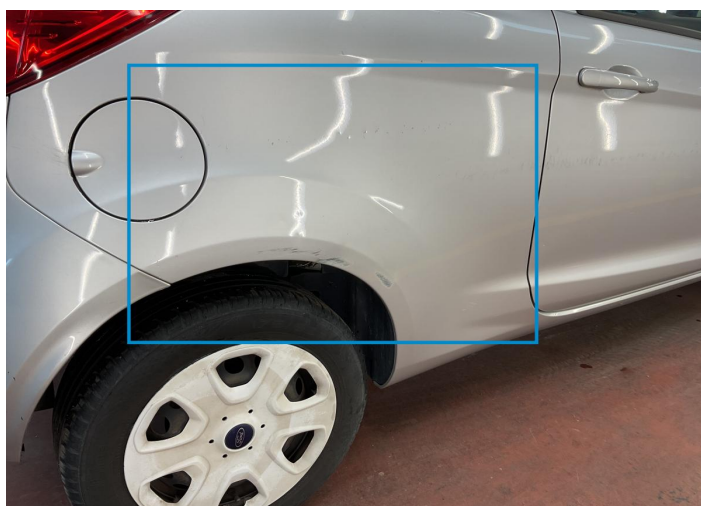
| 21 | Fender / Back Right | Bodywork / Dent |

21. Fender / Back Right  
Bodywork / Dent -

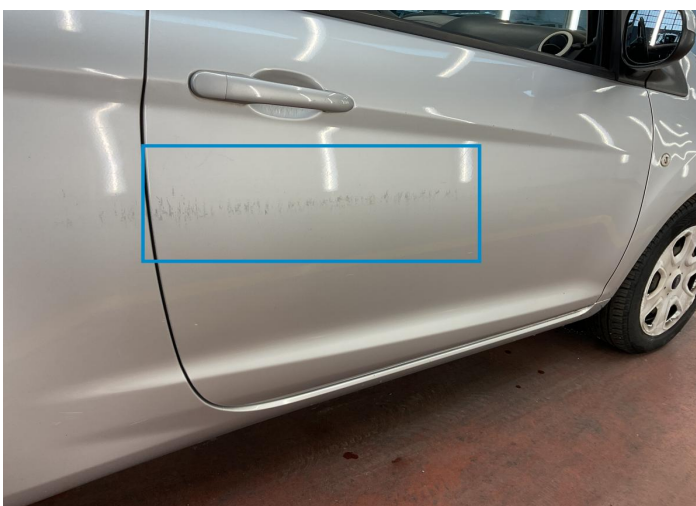
| 22 | Door / Front Right | Bodywork / Dent |

22. Door / Front Right  
Bodywork / Dent -

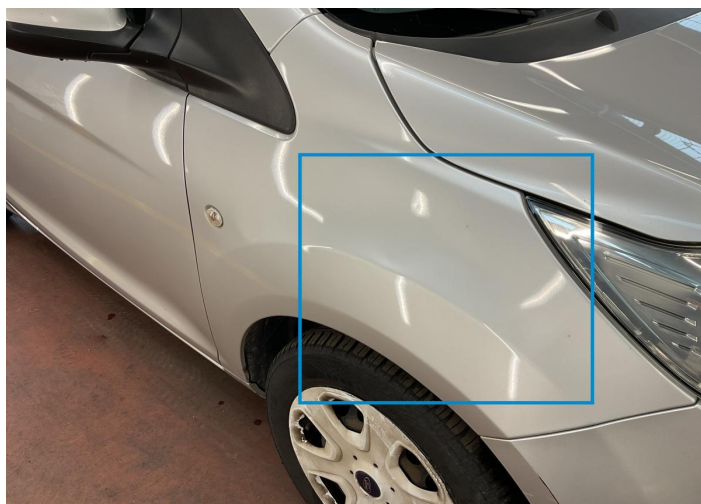
| 23 | Fender / Front Right | Bodywork / Dent |

23. Fender / Front Right  
Bodywork / Dent -

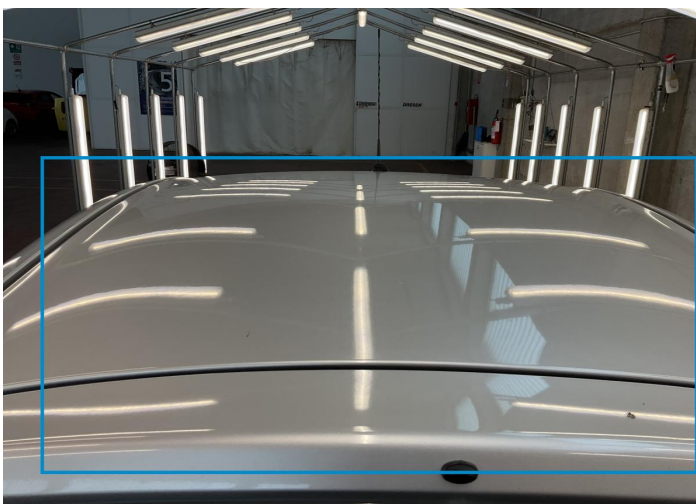
| 24 | Roof | Bodywork / Dent |

24. Roof  
Bodywork / Dent -

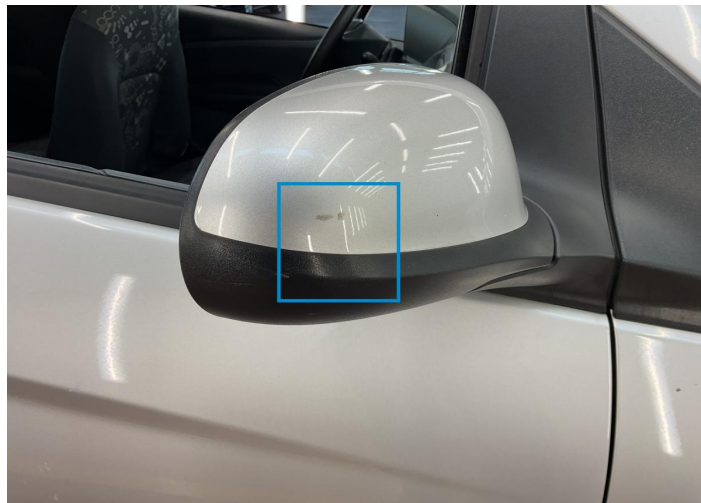
| 25 | Mirror Shell / Front Right | Paint / Scratch / Line |

25. Mirror Shell / Front Right  
Paint / Scratch / Line -
