Expertise

Protocol number: 41610465
Order No. / Reference: 25193734
Inspection date: 18 Sept 2025

Manufacturer: Ford

Model: Transit 310 L2H3 Lkw VA Trend

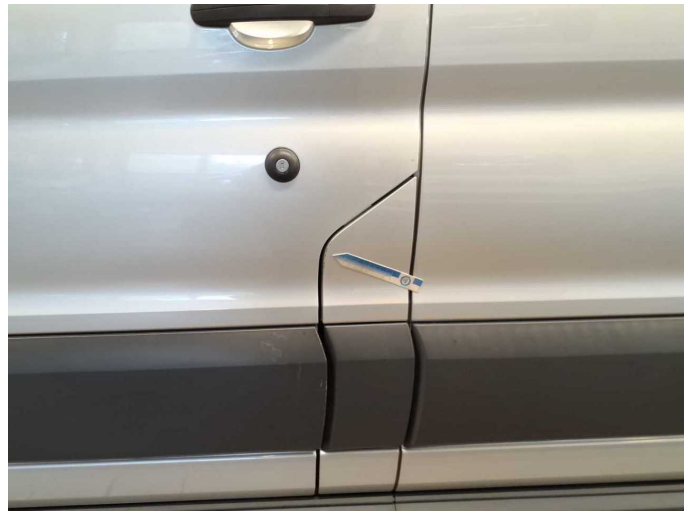
Damage 3: Fuel system: Tank flap - Scratch(es) - Smart repair

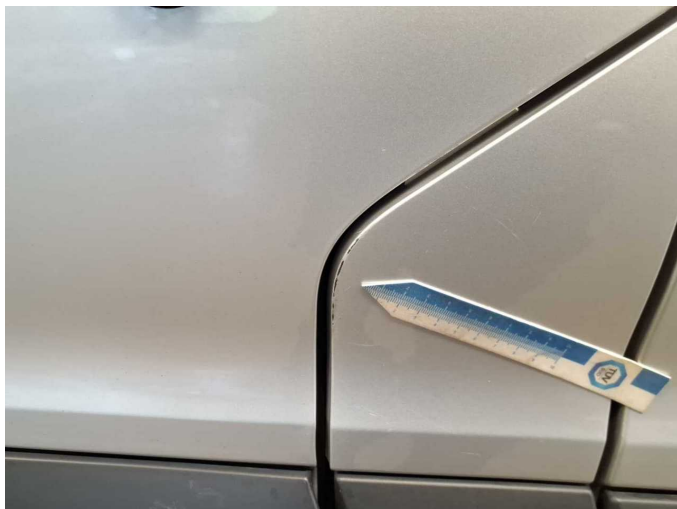
Damage 3: Fuel system: Tank flap - Scratch(es) - Smart repair

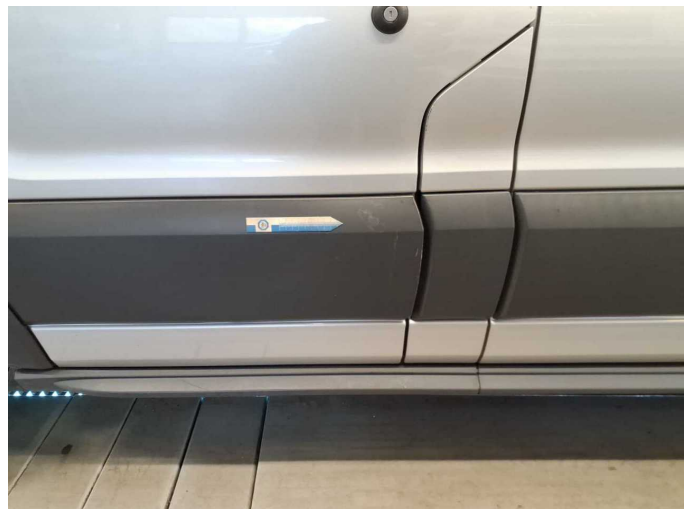
Damage 4: Door - front left side: Brightware - lower - Scratch(es) - Replace

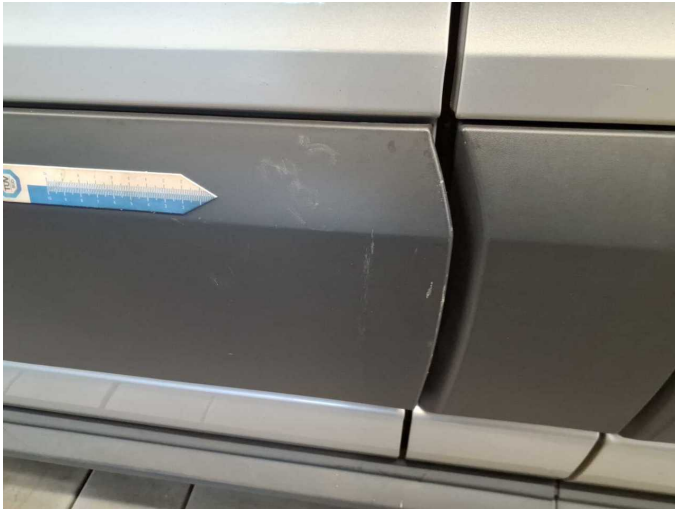
Damage 4: Door - front left side: Brightware - lower - Scratch(es) - Replace

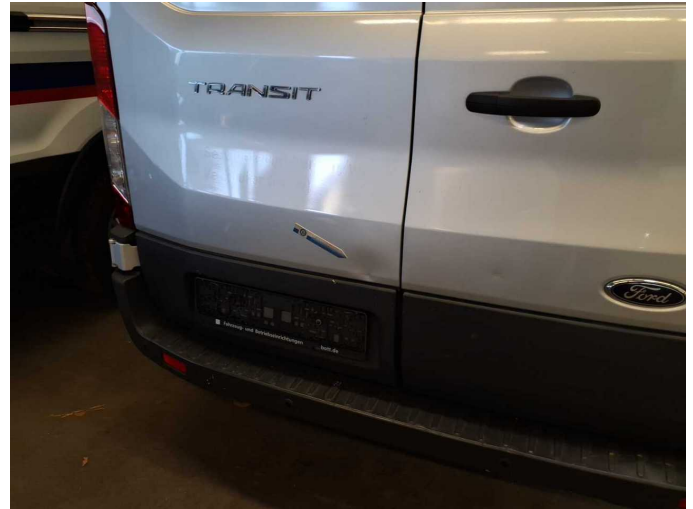
Damage 5: Boot lid / rear door: Boot lid (Links) - Dent / paintcoat damage - Smart repair

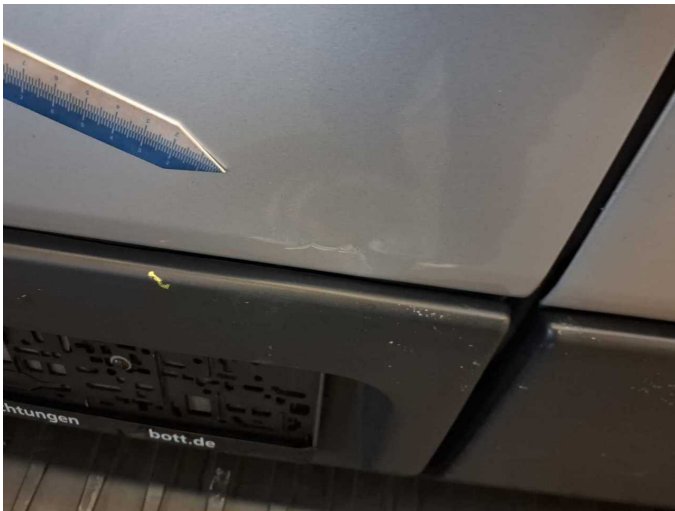
Damage 5: Boot lid / rear door: Boot lid (Links) - Dent / paintcoat damage - Smart repair

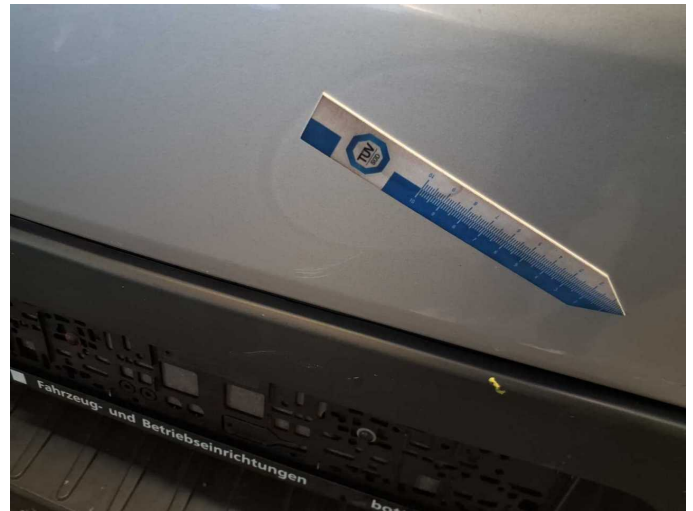
Damage 5: Boot lid / rear door: Boot lid (Links) - Dent / paintcoat damage - Smart repair

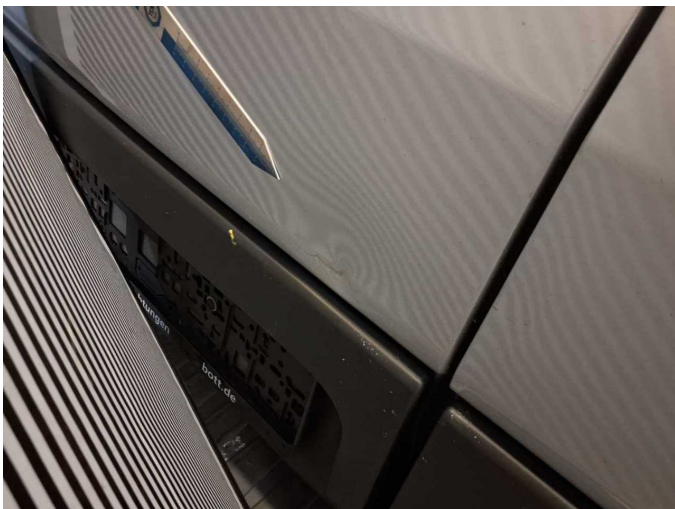
Damage 5: Boot lid / rear door: Boot lid (Links) - Dent / paintcoat damage - Smart repair

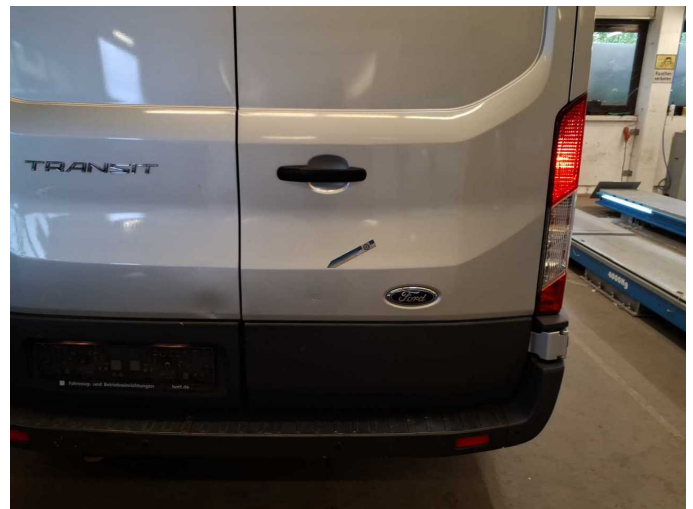
Damage 6: Boot lid / rear door: Boot lid (Rechts) - Dent / paintcoat damage - Smart repair

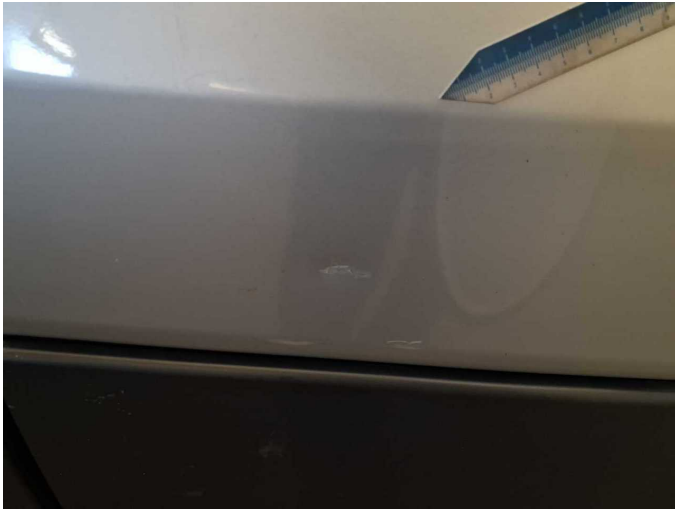
Damage 6: Boot lid / rear door: Boot lid (Rechts) - Dent / paintcoat damage - Smart repair

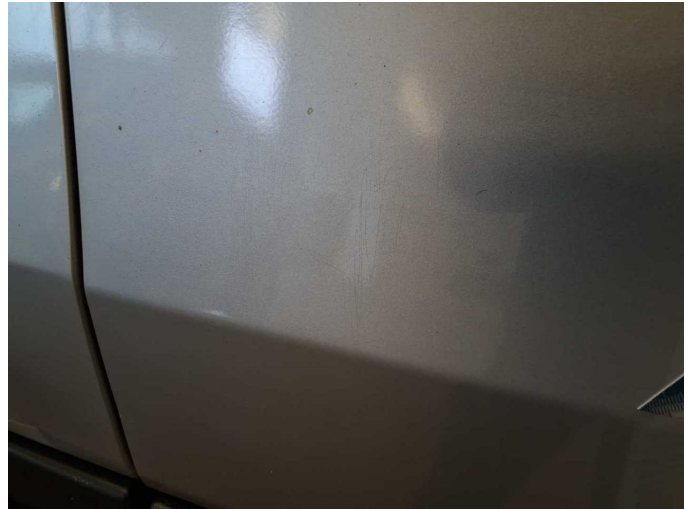
Damage 6: Boot lid / rear door: Boot lid (Rechts) - Dent / paintcoat damage - Smart repair

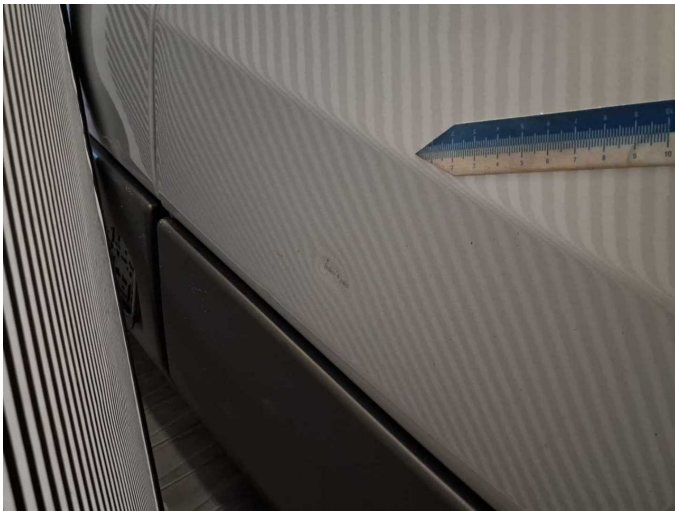
Damage 6: Boot lid / rear door: Boot lid (Rechts) - Dent / paintcoat damage - Smart repair

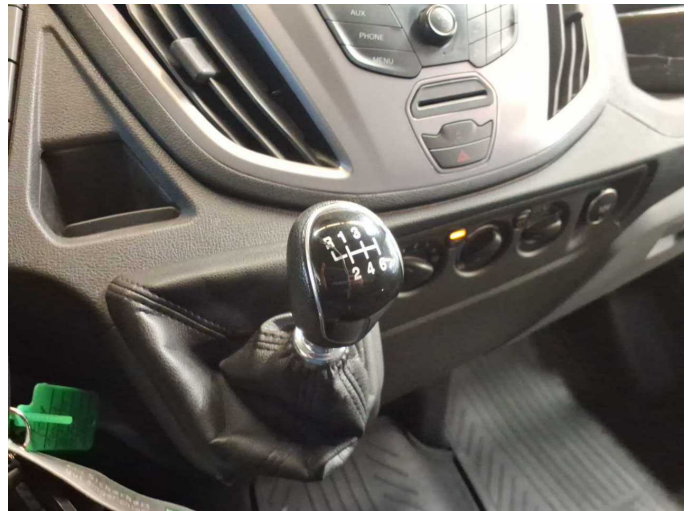
Damage 7: Gearbox: Gear knob - Broken / torn - Replace

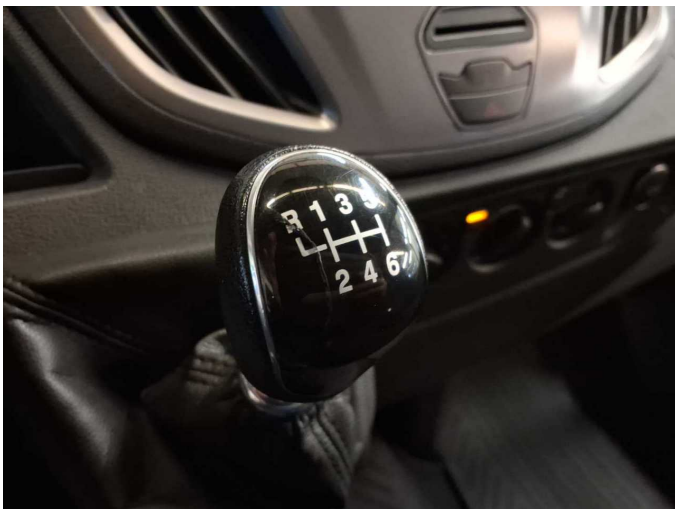
Damage 7: Gearbox: Gear knob - Broken / torn - Replace

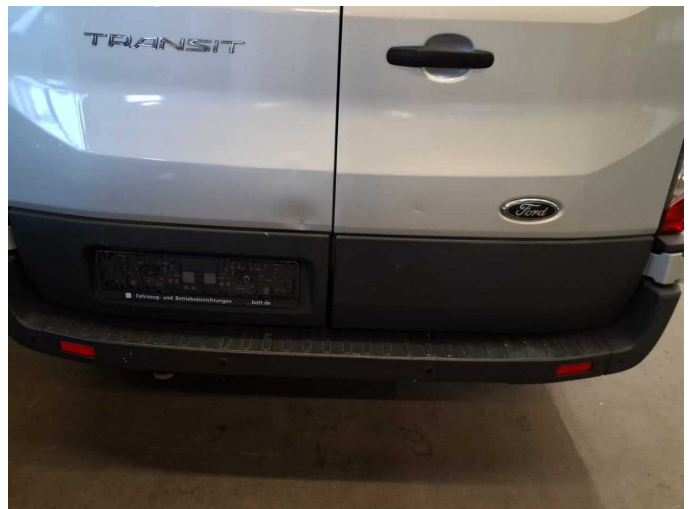
Damage 8: Boot lid / rear door: Boot lid (Verkleidung L + R) - Scratch(es) - Replace

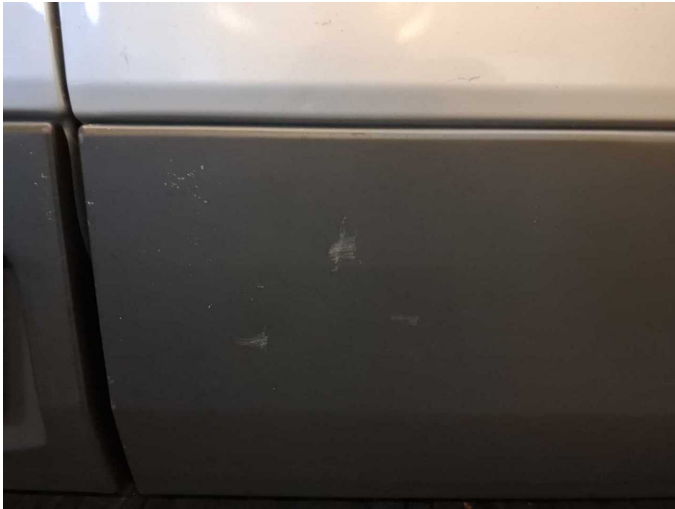
Damage 8: Boot lid / rear door: Boot lid (Verkleidung L+ R) - Scratch(es) - Replace

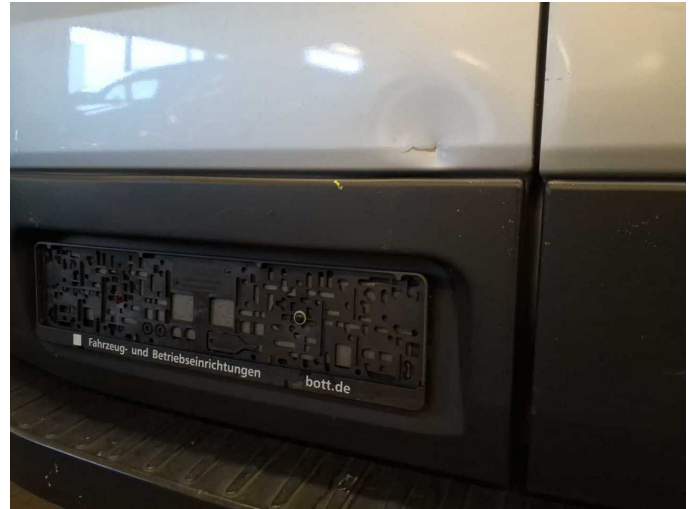
Damage 8: Boot lid / rear door: Boot lid (Verkleidung L+ R) - Scratch(es) - Replace

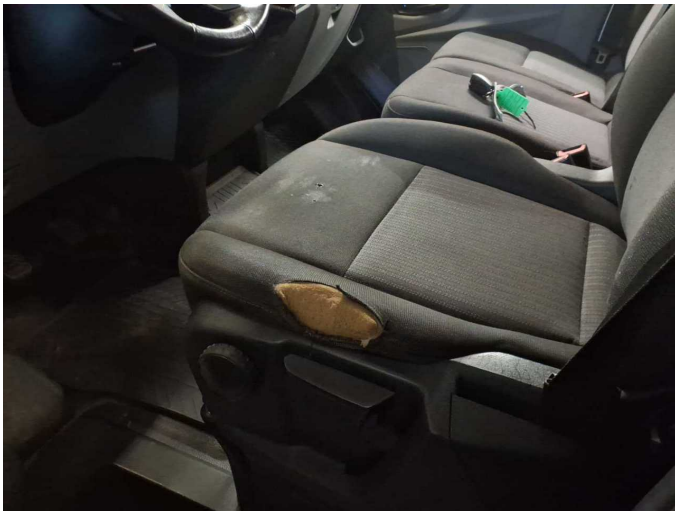
Damage 9: Seat - front: Seat cover - left side (und Polster) - Broken / torn - Replace

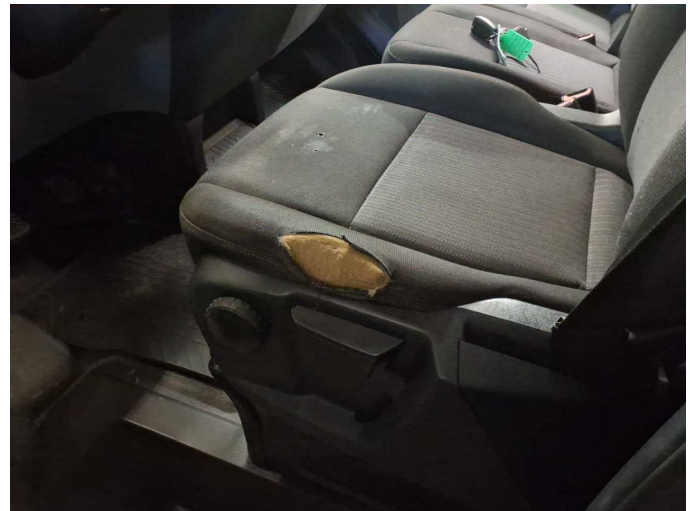
Damage 9: Seat - front: Seat cover - left side (und Polster) - Broken / torn - Replace

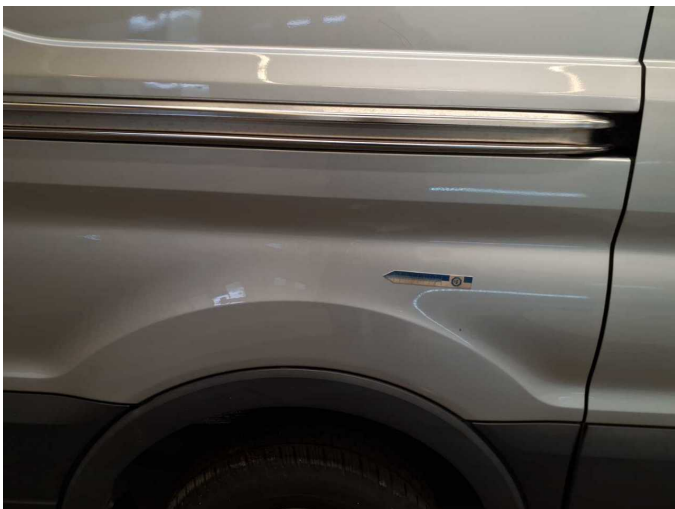
Damage 10: Side panel - rear right side: Side panel (unterhalb) - Scratch(es) - Paint

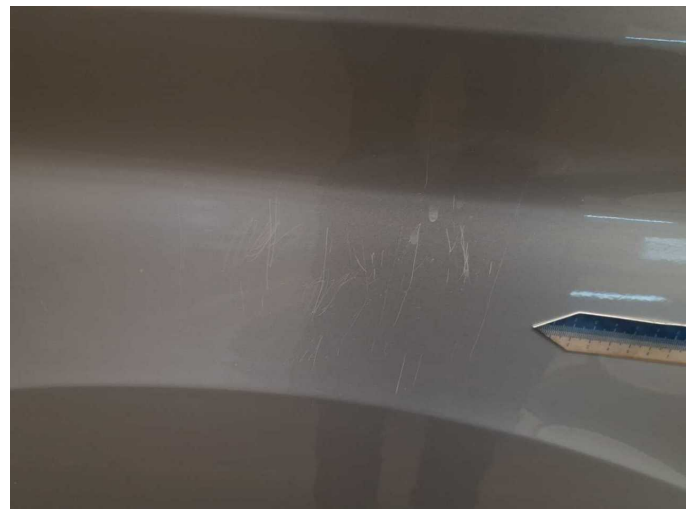
Damage 10: Side panel - rear right side: Side panel (unterhalb) - Scratch(es) - Paint

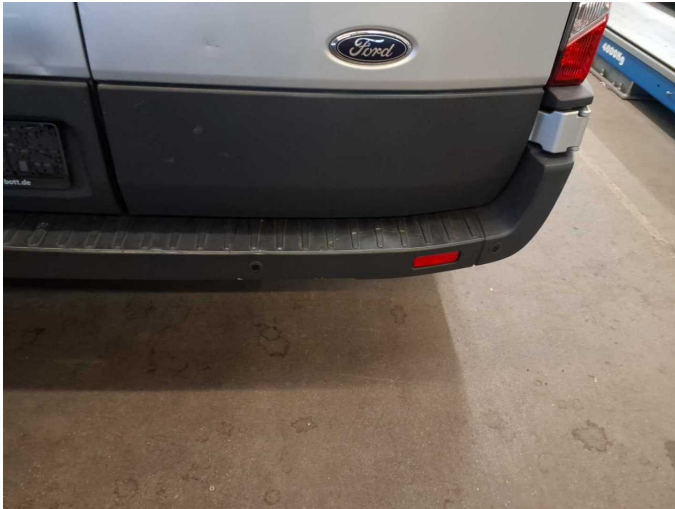
Damage 11: Rear bumper: Rear bumper (unpainted) - Deformed - Replace

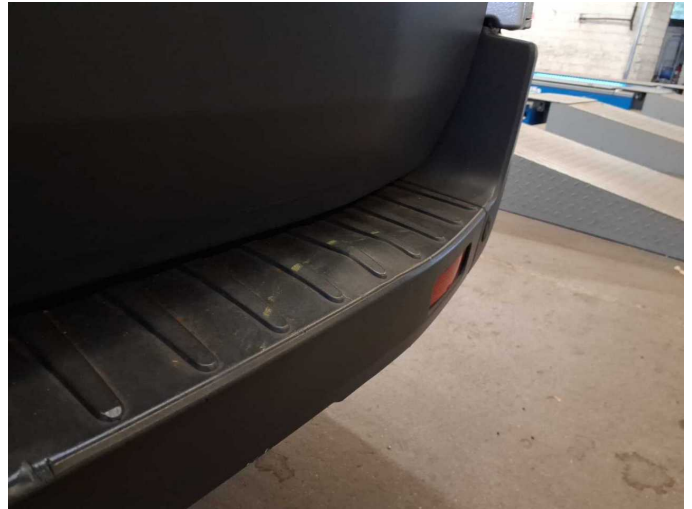
Damage 11: Rear bumper: Rear bumper (unpainted) - Deformed - Replace

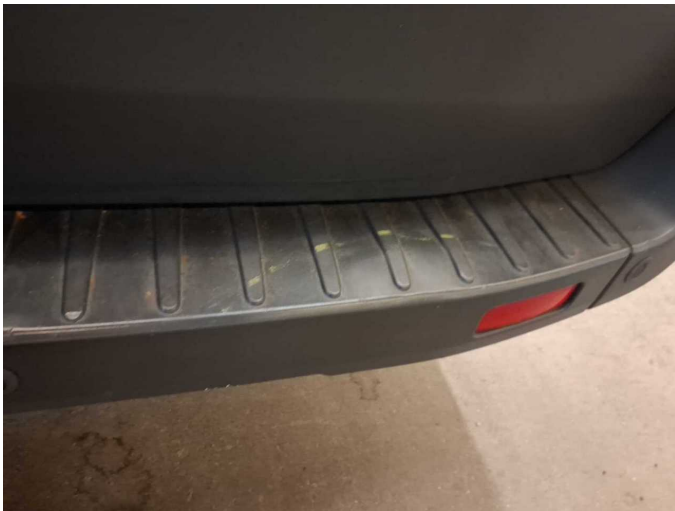
Damage 11: Rear bumper: Rear bumper (unpainted) - Deformed - Replace

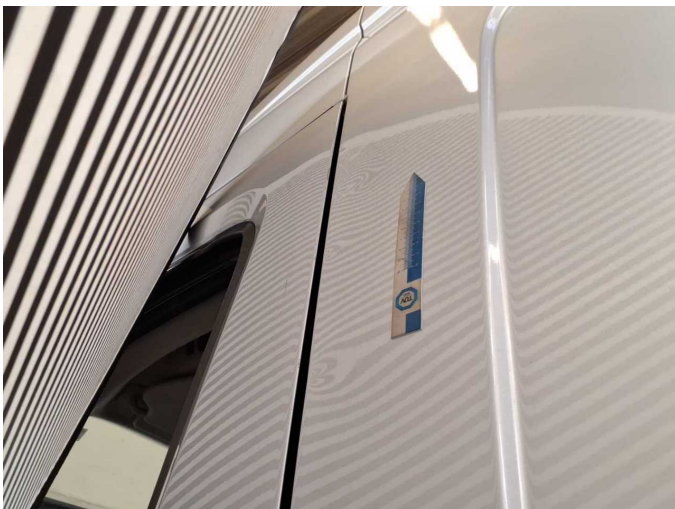
Damage 12: Side panel - rear left side: Side panel (teilweise) - Deformed - Repair and paint

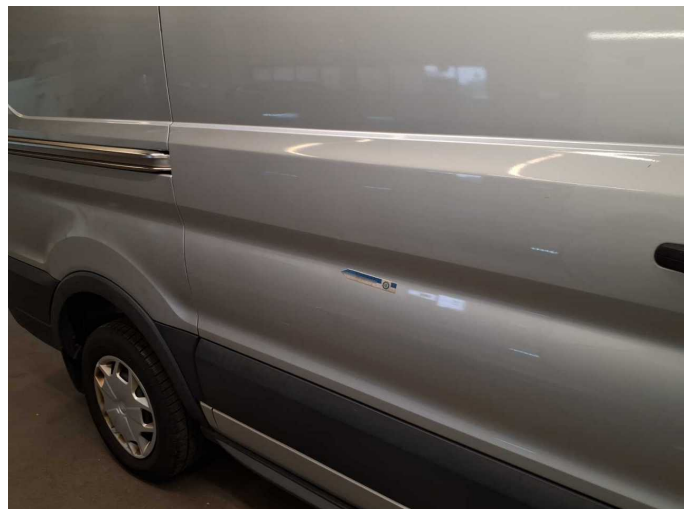
Damage 13: Sliding door, right: Sliding door - Dent / paintcoat damage - Repair and paint

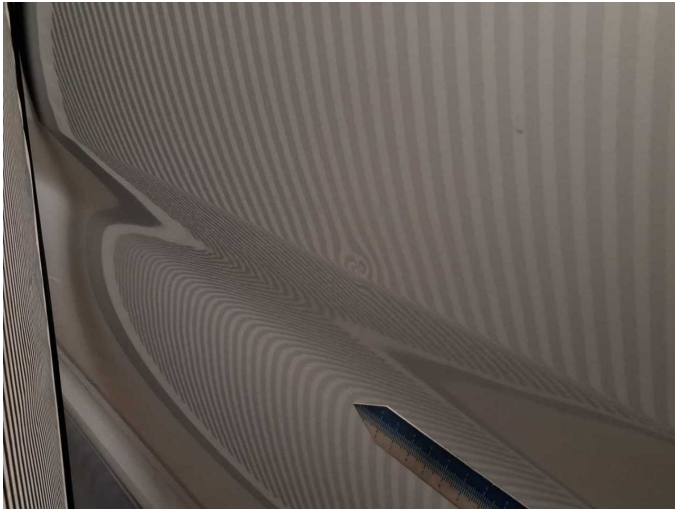
Damage 13: Sliding door, right: Sliding door - Dent / paintcoat damage - Repair and paint

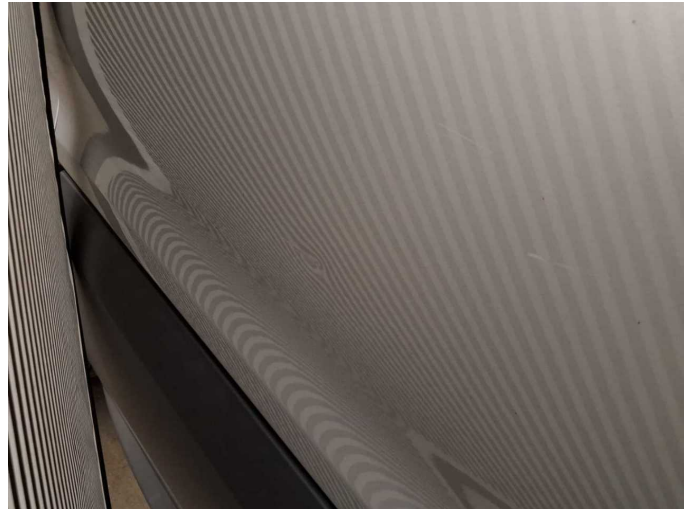
Damage 13: Sliding door, right: Sliding door - Dent / paintcoat damage - Repair and paint

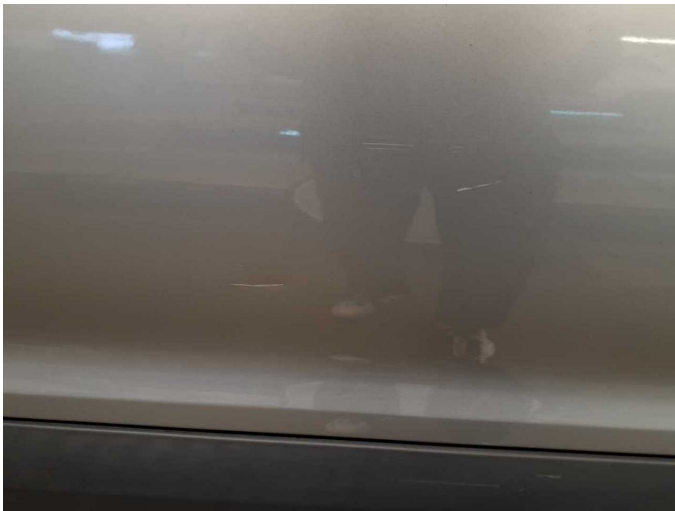
Damage 13: Sliding door, right: Sliding door - Dent / paintcoat damage - Repair and paint

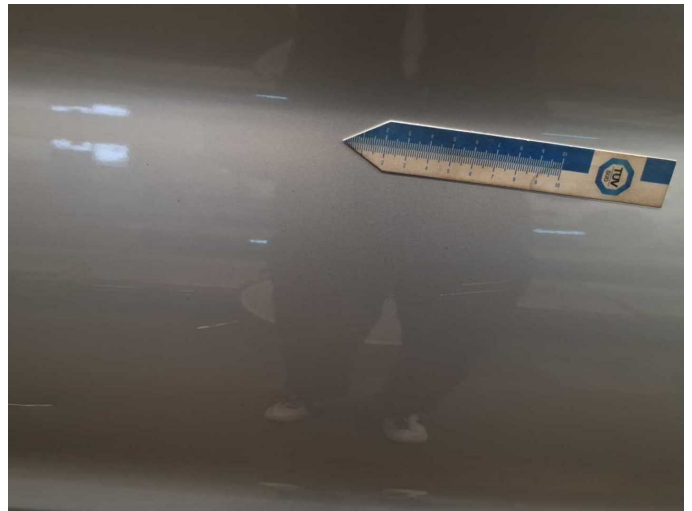
Damage 13: Sliding door, right: Sliding door - Dent / paintcoat damage - Repair and paint

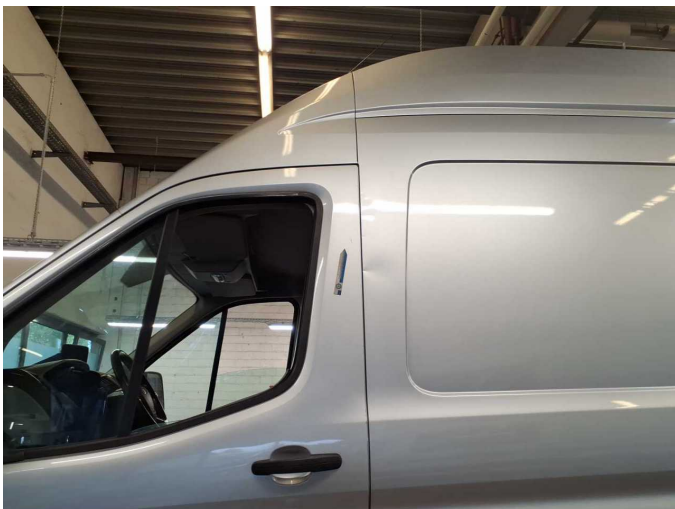
Damage 14: Door - front left side: Door - Dent / paintcoat damage - Repair and paint

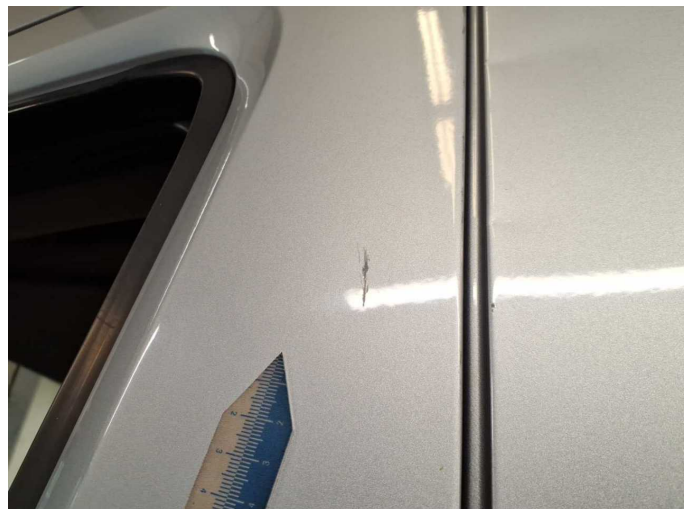
Damage 14: Door - front left side: Door - Dent / paintcoat damage - Repair and paint

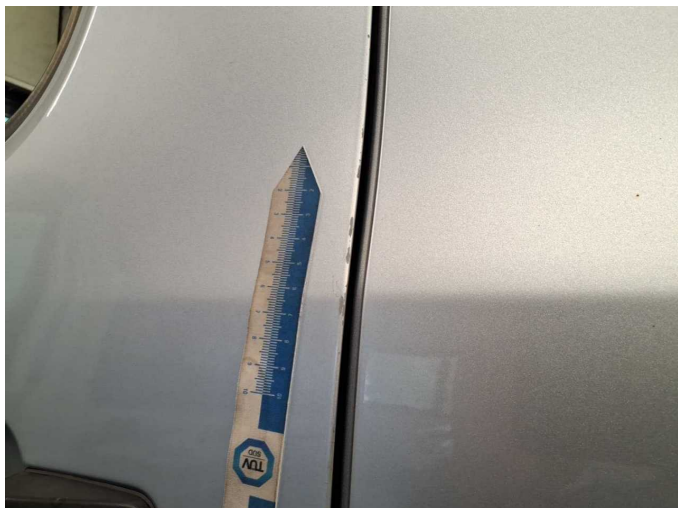
Damage 14: Door - front left side: Door - Dent / paintcoat damage - Repair and paint

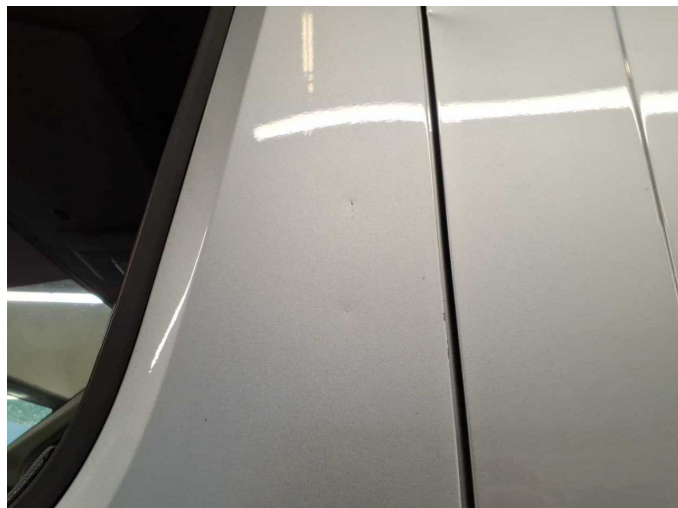
Damage 14: Door - front left side: Door - Dent / paintcoat damage - Repair and paint

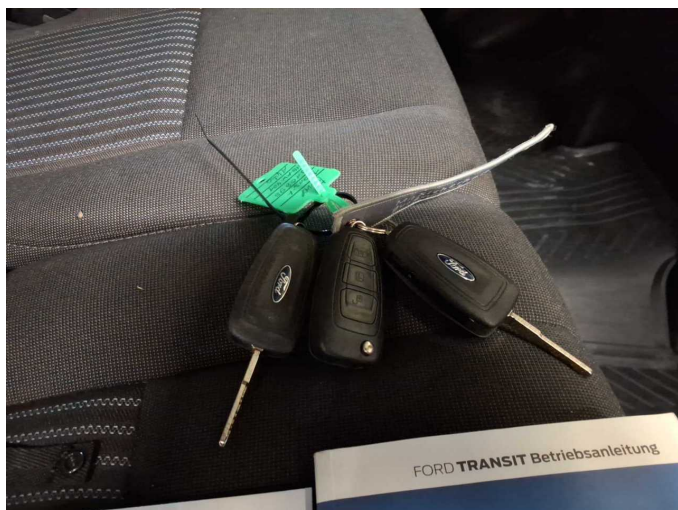
Missing part 2: Equipment: Vehicle key - Missing - Replace
