Expertise

Protocol number: 41850181
Order number / reference: 25197769
Inspection date: 7 Oct 2025

Manufacturer: Ford

Model: Transit Custom 280 L1H1 LKW VA MH Trend

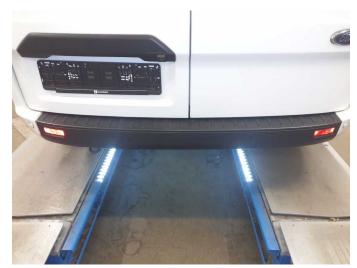
Damage 1: Rear bumper: Rear bumper - Malposition - Un- / install

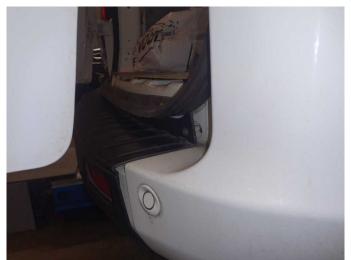
Damage 1: Rear bumper: Rear bumper - Malposition - Un- / install

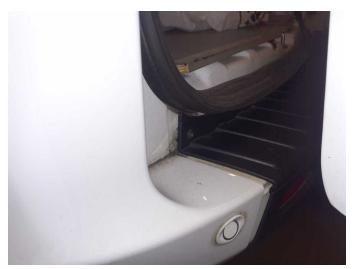
Damage 1: Rear bumper: Rear bumper - Malposition - Un- / install

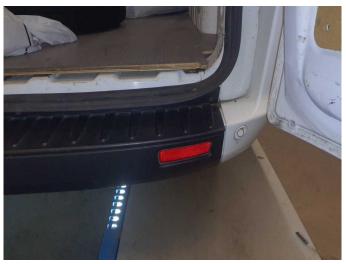
Damage 1: Rear bumper: Rear bumper - Malposition - Un- / install

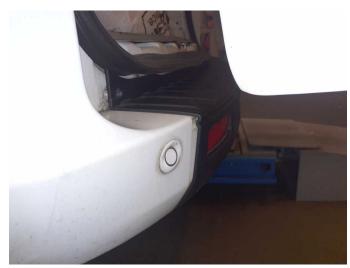
Damage 1: Rear bumper: Rear bumper - Malposition - Un- / install

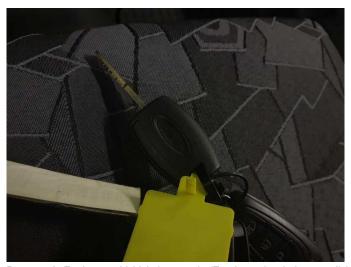
Damage 3: Equipment: Vehicle key mech. (Zündung einschalten möglich jedoch kein start-muss angelernt) - Non-operational - Diagnosed and repair if necessary

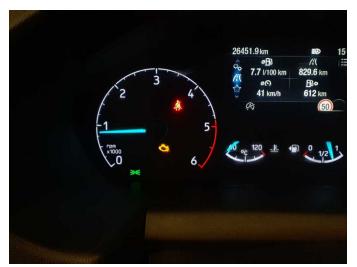
Damage 4: Instrument panel: Indicator light (Motorkontrolle) - on - Perform diagnosis

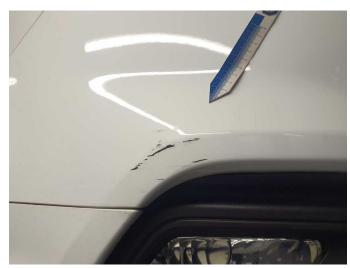
Damage 5: Front bumper: Front bumper - Scratch(es) - Paint

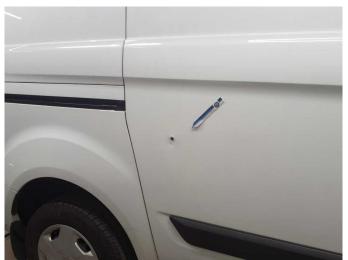
Damage 6: Sliding door, right: Sliding door - Holes - Repair and paint

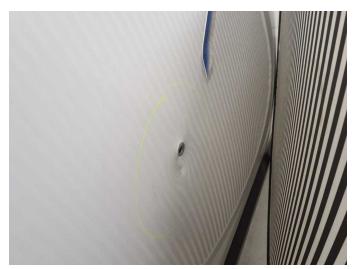
Damage 6: Sliding door, right: Sliding door - Holes - Repair and paint

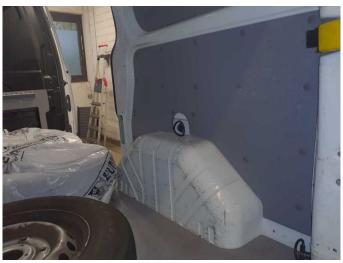
Wear and tear 2: Interior: Cargo space division - Scratch(es) - No deduction

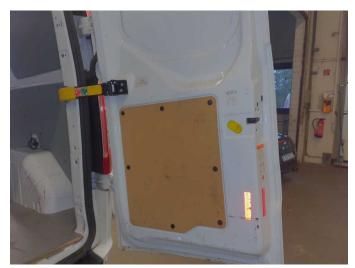
Wear and tear 2: Interior: Cargo space division - Scratch(es) - No deduction

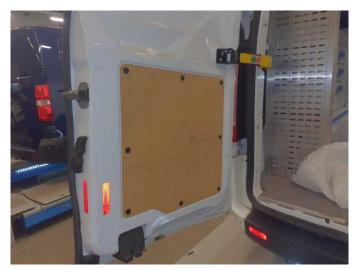
Wear and tear 2: Interior: Cargo space division - Scratch(es) - No deduction
