Expertise

Protocol number: 41553891
Order No. / Reference: 25185733
Inspection date: 15 Sept 2025

Manufacturer: Ford

Model: Transit Custom 320 L2H1 LKW VA Trend

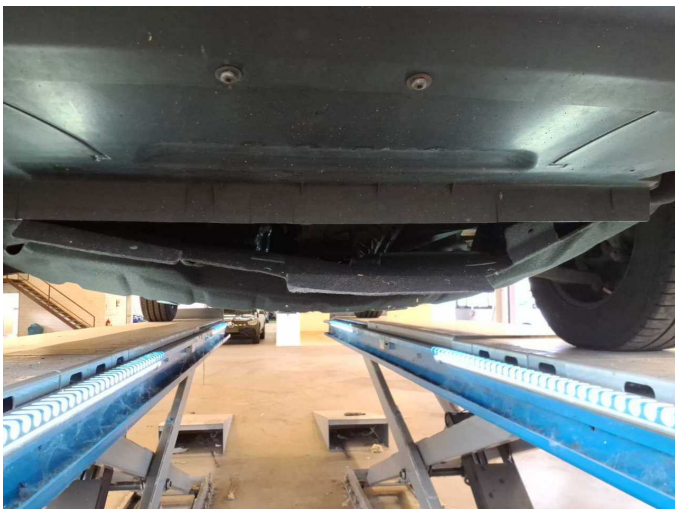
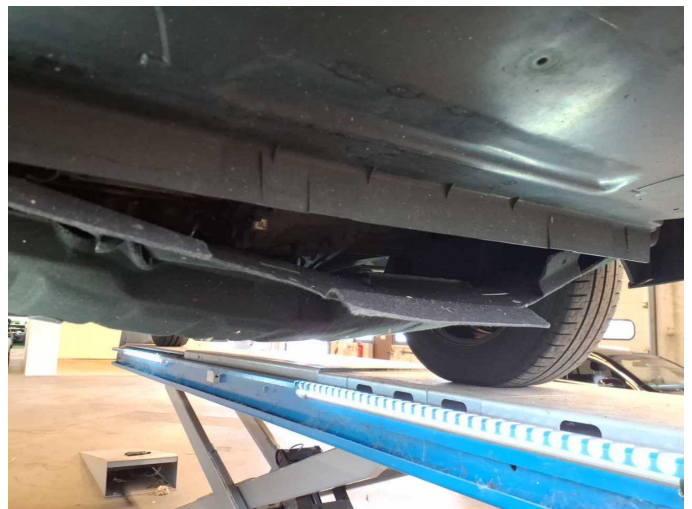
Damage 4: Body: Underbody panelling - Malposition - Repair

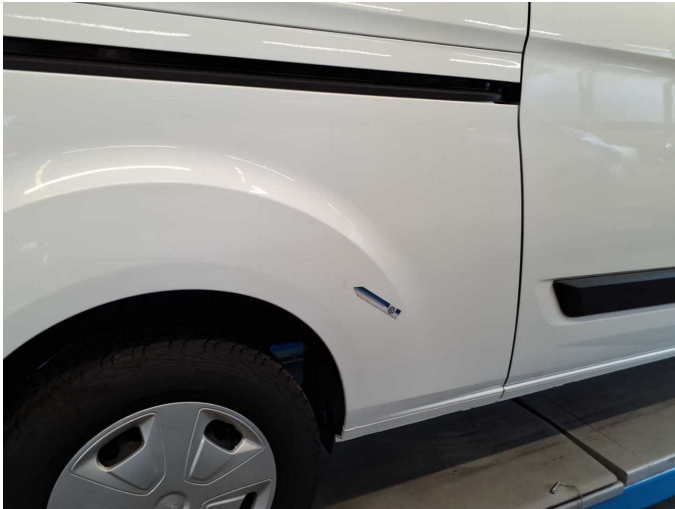
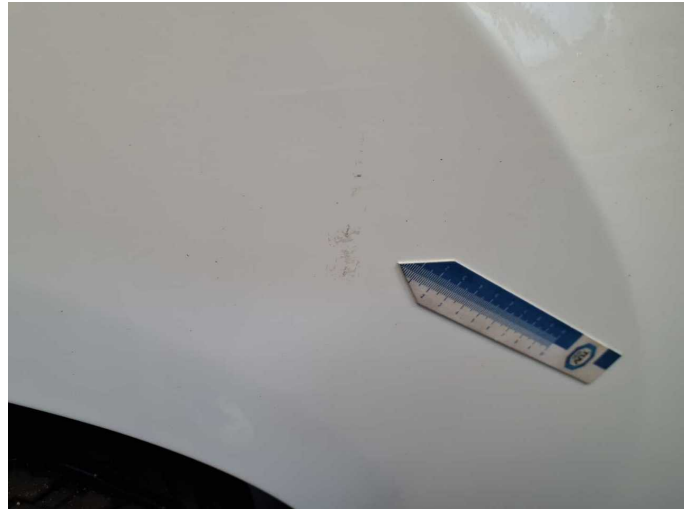
Damage 5: Side panel - rear right side: Side panel - Scratch(es) - Smart repair

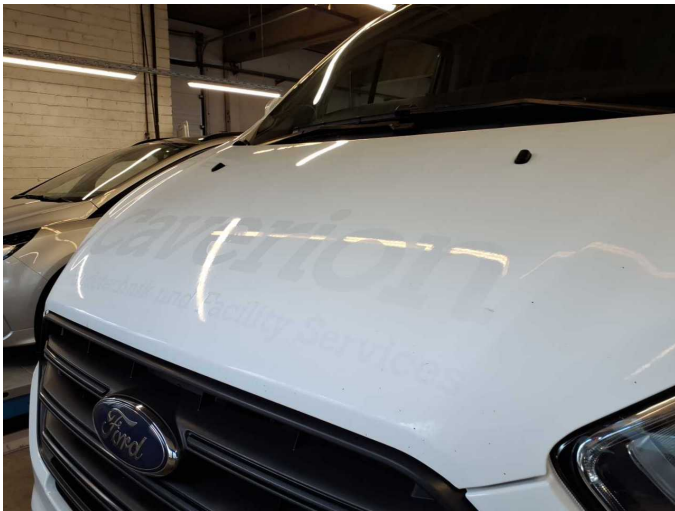
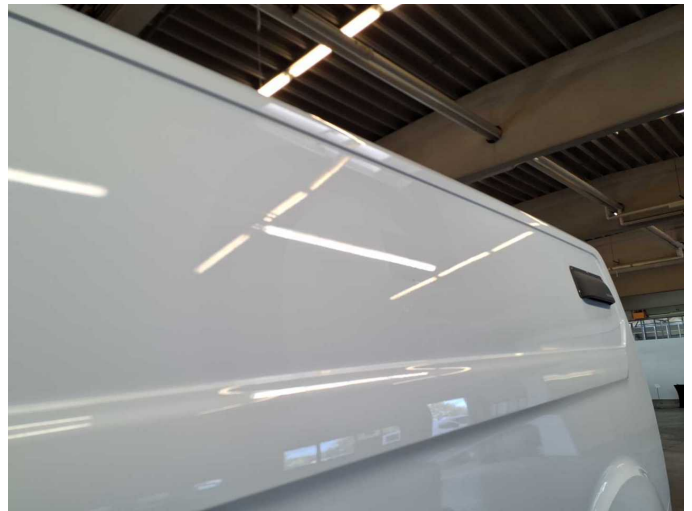
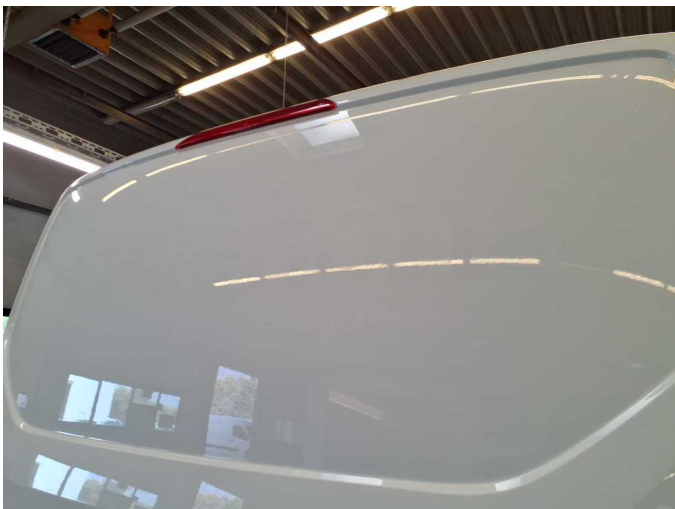
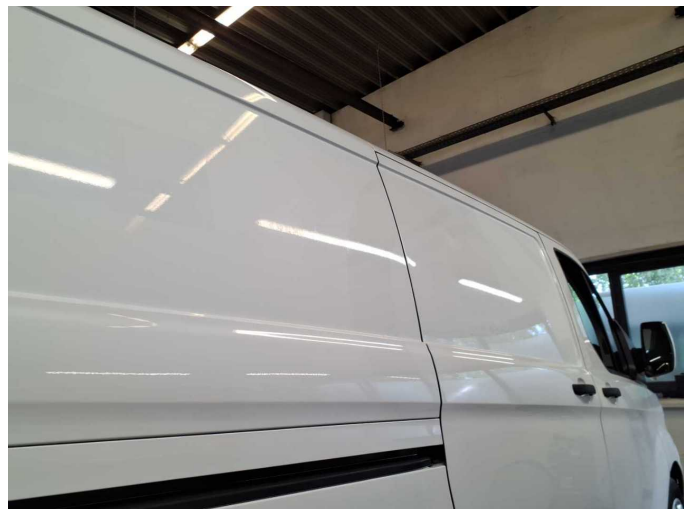
Damage 6: Body: Body (Klebereste) - Glued / labelled - De-glue / neutralise

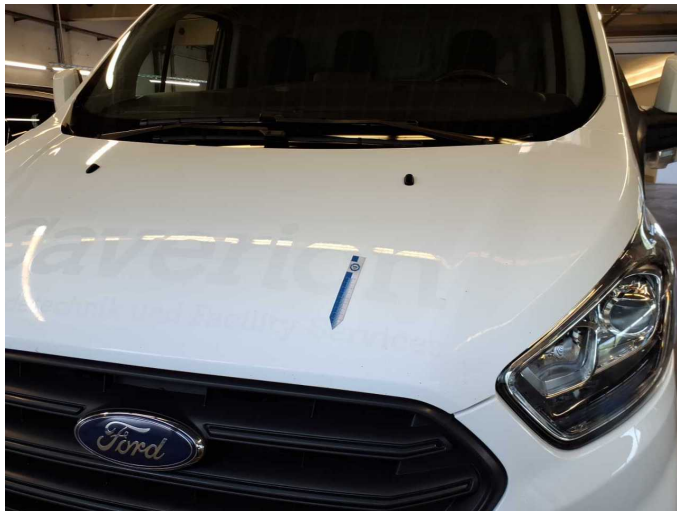
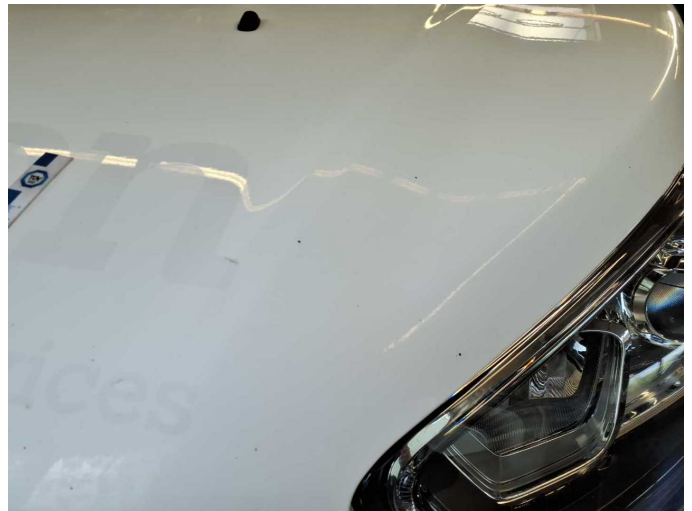
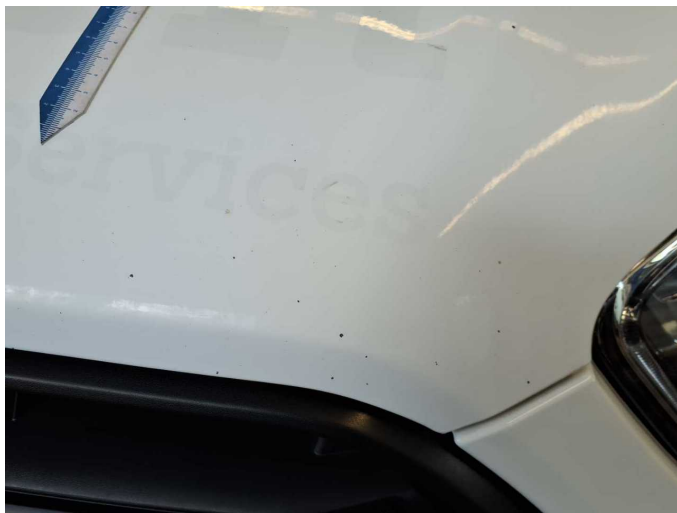
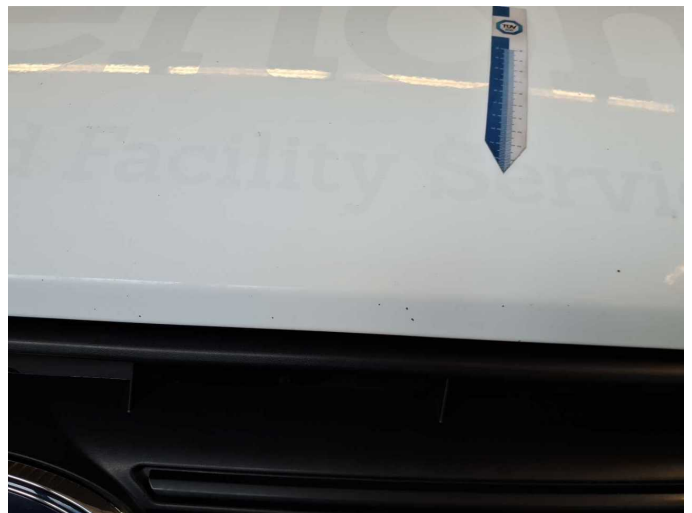
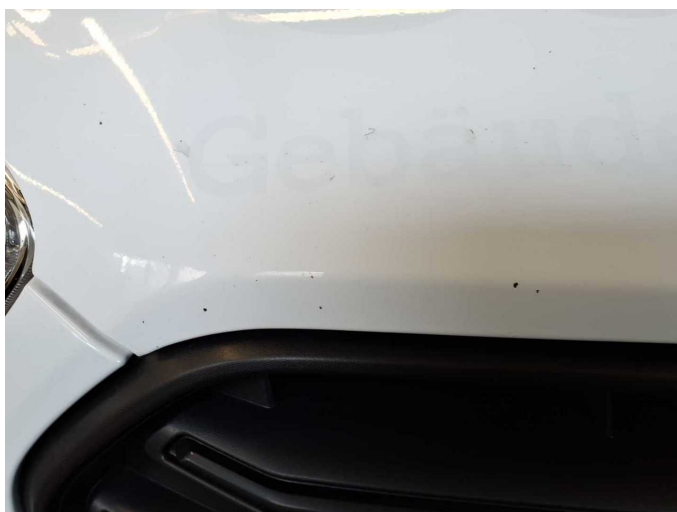
Damage 7: Bonnet: Bonnet - Stone chips - Paint

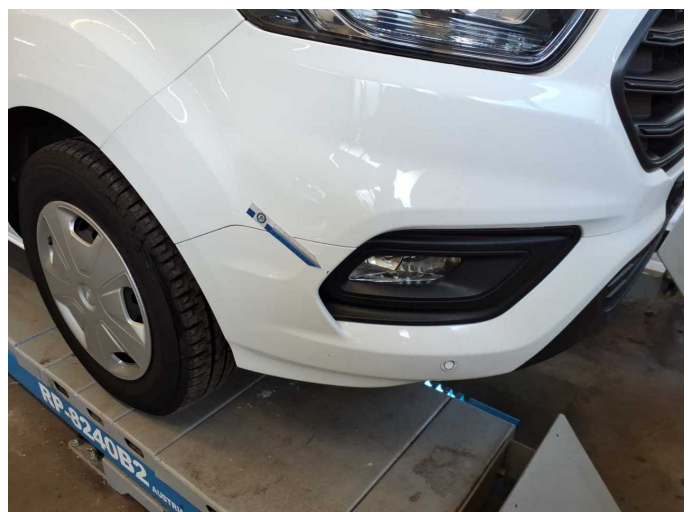
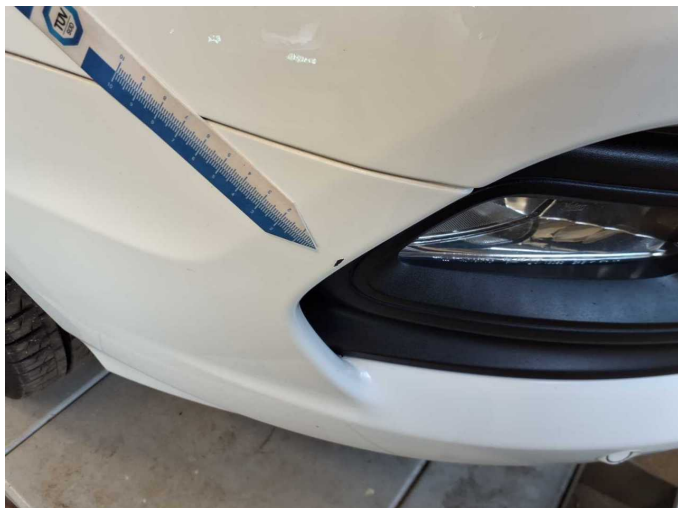
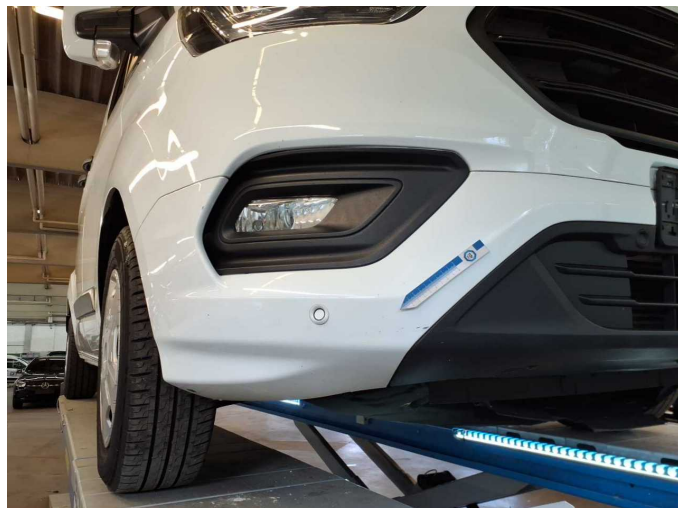
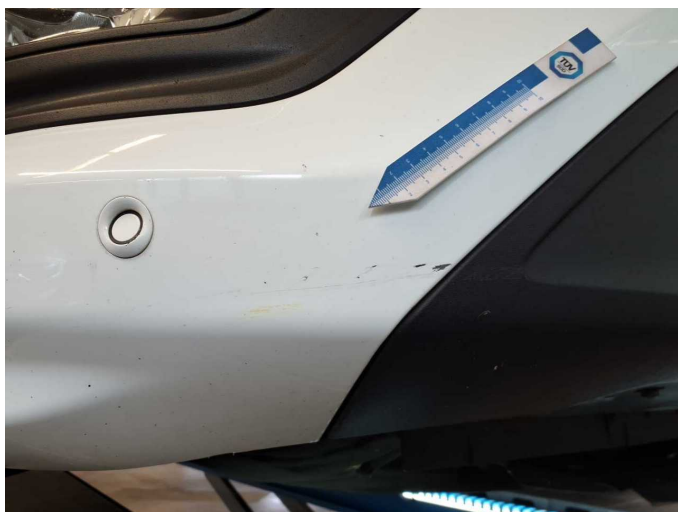
Damage 8: Front bumper: Front bumper (unterhalb) - Scratch(es) - Paint
