## status report

**customer:** BCA Autoauktionen GmbH

#### Ford Transit Custom Kasten 290 L1 Sport

| Vehicle identification number | <b>WF0YXXTTGYKP54683</b> | mileage read: | <b>114595 km</b> |

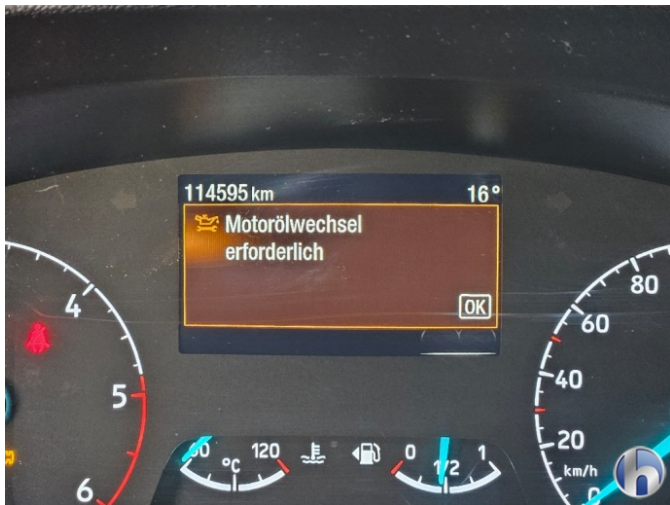
| component | Damage | Rep kind |
|---|---|---|
| 1. maintenance | Due | Replace |

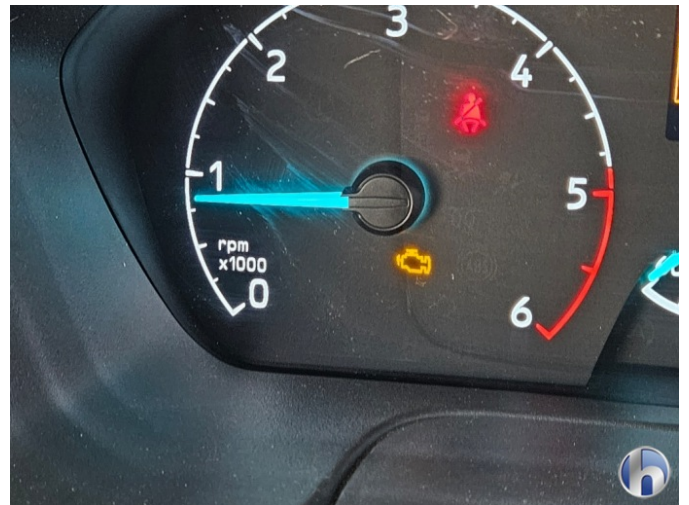
| Performed testing technology | |
|---|---|
| <b>engine running:</b> | A field test of the engine had to acoustic or visual defects for visiting time .<br>**Engine warning light. |

| component | Damage | Rep kind |
|---|---|---|
| 2. motor | Error message | Carry out a fault diagnosis |

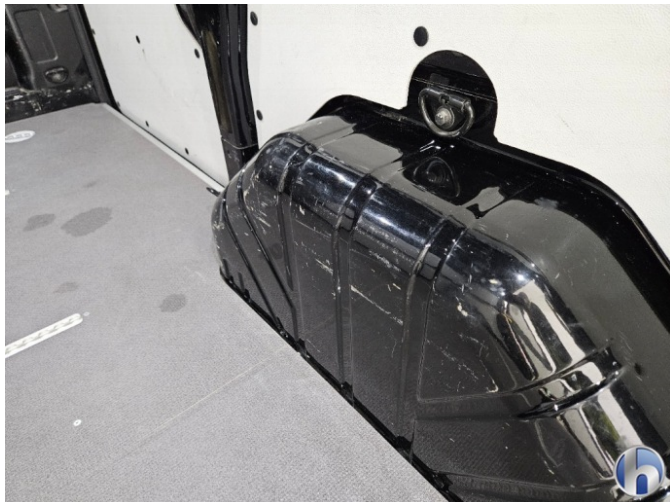
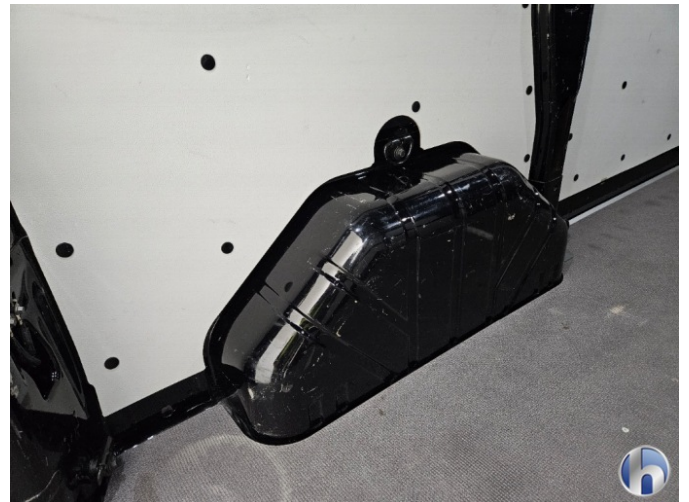
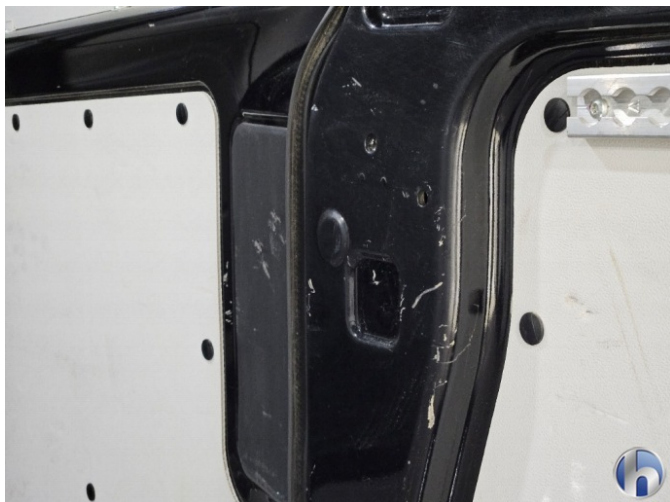
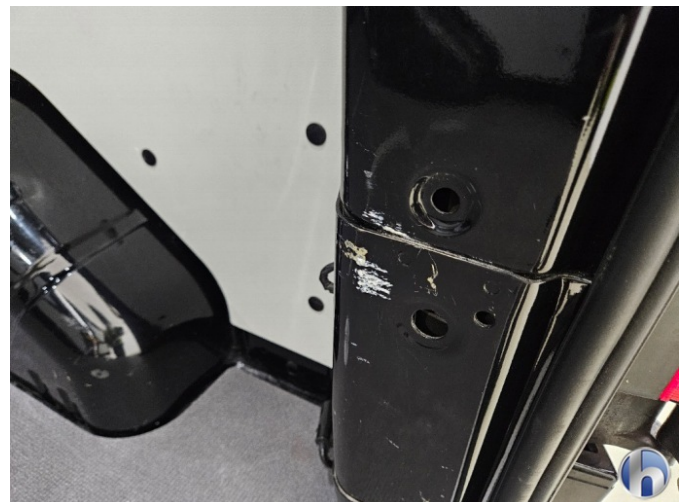
| component | Damage | Rep kind |
|---|---|---|
| 4. | Wear and tear | acceptable |

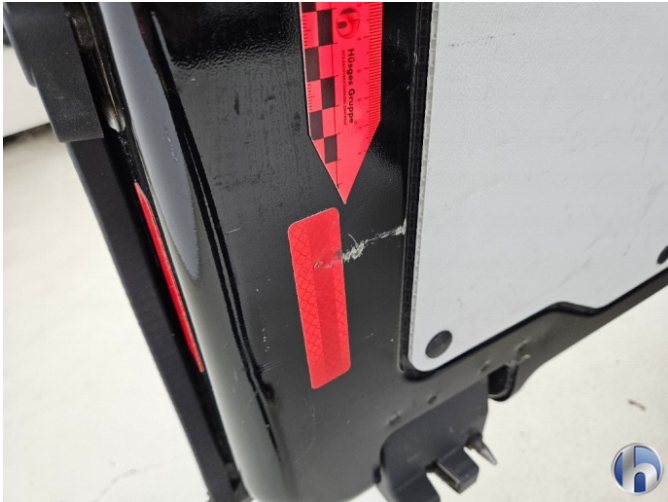
| component | Damage | Rep kind |
|---|---|---|
| 5. Tailgate left | Wear and tear | acceptable |

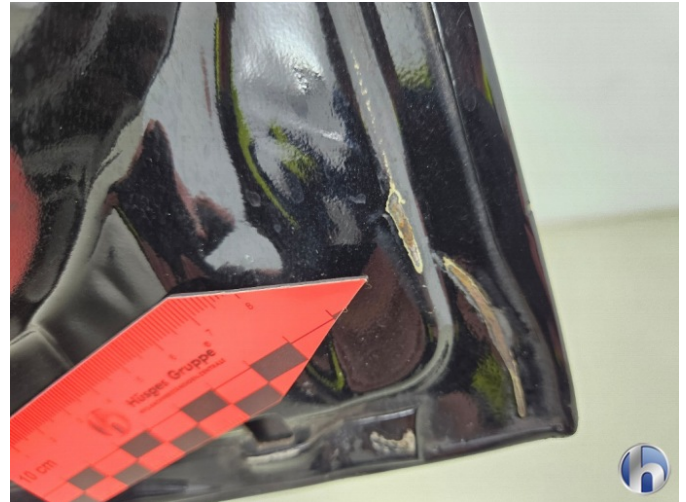
| component | Damage | Rep kind |
|---|---|---|
| 6. Tailgate right | Corroded | Paint |

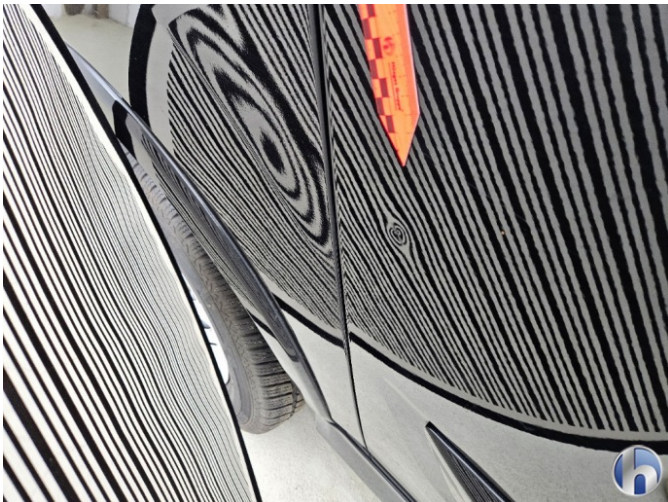
| component | Damage | Rep kind |
|---|---|---|
| 8. Door Rear - right | Wear and tear | acceptable |

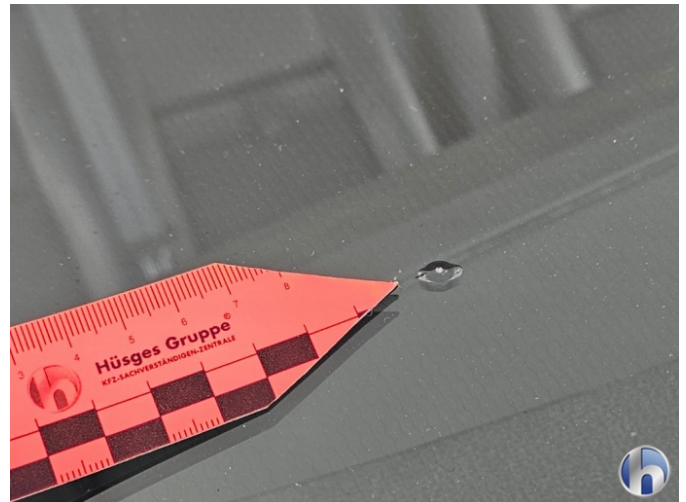
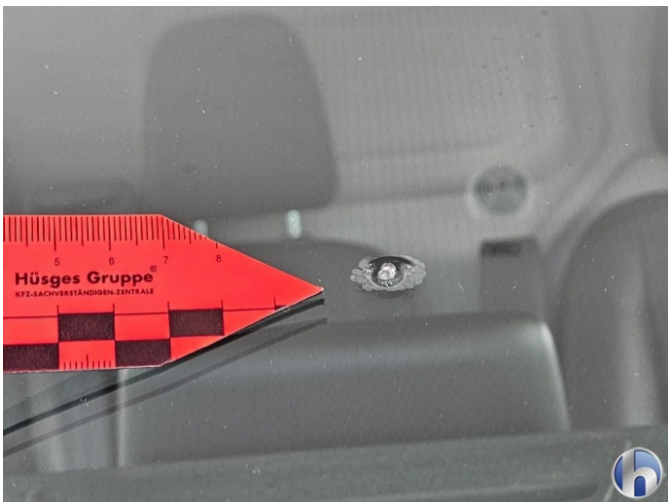
| <b>Note Road Safe:</b> | Frontscheibe beschädigt |

| component | Damage | Rep kind |
|---|---|---|
| 9. Windshield | Damaged | Replace |

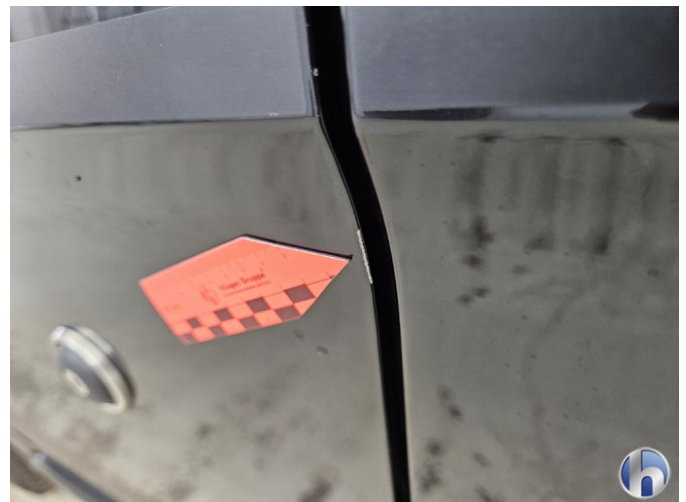
| component | Damage | Rep kind |
|---|---|---|
| 10. Front door - left | Wear and tear | acceptable |

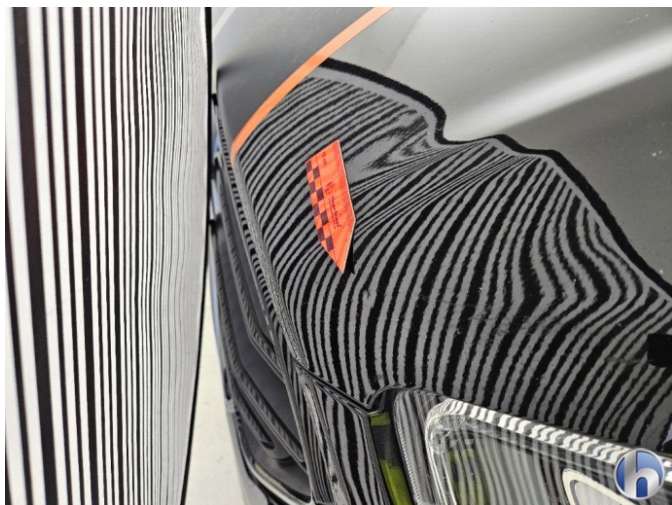
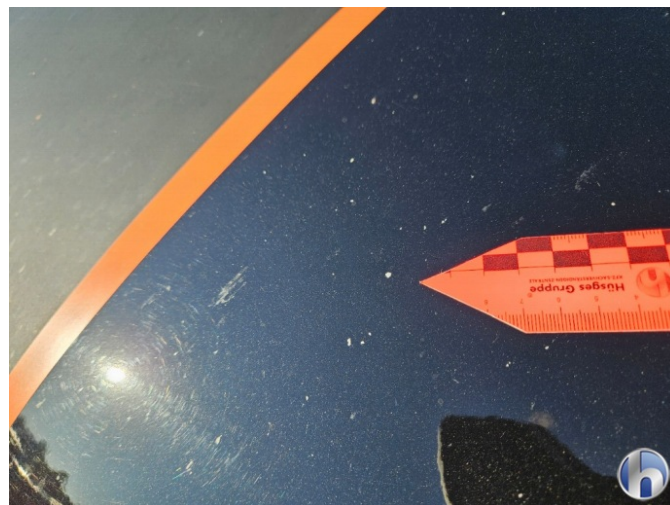
| component | Damage | Rep kind |
|---|---|---|
| 11. hood | Wear and tear | acceptable |
