Expertise

Protocol number: 41849222
Order number / reference: 25273724
Inspection date: 7 Oct 2025

Manufacturer: Ford

Model: Transit Custom 320 L1H1 LKW VA Trend

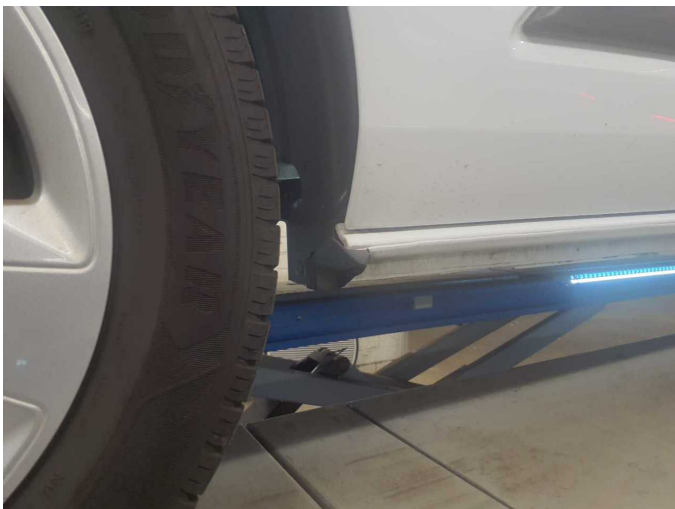
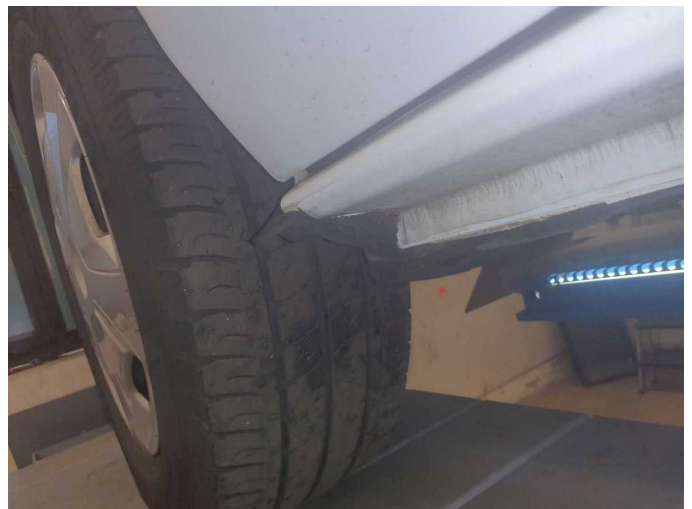
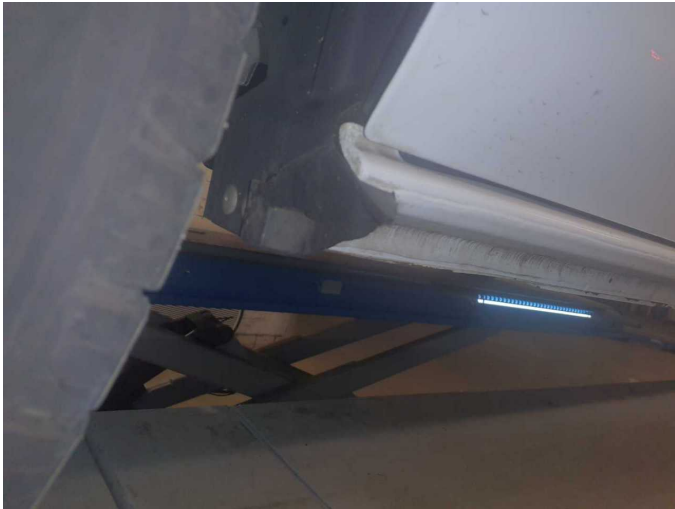
No.	Component group	Description
1	Mudguard - left side	Mud flap - Broken / torn - Replace
2	Mudguard - right side	Mud flap - Broken / torn - Replace
3	Trim / covers	Boot lid - interior trim - Broken / torn - Replace
4	Body	Underbody panelling (Hängt runter/bauch nach unten) - Damaged - Replace
5	Rear bumper	Bumper - rear right side - Scratch(es) - Paint
6	Bonnet	Bonnet (viele Steinschläge) - Scratch(es) - Paint

Damage 1: Mudguard - left side: Mud flap - Broken / torn - Replace

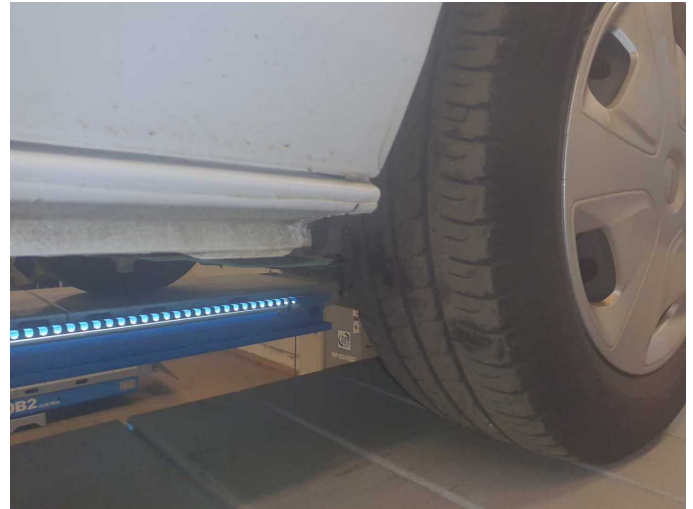
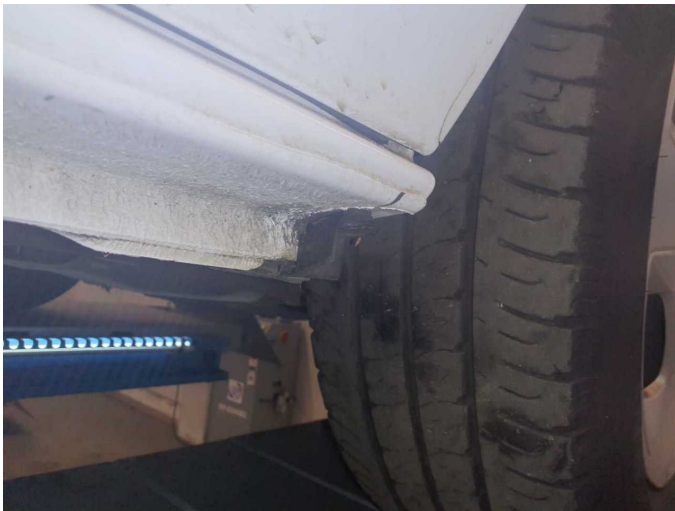
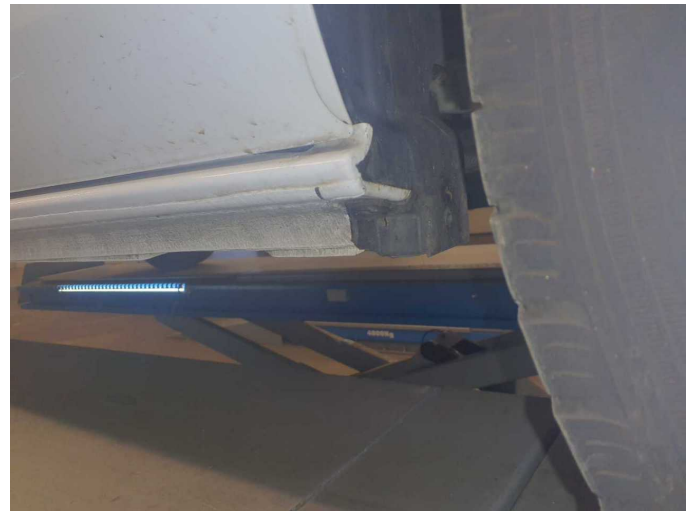
Damage 2: Mudguard - right side: Mud flap - Broken / torn - Replace

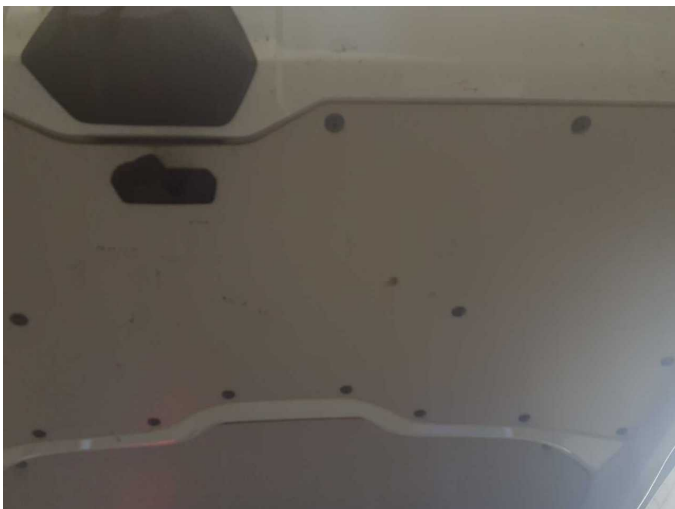
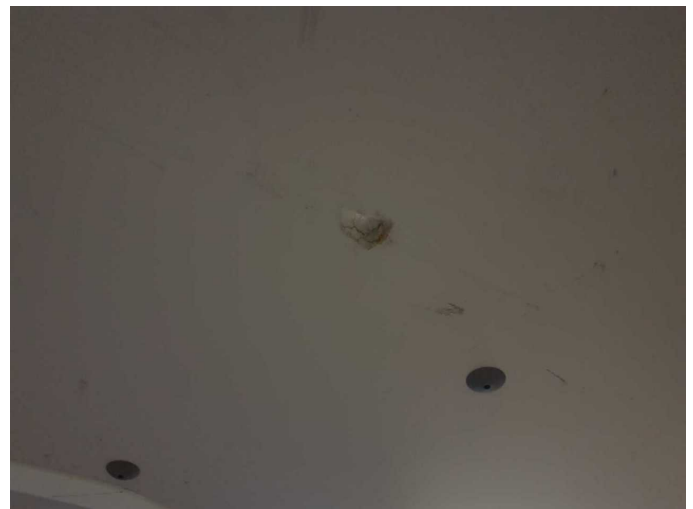
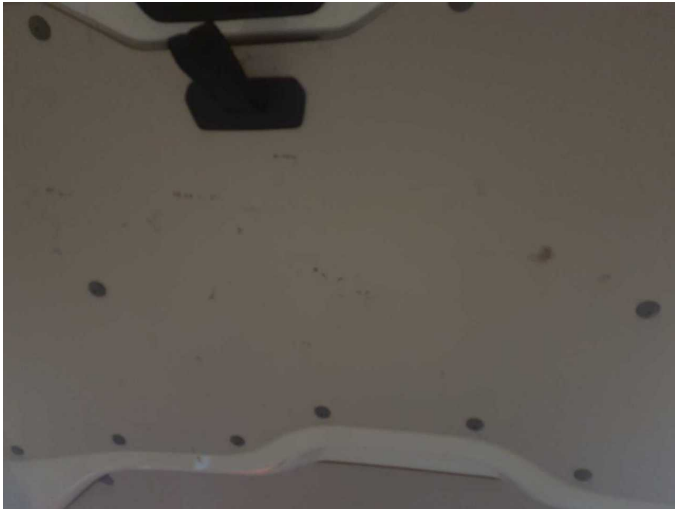
Damage 3: Trim / covers: Boot lid - interior trim - Broken / torn - Replace

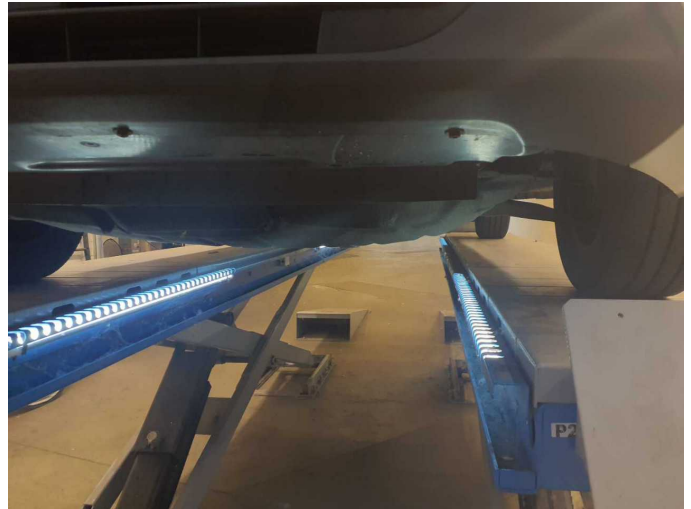
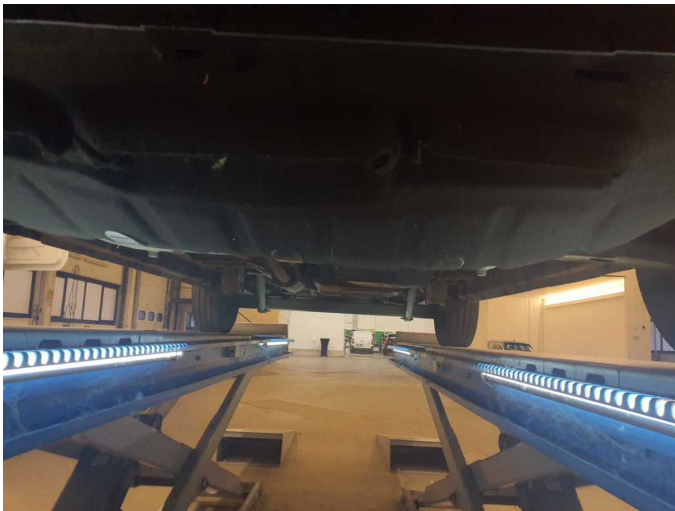
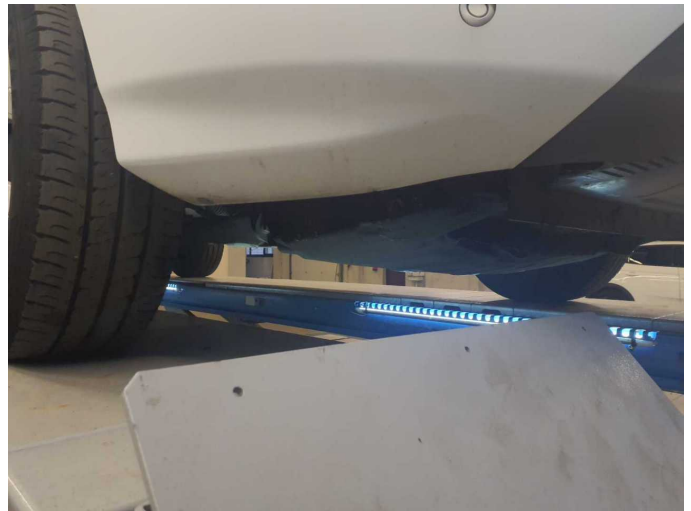
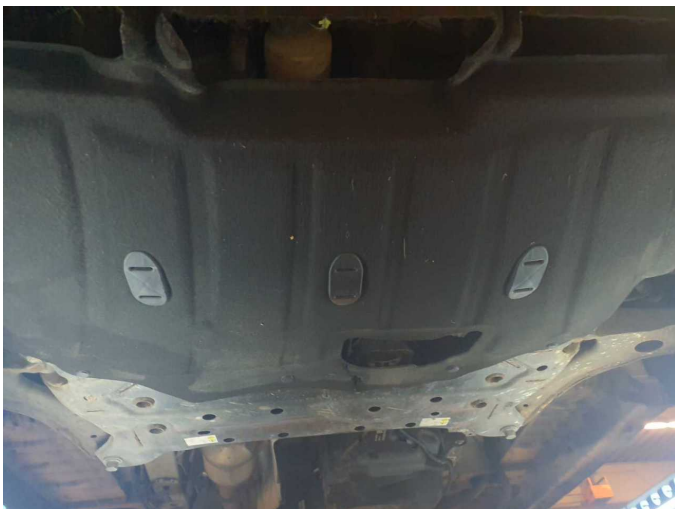
Damage 4: Body: Underbody panelling (Hängt runter/bauch nach unten)
- Damaged - Replace

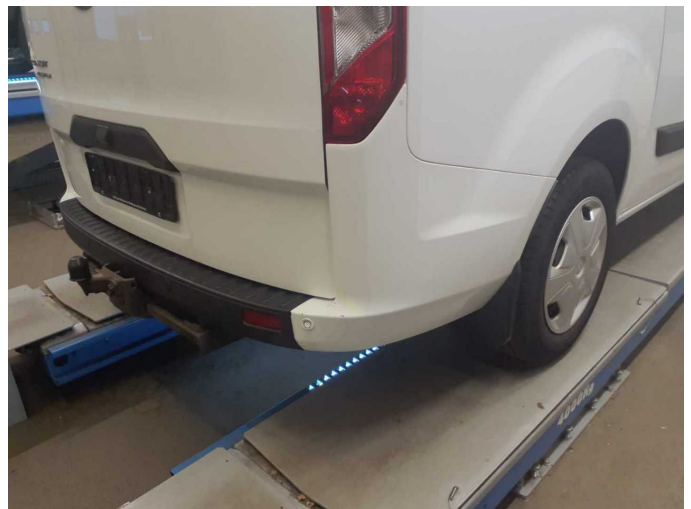
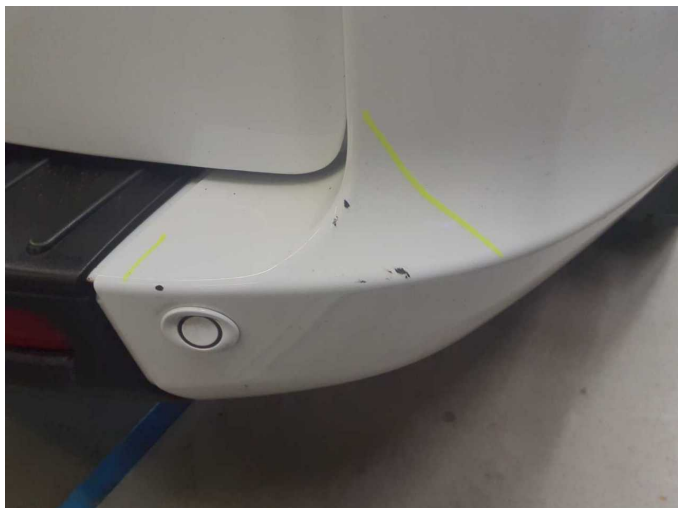
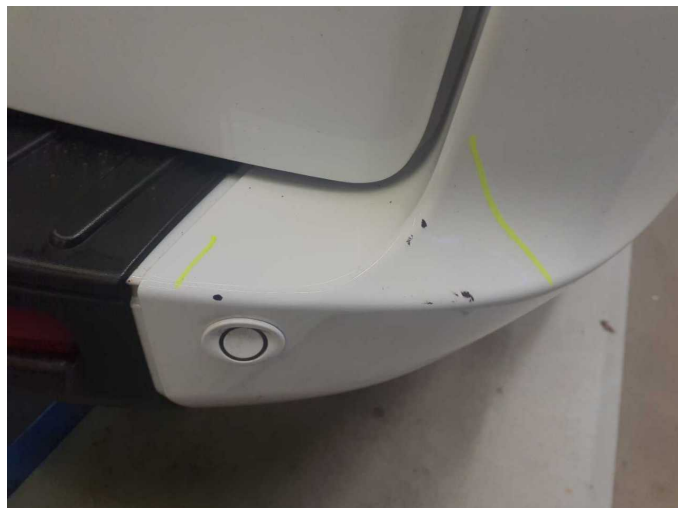
Damage 5: Rear bumper: Bumper - rear right side - Scratch(es) - Paint

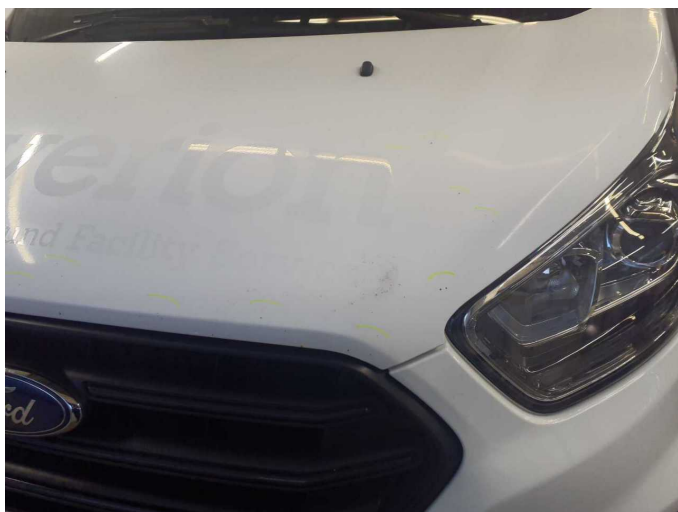
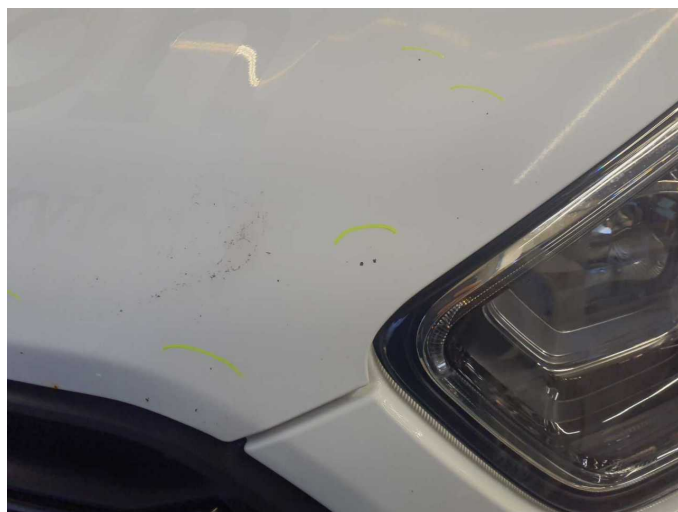
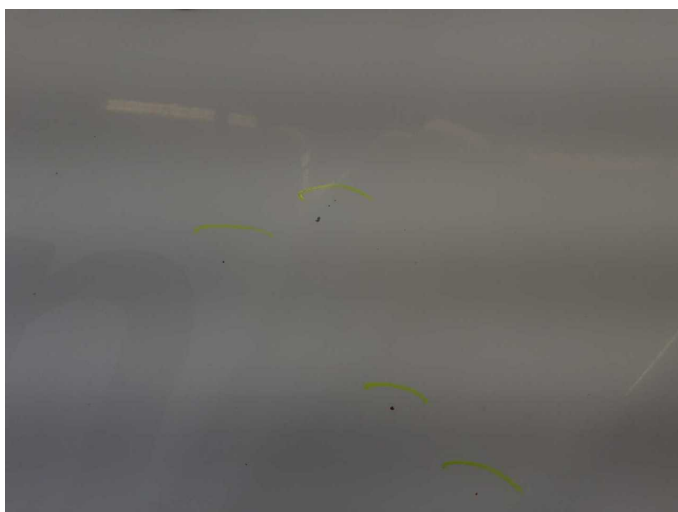
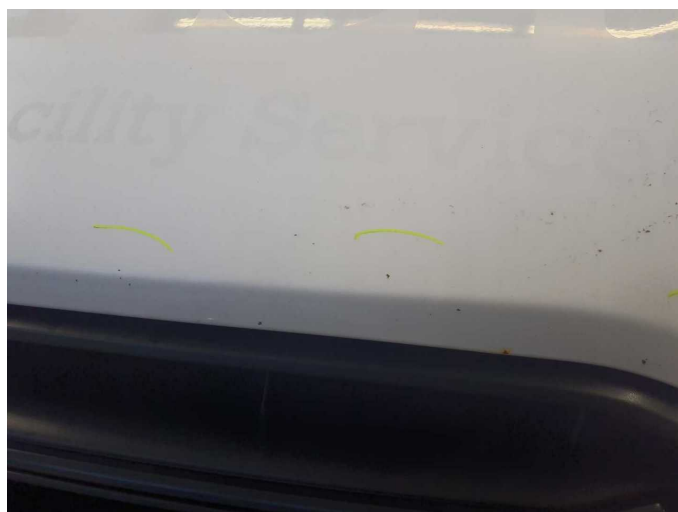
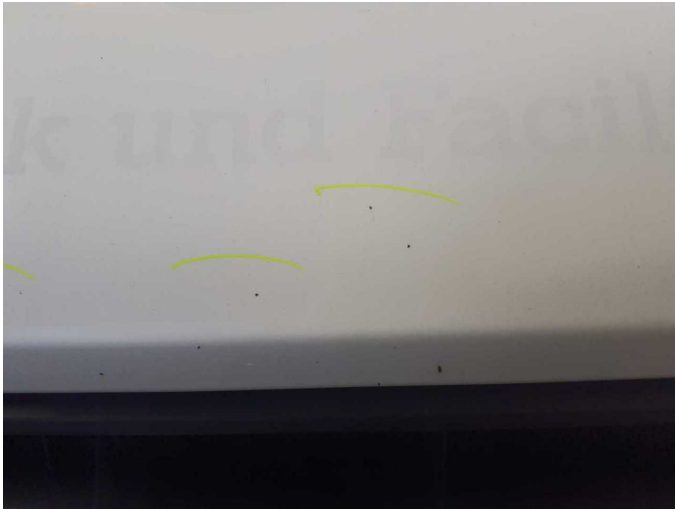
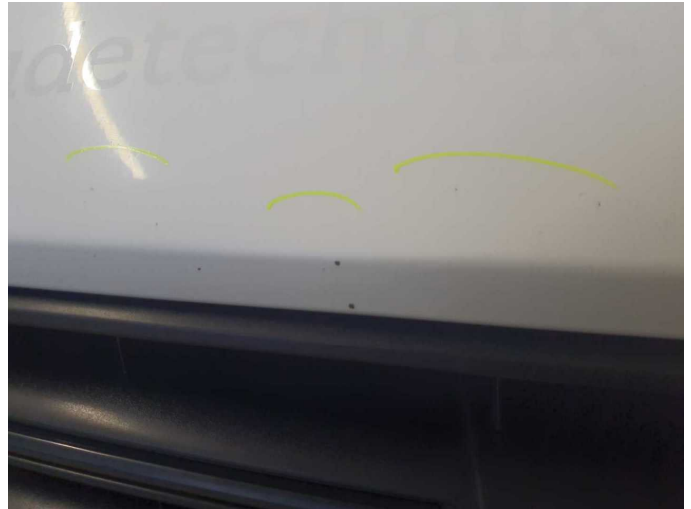
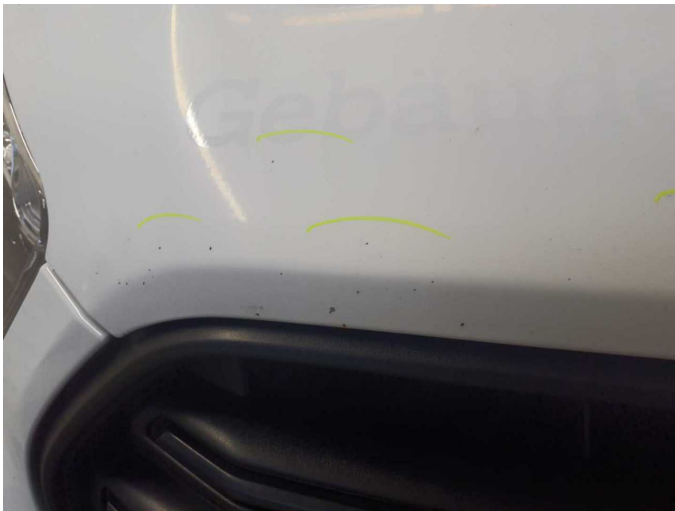
Damage 6: Bonnet: Bonnet (viele Steinschläge) - Scratch(es) - Paint

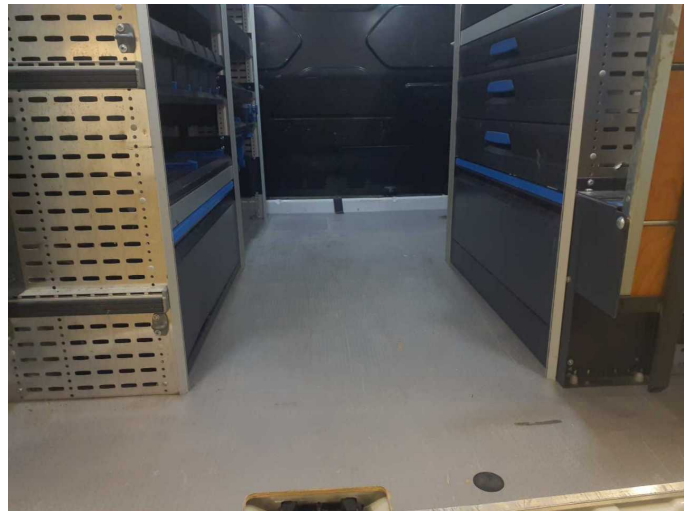
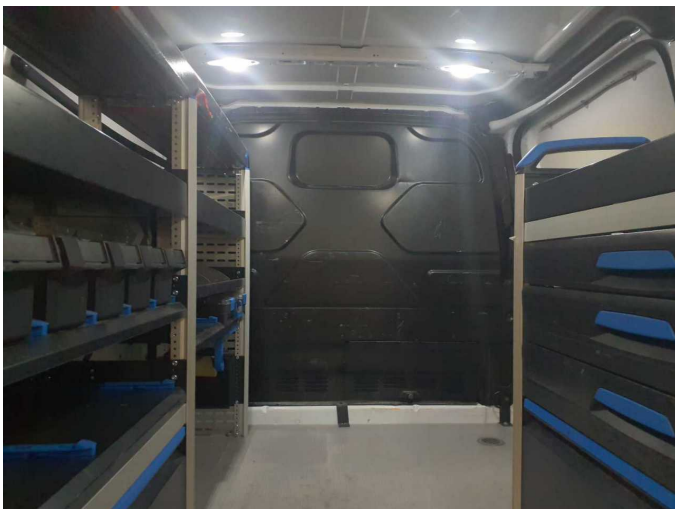
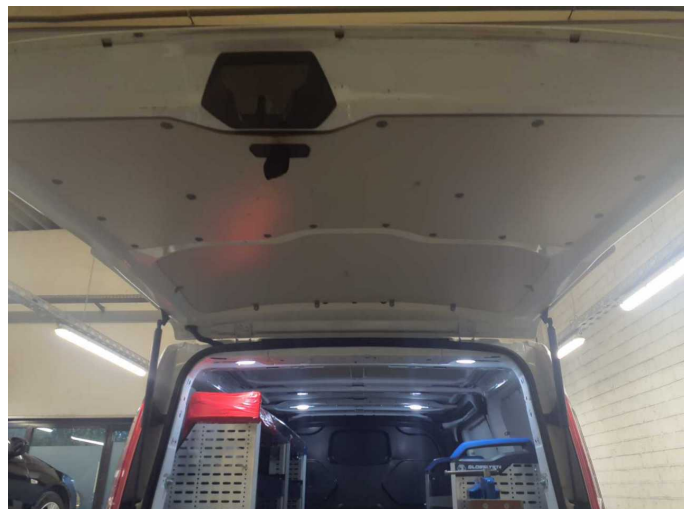
No.	Component group	Description
1	Interior	Cargo space division - Scratch(es) - No deduction

Wear and tear 1: Interior: Cargo space division - Scratch(es) - No deduction

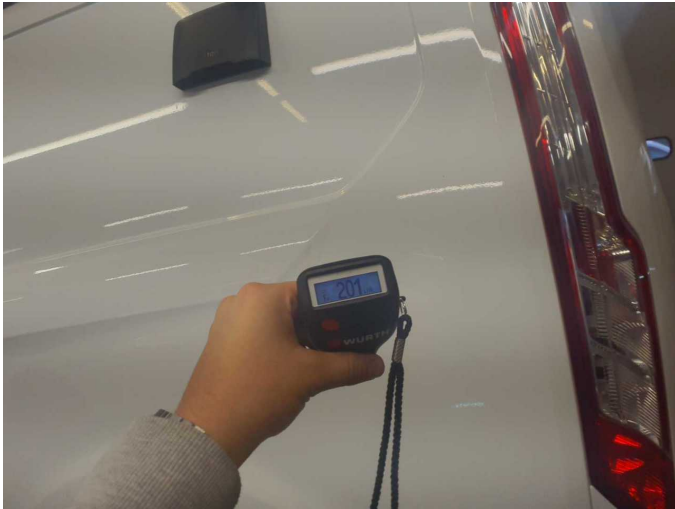
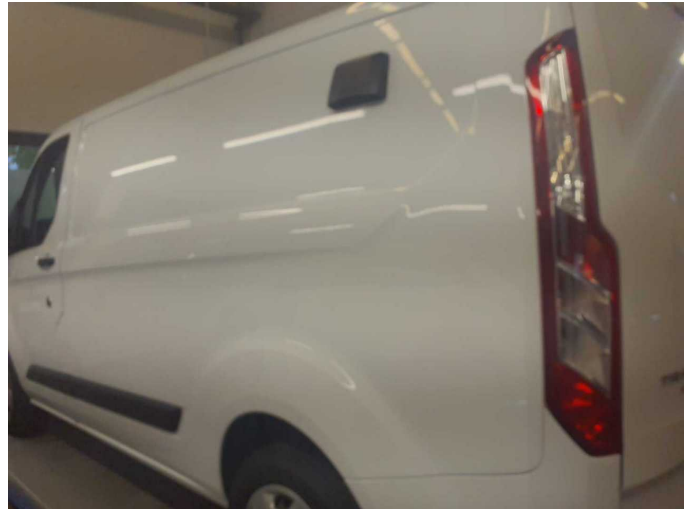
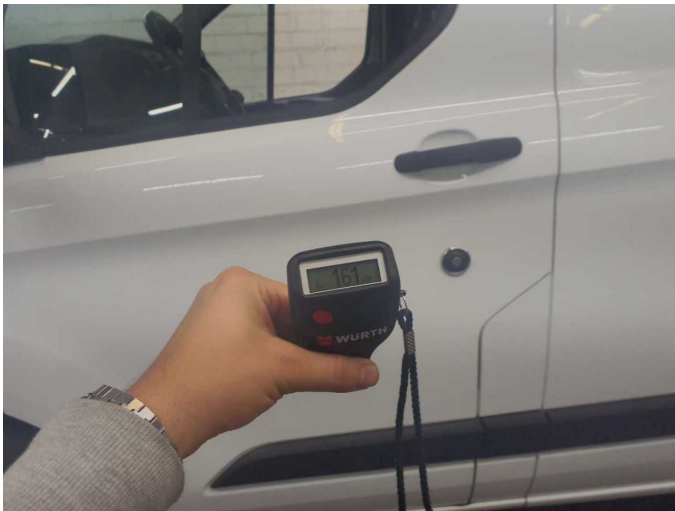
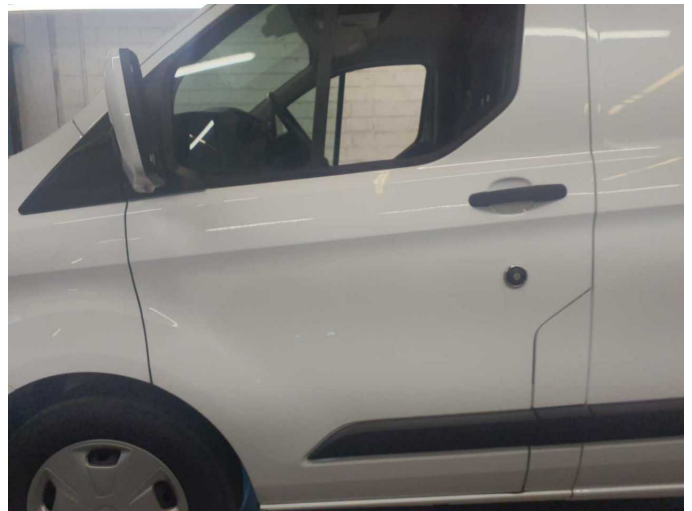
No.	Repainting
1	Side panel - rear left side, Door - front left side, Professionally carried out, Invoice of repair done Non-existent

Side panel - rear left side	201 µm	Door - front left side	161 µm
-----------------------------	--------	------------------------	--------

Repainting 1: Side panel - rear left side, Door - front left side
