Expertise

Protocol number: 41506021
Order No. / Reference: 25214813
Inspection date: 12 Sept 2025

Manufacturer: Ford

Model: Transit Custom 340 L1H1 LKW VA Autm. Trend

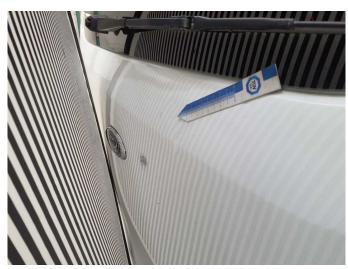
Damage 1: Boot lid / rear door: Boot lid - dent(s) - Smooth repair work

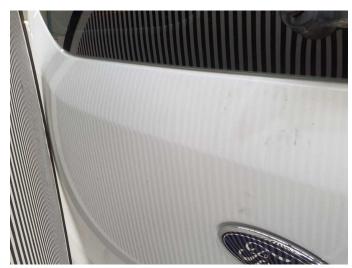
Damage 1: Boot lid / rear door: Boot lid - dent(s) - Smooth repair work

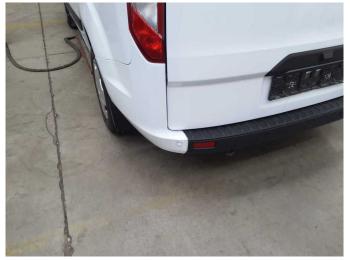
Damage 1: Boot lid / rear door: Boot lid - dent(s) - Smooth repair work

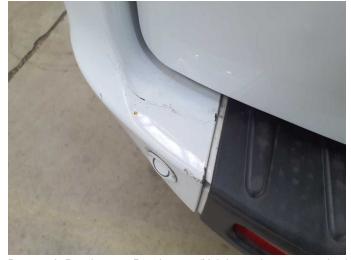
Damage 2: Rear bumper: Rear bumper (Mehrkosten können entstehen) - Scratched - Repair and paint

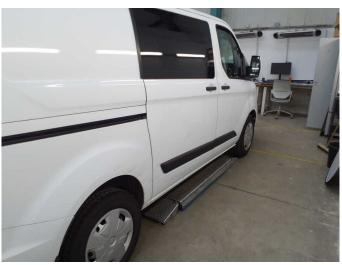
Damage 2: Rear bumper: Rear bumper (Mehrkosten können entstehen) - **Accident 1:** Side right Scratched - Repair and paint
