Expertise

Protocol number: 41545947
Order No. / Reference: 25133081
Inspection date: 12 Sept 2025

Manufacturer: Ford

Model: Transit Custom 320 L2H1 LKW VA Trend

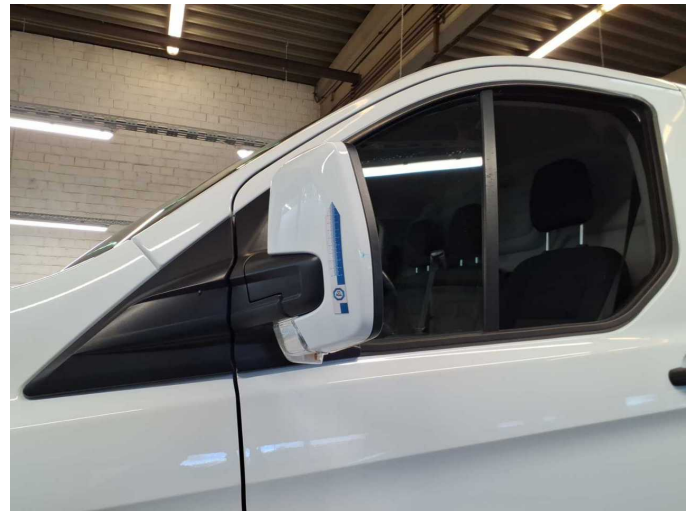
Damage 2: Wing mirror - left side: Cap - Scratch(es) - Smart repair

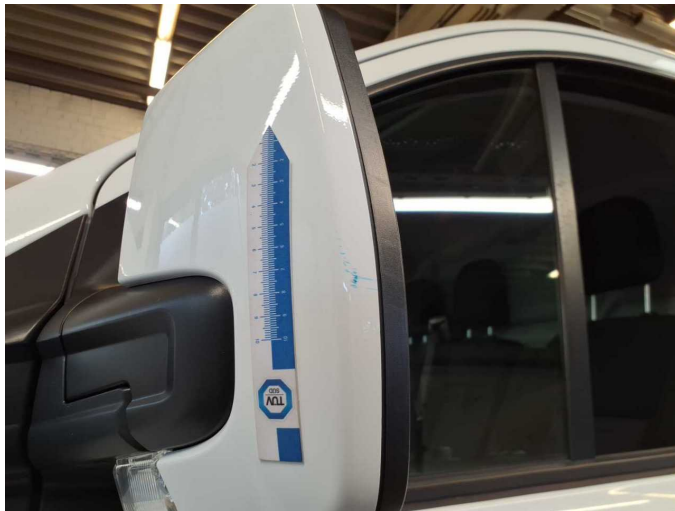
Damage 2: Wing mirror - left side: Cap - Scratch(es) - Smart repair

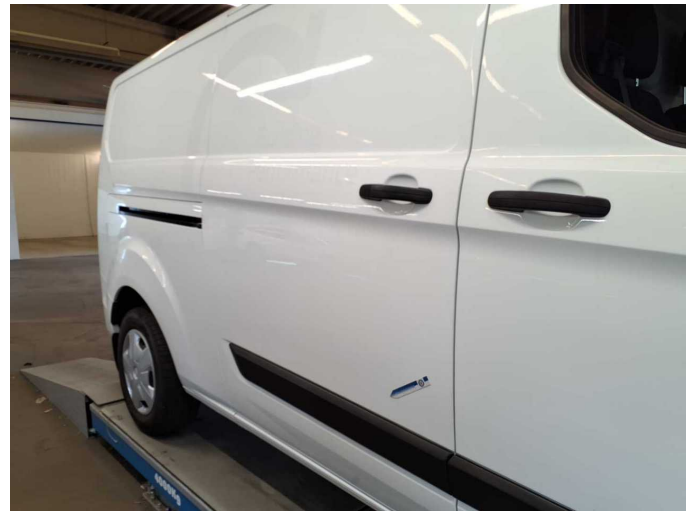
Damage 3: Door - rear right side: Door - Scratch(es) - Smart repair

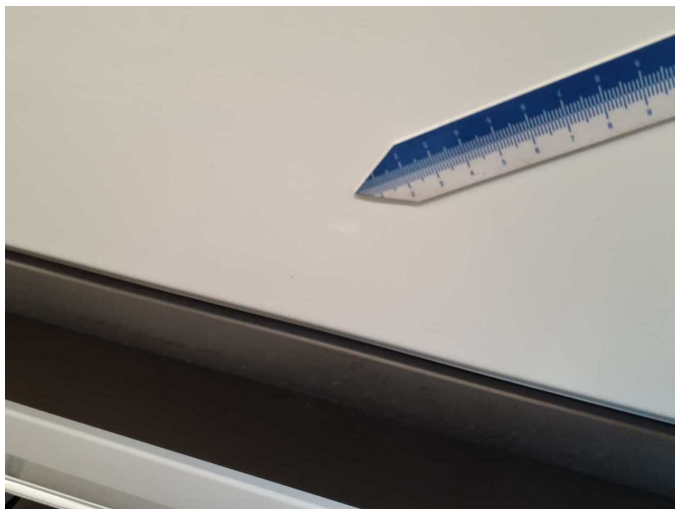
Damage 3: Door - rear right side: Door - Scratch(es) - Smart repair

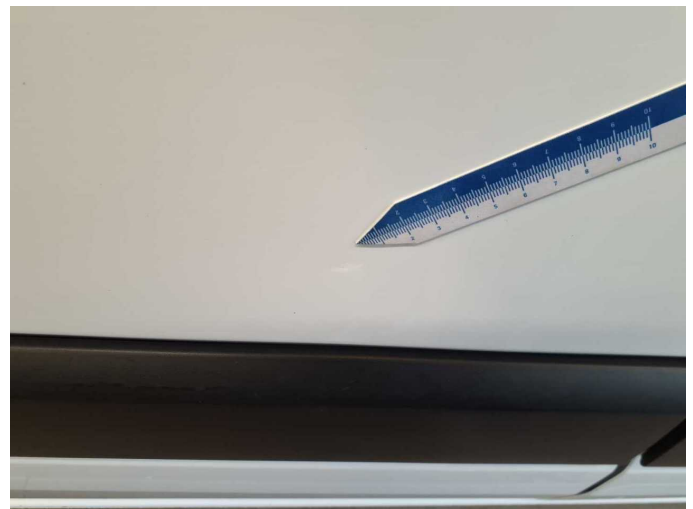
Damage 3: Door - rear right side: Door - Scratch(es) - Smart repair

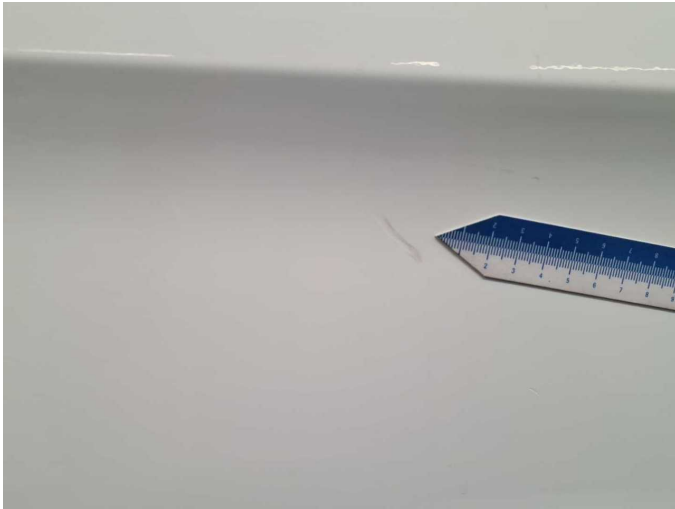
Damage 3: Door - rear right side: Door - Scratch(es) - Smart repair

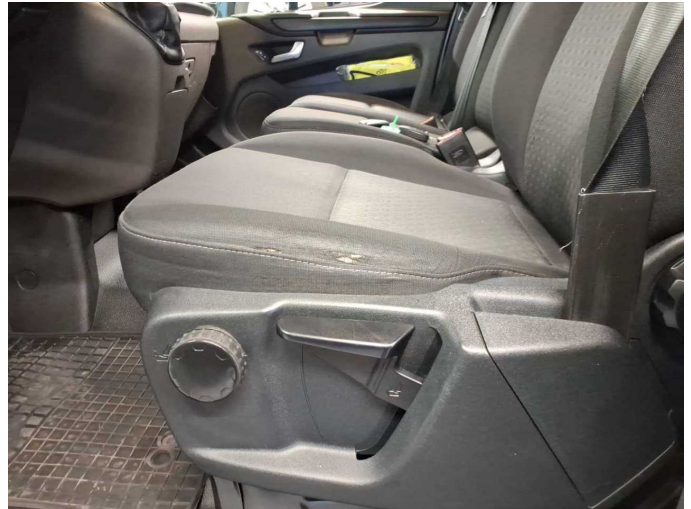
Damage 4: Seat - front: Seat cover - left side - Broken / torn - Replace

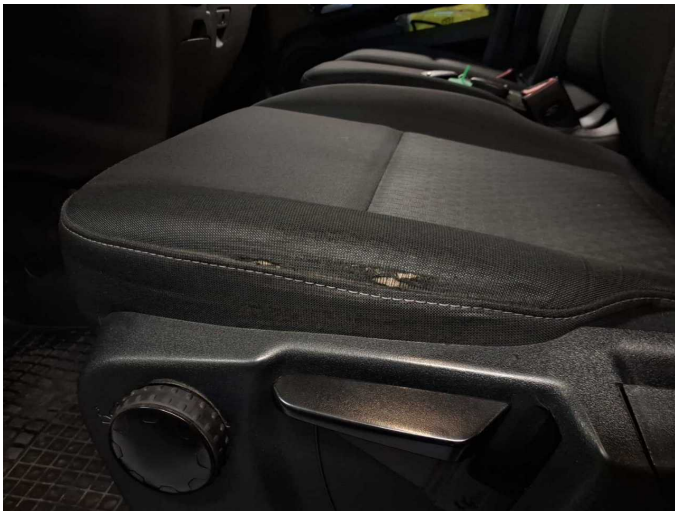
Damage 4: Seat - front: Seat cover - left side - Broken / torn - Replace

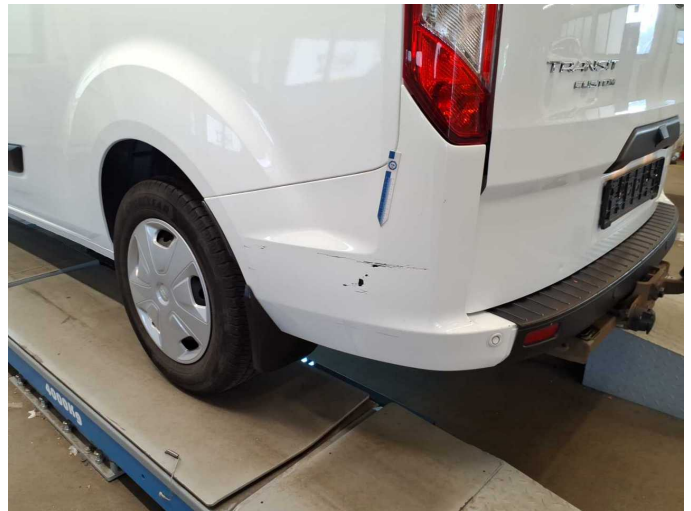
Damage 5: Rear bumper: Bumper - rear left side - Scratch(es) - Paint

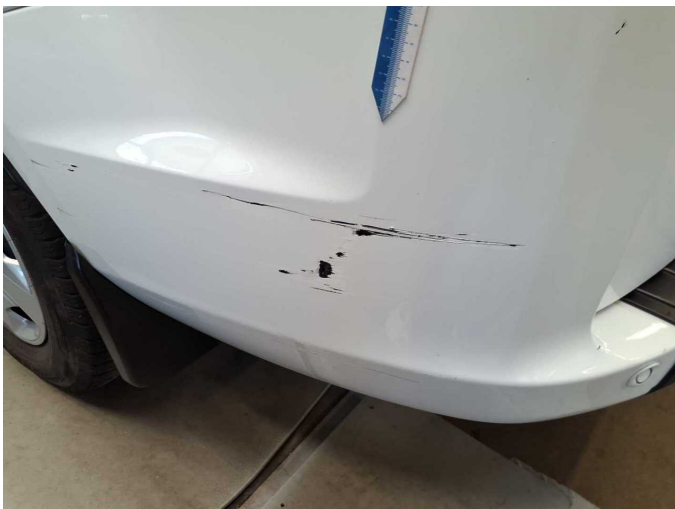
Damage 5: Rear bumper: Bumper - rear left side - Scratch(es) - Paint

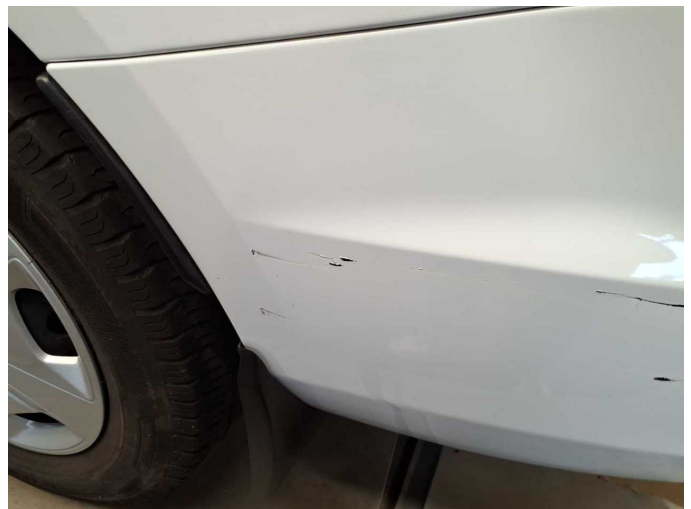
Damage 5: Rear bumper: Bumper - rear left side - Scratch(es) - Paint

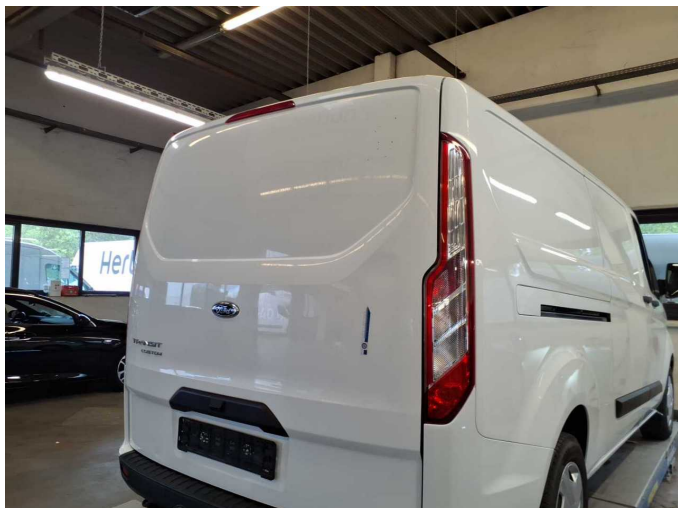
Damage 6: Boot lid / rear door: Boot lid - Dent / paintcoat damage - Repair and paint

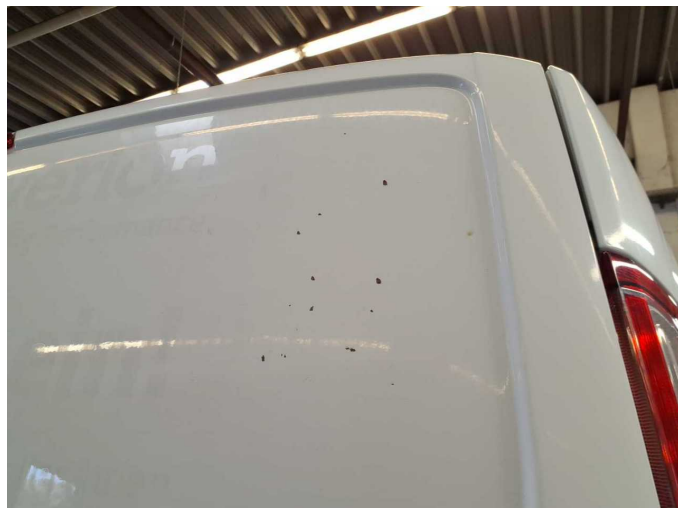
Damage 6: Boot lid / rear door: Boot lid - Dent / paintcoat damage - Repair and paint

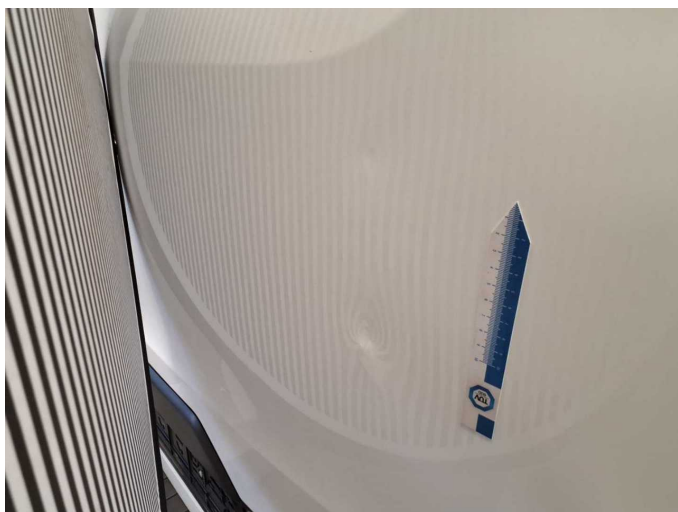
Damage 6: Boot lid / rear door: Boot lid - Dent / paintcoat damage - Repair and paint

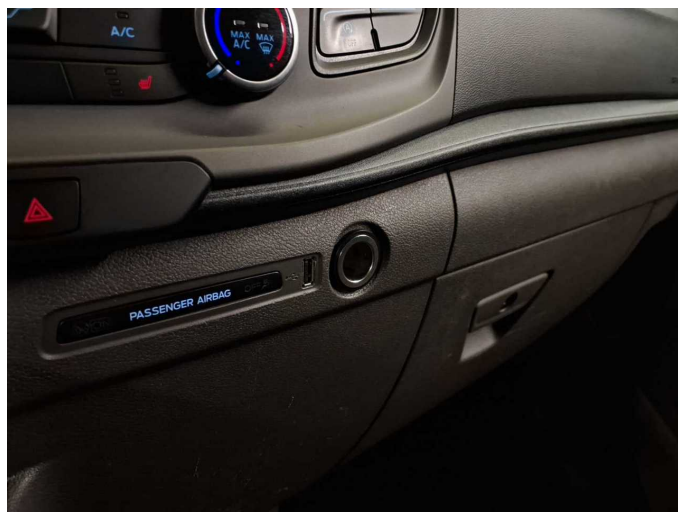
Missing part 1: Interior: Cigarette lighter - Missing - Replace
