Expertise

Protocol number: 41540847
Order No. / Reference: 25133119
Inspection date: 12 Sept 2025

Model: Transit Custom 320 L1H1 LKW VA Trend

VIN: WF0YXXTTGYLD03706

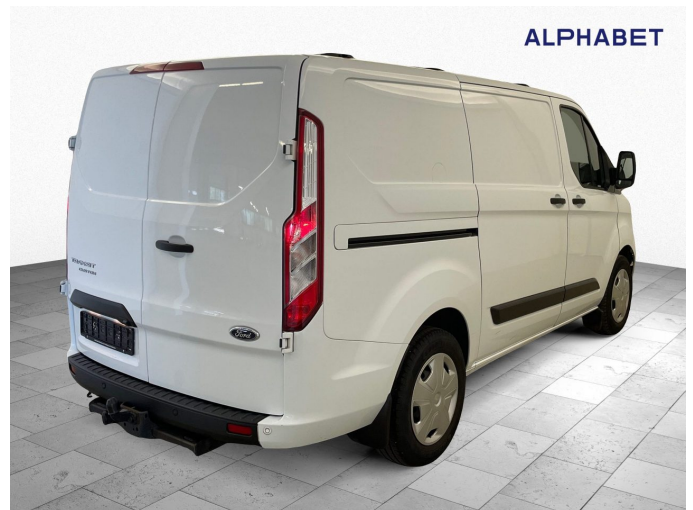
No.	Component group	Description
1	Rear bumper	Rear bumper - Scratch(es) - No deduction

Figure 4: Diagonal rear (right)

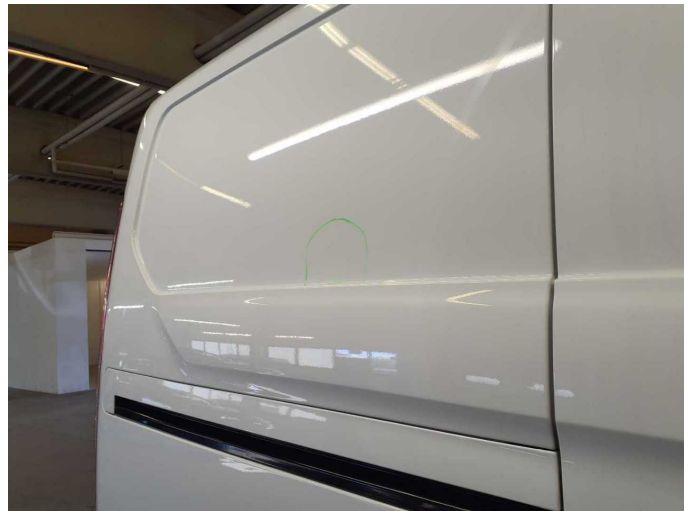
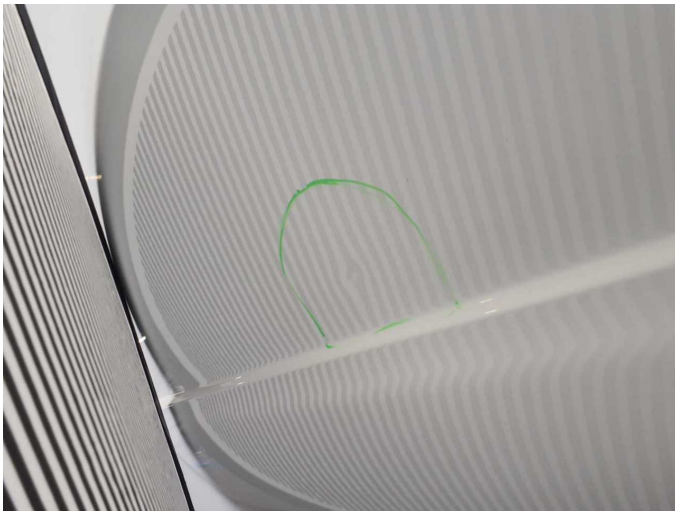
Damage 1: Side panel - rear right side: Side panel (1) - dent(s) - Smart repair

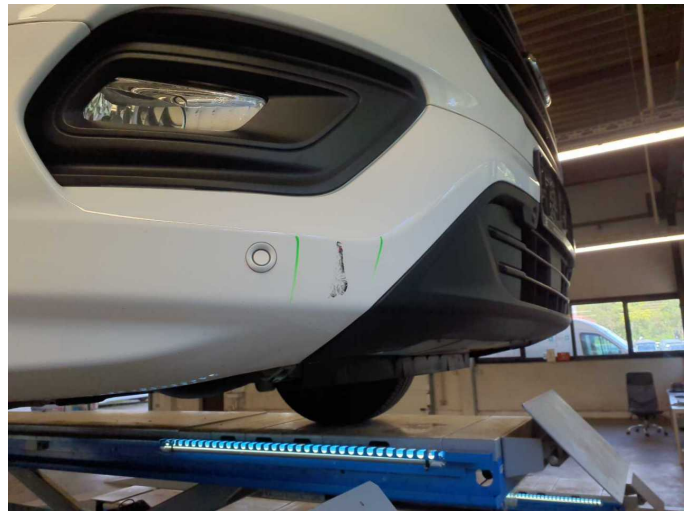
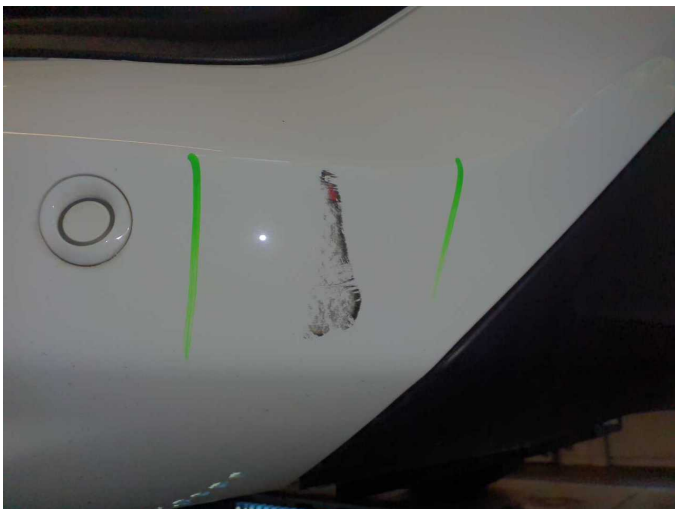
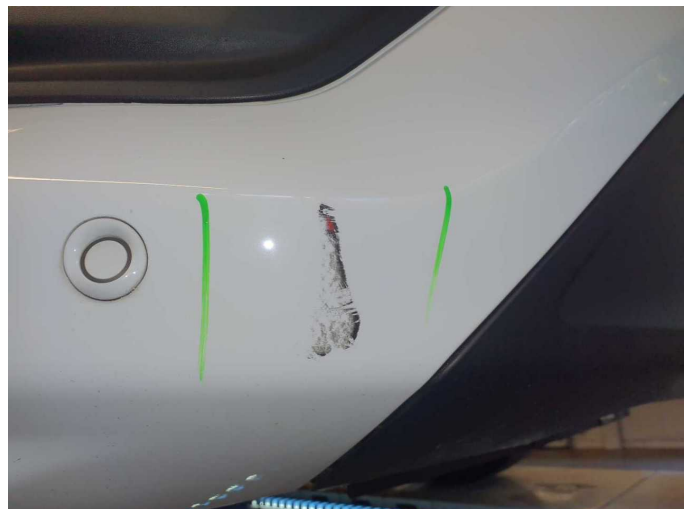
Damage 2: Front bumper: Front bumper (Nur oberfläche) - Scratch(es) - Smart repair

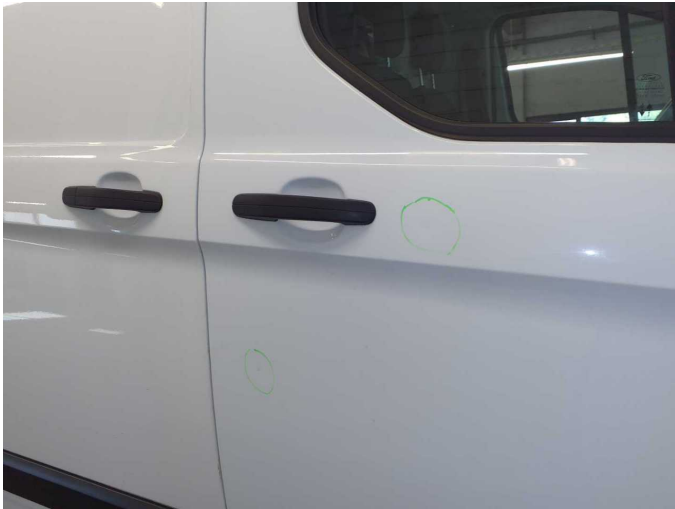
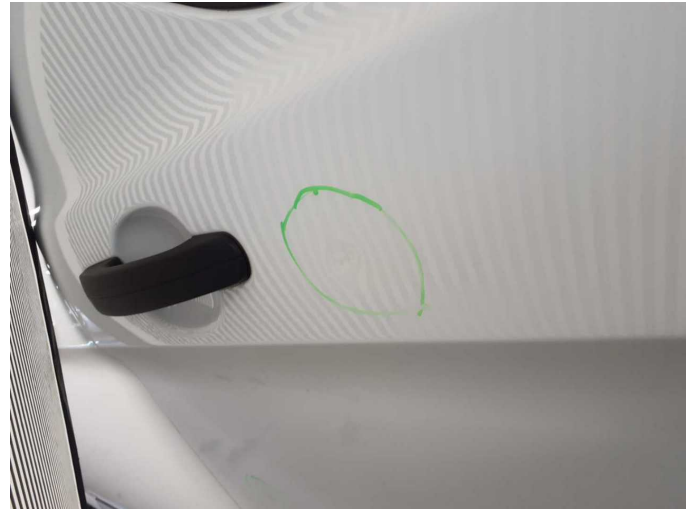
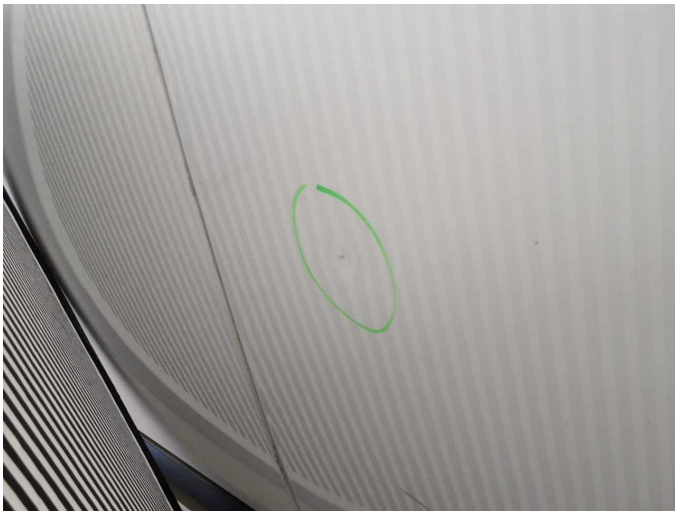
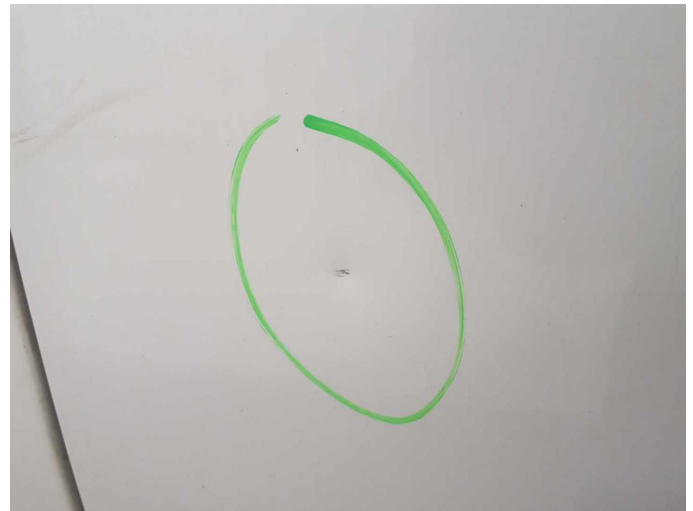
Damage 3: Door - front right side: Door (2dellen+minimaler kratzer) - dent(s) - Smart repair

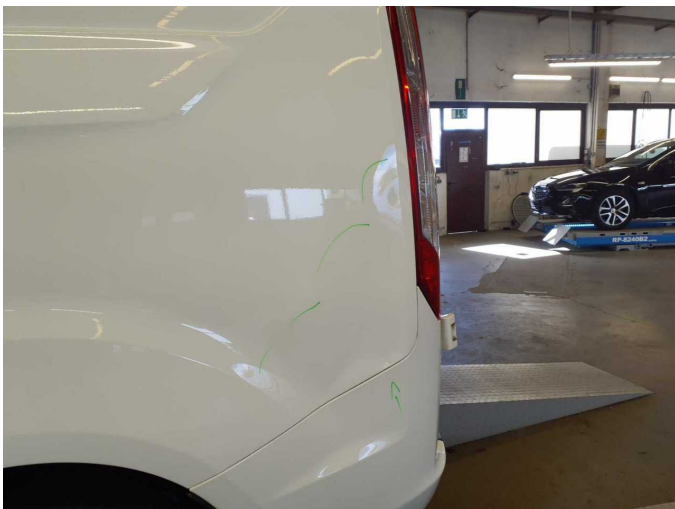
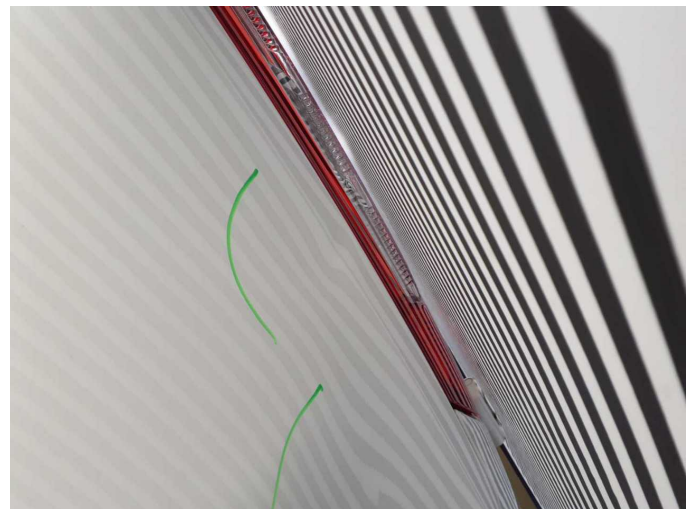
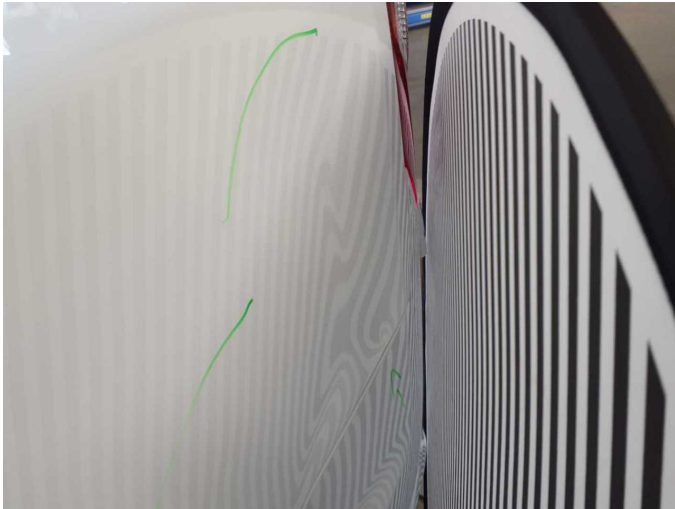
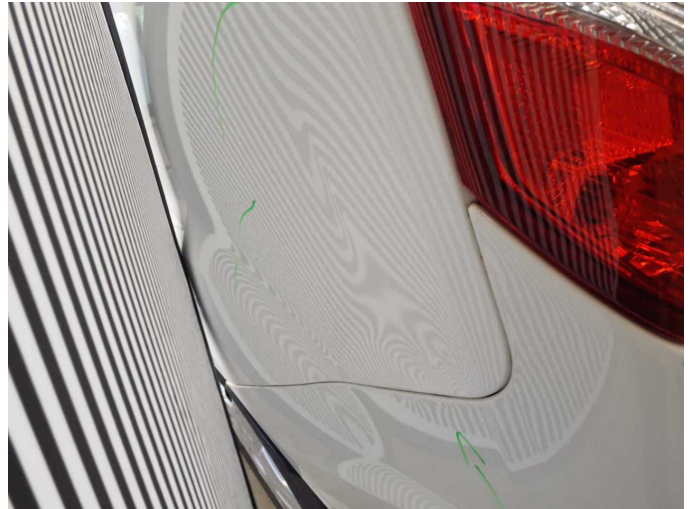
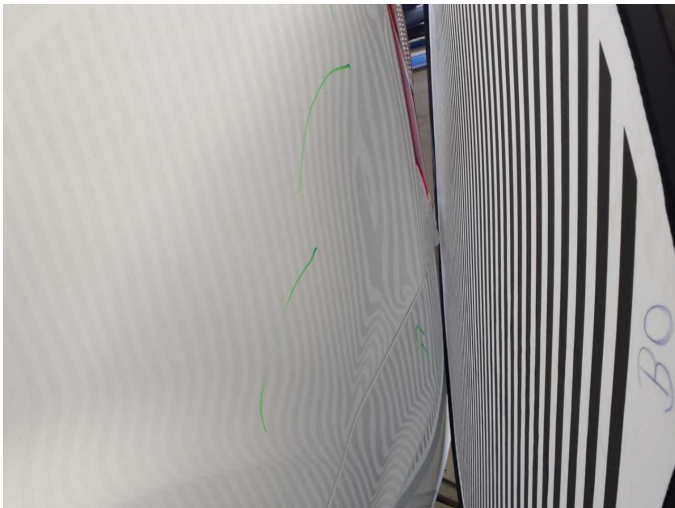
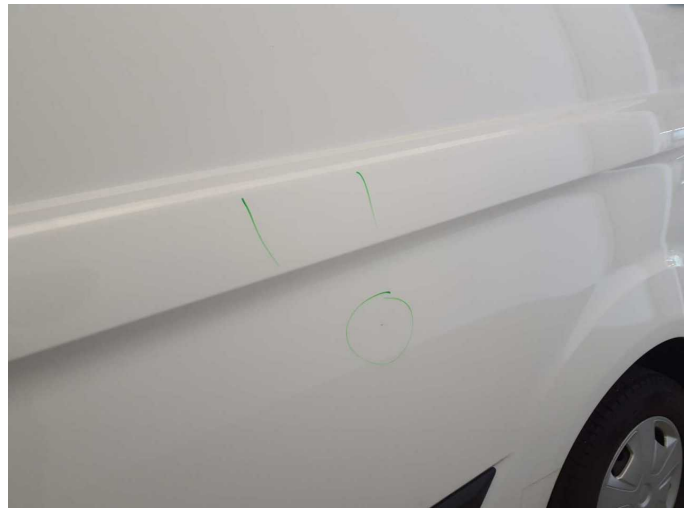
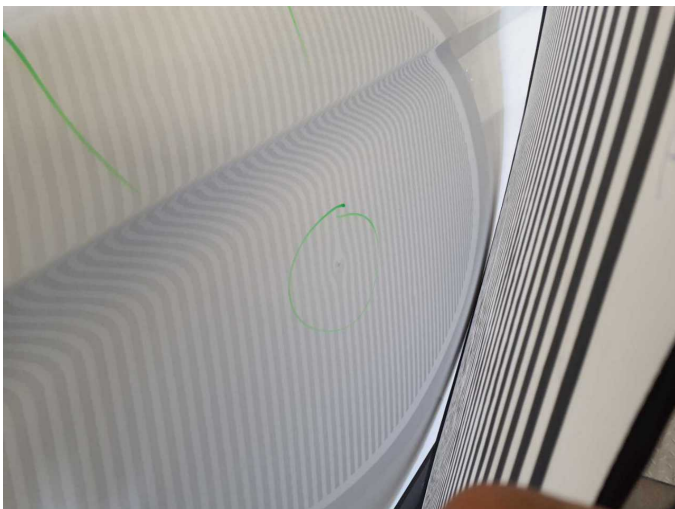
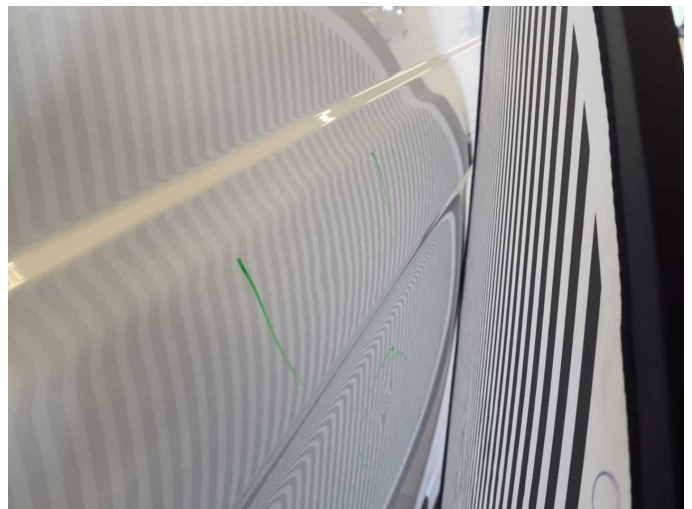
Damage 4: Side panel - rear left side: Side panel - Deformed - Repair and paint

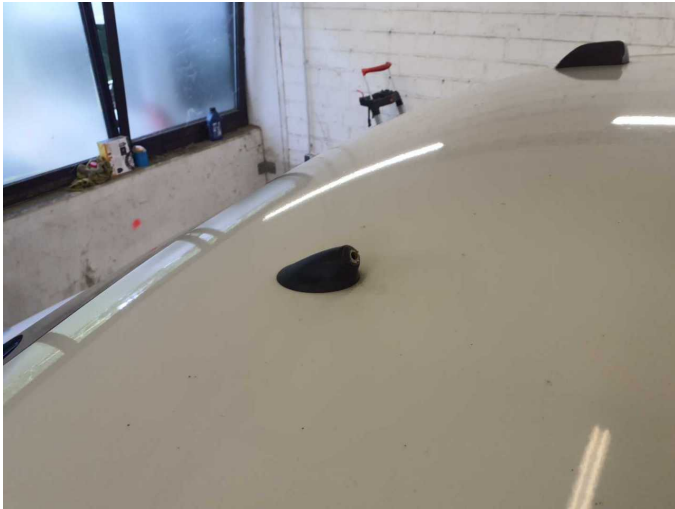
Missing part 1: Roof: Stub aerial - Missing - Replace

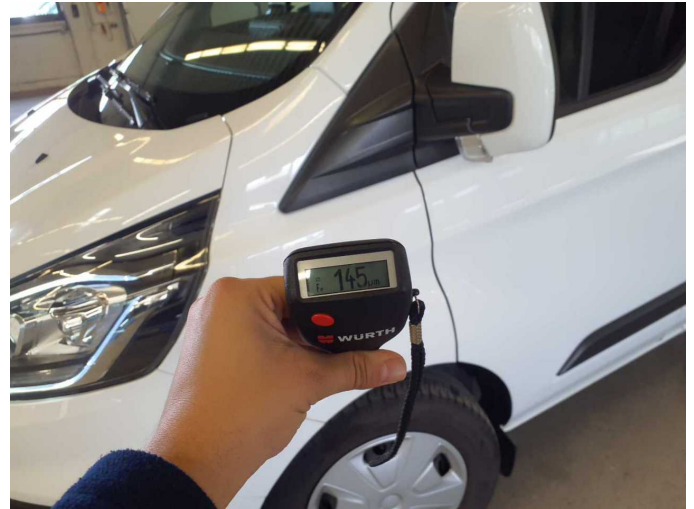
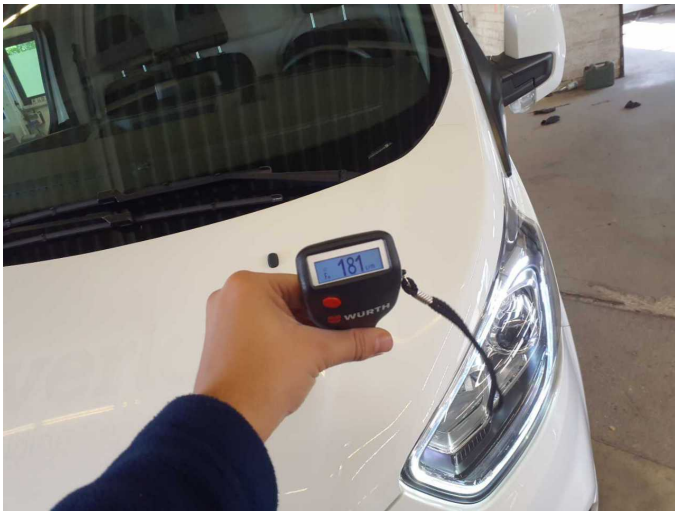
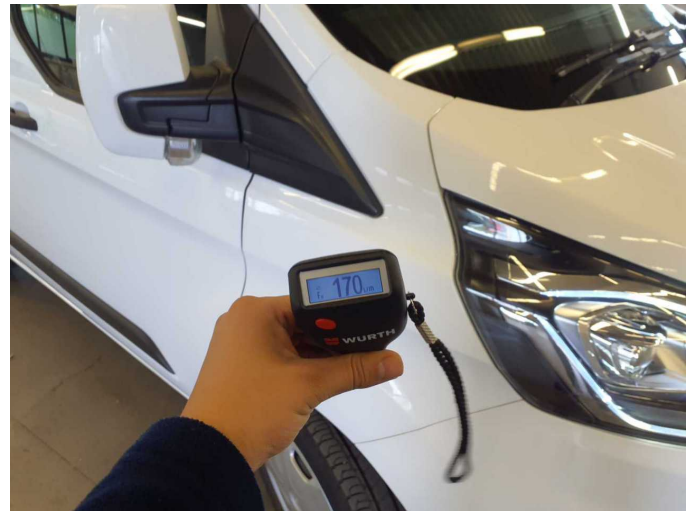
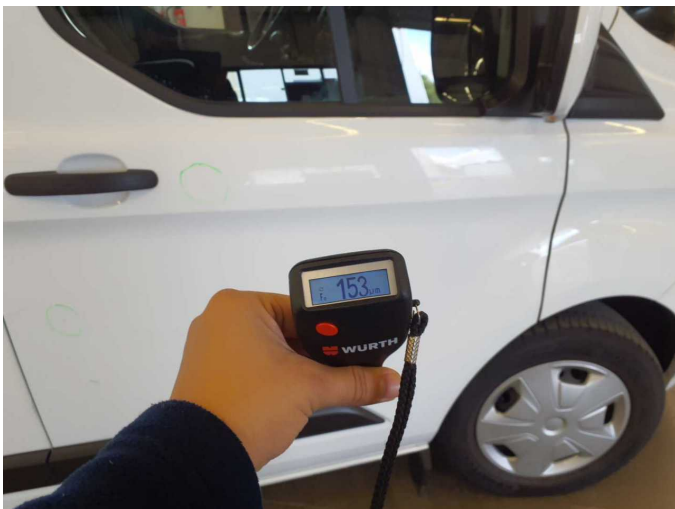
Mudguard - left side	145 µm	Mudguard - right side	170 µm
Bonnet	181 µm	Door - front right side	153 µm

Repainting 1: Mudguard - left side, Mudguard - right side, Bonnet, Door - front right side
