Expertise

Protocol number: 41596458
Order No. / Reference: 25133005
Inspection date: 17 Sept 2025

Manufacturer: Ford

Model: Transit Custom 320 L1H1 LKW VA Trend

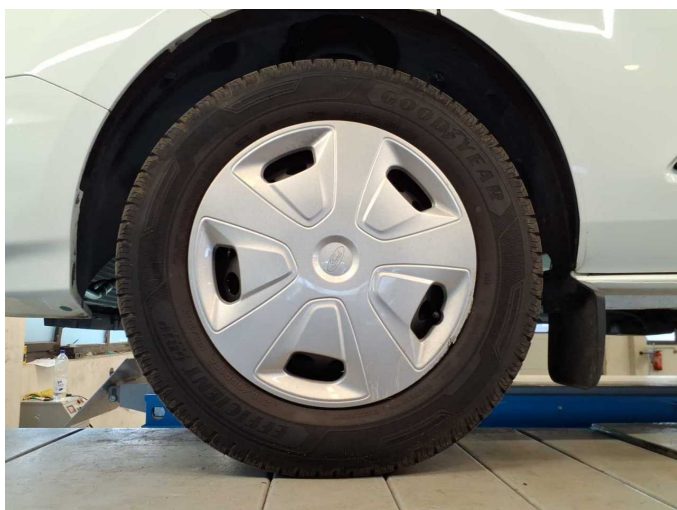
Damage 1: Wheel / tyres: Wheel cover - front left side - Damaged - Replace

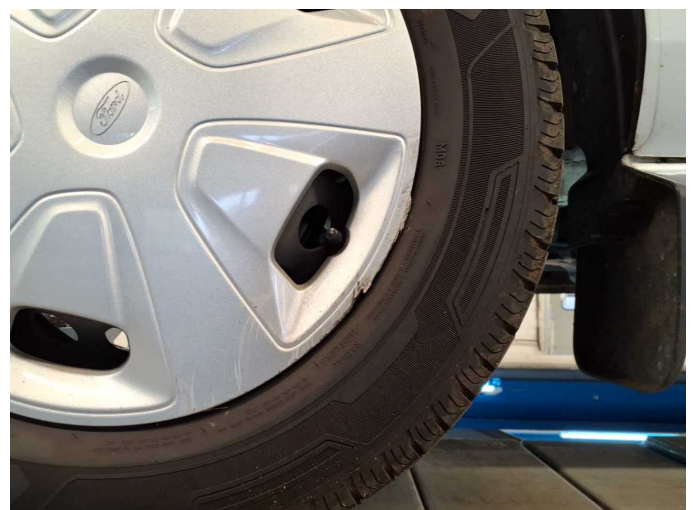
Damage 1: Wheel / tyres: Wheel cover - front left side - Damaged - Replace

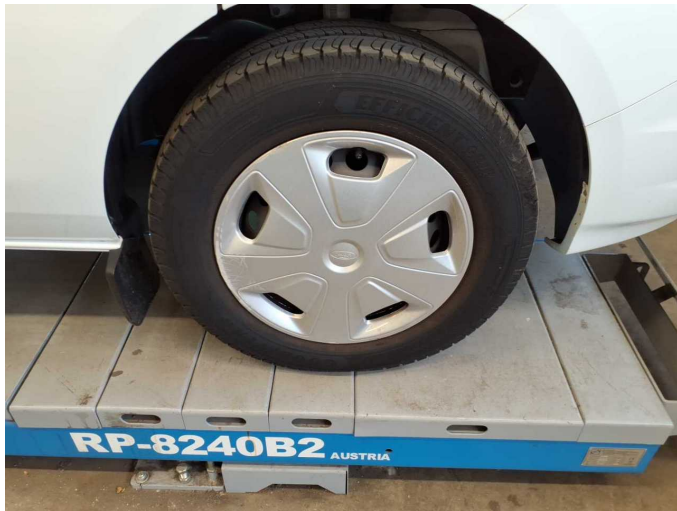
Damage 2: Wheel / tyres: Wheel cover - front right side - Scratch(es) - Replace

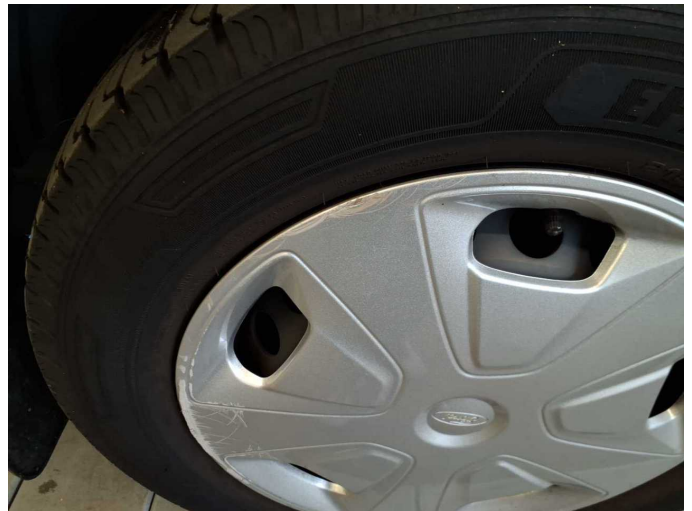
Damage 2: Wheel / tyres: Wheel cover - front right side - Scratch(es) - Replace

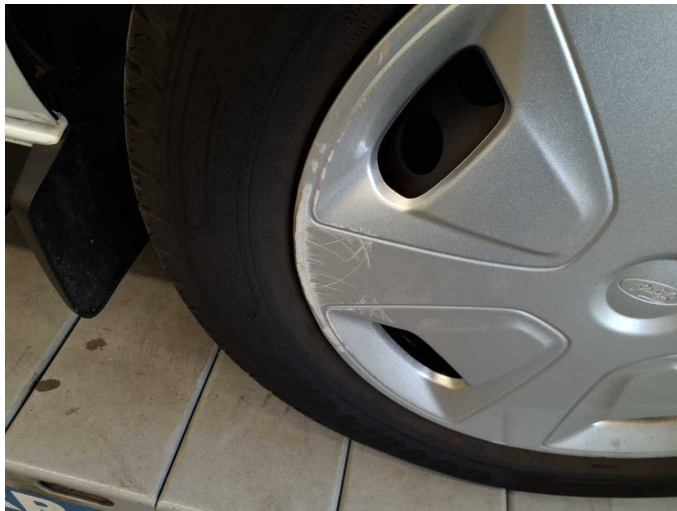
Damage 2: Wheel / tyres: Wheel cover - front right side - Scratch(es) - Replace

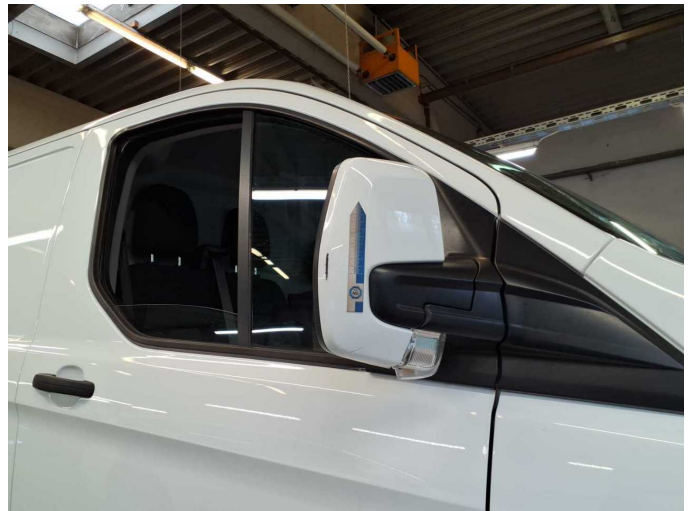
Damage 3: Wing mirror - right side: Cap - Scratch(es) - Smart repair

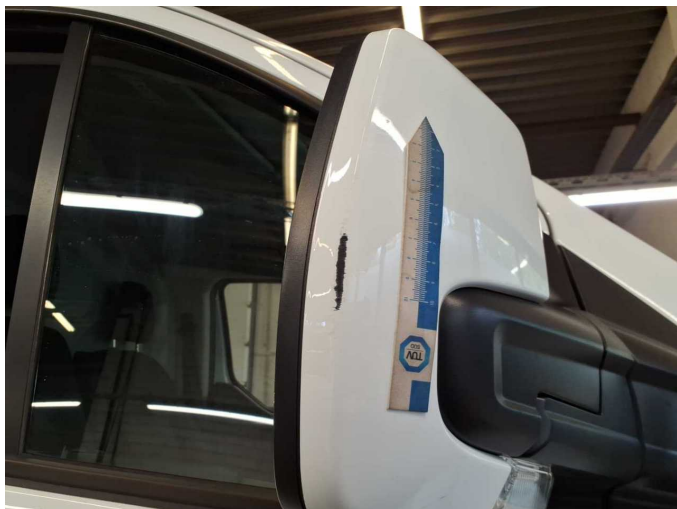
Damage 3: Wing mirror - right side: Cap - Scratch(es) - Smart repair

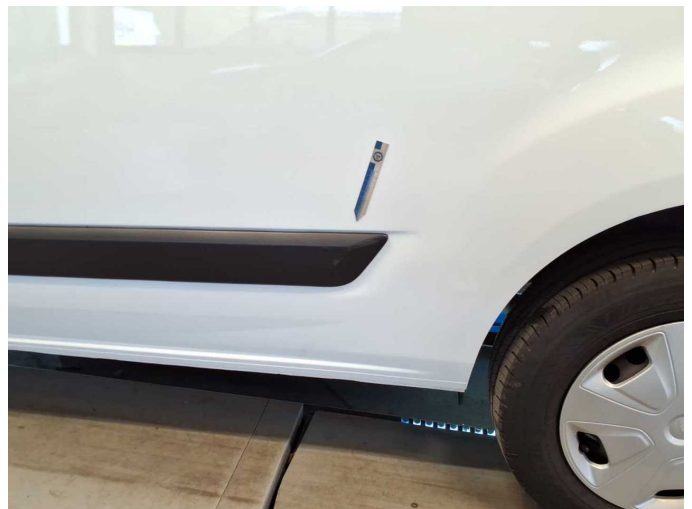
Damage 4: Side panel - rear left side: Brightware - Scratch(es) - Replace

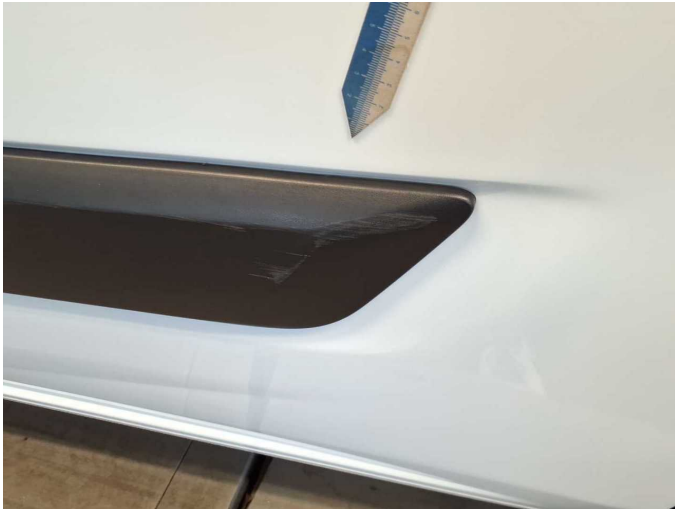
Damage 4: Side panel - rear left side: Brightware - Scratch(es) - Replace

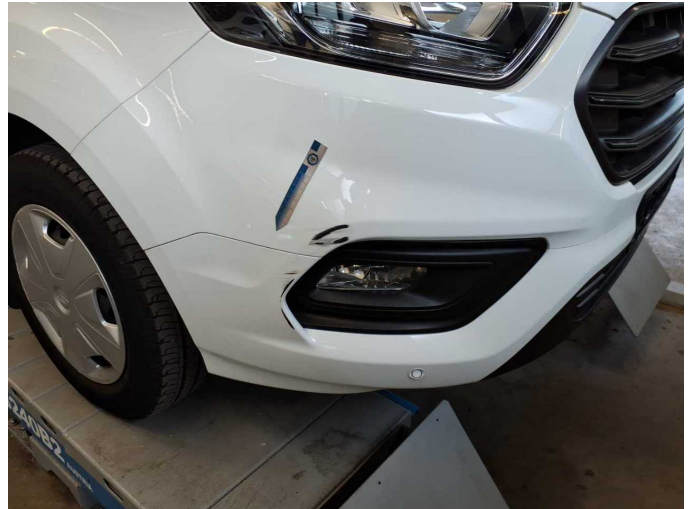
Damage 5: Front bumper: Front bumper - Scratch(es) - Paint

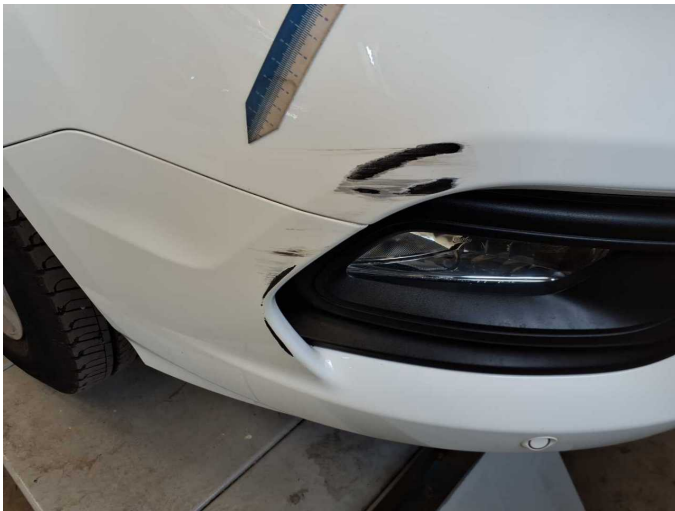
Damage 5: Front bumper: Front bumper - Scratch(es) - Paint

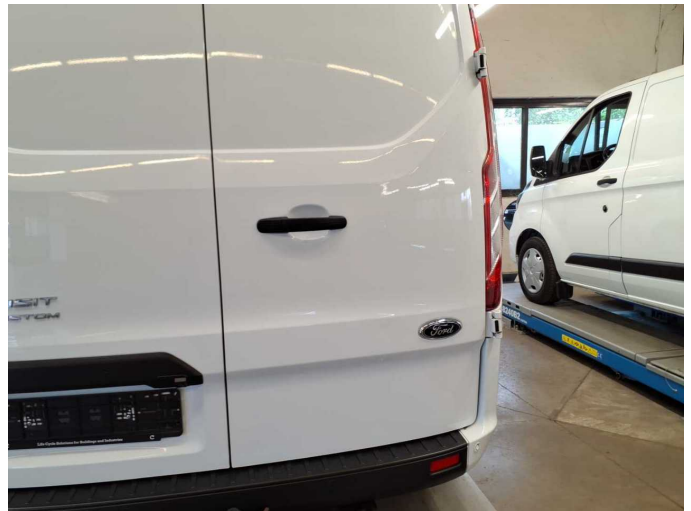
Damage 6: Boot lid / rear door: Boot lid (Rechts) - Deformed - Repair and paint

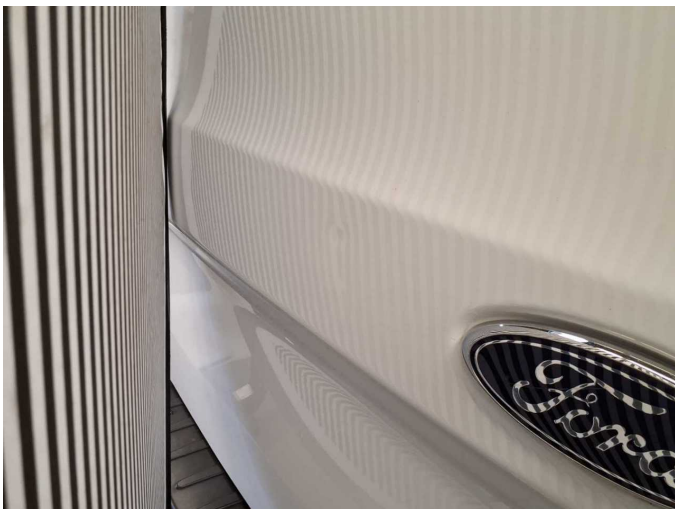
Damage 6: Boot lid / rear door: Boot lid (Rechts) - Deformed - Repair and paint

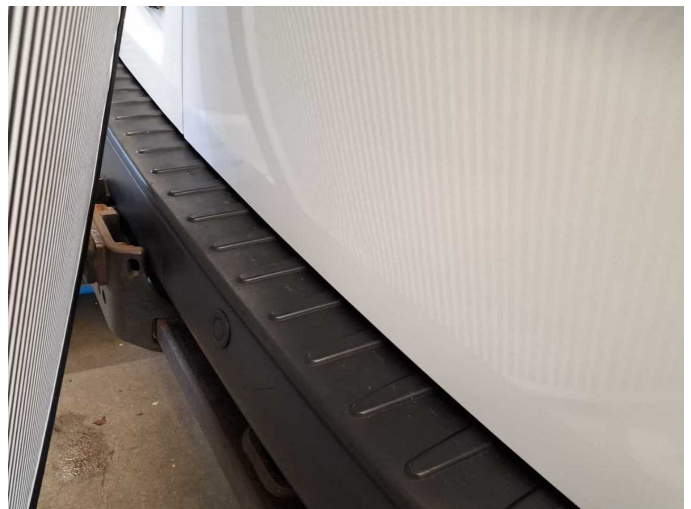
Damage 6: Boot lid / rear door: Boot lid (Rechts) - Deformed - Repair and paint

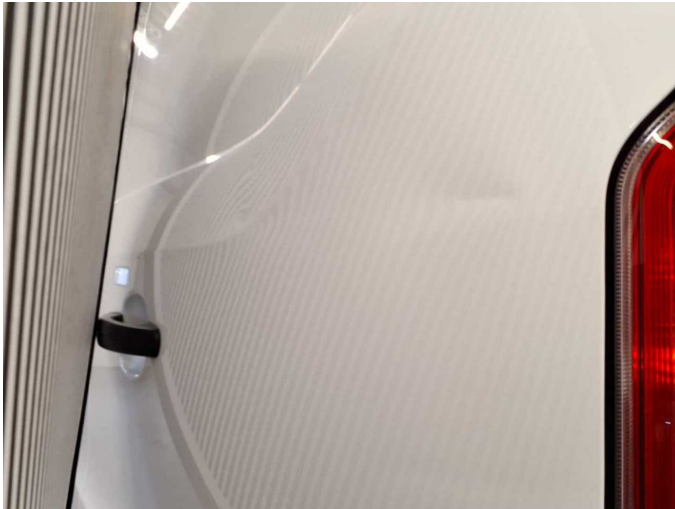
Damage 6: Boot lid / rear door: Boot lid (Rechts) - Deformed - Repair and paint

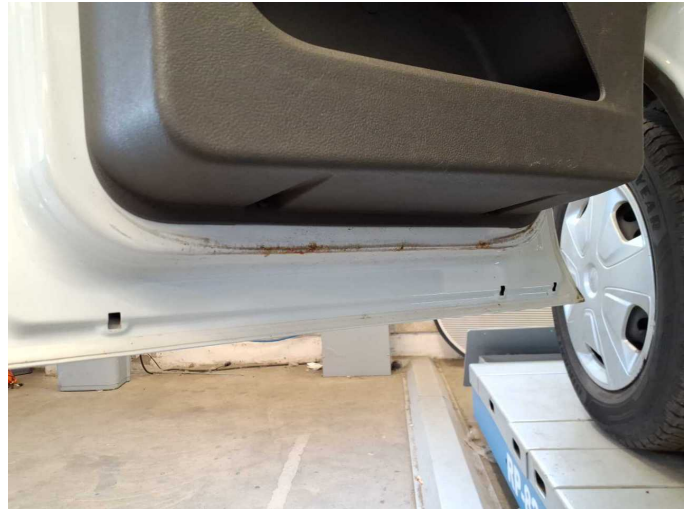
Damage 7: Door - front left side: Door - Corrosion - Repair and paint

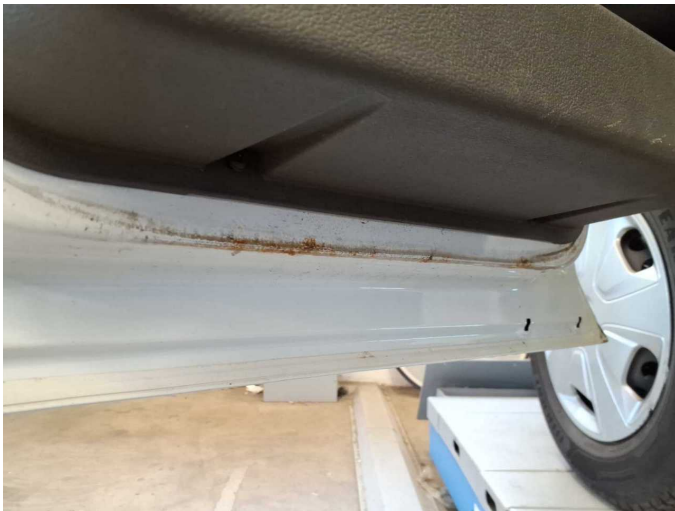
Damage 7: Door - front left side: Door - Corrosion - Repair and paint

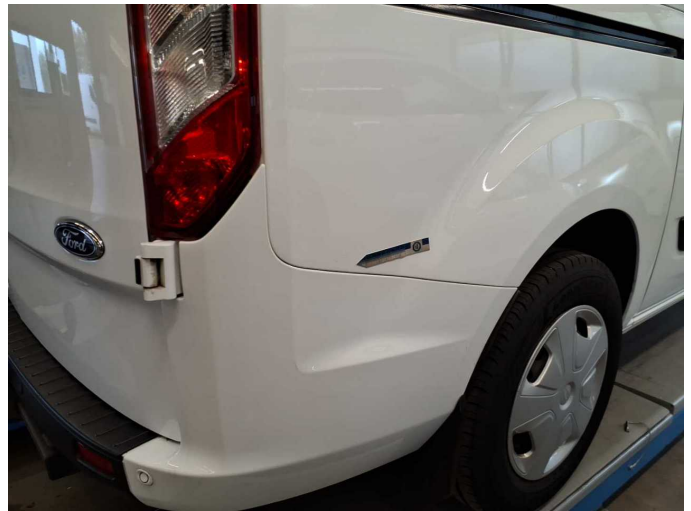
Side panel - rear left side	539 µm	Side panel - rear right side	179 µm
-----------------------------	--------	------------------------------	--------

Damage 8: Side panel - rear right side: Side panel (Lackläufer) - Unprofessionally repaired - Repair and paint

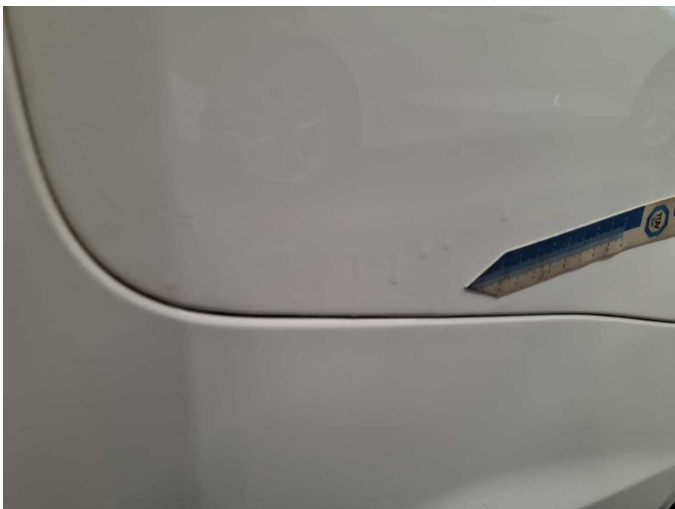
Damage 8: Side panel - rear right side: Side panel (Lackläufer) - Unprofessionally repaired - Repair and paint

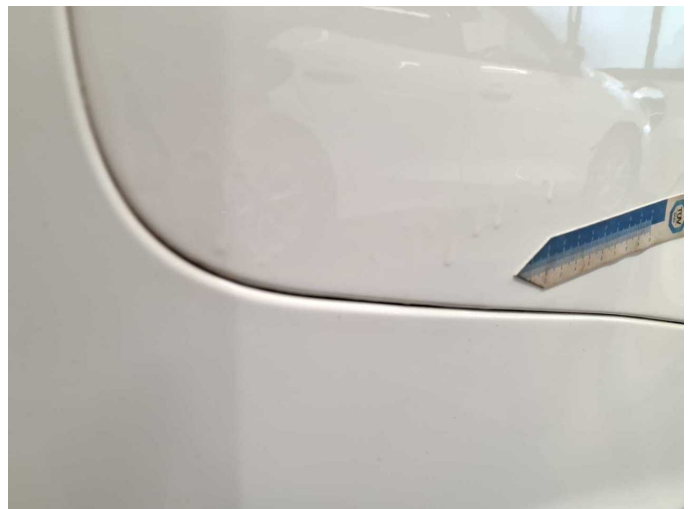
Damage 8: Side panel - rear right side: Side panel (Lackläufer) - Unprofessionally repaired - Repair and paint

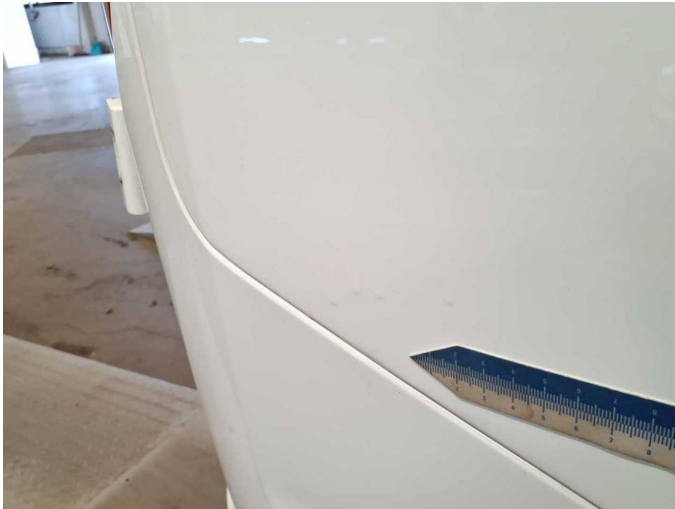
Damage 8: Side panel - rear right side: Side panel (Lackläufer) - Unprofessionally repaired - Repair and paint

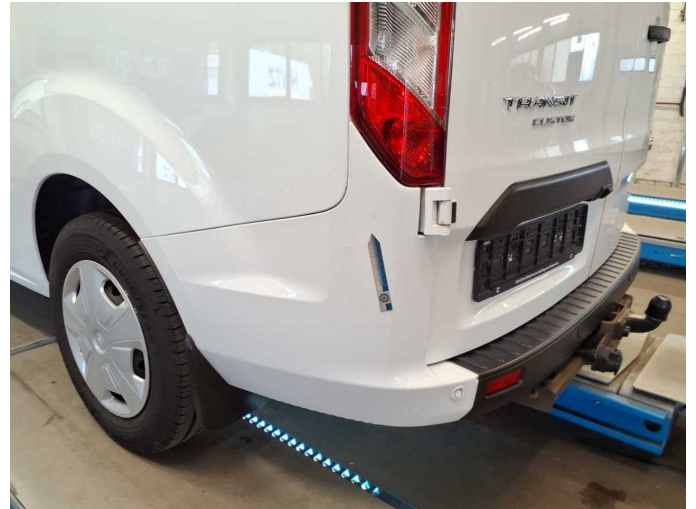
Wear and tear 2: Rear bumper: Bumper - rear left side - Scratch(es) - No deduction

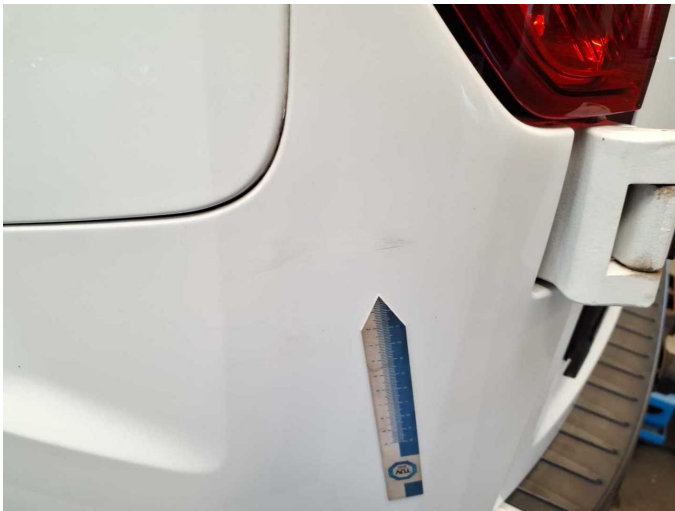
Wear and tear 2: Rear bumper: Bumper - rear left side - Scratch(es) - No deduction

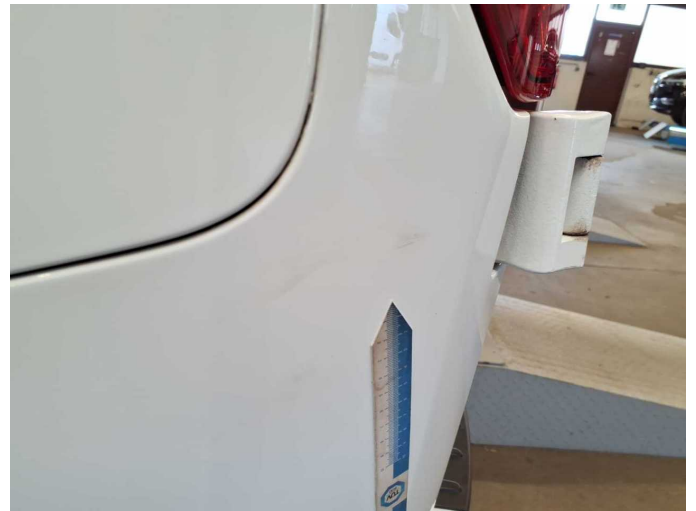
Wear and tear 2: Rear bumper: Bumper - rear left side - Scratch(es) - No deduction

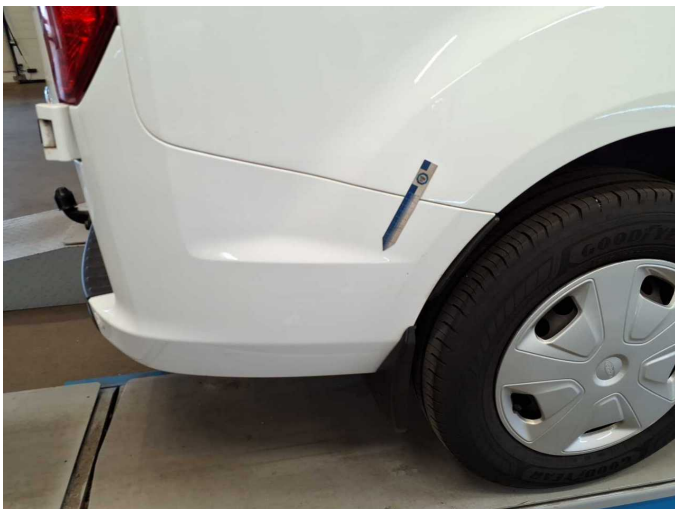
Wear and tear 3: Rear bumper: Bumper - rear right side - Scratch(es) - No deduction

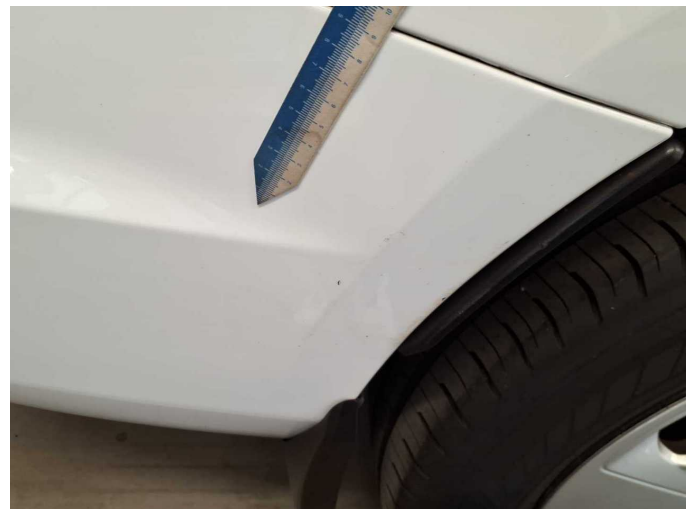
Wear and tear 3: Rear bumper: Bumper - rear right side - Scratch(es) - No deduction

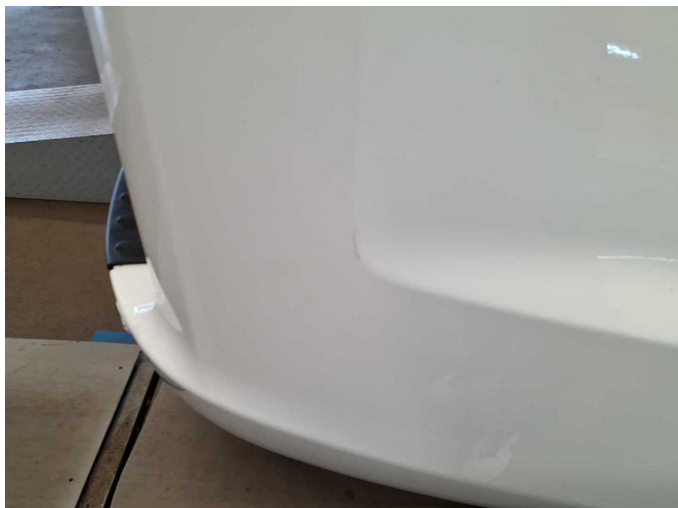
Wear and tear 3: Rear bumper: Bumper - rear right side - Scratch(es) - No deduction

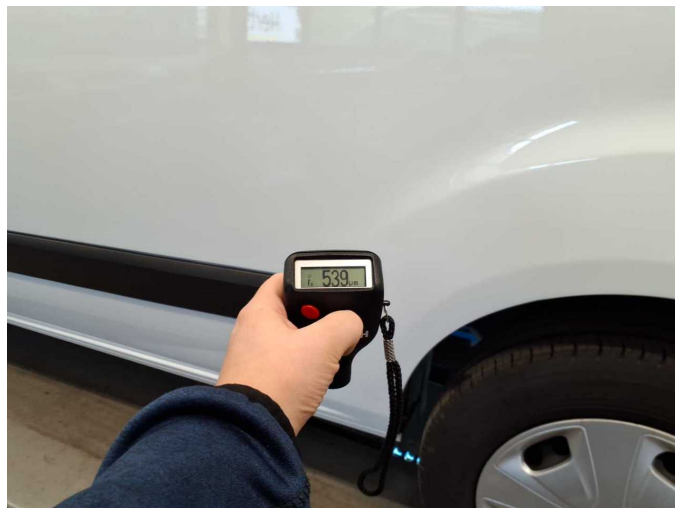
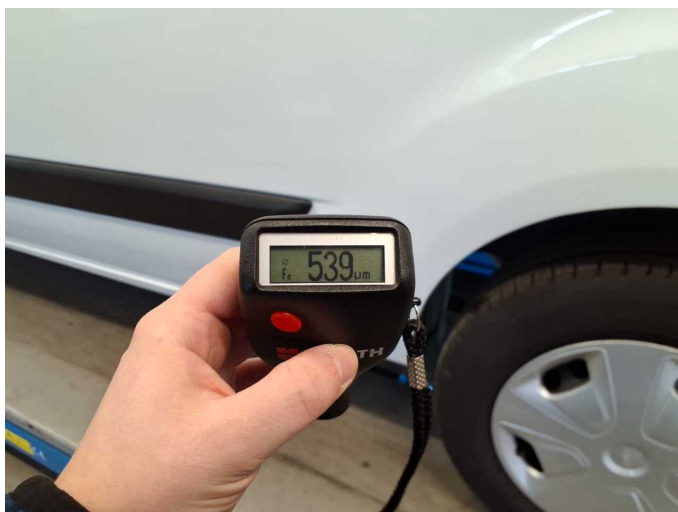
Repainting 1: Side panel - rear left side

No.	Repainting
1	Side panel - rear left side, Professionally carried out, Invoice of repair done Non-existent
2	Side panel - rear right side, Unprofessionally carried out, Invoice of repair done Non-existent
