Expertise

Protocol number: 41642654
Order No. / Reference: 25229579
Inspection date: 22 Sept 2025

Manufacturer: Ford

Model: Transit Custom 320 L2H1 LKW VA Trend

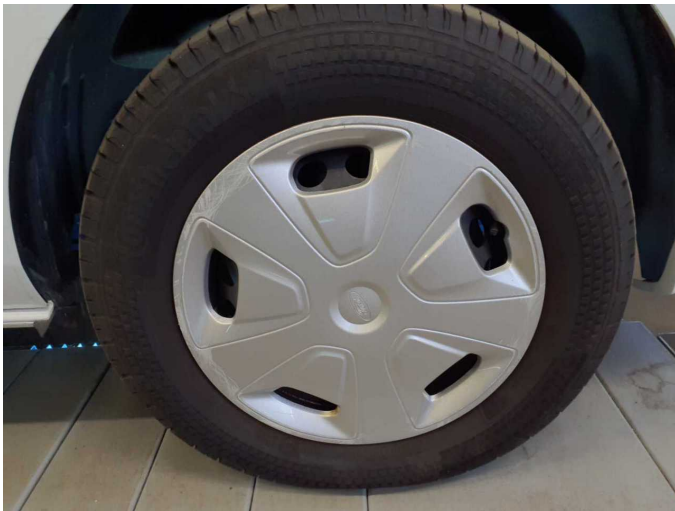
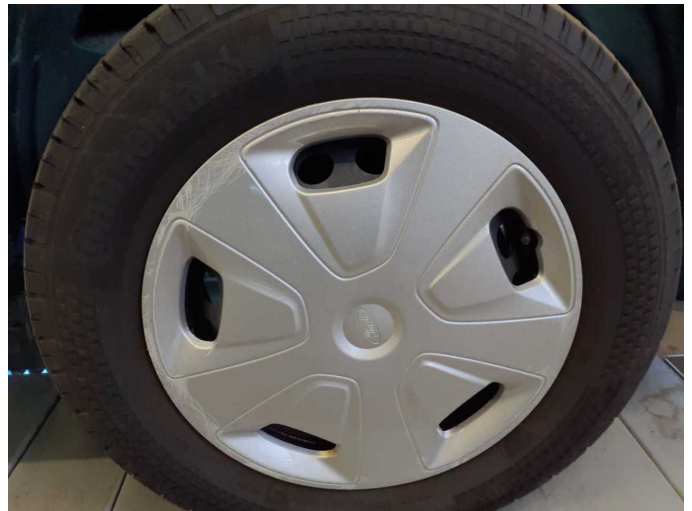
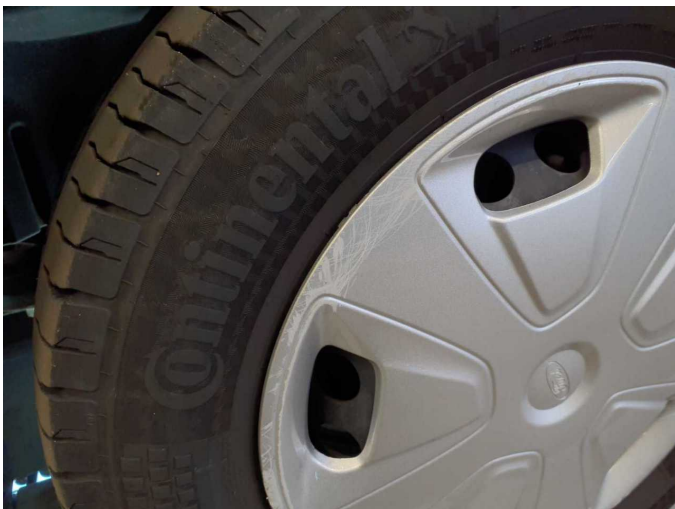
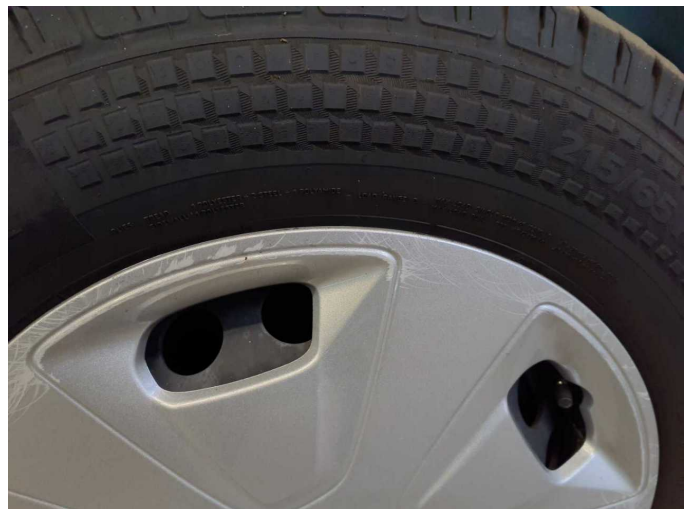
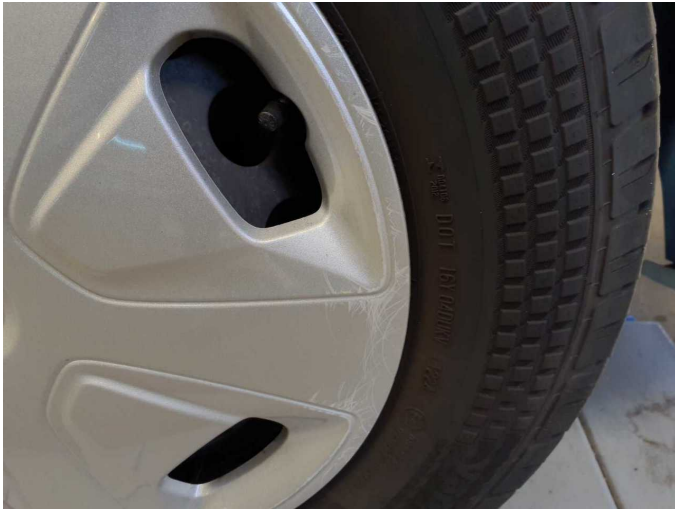
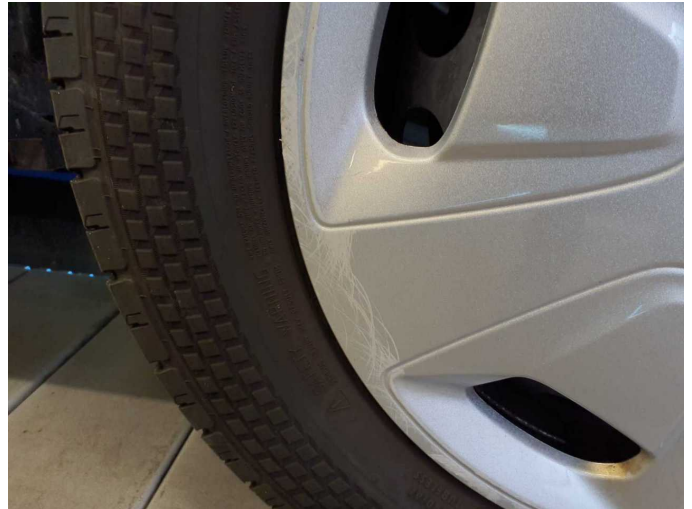
Damage 1: Wheel / tyres: Wheel cover - front right side - Scratched - Replace

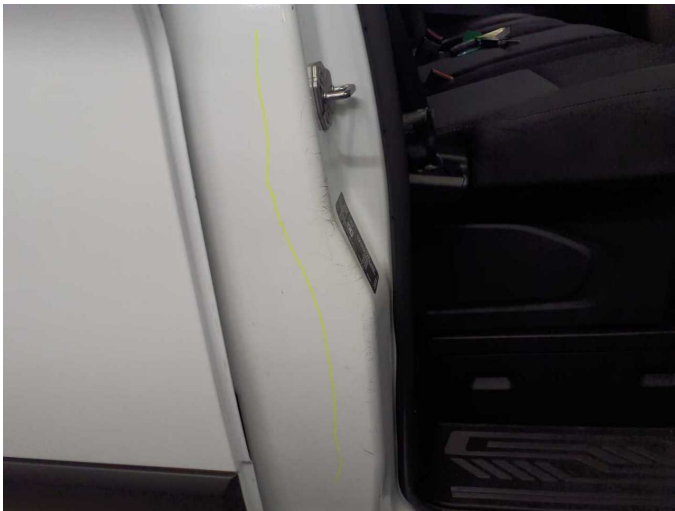
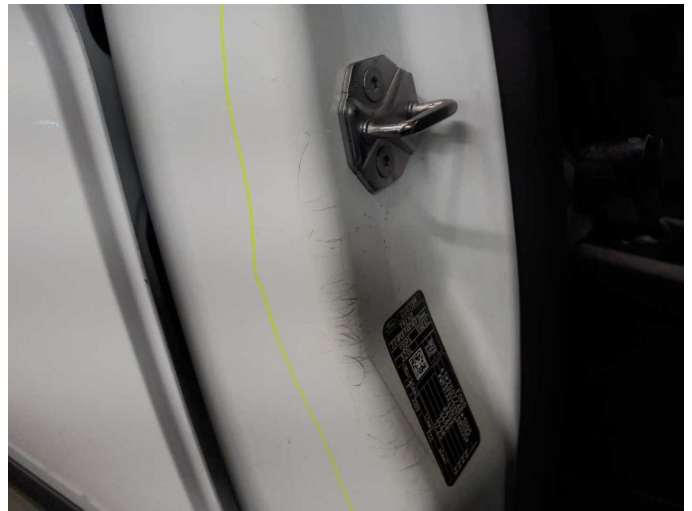
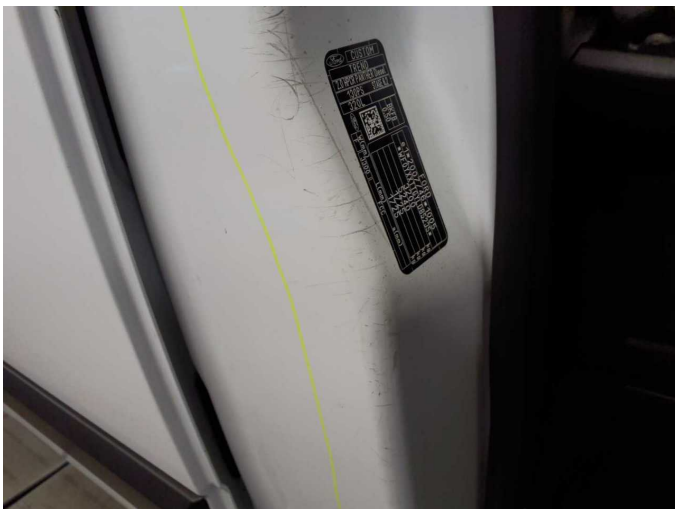
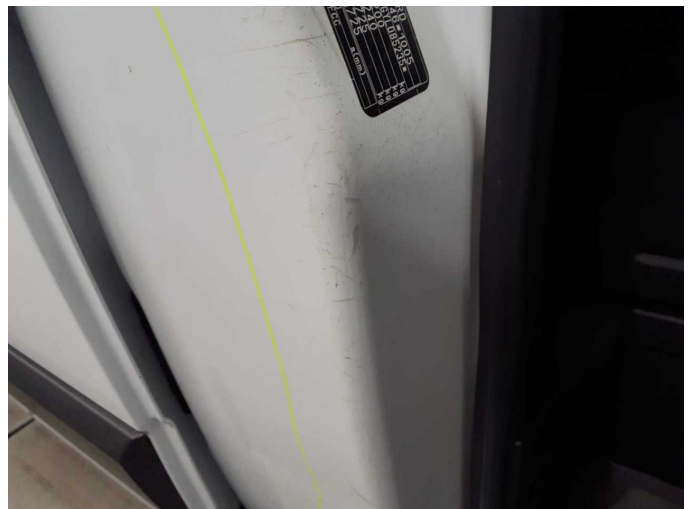
Damage 2: Body: B-pillar - right side - Scratch(es) - Smart repair

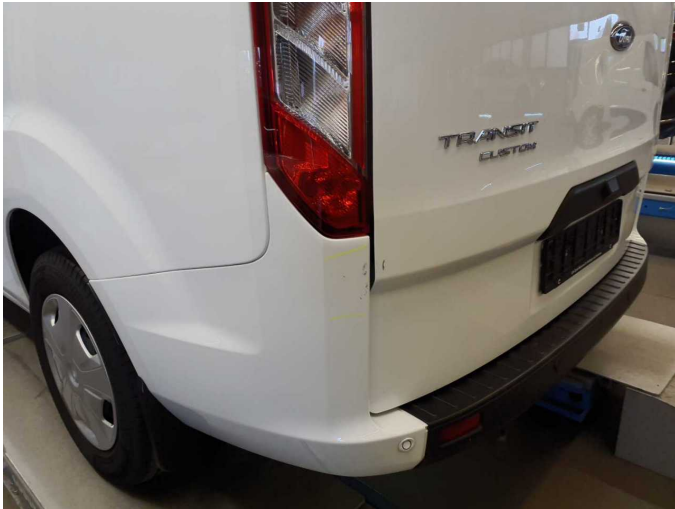
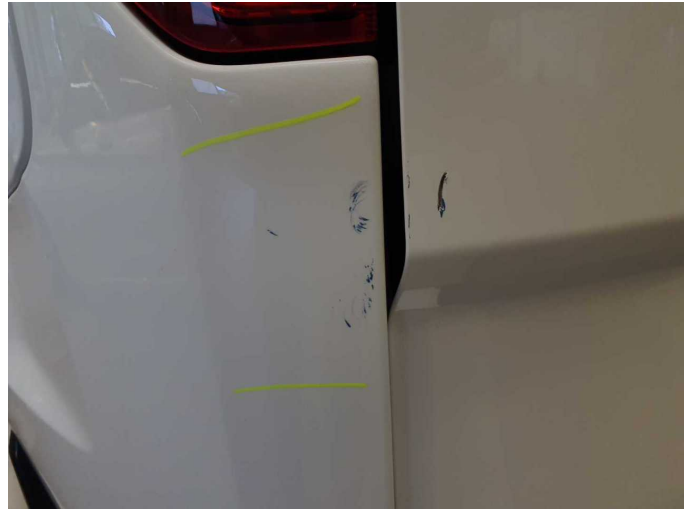
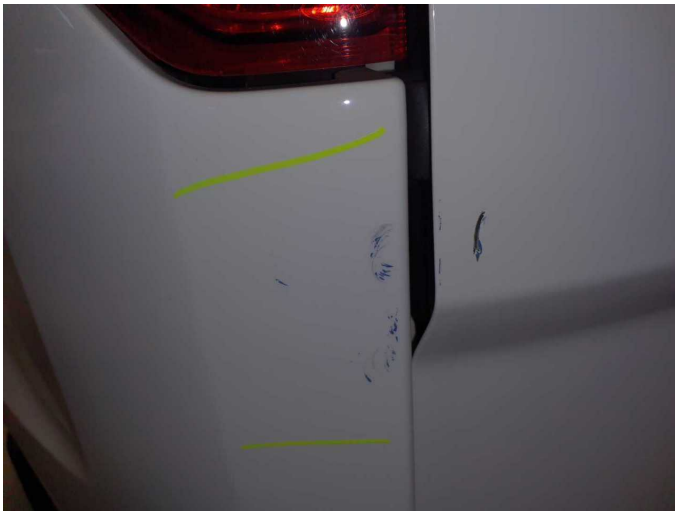
Damage 3: Rear bumper: Bumper - rear left side - Scratch(es) - Smart repair

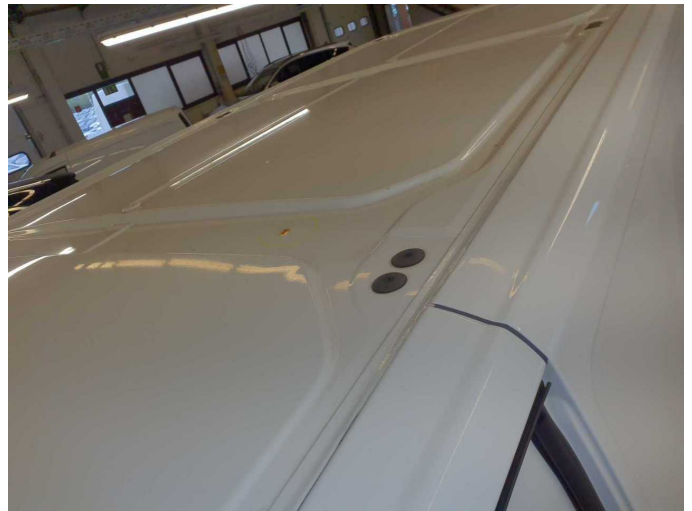
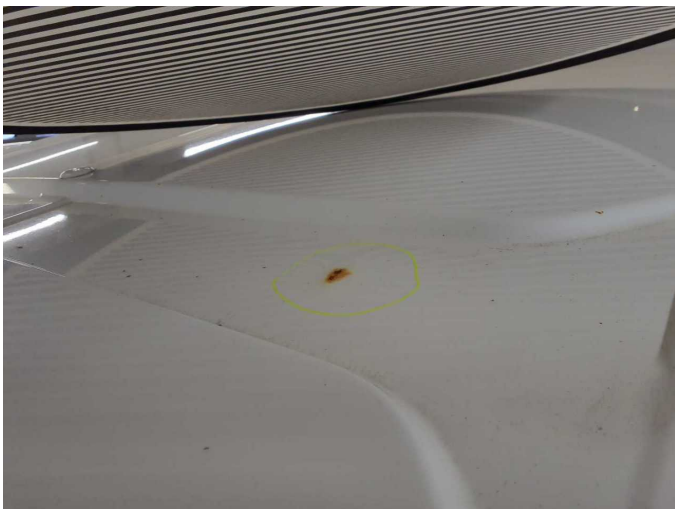
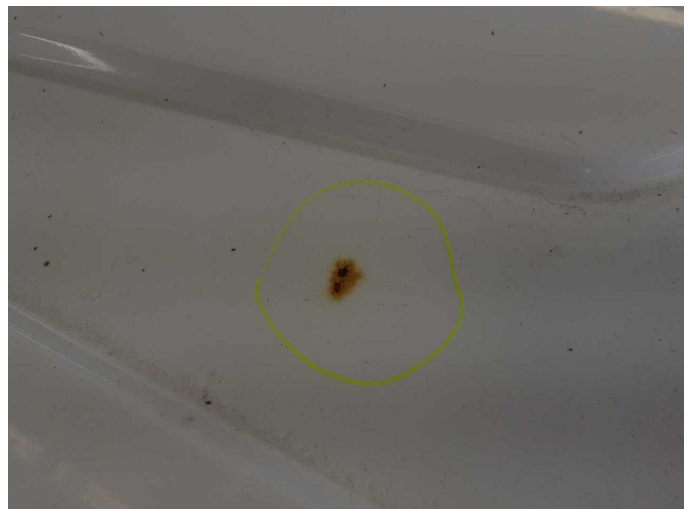
Damage 4: Roof: Roof (+Beule) - Corrosion - Smart repair

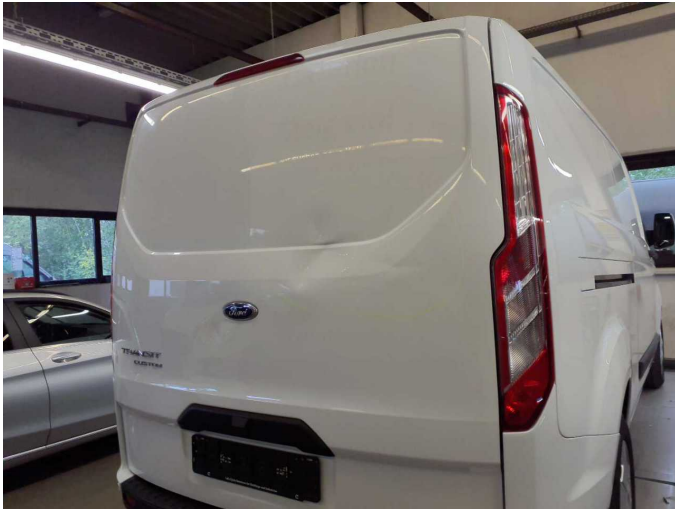
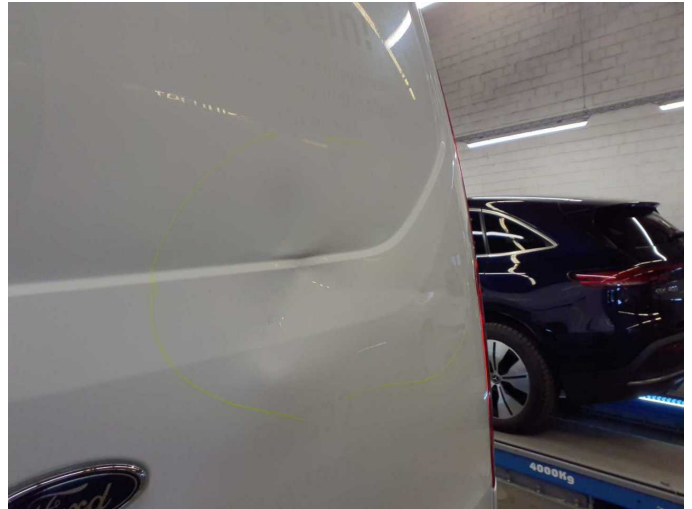
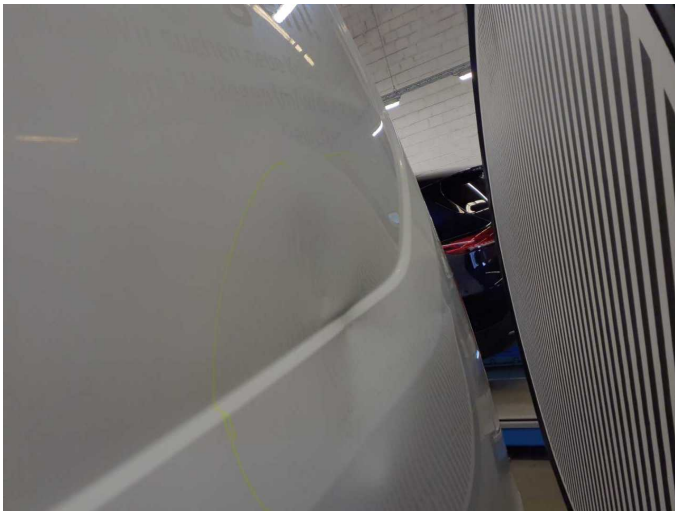
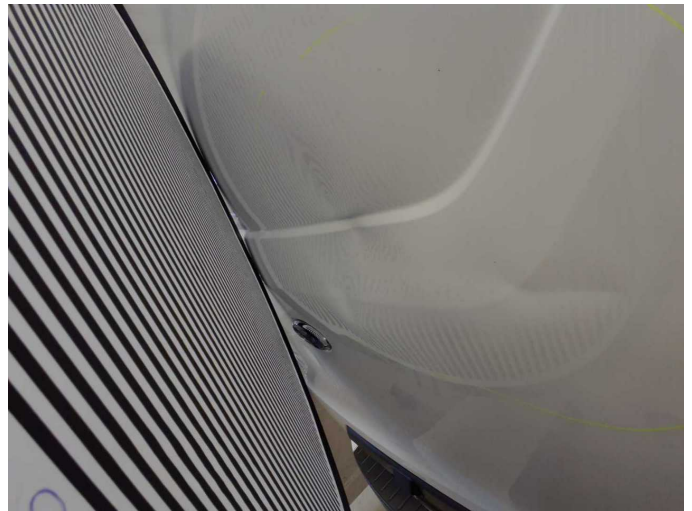
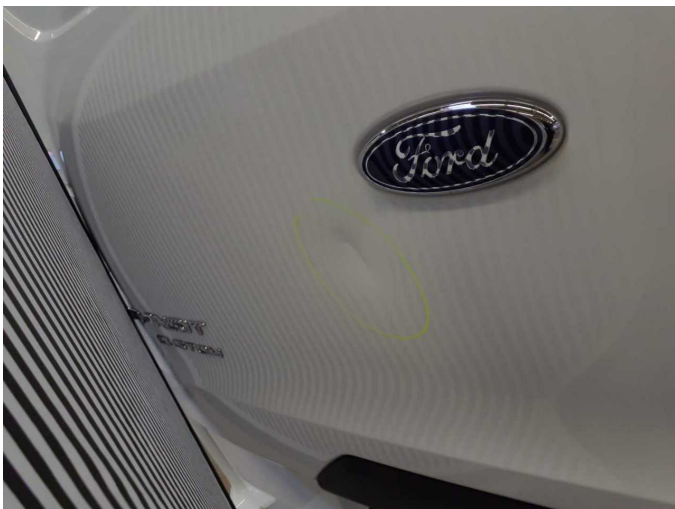
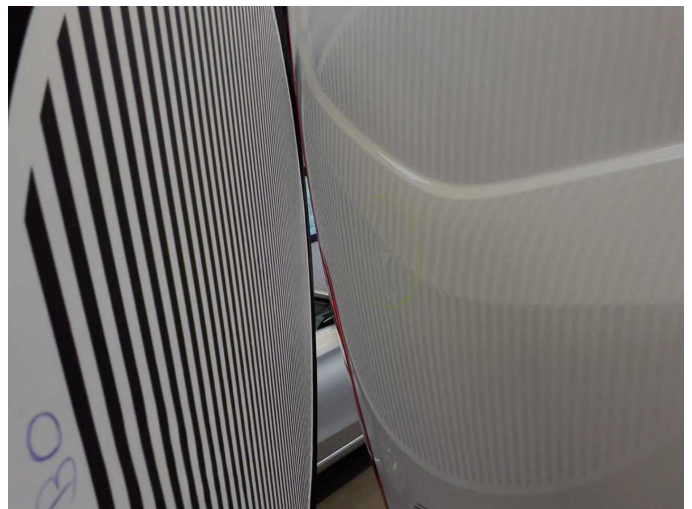
Heckklappe wurde aufgrund des Alters gemindert.

Damage 5: Boot lid / rear door: Boot lid - Deformed - repair according to calculation
