Expertise

Protocol number: 41601540  
Order No. / Reference: 25133138  
Inspection date: 17 Sept 2025

Manufacturer: Ford

Model: Transit Custom 320 L1H1 LKW VA Trend

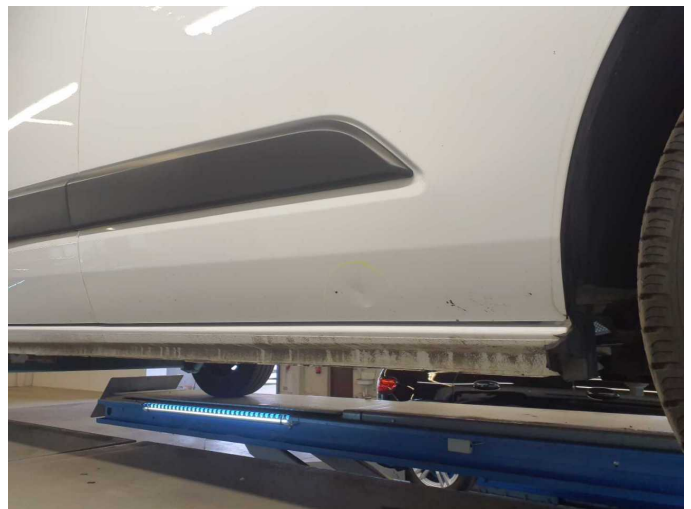
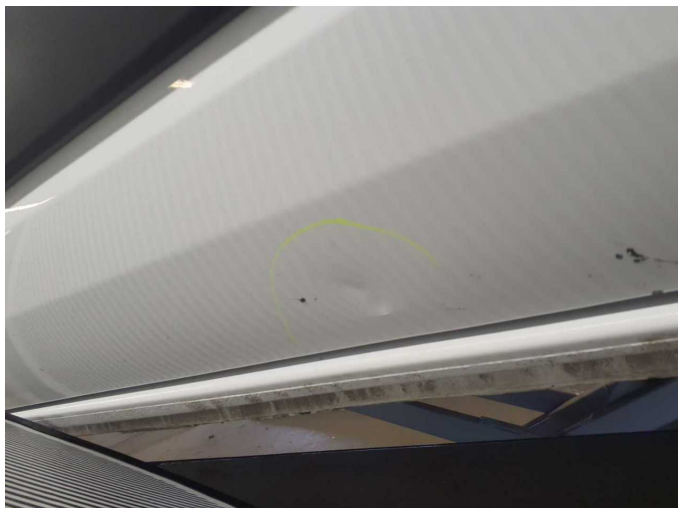
Damage 1: Door - front right side: Door - dent(s) - Smart repair

**Damage 1:** Door - front right side: Door - dent(s) - Smart repair

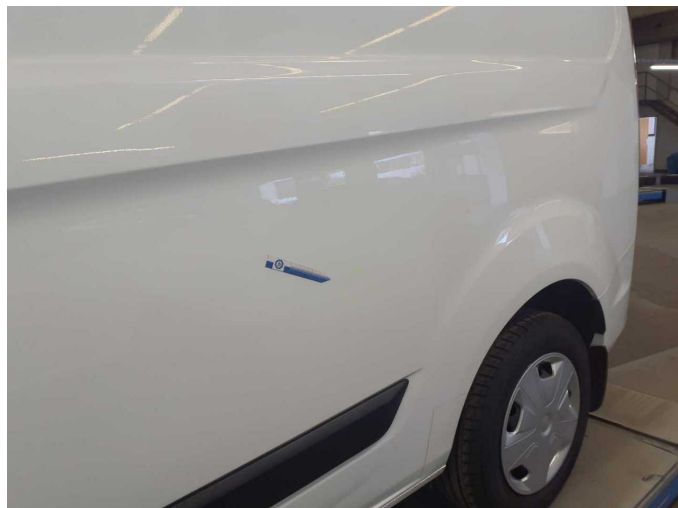
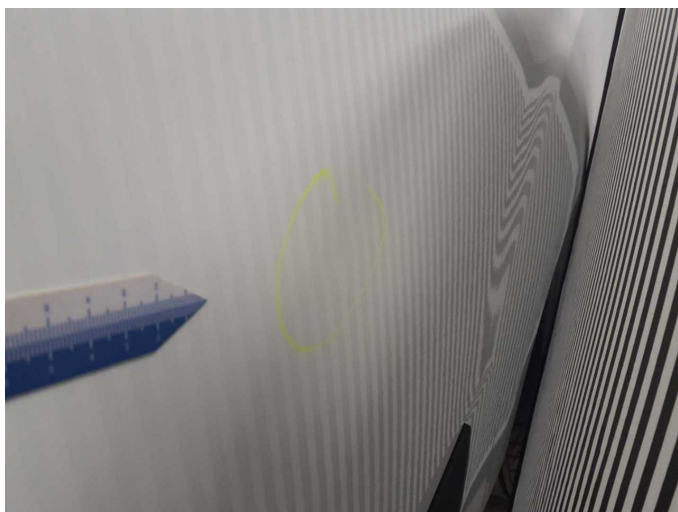
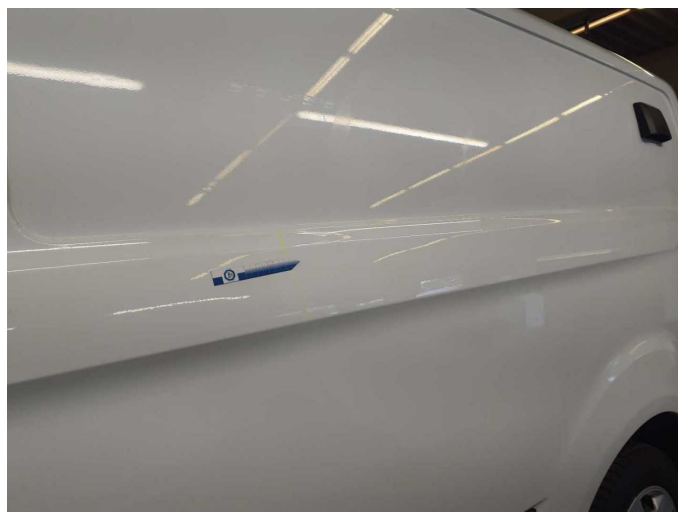
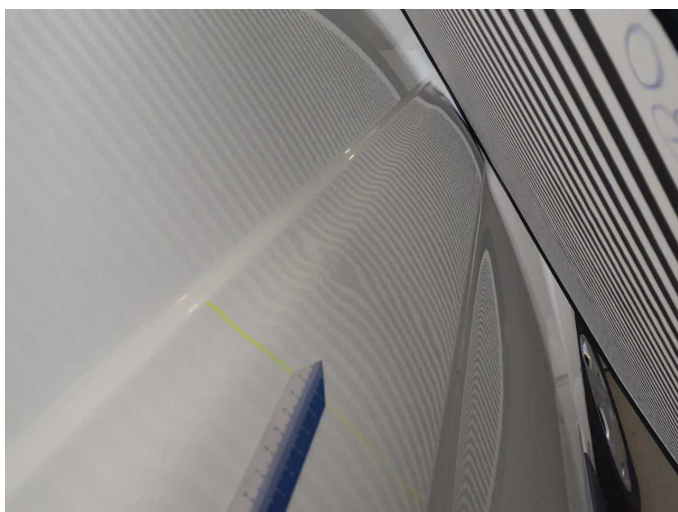
**Damage 2:** Side panel - rear left side: Side panel - dent(s) - Smooth repair work

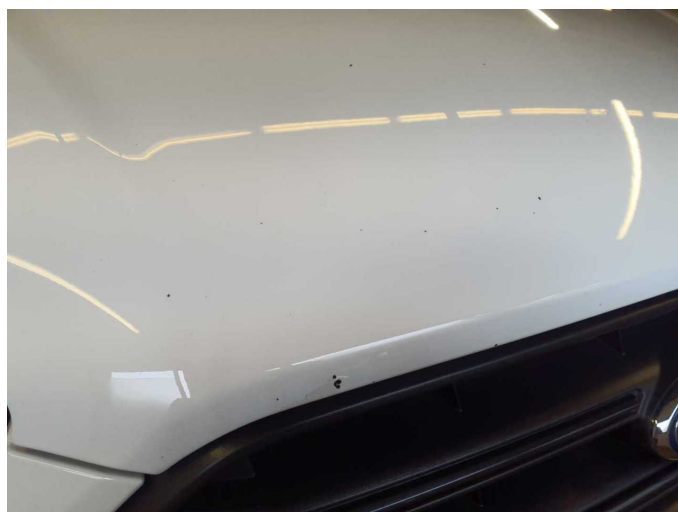
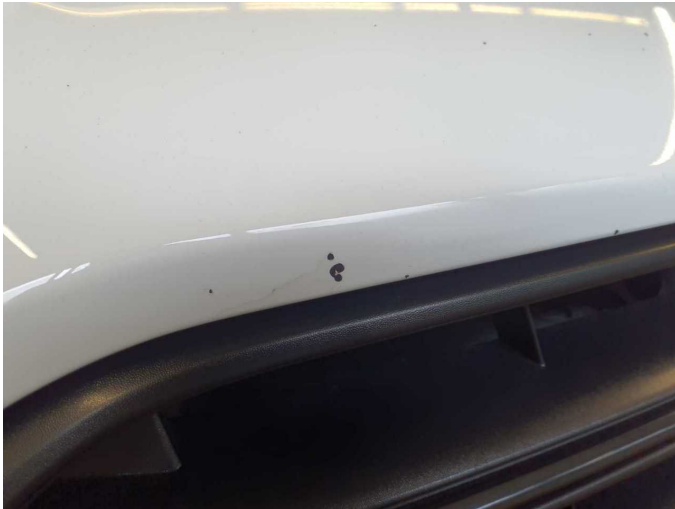
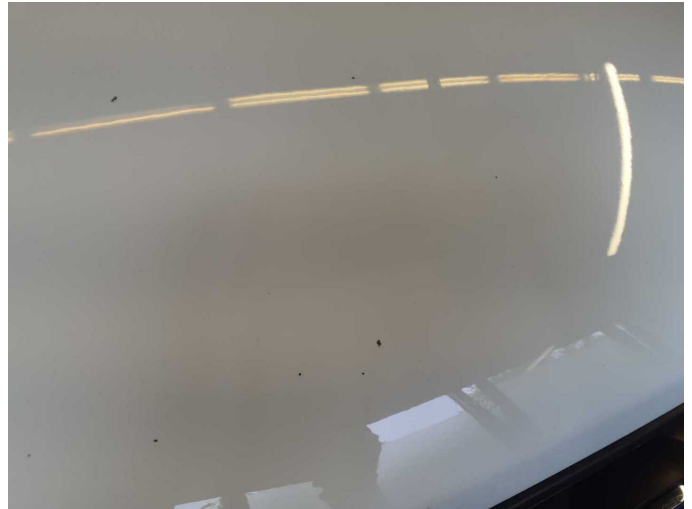
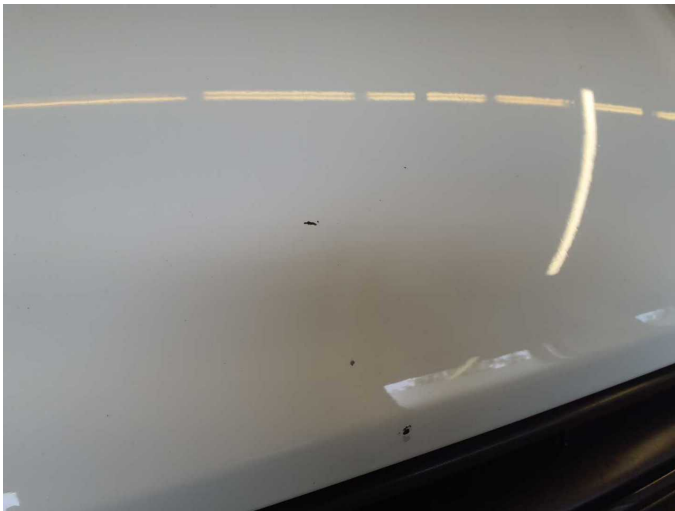
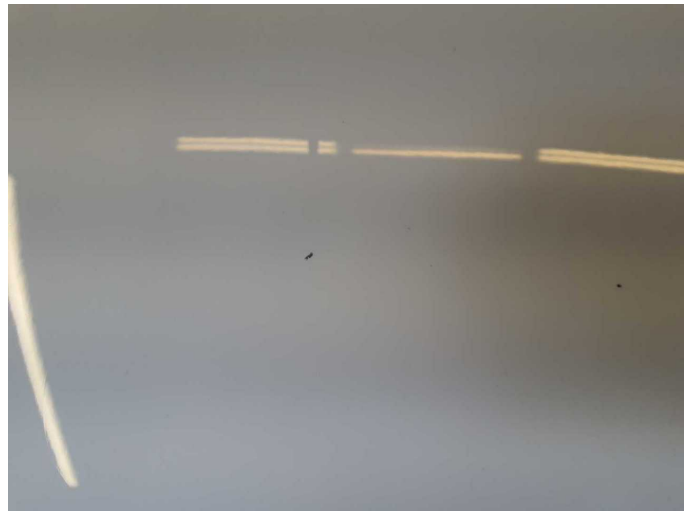
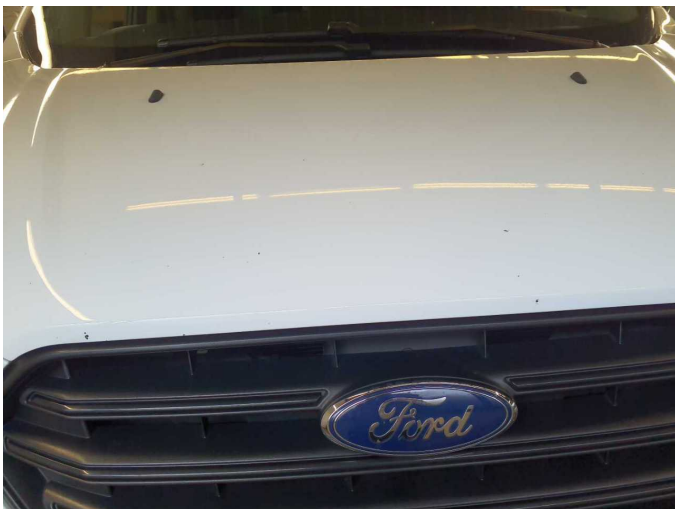
**Damage 3:** Bonnet: Bonnet - Scratch(es) - Paint

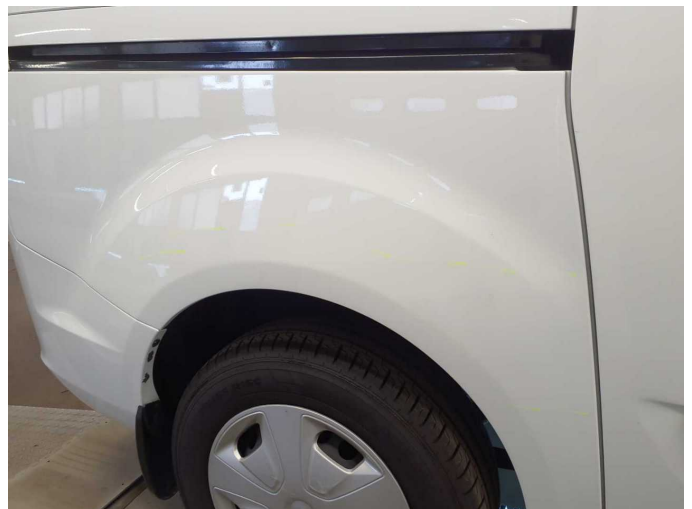
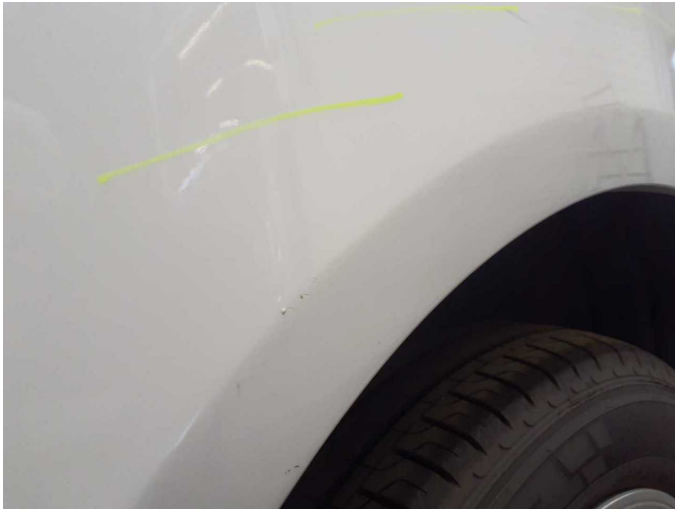
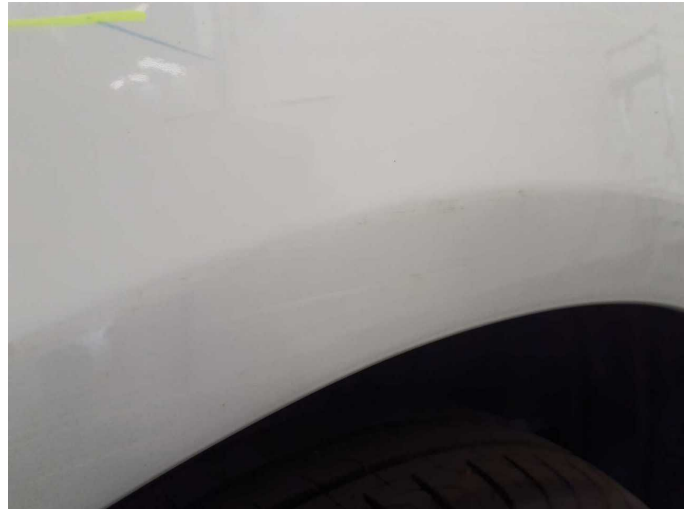
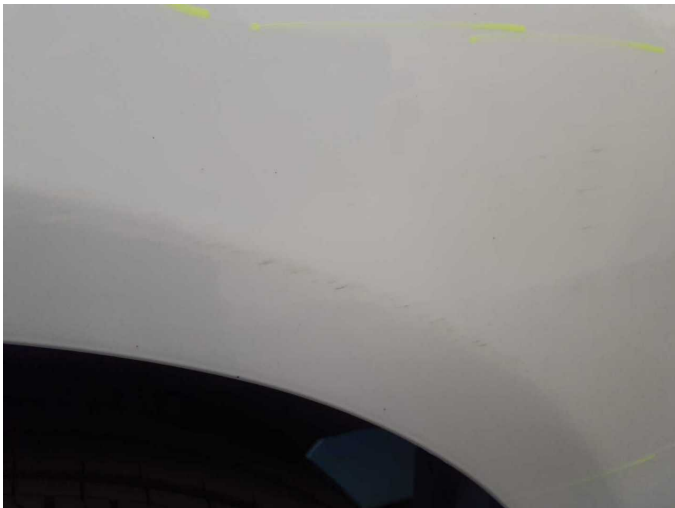
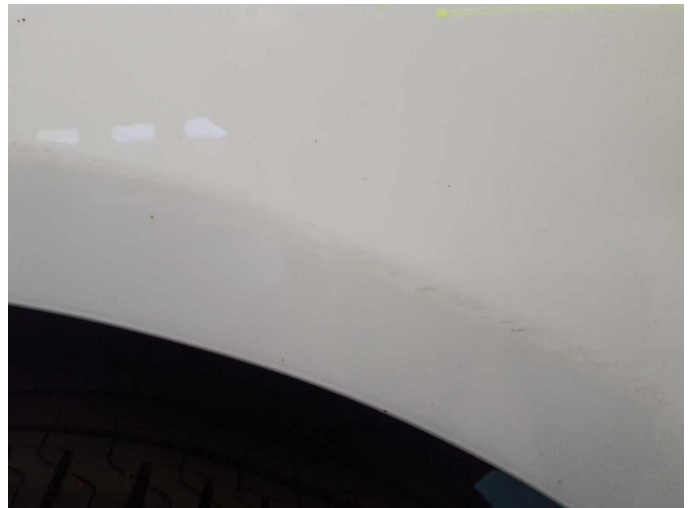
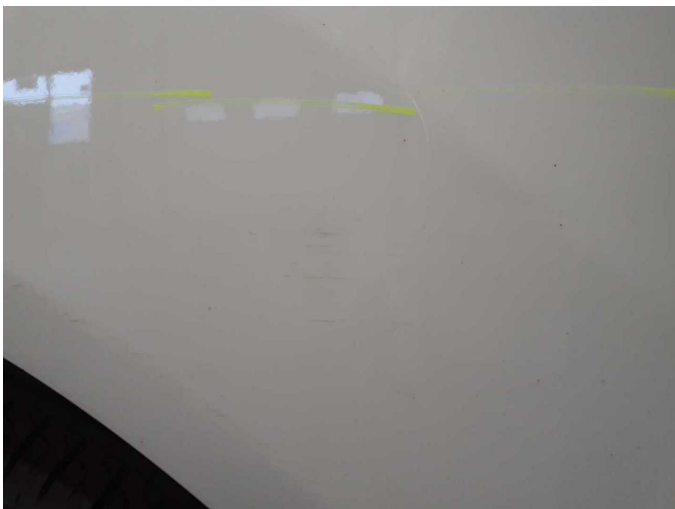
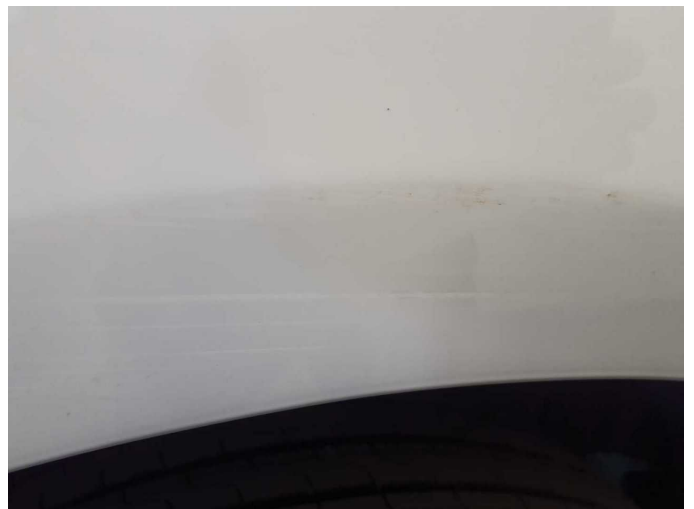
**Damage 4:** Side panel - rear right side: Side panel - Scratch(es) - Paint

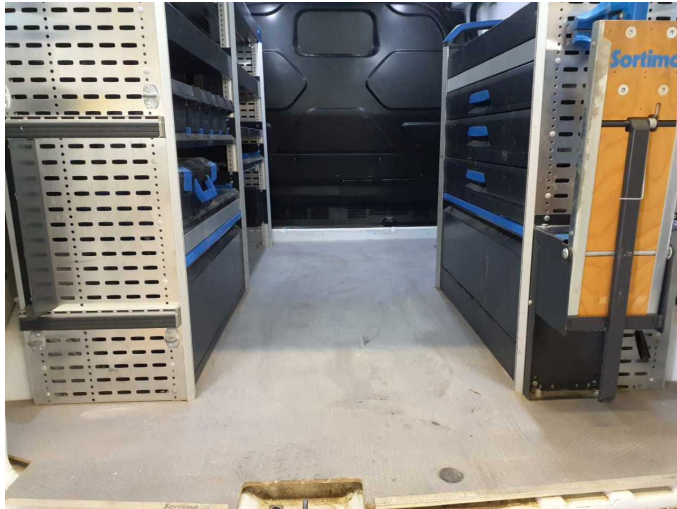
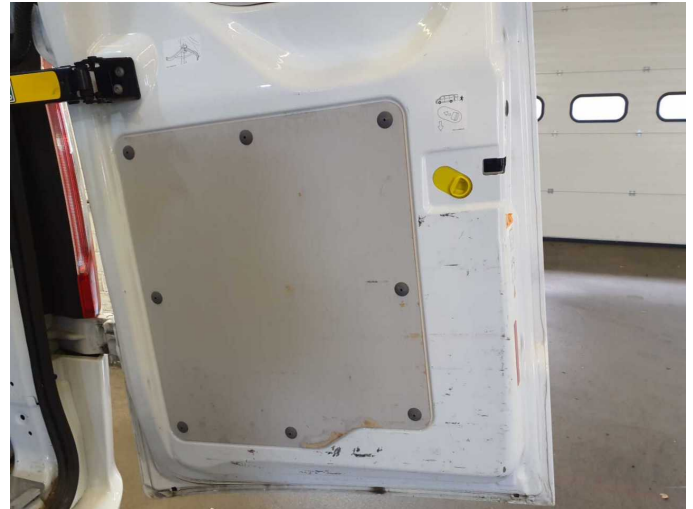
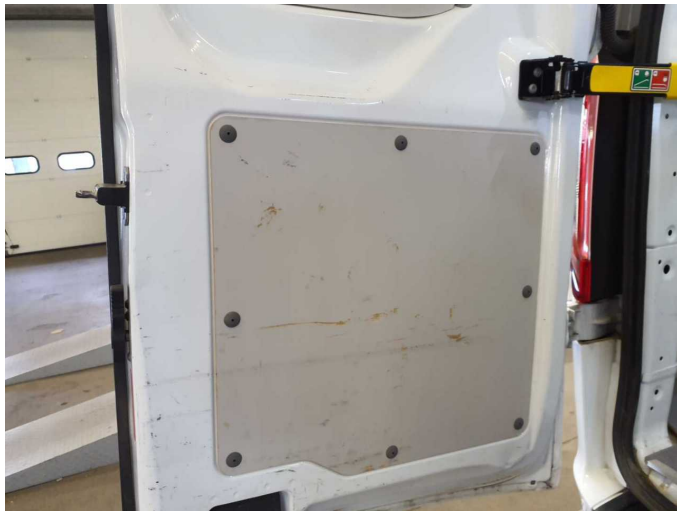
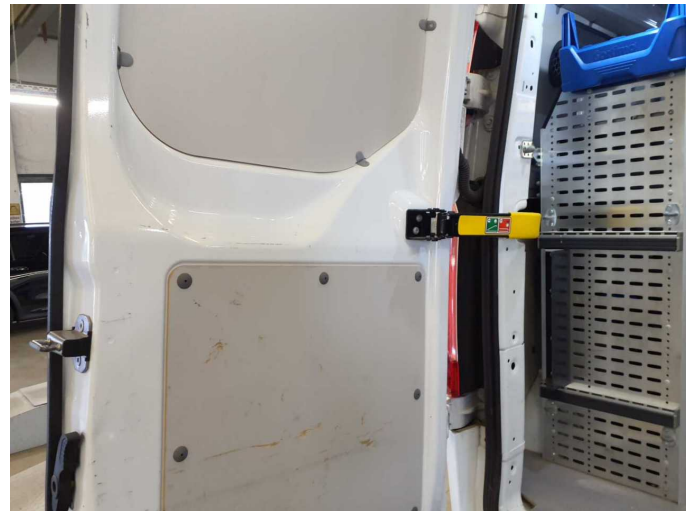
**Wear and tear 1:** Interior: Cargo space division - Scratch(es) - No deduction

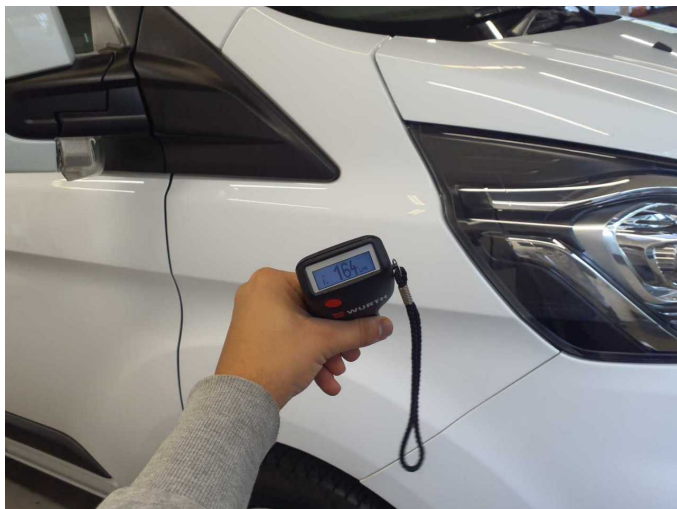
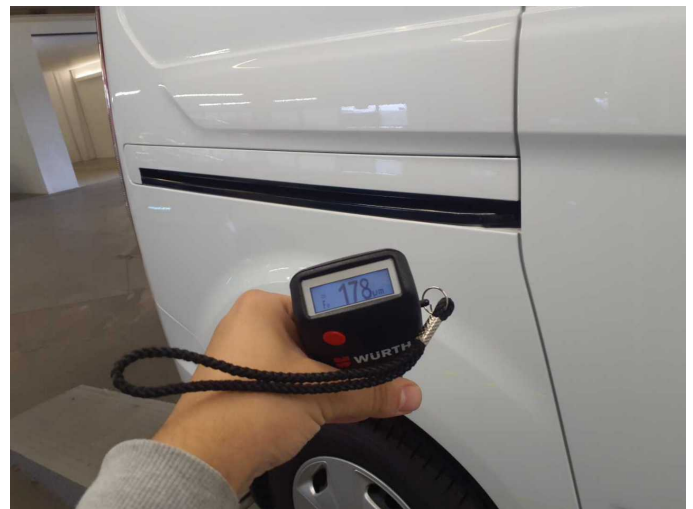
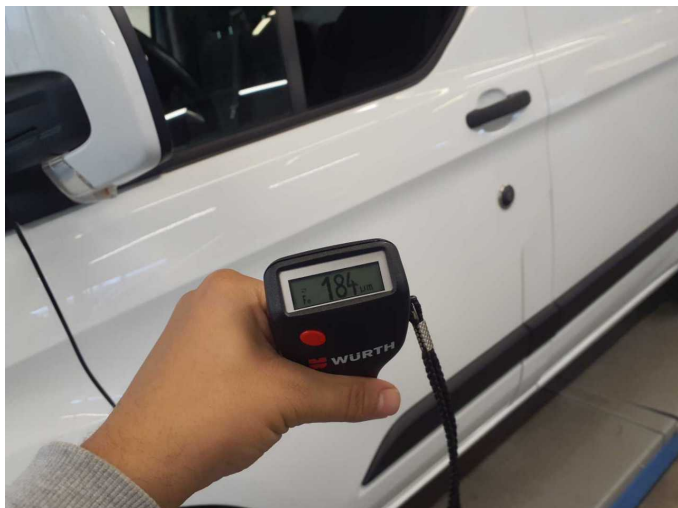
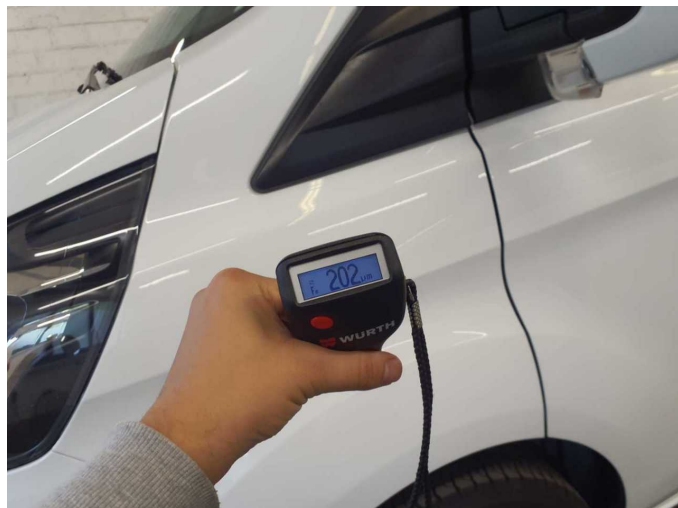
Mudguard - left side	202 µm	Mudguard - right side	164 µm
Side panel - rear right side	178 µm	Door - front left side	184 µm

**Repainting 1:** Mudguard - left side, Mudguard - right side, Side panel - rear right side, Door - front left side
