Expertise

Protocol number: 41614085
Order No. / Reference: 25138818
Inspection date: 18 Sept 2025

Manufacturer: Ford

Model: Transit Custom 320 L1H1 LKW VA Trend

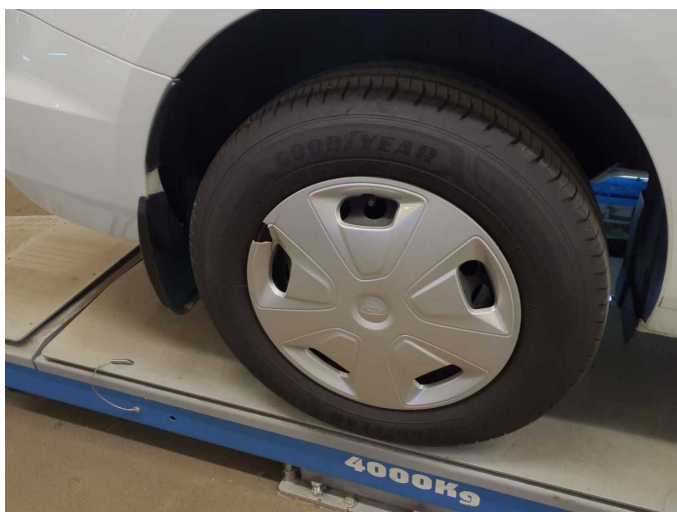
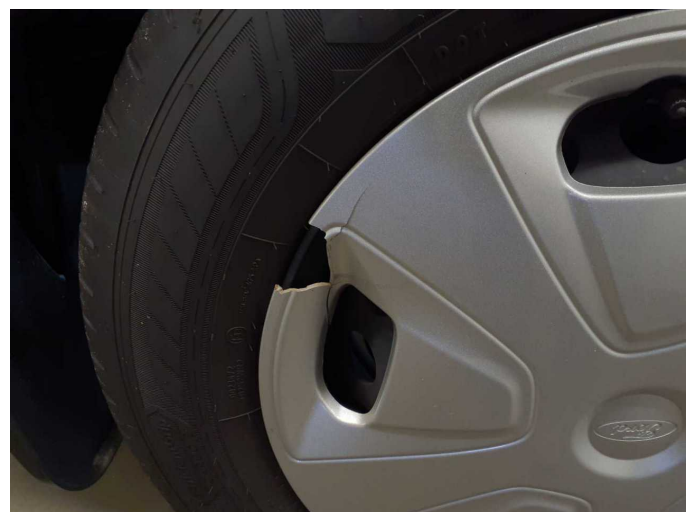
Damage 1: Wheel / tyres: Wheel cover - rear right side - Broken / torn - Replace

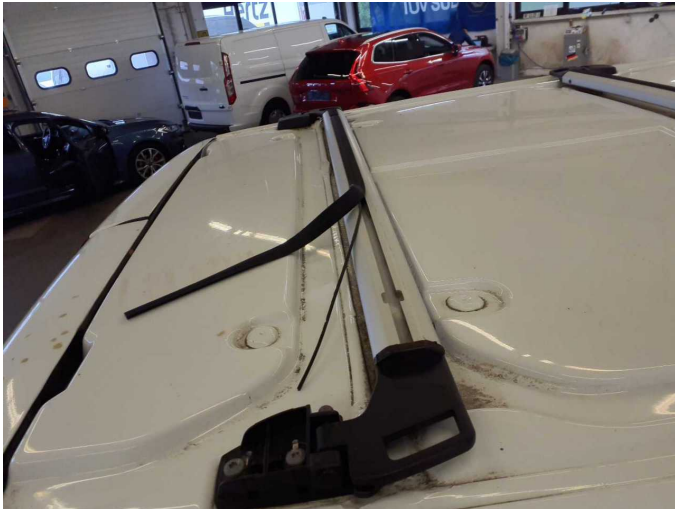
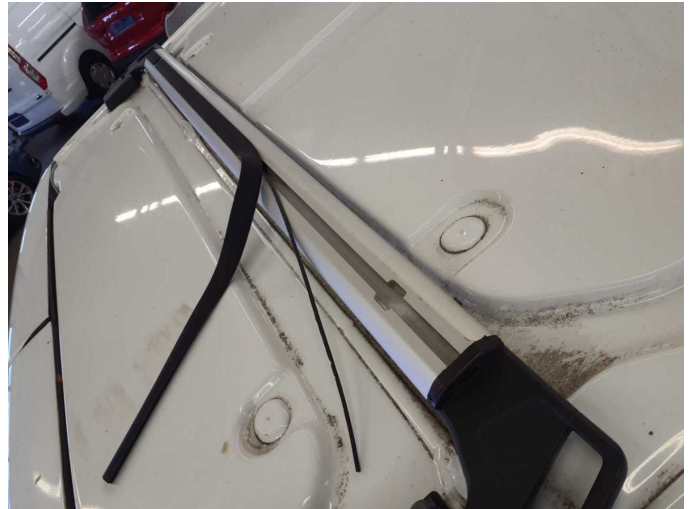
Damage 2: Equipment: Roof rack system (Dichtung hintere schiene) - Broken / torn - Replace

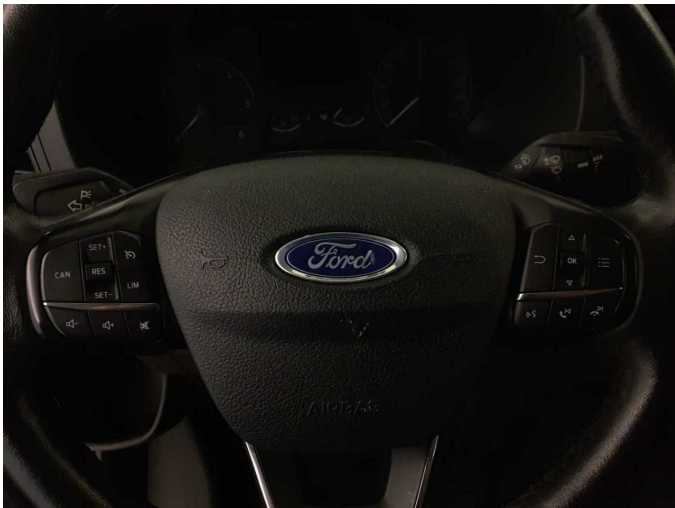
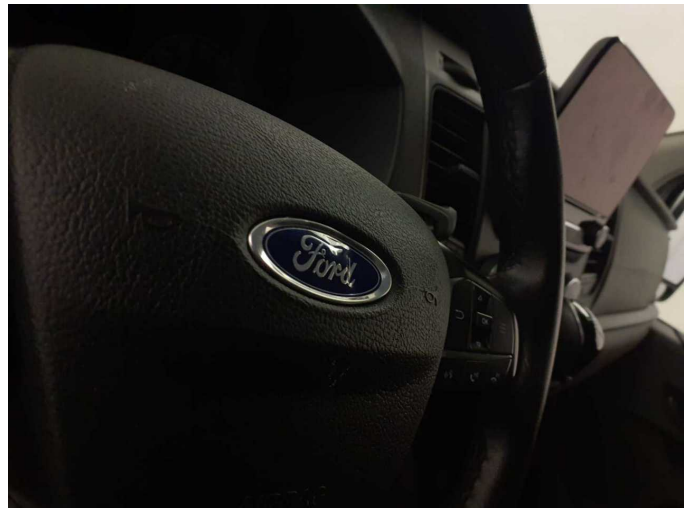
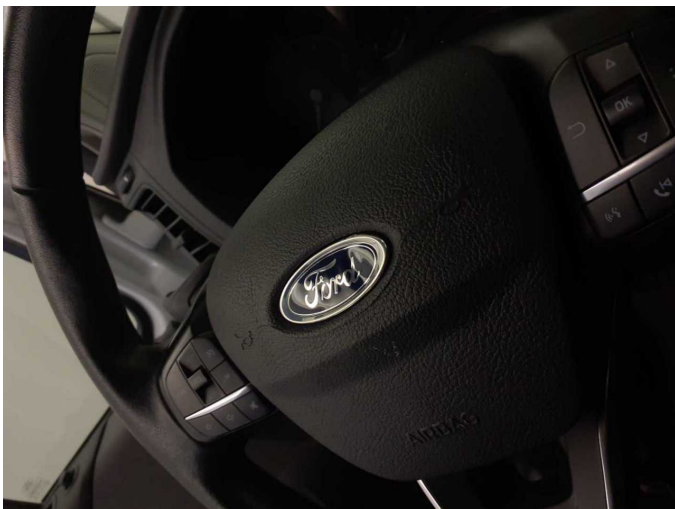
Damage 3: Steering system: Steering wheel (Emblem) - Deformed - Replace

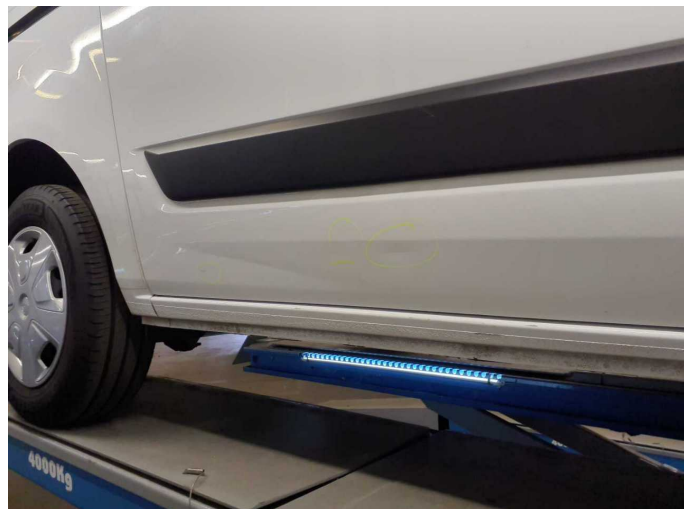
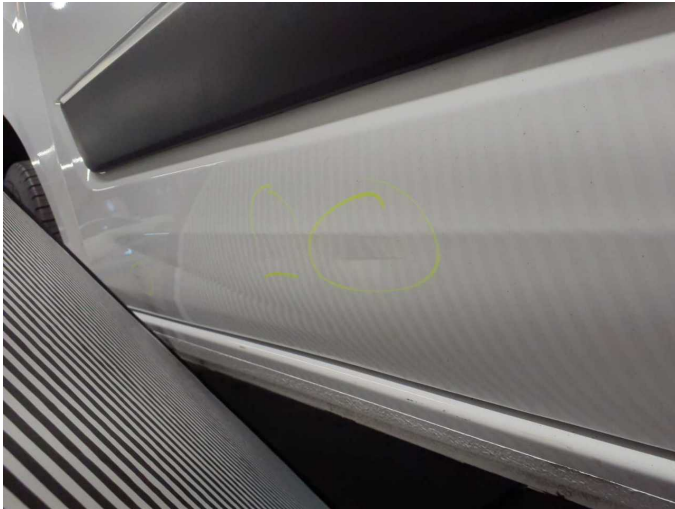
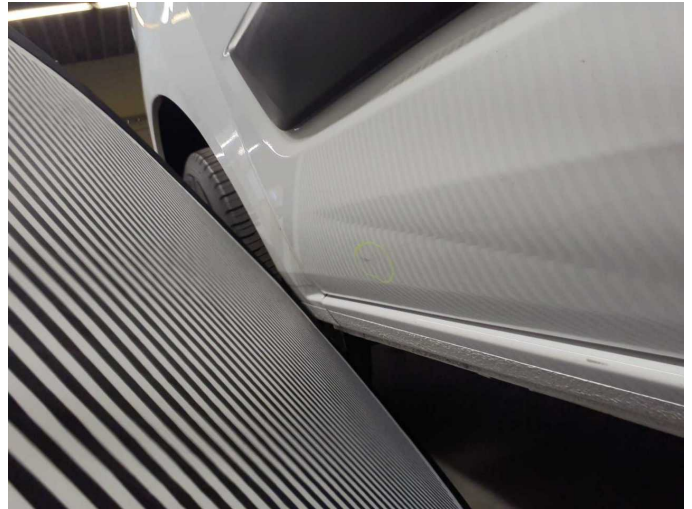
Damage 4: Sliding door, right: Sliding door (3 Dellen+Kratzer + (Gebrauchsspuren)) - dent(s) - Smart repair

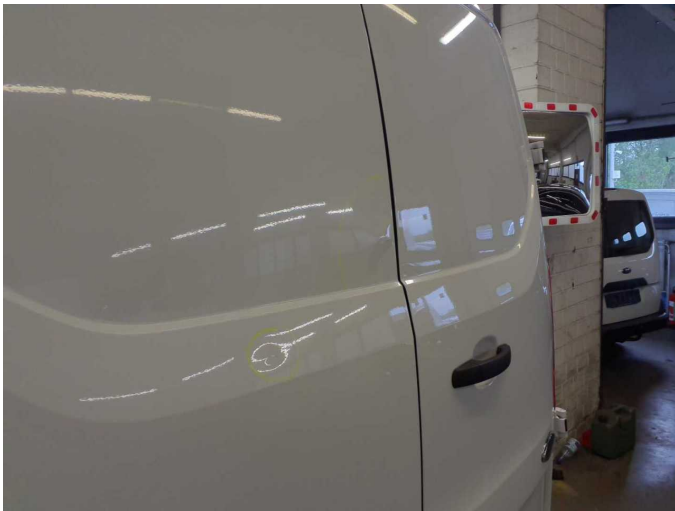
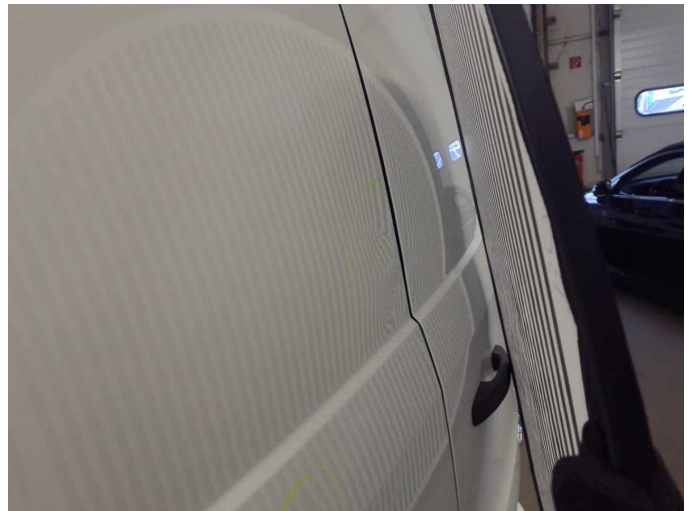
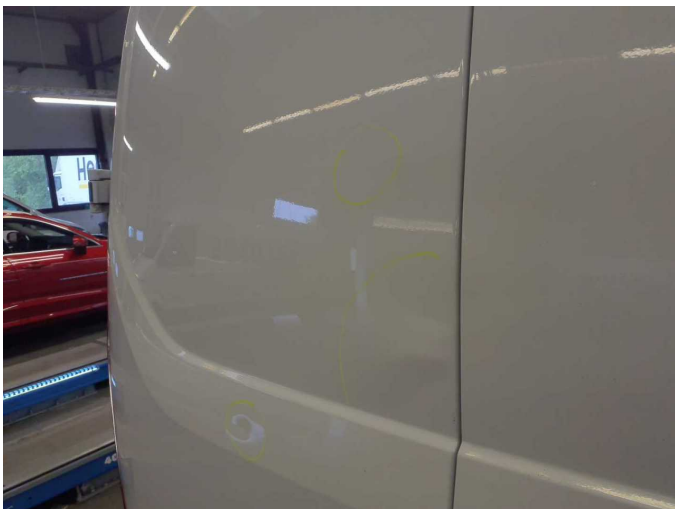
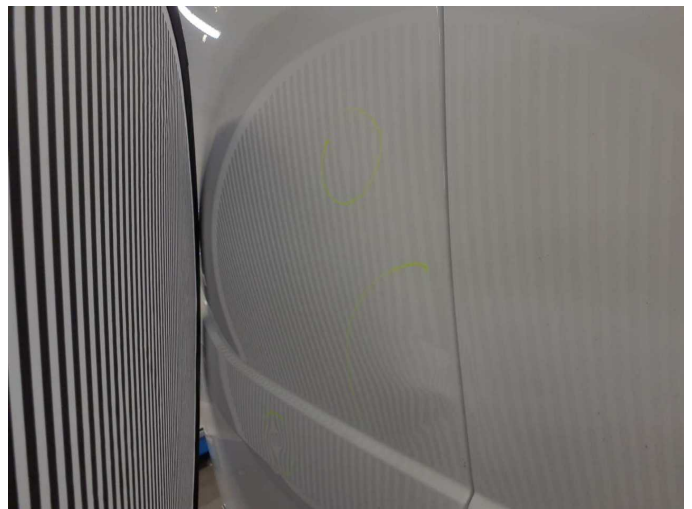
Damage 5: Boot lid / rear door: Rear door - left side - dent(s) - Smart repair

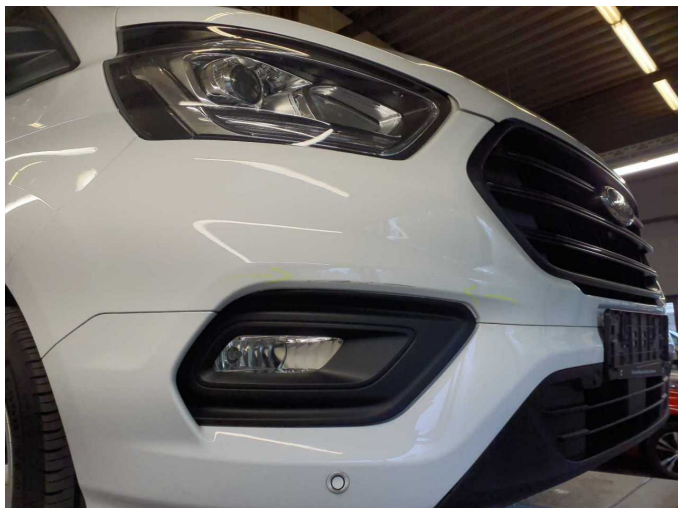
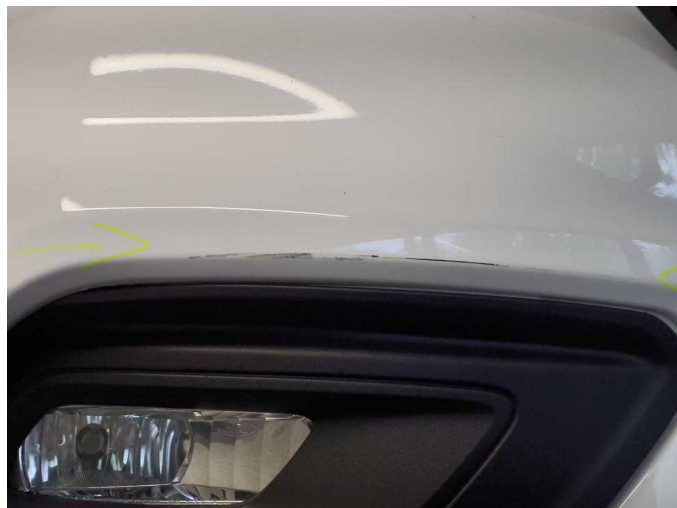
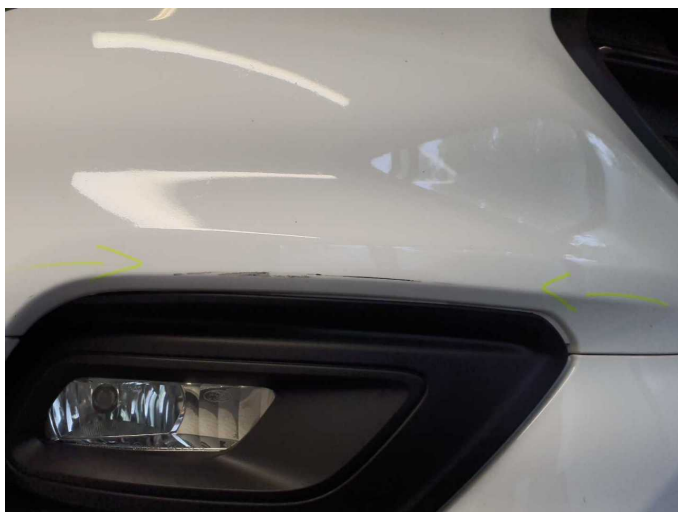
Damage 6: Front bumper: Front bumper - Scratch(es) - Paint

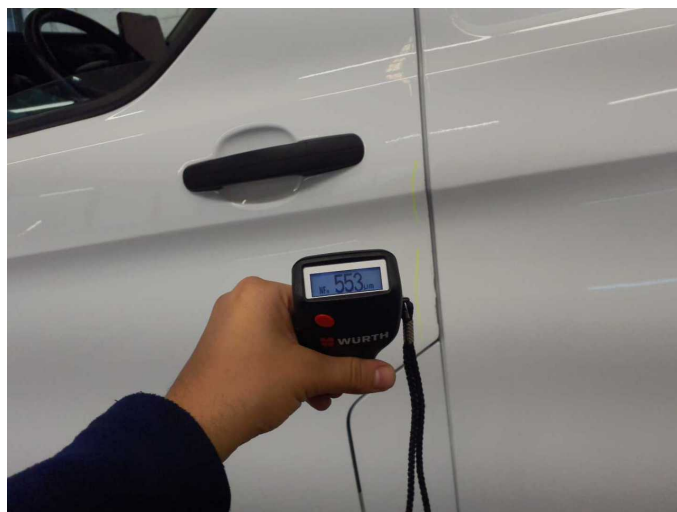
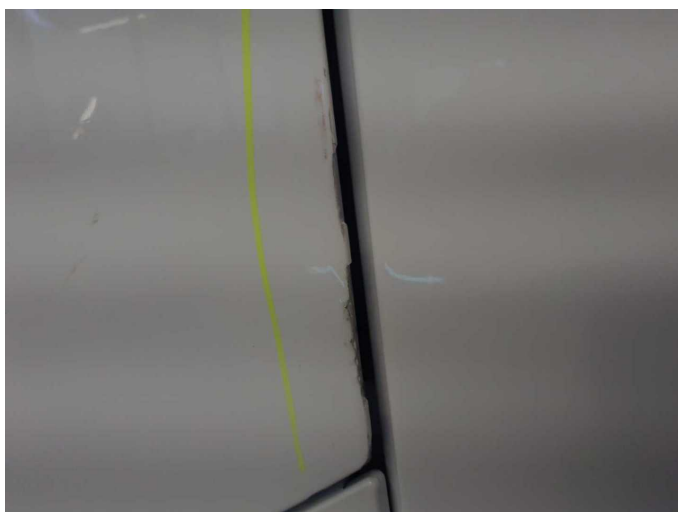
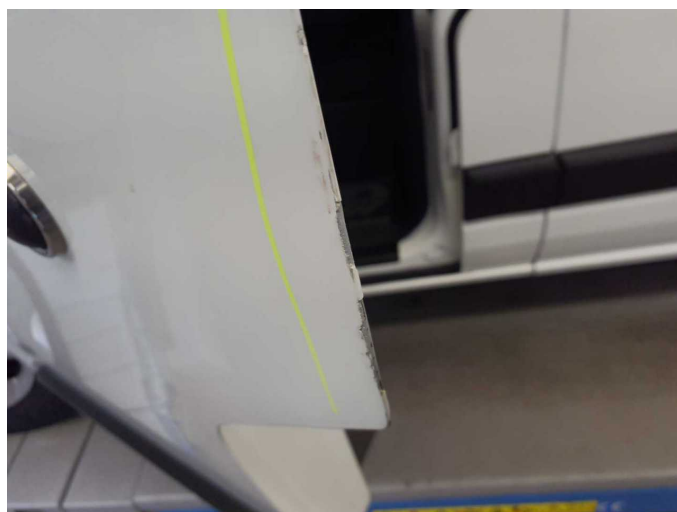
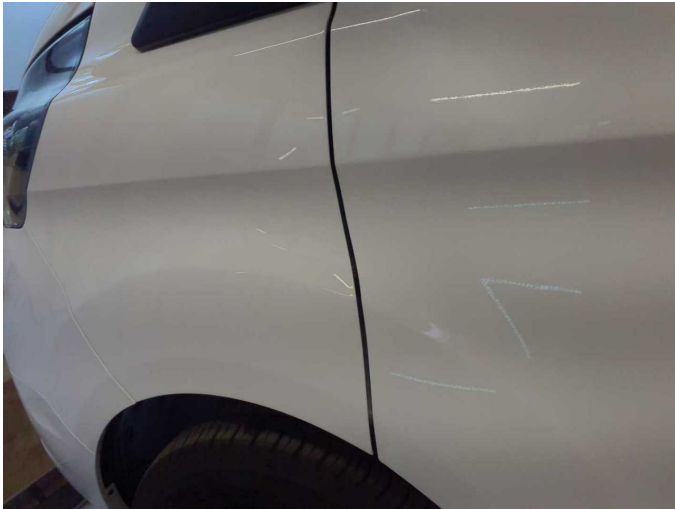
Damage 7: Door - front left side: Door - Scratched - Repair and paint

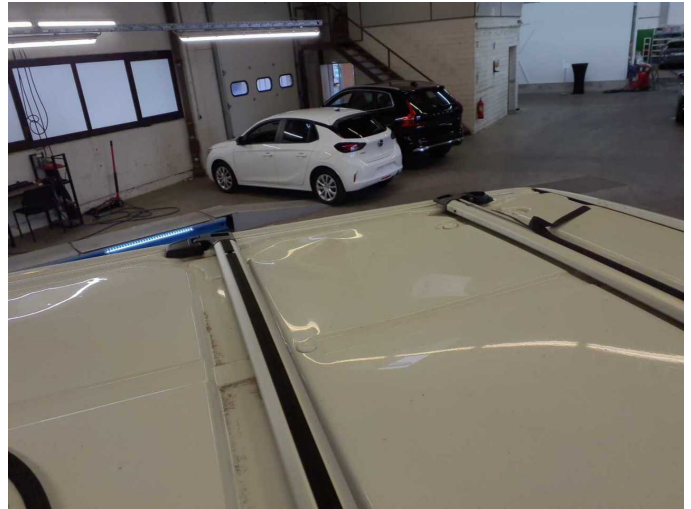
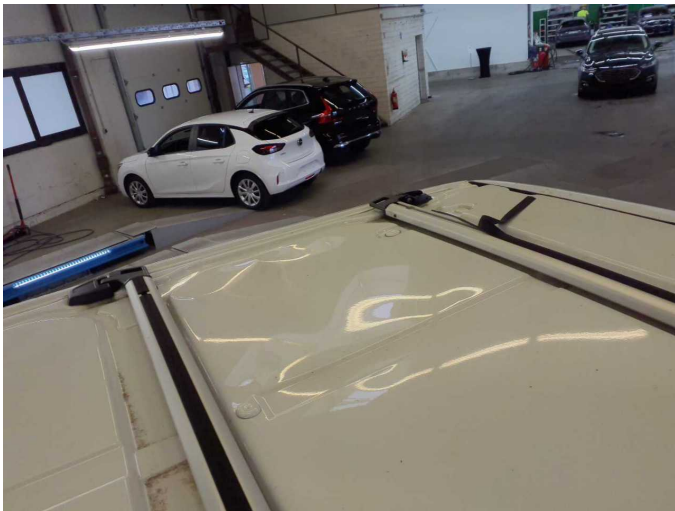
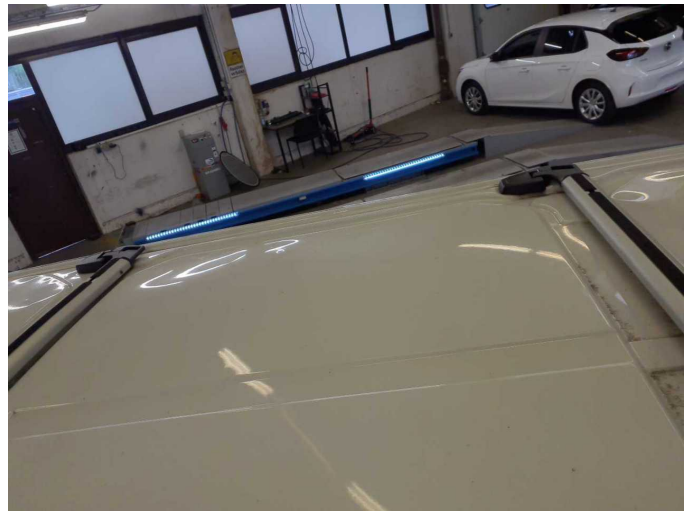
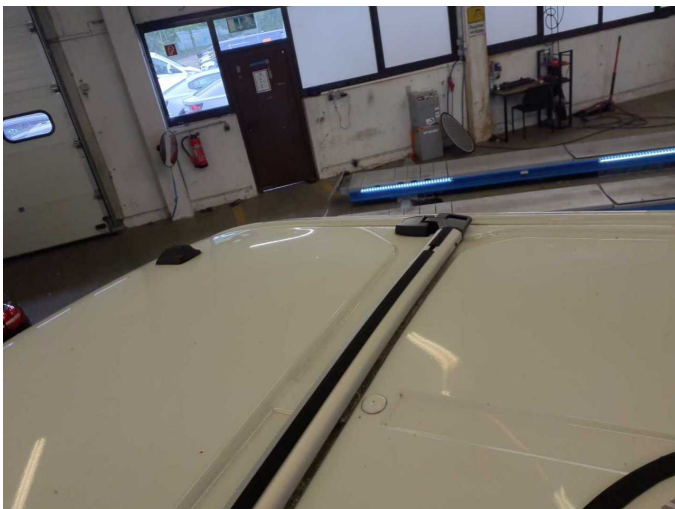
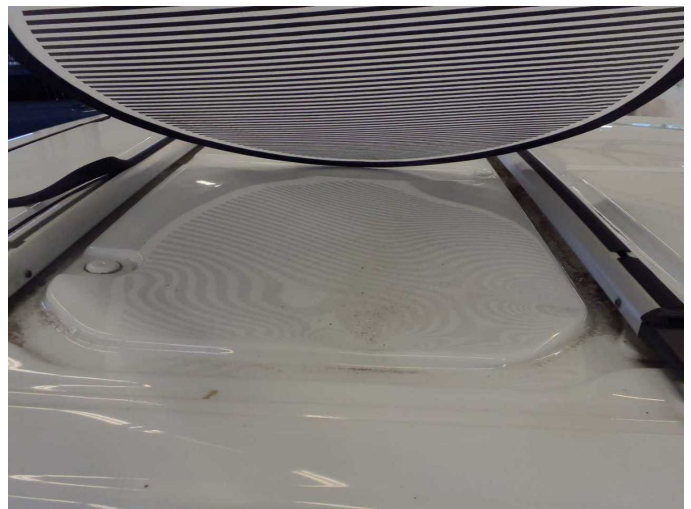
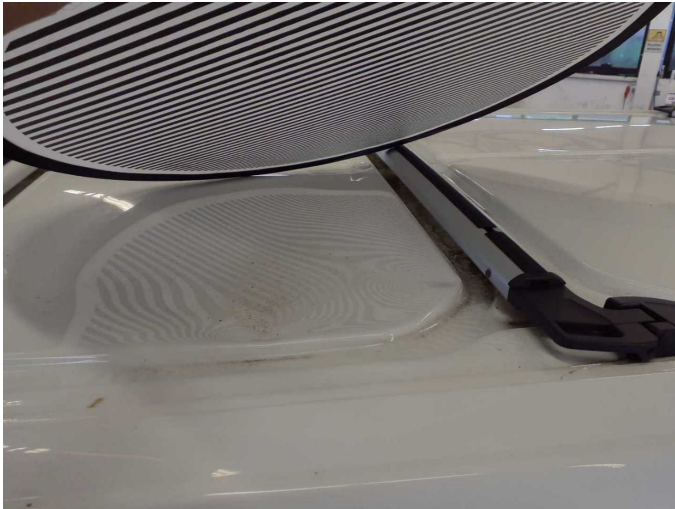
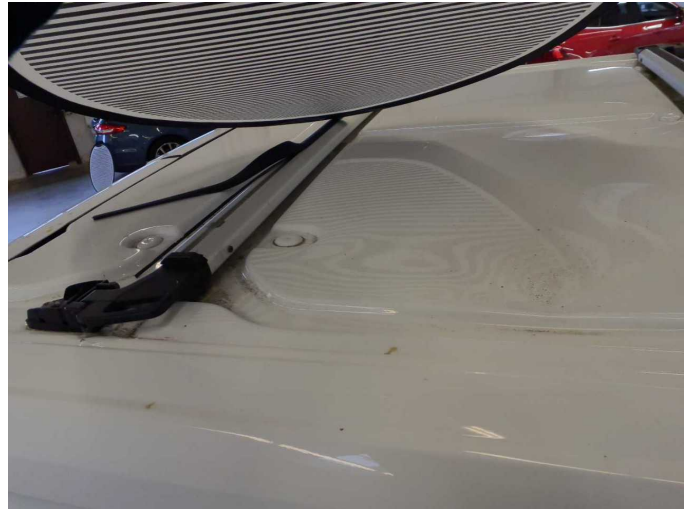
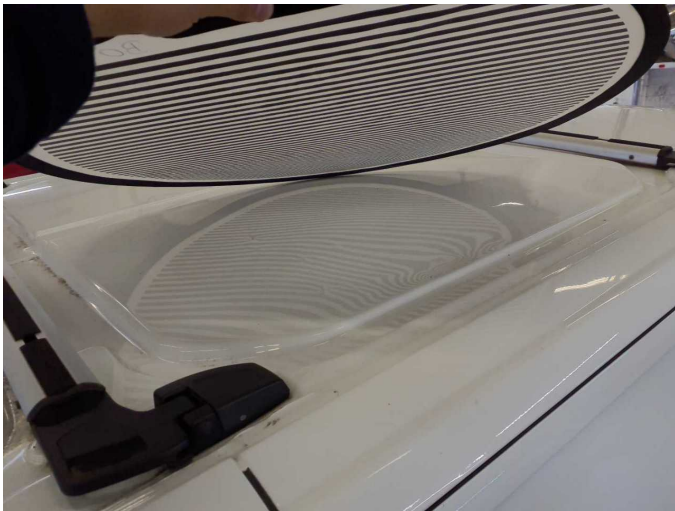
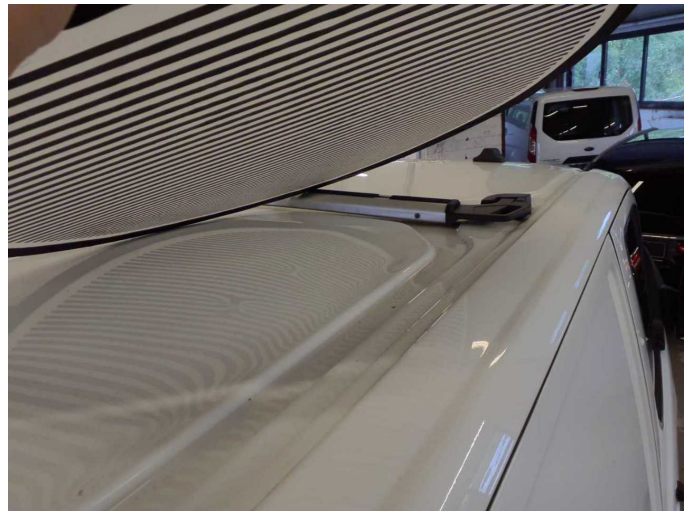
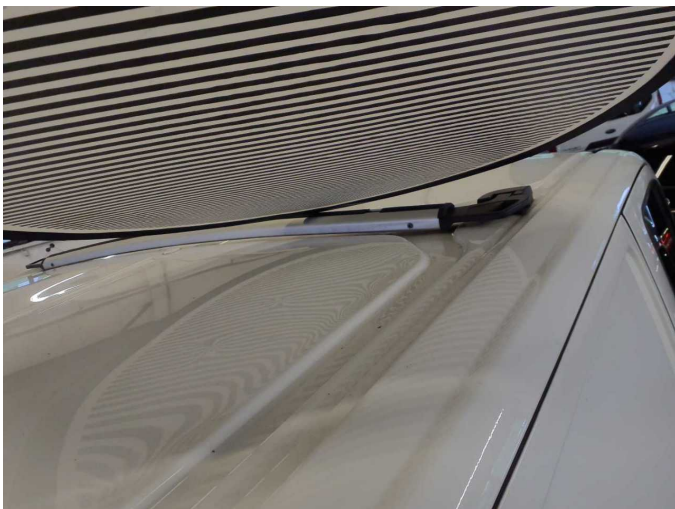
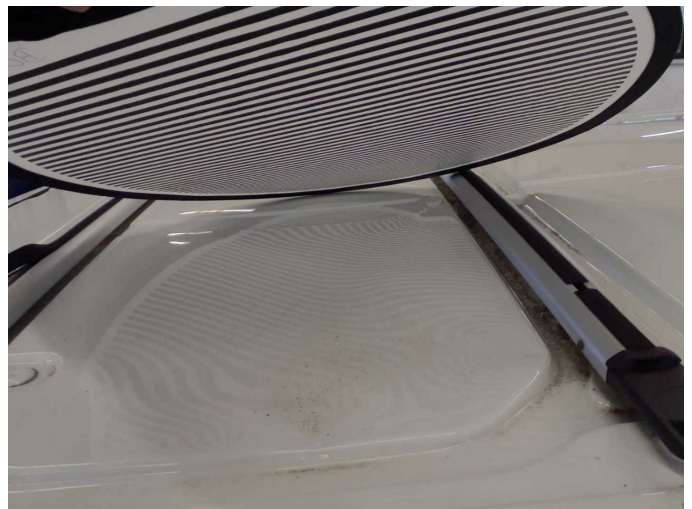
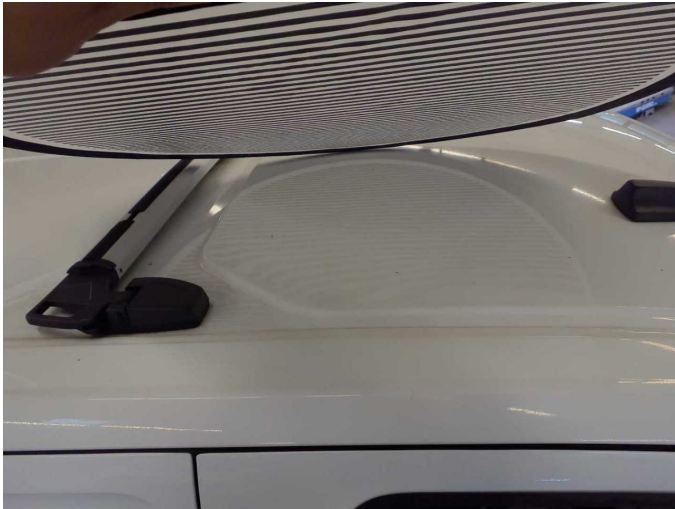
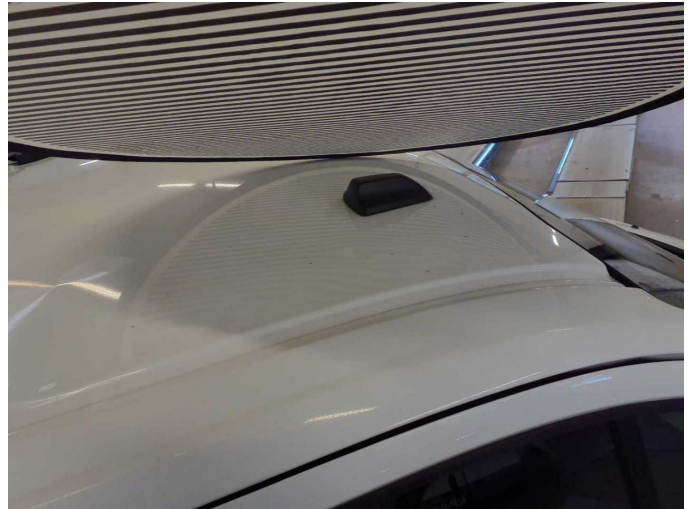
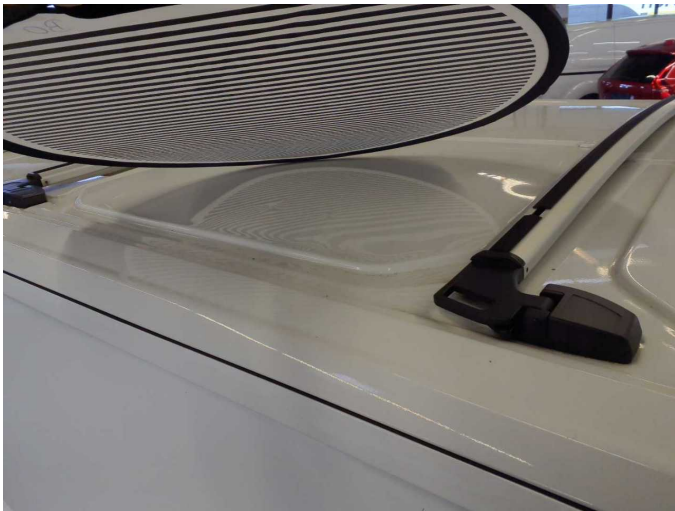
Damage 8: Roof: Roof (Rechte dach seite viele stellen eingedrückt +bäulen) - Deformed - Repair and paint

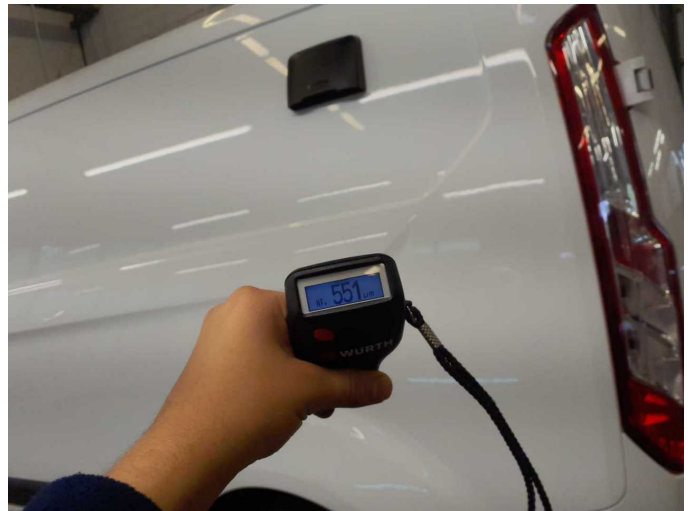
Repainting 1: Side panel - rear left side

Side panel - rear left side	551 µm	Door - front left side	522 µm
-----------------------------	--------	------------------------	--------
