Expertise

Protocol number: 41610648
Order No. / Reference: 25138840
Inspection date: 18 Sept 2025

Manufacturer: Ford

Model: Transit Custom 320 L1H1 LKW VA Trend

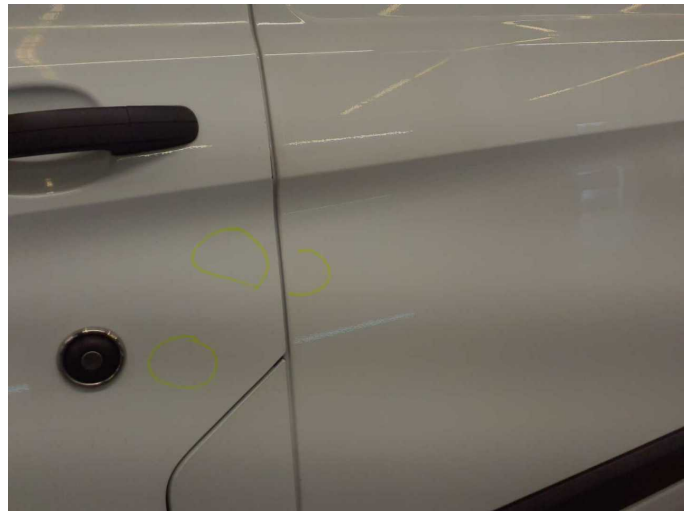
Damage 1: Side panel - rear left side: Side panel (1) - dent(s) - Smart repair

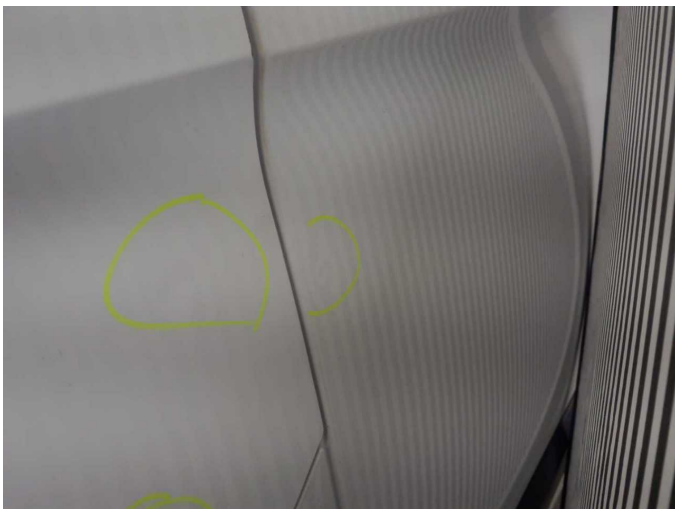
Damage 1: Side panel - rear left side: Side panel (1) - dent(s) - Smart repair

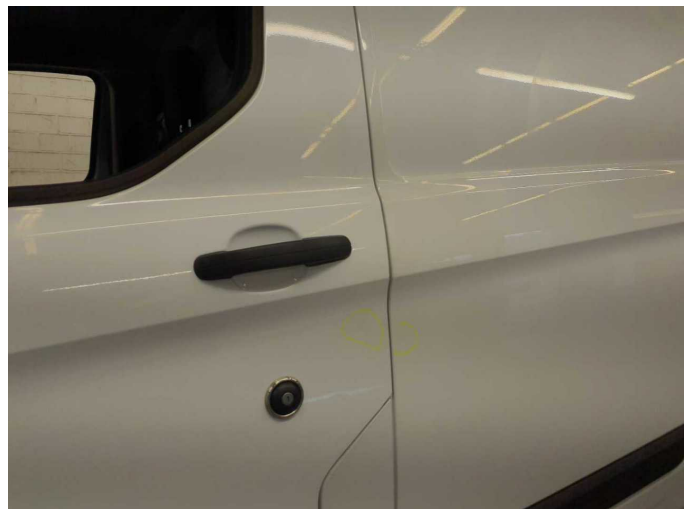
Damage 2: Door - front left side: Door (2) - dent(s) - Smart repair

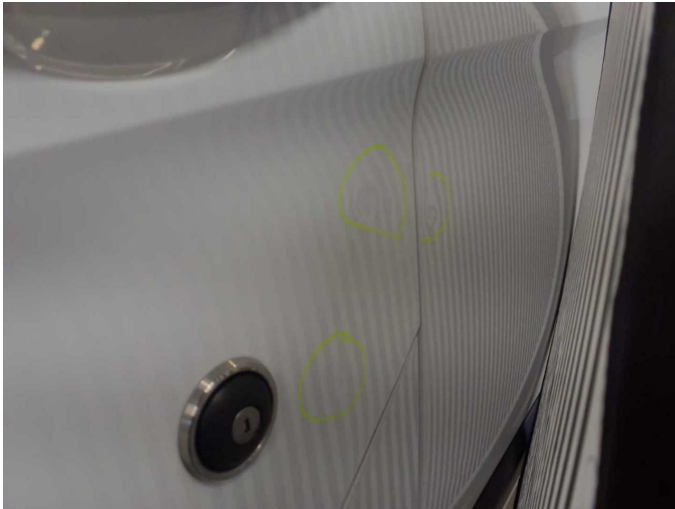
Damage 2: Door - front left side: Door (2) - dent(s) - Smart repair

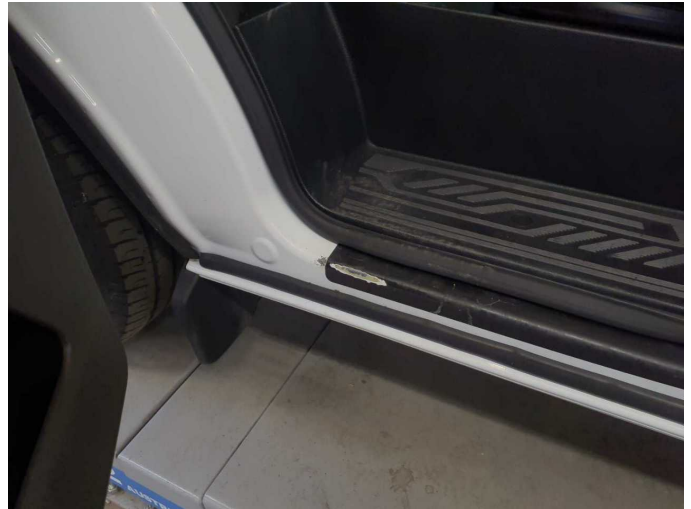
Damage 3: Sill - left side: Sill - Scratch(es) - Smart repair

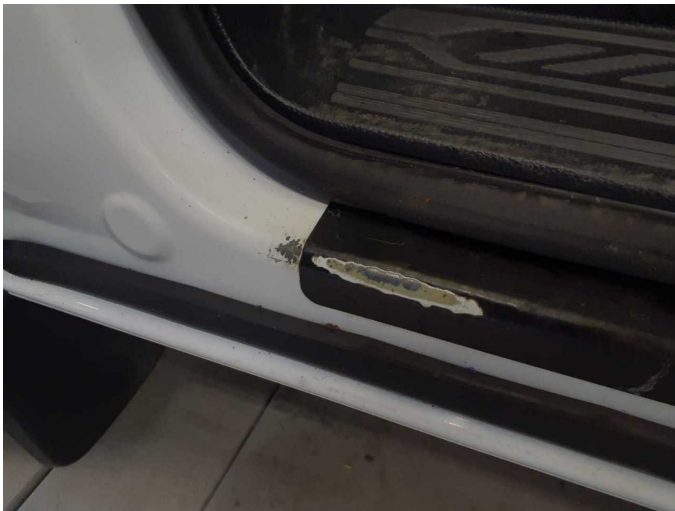
Damage 3: Sill - left side: Sill - Scratch(es) - Smart repair

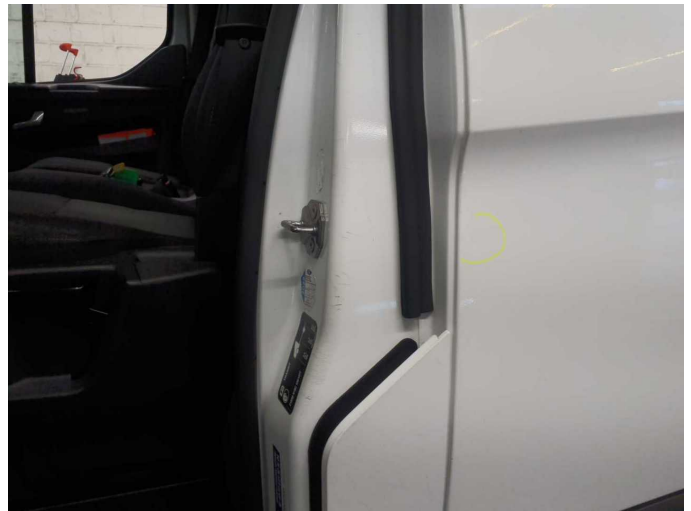
Damage 4: Body: B-pillar - left side - Scratch(es) - Smart repair

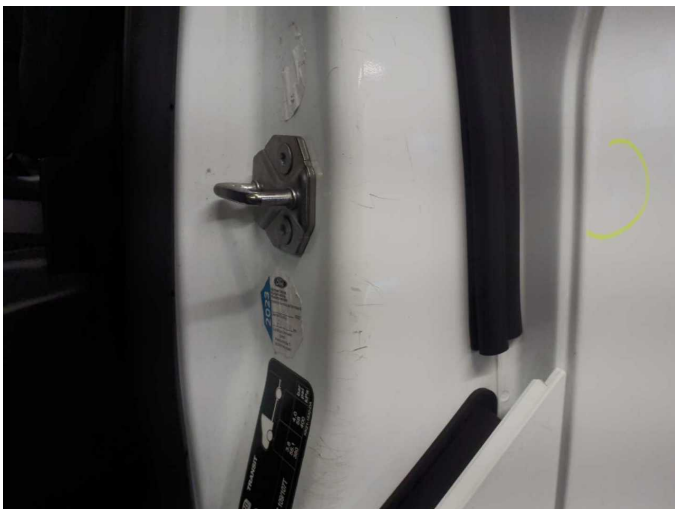
Damage 4: Body: B-pillar - left side - Scratch(es) - Smart repair

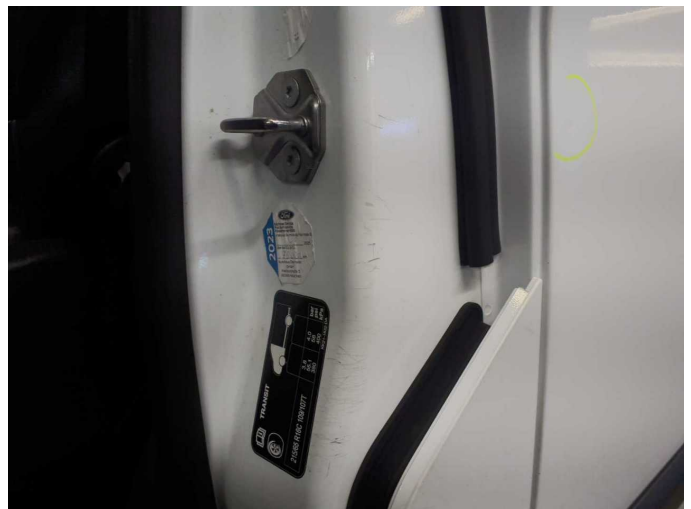
Damage 4: Body: B-pillar - left side - Scratch(es) - Smart repair

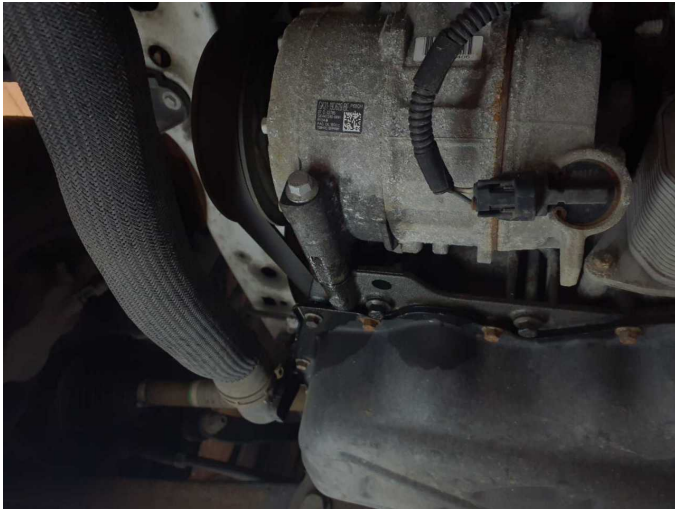
Damage 5: Engine: Engine - Leaking - Perform diagnosis

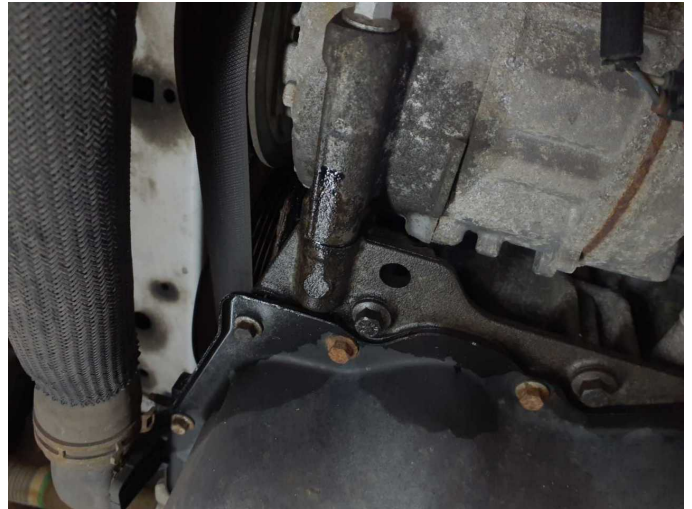
Damage 5: Engine: Engine - Leaking - Perform diagnosis

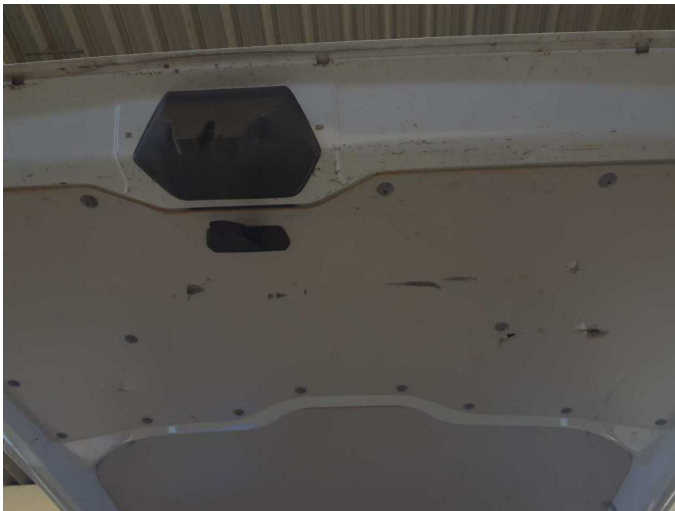
Damage 6: Trim / covers: Boot lid - interior trim - Broken / torn - Replace

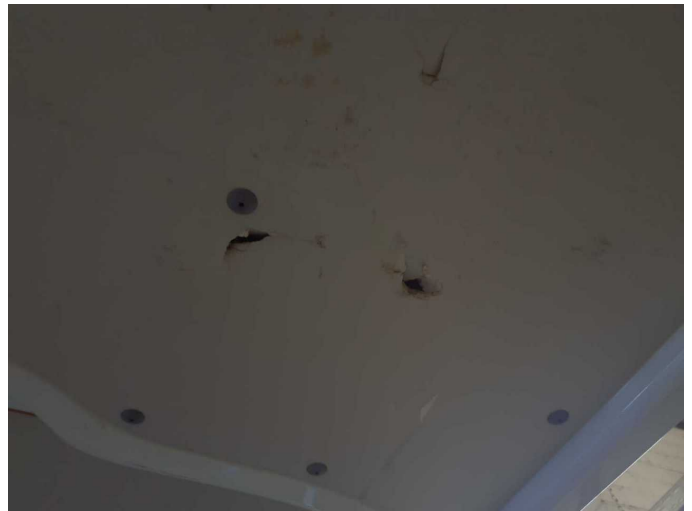
Damage 6: Trim / covers: Boot lid - interior trim - Broken / torn - Replace

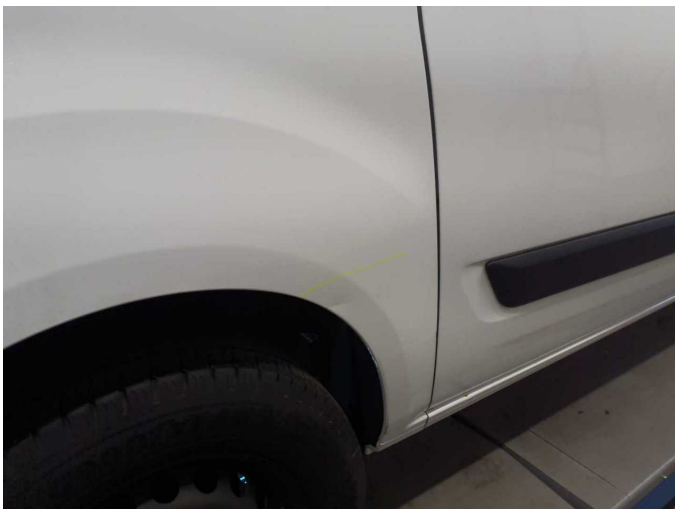
Damage 7: Side panel - rear right side: Side panel - Dent / paintcoat damage - Smart repair

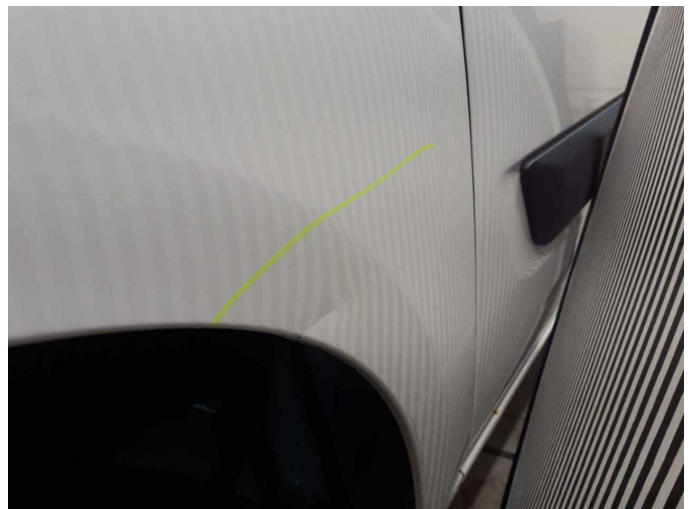
Damage 7: Side panel - rear right side: Side panel - Dent / paintcoat damage - Smart repair

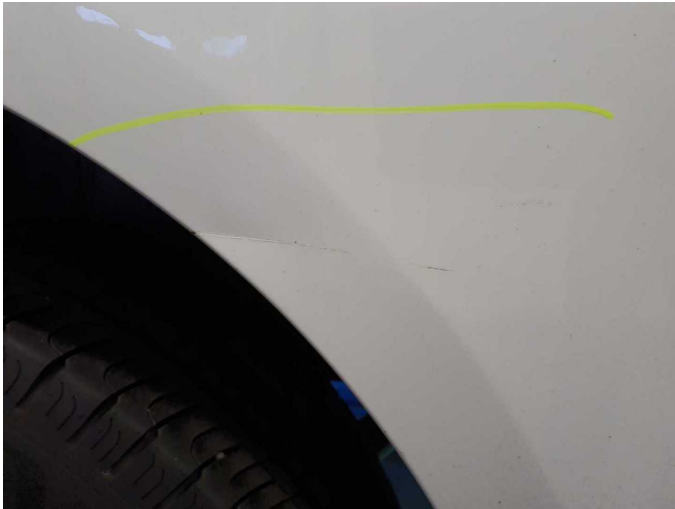
Damage 7: Side panel - rear right side: Side panel - Dent / paintcoat damage - Smart repair

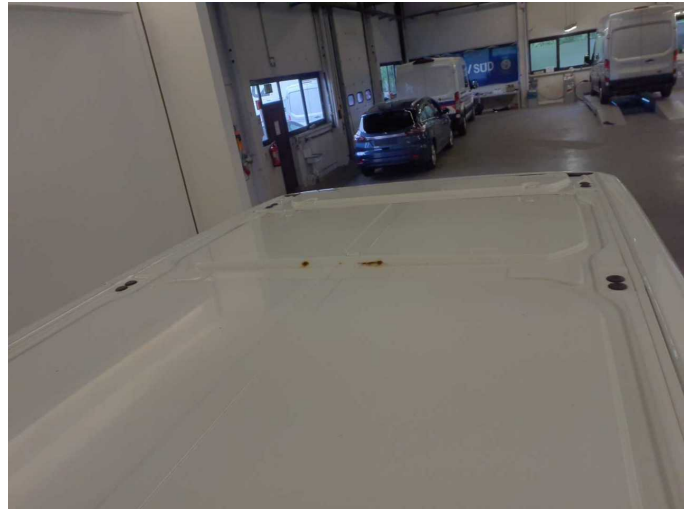
Damage 8: Roof: Roof - Corrosion - Smart repair

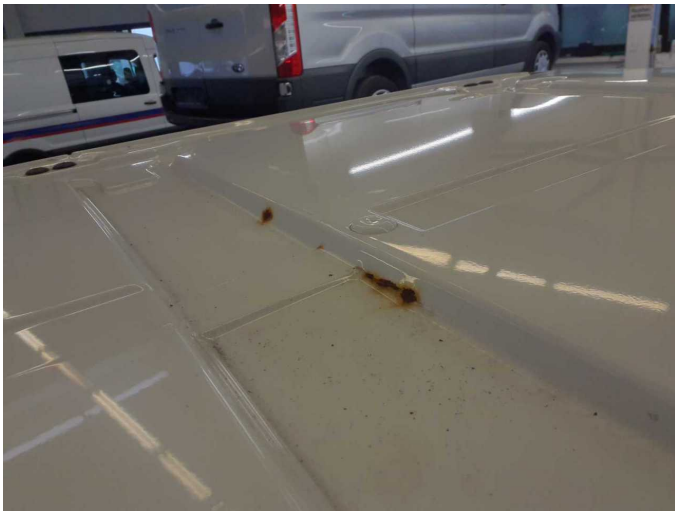
Damage 8: Roof: Roof - Corrosion - Smart repair

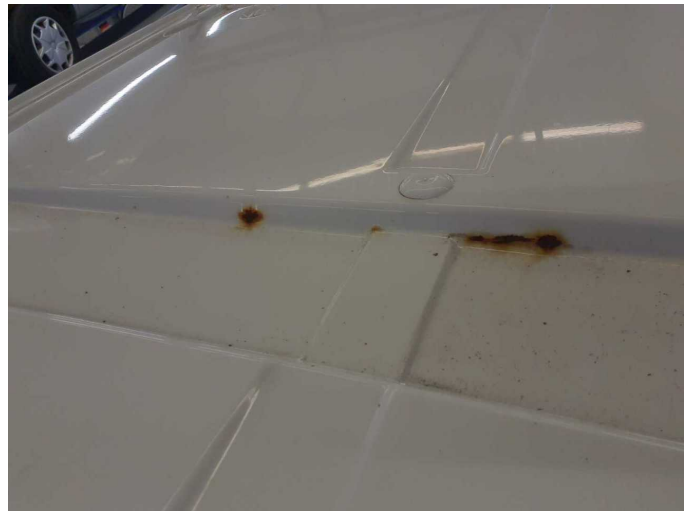
Damage 8: Roof: Roof - Corrosion - Smart repair

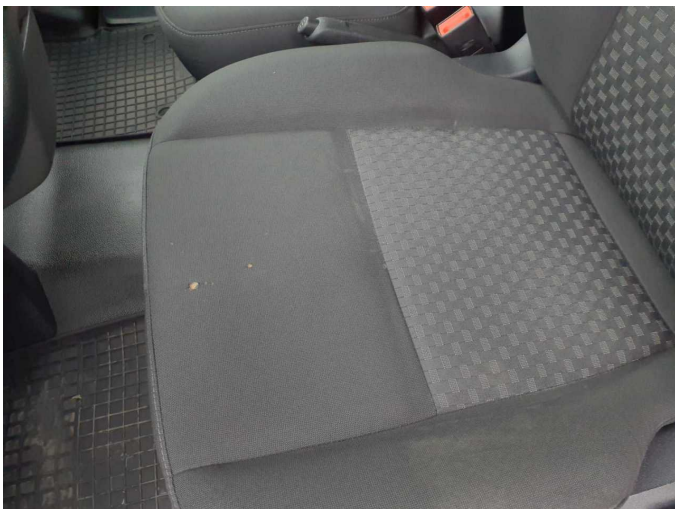
Damage 9: Seat - front: Seat cover - left side - Holes - Replace

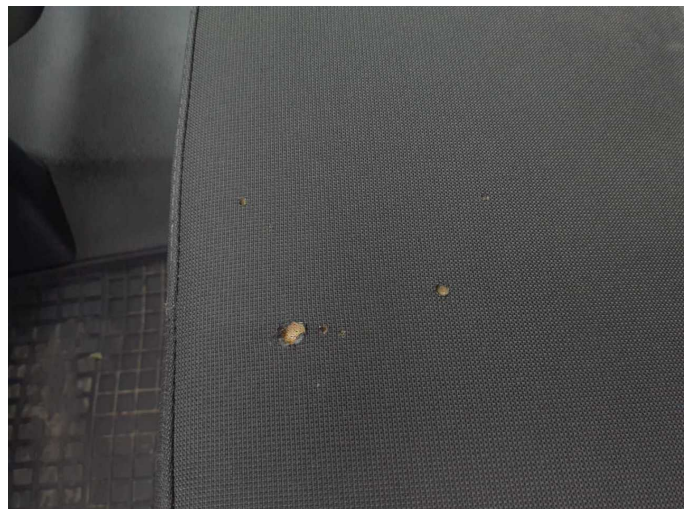
Damage 9: Seat - front: Seat cover - left side - Holes - Replace

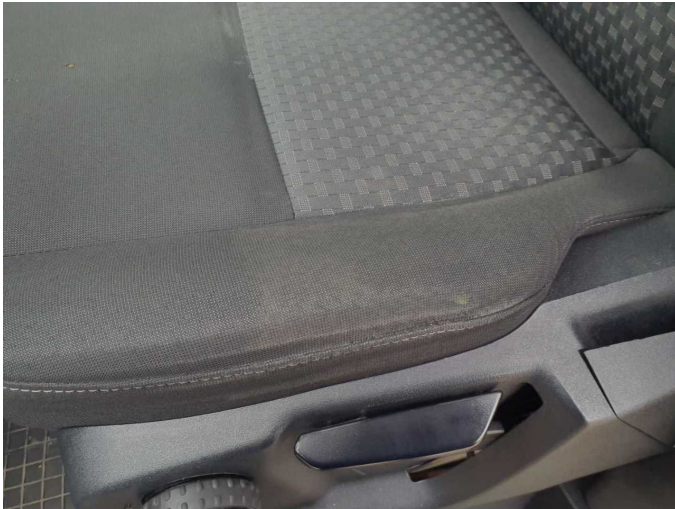
Damage 9: Seat - front: Seat cover - left side - Holes - Replace

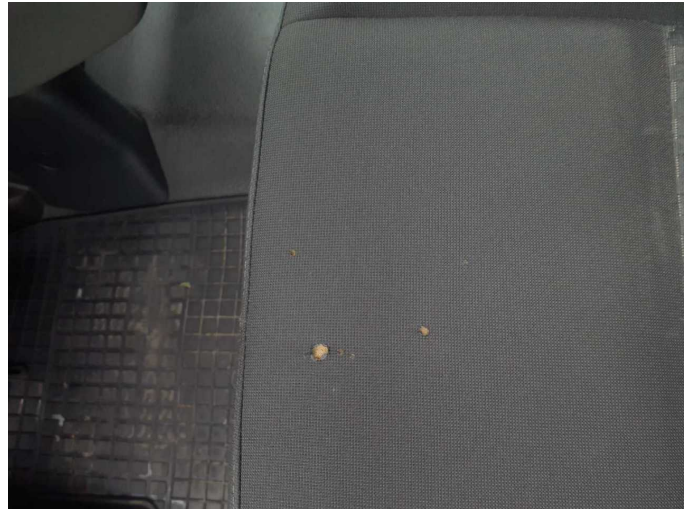
Damage 9: Seat - front: Seat cover - left side - Holes - Replace

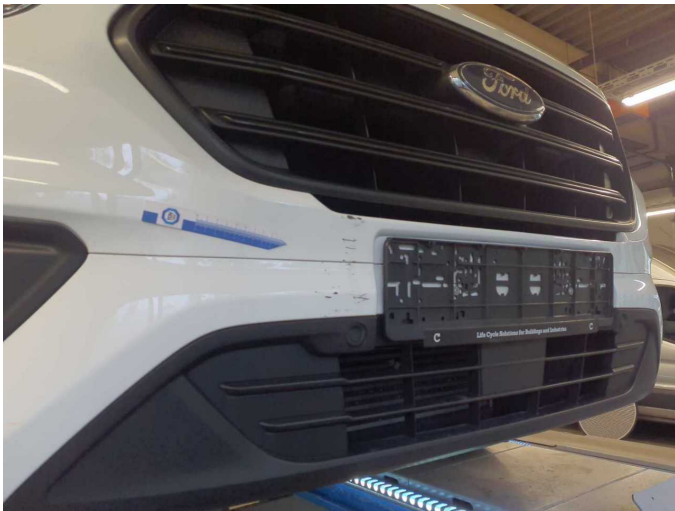
Damage 10: Front bumper: Front bumper - Scratch(es) - Repair and paint

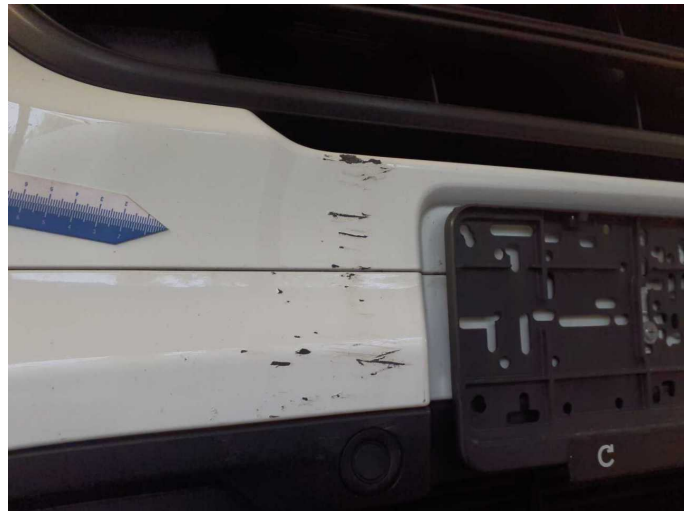
Damage 10: Front bumper: Front bumper - Scratch(es) - Repair and paint

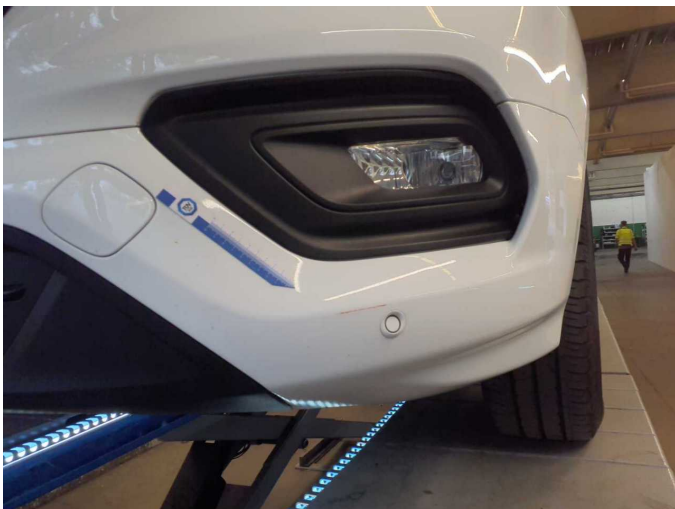
Damage 10: Front bumper: Front bumper - Scratch(es) - Repair and paint
