Expertise

Protocol number: 41616068
Order No. / Reference: 25185677
Inspection date: 18 Sept 2025

Manufacturer: Ford

Model: Transit Custom 320 L2H1 LKW VA Trend

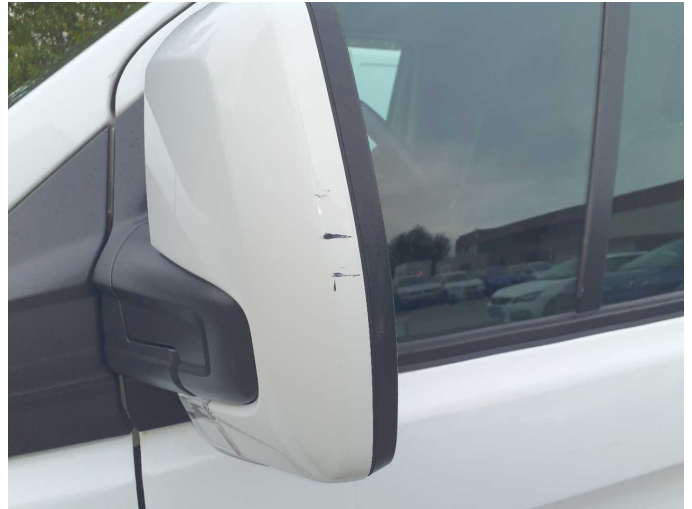
Damage 1: Wing mirror - left side: Cap - Scratch(es) - Smart repair

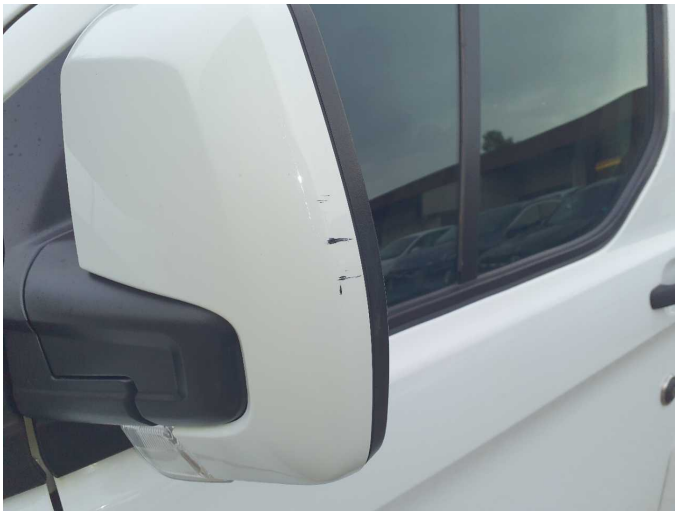
Damage 1: Wing mirror - left side: Cap - Scratch(es) - Smart repair

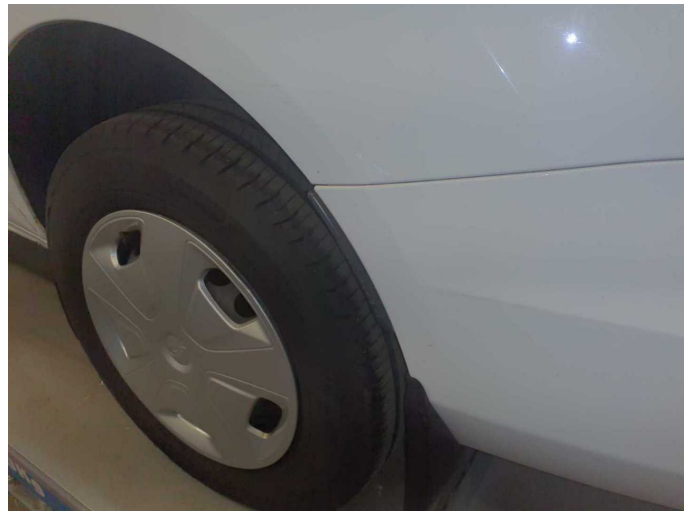
Damage 2: Side panel - rear left side: Mud flap - Scratched - Replace

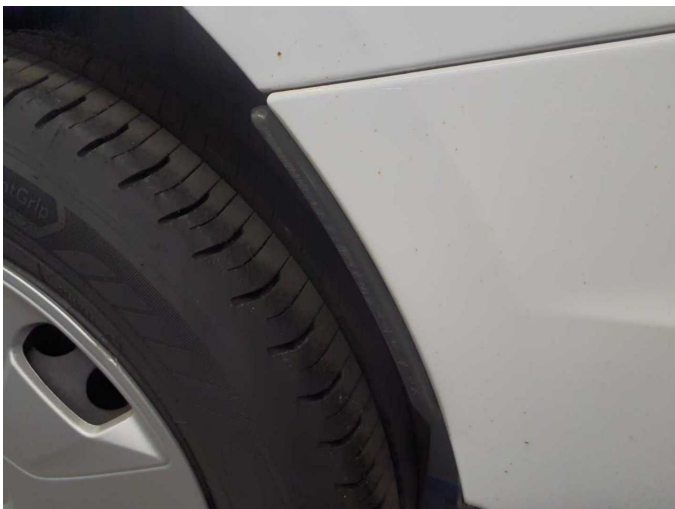
Damage 2: Side panel - rear left side: Mud flap - Scratched - Replace

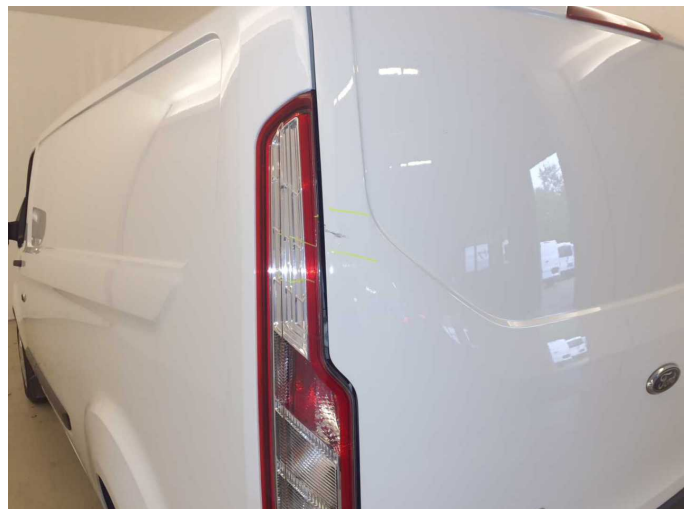
Damage 3: Boot lid / rear door: Boot lid (Delle) - Scratch(es) - Smart repair

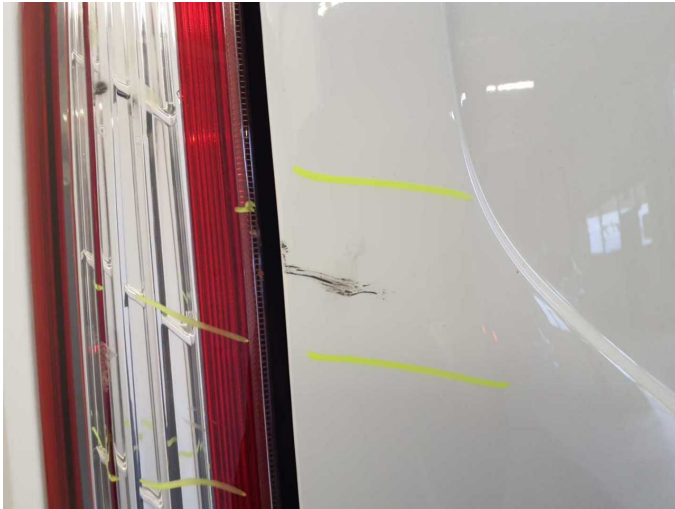
Damage 3: Boot lid / rear door: Boot lid (Delle) - Scratch(es) - Smart repair

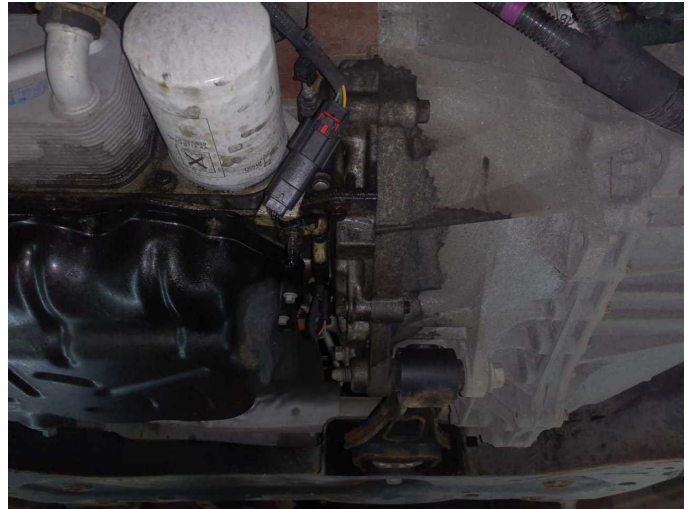
Damage 4: Engine: Engine (/getriebe) - Leaking - Perform diagnosis

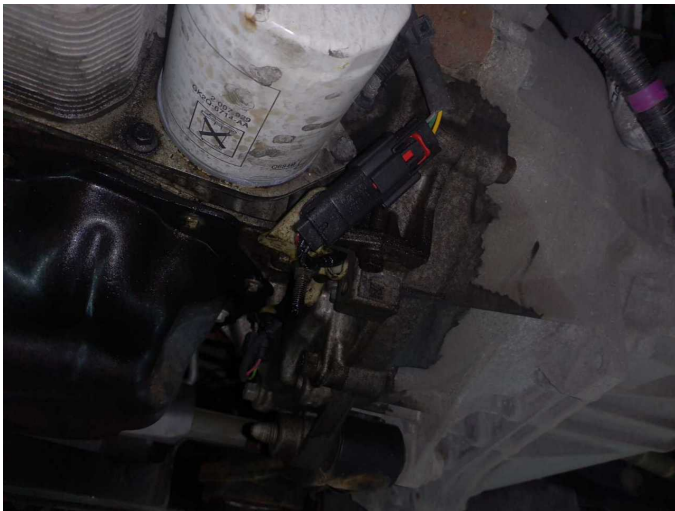
Damage 4: Engine: Engine (/getriebe) - Leaking - Perform diagnosis

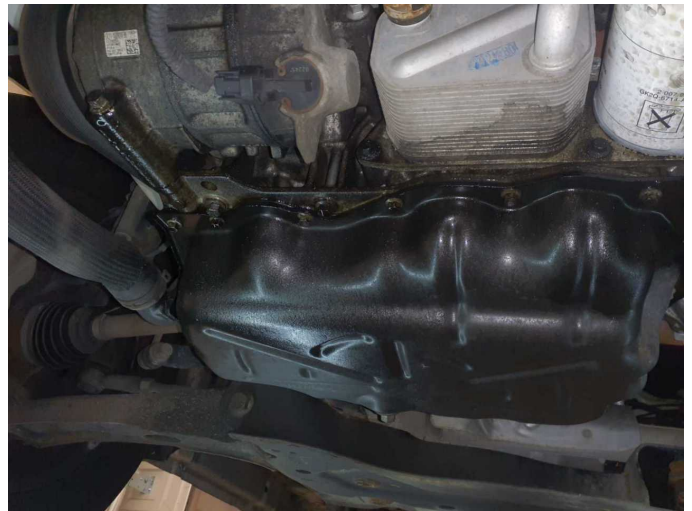
Damage 4: Engine: Engine (/getriebe) - Leaking - Perform diagnosis

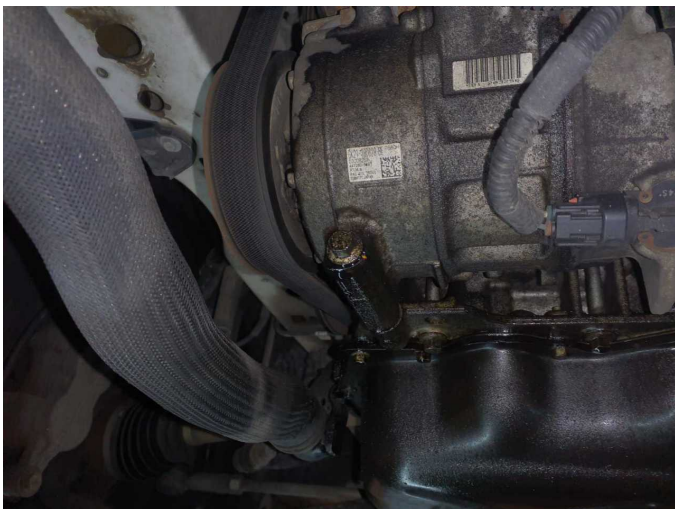
Damage 4: Engine: Engine (/getriebe) - Leaking - Perform diagnosis

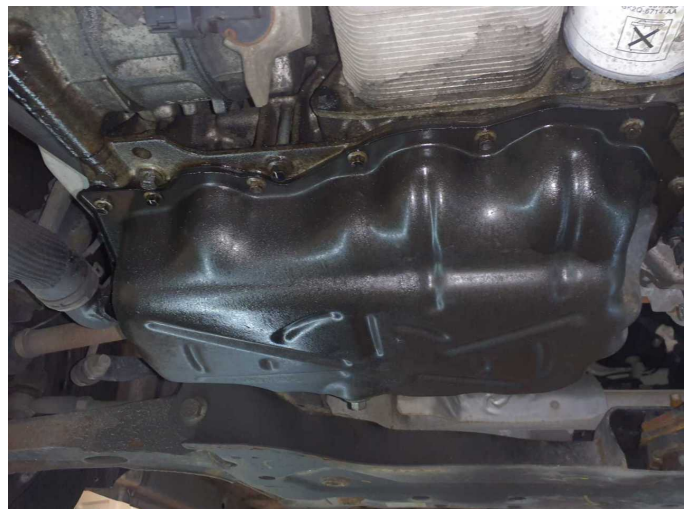
Damage 4: Engine: Engine (/getriebe) - Leaking - Perform diagnosis

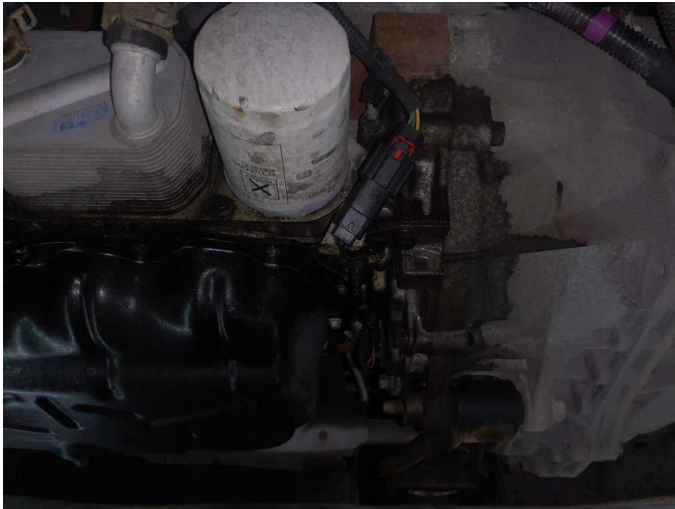
Damage 4: Engine: Engine (/getriebe) - Leaking - Perform diagnosis

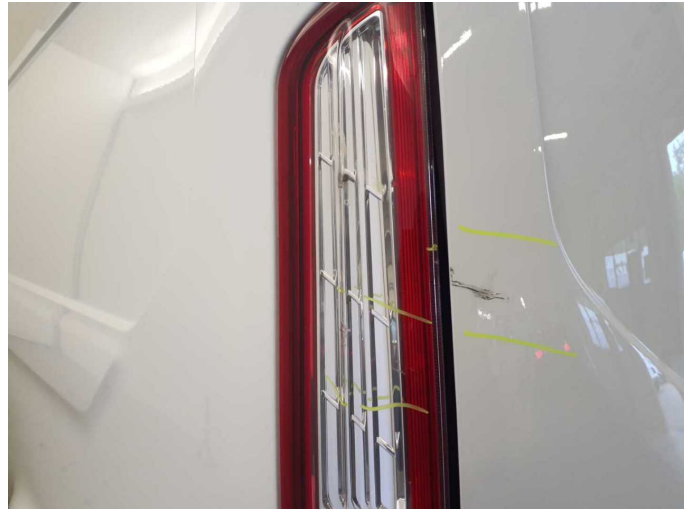
Damage 5: Tail light: Tail lamp - left side - Scratch(es) - Replace

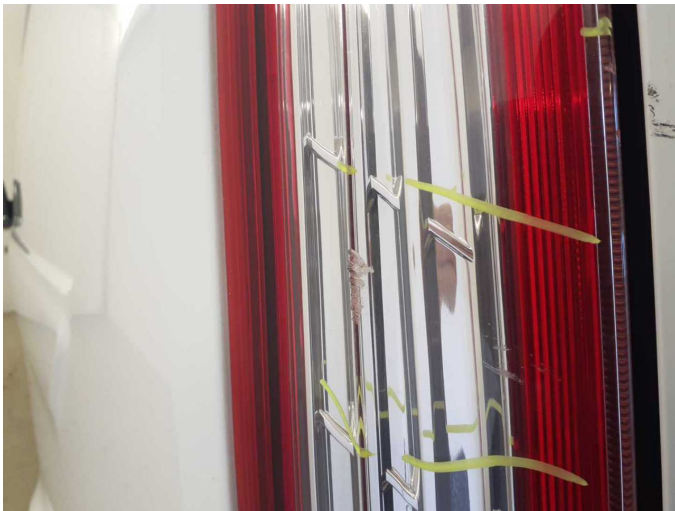
Damage 5: Tail light: Tail lamp - left side - Scratch(es) - Replace

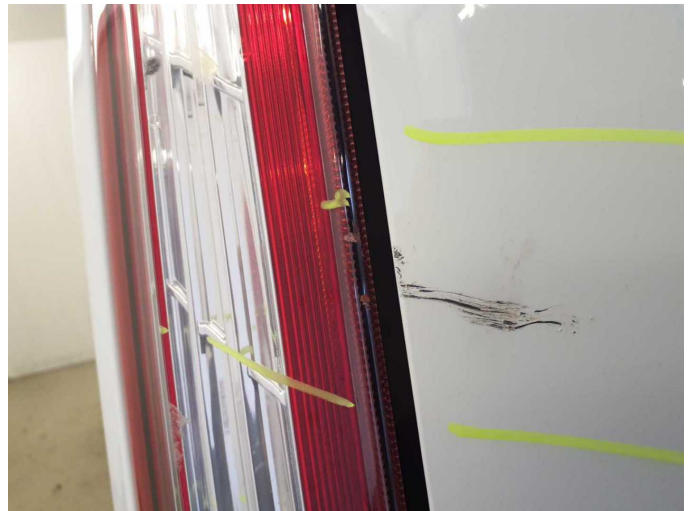
Damage 5: Tail light: Tail lamp - left side - Scratch(es) - Replace

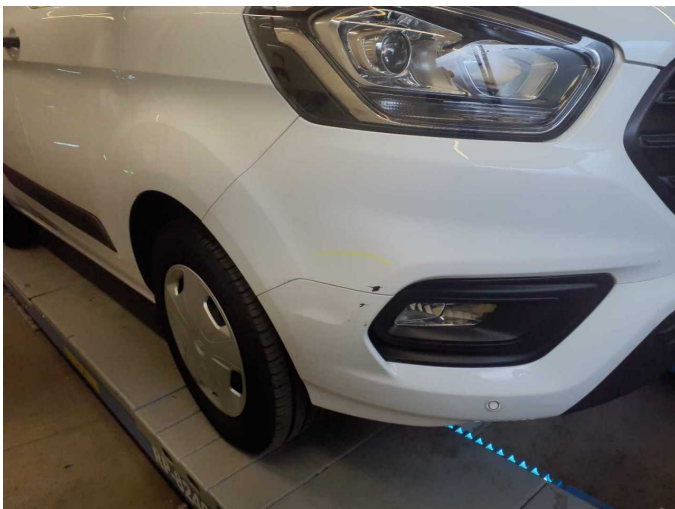
Damage 6: Front bumper: Front bumper - Scratch(es) - Paint

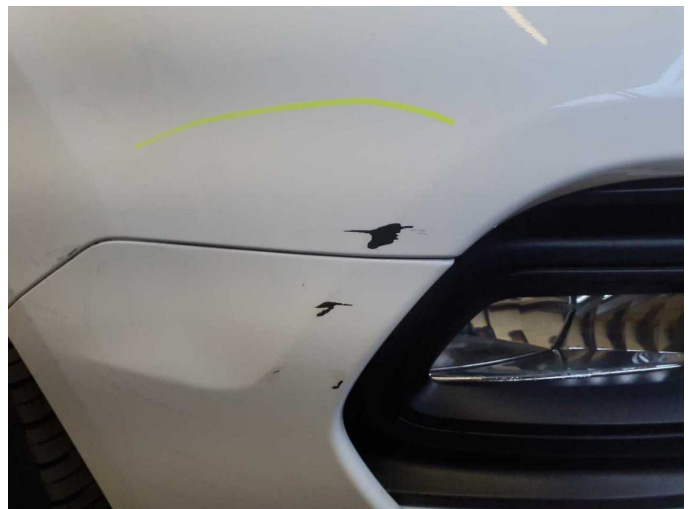
Damage 6: Front bumper: Front bumper - Scratch(es) - Paint

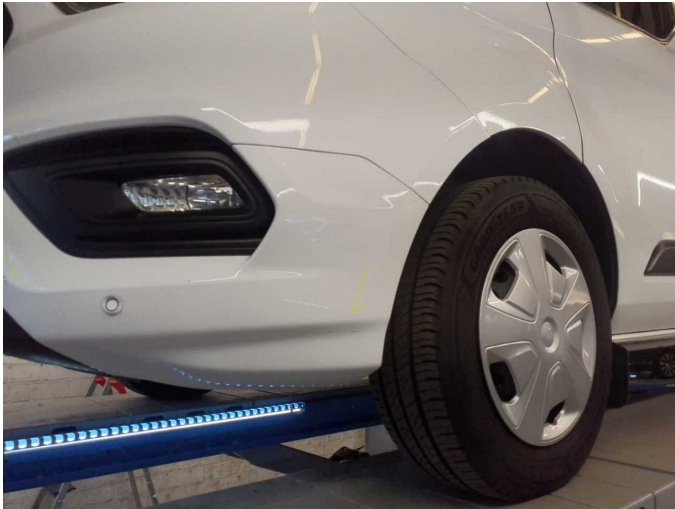
Damage 6: Front bumper: Front bumper - Scratch(es) - Paint

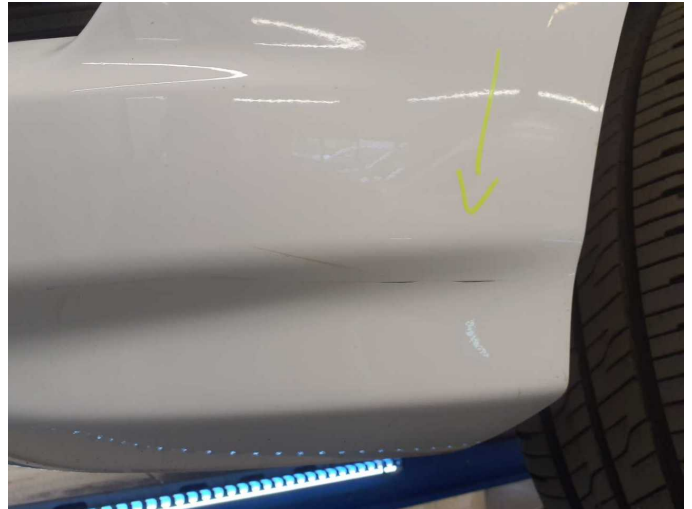
Damage 6: Front bumper: Front bumper - Scratch(es) - Paint

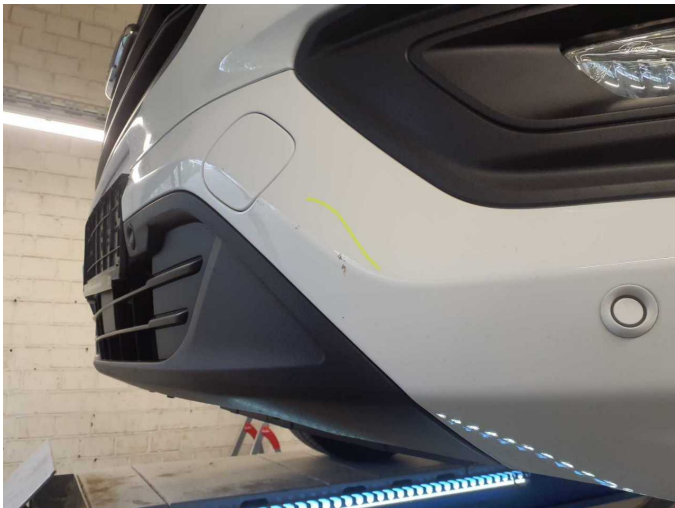
Damage 6: Front bumper: Front bumper - Scratch(es) - Paint

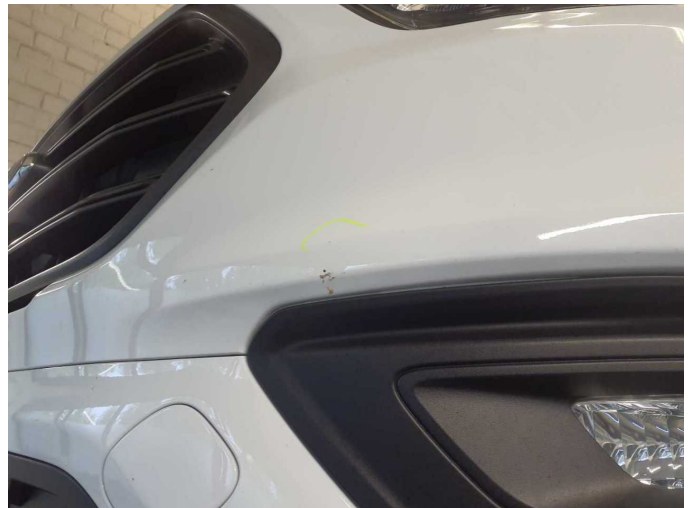
Damage 6: Front bumper: Front bumper - Scratch(es) - Paint

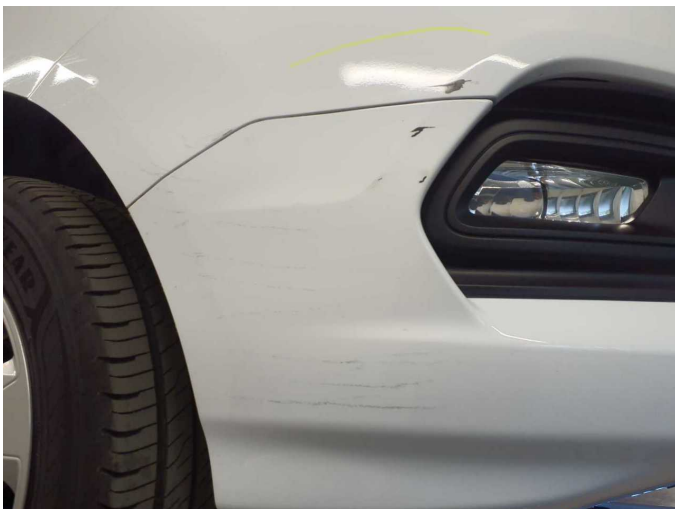
Damage 6: Front bumper: Front bumper - Scratch(es) - Paint

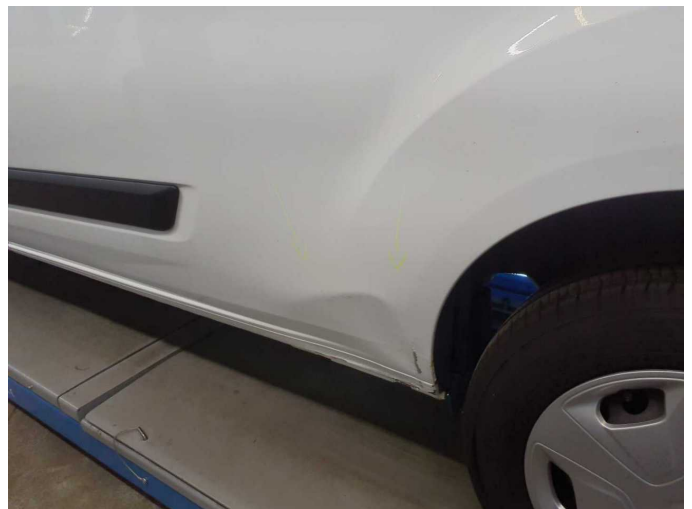
Damage 7: Sill - left side: Sill (/Seitenwand) - Deformed - Repair and paint

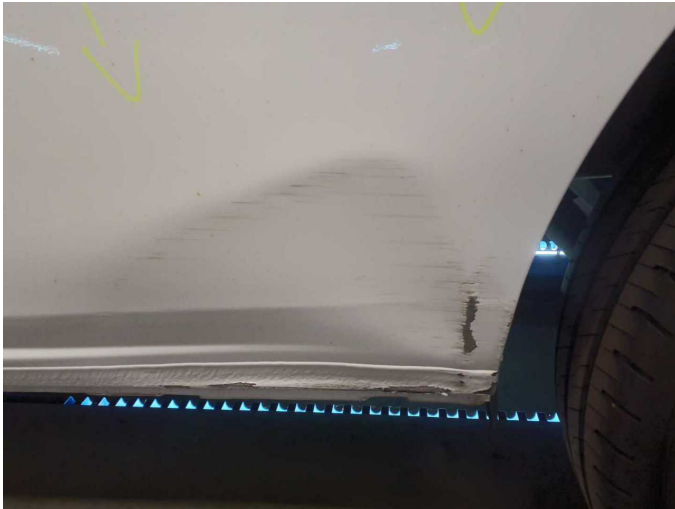
Damage 7: Sill - left side: Sill (/Seitenwand) - Deformed - Repair and paint

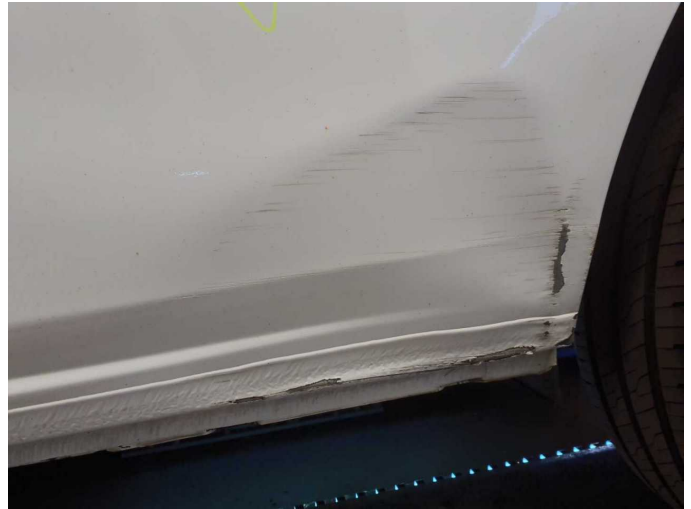
Damage 7: Sill - left side: Sill (/Seitenwand) - Deformed - Repair and paint

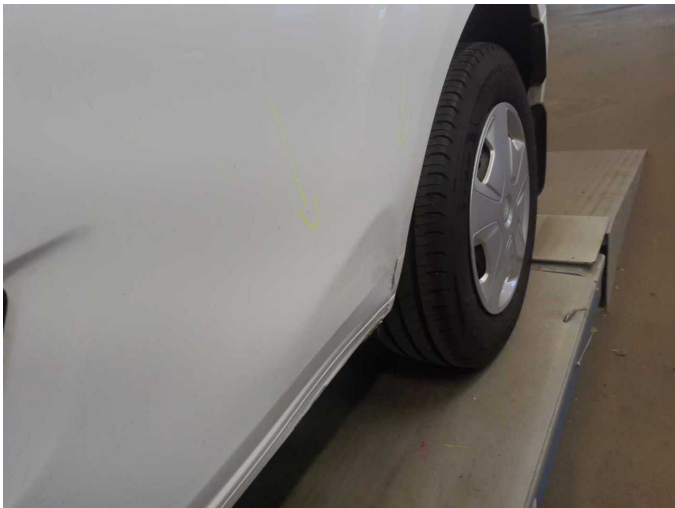
Damage 7: Sill - left side: Sill (/Seitenwand) - Deformed - Repair and paint

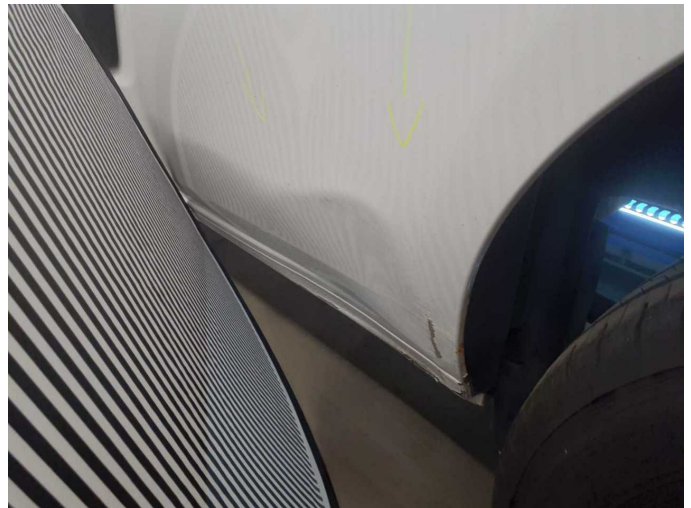
Damage 7: Sill - left side: Sill (/Seitenwand) - Deformed - Repair and paint

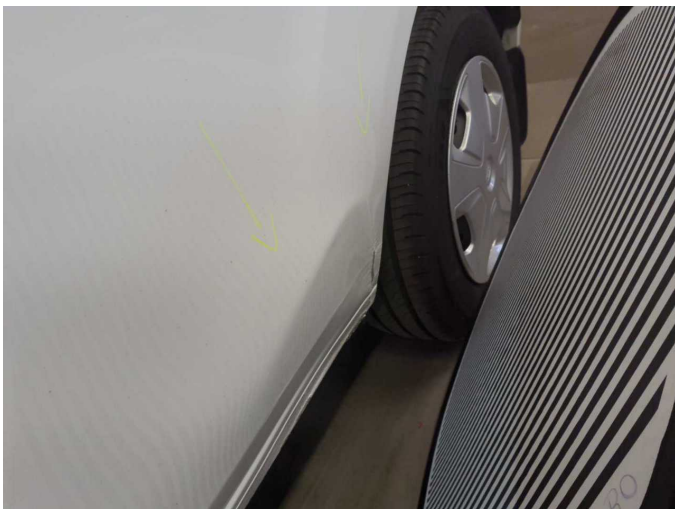
Damage 7: Sill - left side: Sill (/Seitenwand) - Deformed - Repair and paint

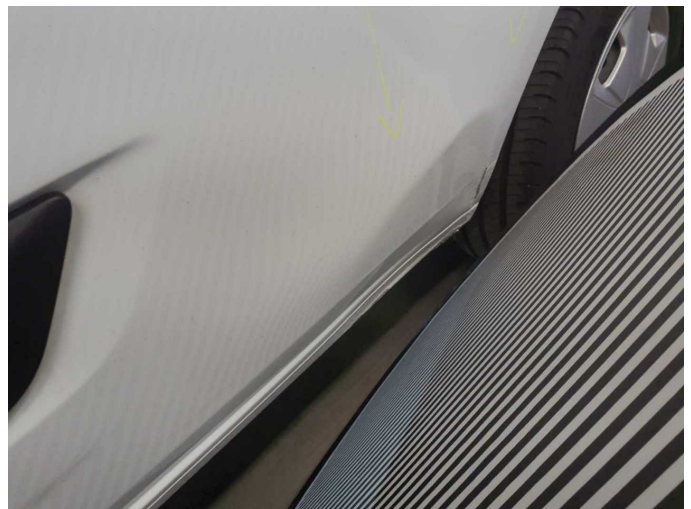
Damage 7: Sill - left side: Sill (/Seitenwand) - Deformed - Repair and paint

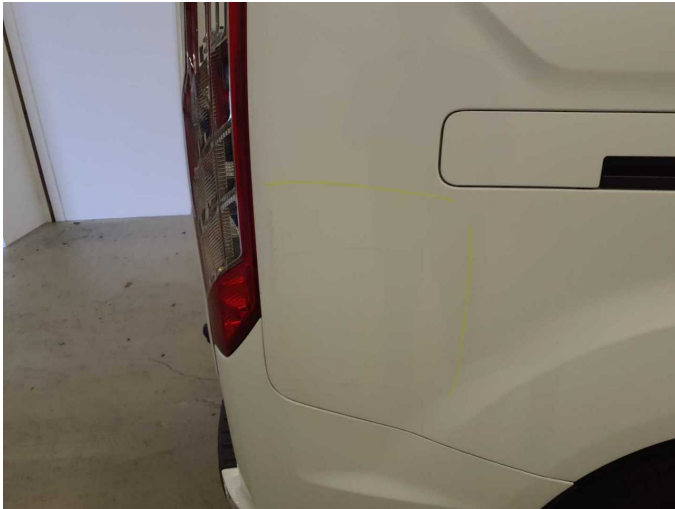
Wear and tear 3: Side panel - rear right side: Side panel - Scratch(es) - Conditioning

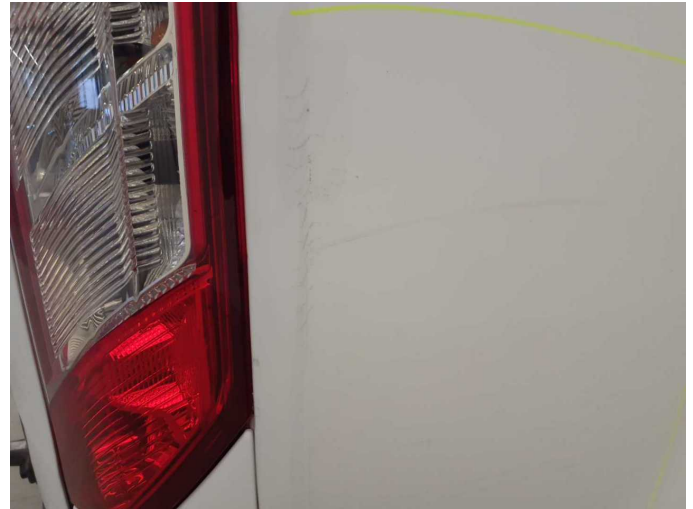
Wear and tear 3: Side panel - rear right side: Side panel - Scratch(es) - Conditioning

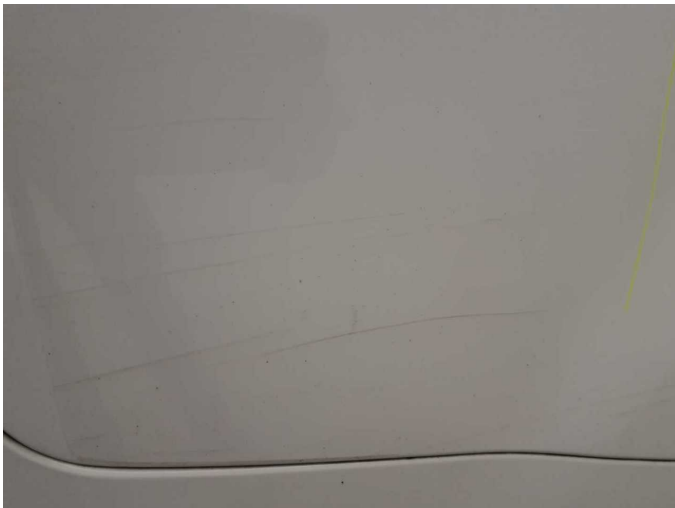
Wear and tear 3: Side panel - rear right side: Side panel - Scratch(es) - Conditioning

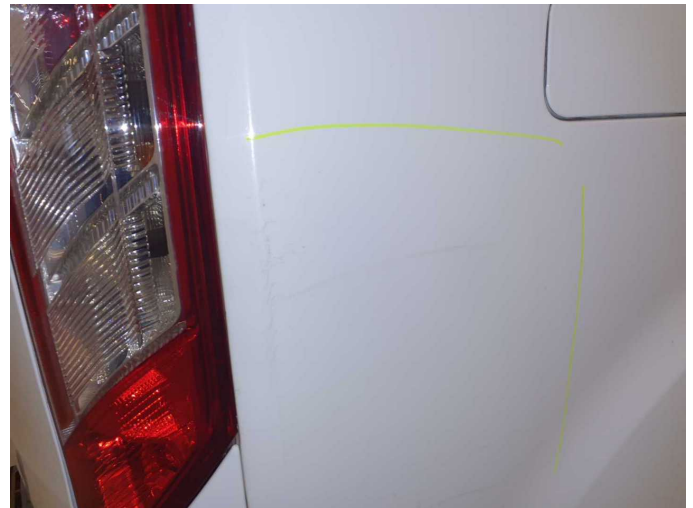
Wear and tear 3: Side panel - rear right side: Side panel - Scratch(es) - Conditioning

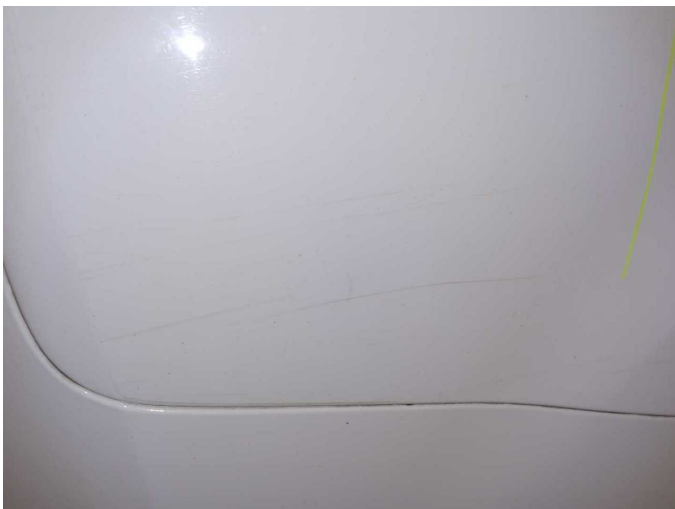
Wear and tear 3: Side panel - rear right side: Side panel - Scratch(es) - Conditioning

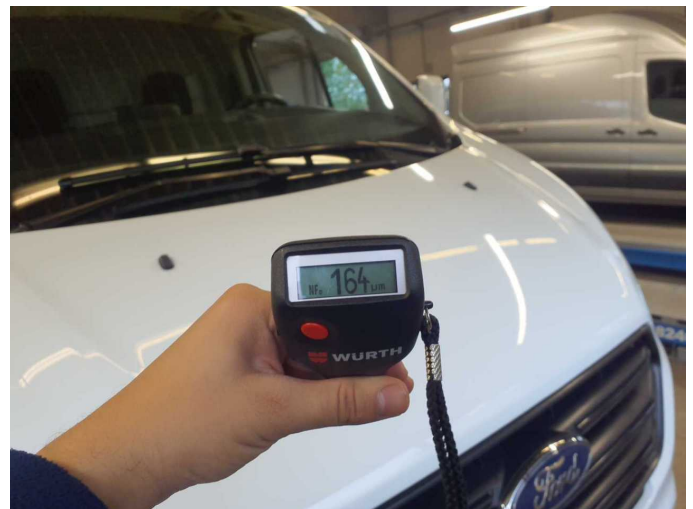
Boot lid / rear door	174 µm	Bonnet	164 µm
Side panel - rear left side	173 µm

Repainting 1: Boot lid / rear door, Bonnet, Side panel - rear left side

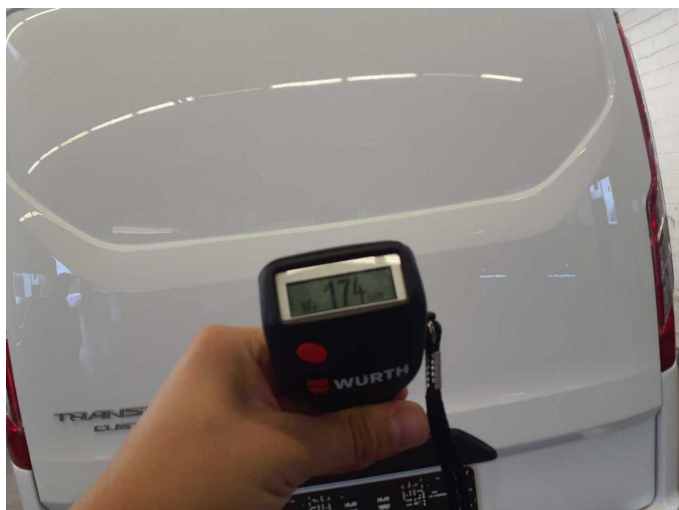
Repainting 1: Boot lid / rear door, Bonnet, Side panel - rear left side

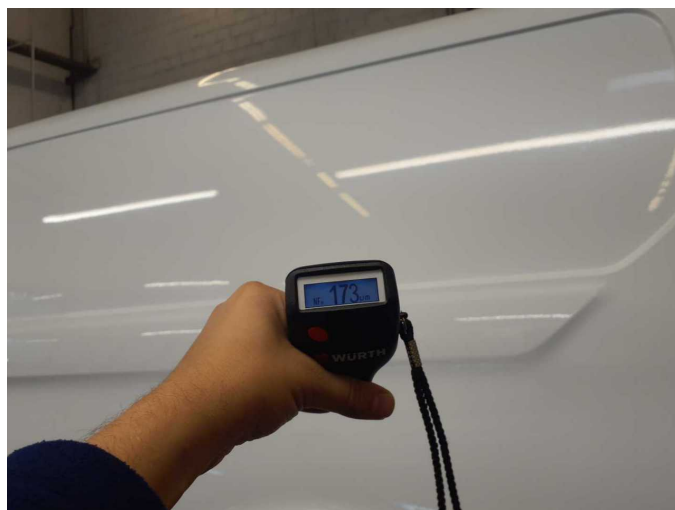
Repainting 1: Boot lid / rear door, Bonnet, Side panel - rear left side
