Expertise

Protocol number: 41643393
Order No. / Reference: 25229372
Inspection date: 22 Sept 2025

Manufacturer: Ford

Model: Transit Custom 320 L1H1 LKW VA Trend

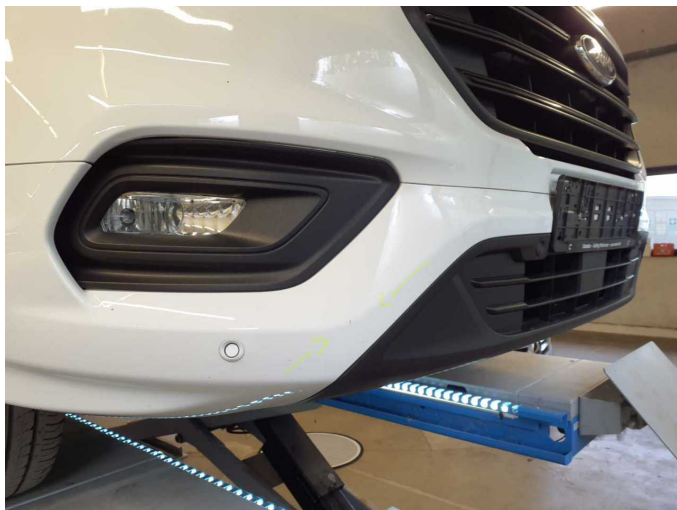
No.	Component group	Description
1	Front bumper	Front bumper - Scratch(es) - Smart repair
2	Side panel - rear right side	Side panel - Scratch(es) - Smart repair

Damage 1: Front bumper: Front bumper - Scratch(es) - Smart repair

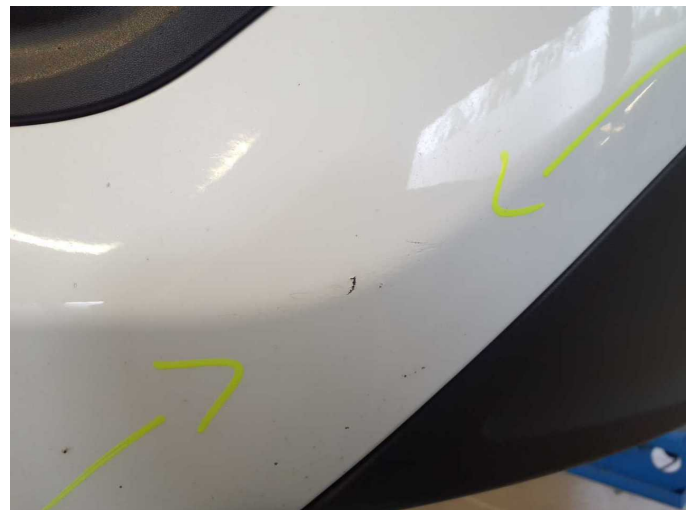
Damage 1: Front bumper: Front bumper - Scratch(es) - Smart repair

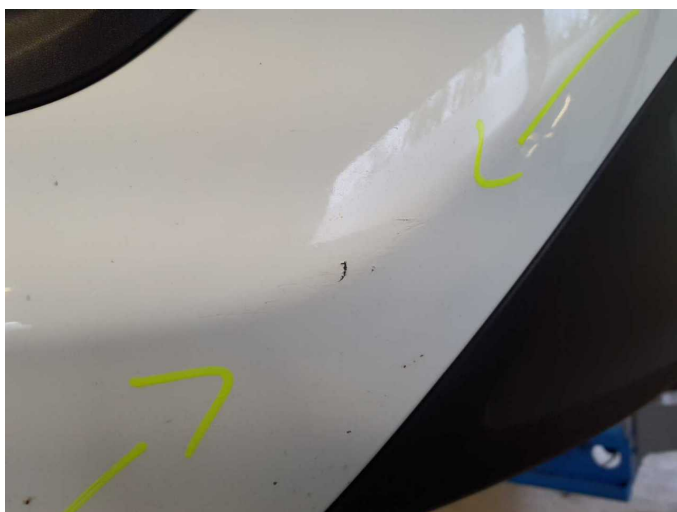
Damage 1: Front bumper: Front bumper - Scratch(es) - Smart repair

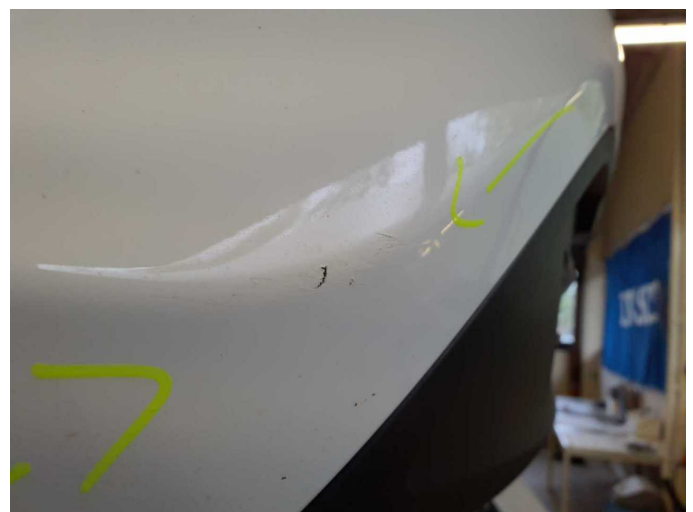
Damage 1: Front bumper: Front bumper - Scratch(es) - Smart repair

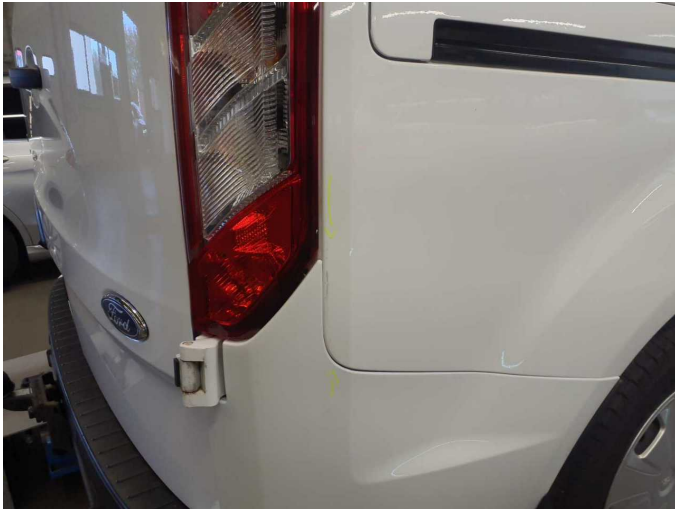
Damage 2: Side panel - rear right side: Side panel - Scratch(es) - Smart repair

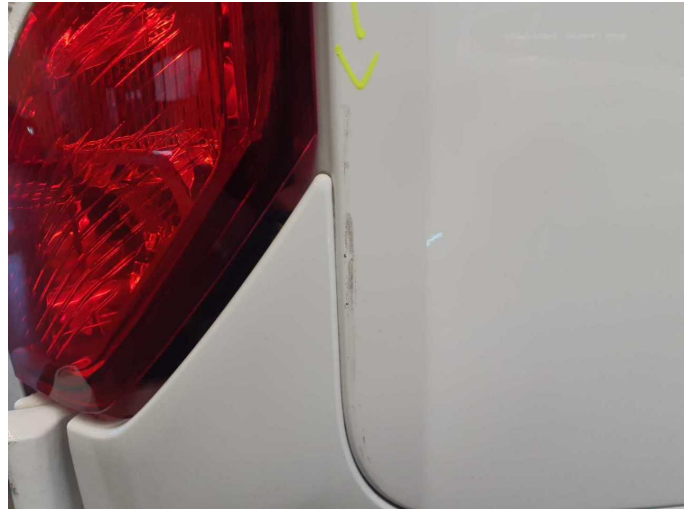
Damage 2: Side panel - rear right side: Side panel - Scratch(es) - Smart repair

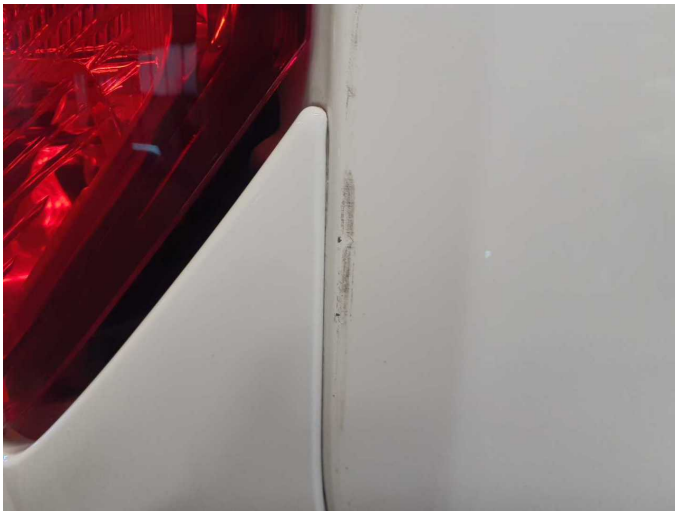
Damage 2: Side panel - rear right side: Side panel - Scratch(es) - Smart repair

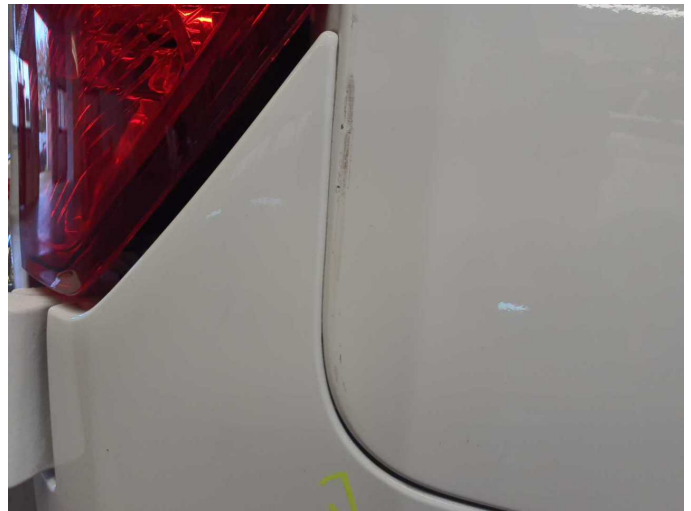
Damage 2: Side panel - rear right side: Side panel - Scratch(es) - Smart repair

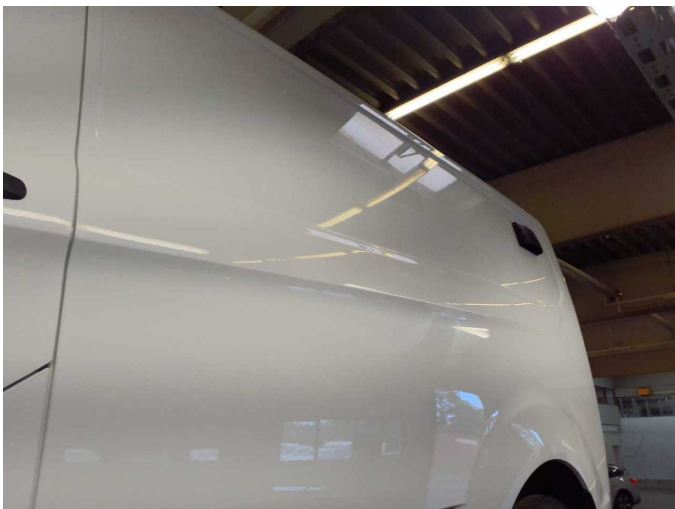
No.	Component group	Description
1	Interior	Cargo space division - Scratch(es) - No deduction
2	Body	Body (Klebe Umrandungen(polieren)) - Glued / labelled - No deduction
3	Boot lid / rear door	Rear door - right side - Scratch(es) - No deduction
4	Bonnet	Bonnet - Scratch(es) - No deduction

Wear and tear 2: Body: Body (Klebe Umrandungen(polieren)) - Glued / labelled - No deduction

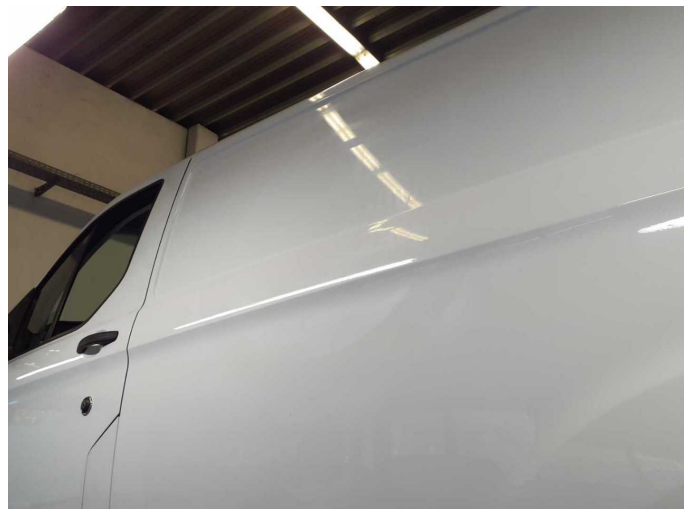
Wear and tear 2: Body: Body (Klebe Umrandungen(polieren)) - Glued / labelled - No deduction

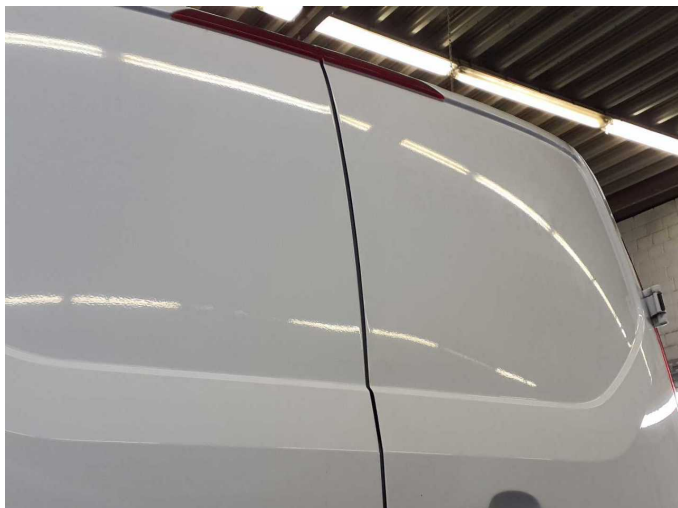
Wear and tear 2: Body: Body (Klebe Umrandungen(polieren)) - Glued / labelled - No deduction

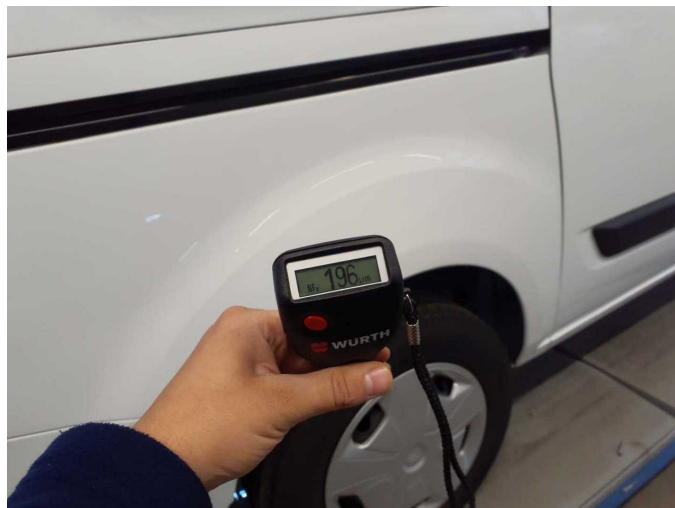
1 Side panel - rear right side, Professionally carried out, Invoice of repair done Non-existent

Side panel - rear right side 196 µm |

Repainting 1: Side panel - rear right side
