Expertise

Protocol number: 41743161
Order number / reference: 25287836
Inspection date: 26 Sept 2025

Manufacturer: Ford

Model: Transit Custom 320 L1H1 LKW VA Trend

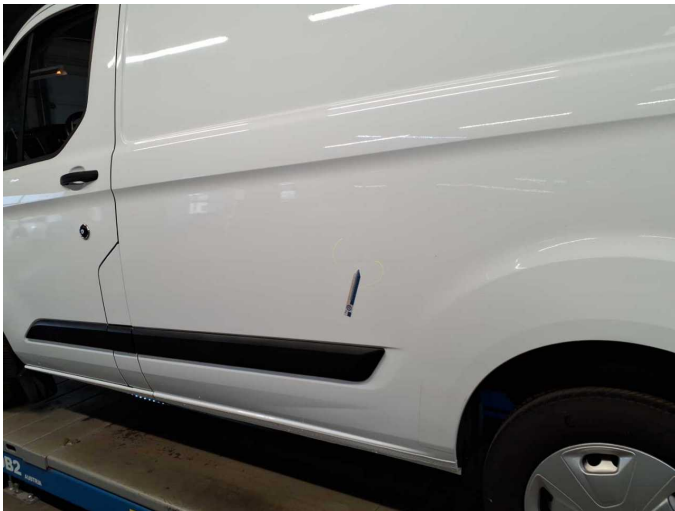
Damage 2: Side panel - rear left side: Side panel - dent(s) - Smooth repair work

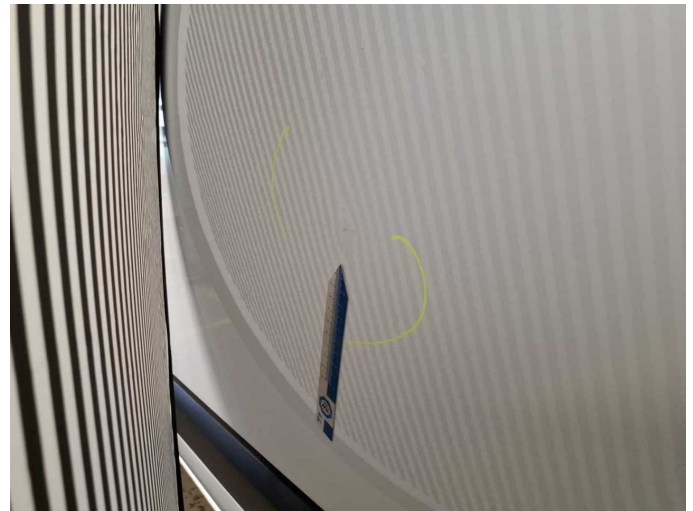
Damage 2: Side panel - rear left side: Side panel - dent(s) - Smooth repair work

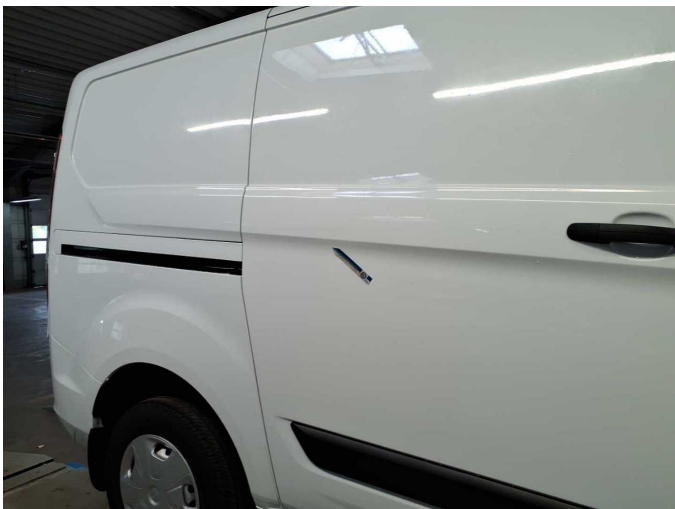
Damage 3: Sliding door, right: Sliding door - dent(s) - Smooth repair work

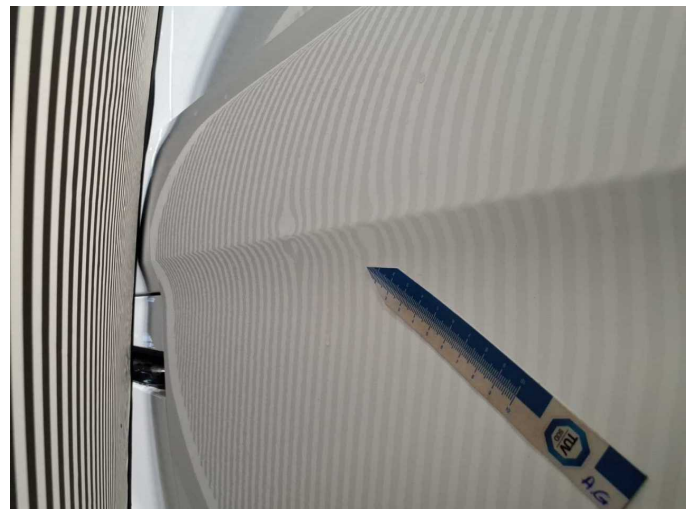
Damage 3: Sliding door, right: Sliding door - dent(s) - Smooth repair work

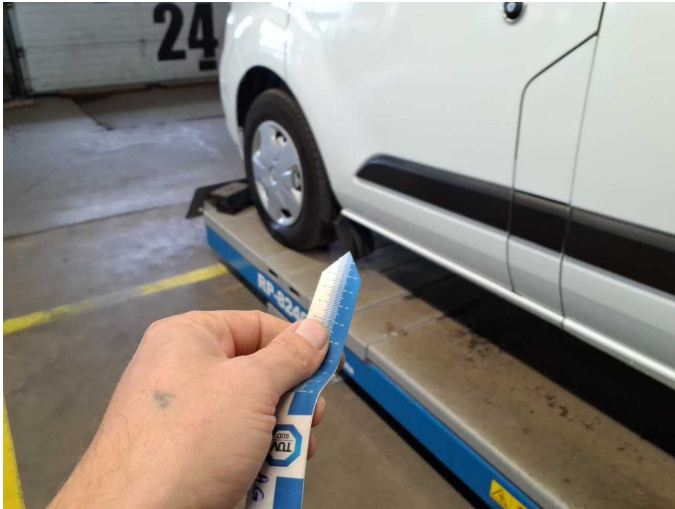
Damage 4: Mudguard - left side: Mud flap - Broken / torn - Replace

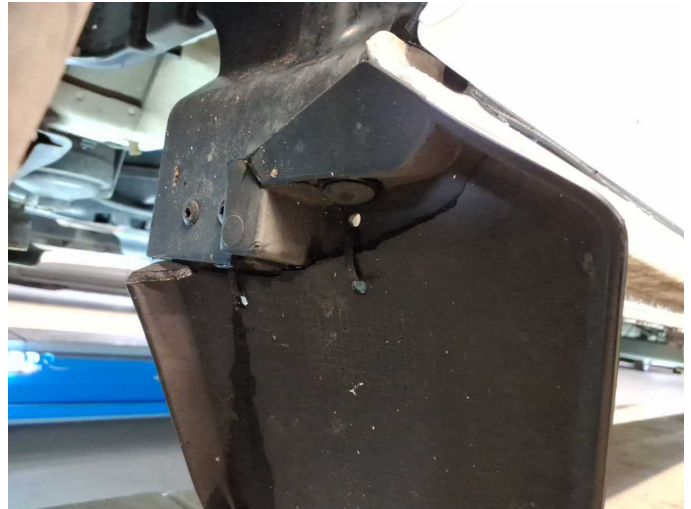
Damage 4: Mudguard - left side: Mud flap - Broken / torn - Replace

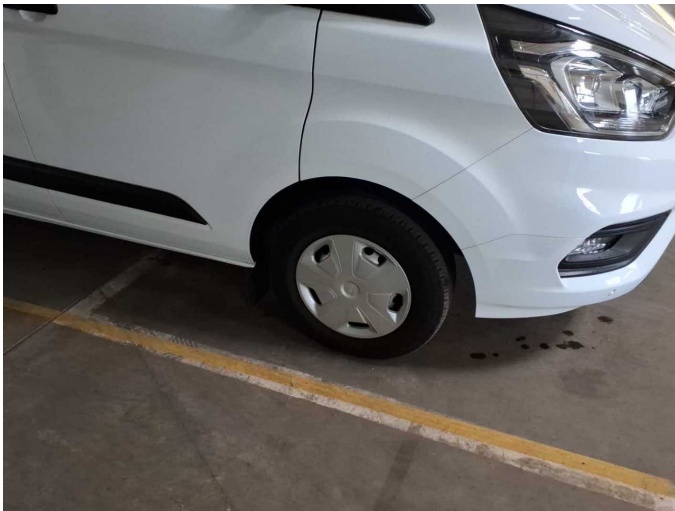
Damage 5: Wheel / tyres: Tyre - front right side (Flanke, nicht fahrbereit) - Damaged - Replace

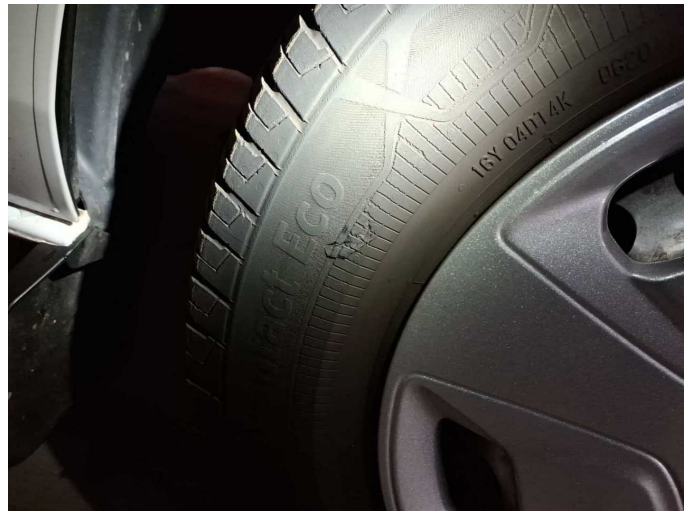
Damage 5: Wheel / tyres: Tyre - front right side (Flanke, nicht fahrbereit) - Damaged - Replace

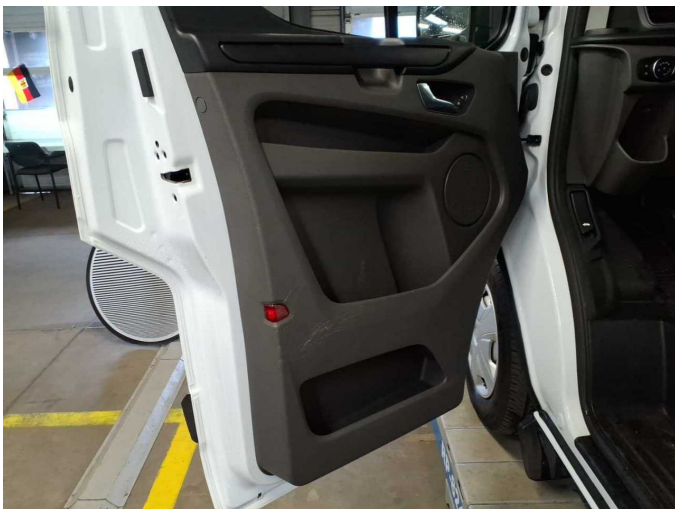
Damage 6: Trim / covers: Door trim - front left side - Scratch(es) - Replace

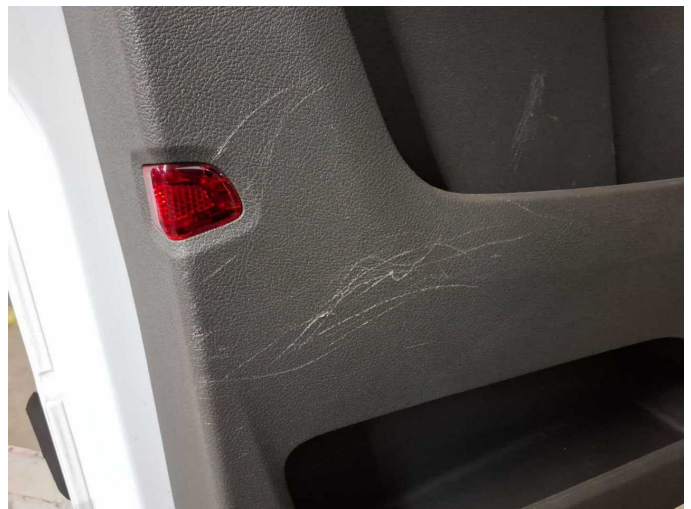
Damage 6: Trim / covers: Door trim - front left side - Scratch(es) - Replace

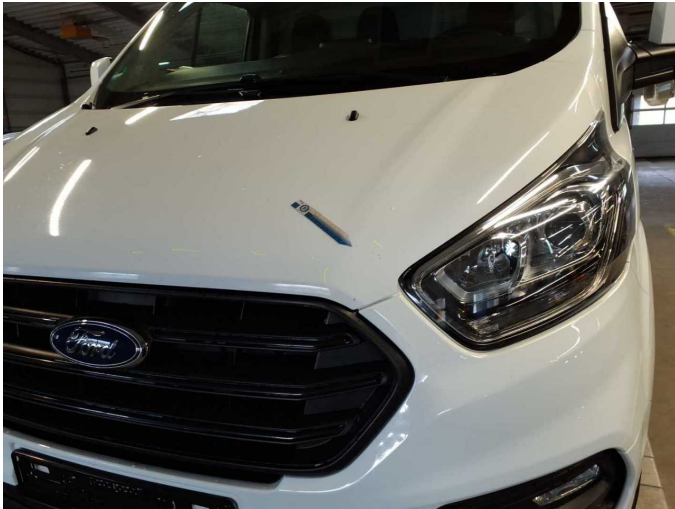
Damage 7: Bonnet: Bonnet - Stone chips - Paint

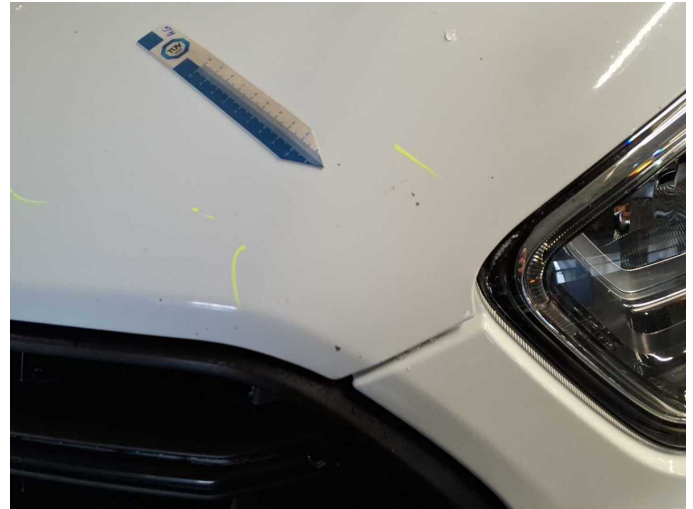
Damage 7: Bonnet: Bonnet - Stone chips - Paint

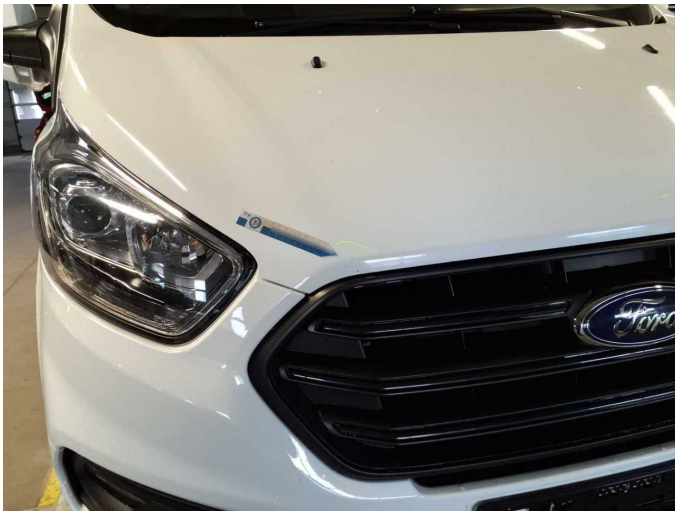
Damage 7: Bonnet: Bonnet - Stone chips - Paint

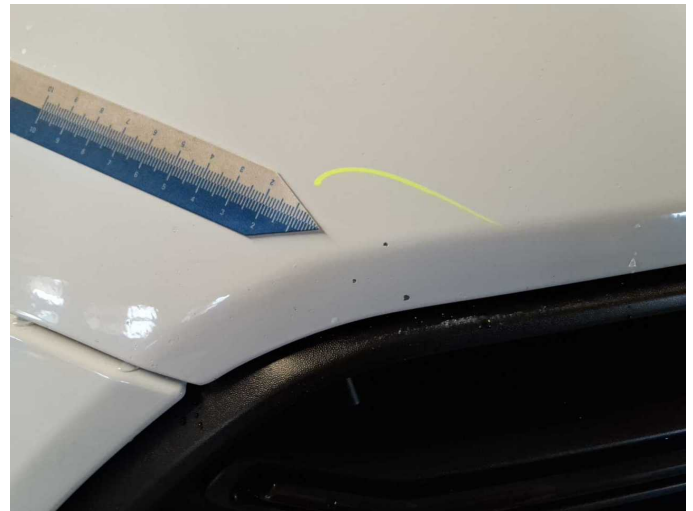
Damage 7: Bonnet: Bonnet - Stone chips - Paint

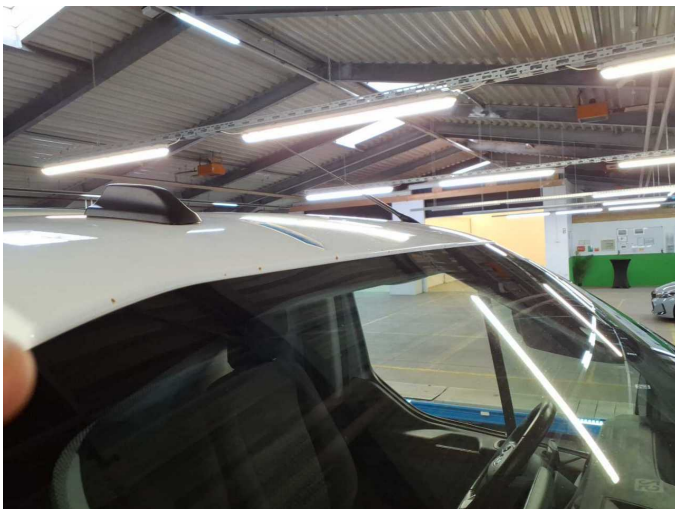
Damage 8: Roof: Roof - Corrosion - Paint

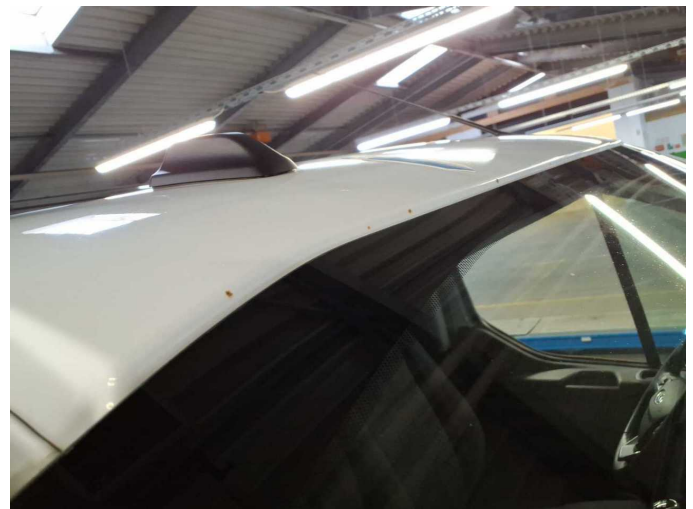
Damage 8: Roof: Roof - Corrosion - Paint

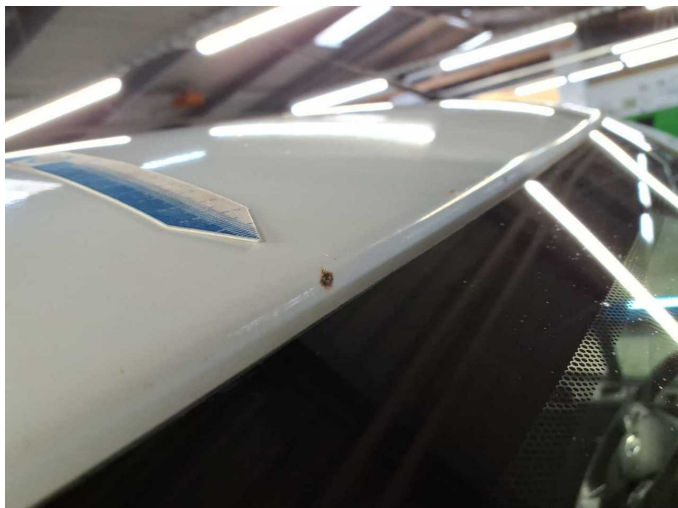
Damage 8: Roof: Roof - Corrosion - Paint

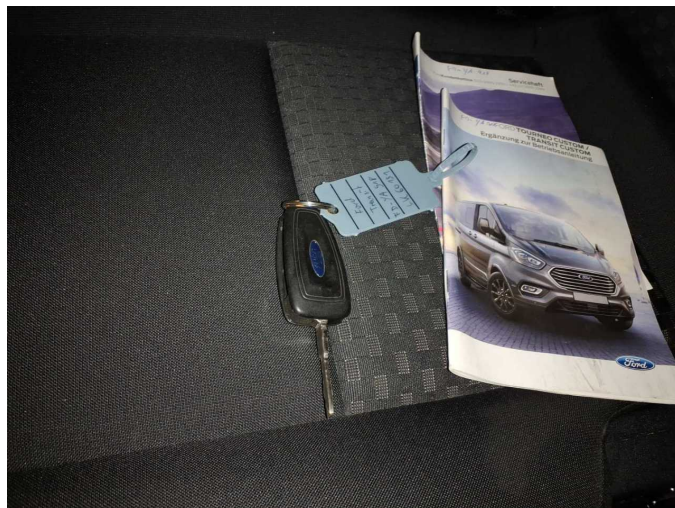
Missing part 1: Equipment: Vehicle key with remote control - Missing - Replace
