Expertise

Protocol number: 41615691
Order No. / Reference: 25179341
Inspection date: 19 Sept 2025

Manufacturer: Ford	Model: Transit Custom Kasten 300 L1H1 LKW VA Trend
VIN: WF0YXXTTGYLR07089

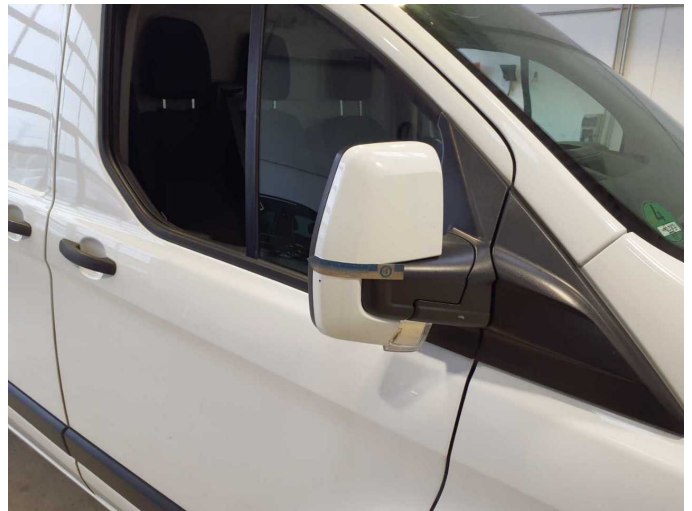
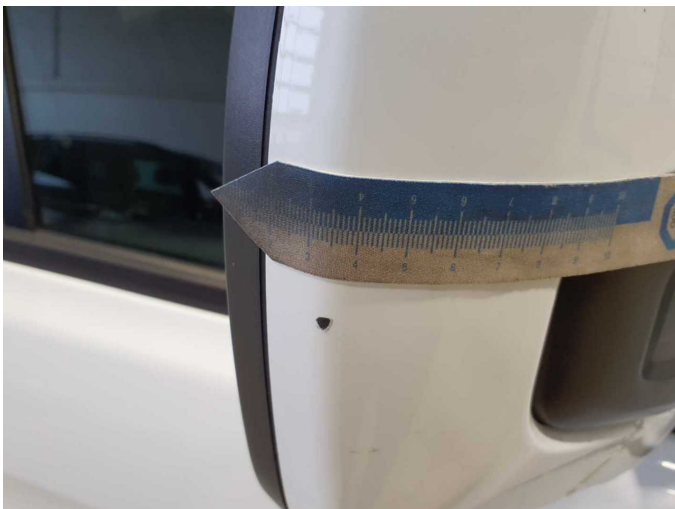
Damage 2: Wing mirror - right side: Cap - Scratch(es) - Paint

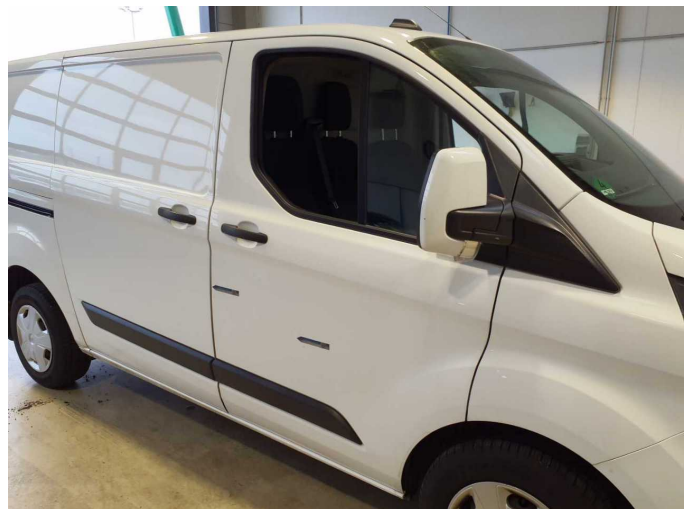
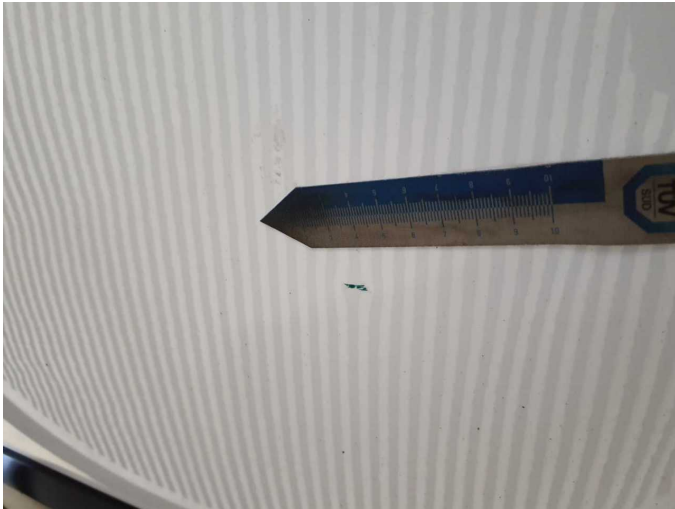
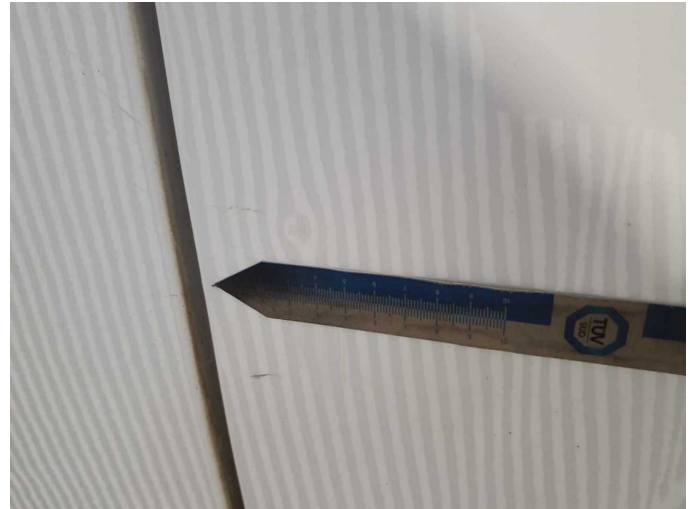
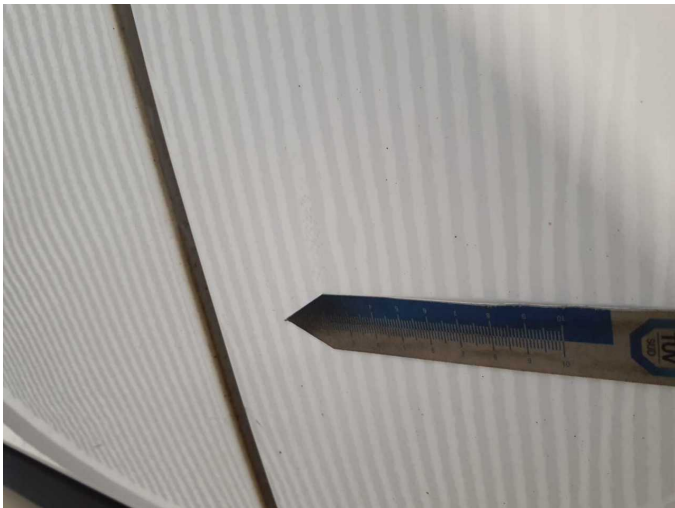
Damage 3: Door - front right side: Door - Dent / paintcoat damage - Repair and paint

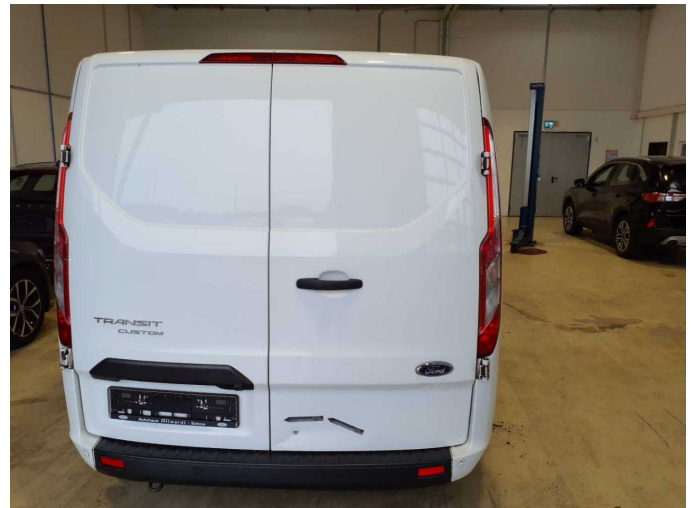
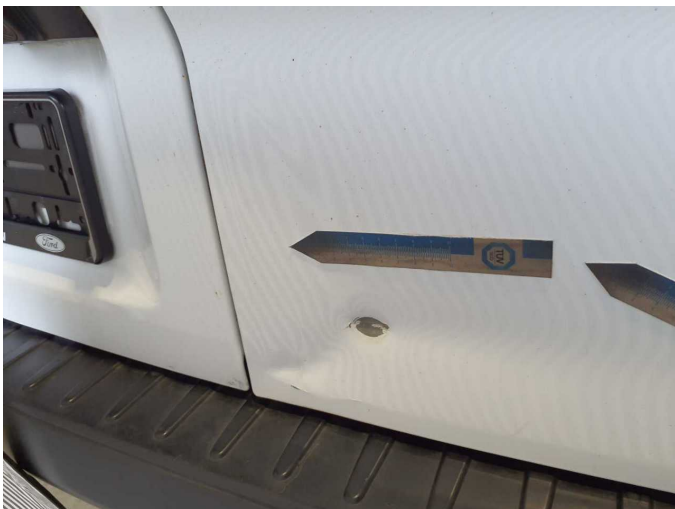
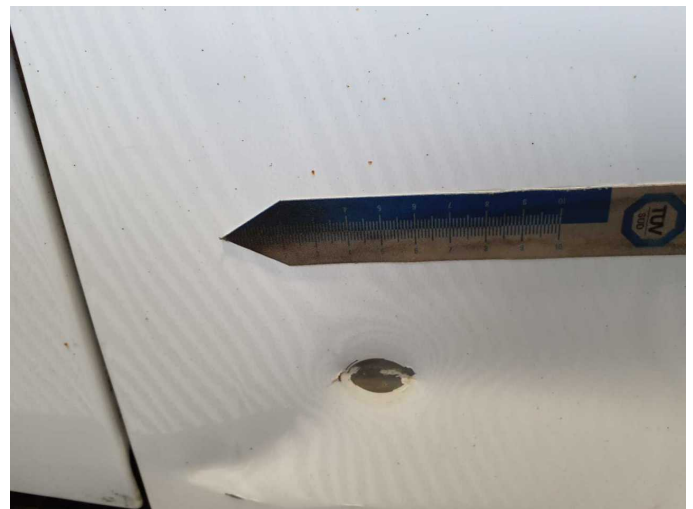
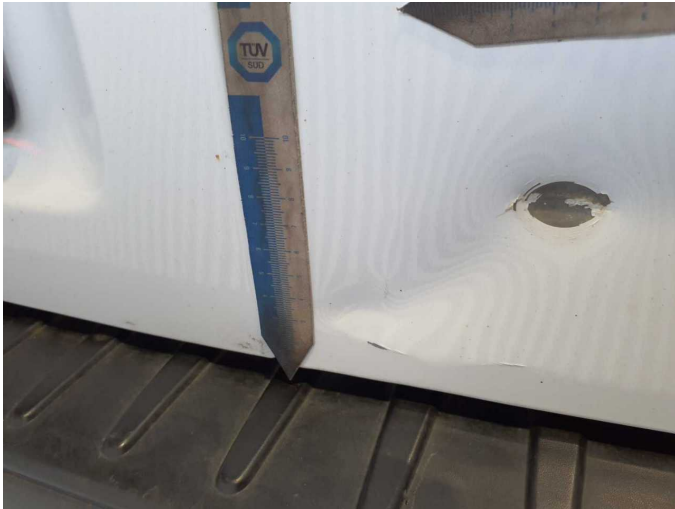
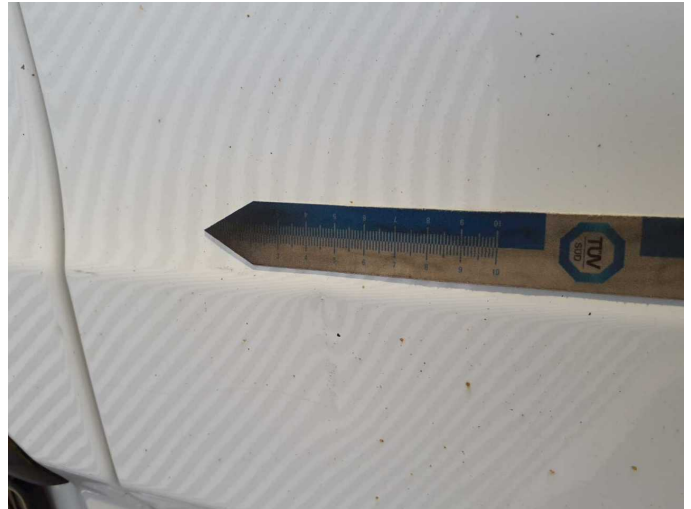
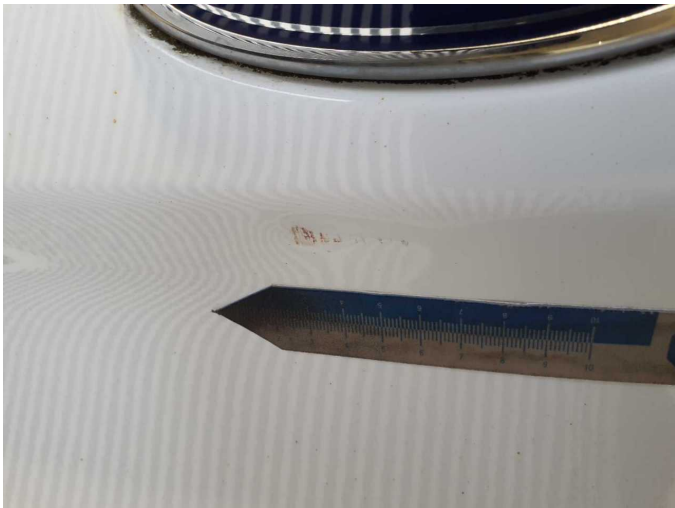
Damage 4: Boot lid / rear door: Rear door - right side - Deformed - Repair and paint

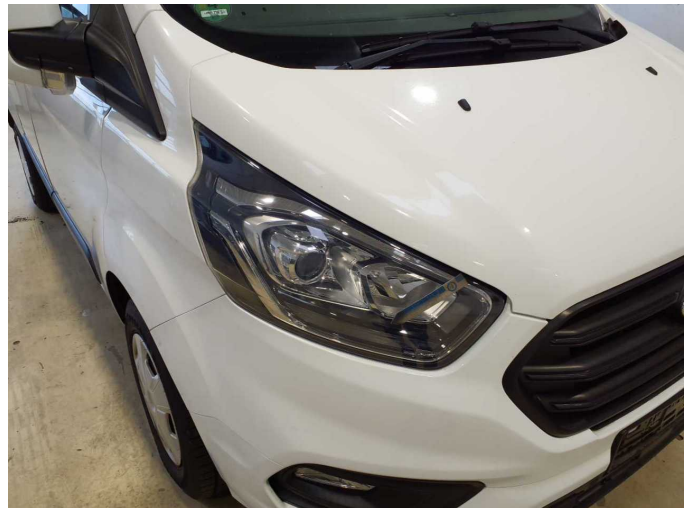
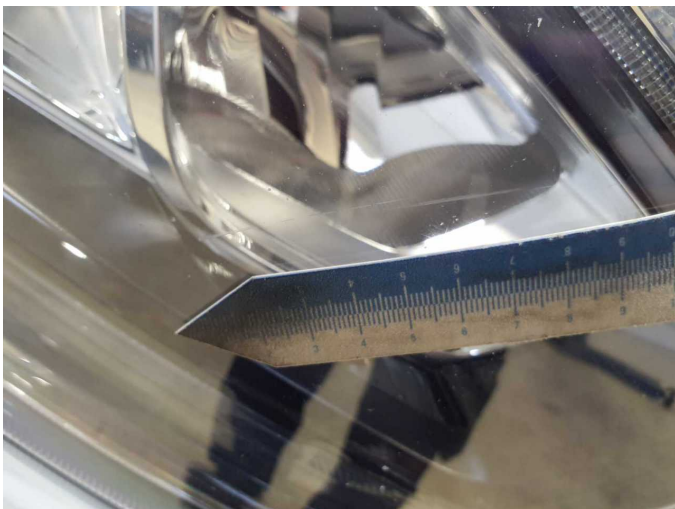
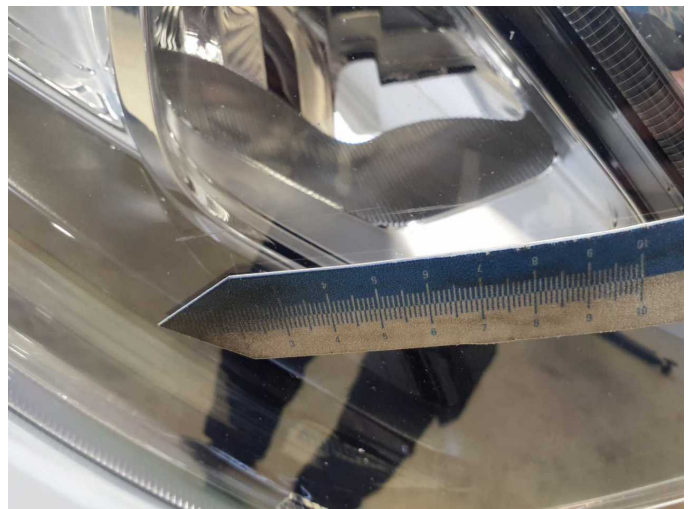
Wear and tear 4: Headlight: Headlight - right side - Scratch(es) - No deduction

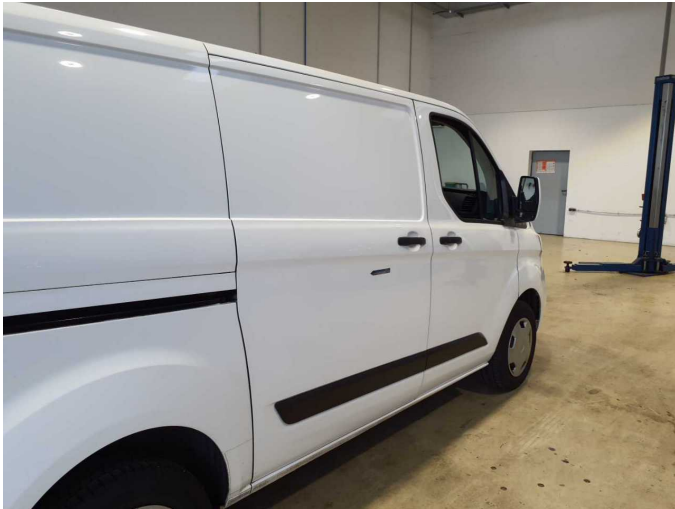
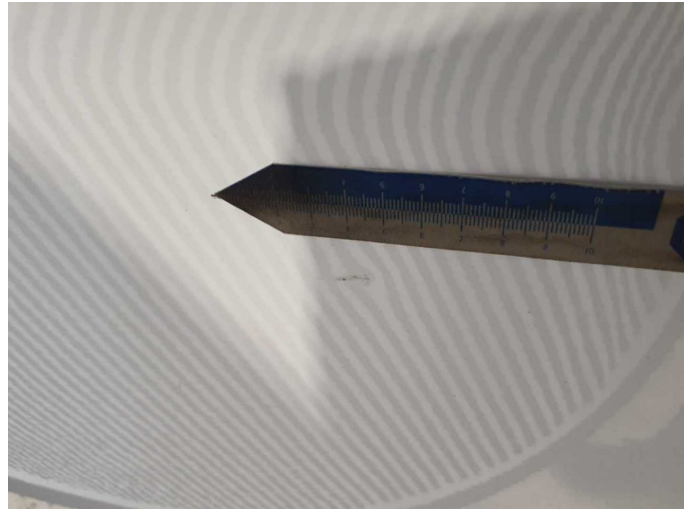
Wear and tear 5: Sliding door, right: Sliding door - dent(s) - No deduction

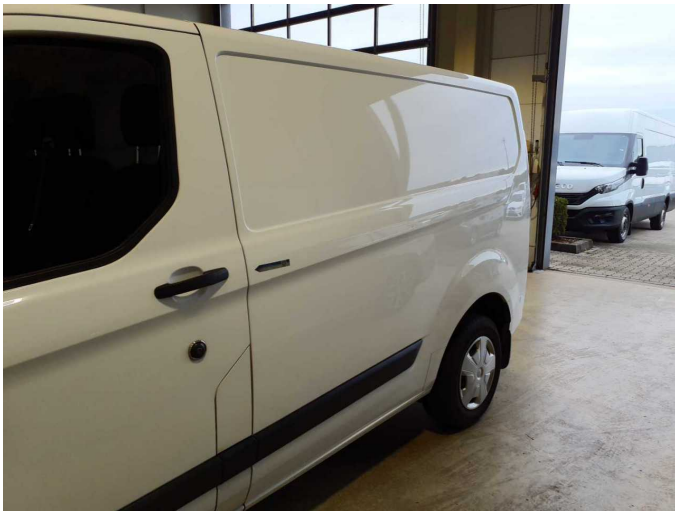
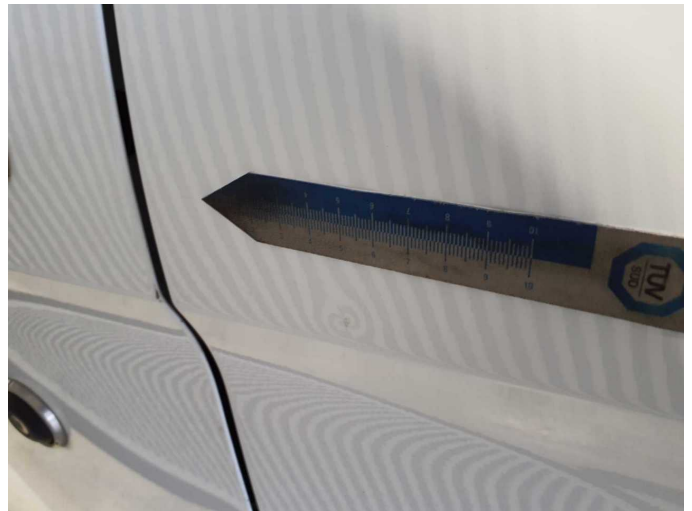
Wear and tear 6: Side panel - rear left side: Side panel - dent(s) - No deduction

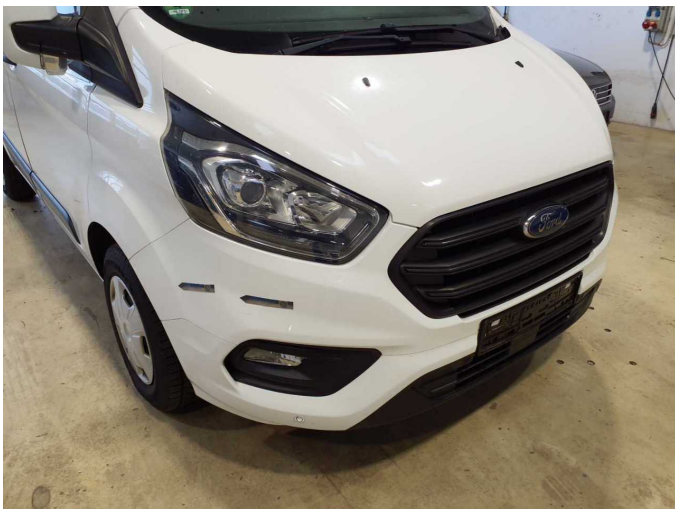
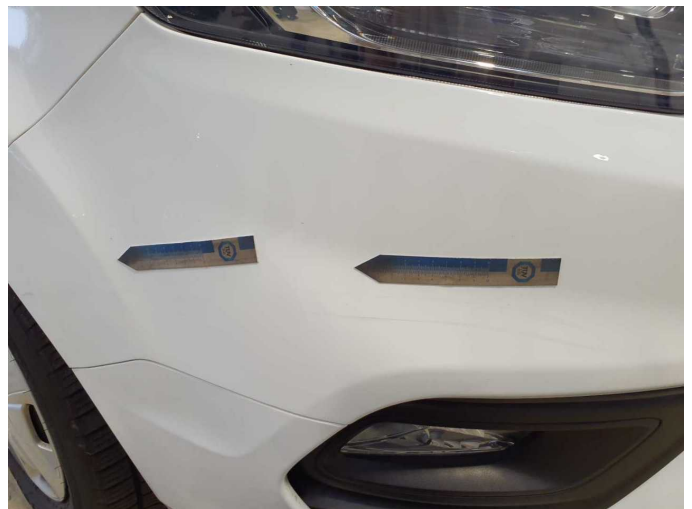
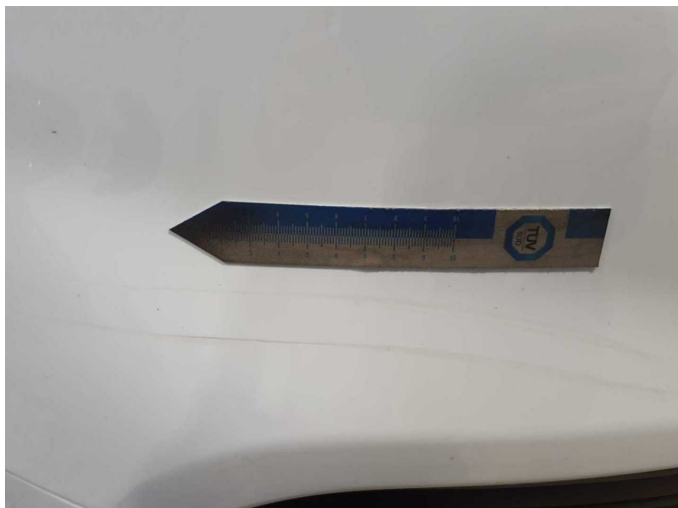
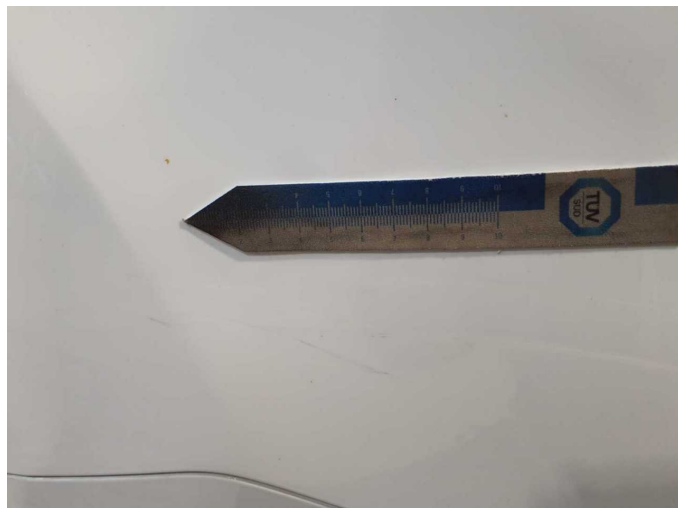
Wear and tear 7: Front bumper: Front bumper - Scratch(es) - No deduction
